Oregon Seismic Status Report - 2019

PORTLAND PUBLIC SCHOOLS HAYHURST ELEMENTARY SCHOOL

SEISMIC EVALUATION AND CONCEPTUAL SEISMIC STRENGTHENING DESIGN

JANUARY 5, 2018

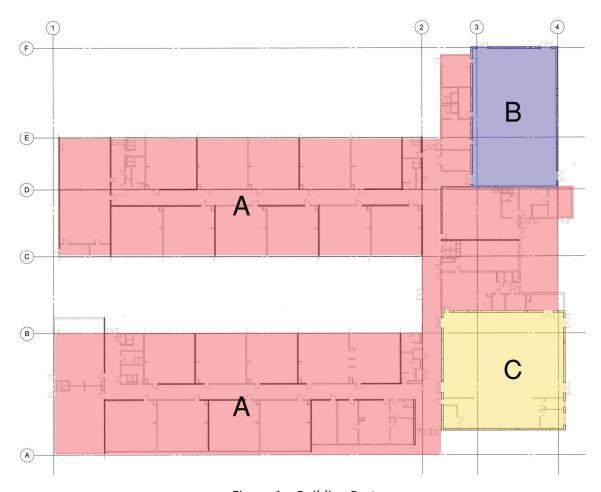
Figure 1 – Building Parts

Figure 1 indicates the building parts as reported for the BCA, the designation is as follows:

Part A – Remaining

Part B - Gymnasium

Part C - Cafetorium
