# North Cascade District – Master Plan

# Project Background

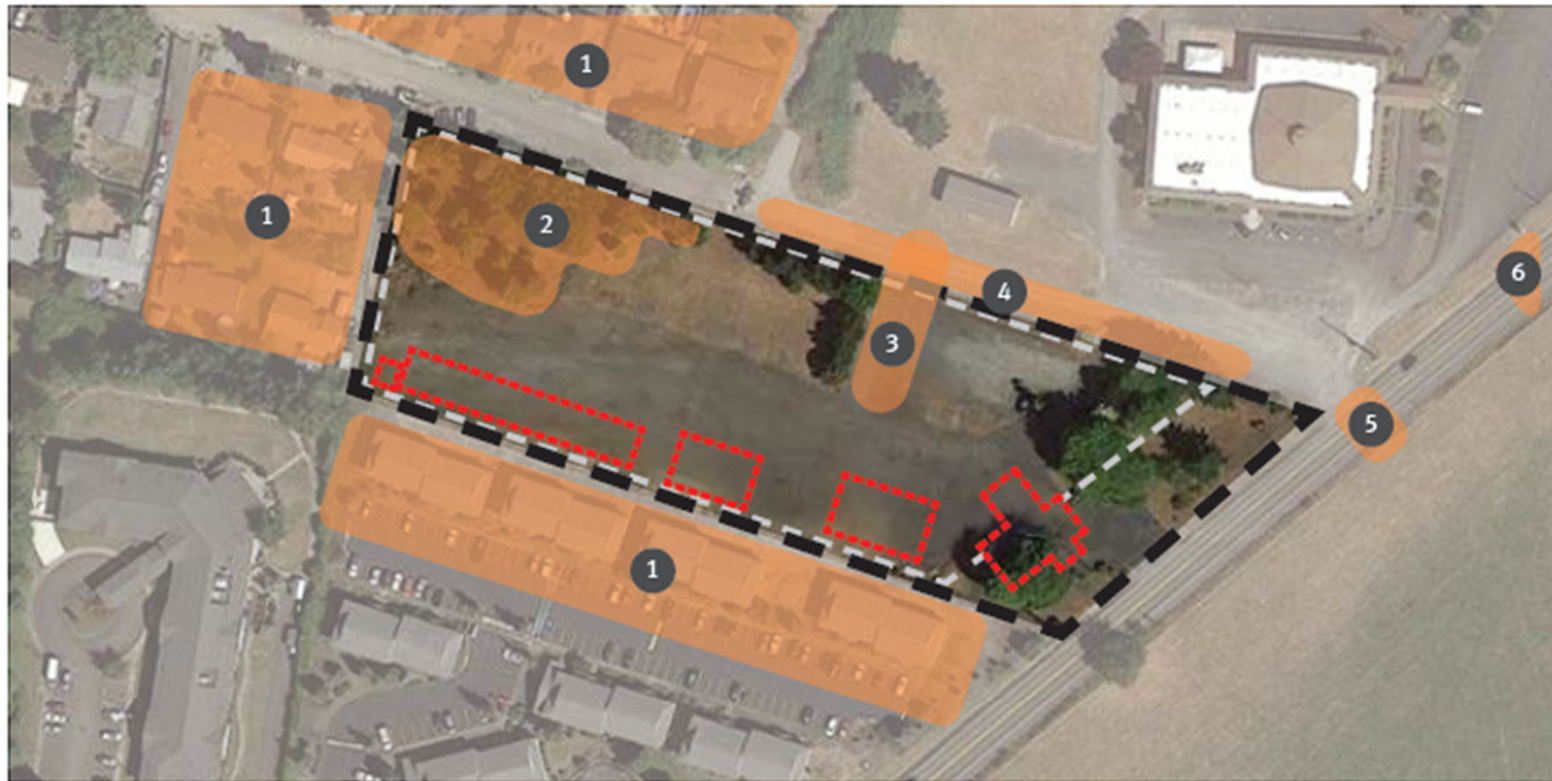
*Molalla Assessment Diagram*

1. Adjacent Residential Properties (ODF has 24/7 operations during fire events)
2. Memorial Arboretum
3. Shop access requires entry through neighboring property
4. Patrol Street is slated to connect to HWY 211 and increase traffic
5. Narrow entry for large vehicles and potential ditch falls
6. Hill Northeast of Highway 211 entrance blocks view

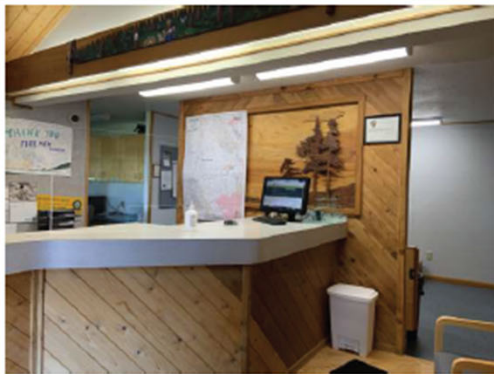
## SMALL ENTRY LOBBY

- Not enough space to accommodate people waiting, filling out documents, and interacting with clerical staff
- Inadequate security preventing entry from lobby to the rest of the building

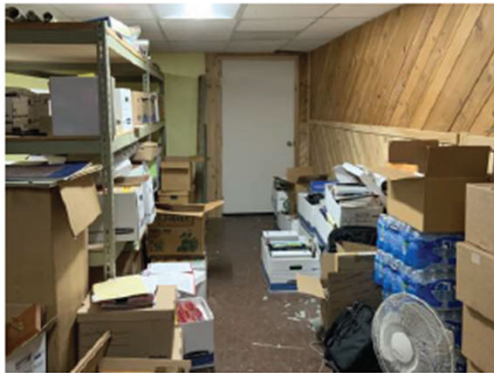
## ARCHIVE AND ADMIN. BUILDING STORAGE

- Storage in the flood-prone basement not ideal
- Additional space for shelves needed for file and equipment storage

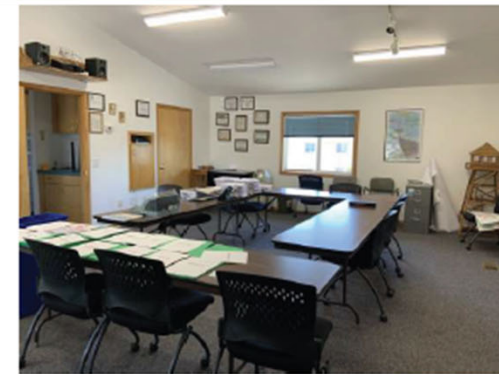
## CONFERENCE ROOM

- Space too small to act as large fire event headquarters or for all-district meetings
- Inadequate wall space and equipment for maps and planning during fire events

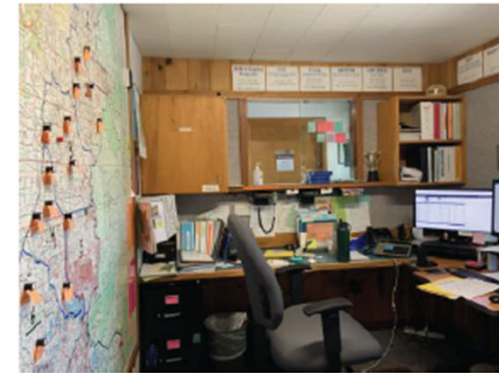
## FIRE DISPATCH

- Small space is crowded and difficult to accommodate extra people during a large fire event

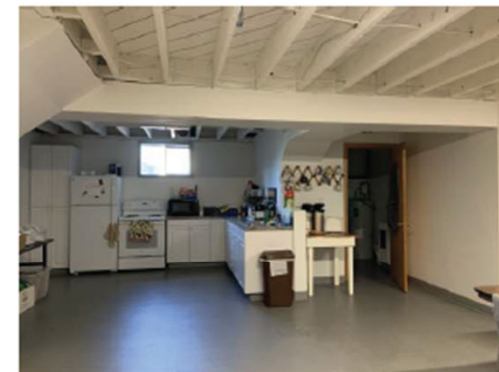
## BREAKROOM WITH AGING RESIDENTIAL APPLIANCES

- Aging residential appliances inadequate for heavy-duty use in an office environment
- Catering kitchen setup would be preferred for large events

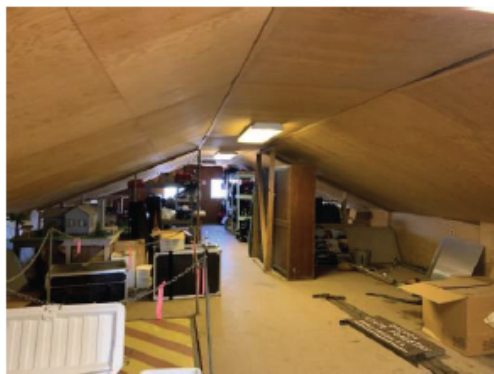
## ATTIC STORAGE ABOVE THE FIRE CACHE BUILDING

- Low head height makes storage difficult
- Lacks adequate climate control
- Storage of heavy and bulky items in a space only accessible by a narrow stairwell poses a safety risk

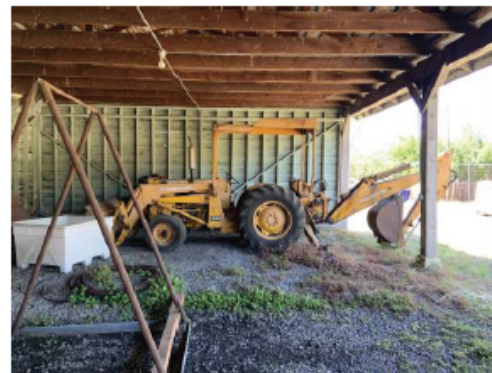
## AGING COVERED STORAGE

- Vehicle bays are neither tall nor deep enough to fit many of ODF's larger vehicles
- Building lacks the ability to be closed off, creating a safety and security risk

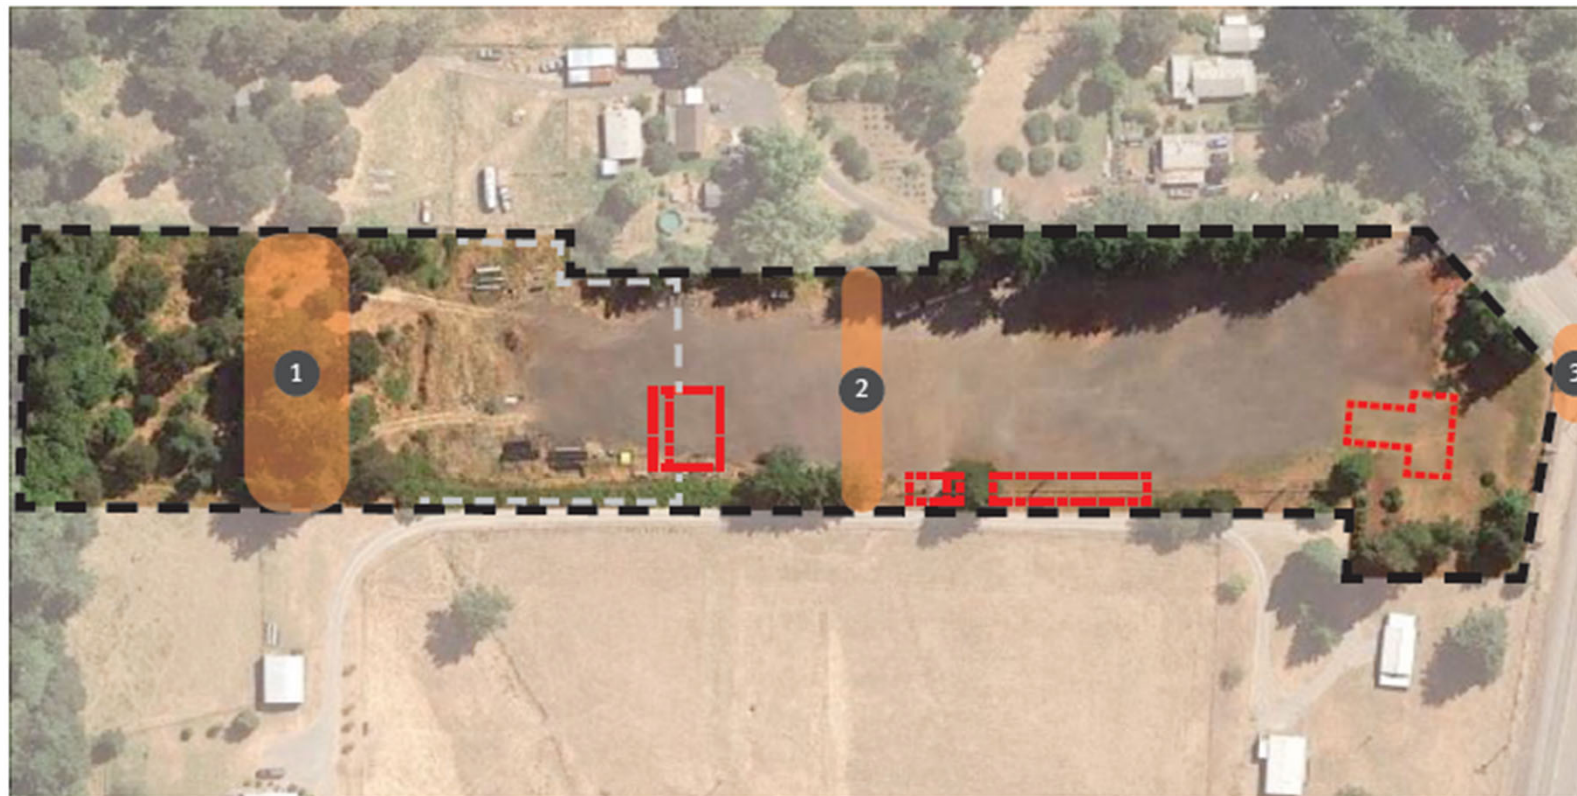
*Santiam Assessment Diagram*

1. Swale (floods in winter)
2. Neighboring residents must cross campus to access their property
3. Access constrained at intersection of North Fork Road and Highway 22

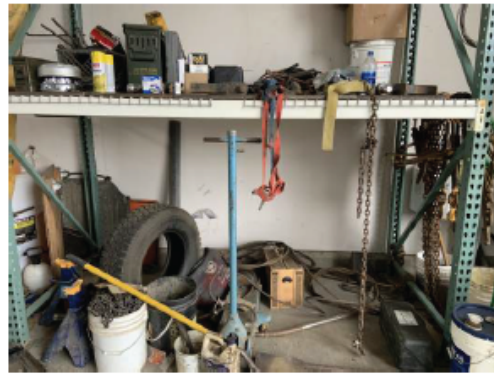
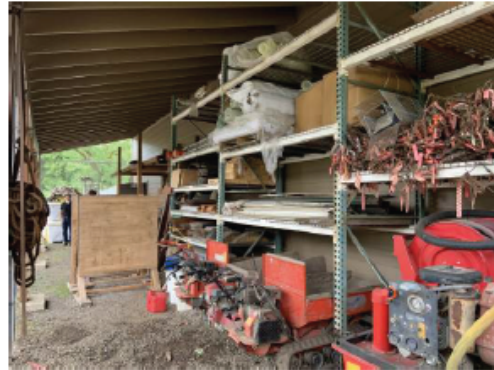
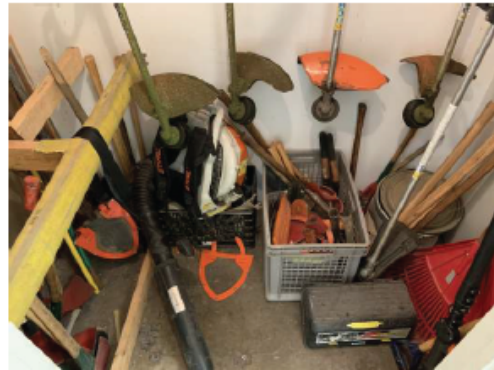
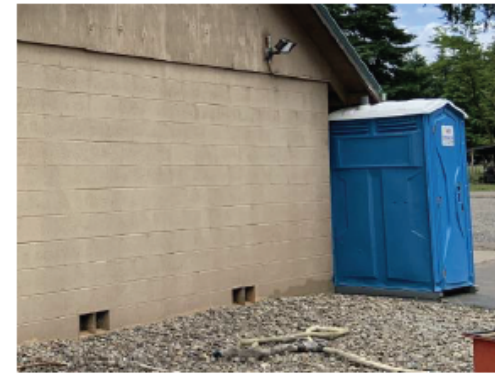
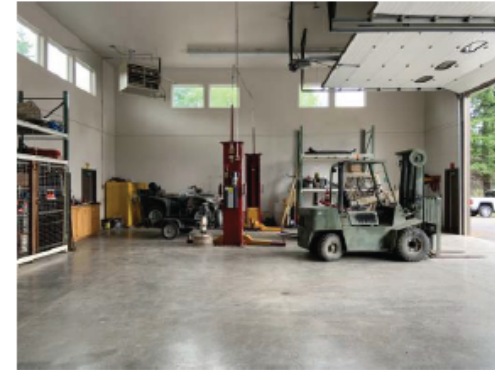
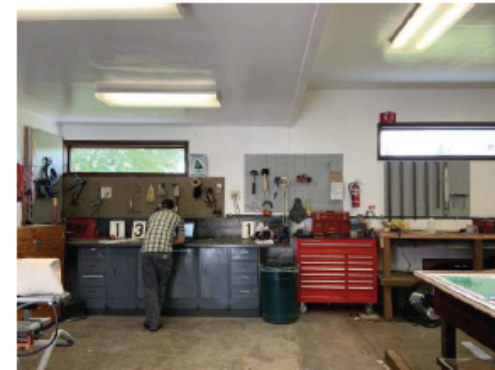
## DISTRICT MECHANIC STORAGE IN STATE FOREST BUILDING

- District mechanic equipment and materials lack adequate storage

## STATE FOREST SEMI-ENCLOSED EQUIPMENT STORAGE

- Small covered storage space requires high storage racks which are difficult to use
- Chain link enclosure is easy to compromise, equipment and materials have been stolen from this location

## GROUNDS MAINTENANCE STORAGE

- Inadequate shelves and racks for grounds maintenance equipment

## PORTABLE RESTROOM

- Portable restrooms located on site to augment inadequate restroom facilities
- Frequently used by members of the public because the site is not able to be secured

## DISTRICT MECHANIC IN STATE FOREST BUILDING

- The State Forest Building is the newest building and is in the best condition between the two campuses
- The district mechanic, who is regularly located in Molalla, occupies a vehicle bay within the building

## FIRE CREW MEMBER WORKING AT HIS COMPUTER IN THE COMBINED WOOD AND METAL SHOP

- Fire and wood shops should be separated to reduce fire risk
- Several fire crew lockers are also located in this space instead of a cleaner room

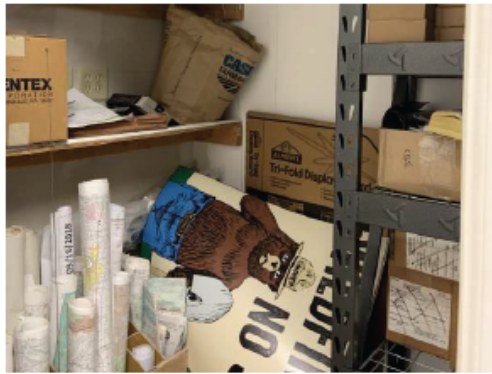
## STORAGE CLOSET

- Inadequate storage for signs, maps, and office supplies

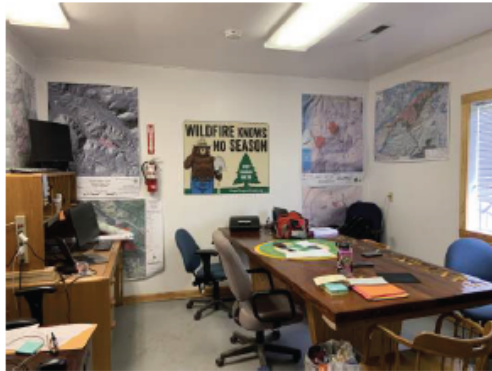
## FIRE CREW OFFICE / FIRE CACHE BREAKROOM

- Space shares incompatible uses

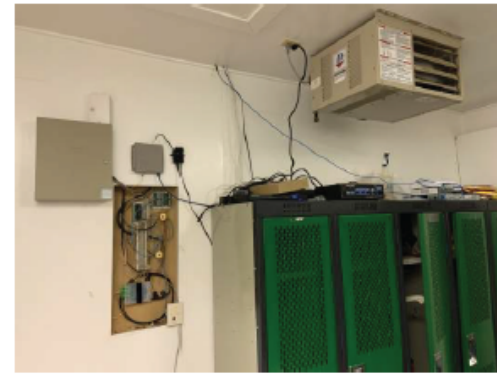
## LOCKER/DRYING ROOM

- Exposed equipment and loose wires in the locker room

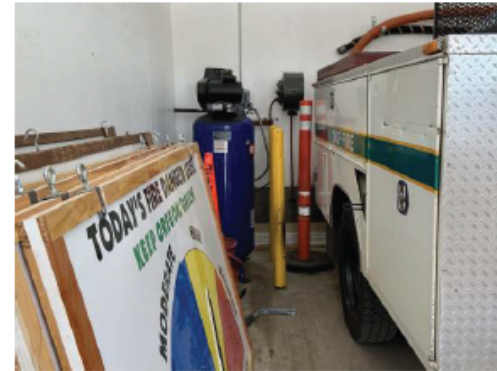
## NOT ENOUGH SPACE FOR EQUIPMENT, STORAGE, AND PARKING IN VEHICLE BAYS

- Material and equipment storage needs to be more secure
- Storage needs better enclosure and protection from the elements

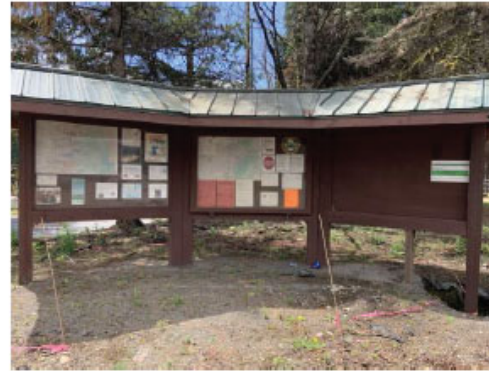
## PUBLIC INFORMATION KIOSK

- Kiosk not accessible

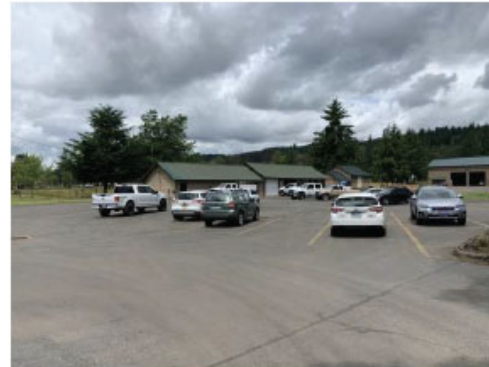
## UNSECURED PARKING

- Parking area unable to be properly secured to allow neighbors access to their property through the campus
- ODF employees who leave their vehicles on campus for extended periods during fire events have had their vehicles broken into and property stolen

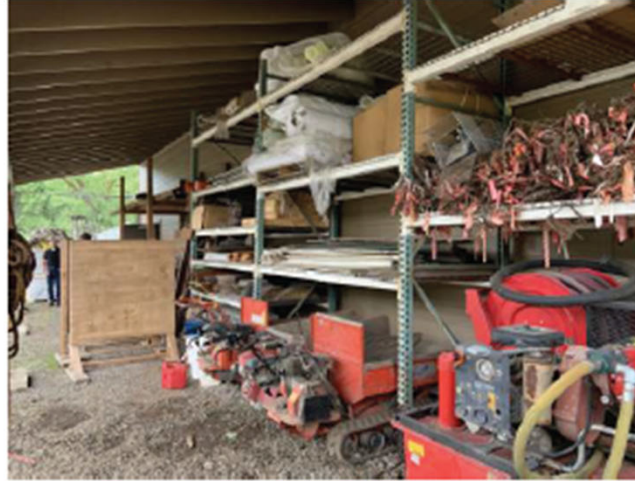
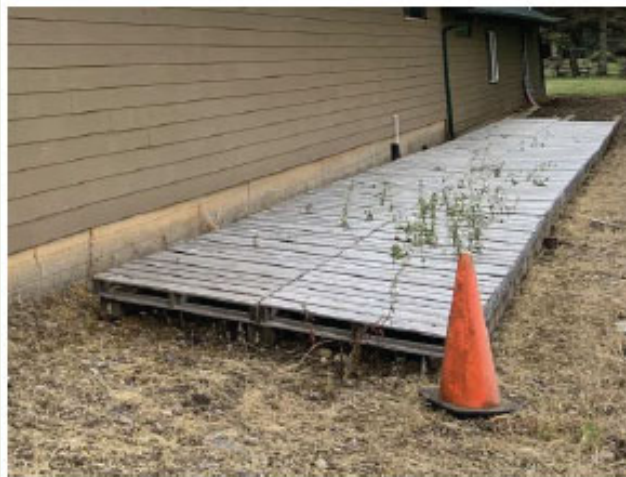
## FLEXIBLE RECREATION STORAGE

- Enclosed storage to keep items from getting damaged
- Designated space for recreational storage only
- Storage for seasonal use vehicles and tools
- Picture illustrates condition at Santiam Unit Office

## HOSE DRYING

- Vertical hose tower, horizontal drying doesn't allow proper hose drainage
- Covered hose drying to allow hoses to dry in wet, rainy conditions
- Picture illustrates condition at Santiam Unit Office

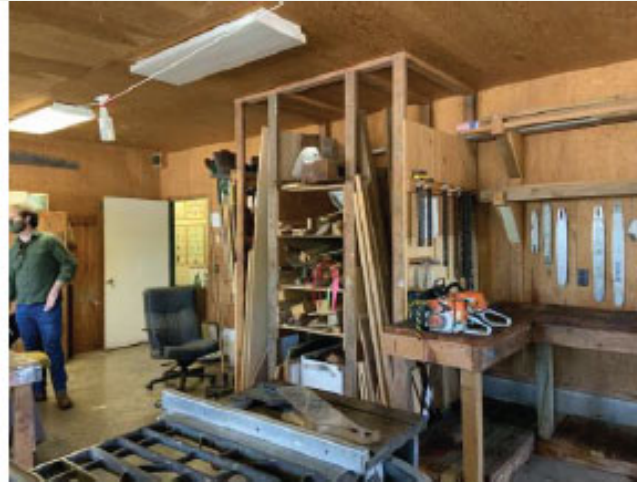
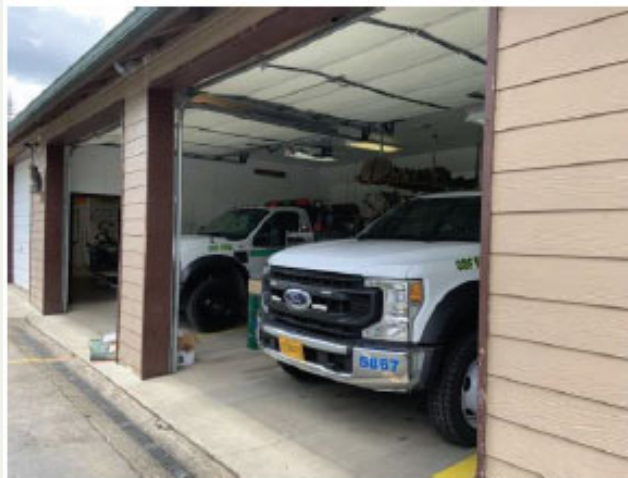
## METAL AND WOODSHOP

- Separate the spaces to its specific uses
- Move lockers and other incompatible uses out of shop space
- Picture illustrates condition at Molalla Unit Office

## VEHICLE BAYS

- Large enough to fit modern vehicles
- Additional bays to house vehicles
- Pass-through preferred over back-in
- Picture illustrates condition at Molalla Unit Office

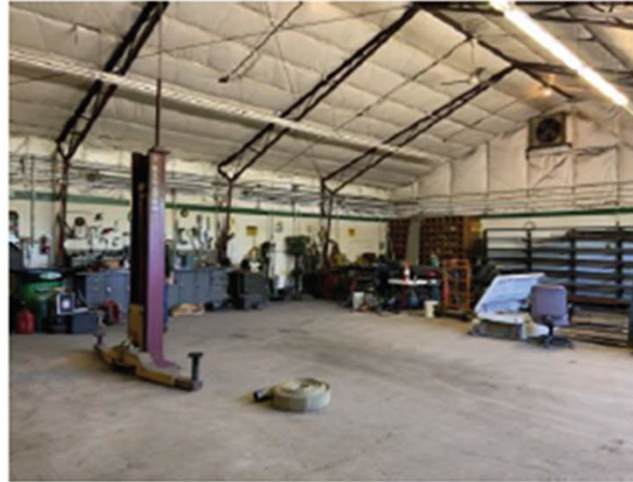
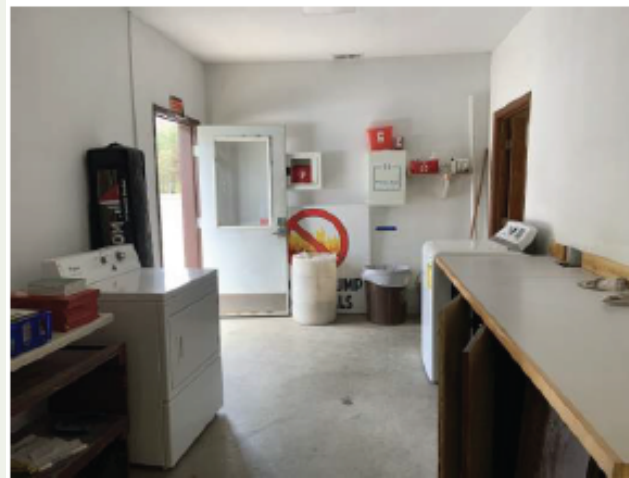
## DISTRICT MECHANIC SHOP

- Brighter lighting for detailed tasks
- Additional bay for workspace
- Pit in addition to the lift to increase safety
- Picture illustrates condition at Molalla Unit Office

## MUD/LAUNDRY ROOM

- Commercial laundry equipment
- Capacity for larger amount of soiled clothing
- Picture illustrates condition at Santiam Unit Office

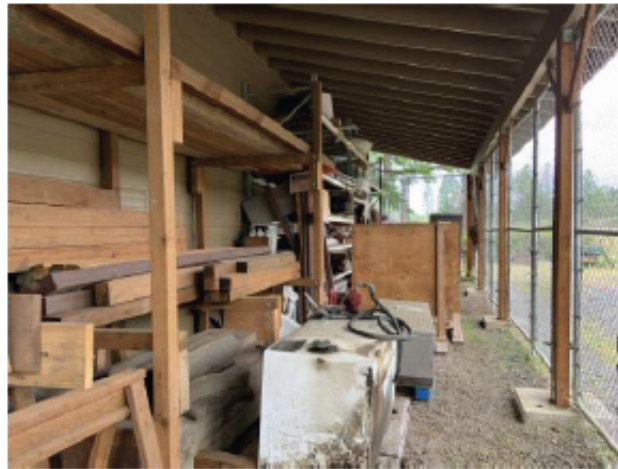
## SAFETY AND SECURITY

- Secure material and equipment storage
- Storage needs better enclosure and protection from the elements
- Picture illustrates condition at Santiam Unit Office

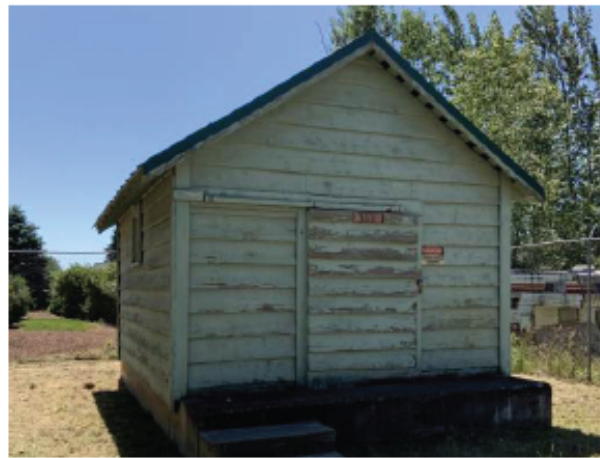
## ADEQUATE HAZARDOUS MATERIAL STORAGE

- Hazardous material storage needs to be brought up to current codes in a safer location
- Picture illustrates condition at Molalla Unit Office
