NORTH CASCADE DISTRICT MASTER PLAN

OREGON DEPARTMENT OF FORESTRY REVISION DATE: 11 FEBRUARY 2022

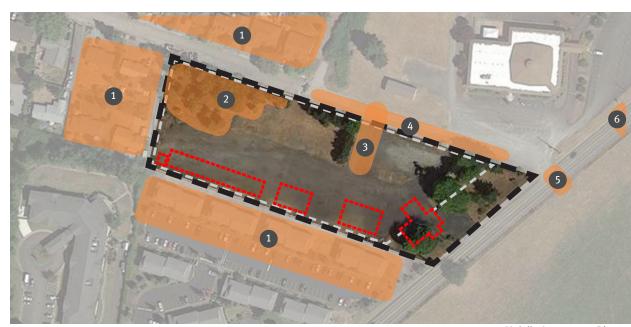
Molalla Assessment Diagram

- 1. Adjacent Residential Properties (ODF has 24/7 operations during fire events)
- 2. Memorial Arboretum
- 3. Shop access requires entry through neighboring property
- Patrol Street is slated to connect to HWY 211 and increase traffic
- 5. Narrow entry for large vehicles and potential ditch falls
- 6. Hill Northeast of Highway 211 entrance blocks view

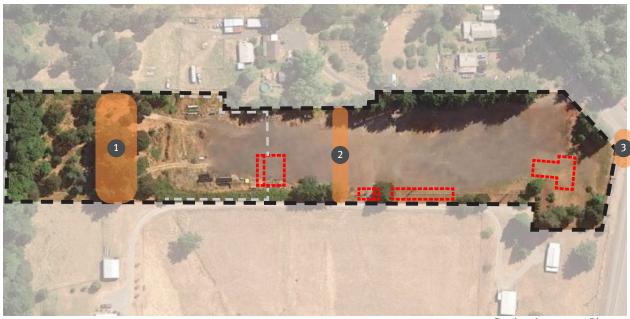
Santiam Assessment Diagram

- 1. Swale (floods in winter)
- 2. Neighboring residents must cross campus to access their property
- 3. Access constrained at intersection of North Fork Road and Highway 22

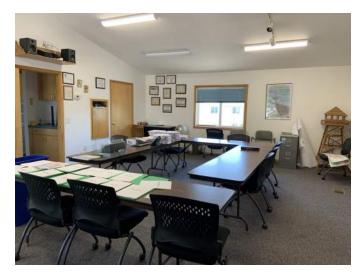
CONFERENCE ROOM

- Space too small to act as large fire event headquarters or for all-district meetings
- Inadequate wall space and equipment for maps and planning during fire events

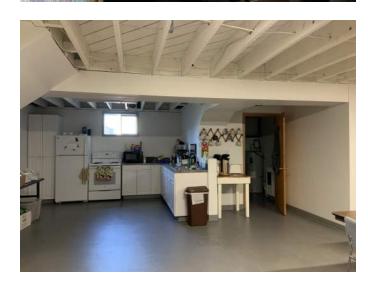
BREAKROOM WITH AGING RESIDENTIAL APPLIANCES

- Aging residential appliances inadequate for heavy-duty use in an office environment
- Catering kitchen setup would be preferred for large events

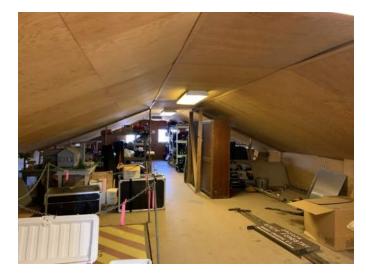
ATTIC STORAGE ABOVE THE FIRE CACHE BUILDING

- Low head height makes storage difficult
- Lacks adequate climate control
- Storage of heavy and bulky items in a space only accessible by a narrow stairwell poses a safety risk

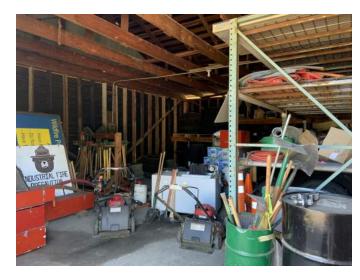
SEMI-ENCLOSED STORAGE SPACE IN THE **COVERED STORAGE BUILDING**

- Storage space too small and lacks adequate shelving and racks for equipment
- Enclosed storage area lacks proper lighting, ventilation, and enclosure

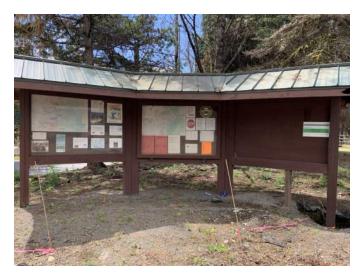
PUBLIC INFORMATION KIOSK

Kiosk not accessible

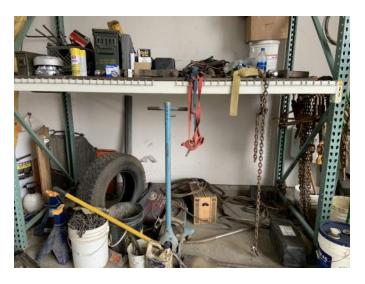
DISTRICT MECHANIC STORAGE IN STATE FOREST BUILDING

• District mechanic equipment and materials lack adequate storage

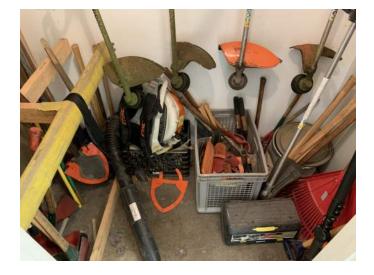
- Small covered storage space requires high storage racks which are difficult to use
- Chain link enclosure is easy to compromise, equipment and materials have been stolen from this location

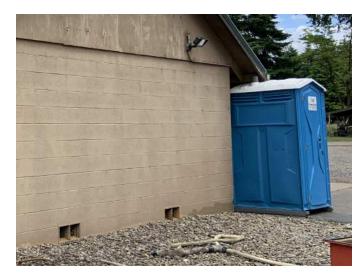
PORTABLE RESTROOM

- Portable restrooms located on site to augment inadequate restroom facilities
- Frequently used by members of the public because the site is not able to be secured

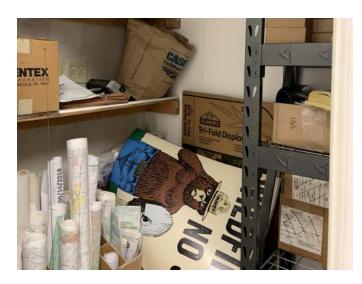
STORAGE CLOSET

• Inadequate storage for signs, maps, and office supplies

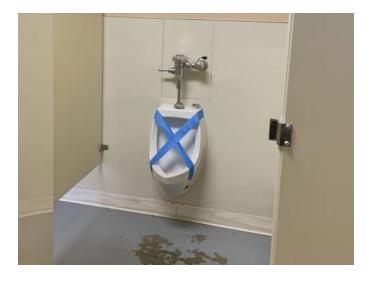
• Space shares incompatible uses

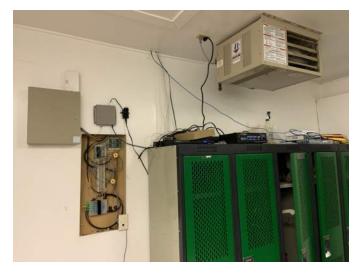
Exposed equipment and loose wires in the locker room

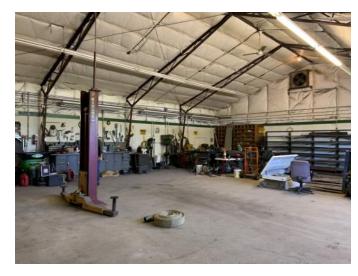
DISTRICT MECHANIC SHOP

- Brighter lighting for detailed tasks
- Additional bay for workspace
- Pit in addition to the lift to increase safety
- Picture illustrates condition at Molalla Unit

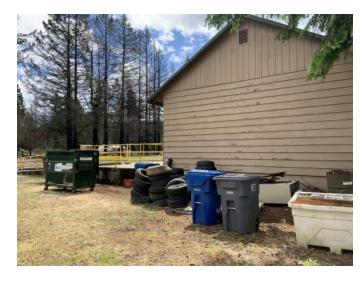
- A better system for receiving, storing, and disposing of waste
- Picture illustrates condition at Santiam **Unit Office**

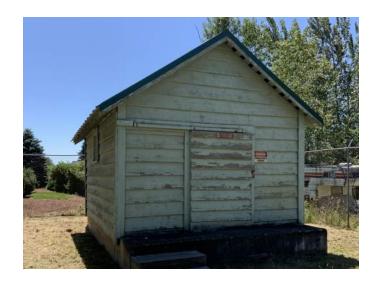
ADEQUATE HAZARDOUS MATERIAL STORAGE

- Hazardous material storage needs to be brought up to current codes in a safer location
- Picture illustrates condition at Molalla Unit Office
