# *Oregon Highway Bridge Maintenance*

## *A Pilot Training Course /Workshop*

# Bridge Scour

Doug McLain  
Clackamas County

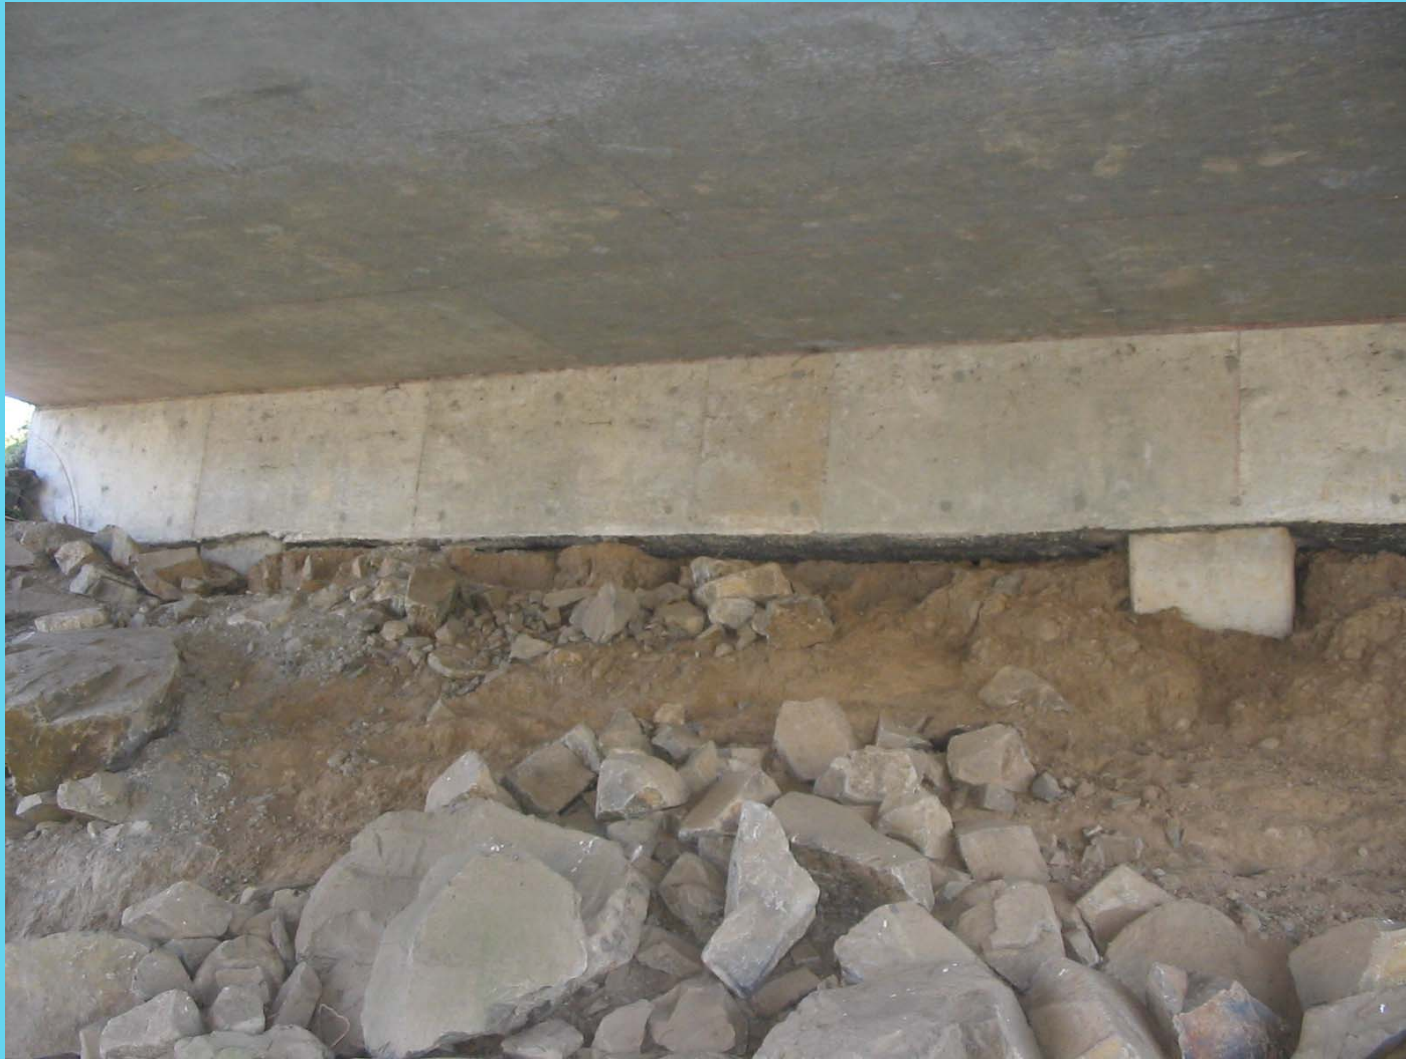
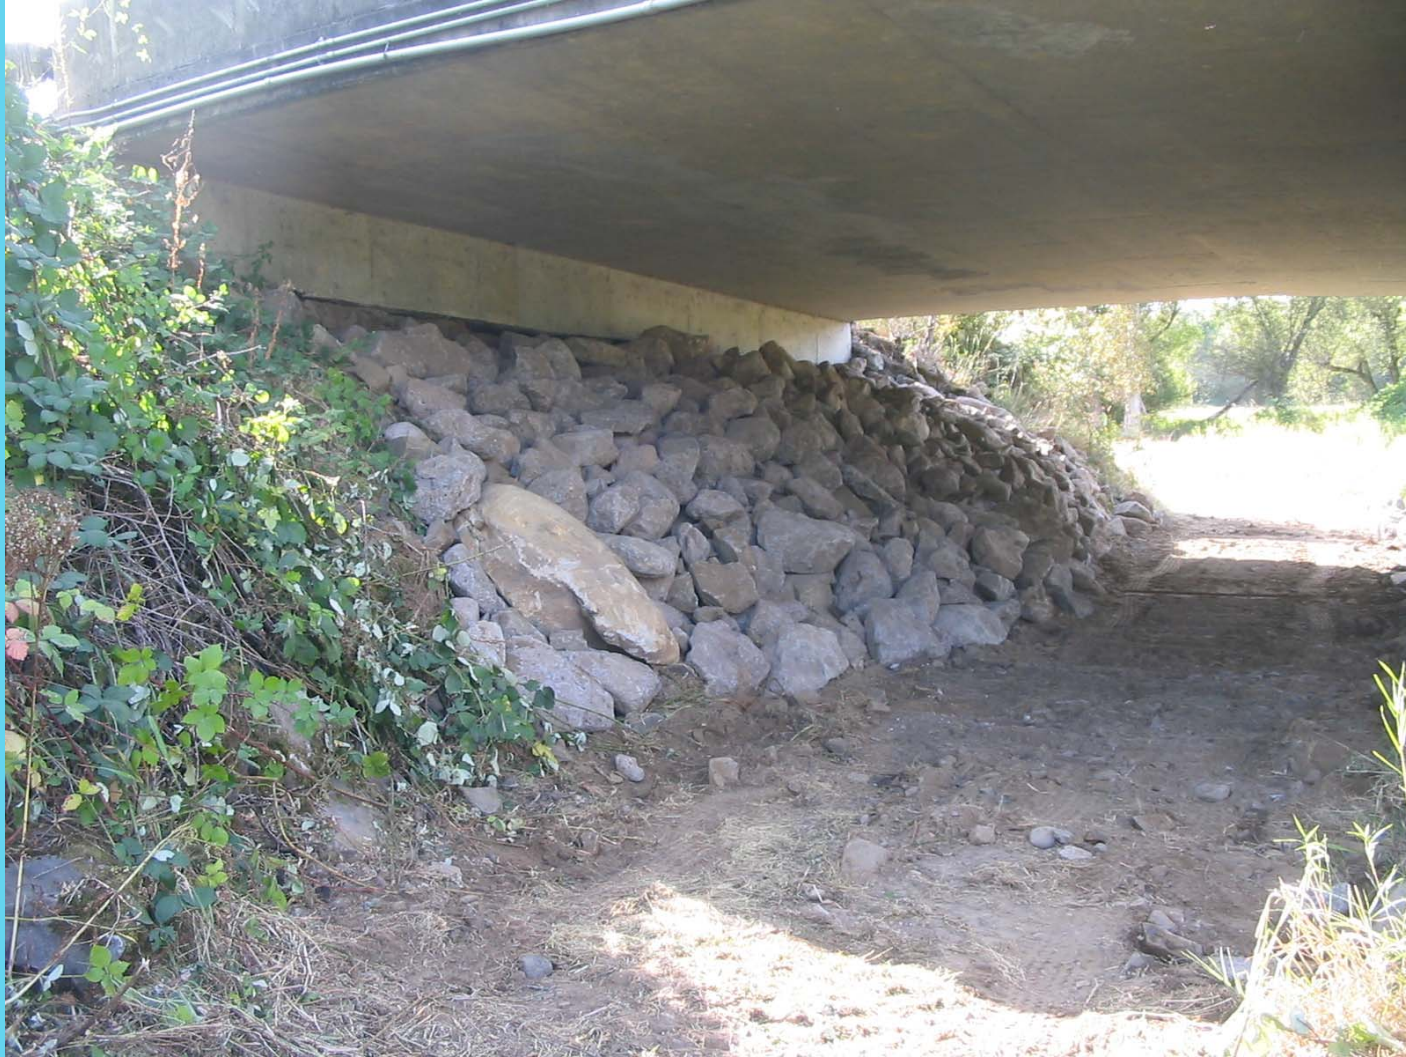
Bridge ID: 19951

### Zigzag River Bridge - Upstream

Lolo Pass Road

⊕ Bent 1

⊕ Bent 2

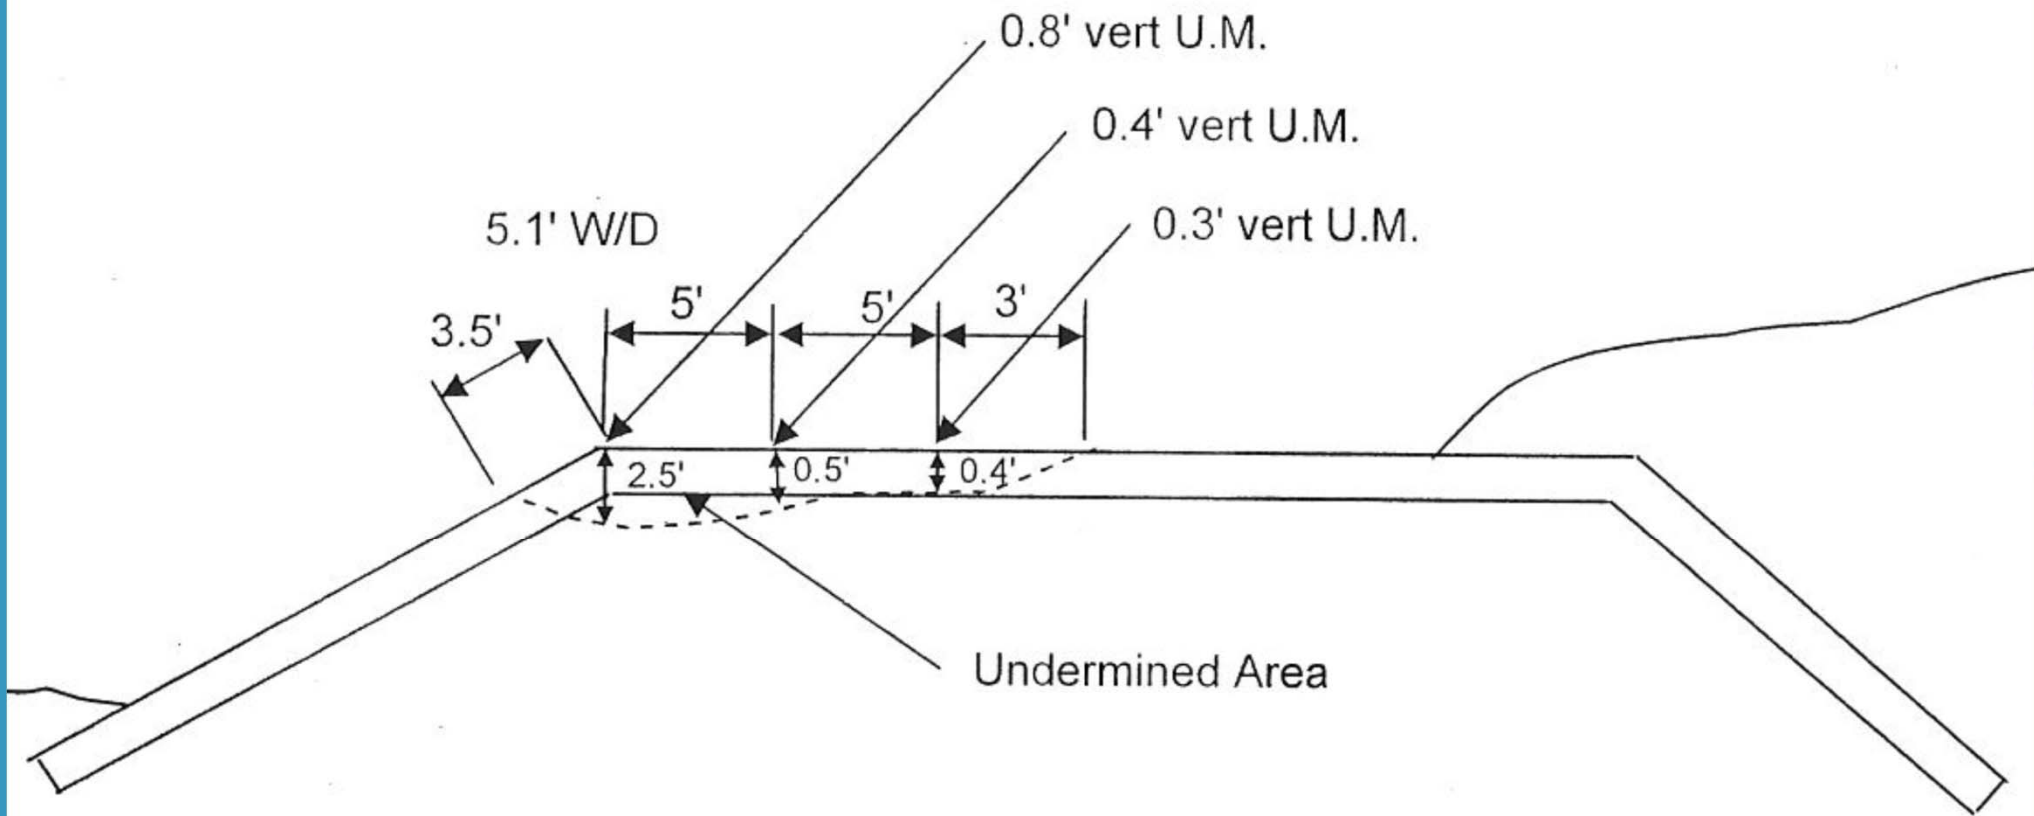
# Underwater Inspection Report

UNDERWATER INSPECTION REPORT					
BRIDGE NAME:	Milk Creek Beaver Creek Road	REGION:		BRIDGE NUMBER:	06198
RIVER NAME:	Milk Creek	OWNER:	County	DISTRICT:	2C
STATE HWY #:		ROUTE NUMBER:		INSPECTION DATE:	6/2/2006
COUNTY:	Clackamas	ROAD NAME:	Beaver Creek Road	MILE POINT:	0.17
FOUNDATION TYPE:		ACCESS:	3	CURRENT:	Low
DIVERS:	Shorb, James, Nelson	INS. INTERVAL:	1	VISIBILITY (Ft.):	1.5
Water Elevation:	Bent #2 from bottom of steel girder down 8.4-ft.	WATER TEMP:	55	MAXIMUM DEPTH:	5
		Constructed in:	1959

UNDERWATER ELEMENT CONDITION STATES:		CONDITION STATES								
Elem.	Description:	Environment	Qty	Units	1	2	3	4	5	Temp
215	Concrete Abutment	Moderate	2	LF	0%	100%	0%	0%	0%	N
361	Scour Smart Flag	Moderate	1	each	0	1	0	0	0	N

Item	Description:	Condition Rating
60	Substructure Condition Assessment	4
61	Channel and Channel Protection Condition Assessment	4
113	Scour	3

- 215 **Bent #1:** Concrete Abutment has some heavy abrasion and is in Condition State 2. The upstream end of the abutment is in the dry. The downstream corner is in 5.1-ft. of water. The downstream corner is undermined 0.8-ft. vertical and 2.5-ft. horizontal for a distance along the abutment of 16.5-ft. See sketch. The streambed consists of silty/gravel.
- 215 **Bent #2:** Concrete Abutment has some heavy abrasion and is in Condition State 2. The downstream end of the abutment is in the dry. The upstream corner is in 4.6-ft. of water. The upstream corner is undermined 0.5-ft. vertical and 2.5-ft. horizontal for a distance along the abutment of 8.5-ft. See sketch. The streambed consists of silty/gravel.

- 215 **Bent #1 & Bent #2** repair undermined abutment walls.

1. FILL VOID BELOW EXISTING FOOTING COMPLETELY WITH CONCRETE.
2. PLACE CONCRETE AGAINST UNDISTURBED GROUND.
3. PLACE CONCRETE TO EXISTING GROUND OR 1'-0" MIN, WHICHEVER IS GREATER.

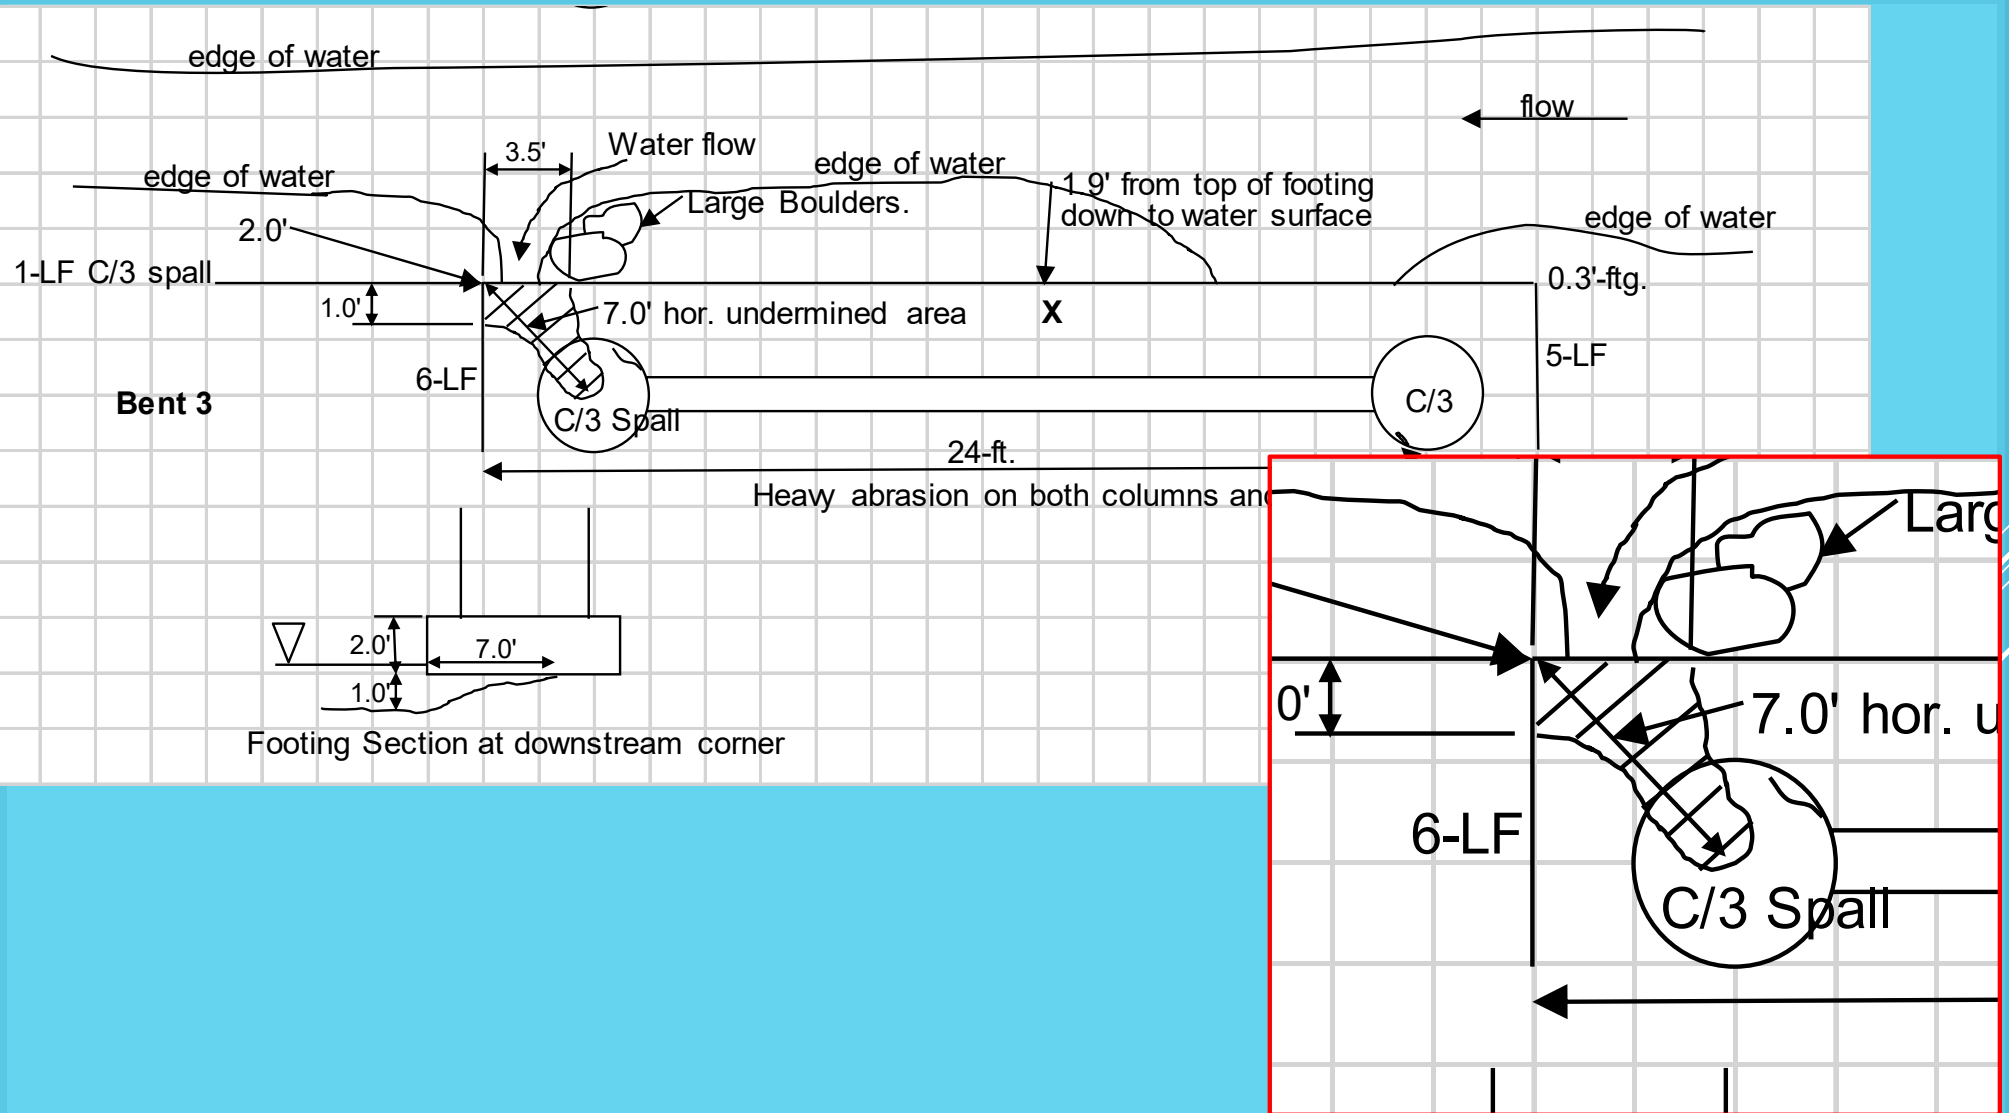
SALMON RIVER BRIDGE, # 01438  
 SCOUR MITIGATION PROJECT, BM2018.17

Undermining found SEP, 2018

- EXISTING Boulders
- Boulders to be added

- \* PLACE 6-10 YD<sup>3</sup> Boulders
- \* COVER W/ 5 YD<sup>3</sup> RIVER RUN (COBBLES/SAND/NATIVE SOIL)
