Technical Memorandum #4: Corridor Issues Summary

January 24, 2023

Project# 270030.007

OR 6: Wilson River Highway Corridor Study (HB 4053)

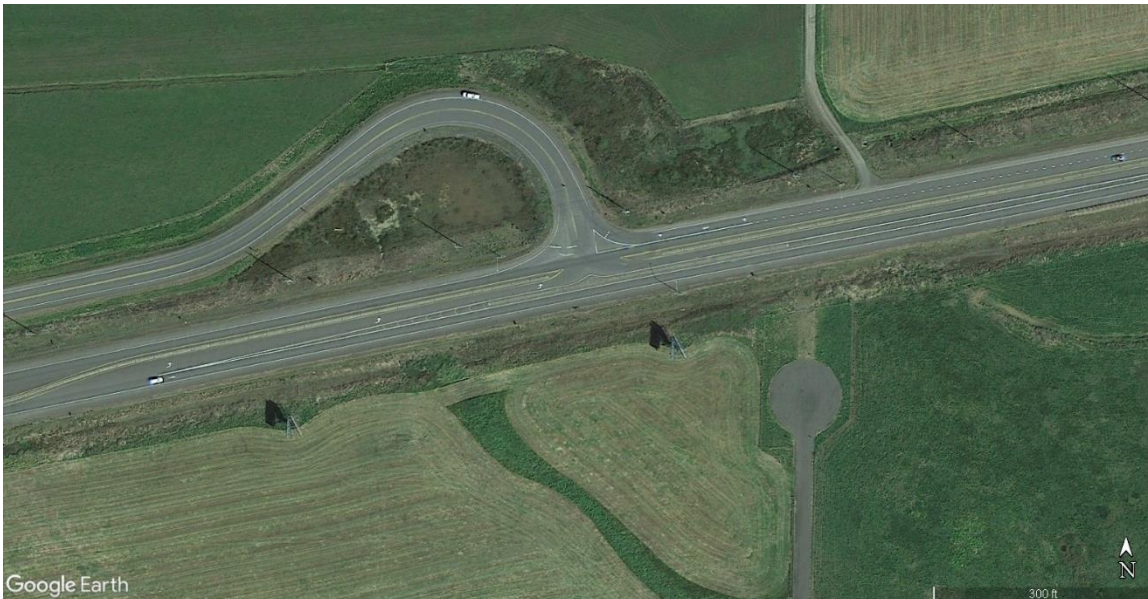
- The East intersection was created when the north leg was realigned to the east, offset from the south leg. A dedicated westbound right-turn lane is provided for the north leg.
- The East intersection is located near a weigh station that creates a short distance between the westbound trucks' merge area and the right-turn lane for Wilson River Loop, resulting in a relatively short weave section.
- Geotechnical and environmental issues are unlikely as long as projects stay within existing road prism.
- Wetlands are present nearby.

- Vehicles in westbound right-turn deceleration lane block sight distance of vehicles waiting to make a southbound turn.
- MP 2 (Wilson River Loop [East]): Needs improvement, there are visibility issues.

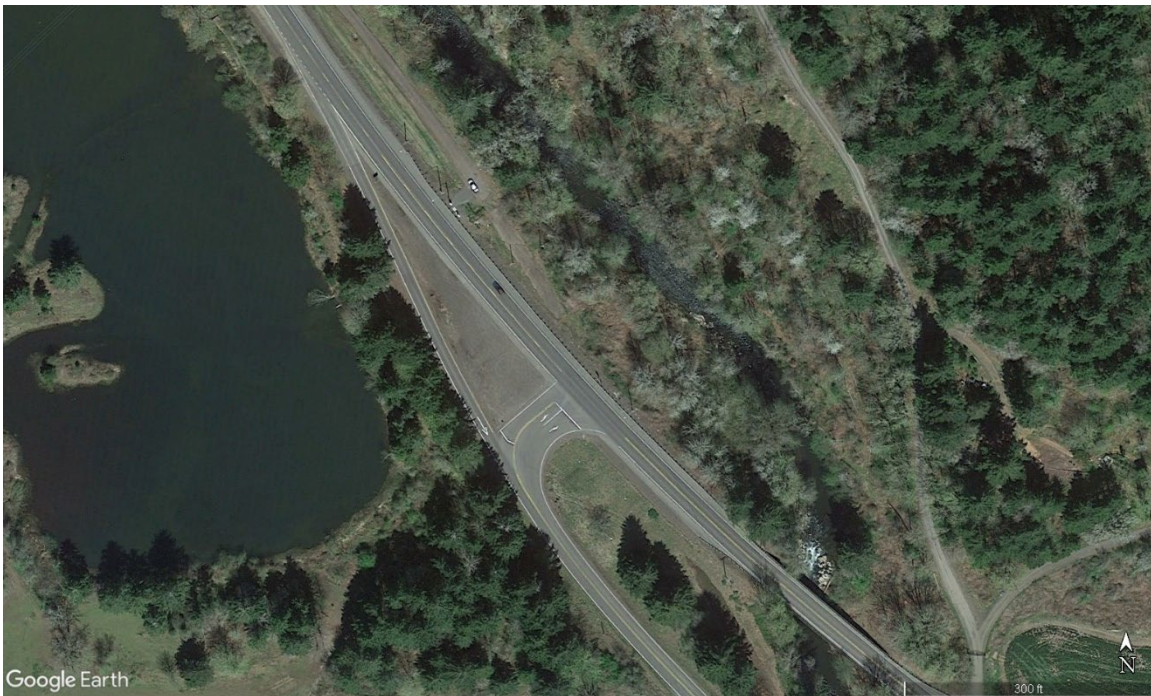
- Construction of a northbound left-turn lane will be challenging and costly due to bridge (approximately 200 feet long) over Gales Creek, located approximately 350 feet east of the intersection
- Sight distance for movements from the side street appears constrained in Google Earth
- Projects at this location are unlikely to trigger geotechnical issues unless fill is needed near Dorman Pond.
- Environmental review may be triggered if the bridge is modified (fish passage) or if any removal/fill were to occur in Gales Creek as it is Essential Salmonid Habitat.

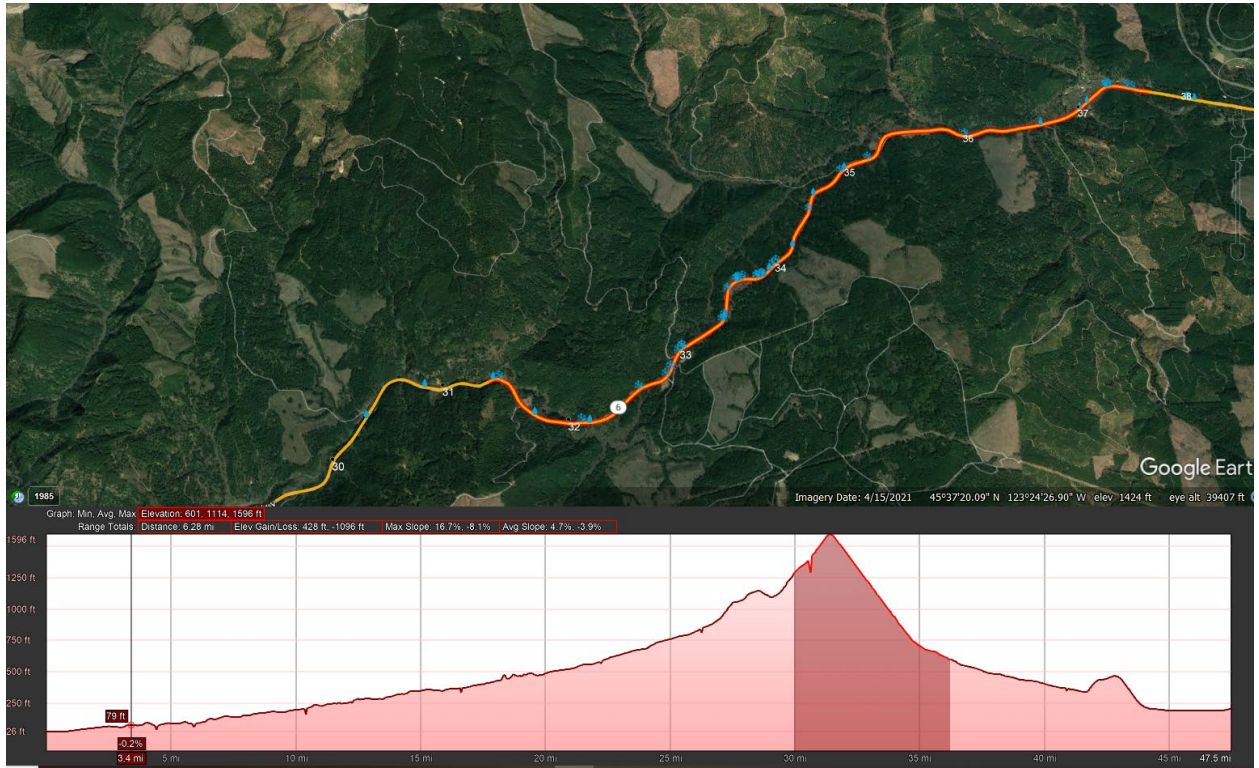
Exhibit 1: OR 6 Study Corridor Profile from Google Earth, with MP 31 to 38 highlighted

Some segments of the corridor have concentrations of crashes occurring on snow/ice conditions or wet pavement conditions. In particular, a pattern of snow/ice crashes is observed between approximately MP 31 and MP 38, which correlates with the peak elevation and grades of the corridor as shown by the approximate roadway profile from Google Earth below. Between MP 31 and 38, snow and ice conditions were present in 38 percent of crashes.

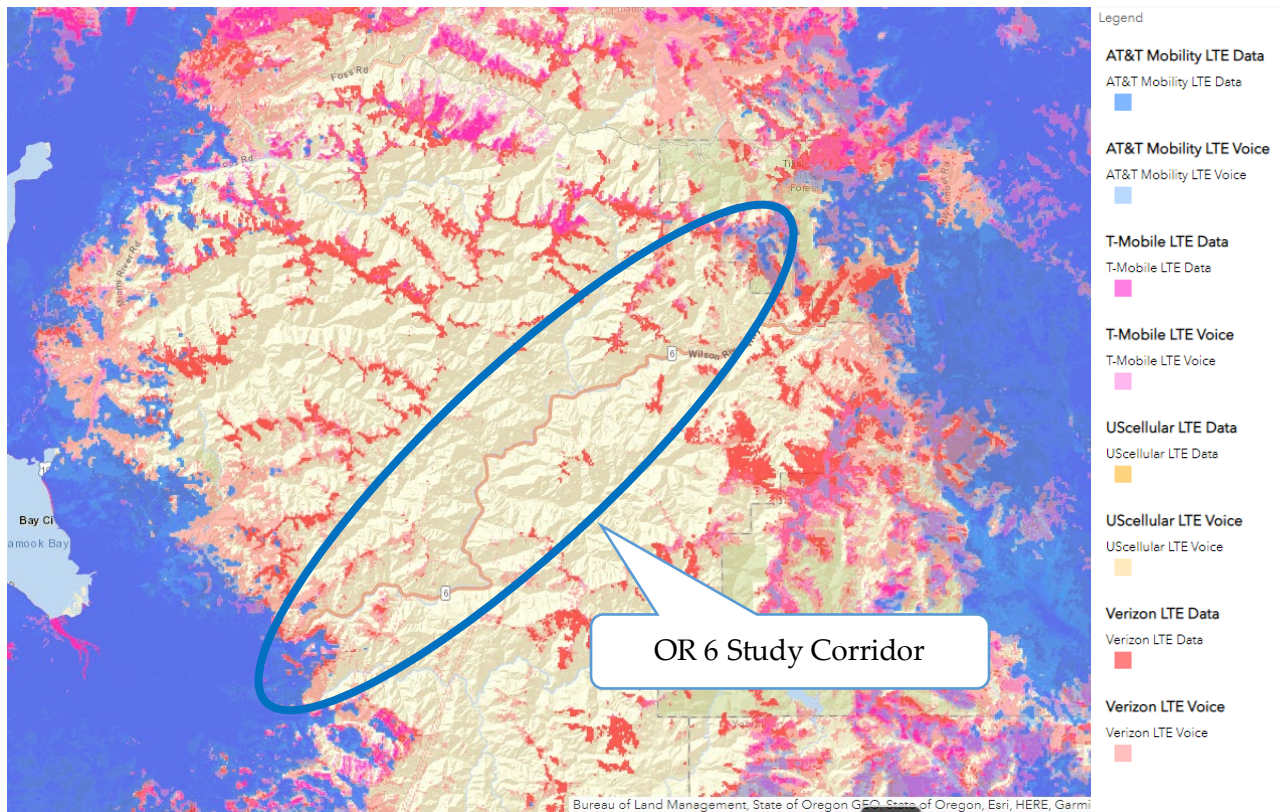
Exhibit 2: Illustration of OR 6 Corridor without AT&T, T-Mobile, US Cellular, or Verizon Coverage

Input from the public and stakeholders revealed that the lack of wireless and optical/wired communications available along the corridor creates additional challenges with reporting and responding to crashes when they occur. Drivers have indicated that they do not know where they are along the corridor after crashes. Drivers also have to travel to obtain service to call for help. This creates delays in responding to crashes and additional challenges for emergency vehicles to access crashes with traffic queues and unknown crash locations.

In addition to the lack of cell phone service throughout the corridor, there is also limited communications infrastructure in place. Some of the issues with installing fiber in long segments of rural highways are limited right-of-way with multiple utilities competing for the same space, lack of power to regenerate the communications over a long distance, and challenging terrain with possibilities of rock impeding boring or trenching. The limited number of customers being served along the corridor makes the cost/benefit calculations for fiber installation lower than other areas.
