Oregon Seismic Status Report - 2018

School District/ESD: Dallas 2

WHITWORTH ELEMENTARY GYMNASIUM SEISMIC RETROFIT

1151 SE MILLER AVE, DALLAS, OR 97338

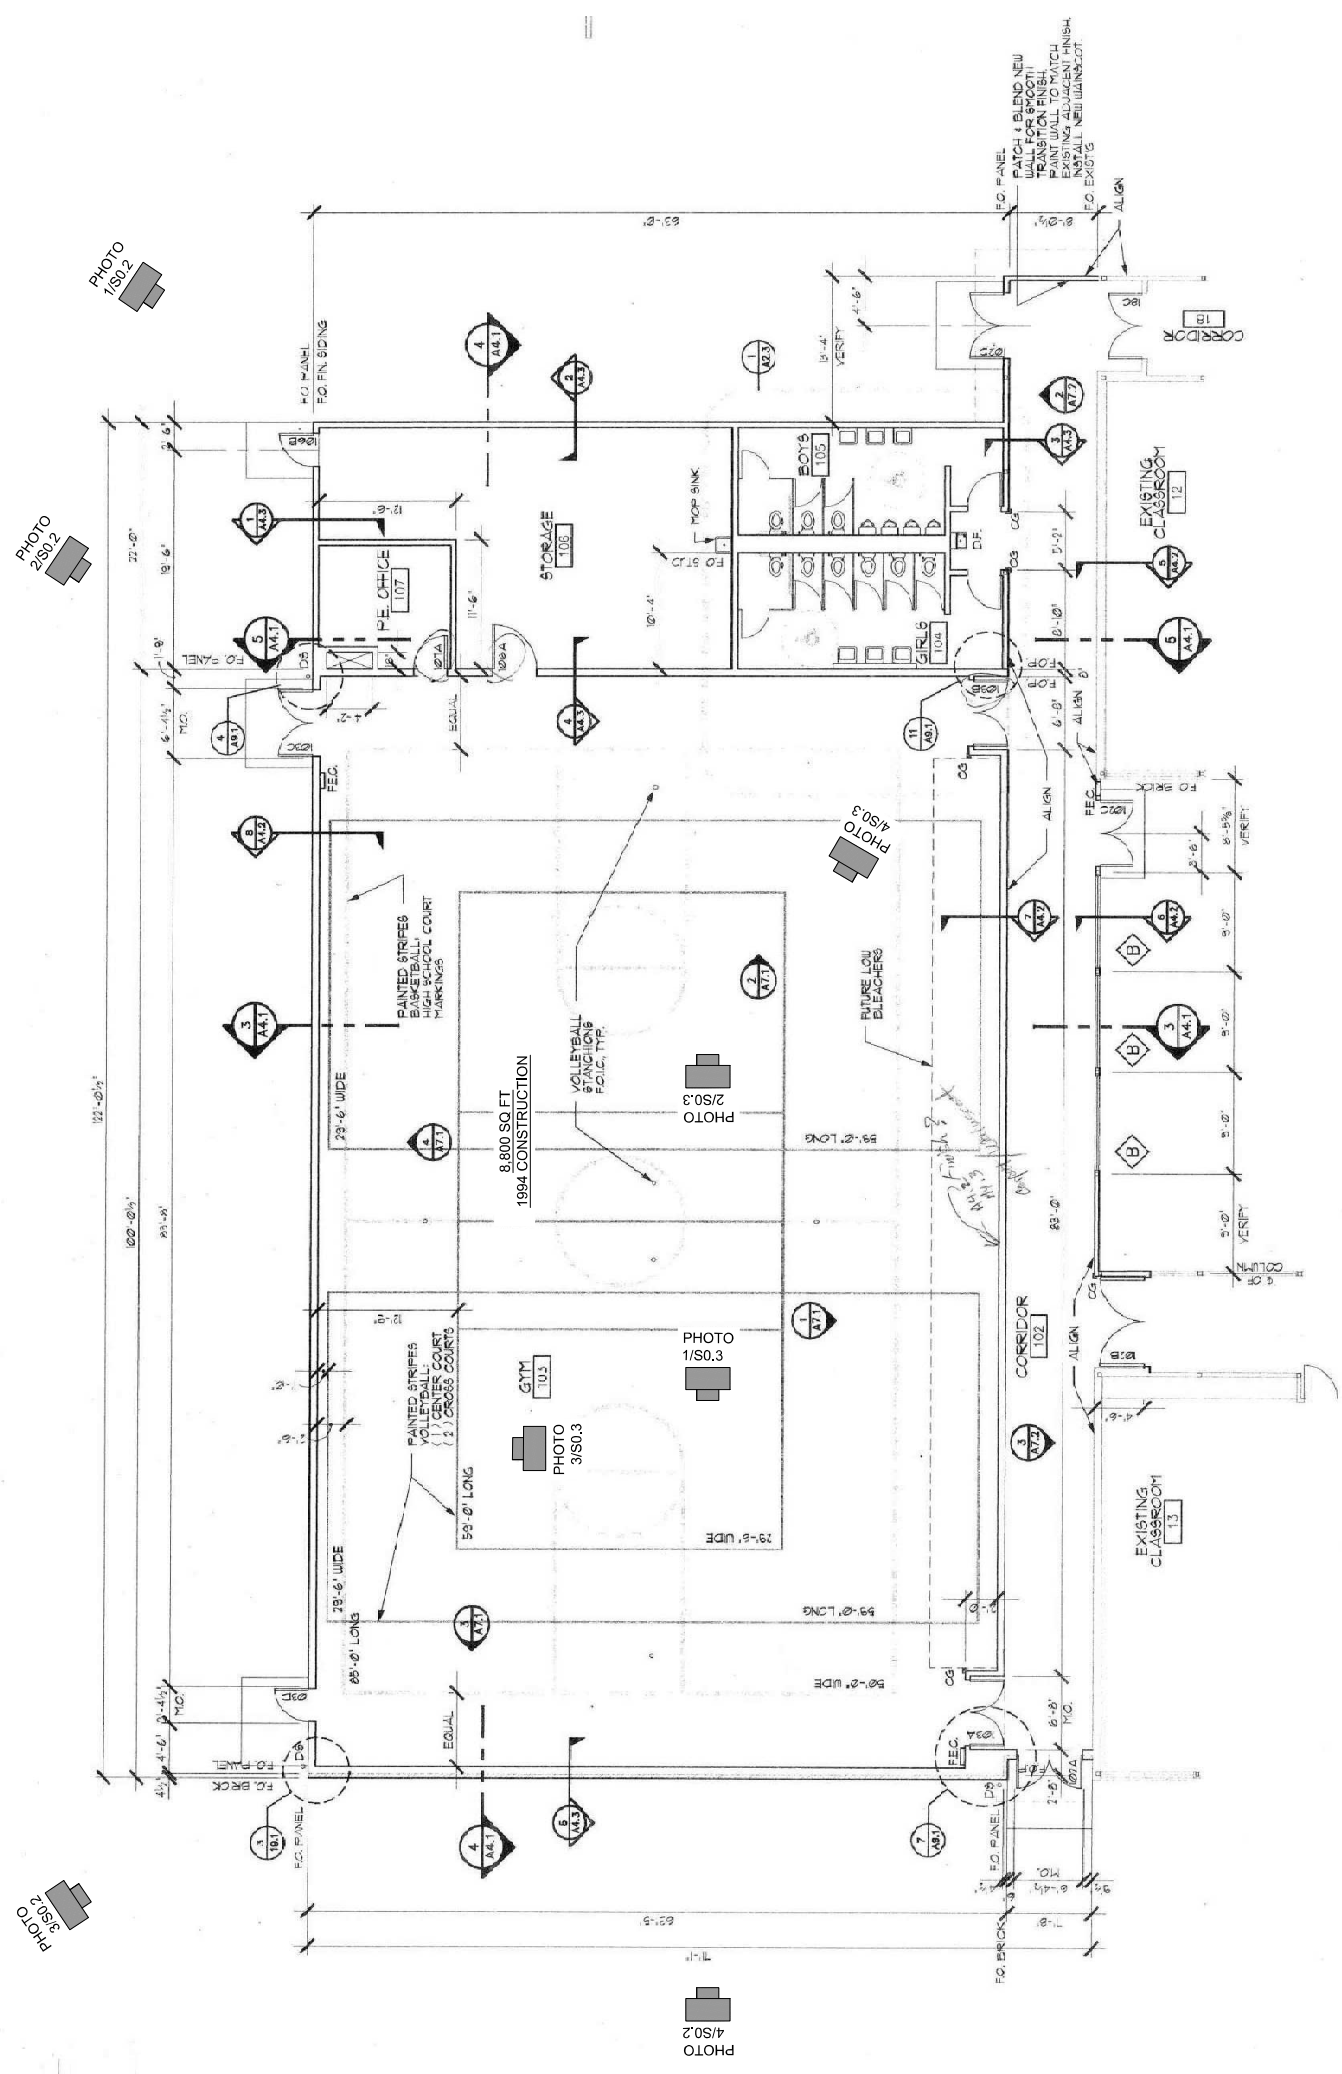
1 FLOOR PLAN
 1/8" = 1'-0"

- TILT-UP CONCRETE SHEAR WALLS ARE NOT PROPERLY ATTACHED TO THE ROOF DIAPHRAGM FOR IN-PLANE AND OUT-OF-PLANE LOADING.
- THE GLULAM BEAMS ARE NOT PROPERLY ATTACHED TO THE PRECAST WALLS TO ACT AS A CONTINUOUS TIE.
- THE GYM FLOOR IS TALLER THAN OTHER ROOMS OF THE BUILDING, WHICH INCREASES VERTICAL IRREGULARITY. THIS VERTICAL IRREGULARITY COULD RESULT IN FOUNDING. THE FOUNDING EFFECTS INCREASE THE BUCKLING LOADS ON THE WALLS.

- PROVIDE STRAPPING BETWEEN JOISTS AT INTERSECTING BEAM LINES TO PROVIDE CONTINUOUS CROSS TIES.
- THE GYM FLOOR IS TALLER THAN OTHER ROOMS OF THE BUILDING, WHICH INCREASES VERTICAL IRREGULARITY. THIS VERTICAL IRREGULARITY COULD RESULT IN FOUNDING. THE FOUNDING EFFECTS INCREASE THE BUCKLING LOADS ON THE WALLS.

- SEISMIC RETROFIT PROJECT A SEISMIC ISOLATION JOINT IS SLATED TO BE INSTALLED TO SEPARATE THE MAIN CLASSROOM WINGS FROM THE GYM.
- ALL PIPING AND HVAC EQUIPMENT FOUND THROUGHOUT THE BUILDING SHALL BE PROPERLY BRACED AND ATTACHED TO THE STRUCTURE.

- THE BRICK VENEER OVER THE EXIT DOORS WILL BE ATTACHED TO THE WOOD WALLS TO MINIMIZE THE FALLING HAZARD.

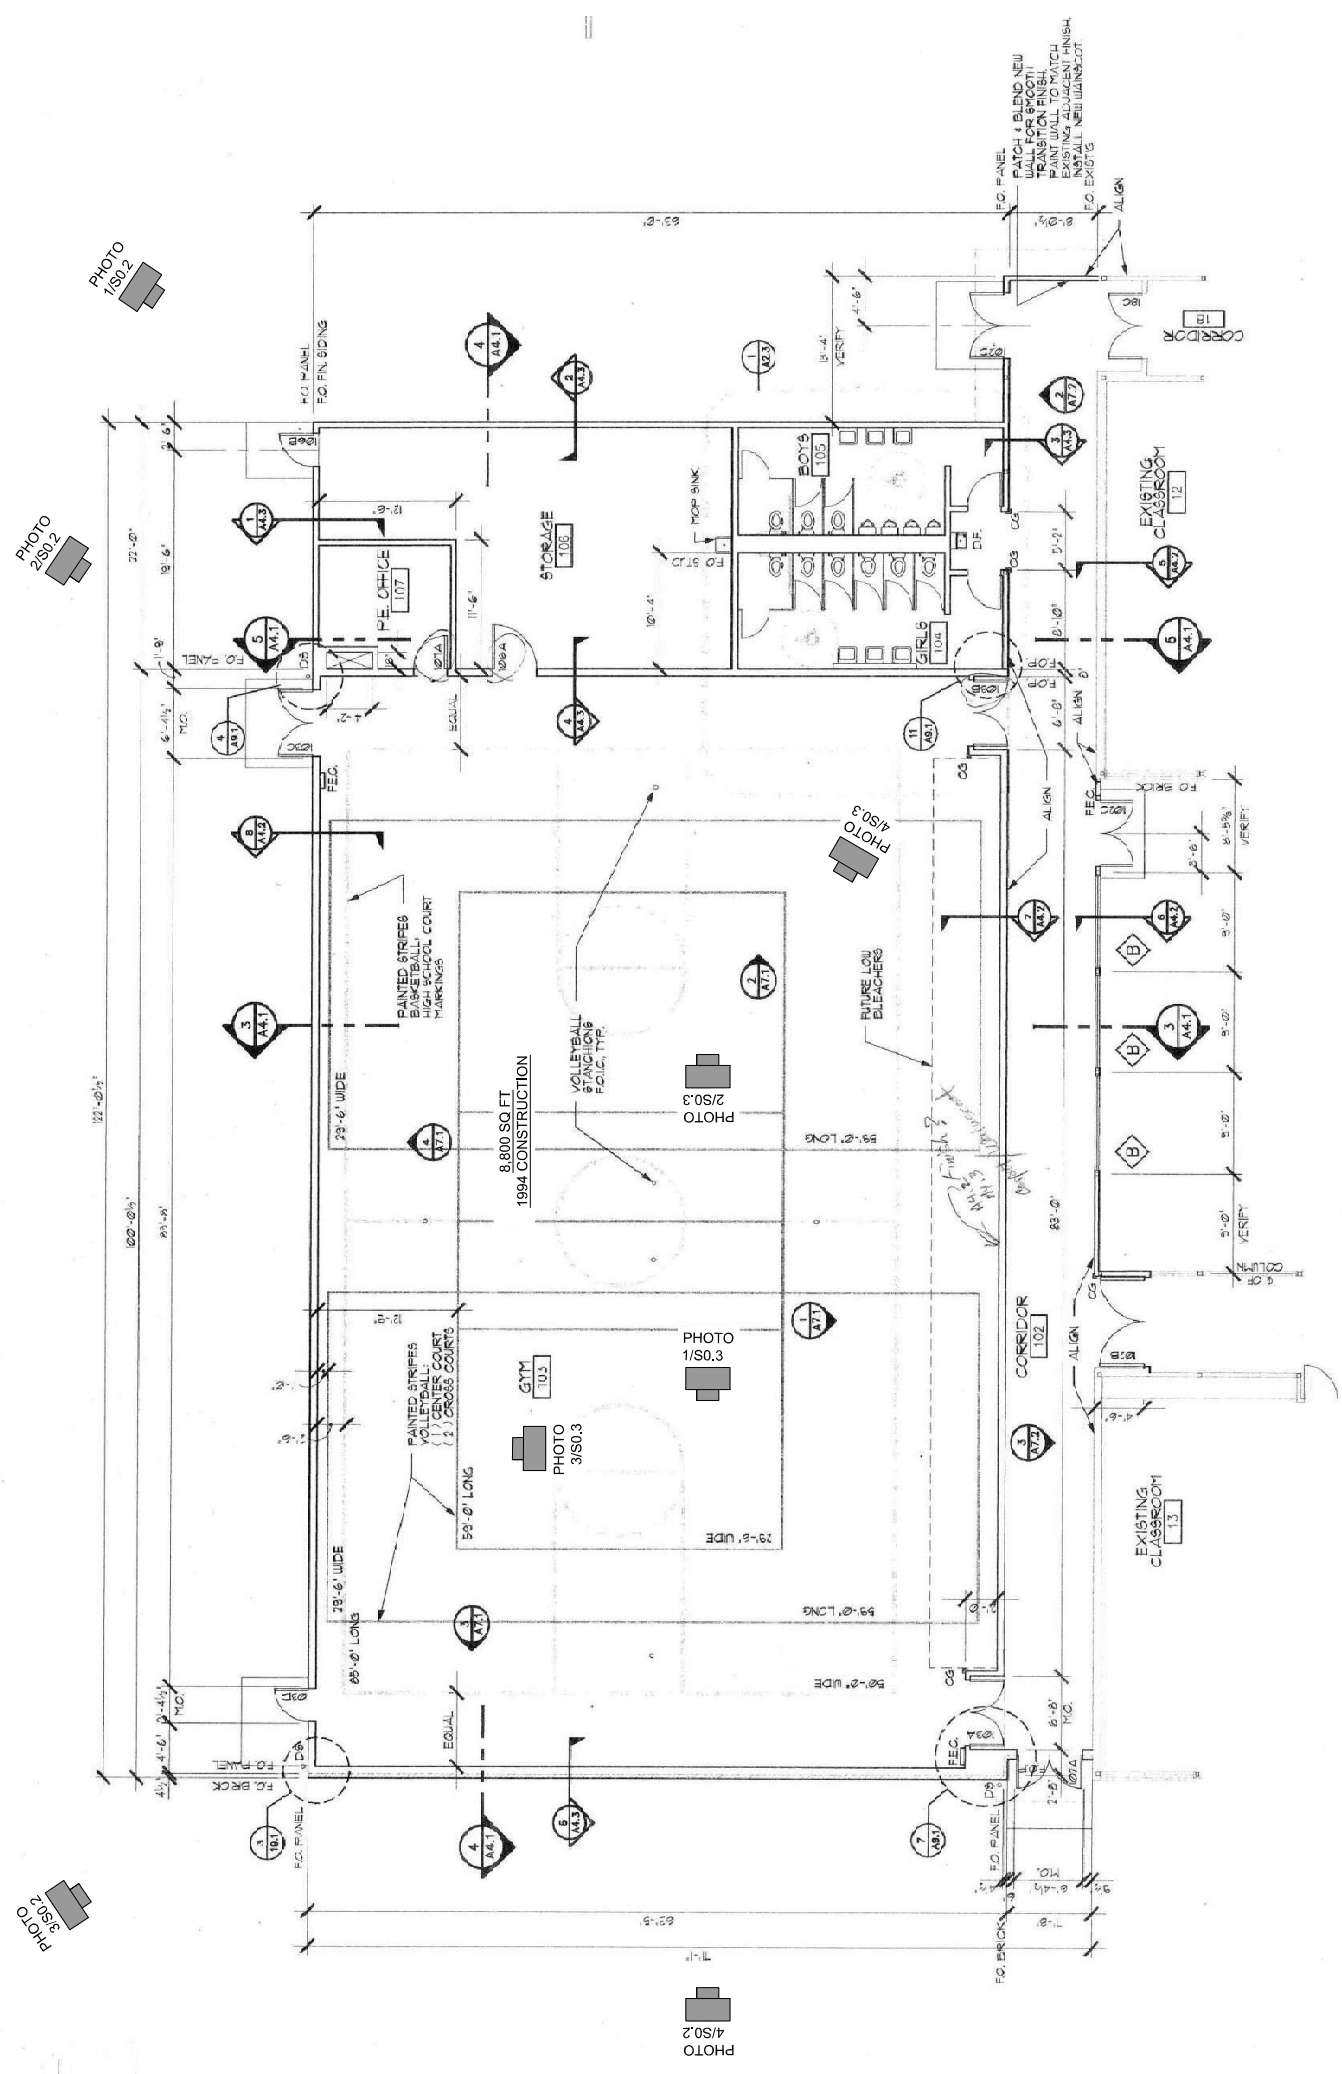
1 FLOOR PLAN
 1/8" = 1'-0"

- TILT-UP CONCRETE SHEAR WALLS ARE NOT PROPERLY ATTACHED TO THE ROOF DIAPHRAGM FOR IN-PLANE AND OUT-OF-PLANE LOADING.
- THE GLULAM BEAMS ARE NOT PROPERLY ATTACHED TO THE PRECAST WALLS TO ACT AS A CONTINUOUS TIE.
- THE GYM FLOOR IS TALLER THAN OTHER ROOMS OF THE BUILDING, WHICH INCREASES VERTICAL IRREGULARITY. THIS VERTICAL IRREGULARITY COULD RESULT IN FOUNDDING. THE FOUNDDING EFFECTS INCREASE THE BUCKLING LOADS ON THE WALLS.

- THE TOPS OF THE REINFORCED CONCRETE TILT-UP WALLS IN THE GYMNASIUM NEED TO BE PROPERLY ATTACHED TO THE ROOF DIAPHRAGM FOR OUT-OF-PLANE LOADING.
- PROVIDE BLOCCING, CLIPPING AND WALLING CONNECTIONS ALONG TOP OF WALLS TO ESTABLISH ADEQUATE CONNECTION BETWEEN TOP OF WALL AND DIAPHRAGM.
- PROVIDE STRAPPING BETWEEN JOISTS AT INTERSECTING BEAM LINES TO PROVIDE CONTINUOUS CROSS TIES.
- THE SEISMIC RETROFIT PROJECT A SEISMIC ISOLATION JOINT IS SLATED TO BE INSTALLED TO SEPARATE THE MAIN CLASSROOM WINGS FROM THE GYM.
- ALL PIPING AND HVAC EQUIPMENT FOUND THROUGHOUT THE BUILDING SHALL BE PROPERLY BRACED AND ATTACHED TO THE STRUCTURE.
- THE BRICK VENEER OVER THE EXIT DOORS WILL BE ATTACHED TO THE WOOD WALLS TO MINIMIZE THE FALLING HAZARD.
