Commissioning Solves Building Problems That Robbed State Police of Comfort, Healthy Air

Commissioning Finds and Solves Deficiencies Before They're a Problem: State Police Headquarters - Southern Oregon

Commissioning Oregon State Police Headquarters - Southern Oregon

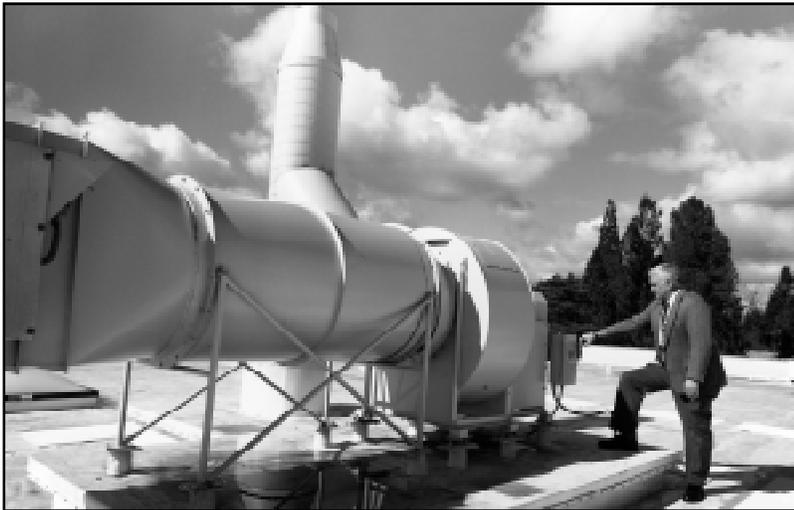
One of the first things the commissioning team found was control wires rubbing against sheet metal edges in the rooftop package units that heat and cool the buildings.

Lieutenant Gary Knowles, forensic lab director, beside one of the rooftop heating and cooling units that was waiting to fail. Commissioning found and fixed control wires rubbing against sheet metal edges.

“You could already see the wear on some of them,” Haeg said. “We inspected all 13 package units and added grommets to make sure there was no friction potential with any of the control wires. Because we were down there looking at everything systematically, we found it. Otherwise, we wouldn’t have known about the problem until the wires frayed and the unit failed.”

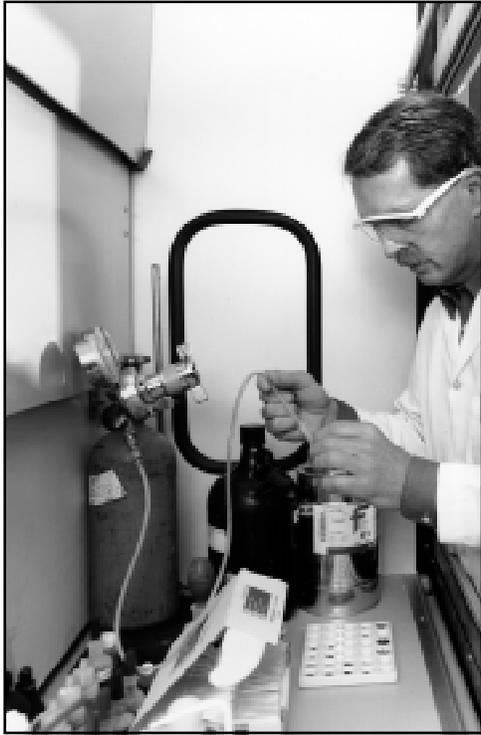
John Amish, criminalist, working at an exhaust hood in the forensic lab. Commissioning uncovered that constant-volume hoods had never been modified for variable-air volume, and exhaust hoods and ductwork hadn't been sealed.

Lab exhaust hoods, room exhaust and room supply are supposed to work together to maintain a constant static pressure in the lab. But Teague and Haeg discovered several problems with the system. Chief among them was that the constant-air volume hoods the State Police already owned and specified for modification to variable-air volume for the new lab had never been modified. The consequences for comfort and energy use were enormous. Teague estimates the oversight would have cost the State Police \$6,500 a year.

They checked the 7,600 cfm fan that exhausted air from the general lab area and the four lab hoods. It was running full-tilt. Yet airflow through the system was insufficient to maintain safe exhaust volumes through the hoods. Meantime, lab hoods were drawing conditioned air from the room, and cold makeup air was drawn into the room from outside. The reason: The exhaust hoods and ductwork hadn’t been sealed.

“The mechanical designer didn’t realize that the hoods as they’re manufactured are not airtight,” Haeg said. “They needed to be sealed in this application.”

The commissioning team sealed the hoods and sealed ductwork from the hoods to the exhaust fan to ensure that all air handled by the fan was exhausted through the hoods, as intended.

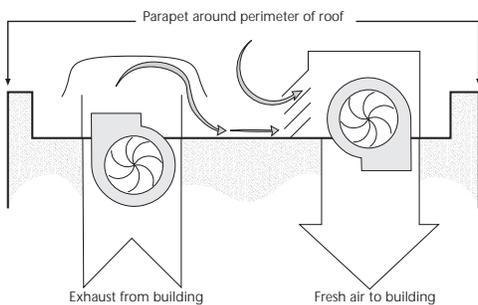
Weather protection on rooftop exhaust fans pushed exhaust from the autopsy and drying rooms onto the roof, where just a few feet away the contaminated exhaust was sucked into fresh air intakes.

The new support services building had its own ventilation problems: Standard hooded exhaust fans for the drying and autopsy rooms were short-circuiting exhaust flow.

“They put evidence in the drying room that is wet or bloody, apply heat and exhaust the air,” Haeg said. “But the exhaust fan hood pushes the exhaust onto the roof. Right next to it is an air intake that’s bringing it back inside.”

The autopsy area had the same problem. “Sometimes they’re taking a saw to the bodies,” Haeg said, “and the particulates that were exhausted were being drawn right back inside through the air intake. If we weren’t commissioning the buildings, we wouldn’t have realized we had an inversion problem on the autopsy roof, so it never would have been fixed.”

The commissioning team changed the fan units so exhaust from the drying and autopsy rooms shoots straight out, Haeg said, away from the fresh air intakes.

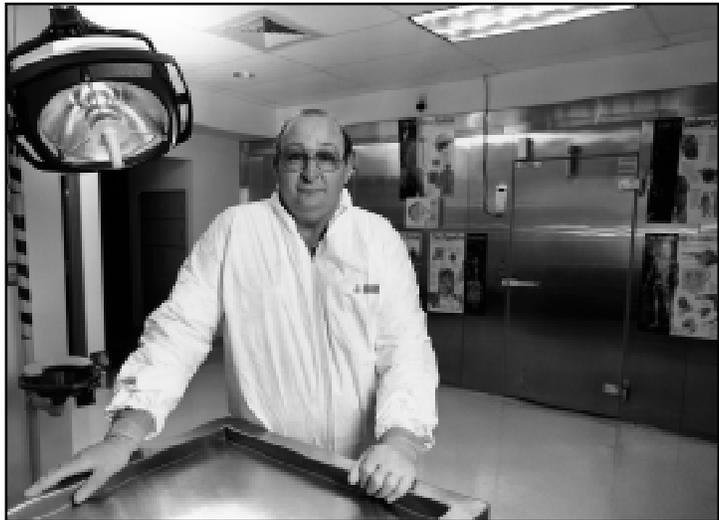
Haeg discovered another problem with the autopsy area during commissioning: The medical examiner was overheated working in his Tyvek suit and needed room temperature reduced to 65°F during autopsies. Fixing the problem required an auxiliary cooling unit, working in unison with the unit already installed.

Chief Deputy Medical Examiner Spencer Smith in the autopsy room. Commissioning identified and solved ventilation and comfort problems and protected the health and safety of staff.
