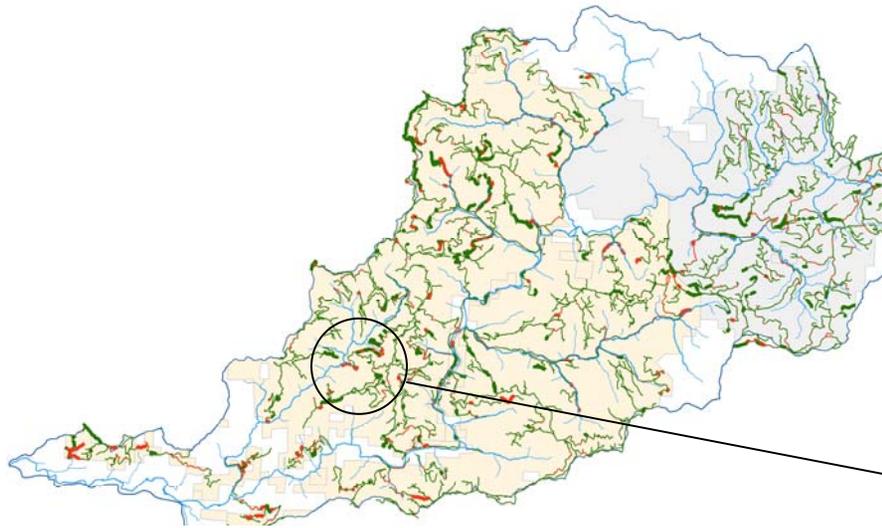
Photographic Plate 17. Closed road segment near the Little North Fork of the Wilson River where hydrologic connectivity and actively erosion occur intermittently. The highlighted yellow road traversing the harvest unit was eroding large amounts of sediment, but it was not hydrologically connected. The red segments of road illustrate areas that were actively eroding and delivering sediment to streams. Orange segments were hydrologically connected, but not actively eroding; black segments were neither connected nor eroding.

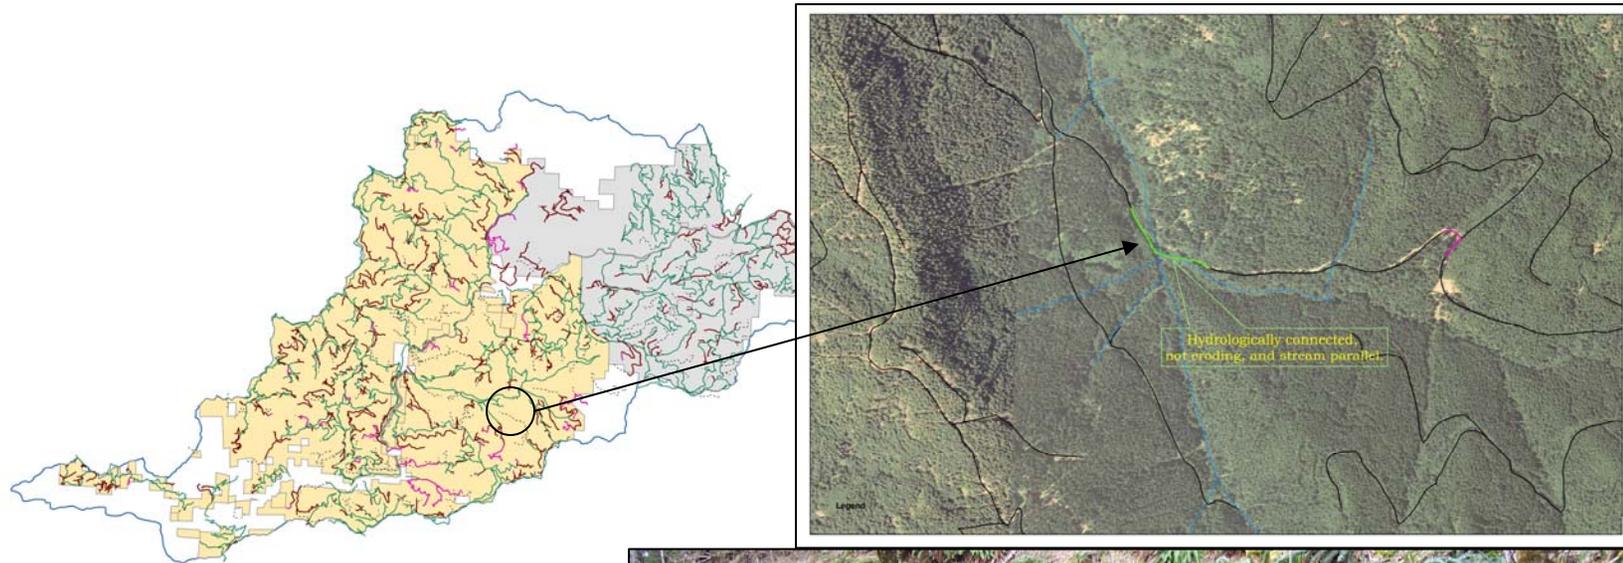
Photographic Plate 18. This segment of road was classified as stream parallel, hydrologically connected, and not eroding during the 2006 field assessment. The photograph was taken after the November 2006 storm illustrating how quickly conditions change in the watershed and the temporal nature to the survey.

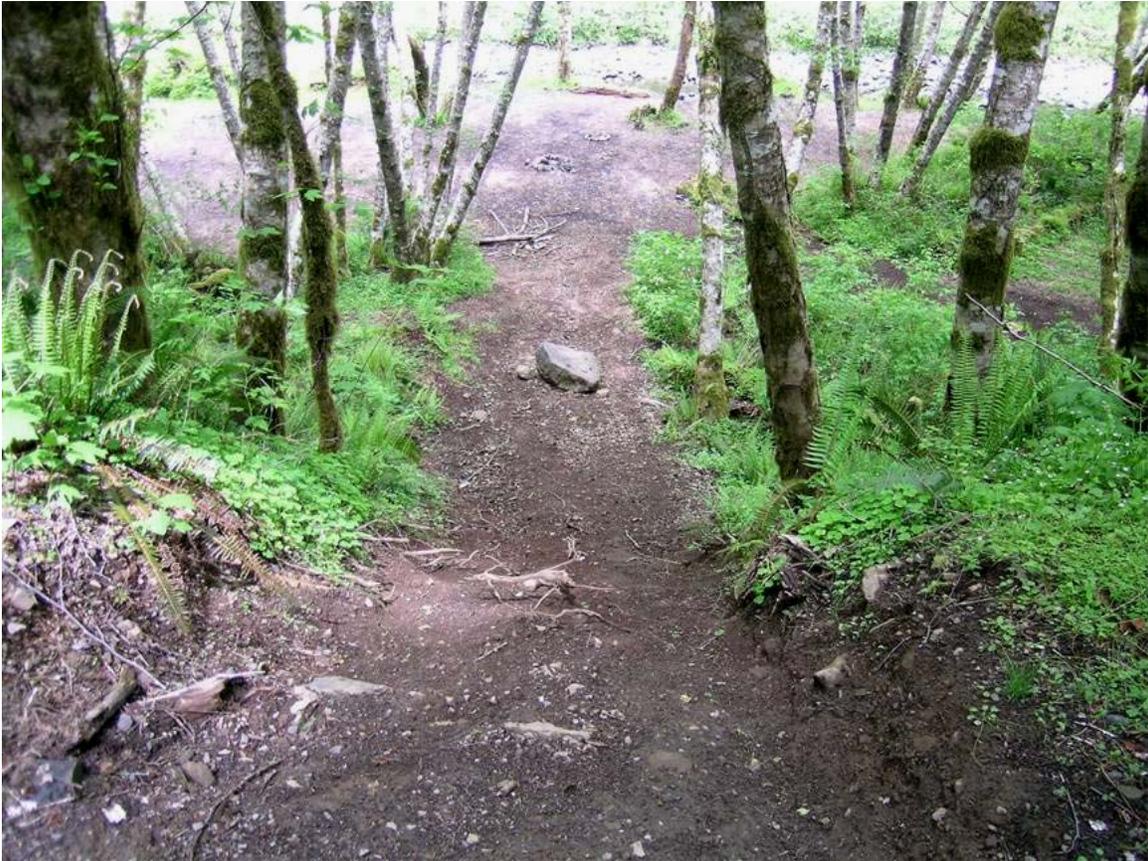
Photographic Plate 19. Example of hydrologically connected OHV Fall-Line Trail. OHV use of the riparian areas directly affects water quality through vegetation loss, soil compaction, and erosion.

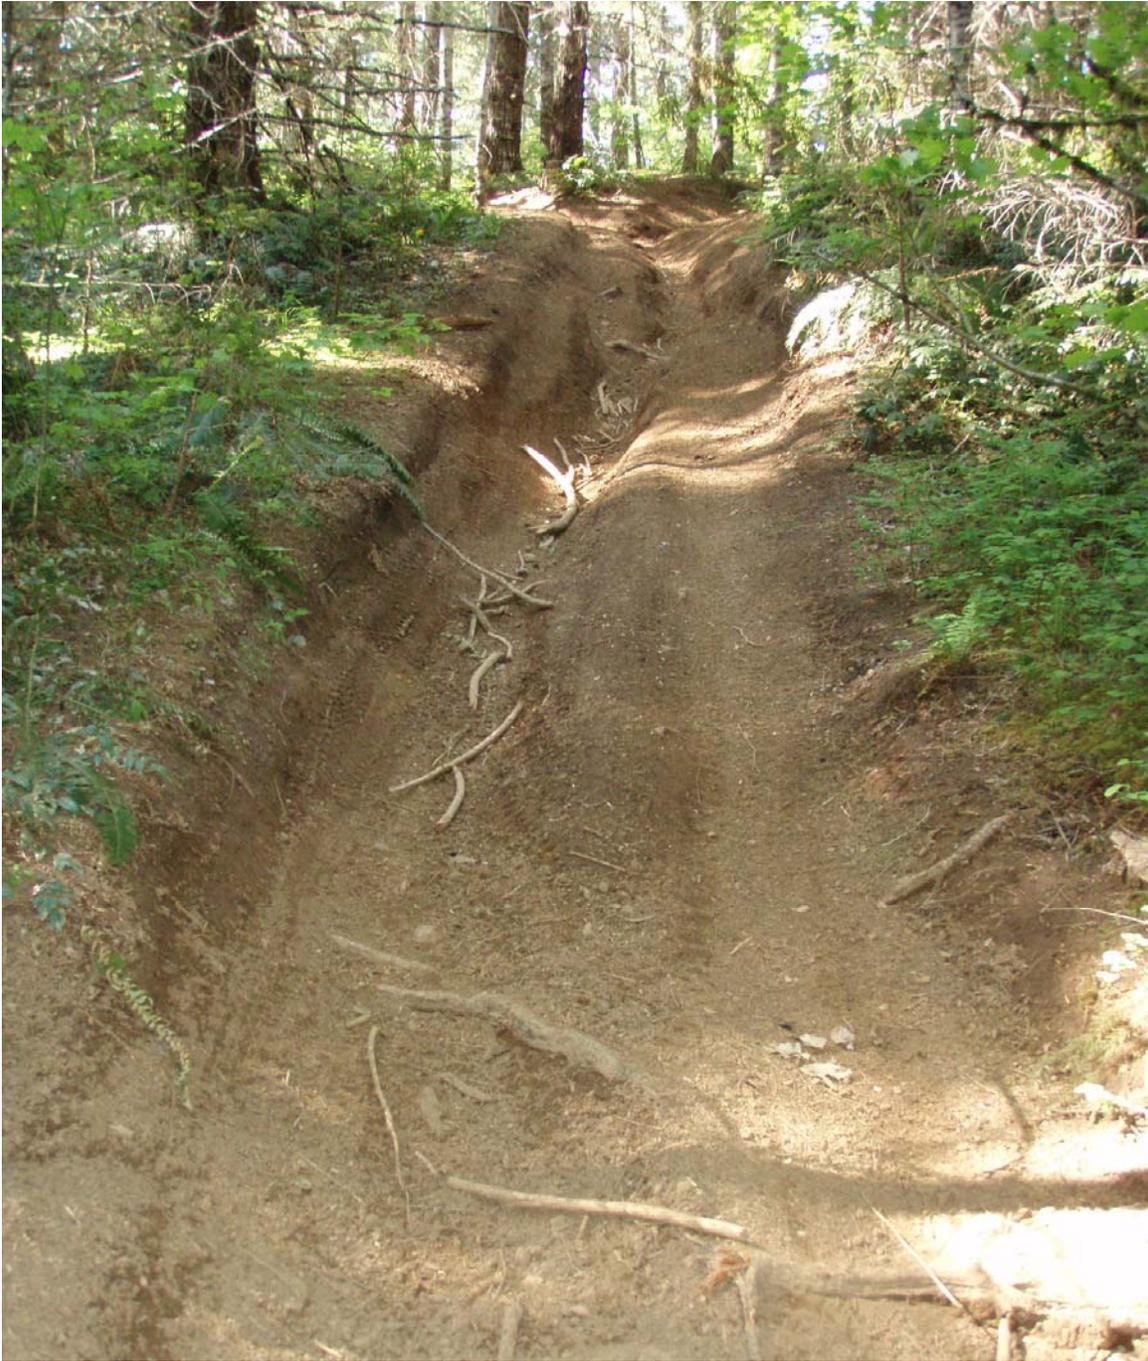
Photographic Plate 20. Example of hydrologically connected Designated OHV Fall-Line Trail. Steep slope, incised trail, with no drainage structures.

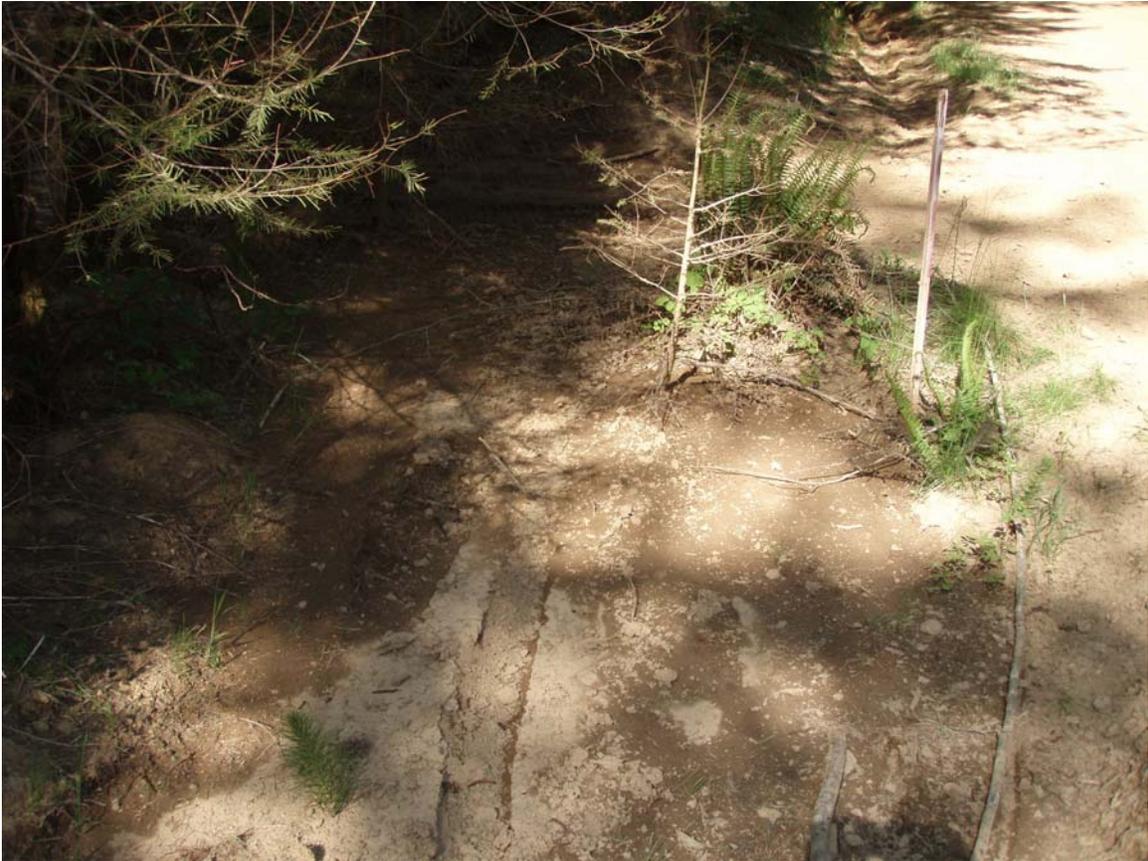
Photographic Plate 21. Example of hydrologically connected OHV Fall-Line Trail above. Sedimentation delivered to road crossing, blocking culvert (stake at upper right).

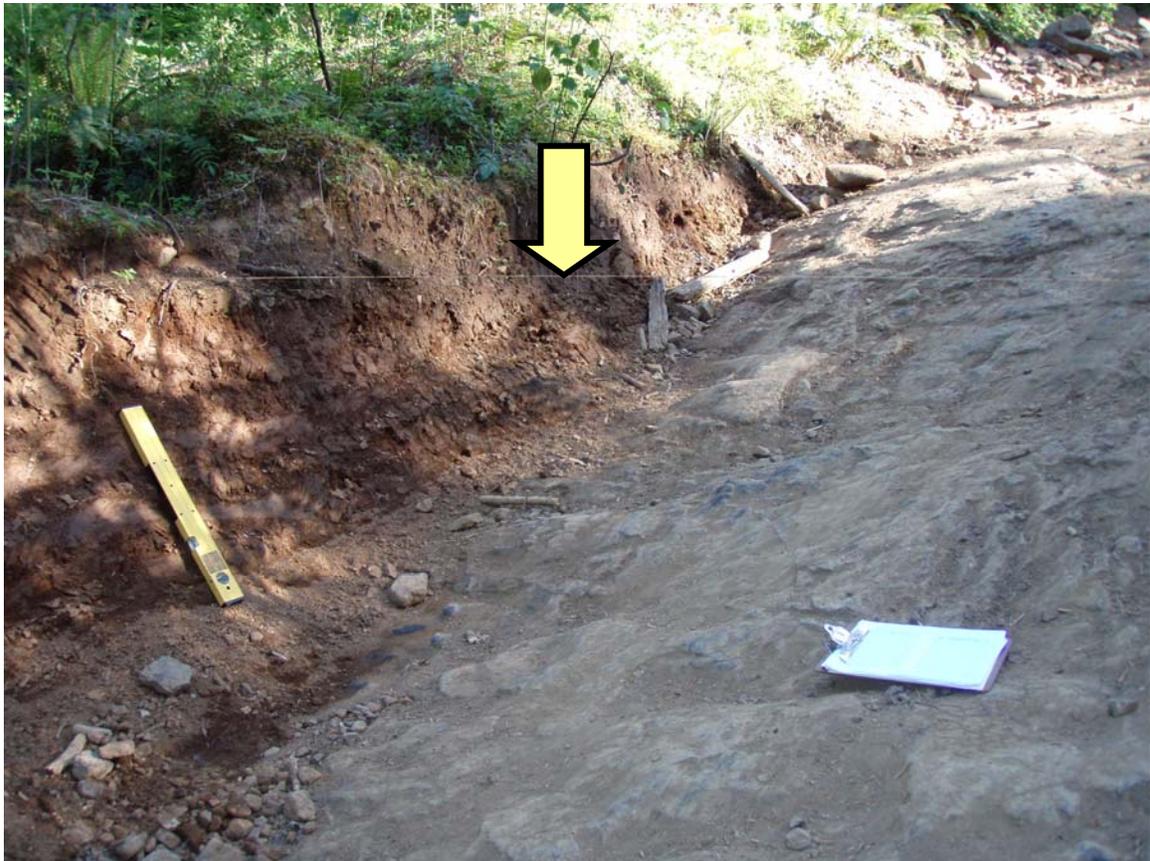
Photographic Plate 22. Example CSA Transect on an hydrologically connected OHV trail. OHV use has resulted in deeply incised trail treads and erosion, (transect horizon indicated by arrow pointing to string above trail tread).

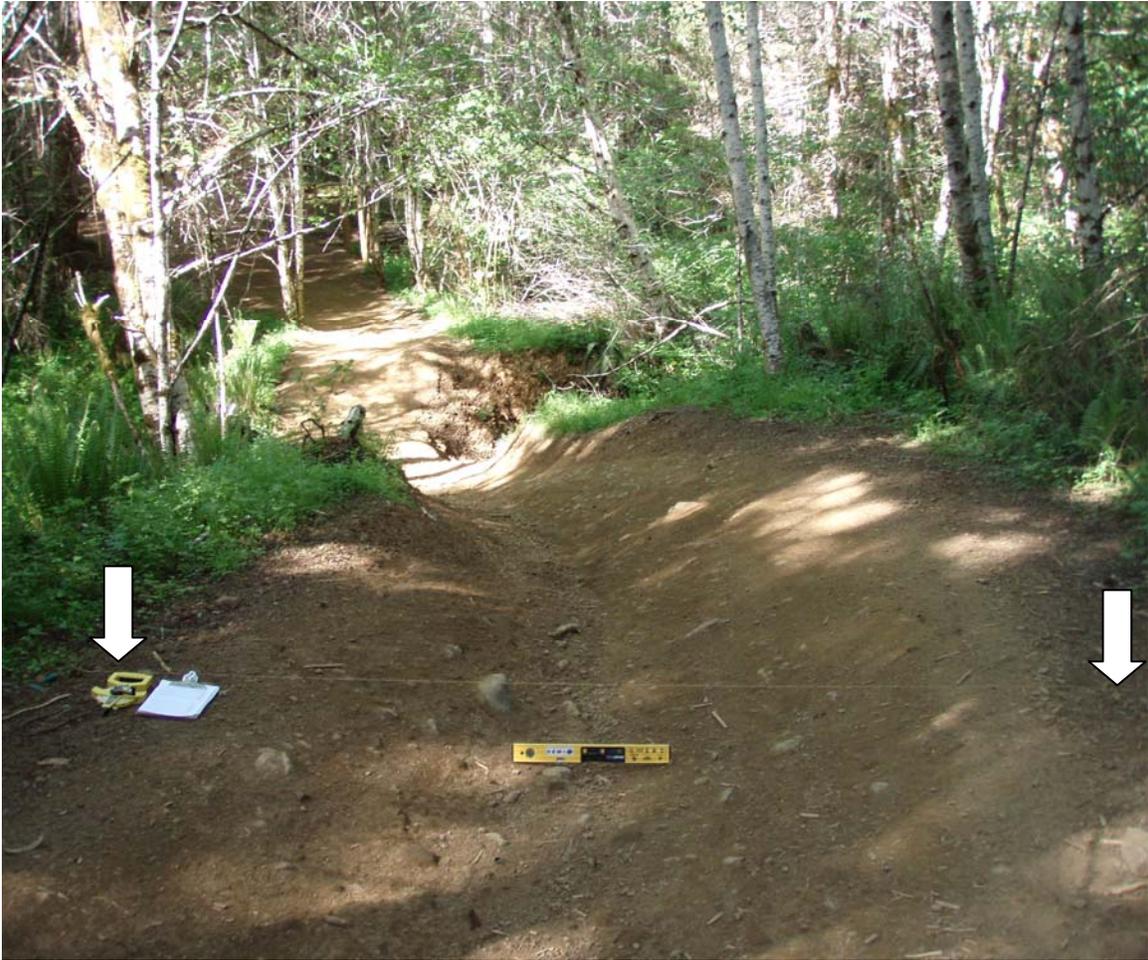
Photographic Plate 23. Transect String Line. The tread width is defined by the outer edges of the recent wear pattern.

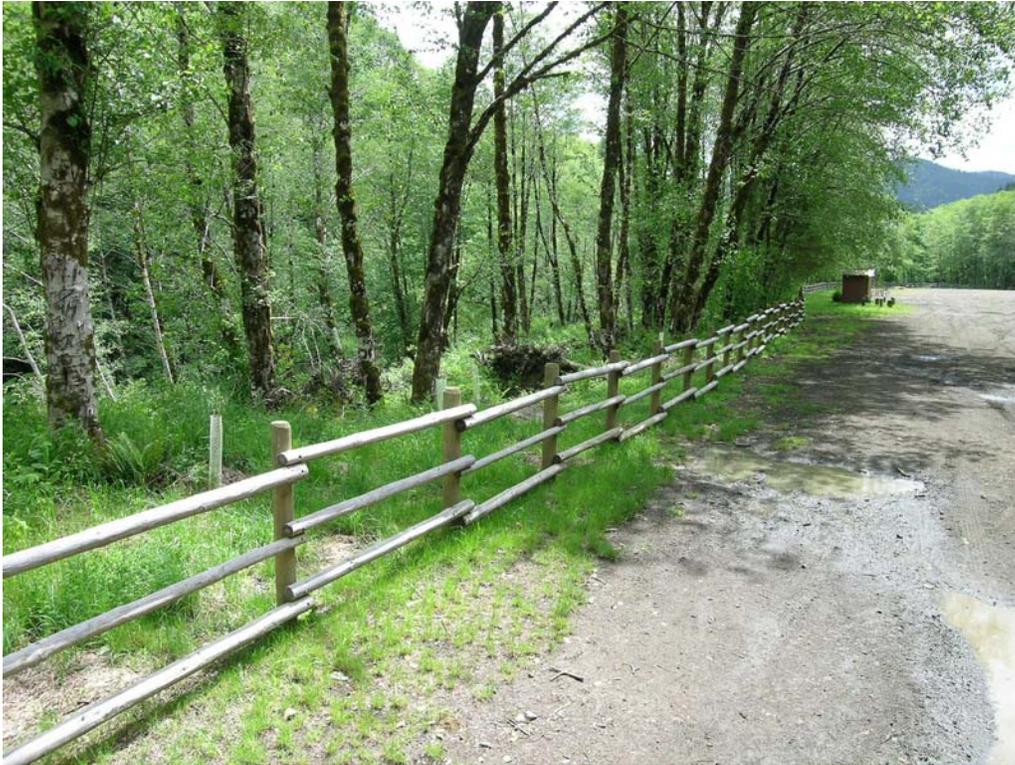
Photographic Plate 24. Recent upgrades, like this fence in Cedar Creek, prove robust enough to be effective at keeping Off-Highway Vehicles out of the Inner Riparian Zone.

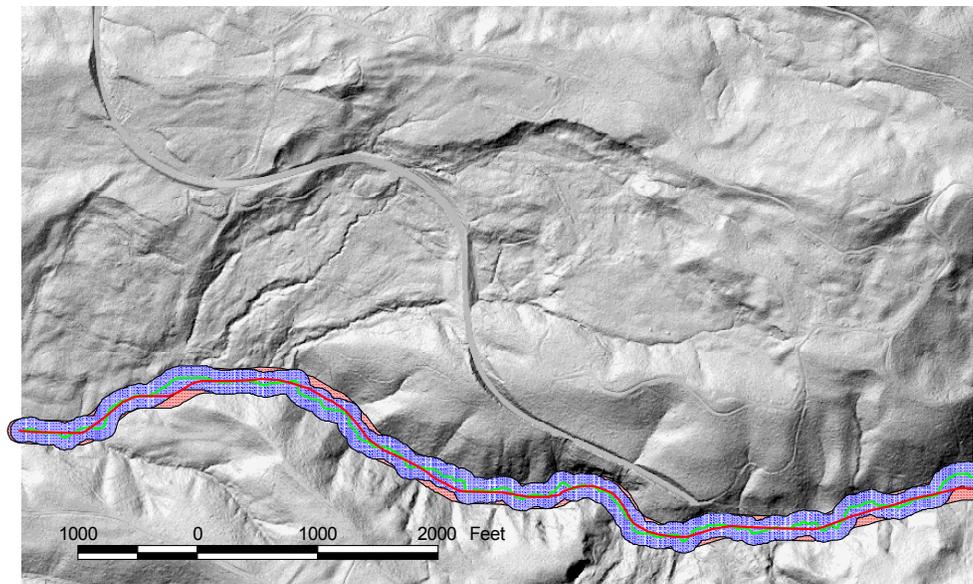
Photographic Plate 25. Differences in Buffer Areas. LiDAR (green line) versus ODF stream layer (red line) delineations for a tributary to the Nehalem River. Note the blue buffer area is based on 100 ft from the LiDAR delineation; the red buffer is 100 ft from the ODF stream layer. The overlap represents ~82% accuracy of the ODF layer, when compared with the buffers based on LiDAR delineation.

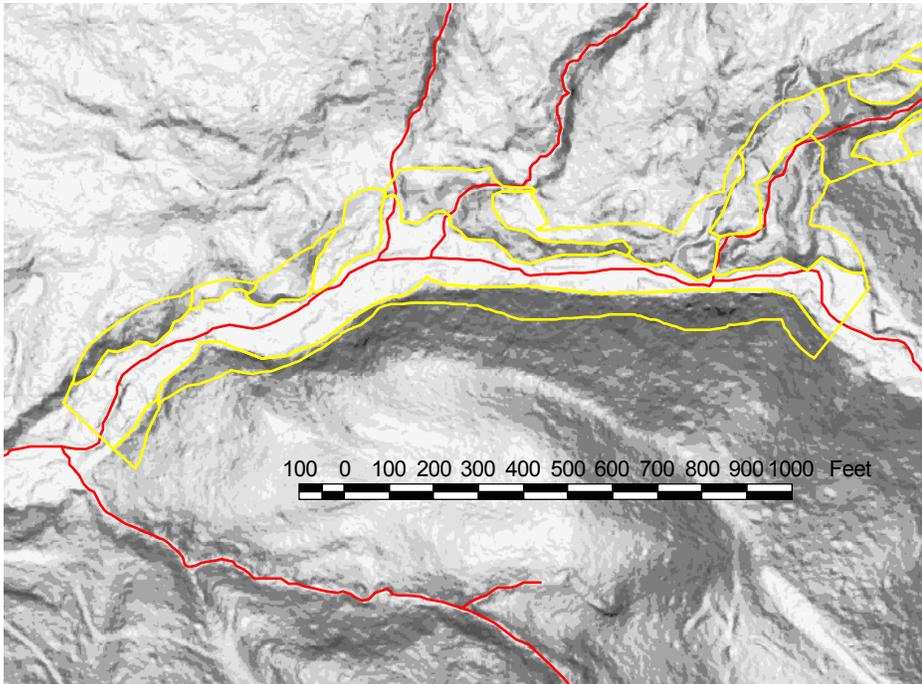
Photographic Plate 26. Delineations based upon Slope. The riparian zone can be delineated on the basis of slope (darker is steeper) to identify areas having different opportunities for interaction and/ or potential treatments. This stream is the main stem Quartz Creek.

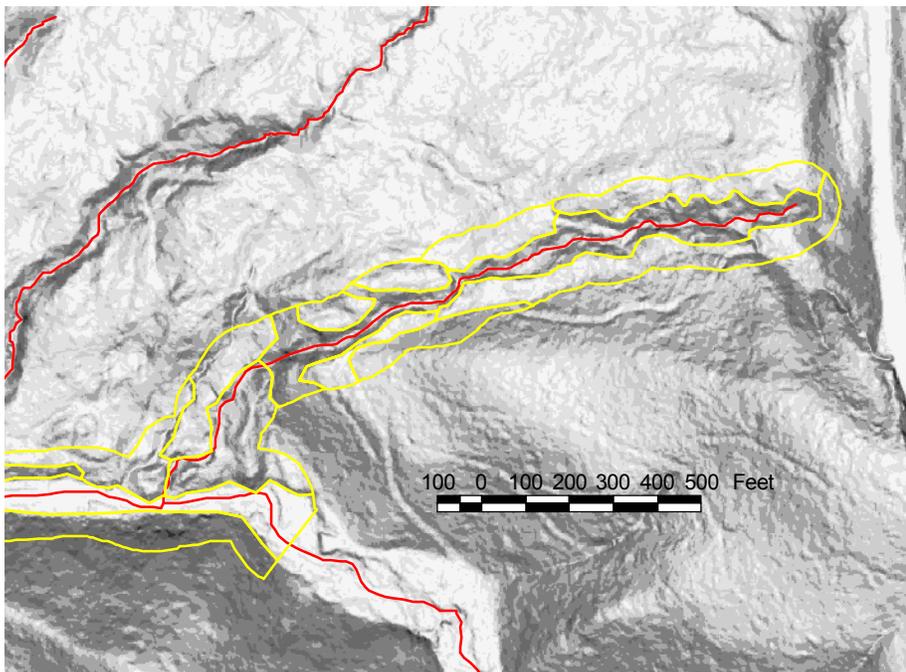
Photographic Plate 27. Delineations based upon Slope. The riparian zone can be delineated on the basis of slope (darker is steeper) to identify areas having different opportunities for interaction and/ or potential treatments. This stream system has areas in the riparian buffer (outer edges) that are likely to have low levels of interaction with the stream channel (upper terraces and outside the immediate drainage area).

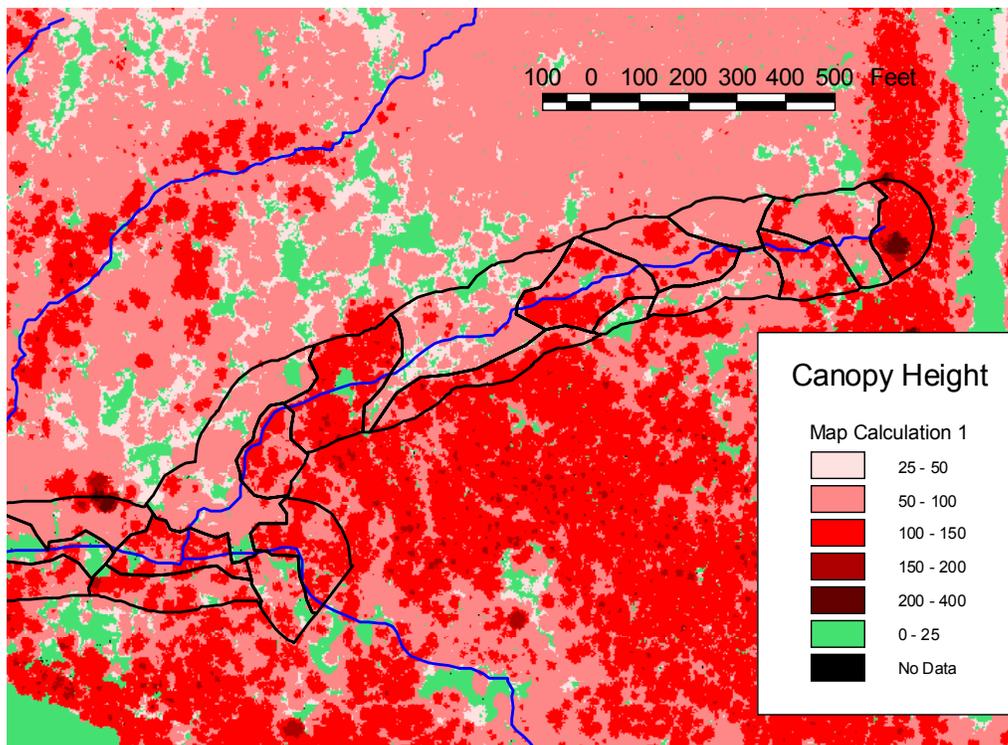
Photographic Plate 28. Delineations based on canopy height. A calculated estimate of canopy height, using the above-ground and bare earth LiDAR coverages was used to delineate vegetation structure and patch qualities. These features, in combination with slope delineations, provide a framework for patch-management.
