**Clatsop, Columbia, and Tillamook Counties
and the
Oregon Department of Forestry**

Forest and Debris Recovery Final Report Winter Storm - December 2007

**Prepared by the
Forest and Debris Recovery Team**

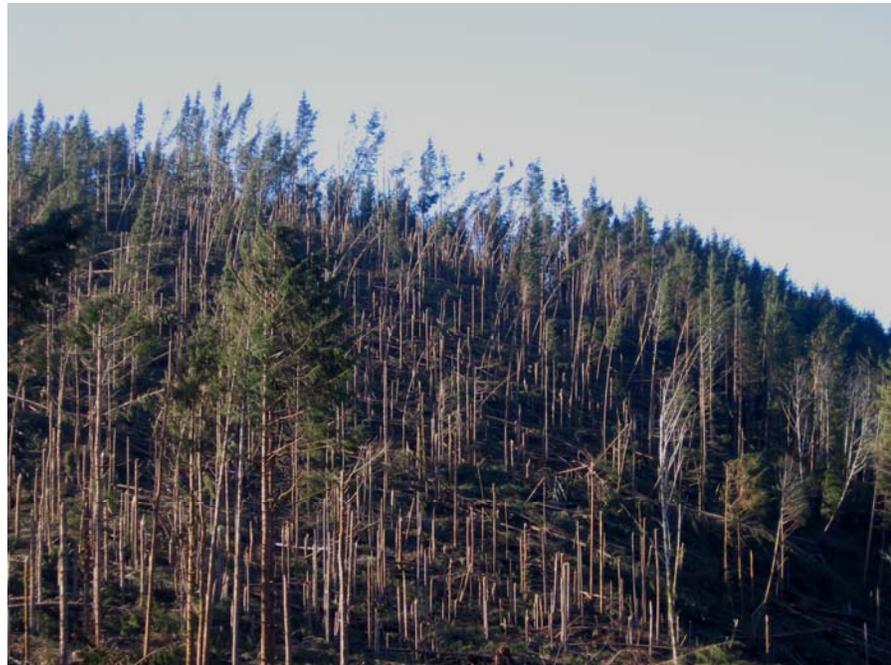
An estimated 16,500 acres of timber was heavily damaged by wind, which constitutes about 3 percent of Clatsop County’s total land base. The total **merchantable** volume (does not include estimated non-merchantable defect) is estimated at 260 million board feet, which is approximately 75 percent of what is harvested annually in the county (5-year average). This suggests that the milling capacity in the area is capable of handling the instantaneous influx of merchantable, wind damaged volume. If the timing of salvage is well-planned, and stand dominated by rot resistant species are salvaged last, then value losses due to decay can be minimized.

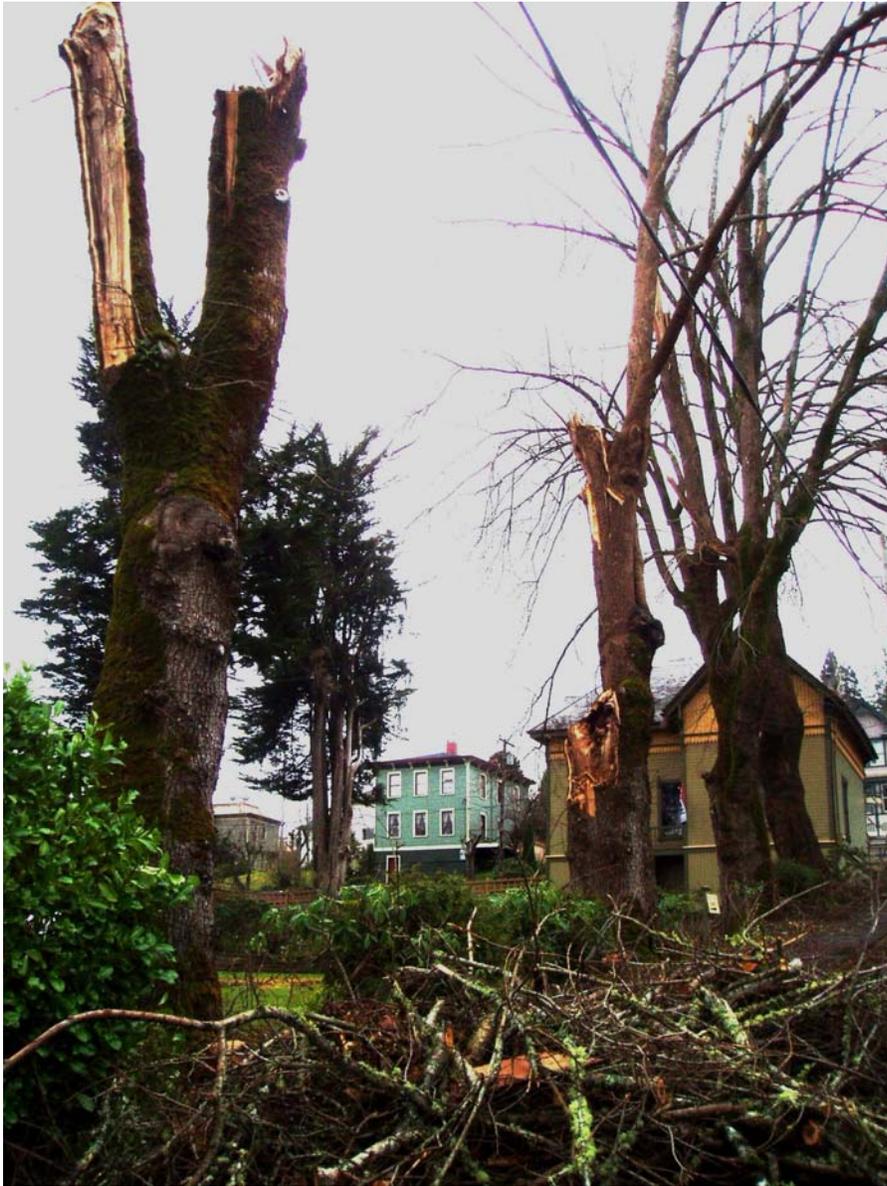
Within municipal boundaries and adjacent county properties, initial investigations suggest there is at least 8 million board feet of wind damaged timber. None of the 19 cities surveyed have a municipal tree inventory, so the responses collected is raw data and anecdotal information that has not yet been quantified in terms of the overall damage. See Appendix 4 for specific details.

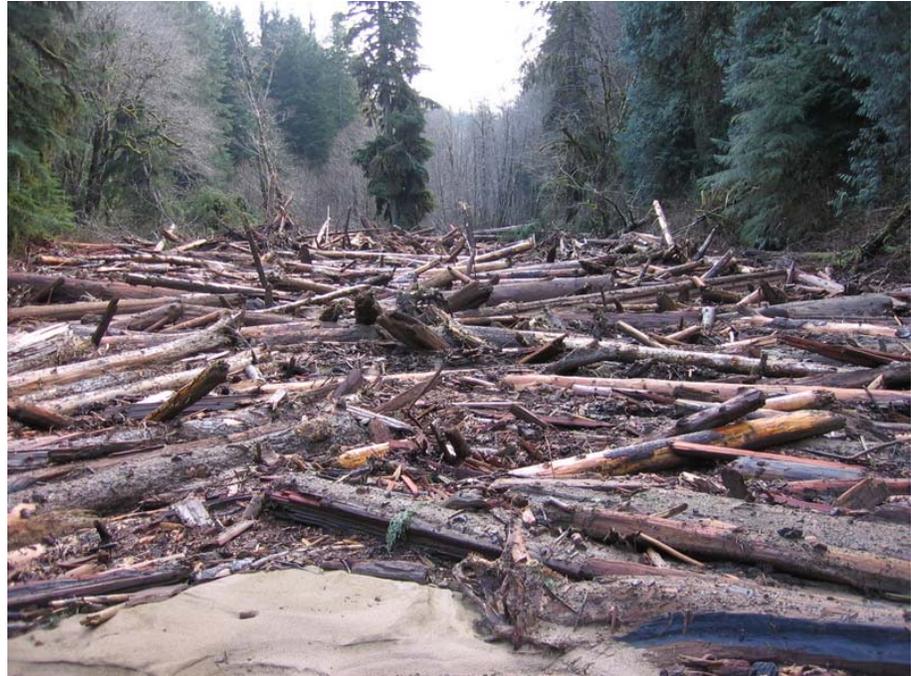
Most of the landslide and debris flows surveyed from this storm were concentrated in eastern Clatsop County, western Columbia County, and northeast Tillamook County, with scattered landslides elsewhere. The combination of intense rainfall on steep slopes composed of weak or highly weathered rocks and erosion-prone soils, (particularly in western Columbia County and the Nehalem River valley), and an

abundance of woody debris from standing and downed timber lead to the occurrence of flash floods, landslides, debris flows, and woody debris deposits.

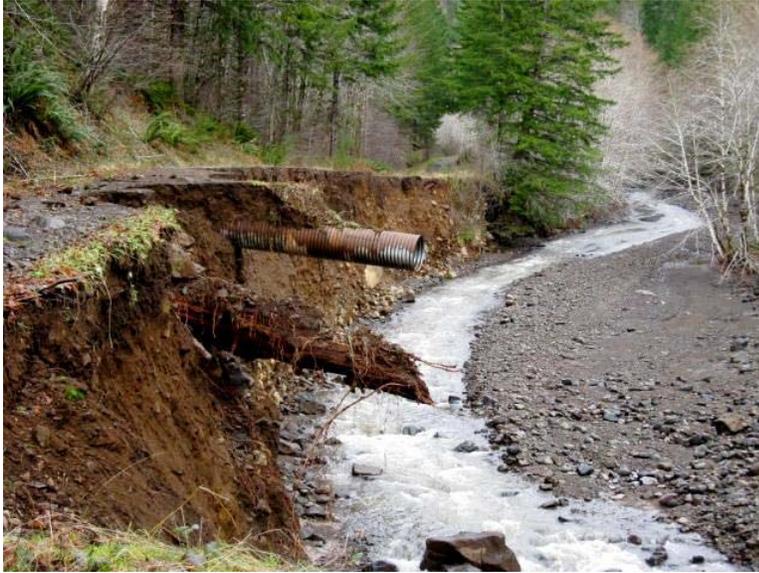
There are two distinct and separate types of forest road damage. The first is wind related. This damage is to road access, with limited damage to the actual road structure. The wind damage is greatest near Astoria. Most major roads have been opened. Wind damage to forests in the Astoria basin of the Clatsop State Forest and on some adjacent industrial forests to south is extensive, but with the planned response most roads should be open soon. Because most of these impacts should be resolved quickly, they have not been summarized.

Further east, in the same area with high landslide damage, many forest roads are impassable due to landslides, washouts, and bridge damage. Some of these sites will require drier conditions before repair can take place, so repairs may not be completed until next summer or later. In some cases, entire segments of a damaged road may need to be re-located.

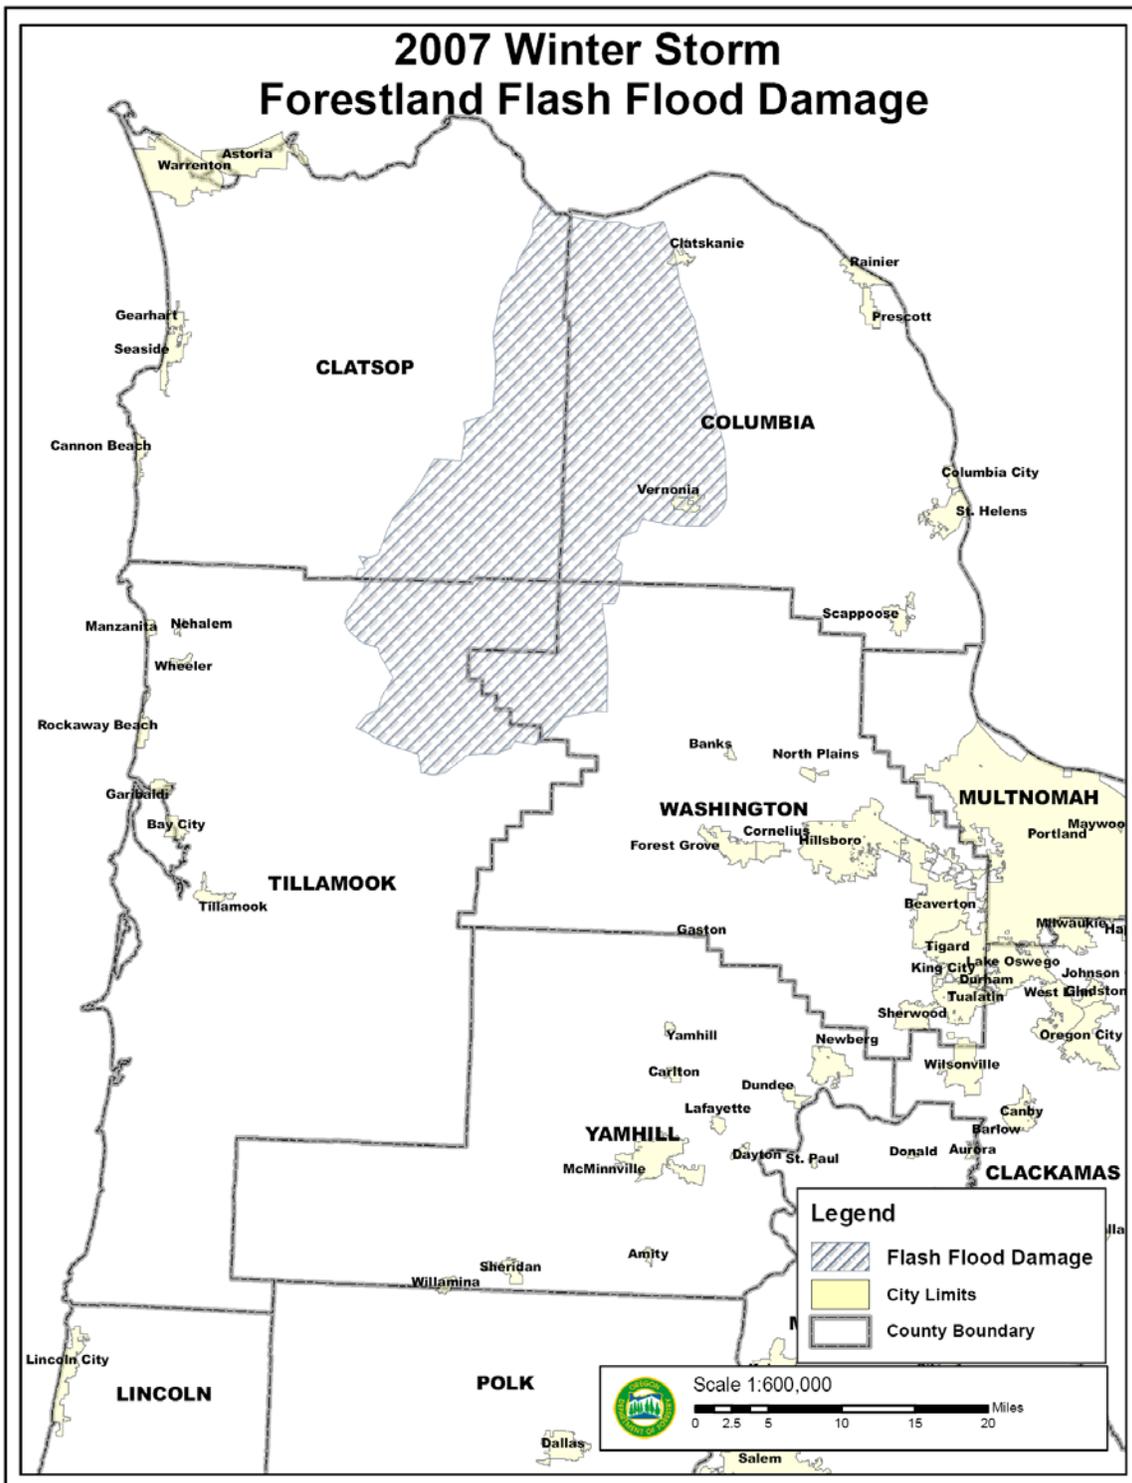
2007 Winter Storm Forestland Flash Flood Damage

The general proximity of the heaviest rainfall of the December 2007 storm was centrally located around the eastern half of Clatsop County, the western portion of Columbia County, the northeastern corner of Tillamook County, and the far northwestern corner of Washington County. The torrential rains in this general area resulted in a concentration of flash flood-related damage on forest lands (see Forest Land Flash Flood Damage Map, p. 20).
