Measuring the Impacts of Speed Reduction Technologies: A Dynamic Advanced Curve Warning System Evaluation

Submitted for presentation and publication to the
84th Annual Meeting of the Transportation Research Board
January 9–13, 2005

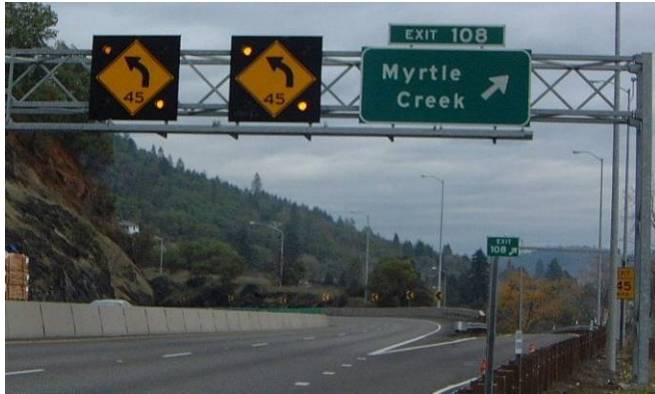
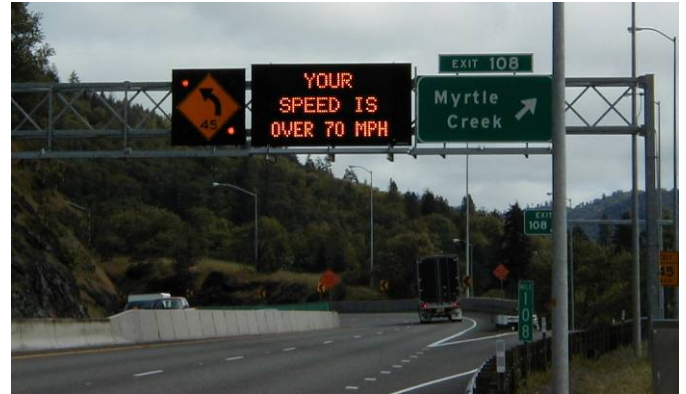
FIGURE 1 Northbound Sign Bridge, I-5 Milepost 108.00

Before

After

The static warning signing in place prior to the installation of the ACWS consisted of dual overhead horizontal alignment/advisory speed combination sign assemblies (MUTCD W1-2a) with 4 flashing beacons. A ground mounted truck rollover warning sign was also present (Oregon OW8-12) slightly upstream of the sign bridge in the northbound direction and on the sign bridge support pole in the southbound direction. There are chevrons (MUTCD W1-8) installed through the curves in the northbound direction but there are no chevrons in the southbound direction. The “before” sign conditions are visible in Figures 1 and 2.

The ACWS was installed for both northbound and southbound traffic. The system was installed in March 2004 and following field testing was made operational. The ACWS, as originally conceived, was to focus on trucks. Budget limitations, however, dictated that the system could only be designed to measure the speeds of all approaching vehicles without discerning between autos and trucks. As such, the system as deployed is designed to convey messages to all vehicles and is similar in concept to the system deployed by Caltrans in Shasta County, California. The Myrtle Creek ACWS consists of the following key elements at each sign location: a dynamic message sign (DMS), a radar unit for speed measurement, a controller unit and computer software to manage the speed inputs and (locally) modify the sign message. Fortunately, the existing sign bridges were of sufficient structural capacity to accommodate the DMS without modifications. For the northbound sign bridge one of the W1-2a assemblies was removed to provide sufficient space for the DMS. The DMS were installed overhead on existing sign bridges as shown in Figures 1 and 2.

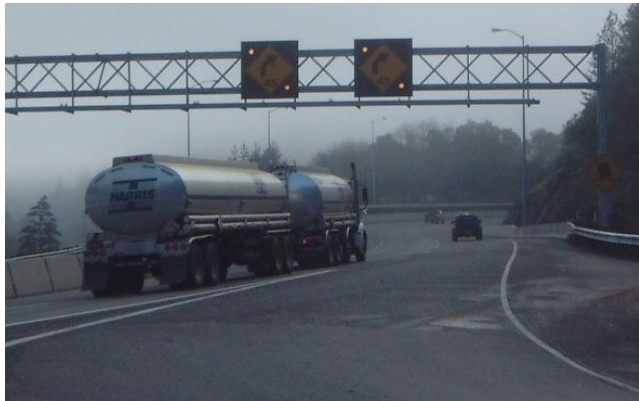
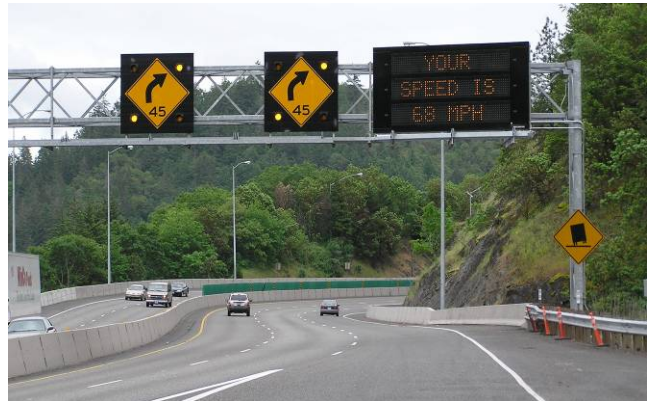
FIGURE 2 Southbound Sign Bridge, I-5 Milepost 108.35

Before

After

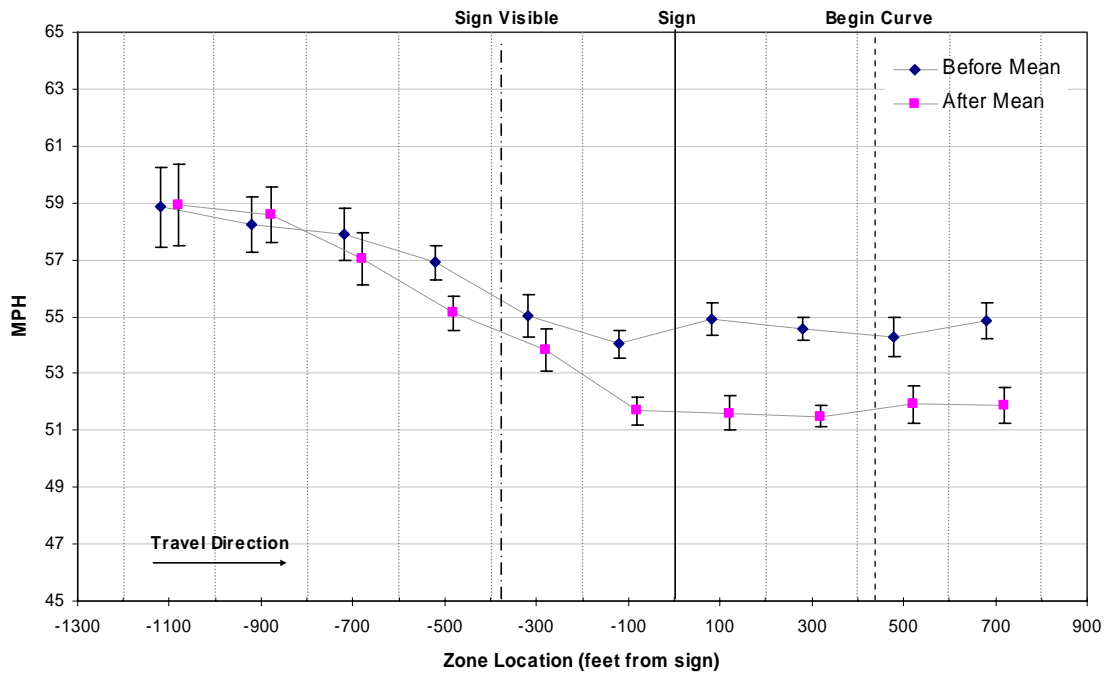
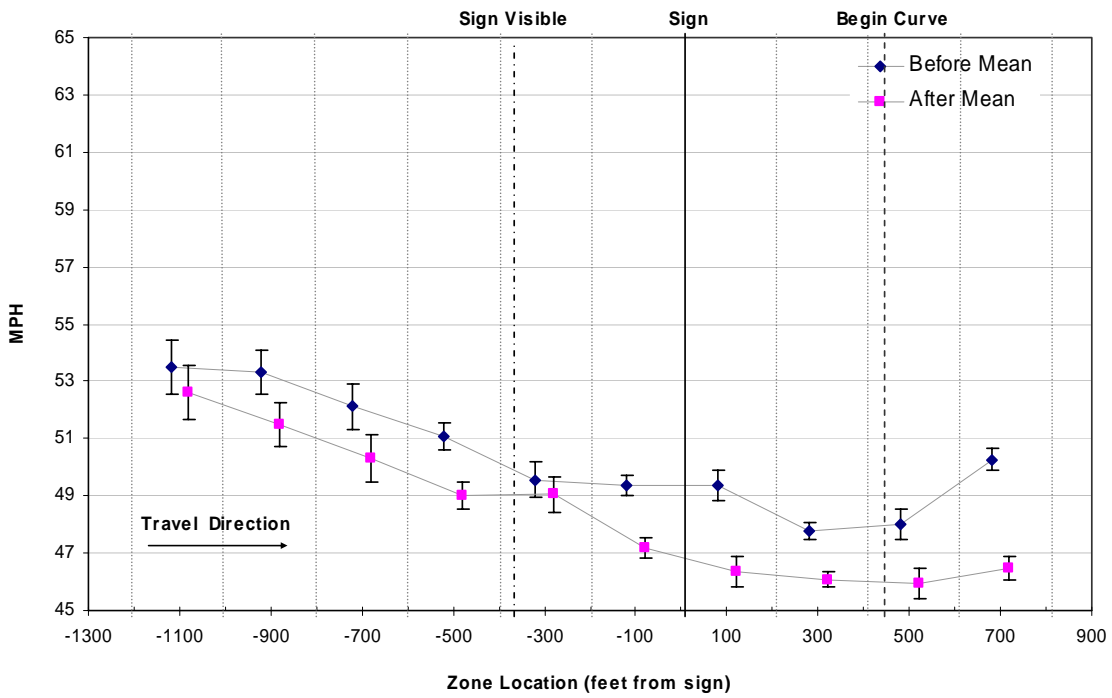
FIGURE 4 Before and After Comparison of Mean Speeds, Southbound

(b) Passenger Vehicles

(b) Commercial Vehicles

For each zone, the mean speed, the standard deviation, and the 95th percentile confidence intervals were calculated. These data are plotted for commercial and passenger vehicles for both directions in Figures 4 (a) and (b) and Figures 5 (a) and (b). As shown in the figures, distances upstream of the sign are displayed as negative numbers. For purposes of display, the mean speed for each speed zone is plotted at the midpoint of that zone. For example, the mean speed for the zone that includes all speed samples with distances from the sign to 200 feet downstream is plotted at +100 feet. The before and after speed midpoints are slightly offset for plotting purposes. For each direction, the location of the beginning of the curve, as measured from the ACWS was determined from the plan drawings. This distance is shown approximately on each chart in Figures 4 and 5. The ODOT digital video log,

The equality of means for the speeds of each vehicle class for each zone was tested using the *t*-test for significance. Results of the test are displayed in Table 3. For both directions, shown in Figures 4 and 5, the critical location for speed reduction is the location between the “sign visible” line and the “begin curve” line. It should be noted that all mean observed speeds lie above the posted advisory speed of 45 mph for the curve. The plots in Figure 4 for the sharper southbound curve clearly show a change in vehicle speed for both passenger cars and commercial trucks. For the farthest upstream zones, the before and after mean speeds are not statistically significantly different, as indicated by *t*-tests in zone -1100, -900, and -700 in Table 3 for passenger cars. As drivers approached the sign, however, there was a statistically significant reduction in the mean speeds that appears to be associated with the presence of the ACWS (because before speeds are similar when the sign is not visible). For commercial vehicles, the same speed trend is evident; however, the results are not as conclusive statistically. Only in the -1100 and -300 zone are the differences in speeds not significant. After the sign, starting in zone -100, all of the differences are statistically different. The maximum mean speed reduction occurred in the zone immediately following the sign location and is 3.3 mph for passenger cars and 3.0 mph for commercial vehicles.

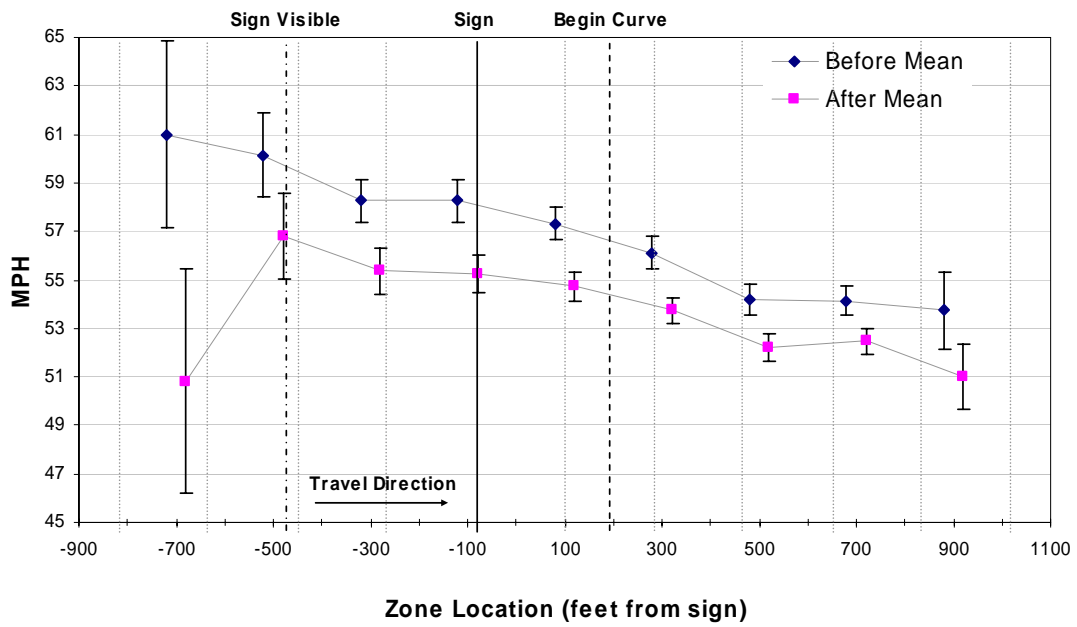
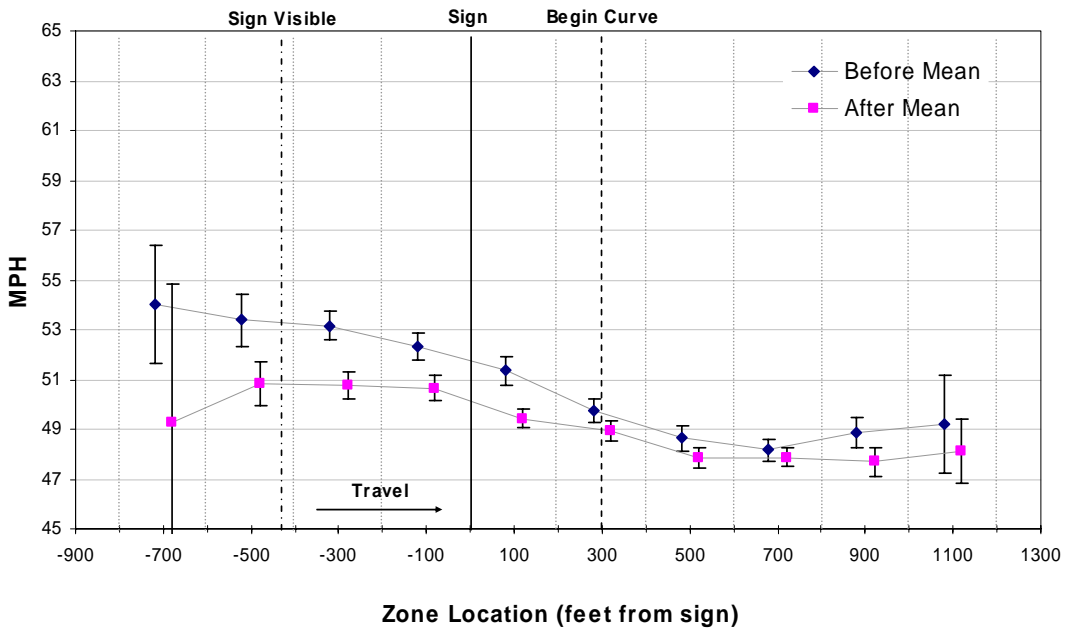
FIGURE 5 Before and After Comparison of Mean Speeds, Northbound

(a) Passenger Vehicles

(a) Commercial Vehicles

The plots in Figure 5 for the northbound curve also display reductions in the mean speeds after ACWS implementation, but the clear driver reaction to the sign observed in the southbound direction is not evident. The after speeds are statistically significantly lower in all zones except two (-700 commercial vehicles, and 700 commercial vehicles) making it difficult to conclude that speed reductions are attributable only to the ACWS. Part of the difficulty is related to the available data. Unlike the southbound direction, the data collection point was downstream of the ACWS, and as a result, data points in advance of the sign were not as easy to collect. For example, in the -700 zone, only 21 before and 10 after samples were collected. However, the data in Figure 5 show speed reductions after the ACWS deployment. There were maximum speed reductions of 2.6 mph for passenger cars and 1.9 mph for commercial vehicles. This is consistent with the southbound direction.

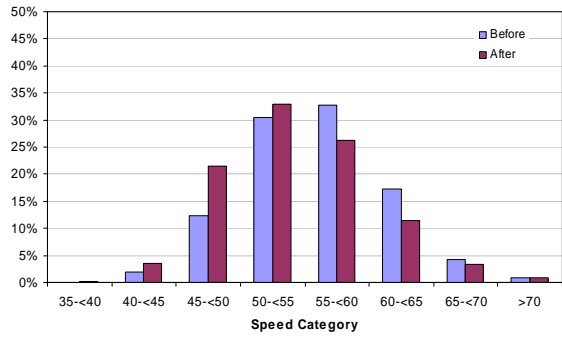
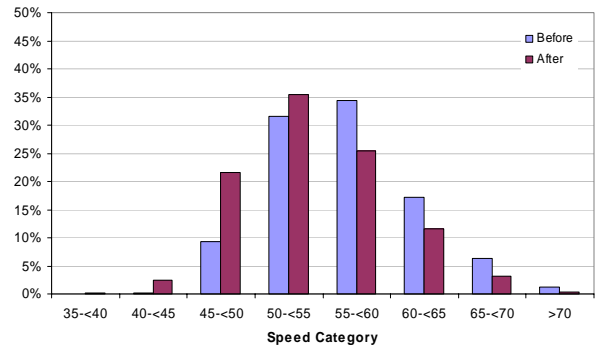
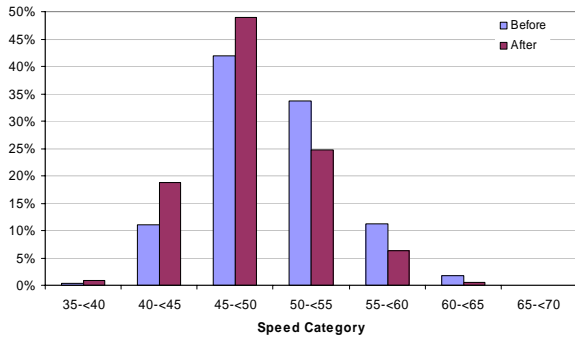
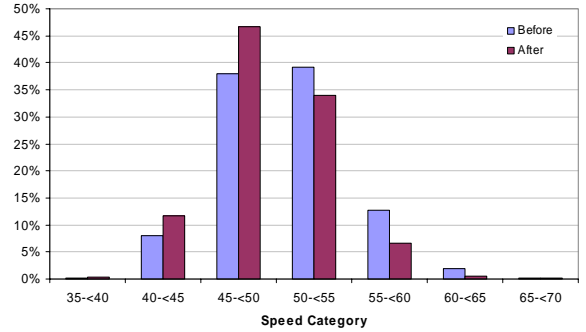
FIGURE 6 Before and After Comparison of Speed Distributions

(a) Southbound, Passenger Vehicles

(b) Northbound, Passenger Vehicles

(c) Southbound, Commercial Vehicles

(d) Northbound, Commercial Vehicles

The speed distributions were tabulated as a percentage of vehicles in each five mile per hour speed and are shown as histograms in Figure 6. The frequency distributions were compared with the chi-square test for goodness of fit. Examination of the speed distributions shown in Figure 6 indicates that there was a shift to the left in the after distributions relative to before distributions for all four graphs. This shift represents a lower number of vehicles in the higher speed bins and at least for commercial vehicles, a higher concentration of vehicles near the mean speed. The chi-square test indicated that all of these distribution shifts were statistically significant at a 95th percent confidence level.
