# PROJECT PROSPECTUS

Section:	Luckiamute River (Buena Vista Rd) Br #10307A (53C048)	Region:	Area:	District:
		2	3	3

**OREGON DEPT OF TRANSPORTATION  
BRIDGE INSPECTION REPORT**

## UNDERWATER INSPECTION REPORT

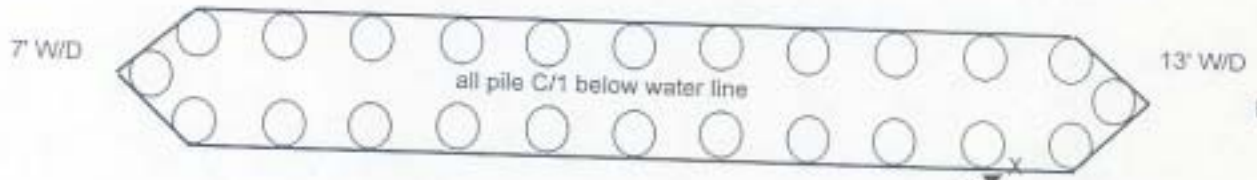
Bent 1

edge of water
