**A FITNESS-FOR-PURPOSE EVALUATION OF  
ELECTRO-SLAG FLANGE BUTT WELDS**

**FINAL REPORT**

**April 2002**

This report summarizes the fracture assessment of the flange plate butt welds in the four 1030-foot box girders of the George Abernethy Bridge (West Linn Bridge) on the I-205 crossing of the Willamette River at West Linn, Oregon. This study was undertaken at the request of the Federal Highway Administration (FHWA), per FHWA Notice numbers N5040.23 dated 2/16/1977, N5040.29 dated 2/23/1977 and HNG-30 dated 6/21/1978. The purpose of this study was to satisfy the FHWA request and insure the safety and serviceability of this structure. The objectives were to quantify the fracture potential of the welds in question and assess their suitability for continued service. The end result of this work is to provide a recommendation on whether to leave the welds in service or to make repairs.

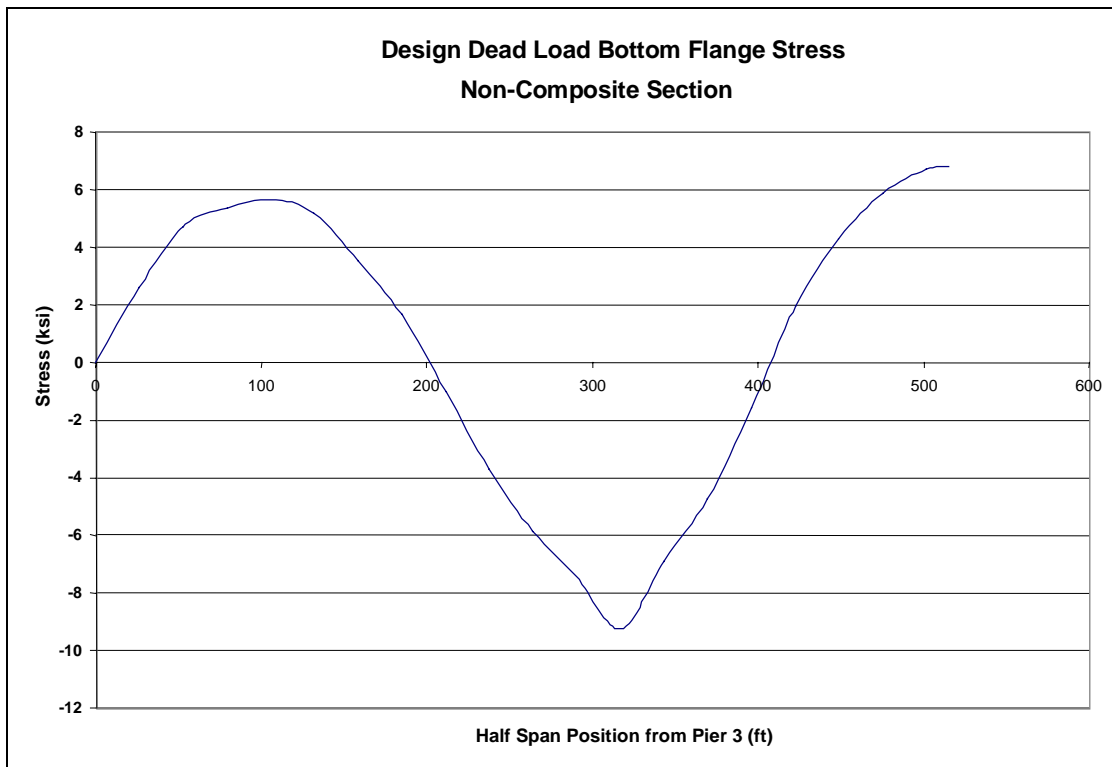
Figure 2.2: Calculated bottom flange stress from design dead loads

For the dead load, the stresses in the steel section were calculated assuming no composite action with the deck. Figure 2.2 shows the calculated bottom flange stresses due to dead load. Considering the top and bottom flange plates are nearly identical over the length of the girder, the neutral axis was assumed to be at mid-depth. Therefore the predicted top flange stresses are the same magnitude but opposite sign of the bottom flange stresses. The maximum dead load stresses are over the cantilever piers (4 and 5) with a magnitude of 9.3 ksi.

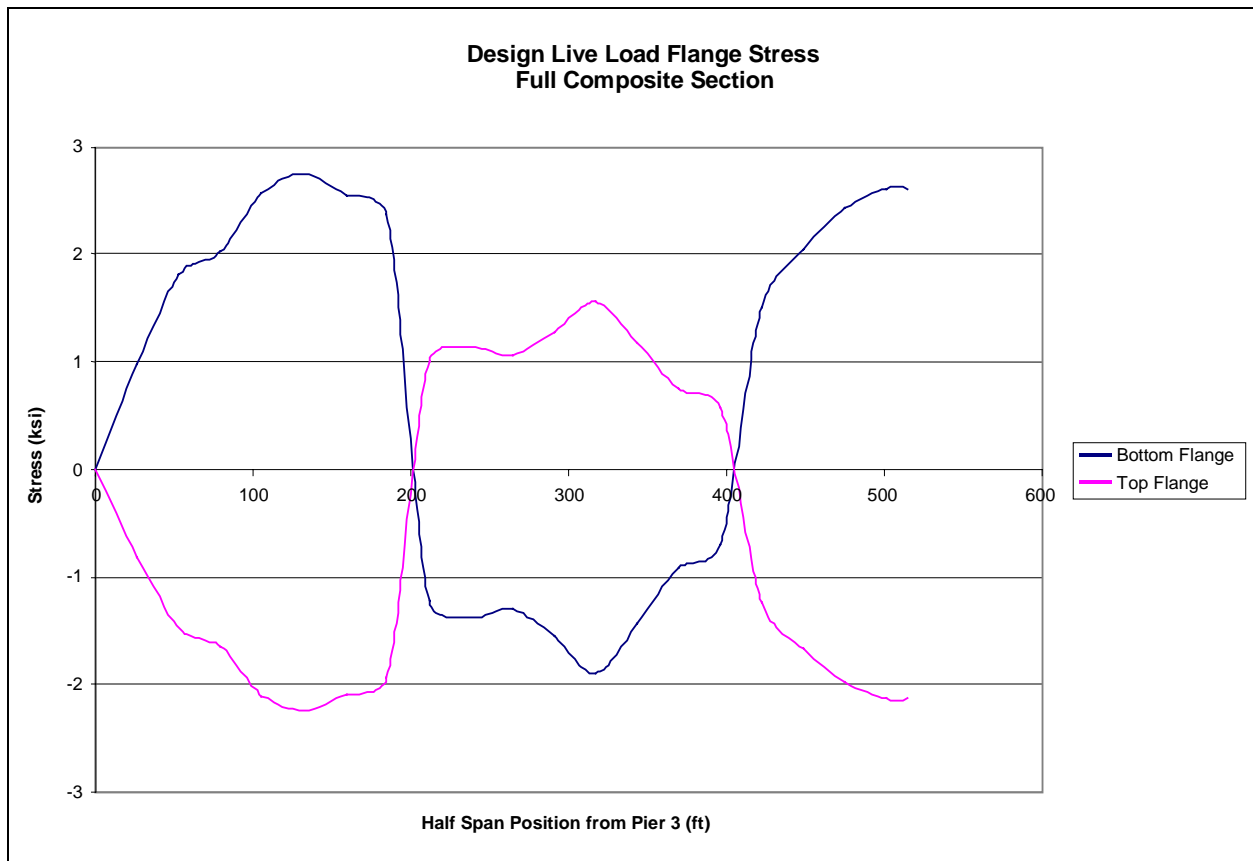
Figure 2.3: Calculated flange stresses from design live loads

Using the inflection points from the non-composite section and dead loads, a live load model was developed using composite section properties in the positive moment regions. The negative moment regions were left non-composite. Uniform lane loading was applied over the entire model, and point loads were applied mid-span between piers 4 and 5. Figure 2.3 shows the resulting live load stress influence lines for the top and bottom flanges of the box girder. The maximum live load stress range is 2.8 ksi and occurs near  $0.4L_1$  in the bottom flange of span 4

between piers 3 and 4.  $L_1$  is the length of the end span in a three-span structure. Span 5 between piers 4 and 5 has a bottom flange stress range of 2.7 ksi and the stress in the top flange above the cantilever piers is 2.3 ksi.

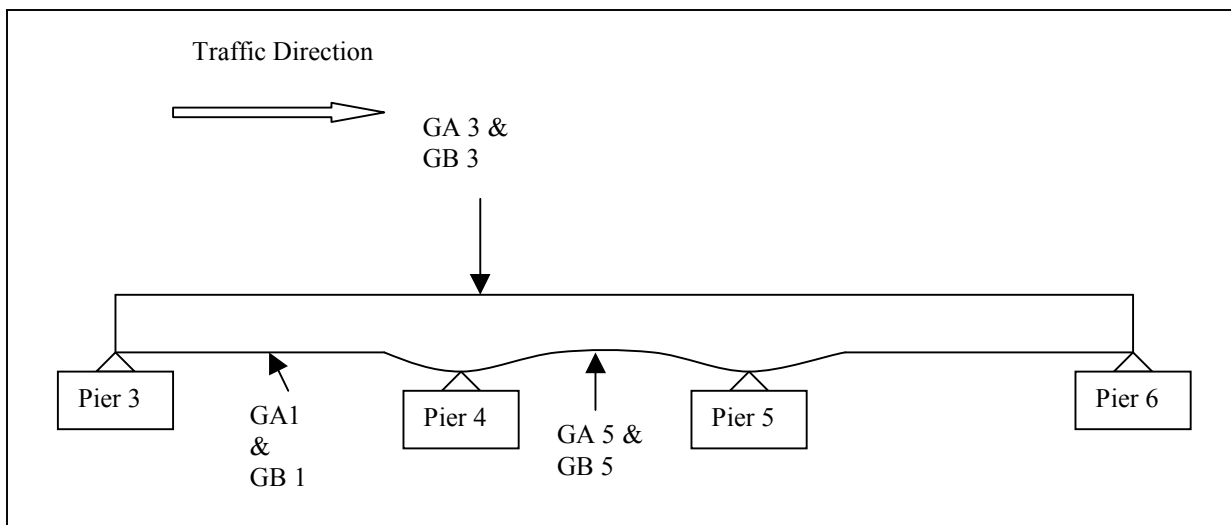
Figure 2.4: Location of strain gauges in A and B girders

In order to better characterize the live load spectrum, two of the four steel box girders were fitted with strain gauges. Uniaxial strain gauges were installed coincident with the longitudinal direction of the girder. The first location was inside the girder midway across span 4 on the upper surface of the bottom flange. This gauge is labeled GA1 and GB1 in girders A and B respectively in Figure 2.4. This location was subjected to positive bending and was near the theoretical position of maximum moment at  $0.4L_1$ .

The second location was on the underside of the top flange centered over Pier 4. This was the position of maximum negative bending moment. The gauges at this location are labeled GA3 and GB3 in Figure 2.4 for girders A and B respectively. The third gauge installation was midway across span 5, the navigation channel. This was a region of large positive bending moments. Gauges labeled GA5 and GB5 were mounted to the top surface of the bottom flange in girders A and B respectively. Figure 2.4 shows the gauge locations in elevation view.

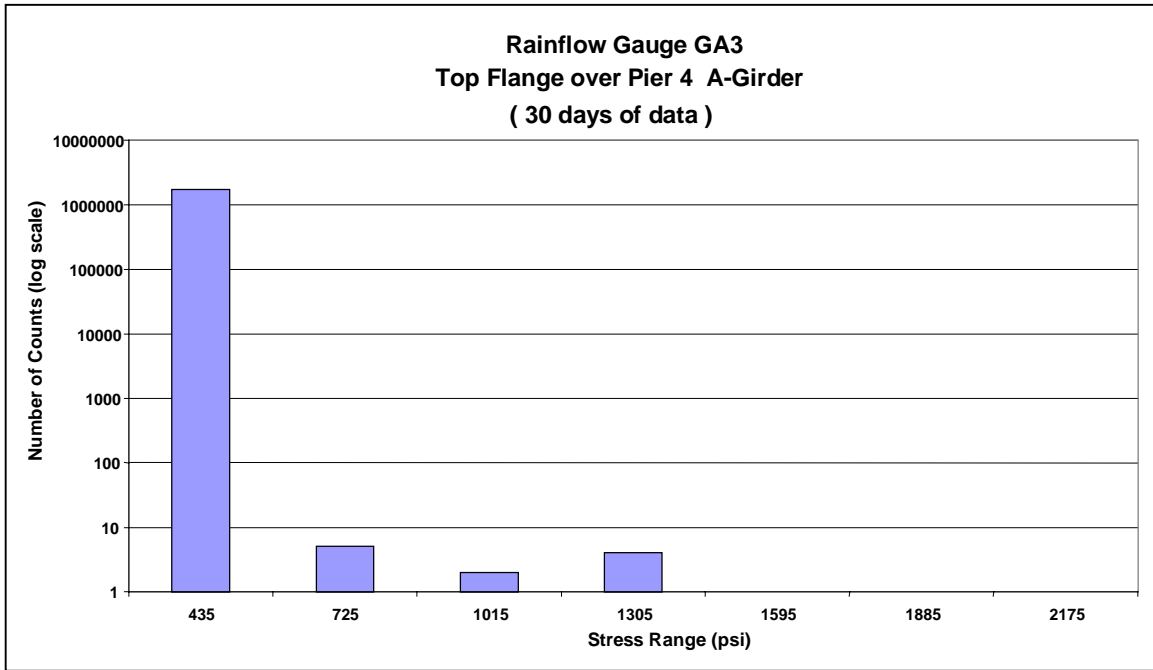
Girder A had the longest test duration at 30 days or approximately 720 hours. Figures 2.5- 2.7 show the histograms of the stress cycle counting gauges GA1, GA3 and GA5 respectively. The maximum stress cycles recorded were 2175 psi, 1305 psi and 1885 psi. The root-mean-cube (r.m.c.) effective stress ranges,  $\Delta\sigma_{rmc}$ , for these distributions were 465 psi, 435 psi and 452 psi.

Figure 2.5: Rainflow histogram for gauge GA1

Figure 2.6: Rainflow histogram for gauge GA3

Figure 2.7: Rainflow histogram for gauge GA5

The effective stress range for these distributions was greatly influenced by the large number of low stress cycles from lighter vehicles. If only stress cycles with magnitudes above 500 psi are counted, then the effective stress range increases to 831 psi, 1054 psi and 795 psi respectively. These could be considered the r.m.c. stress ranges for truck traffic. Both of the mid-span positive moment locations showed higher stress ranges than did the negative moment location over pier 4. As expected, the pier 4 location showed a much higher number of measurable cycles, since trucks on spans 4, 5 and 6 could cause load changes in these flange plates.

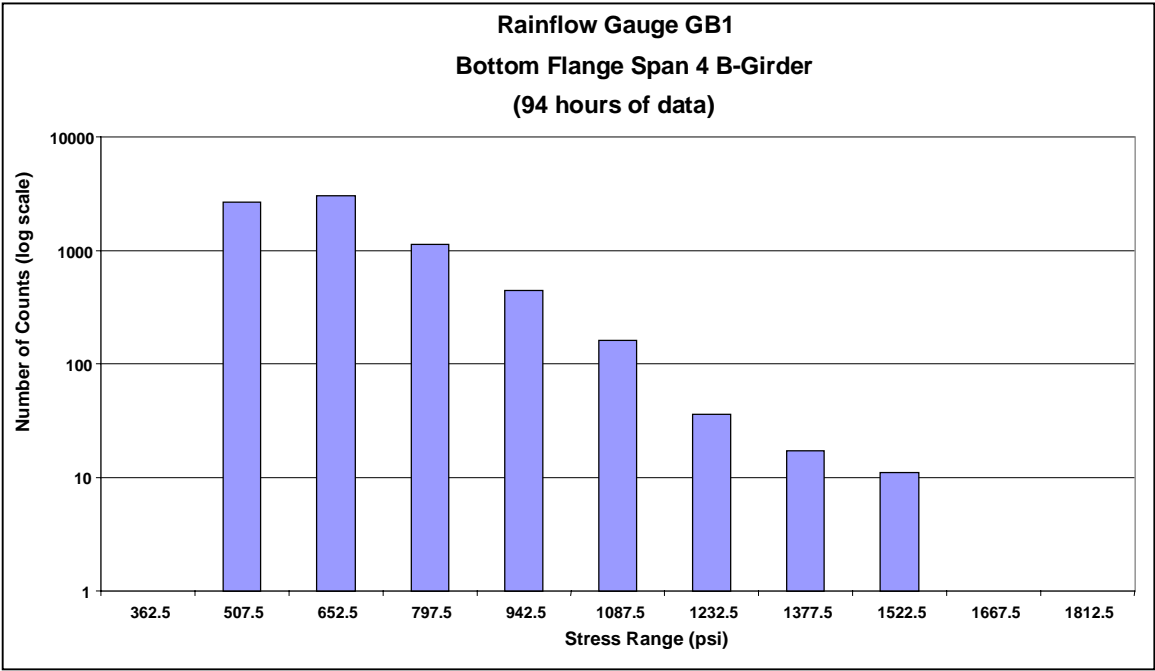
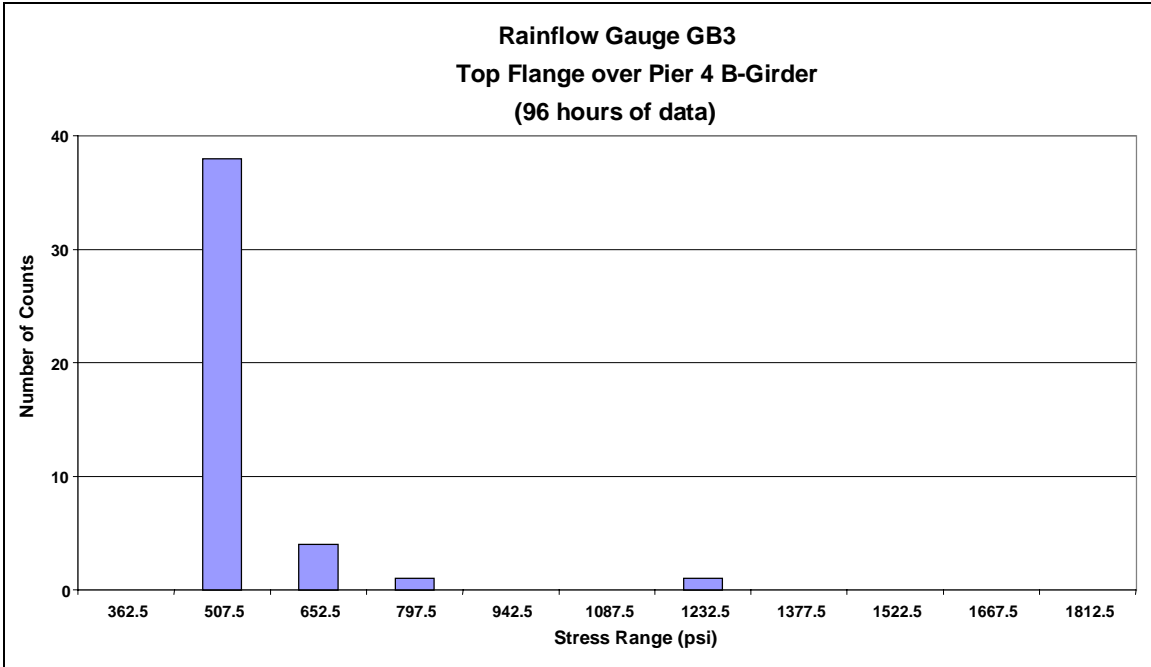
Girder B had test lengths ranging from 94 to 169 hours. Figures 2.8 - 2.10 show the histograms of the stress cycle counting for gauges GB1, GB3 and GB5 respectively. The maximum stress cycles recorded were 1812 psi, 1233 psi and 1812 psi for GB1, GB3 and GB5 respectively. The  $\Delta\sigma_{rmc}$  for these distributions were 694 psi, 577 psi and 689 psi. If only stress cycles with a magnitude greater than 500 psi are counted the effective stress ranges become 764 psi, 835 psi and 1060 psi. These data are summarized in Table 2.1.

Figure 2.8: Rainflow histogram from gauge GB1

Figure 2.9: Rainflow histogram from gauge GB3

Figure 2.10: Rainflow histogram from gauge GB5

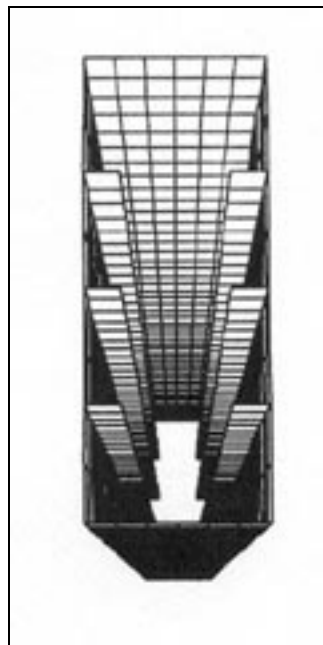
Figure 2.13: End view of finite element model used to estimate thermal stresses in flange of box girders

An attempt to quantify thermal stresses was made using finite element analysis (FEA). Figure 2.13 shows the mesh of a thermal stress model of a section of box girder. One web plate was given an increasing thermal load while the other was held at constant temperature. The flange plates were also held at the same temperature as the cooler web plate. As the heated web plate increased in temperature, internal forces shift and the flanges were put into in-plane bending due to the difference in thermal strain in the webs. Longitudinal stiffeners were added to prevent buckling of the web plates, which would manifest itself as a numerical instability in the FEA model. The stiffeners incorporated into the model supplied slightly more stiffness than those in the real girders. This error, though necessary for numerical stability, yielded conservative results due to the extra section that imparted larger thermal loads into the flanges. Based on the measured temperature data, a temperature gradient between opposite web plates of less than 50° F was typical for a sunny summer day.

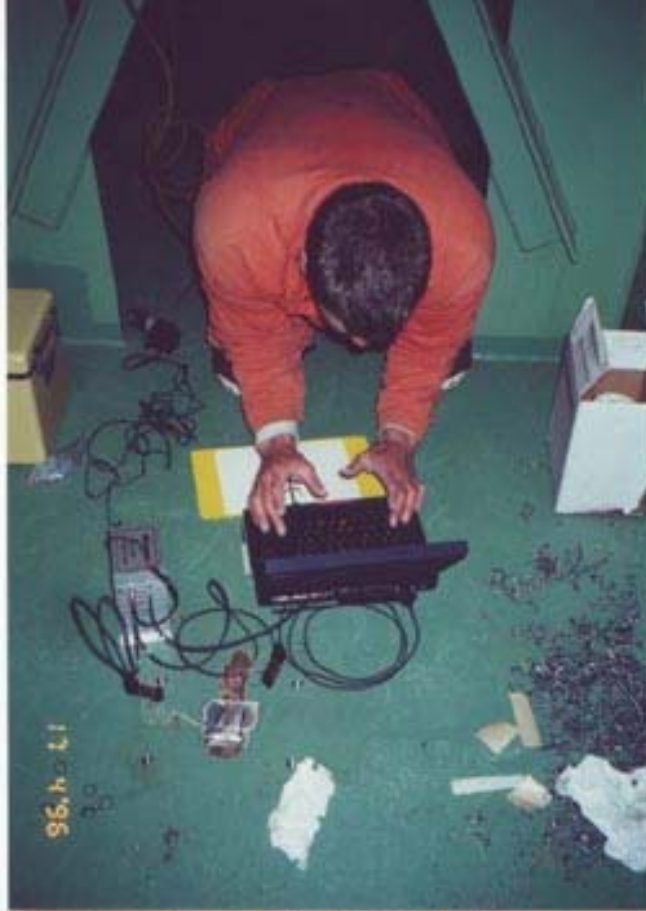
Figure 2.17: Weld metal core strain measurements. Top photo shows gauge reading prior to core removal and bottom photo shows strain measurements after cores were removed from flange ESW.

Figure 2.17 shows core strain measurements before and after removal from the compression flanges. Figure 2.18 shows one of the strain rosettes being read during the hole-drilling method (E837) of residual stress measurement.

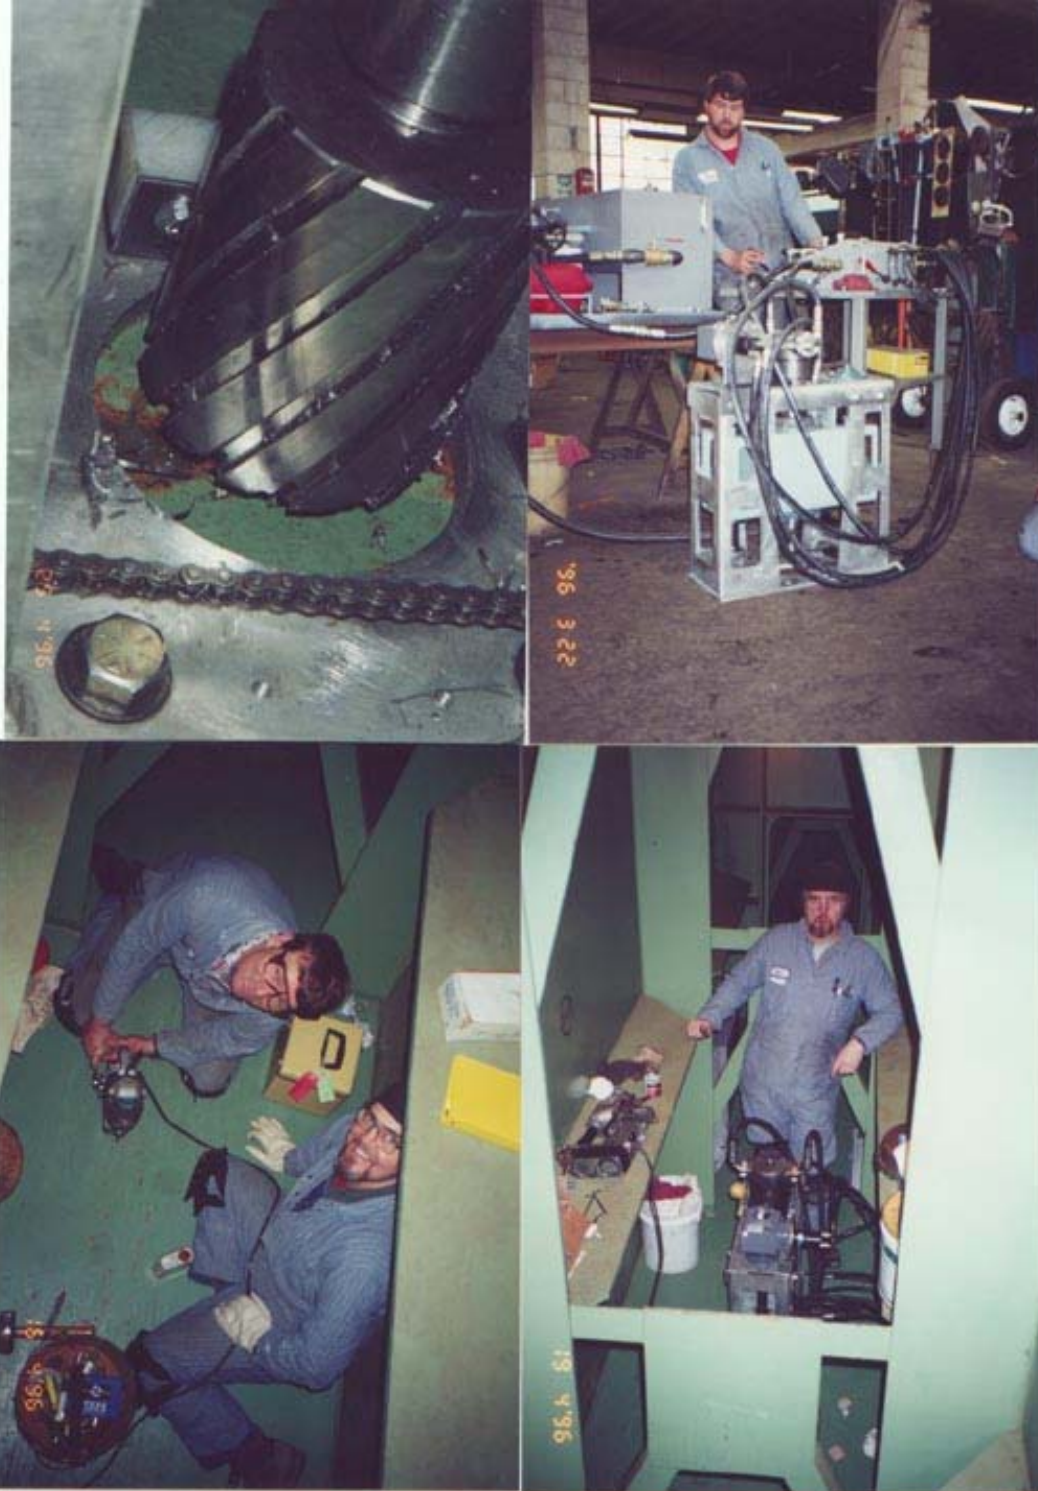
Figure 3.1: Coring ESW for material testing: 1) top left: close-up view of 4-inch diameter cutter; 2) top right: custom built drill; 3) bottom left: drilling and tapping mounting holes; 4) drill in place ready to core

The material testing plan required compact tension specimens with a thickness on the order of 1 inch, which means that the size of the core extracted from the flange needed to be at least 3 inches in diameter. The largest trepanning type core drill located would remove a 3½-inch diameter core. Finding a portable machine to operate this cutter at its recommended speed was very difficult. The cutter is designed for fast and efficient stock removal used in production work. Cutting a 4-inch diameter hole 3½ inches deep in less than 60 seconds requires large values of torque and horsepower for a portable machine. A custom drill was designed and fabricated, as shown in Figure 3.1. This unit developed over 800 ft-lbs of torque at the cutter and required nearly 27 hp to run the hydraulic pump, which was remotely located on the roadway.

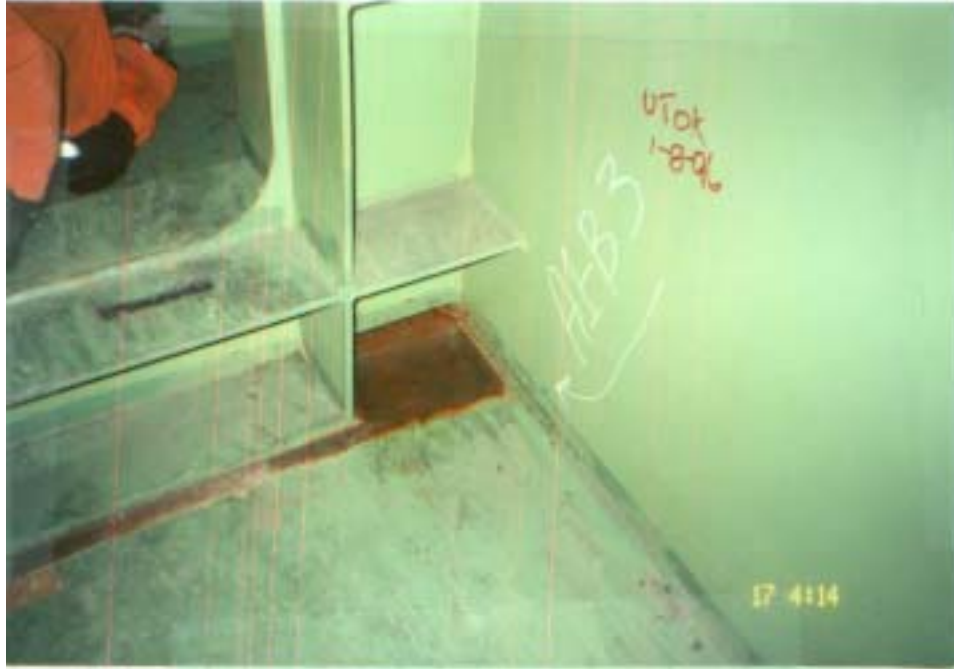
Figure 5.4: Fatigue Category E' detail found in box girders at diaphragm connection to flange. The detail does not effect the butt welds.

It should be noted that there is a fatigue Category E' detail fabricated into the box girders. At the access hole in each diaphragm, a 3/4 inch thick plate has been welded to the bottom flange. Figure 5.4 shows a picture of one of these details. The CAFL for Category E' is 1.3 ksi, which, using the above procedures, is predicted to have a finite fatigue life because the maximum stress range measured exceeds the CAFL. Using an effective stress range of 1000 psi and an ADTT per direction of traffic of 3500, the estimated remaining fatigue life of these details is 280 years. None of these details is attached to an ESW in this structure and thus does not effect the fatigue lives of the welds in question.
