**A FITNESS-FOR-PURPOSE
EVALUATION OF FRACTURE
CRITICAL ELECTRO-SLAG WELDS**

FINAL REPORT

Steven Lovejoy PhD, PE
Bridge Engineering Section
Oregon Department of Transportation
Salem, Oregon

March 2009

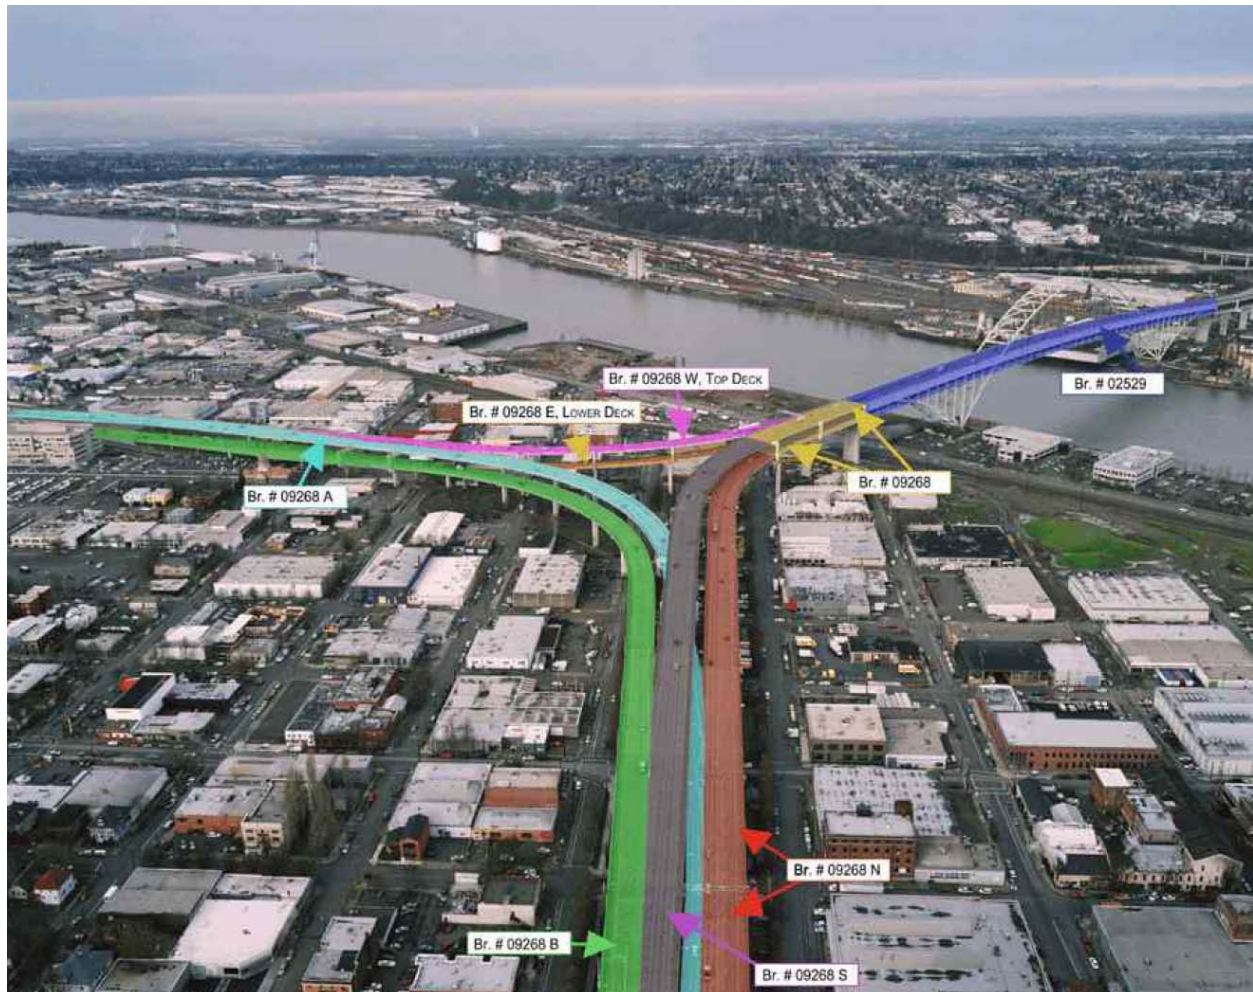
Figure 1.1: West Fremont approach complex.

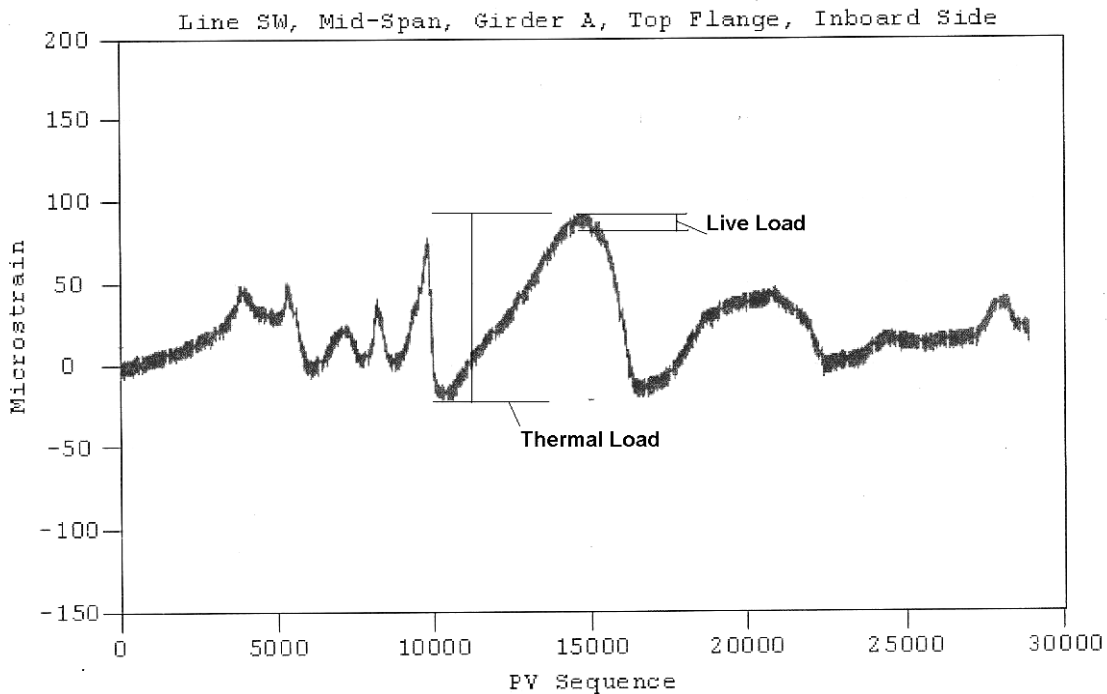
Figure 3.6: Typical peak-valley strain data for a top flange in positive moment section.

The peak-valley strain history presentation took the full transient time history and removed data where there was little to no change in strain. This is particularly useful for highway bridge loading that has cyclic loading with randomly occurring components in the temporal domain. Typical results for the top and bottom flanges at both positive and negative moment sections are shown in Figures 3.6 through 3.9 respectively.

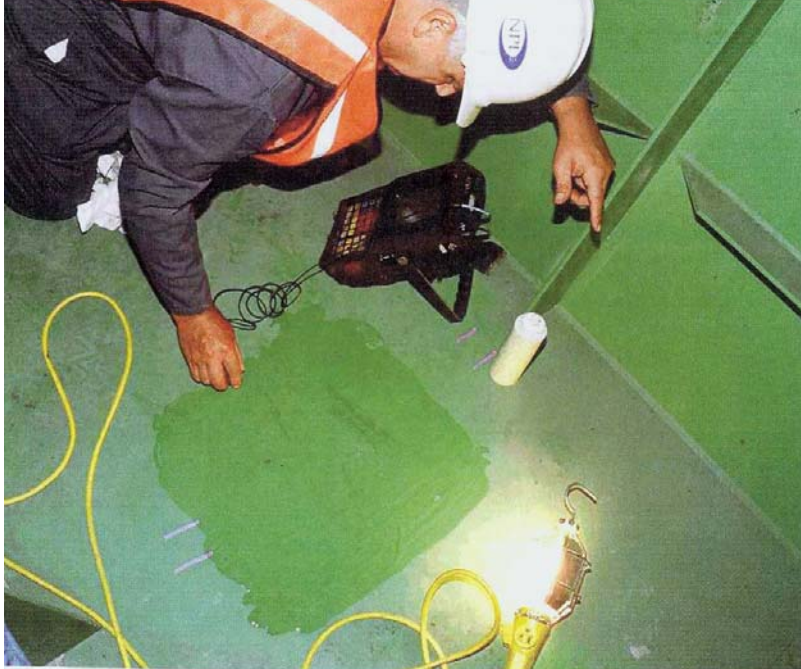
Figure 4.1: Ultrasonic testing of ESW prior to core removal.

At each core location the coating was removed from the top flange face and the surface was acid etched to precisely locate the weld and HAZ. Ultrasonic Testing (UT) was performed at each proposed core location to verify defect free material. The cores were removed and structural compression plugs were installed in each hole to replace the material. Details of the core removal can be found in the MEI-Charlton Inc. report (2007). Figure 4.1 shows the UT prior to core removal. Figure 4.2 shows an etched ESW prior to core removal (including probable SMAW shop repairs to undercut near the fusion boundary). Figure 4.3 shows the core removal. Figure 4.4 shows the core plug and its installation. Figure 4.5 shows the Phase 1 cores after removal. Figure 4.6 shows the Phase 2 cores after removal.

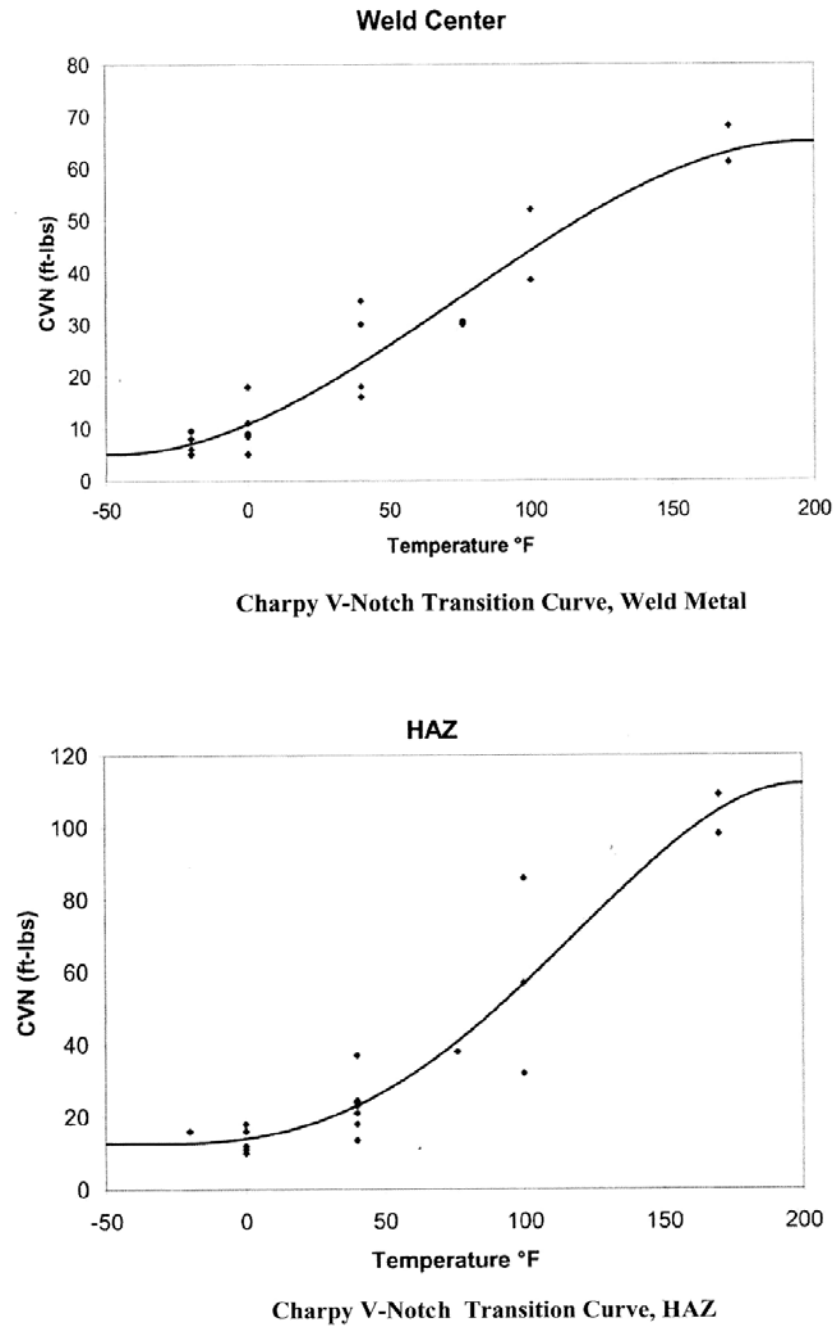
Figure 4.7: Results of Phase 1 impact testing of ESW cores.

The data labeled “center” was extracted from mid-thickness or T/2 of the core. The data labeled ‘surface’ was extracted at the quarter point or T/4. As discussed in the MEI-Charlton Inc. report (2007), the HAZ samples were mounted, polished and etched after testing to confirm the location of the notch tip relative to the microstructure. The notches were found to be located 1 to 2 mm off of the intended HAZ microstructure, so the test results are more indicative of the impact energy of the weld metal near the HAZ. The minimum recommended impact energy required for qualifying standard gap ESW of 15 ft-lbf is shown on the plotted data. The all-weld metal was substandard at 0°F, but the HAZ passes the recommendations at 40 °F.

Ten CVN test bars were machined from each of the five Phase 1 material cores, yielding a total of 50 test bars that were tested from -20 to 170 °F. The results of the impact testing can be seen in Figure 4.7.

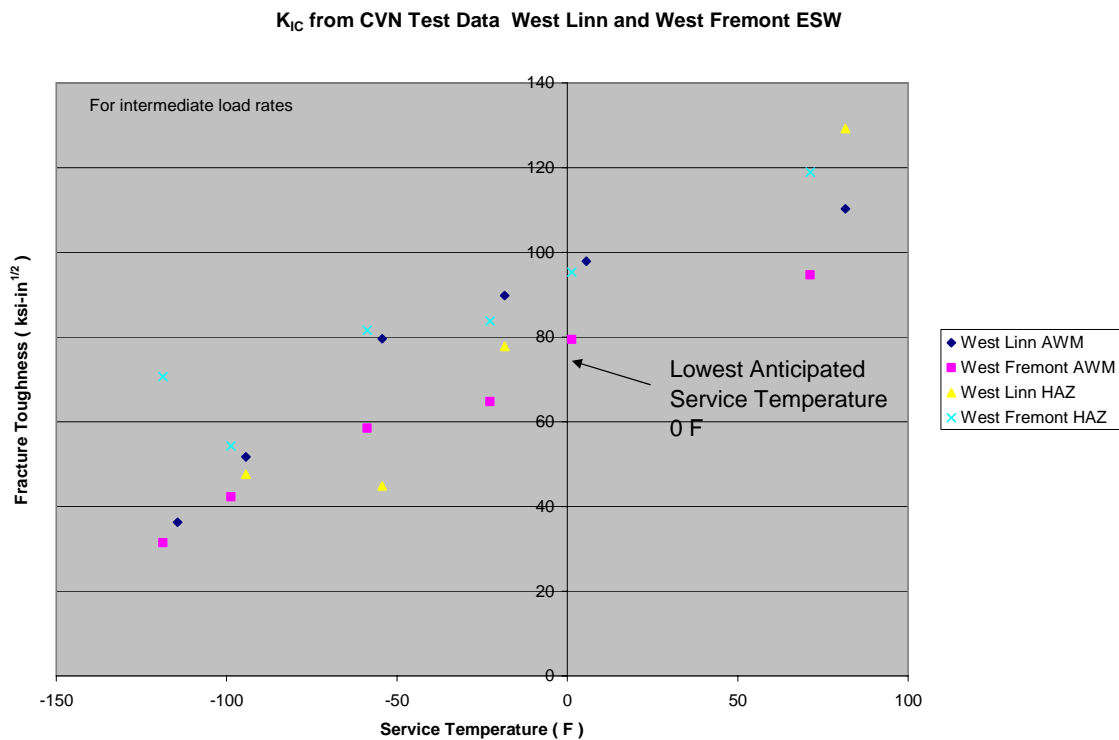
Figure 4.8: Estimated fracture toughness from impact data using the Barsom-Rolfe two stage correlation to adjust for intermediate loading rates.

The impact test data were used to estimate the fracture toughness of the weld metal and HAZ using the Barsom-Rolfe two stage correlation between Charpy V-notch (CVN) impact test data and plane strain fracture toughness K_{IC} data for bridge steels at intermediate strain rates (*Barsom and Rolfe 1987*). Figure 4.8 shows the results of this correlation for both the West Fremont (current study) and West Linn (similar previous study) Phase 1 testing. The data shown are averages from each set at each temperature. This correlation predicts that the weld metal and HAZ will have a fracture toughness between 80 and 95 $\text{ksi}\cdot\text{in}^{1/2}$ at the LAST of 0°F.

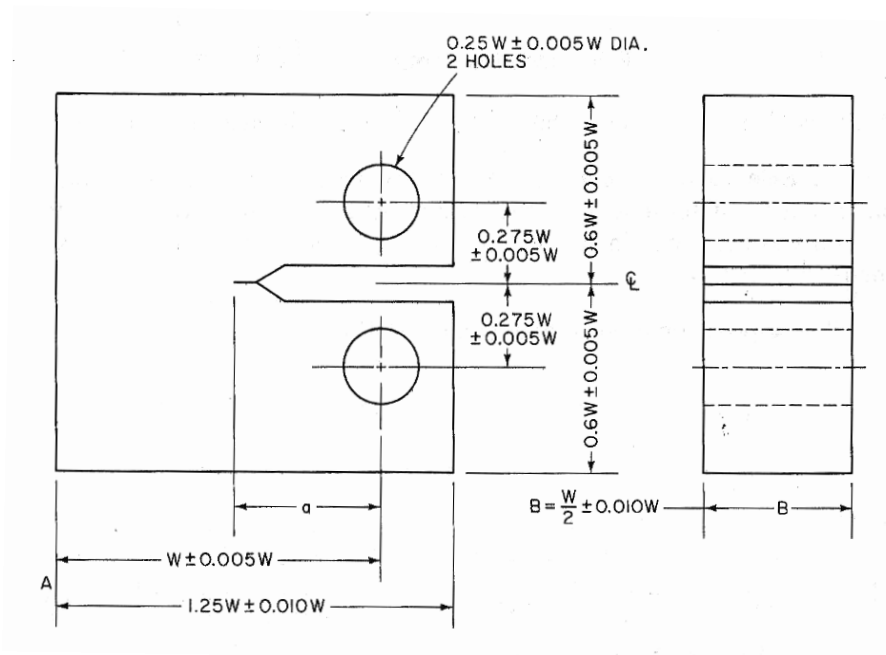
Figure 4.9: Compact tension specimen geometry used for JR curve and crack growth testing.

The test specimens were machined into compact tension specimens with the geometry shown in Figure 4.9 and 4.10. The specific specimen measurements are summarized in Table 4.2.

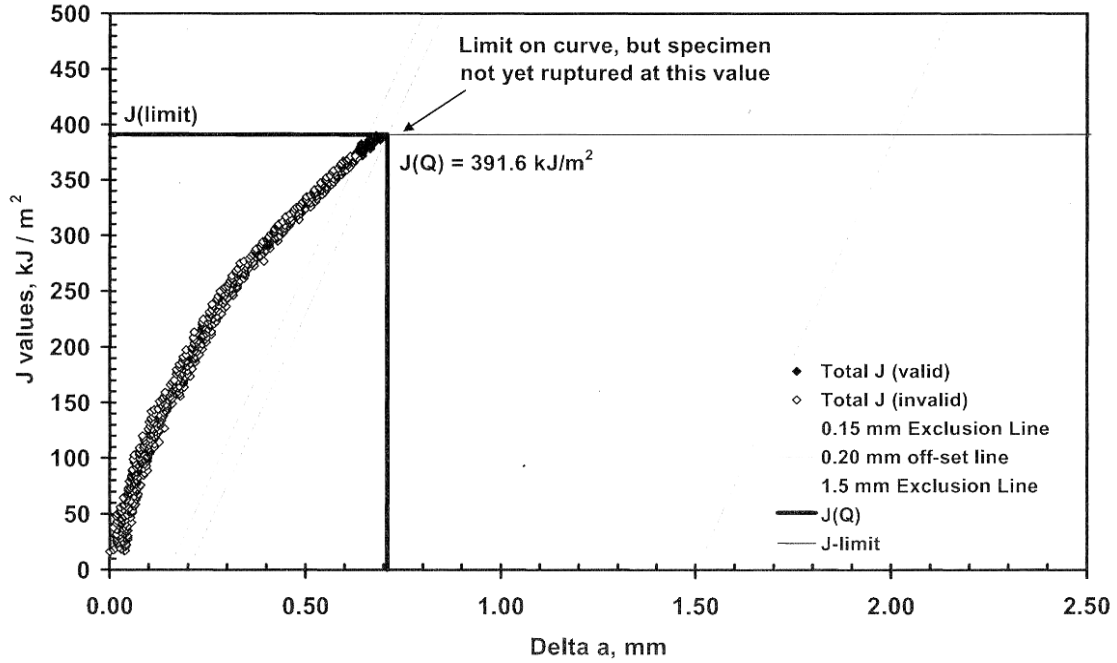
Figure 4.12: HAZ JR curve for specimen 6-WS4AB2 at 0 °F.

The data for the HAZ specimens revealed a steeper slope and had $J(Q)$ values higher than those for the base metal specimen. Specimen 9-WS3AB4 and specimen 11-WS1AB5 failed suddenly within the area of J-R valid values, as seen from the sudden increase in crack length at 976 and 1937 lbf/in (171 and 339 kJ/m^2), respectively. See Figures 4.12 and 4.13. Specimen 6-WS4AB2 did not fail below the J-limit value for valid test data to be reached, and therefore that value 2236 lbf/in (391.6 kJ/m^2) was reported as $J(Q)$. See Figure 4.14.

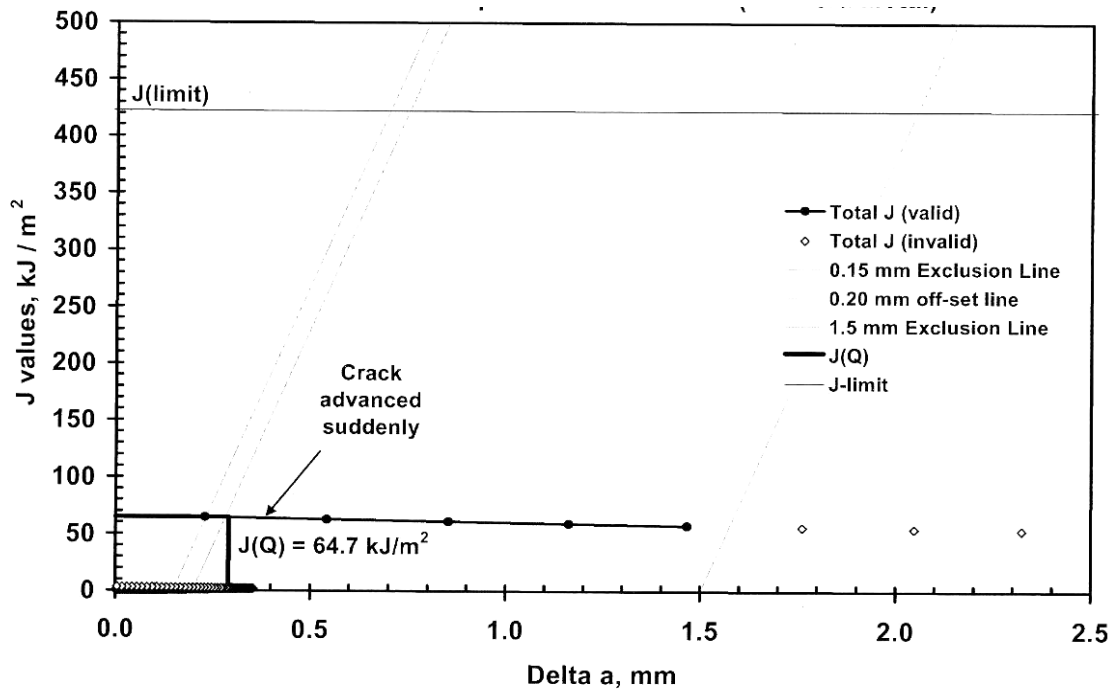
Figure 4.15: Weld metal JR curve for specimen 7-WS4AB1 at 0 °F.

The data for the AWM specimens was difficult to interpret. The EPD signals during the first phase of load increase showed an erroneous crack increase, followed by a decrease to the approximate initial value for the specimens. This is visible as a “nose” in the JR-curves; see figures 4.15, 4.16 and 4.17. This phenomenon occurred in the normally elastic deformation range, where the crack is not expected to grow, but the plastic zone size around the crack tip can increase. By ignoring the nose, and proceeding with the standard analysis of the remainder of the data, a J(Q) value for the specimens could be determined, nonetheless. The three specimens (Specimen 7-WS4AB1, 8-WS3AB5 and 12-WS1AB4) behaved approximately the same, with values of 369,332 and 397 lbf/in (64.7,58.2 and 69.6 kJ/m²), respectively.

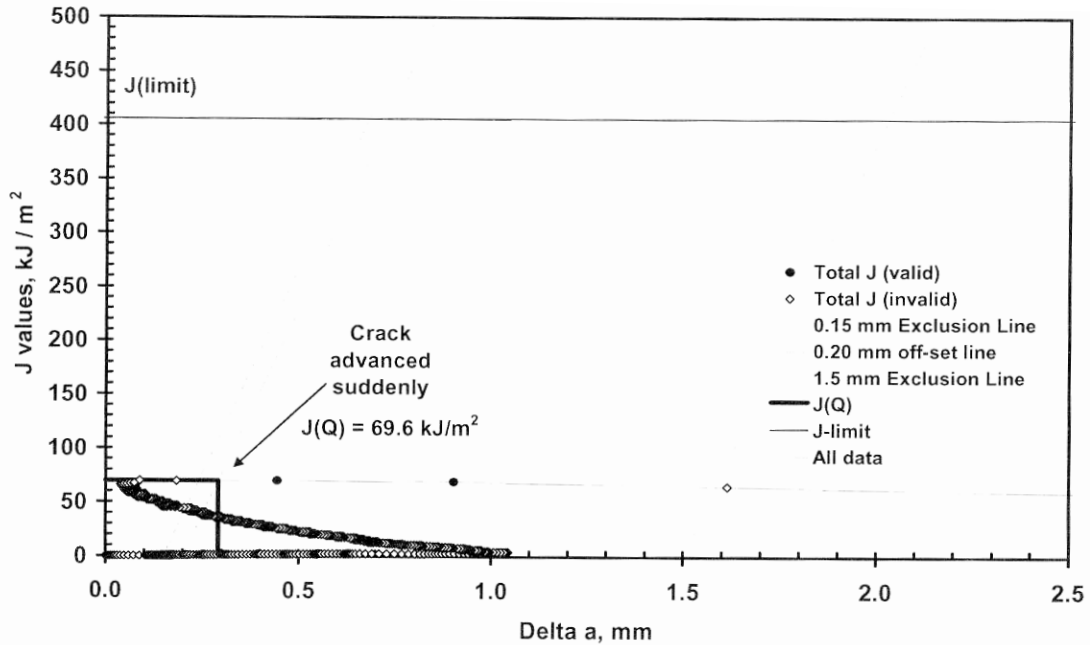
Figure 4.17: Weld metal JR curve for specimen 12-WS1AB4 at 0 °F.

Crack propagation of the all-weld metal (AWM) specimens at zero degrees F is by cleavage, which entails very little plastic deformation or stable crack growth. For these tests, performed in accordance with ASTM E1820, the Electrical Potential Displacement (EPD) method of monitoring crack growth was used as opposed to the alternative of using a clip type displacement transducer. Based on the author's experience, the EPD method has disadvantages compared to the clip gage when cleavage is encountered. But the results of the crack growth during fracture testing of such specimens is of academic interest only since the critical J values are calculated using the initial crack length, which is physically measured after the specimen has failed. In other words, there is no J-R plot for these test specimens because there is no J-R behavior. There is only J_{crit} behavior with the deformation at the crack tip very much elastic with only small (negligible) plasticity. J_{crit} can be calculated from the data using the initial crack length and maximum load, P_{max} , from the load displacement curve, which is the case for the three all weld metal test specimens (Appendix C).

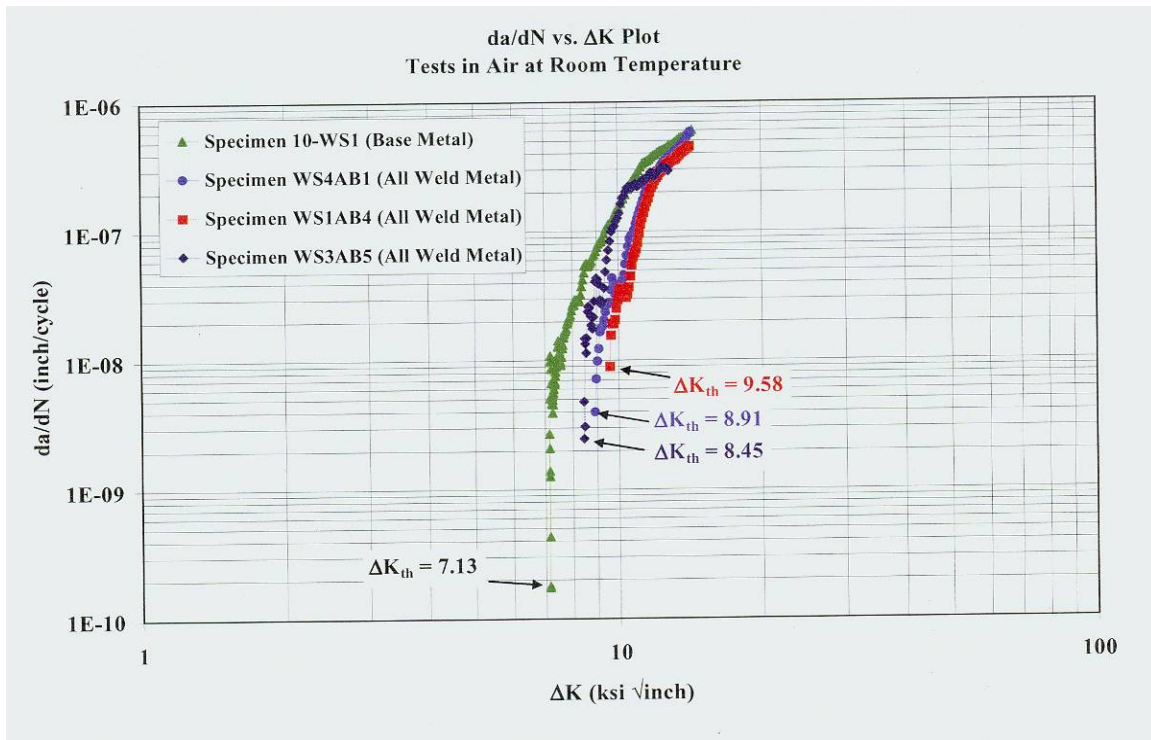
base metal showed the lowest fatigue threshold at 7.13 ksi-in^{1/2} with the weld metal ranging from 8.45 to 9.58 ksi-in^{1/2}.

Figure 4.18: Crack growth rate testing results.

One base metal and three weld metal specimens were tested for crack growth rate characterization and the fatigue threshold stress intensity. Figure 4.18 shows the test results. The

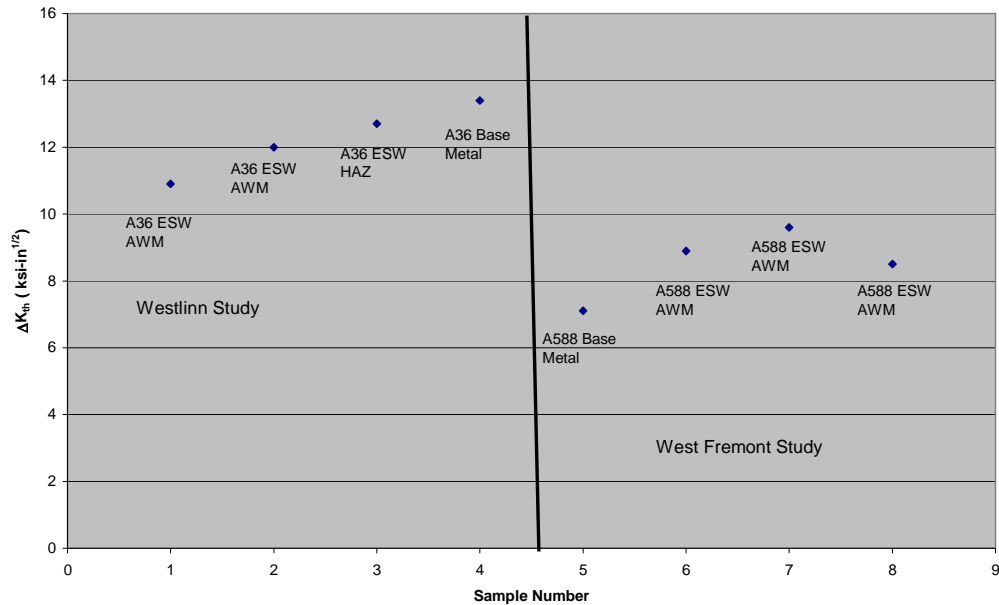
Figure 4.19: Crack growth threshold results for both the West Linn and West Fremont ESW studies.

Coefficients for the crack growth rates are shown in Table 4.3. Fatigue threshold results, from both the West Linn and West Fremont studies, are shown together in Figure 4.19.

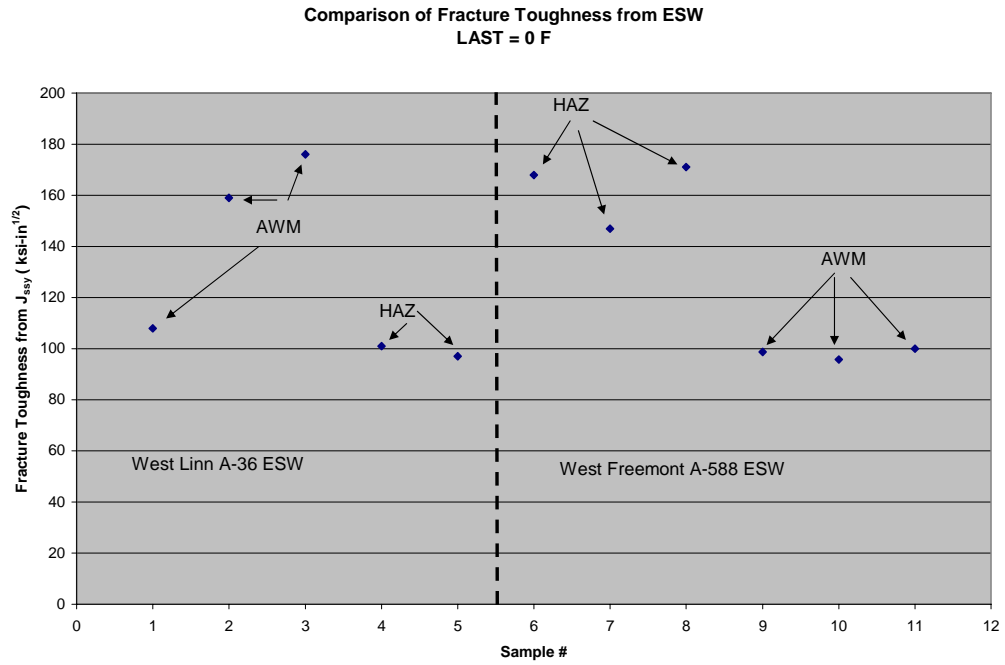
Figure 4.20: Estimated fracture toughness from J-integral testing using small scale yielding adjustments for test specimen thickness.

summary, this method scales the results of sub thickness test specimens to estimate the results for specimens of sufficient thickness to produce small scale yield criteria at the crack tip. If such criteria are met, then a single parameter approach to failure by fracture can be reasonably employed. The scaling parameters are the specimen thickness, b , or in this case net thickness b_n , the crack length ratio a/W , the measured critical J value and the flow stress of the weld metal. Using these data and the finite element analysis (FEA) results presented in Anderson and Dodds (1991), the measured critical J values $J(Q)$ can be converted to the expected critical J values for specimens thick enough to enforce small scale yielding at the crack tip. In-service weldments would be expected to produce this value at the LAST.

This small scale yielding toughness is identified in the report as J_{ssy} . Because it is based on a small plastic zone at the crack tip, the crack propagation can be assumed to be stress dominated, as opposed to strain dominated found in more ductile or tough material like the base metal. With this understanding it is appropriate to convert J_{ssy} to an equivalent critical stress intensity, K_C , using the relationship of $K_C = \text{SQRT}(E * J_{ssy} / (1 - \nu^2))$, which is appropriate for plane strain conditions at the crack tip, where E is Young's Modulus and ν is Poisson's ratio.

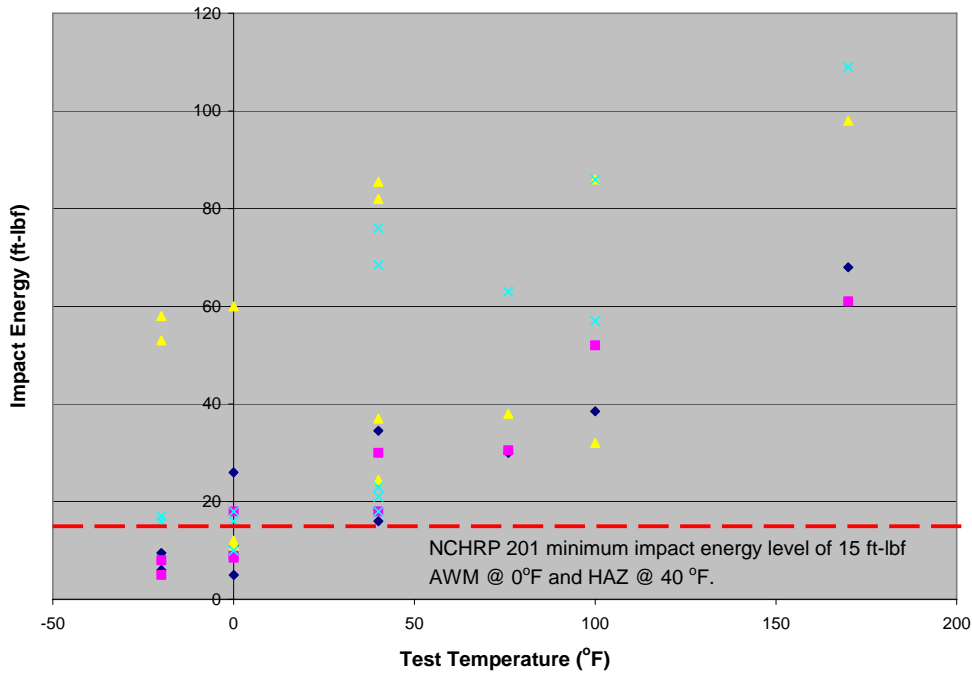
Figure 6.3: Impact test results from Phase 1 testing on West Fremont study.

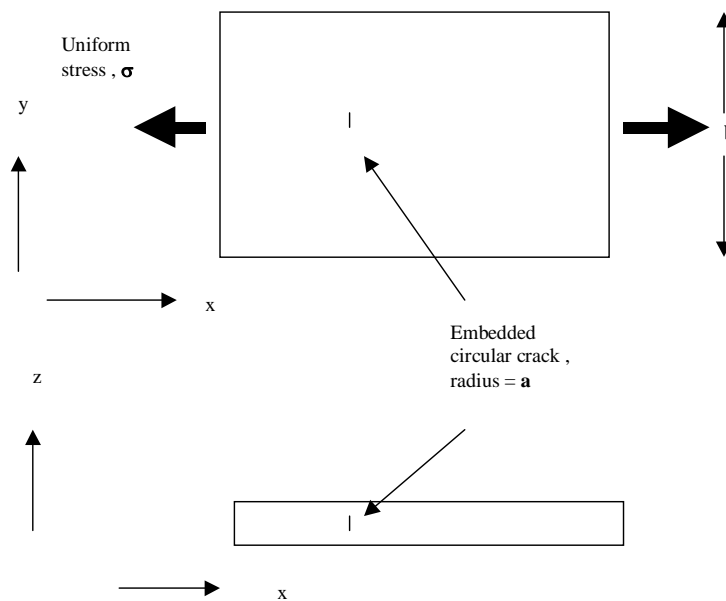
$$K_I = 1.13 \sigma f(a/b) \sqrt{a}$$

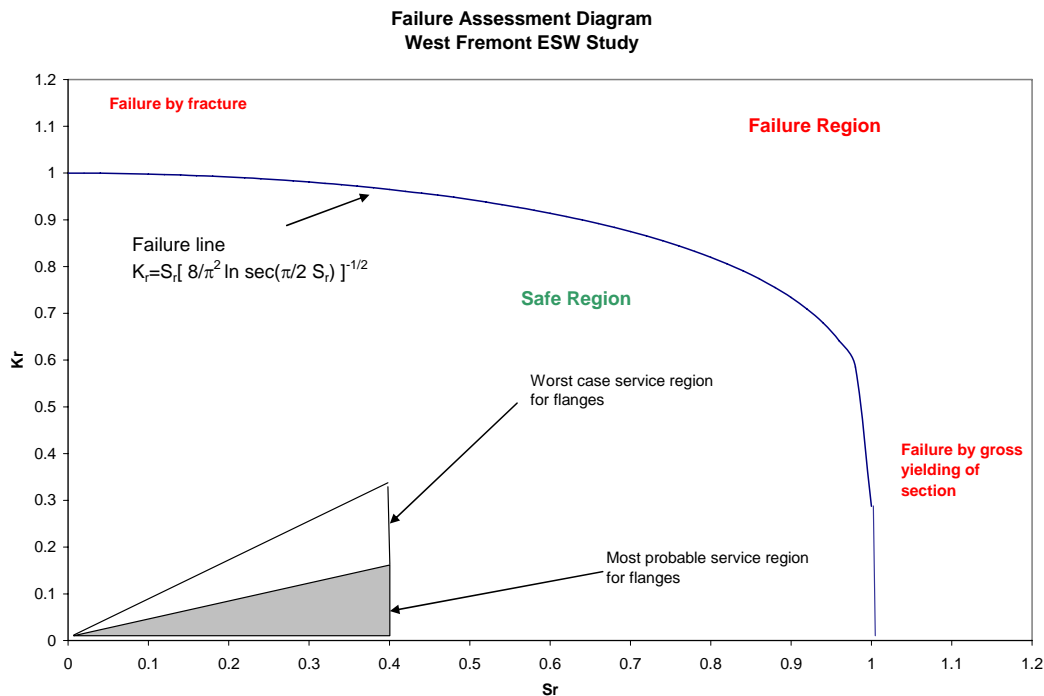
The flanges probably operate in the region shown by the smaller triangle. This is a realistic estimate of maximum service conditions based on a 1/2 inch diameter crack escaping NDT, the maximum design loads occurring, and the lowest toughness measured in the welds. The second triangle area is for the same flaw and loads, but with extremely brittle behavior in the welds with the toughness being near 50 ksi-in^{1/2}. None of the test data indicate a toughness this low, but only 6 toughness tests were used to quantify 261 fracture critical welds. It is possible for the toughness of some welds to be this low near the lowest anticipated service temperature (LAST).

Figure 6.5: Failure Assessment Diagram (FAD) for the flange plates on the West Fremont approach structures. Both the most likely and worst case operating regimes are shown schematically.

$$K_r = K(\text{ service stress intensity }) / K_{JSSy} (\text{ critical stress intensity }) = 15.8 \text{ ksi-in}^{1/2} / 97 \text{ ksi-in}^{1/2} = 0.16$$

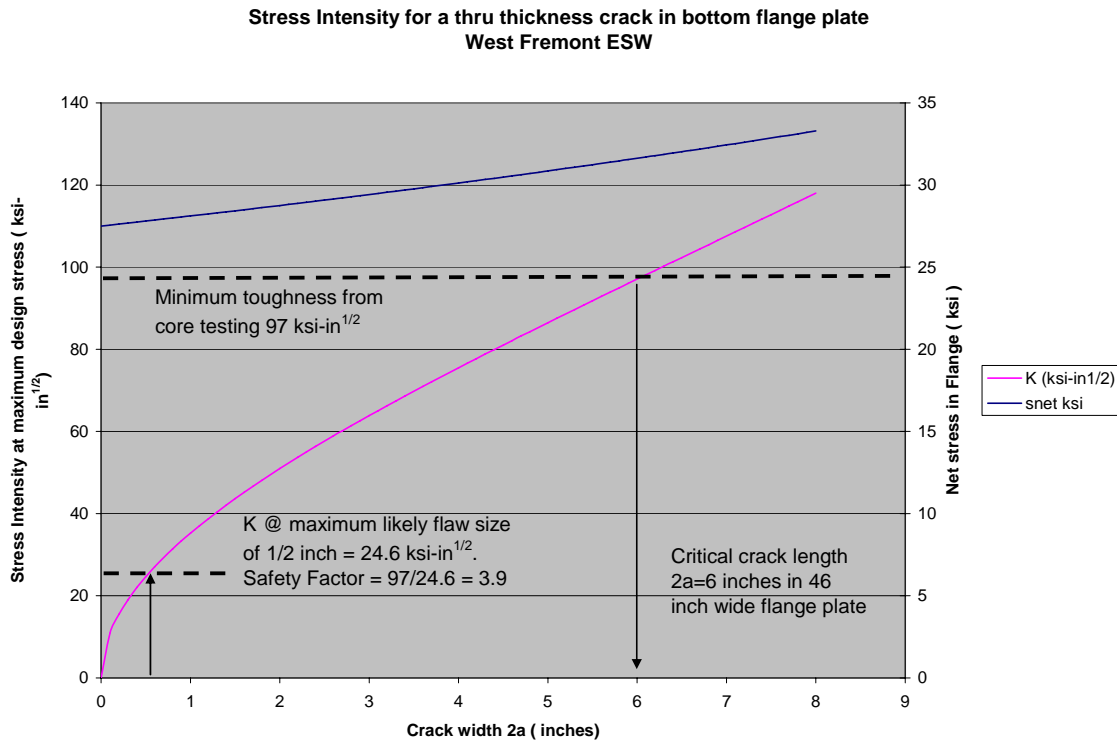
To estimate the critical crack size considering only LEFM, a full thickness through crack could be assumed in a lower flange. If an overload event causes the crack to increase in width, reducing the net section in the flange, the net section stress rises. The stress intensity for such a crack is shown in Figure 6.6. At the minimum estimated weld metal fracture toughness of $97 \text{ ksi-in}^{1/2}$, the crack would need a 6 inch width in the 46 inch wide flange to produce 31.6 ksi on net section and become critical at the maximum design stress of 27.5 ksi on the full section. Presuming a maximum $\frac{1}{2}$ inch size crack-like defect that might escape NDT, the safety factor against brittle fracture is 3.9, as depicted in the figure.

Figure 6.6: Stress intensity from a through crack in bottom flange plate.

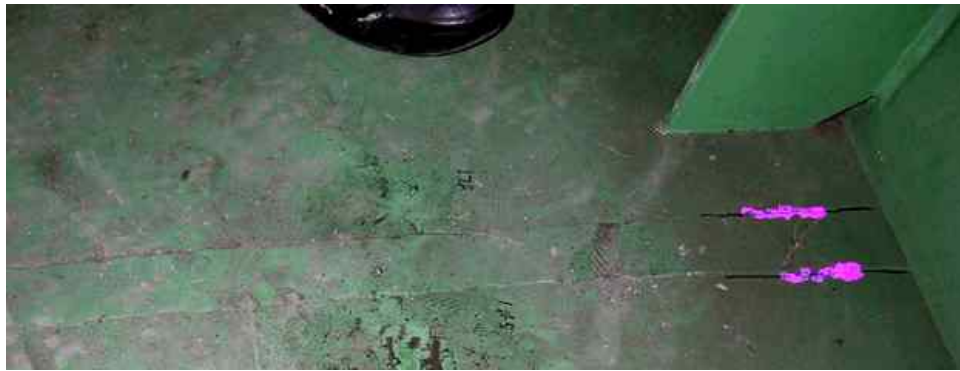
Figures 3 and 4 show typical bottom flange welds observed during our inspection. At some locations, the welds had not been ground at all or were only partially ground and thus, were readily evident with incident lighting (Figure 3). At other locations, the welds had been ground somewhat smooth, but were still relatively easy to find with shallow-angle lighting (Figure 4).

Figure 3 (D71055-08) Bottom Flange Weld

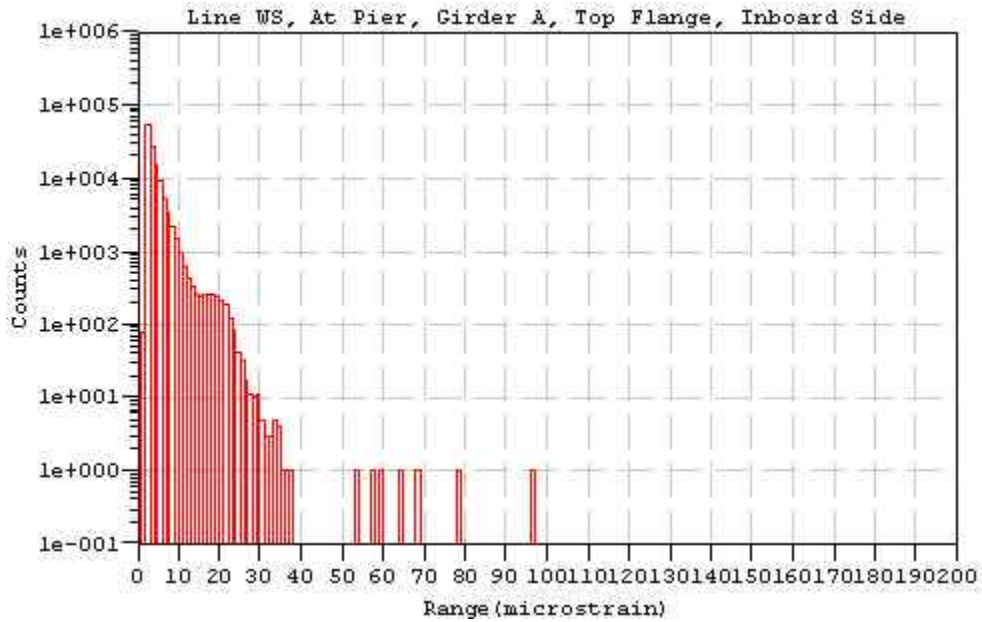
Figure 14. Typical RainFlow Diagram

Individual charts showing rain flow data for each of the strain gages start on page 70 through 101. Individual charts showing seven-day peak-valley histories for each of the gages are on pages 102 through 133. Tables 8 through 11 on pages 134 through 137 show root-mean-cube data for each of the gages.

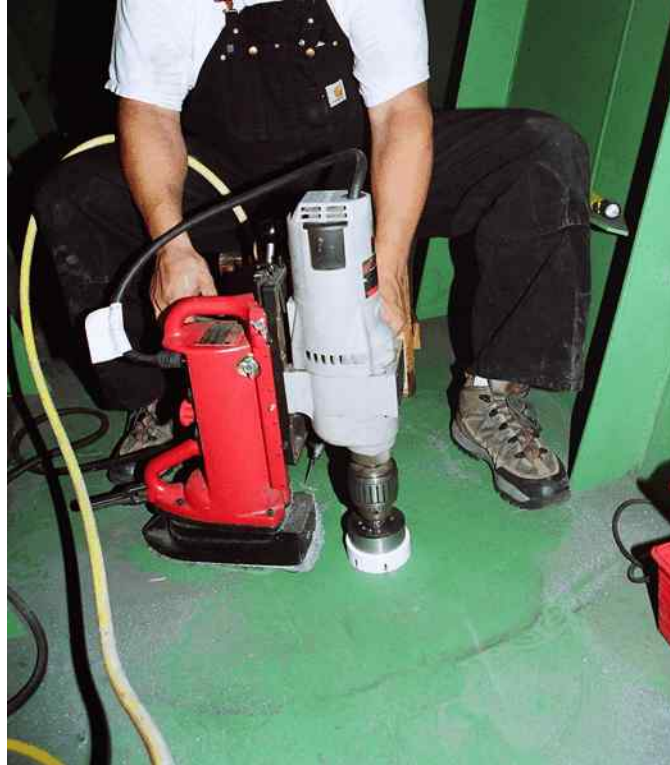
²Initially, it was planned to use a milling cutter to remove the cores, similar to what ODOT had used on the West Linn Bridge. MEIC engineers tested electric, portable drill presses from three manufacturers but found that none had sufficient power to drive the cutter, despite claims to the contrary by the drill/cutter manufacturers. (ODOT had used a large, custom-built, 27-HP hydraulic unit to drive the cutter during the previous sampling.) Subsequently, tests showed that a standard hole saw was capable of making the cut, so the original plan of using a milling cutter was abandoned. An advantage to using hole saws was cost. That is, the hole saws cost less than \$20 each, and even with the cost of adding an extension tube, the cost was still less than \$75, whereas the milling cutters varied in price from \$700 to \$1,300 each and reportedly would require sharpening after 4 to 5 cuts, at a cost of \$400.

Figure 21 (71149-15) Core drilling equipment

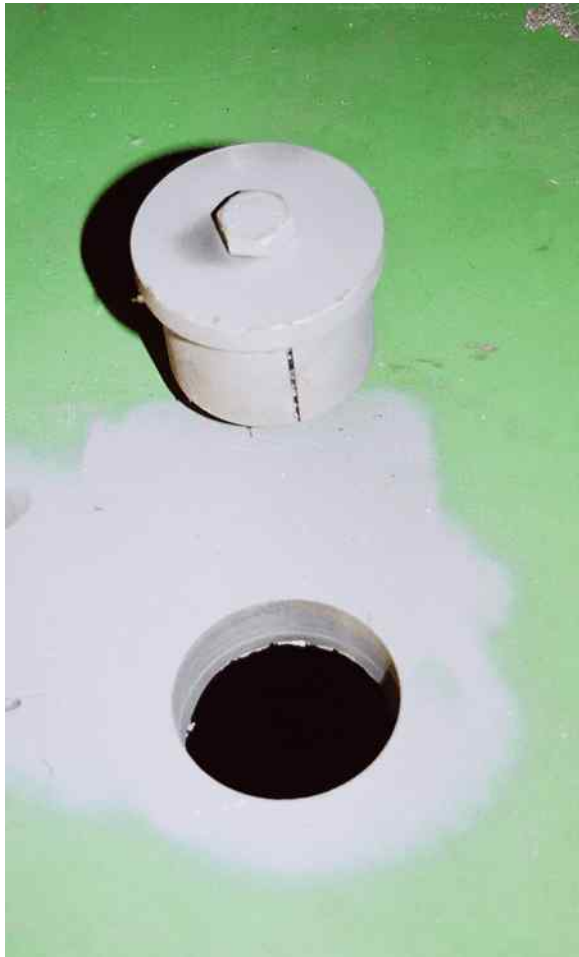
Figure 23
(71149-19)
Core plug ready to be installed

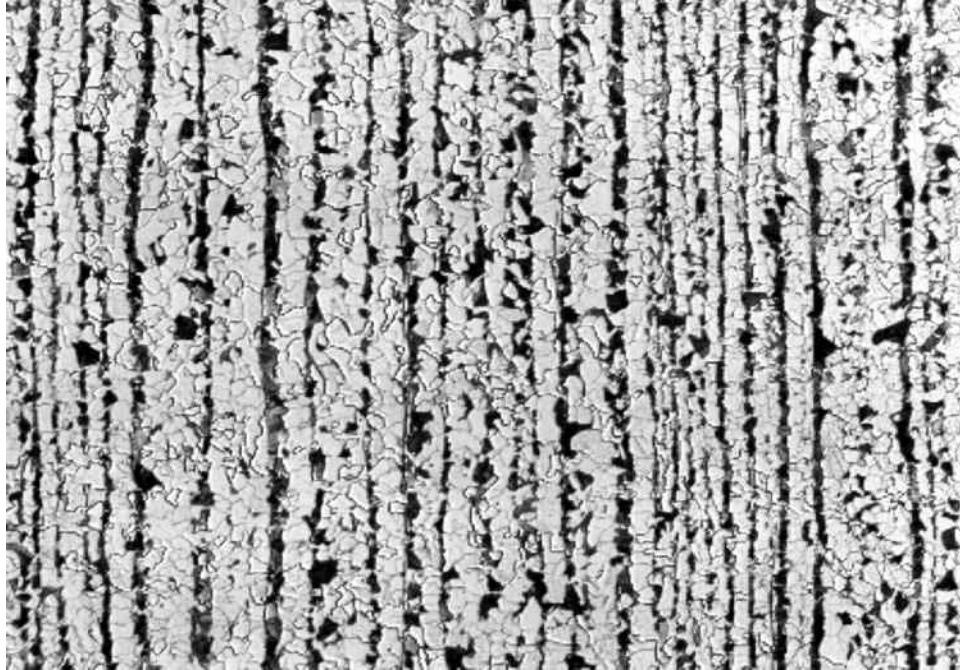
Figure 32 (D34467) 100X Core No. 4, Charpy Bar No. 9, Base Metal

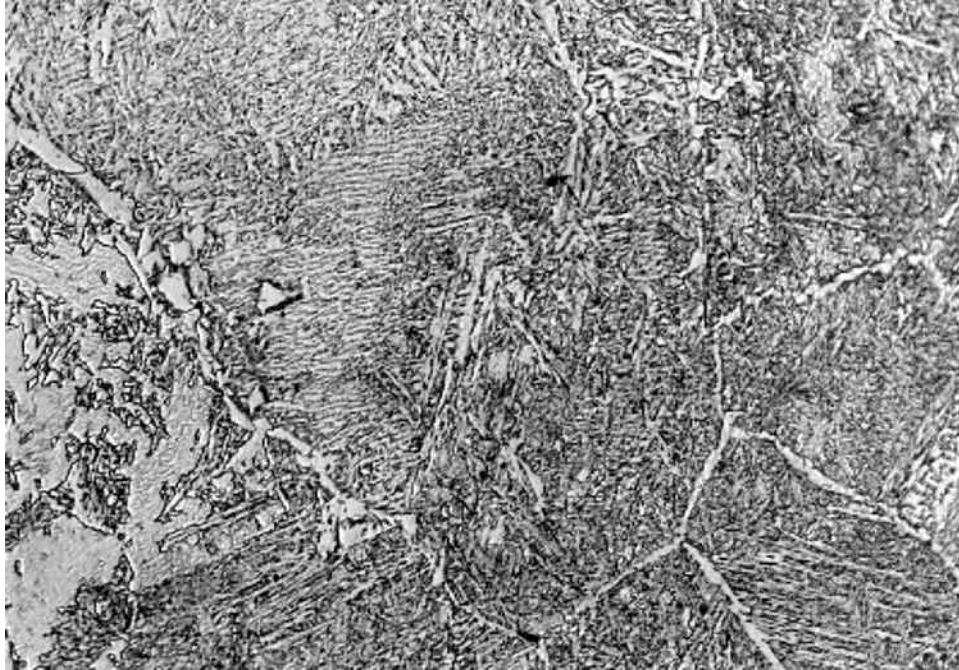
Figure 34 shows an area in the HAZ closer to the weld metal.

Figure 34 (D34469) 100X Core No. 4, Charpy Bar No. 1, HAZ

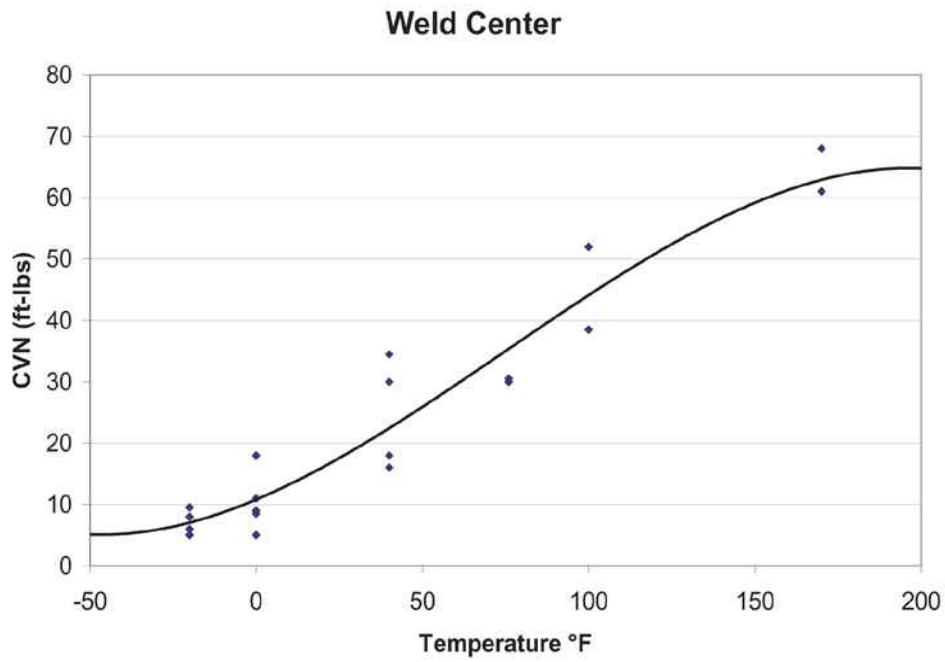
The examination showed that in several cases, the notches were indeed not precisely coincident with the HAZ, but instead were as much as 1 to 2 mm into the weld metal. Consequently, the HAZ data should be discounted somewhat and viewed as more representative of weld metal near the HAZ rather than precise HAZ values. Photographs of the polished Charpy bars after fracture showing the position of the notch in relation to the weld and HAZ are in the following figures.

Figure 36 Charpy V-Notch Transition Curve, Weld Metal

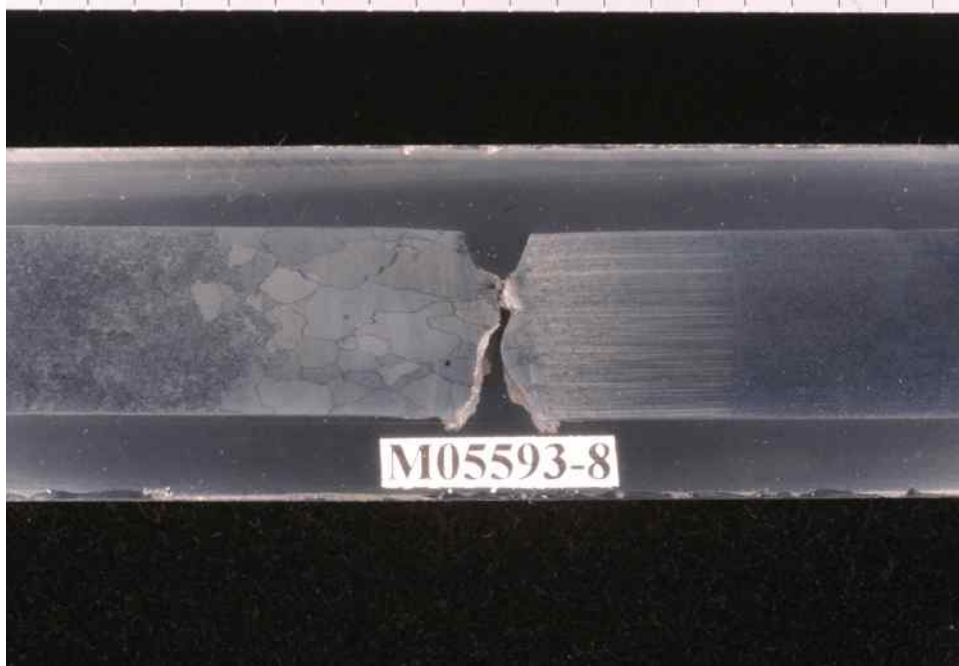
Because the notches were not precisely centered on the HAZ, the HAZ impact data should be discounted somewhat and viewed as more representative of weld metal near the HAZ, rather than precise HAZ values.

Figure 38 (D72112-08) Core No. 4, Charpy V-Notch Impact Bar No. 8

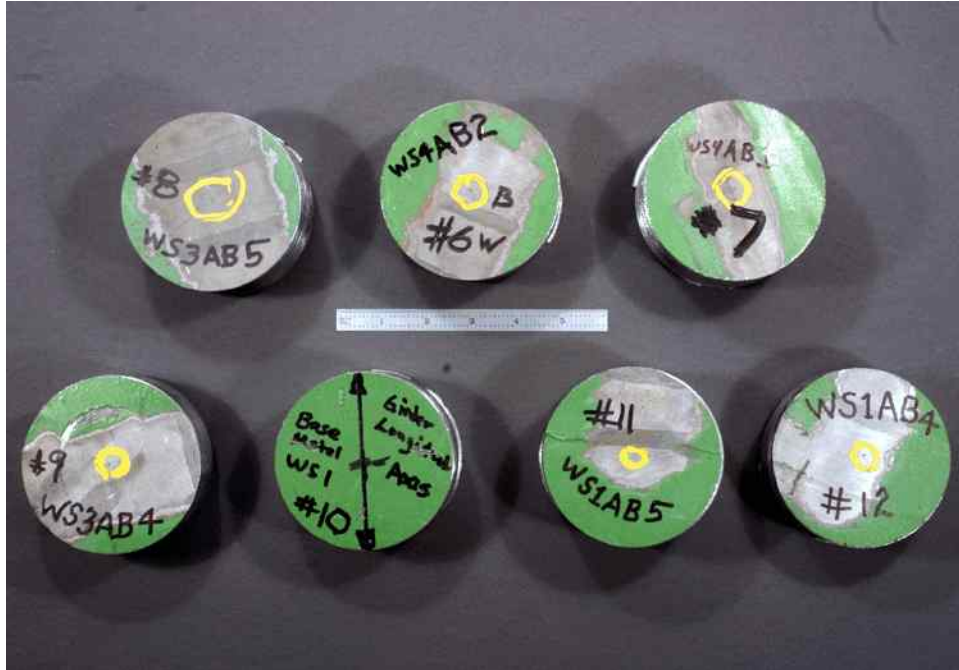
Figure 40 (D71147-01) Phase 2 Cores, Nos. 7 through 12

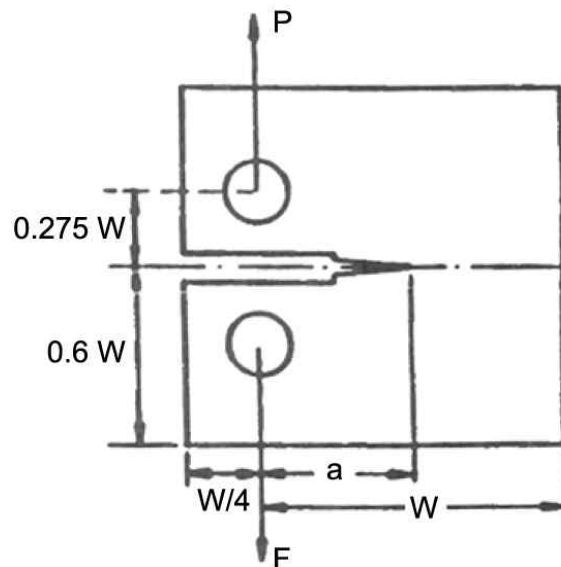
The fatigue crack growth and fatigue threshold test per ASTM E467 and the J-fracture toughness testing per ASTM E 1820 was conducted under subcontract by CC Technologies, Inc. (Dublin, Ohio). One compact tension (CT) specimen (Figure 48) was machined from each of the seven core samples.

Figure 48. Diagram of CT Specimen

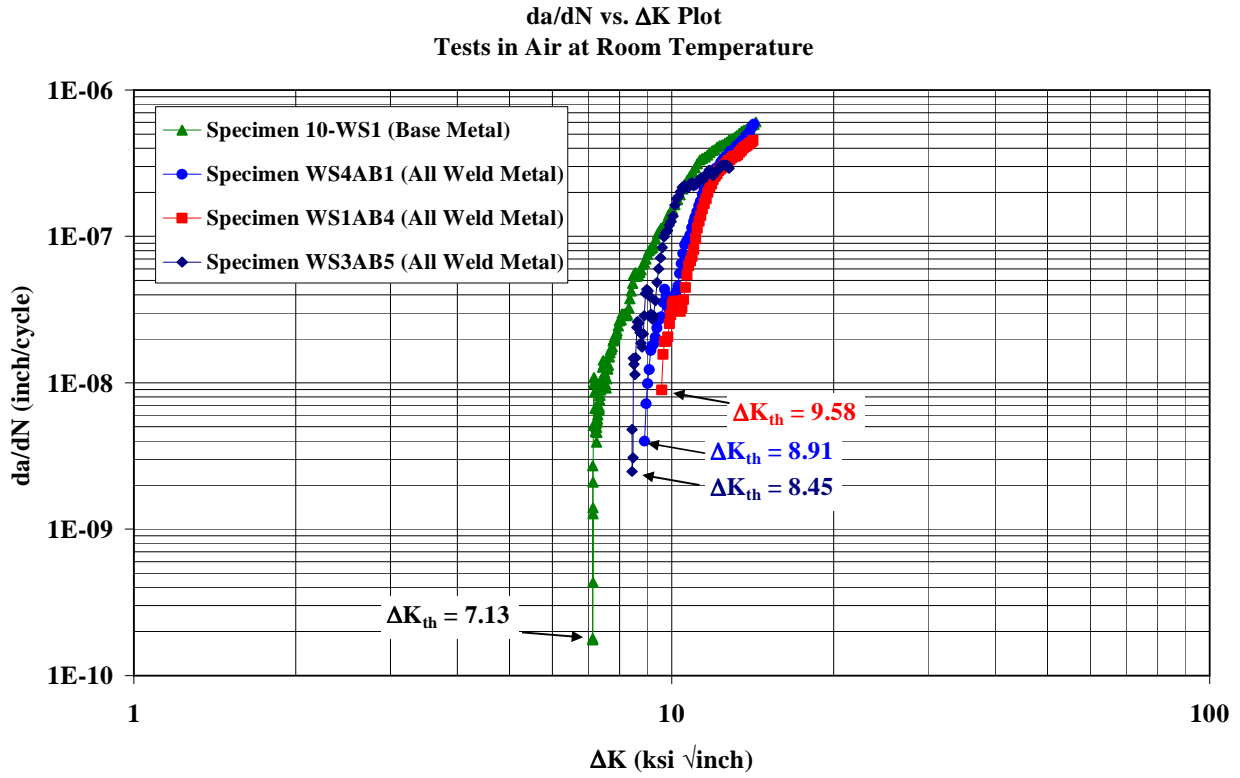
Figure 5. Fatigue crack growth rate curves for tests in air at room temperature.
