**A FITNESS-FOR-PURPOSE
EVALUATION OF FRACTURE
CRITICAL ELECTRO-SLAG WELDS**

FINAL REPORT

Steven Lovejoy PhD, PE
Bridge Engineering Section
Oregon Department of Transportation
Salem, Oregon

March 2009

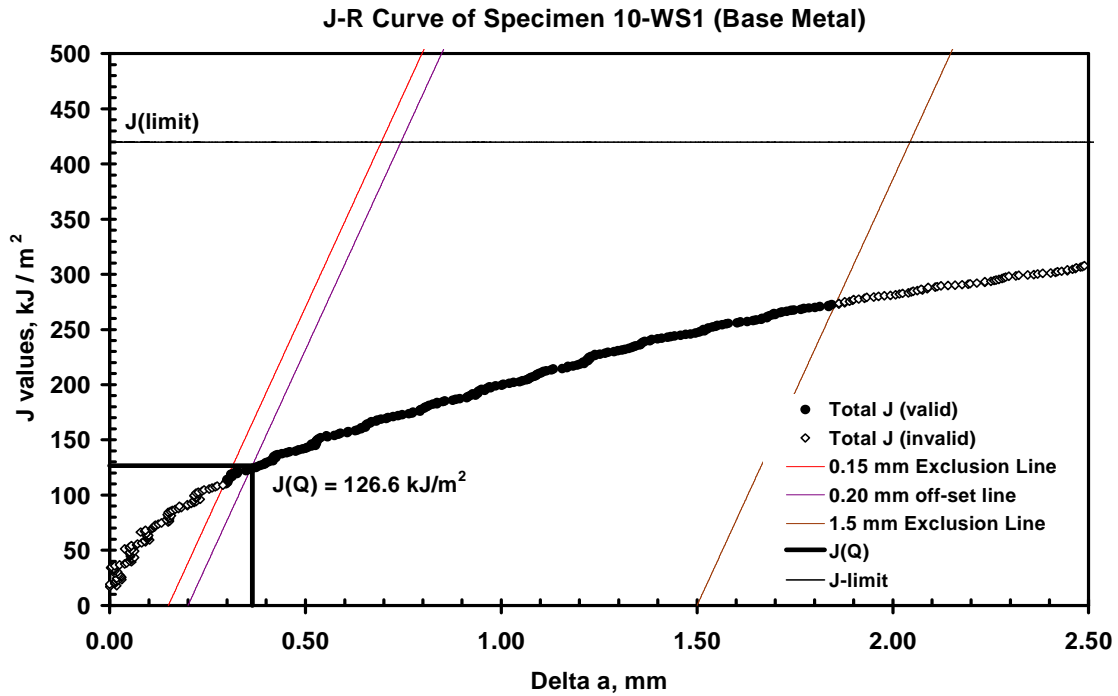
Figure 6a. J-R curve for Specimen 10-WS1 (base metal), at 0 °F (-18 °C).

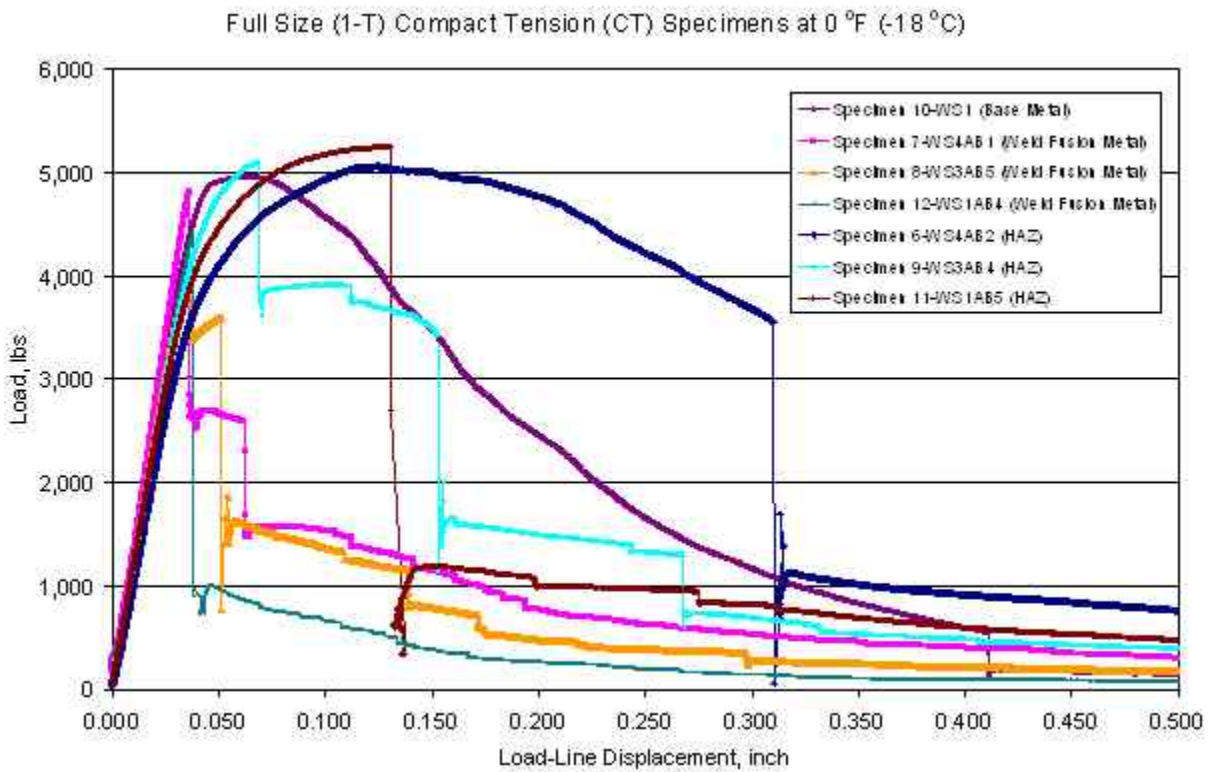
Figures 49 and 50 show the load-displacement curves provided by CC Technologies for all seven CT specimens; Figure 49 shows the full history of the testing, while Figure 50 only shows the initial stage of the testing. Figures 51 through 57 shown individual load-displacement curves for each specimen.

Figure 49. Load-Displacement Curve for Fracture Toughness Tests

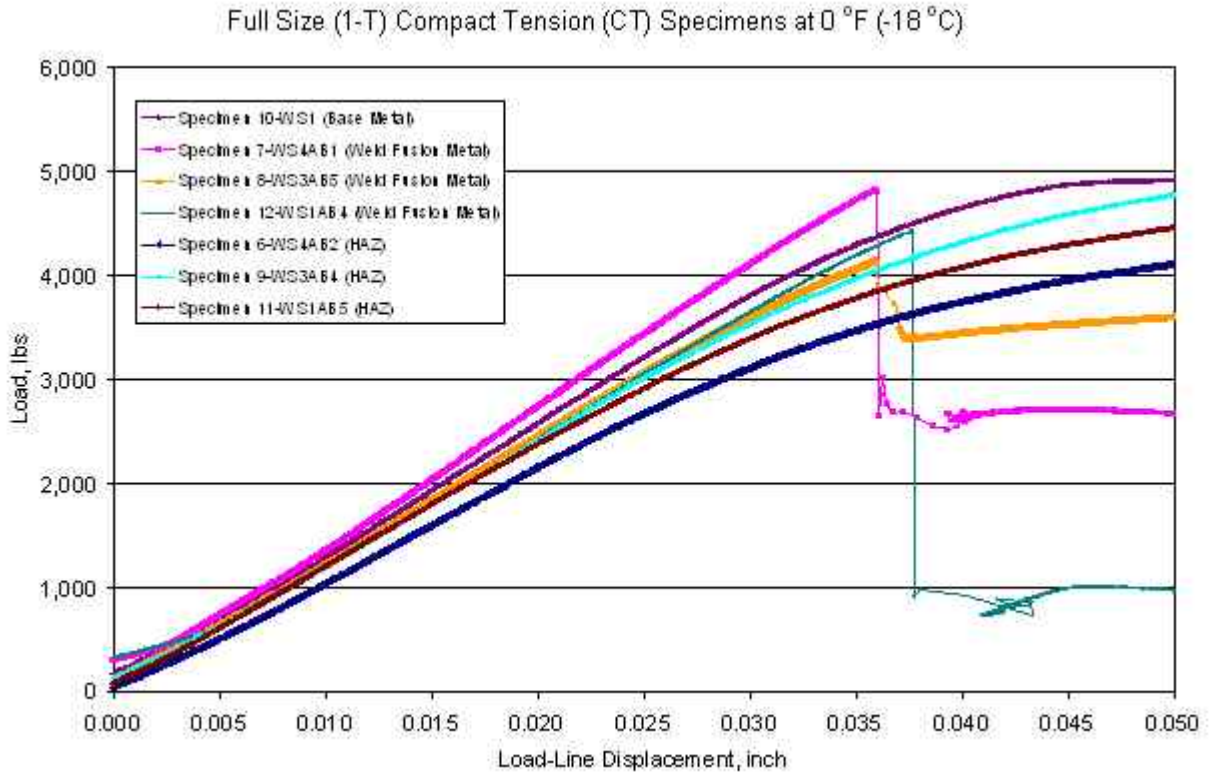
Figure 50. Load-Displacement Curves for Initial Stage of Fracture Toughness Tests

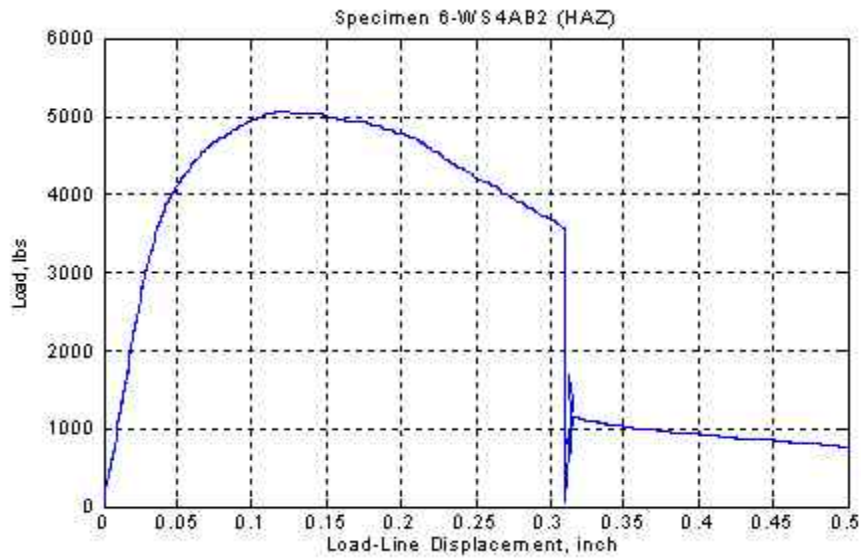
Figure 51. Load-Displacement Curve for Core No. 6. WS4-A-B-2 (HAZ)

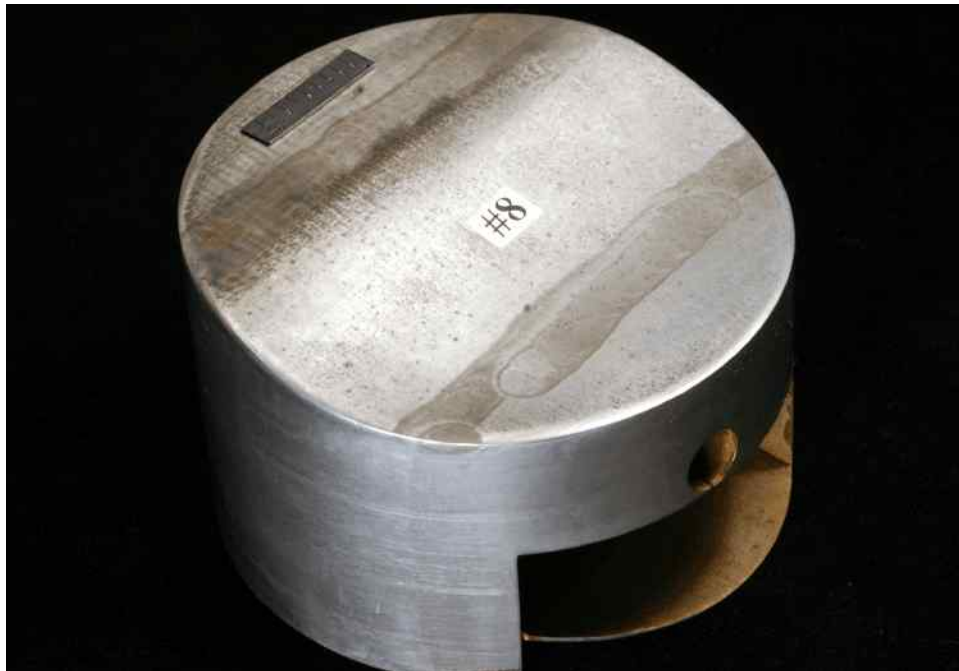
Subsequently, after the coupons had been removed from the girder and returned to our lab, we polished and etched the outside surface of the coupons (i.e., the outside surface of the flange) and the saw-cut surfaces (i.e., the cross sections through the flange). The toes of the electroslag welds contained repair welds that were approximately 1/8 inch deep by 1/4 inch wide and consisted of several overlapping (lengthwise) individual weld beads, likely made by the Shielded Metal Arc Welding (SMAW) process, as shown in Figure 60 (specimen was etched and photographed after removal of the fracture toughness test specimen).

Figure 60 (D72040-02) Core No. 8
