**SAFE AND EFFECTIVE SPEED  
REDUCTIONS FOR FREEWAY  
WORK ZONES PHASE 3**

**Final Report**

Oregon Department of Transportation

**February 2015**

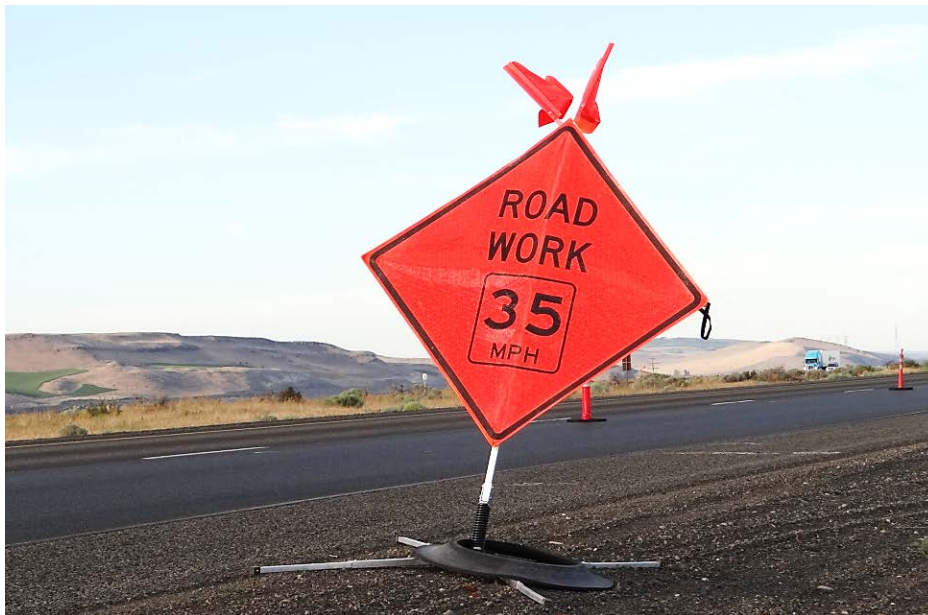
Figure 2.1: 35mph signs on roadway

The traffic control measure (TCM) of interest for this study is the 35mph advisory signs. Figure 2.1 shows an example of a 35mph advisory sign used in the study. Four 35mph signs were used during each night of paving, spaced approximately 0.5 miles apart. The first sign was located approximately 0.5 mile downstream of the beginning of the work. The second sign was located 1 mile downstream of the beginning of the work. The 3<sup>rd</sup> and 4<sup>th</sup> signs were placed at 1.5 and 2 miles from the beginning of the work, respectively.

For this project, the roadway condition enables the implementation of the signs due to a wide shoulder on both sides of the roadway. The roadway could have accommodated more signs. One of the personnel interviewed suggested that more signs are needed, and that the signs should be placed on both sides of the road rather than on only one side. The project is at a windy location, and flexible stands (as shown in Figure 2.1) were selected for use.

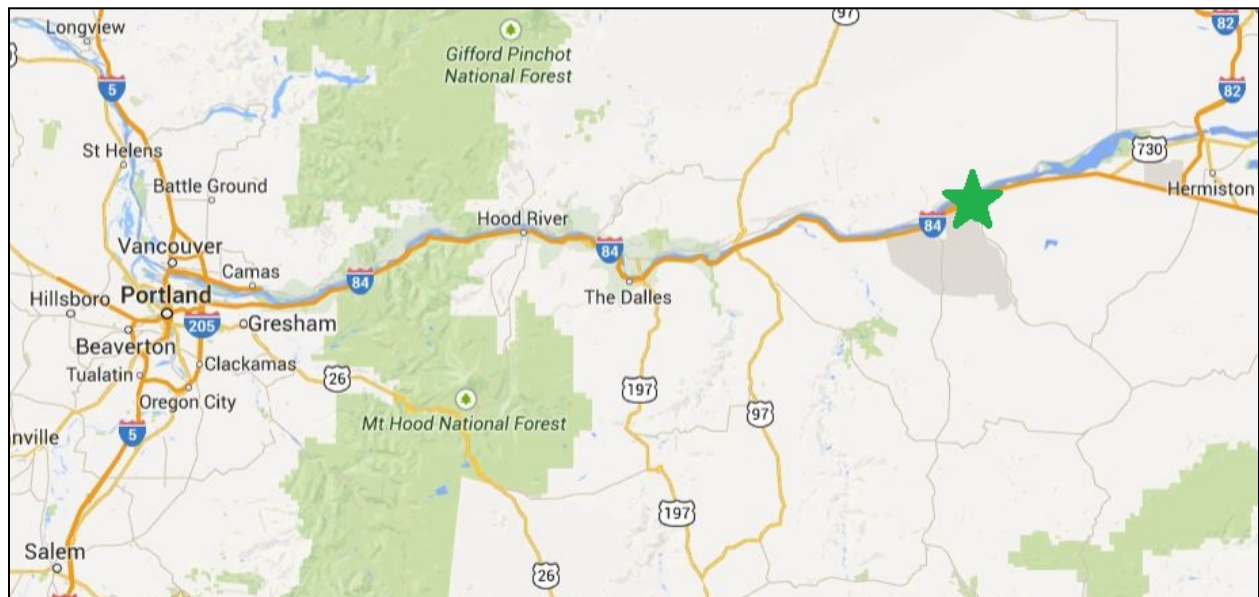
Figure 2.3: Location of the I-84 Arlington to Tower Road project

The case study project selected for this research was the I-84 Arlington to Tower Road project. The project was located at a rural area along the Columbia River. At the location of the project, the roadway is mostly flat and straight. There were no perceived issues related to roadway grade or curves. The location of the project is shown in Figure 2.3.

At the location of the project, the roadway consists of two lanes in each direction (eastbound and westbound). The project extended for 21 miles from MP 138 to MP 159. The paving scope of work consisted of grinding 2 inches of existing highway surface and placing a new layer of asphalt in both the slow lane and fast lane. Both lanes are 14 feet wide. A paved shoulder is present, but no shoulder paving was included in the project. The paving work activities took place at night, typically from approximately 7:00pm until 5:00am the next morning.

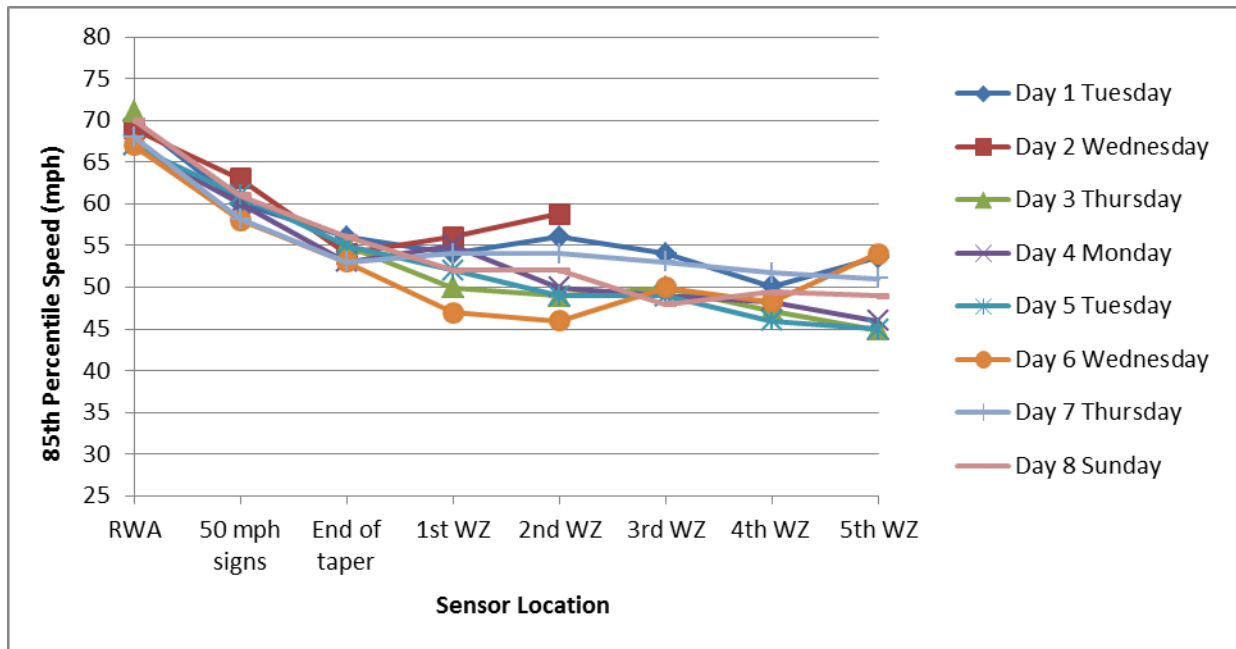
Figure 3.1: 85<sup>th</sup> percentile speed for each day at different locations

Figure 3.1 shows a summary of the 85<sup>th</sup> percentile speed of all of the vehicles on each day at each sensor location. As seen in the figure, the speeds at the Road Work Ahead sign, 50mph signs, and end of taper locations are very similar for the different days. For the speed through the work zone, the figure reveals that the 85<sup>th</sup> percentile speeds on Day 1 and Day 7 (without the 35mph signs) are higher than on Days 3, 4, 5 and 8 (with 35 mph signs). Days 2 and 6 are unique in that the paving operation occurred in two directions on those days. Part of the paving occurred in one direction during the first part of the work shift, and then the work switched to paving the roadway in the other direction (see Table 2.2).

The figure also shows that vehicle speed changes throughout the work zone. At the Road work Ahead (RWA) sign location, the 85<sup>th</sup> percentile speed was recorded to be typically from 65-70mph. After the vehicles pass by the RWA sign location, the speed then drops to approximately 60mph as the vehicles pass the 50mph regulatory signs. At the end of taper location, the speed

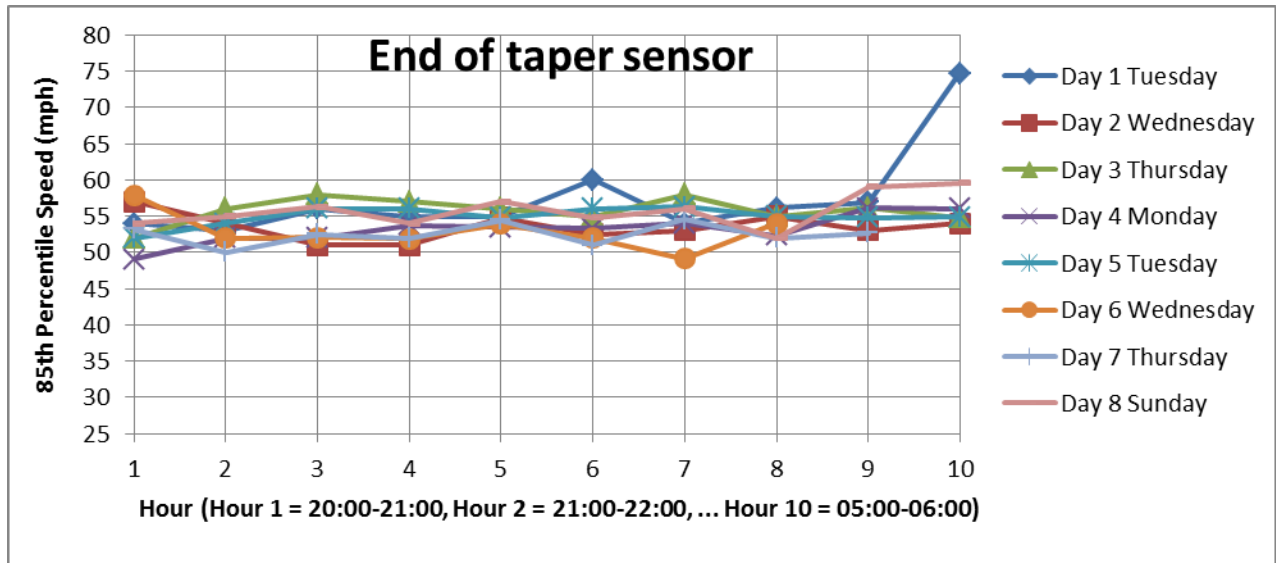
Figure 3.3: 85<sup>th</sup> percentile speed of each hour for each day at end of taper location

Figure 3.3 shows the hourly 85<sup>th</sup> percentile speed for each day at the end of taper location. Similar to the RWA location, there is no apparent significant difference from day to day. The speed during the last hour on Day 1 is very high and is an outlier. On Day 1 the contractor paved a very long distance (4 miles) and moved the taper location to the end of work zone during the last hour. Therefore, given that the sensors were not relocated, the speeds recorded at that location during the last hour reflected speeds when the taper was not present. At the RWA

location, for the last hour (05:00-06:00) the 85<sup>th</sup> percentile speed was approximately 70mph on Day 1, while at the end of the taper the 85<sup>th</sup> percentile speed was approximately 75mph during the same hour. The absence of a taper due to its relocation may have impacted this difference in speed. That is, after seeing the RWA signs, motorist may tend to speed up if they do not see a taper or other traffic control device after driving a short distance downstream. Periodic reminders may be needed.

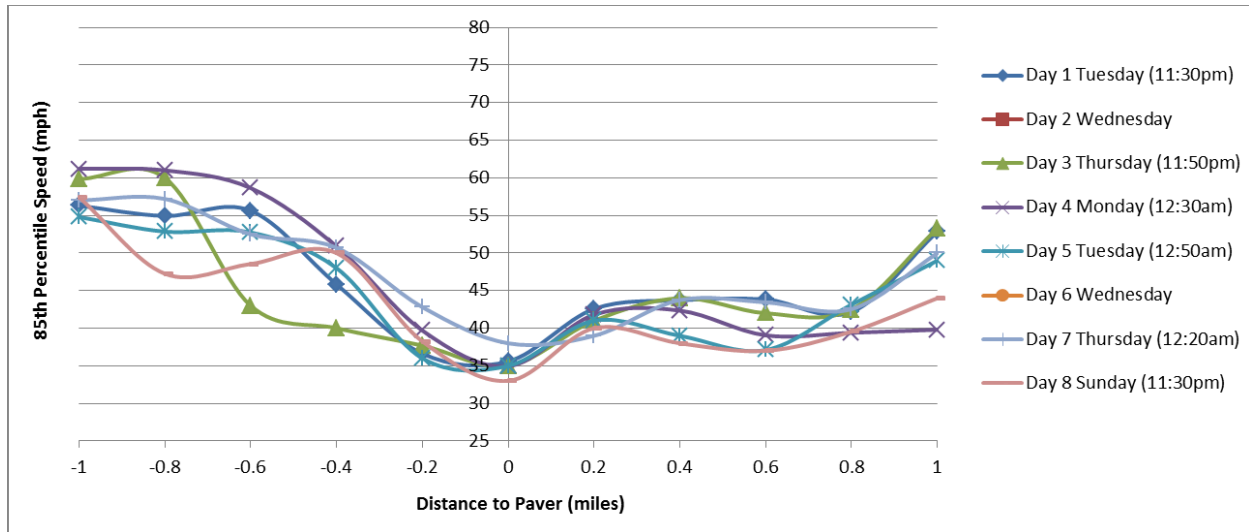
Figure 4.1: Distance to paver graph for each day based on 3<sup>rd</sup> WZ sensor

Vehicle speed relative to the distance to paver was calculated for each day at the 3<sup>rd</sup> sensor in the work zone. Figure 4.1 shows a summary of the distance to paver graphs for all of the days of testing for all vehicles, based on the 3<sup>rd</sup> WZ sensor, excluding Days 2 and 6. Days 2 and 6 were not included in this graph due to the different conditions of these two days as described above. The time in which the paver passed the 3<sup>rd</sup> WZ sensor on each day is shown in the labels for each day. The figure shows that vehicles slow down to approximately 35mph when they pass the paver. The slowdown starts approximately 0.6 miles upstream of the paver. After passing the paver, the vehicles then speed up slightly downstream of the paver. The increase in speed takes place over approximately 0.2 miles, after which the speed levels off for another 0.6 miles. The constant rate of speed (at approximately 40mph) is likely a result of the vehicles passing by the downstream equipment (tack truck, sweeper, grinder, etc.). The speed trends for different days are similar.

As seen in Figure 4.1, on Day 3 vehicle speeds decreased significantly approximately 0.6 miles upstream of the paver. The rate and location of decrease are different for this day than the other days. On Day 3, the radar speed display trailer with 35mph advisory sign attached was initially located between the 1<sup>st</sup> and 2<sup>nd</sup> 35mph signs. The trailer was then moved downstream four times during the work shift. At the time in which the paver passed the 3<sup>rd</sup> work zone sensor on Day 3 (11:50pm), the radar speed trailer may have been placed near, or just downstream, where the significant decrease in speed is seen in the figure. The presence of the radar speed display plus the paver up ahead may have caused the drivers to slow down sooner than on other days.

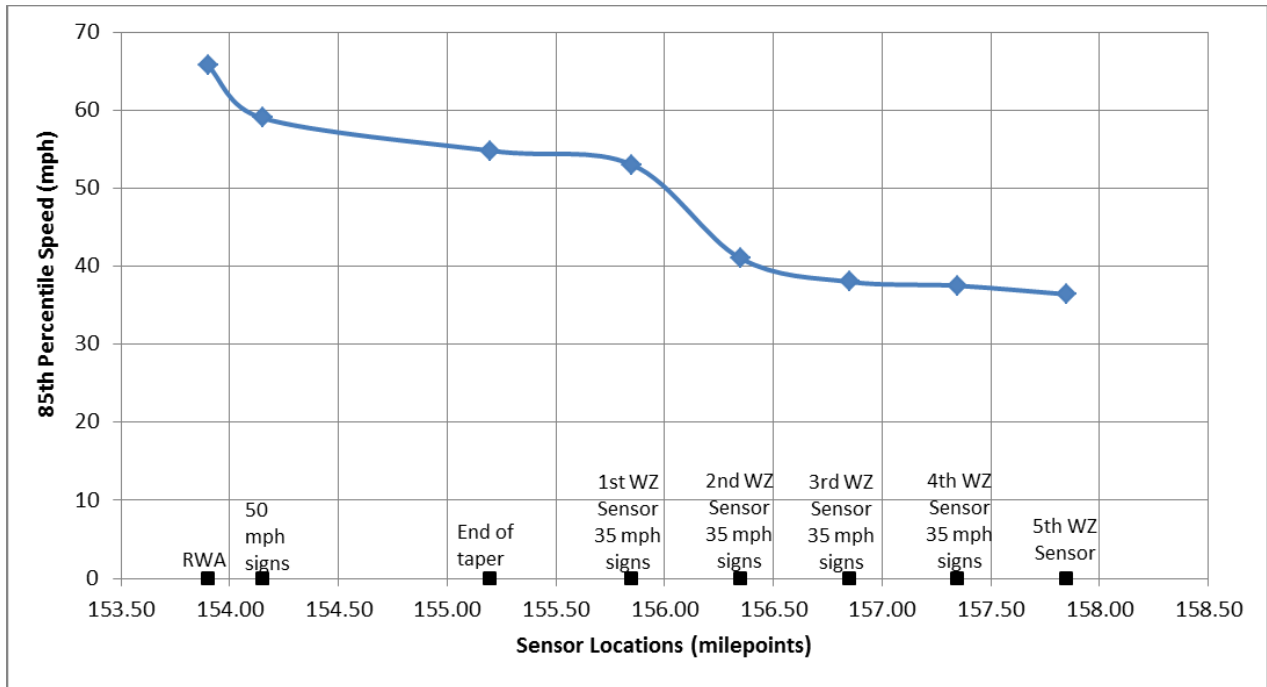
Figure 4.2: 85<sup>th</sup> percentile speed during hour 12:00-1:00am of Day 5 at different locations

Figure 4.2 shows the 85<sup>th</sup> percentile speed of all vehicles during the hour from 12:00 – 1:00am of Day 5 at different locations in the work zone. The figure depicts the speed of a group of vehicles (i.e., those traveling through the work zone from 12:00-1:00am on Day 5) as the vehicles pass through the work zone. The figure reveals that at the RWA location, the majority of vehicles traveled at about 65mph. When they reached the 50mph regulatory signs, which are located approximately 0.3 miles downstream of the RWA signs, their speed dropped to 59mph. When the vehicles reached the end of taper location, the speed dropped to 55mph. At that time, the paver was at approximately the 3<sup>rd</sup> WZ sensor location. When the vehicles passed the 1<sup>st</sup> WZ sensor, they were approximately 1 mile from the paving operation and their speed was about 53mph. When they got closer to the paver (at the 2<sup>nd</sup> WZ sensor about 0.5 mile before the paver), their speed dropped to 41mph. They pass paver at a speed of 38 mph. After passing the paver, the speed was maintained at approximately 37mph through the rest of the work zone. The relatively constant speed following the paver likely was due to the presence of the additional equipment (e.g., tack truck, sweeper, and grinder) ahead of the paver. As the vehicles passed this additional equipment, they keep a low and constant speed.

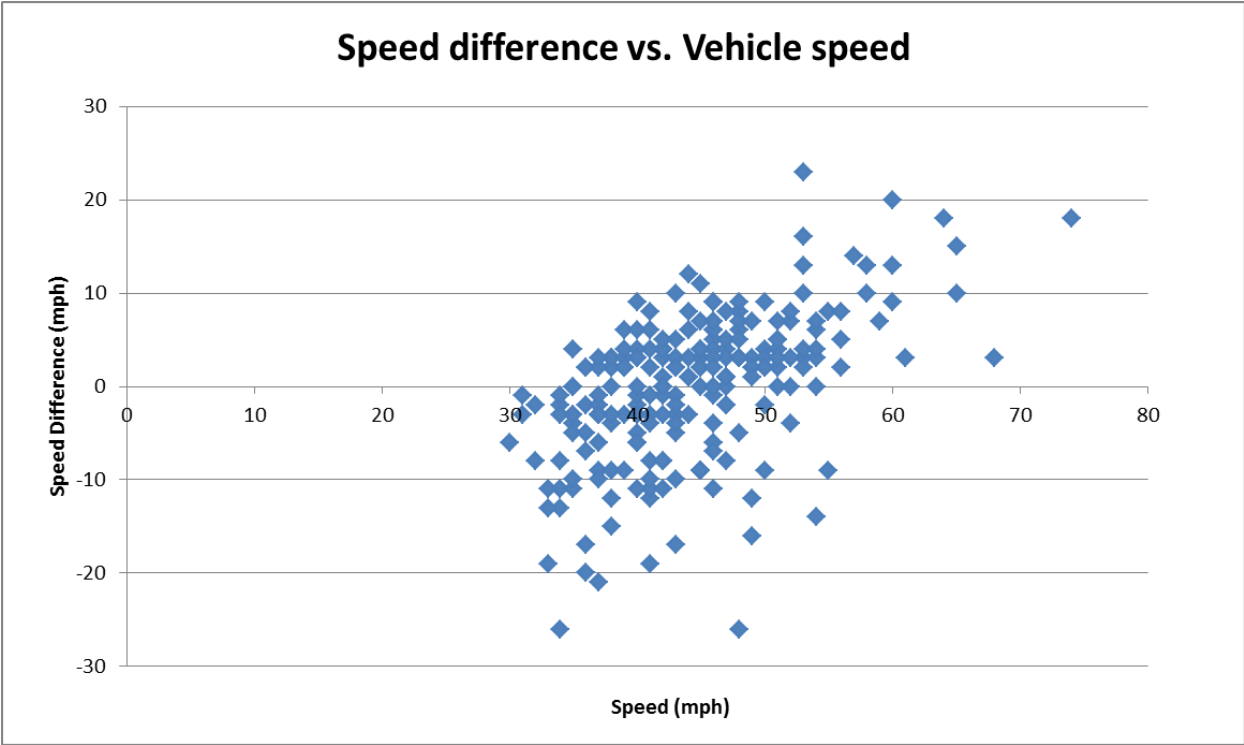
Figure 4.4: Speed difference vs. vehicle speed for vehicles passing 3<sup>rd</sup> WZ sensor from 8:00-9:00pm of Day 5

Figure 4.4 shows the speed differences compared to the vehicle speed. The horizontal axis contains the speed of the trailing vehicle, and the vertical axis contains the difference in speed between the trailing vehicle and the vehicle in front of it. The figure shows an apparent positive slope. That is, as the vehicle's speed increases, the difference in speed between the vehicle under consideration and the vehicle in front of it also increases. This trend is expected because the two factors are related in nature. Speed difference is calculated from vehicle speed. If the speed for the trailing vehicle is high, there is a greater chance that the speed difference will be high also.
