**ASSESSMENT OF DRIVER YIELD  
RATES PRE- AND POST-RRFB  
INSTALLATION, BEND, OREGON**

# **ASSESSMENT OF DRIVER YIELDING RATES PRE- AND POST-RRFB INSTALLATION, BEND, OREGON**

**December 2011**

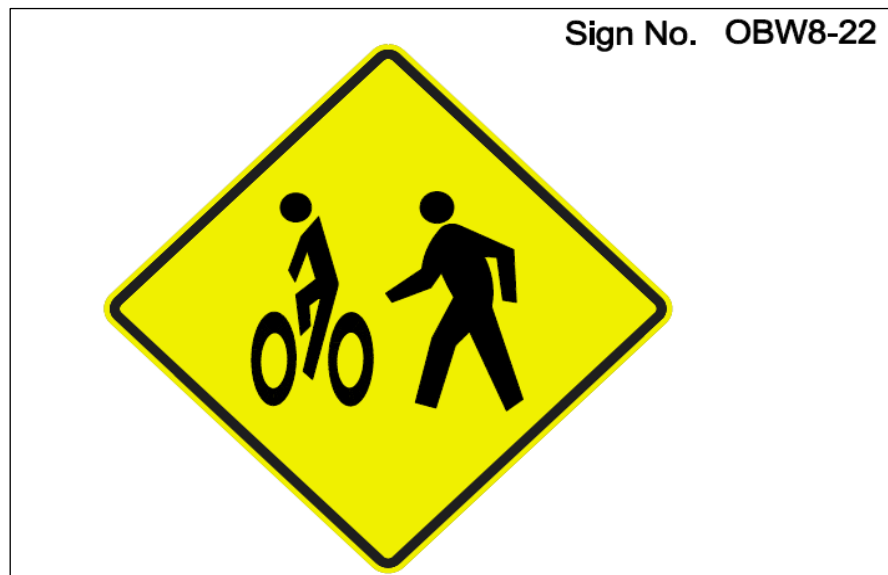
Figure 2.1 Bike/Pedestrian Warning sign displayed at Reed Lane and Badger Road crosswalks

The Bend Parkway, was constructed in 2001 as a bypass with limited access, well-spaced signals, and two marked crosswalks at uncontrolled intersections to accommodate pedestrians. The crosswalks were indicated with continental markings. At the two crosswalks a bike/pedestrian warning sign as shown in Figure 2.1 was accompanied by a diagonal downward pointing arrow. Signs in advance of the intersection were accompanied by a supplemental plaque containing the legend “AHEAD.”

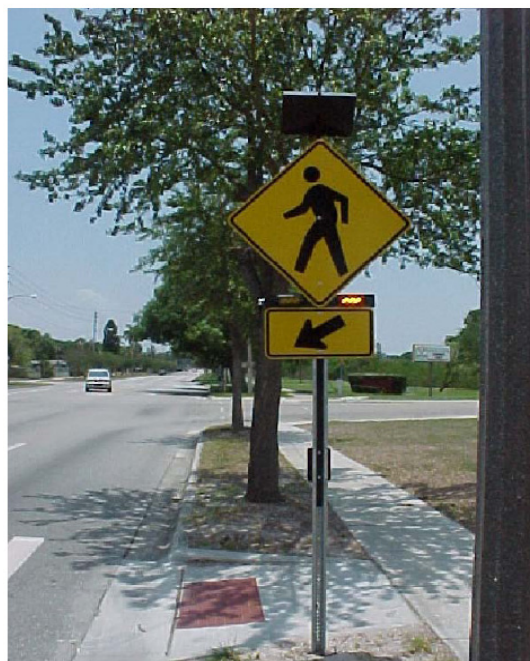
Figure 2.4: Rectangular Flashing Beacon Device (FHWA 2011)

Rapid Rectangular Flashing Beacons (RRFBs) were installed at both intersections in May 2011. Figure 2.4 is a picture of a typical RRFB device.

The RRFBs at both locations were installed in accordance with conditions given in the Federal Highway Administration (FHWA) memorandum regarding Interim Approval for Optional Use of Rectangular Flashing Beacons (IA-11) dated July 16, 2008 as well as conditions noted in an approval letter from the State Traffic Engineer dated December 10, 2010. These include the following:

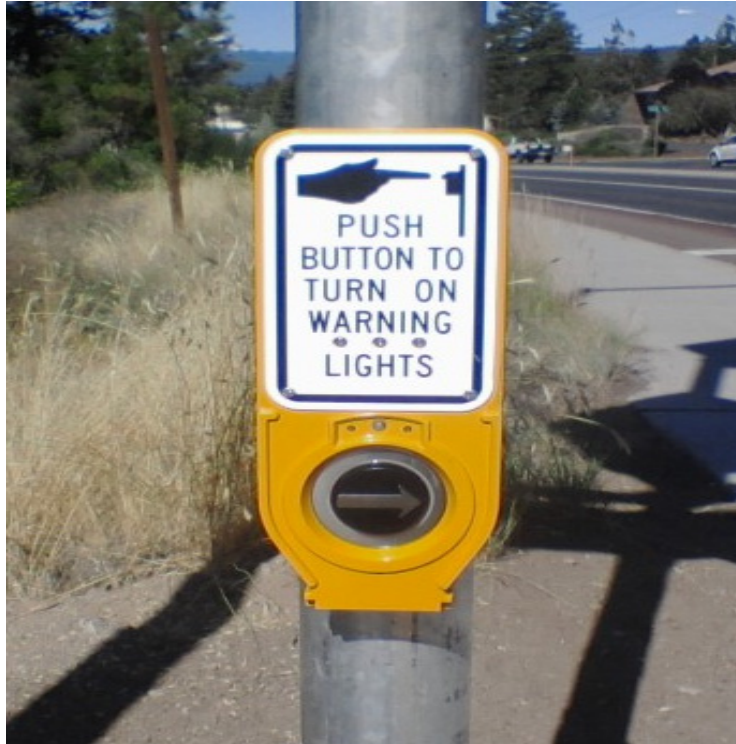
Figure 2.6: Pushbutton at Greenwood Avenue and NE 12<sup>th</sup> Street RRFB location

A pedestrian push button (similar to the photo in Figure 2.6 which shows the push button at 12<sup>th</sup> and Greenwood) was used at the two locations on the Bend Parkway. When the push button was activated on the Parkway the following message was heard: "Warning lights are on to cross Bend Parkway. Traffic may not stop."

Figure 2.6 shows the pushbutton at Greenwood Avenue and NE 12<sup>th</sup> Street. The same pushbutton and warning light is used at the two locations on the Bend Parkway. When the pushbutton is activated the following message is heard: “Warning lights are on to cross Greenwood Avenue. Traffic may not stop.”

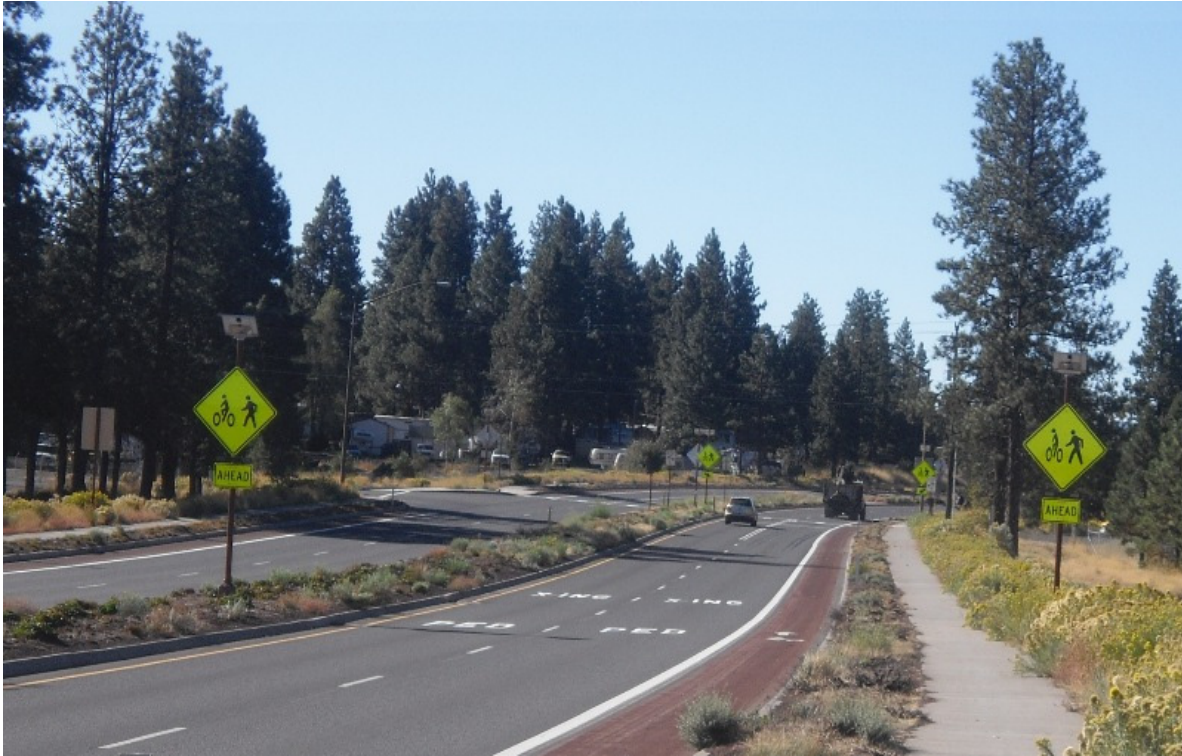
Figure 3.1 Driver's perspective of RRFB installation at the Bend Parkway and Reed Lane

Data were collected at the intersection of the Bend Parkway and Reed Lane on July 28, 2011 from 10:15 AM to 11:50 AM by two ODOT staff following the methodology given in the previous section. The weather was clear and warm. Figures 3.1 and 3.2 show the installation of the RRFB devices at the Reed Lane intersection. Figure 3.1 shows the Reed Lane intersection from the driver’s point of view, taken to include the advance RRFBs as well as the RRFBs at the crossing. Figure 3.2 shows the crossing from the pedestrian’s point of view.

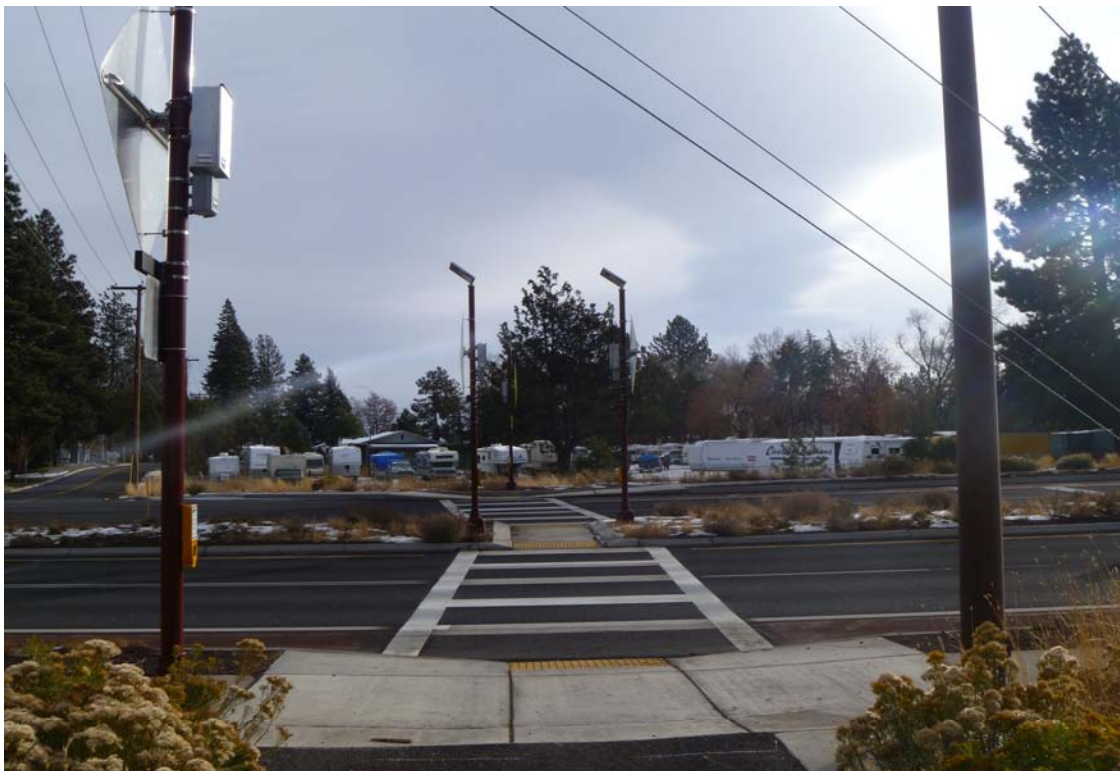
Figure 3.2 Pedestrian's perspective of RRFB installation at the Bend Parkway and Reed Lane

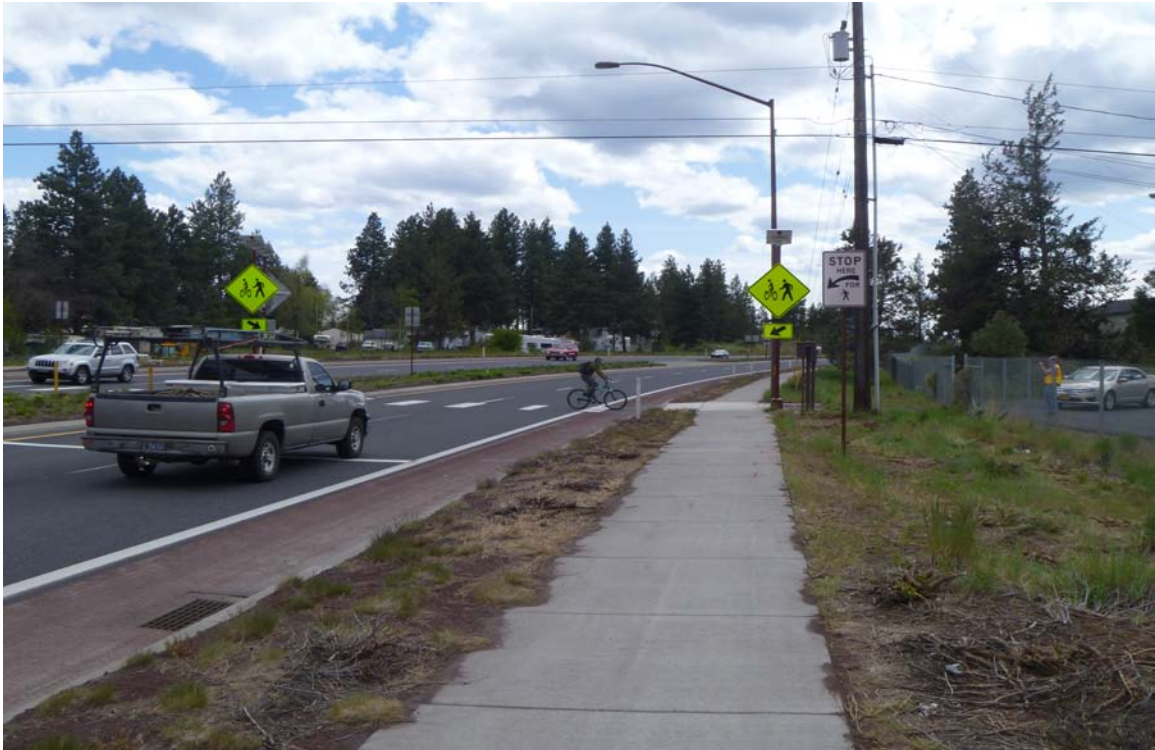
Figure 3.3: Bicycle crossing at the Bend Parkway and Reed Lane

The Reed Lane crosswalk was video recorded from 4:00 AM on Friday, September 23, 2011 to 4:00 AM on Sunday September 25<sup>th</sup>. Pedestrians and bicyclists were observed during this period and it was noted if they activated the RRFBs to cross. There were a total of 78 crossings during the period and majority of the crossers were bicyclists (64%). Half of the bicyclists did not activate the flasher; most pedestrians (75%) activated the flashers. All bicyclists rode their bikes across the highway except one. (See Figure 3.3 which was taken prior to modifying the crosswalk.) Note that the RRFB was not activated and the bicyclist was riding in the crosswalk.

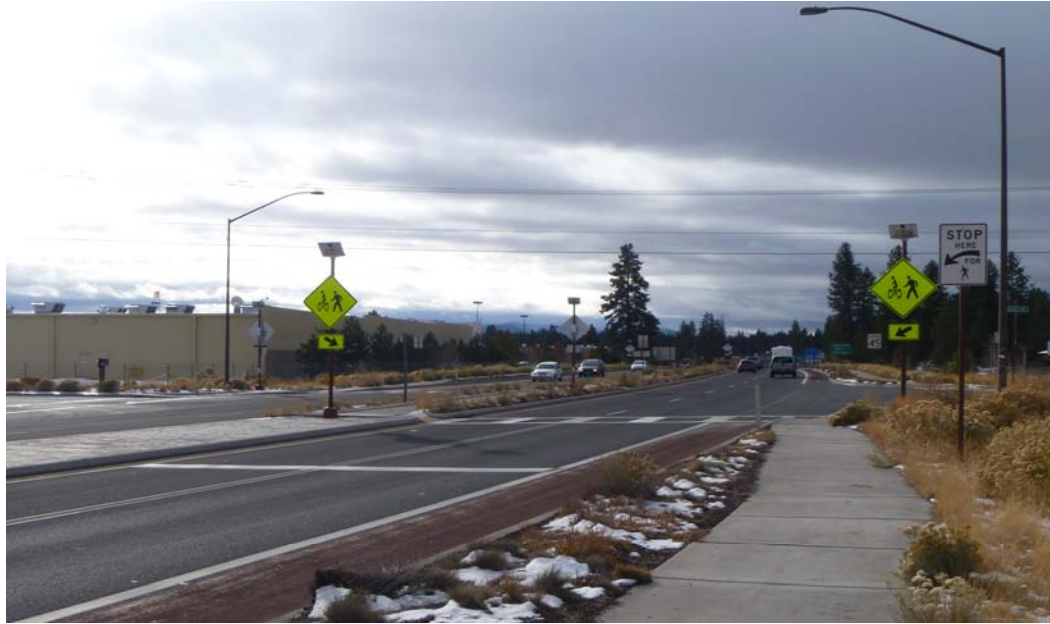
Figure 3.4 Driver's perspective of RRFB installation at the Bend Parkway and Badger Road

Data was collected at the intersection of the Bend Parkway and Badger Road on June 24, 2011 from 10:00 AM to 11:15 AM by two ODOT staff following the methodology given in the previous section. The weather was clear and warm. Figures 3.4 and 3.5 show the installation of the RRFB devices at the Badger Road intersection. Figure 3.4 shows the

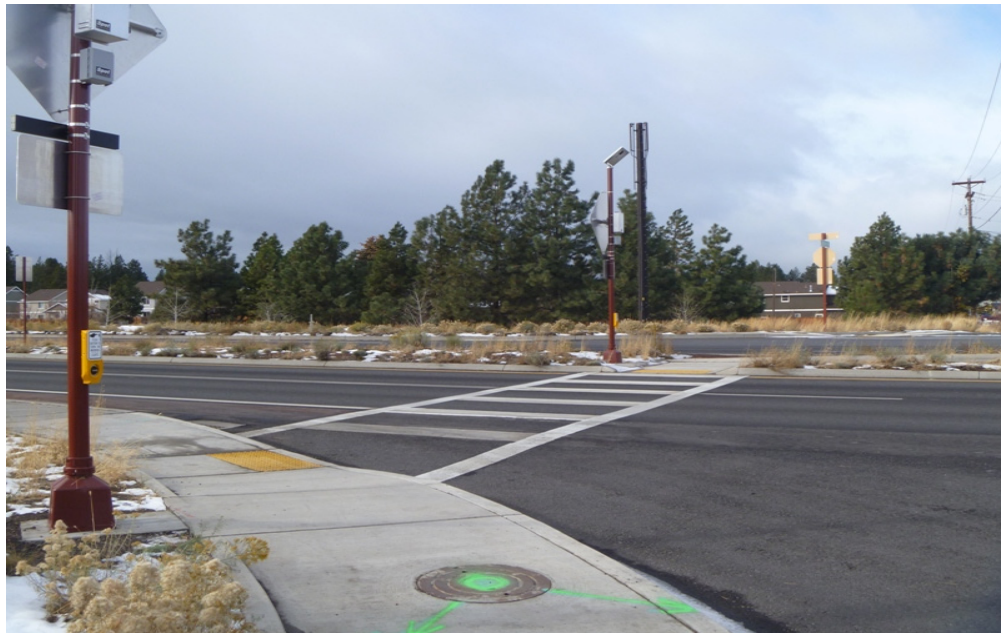
Figure 3.5 Pedestrian's perspective of RRFB installation at the Bend Parkway and Badger Road

crossing from the driver's point of view and Figure 3.4 shows the crossing from the pedestrian's point of view.

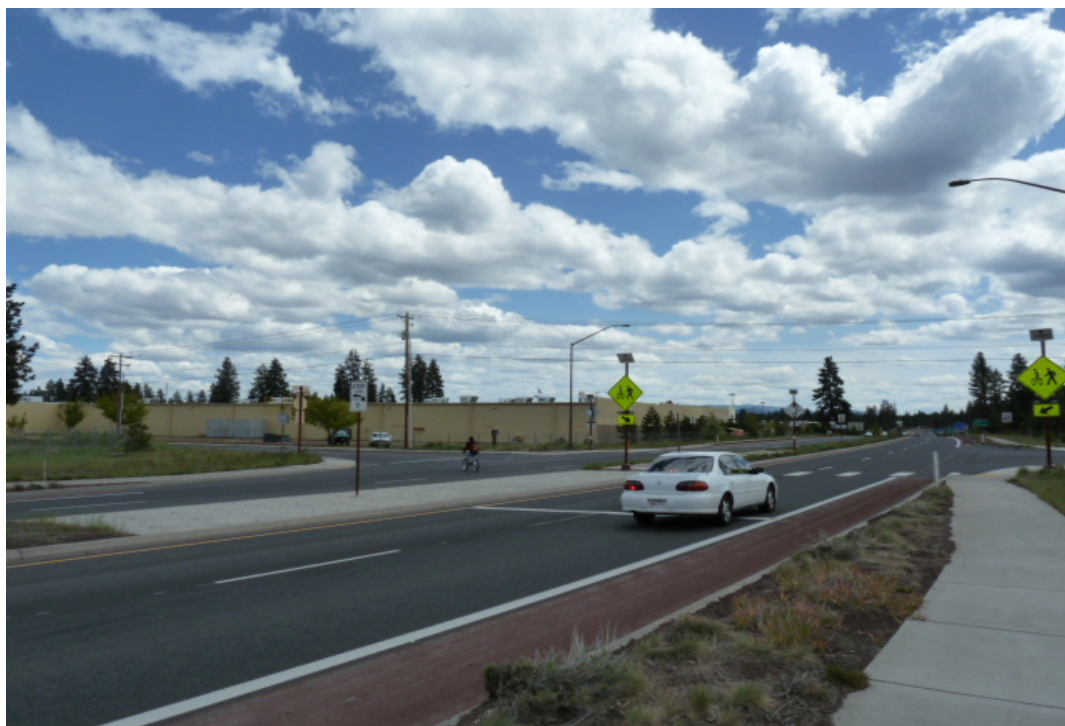
Figure 3.6: Bicyclist traveling across Badger Road not in “Z” crossing (note RRFB is not activated)

- Activation of the RRFBs resulted in a quieter and more comfortable environment for the crossing pedestrian.
- Vehicles often stopped or slowed down far from the intersection when activation occurred, giving the pedestrian a safe opportunity to cross.
- Crossers generally did not activate the pushbutton but typically waited for a safe gap and crossed.
- Pedestrians and bicyclists were observed crossing outside of the Z-Crossing. (See Figure 3.6.).

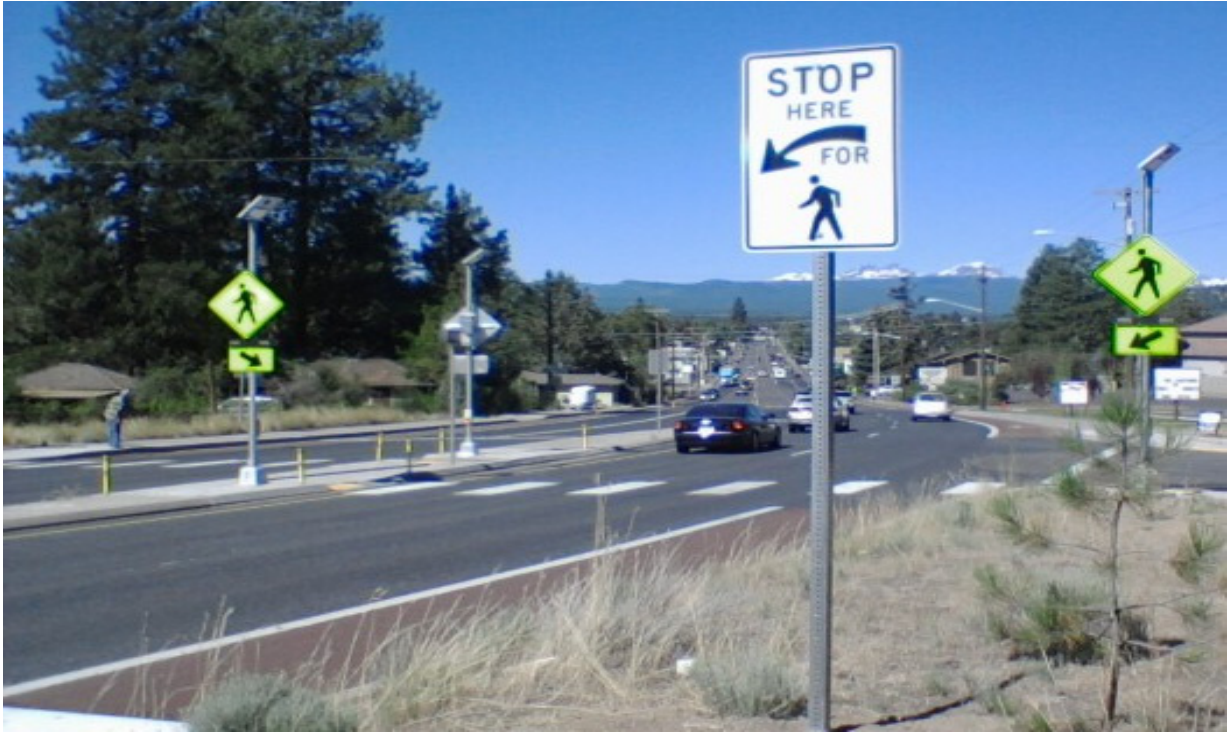
Figure 3.7: Driver's perspective of RRFB crossing at Greenwood Avenue and NE 12<sup>th</sup> Street

Data was collected at the intersection of Greenwood Avenue and NE 12<sup>th</sup> Street in the City of Bend on August 19, 2011 from 10:00AM to 11:00AM by City of Bend staff following the methodology given in the previous section. The weather was warm and sunny. Figures 3.5 and 3.6 show two views of this intersection. Figure 3.7 is taken from the northeast corner of 12<sup>th</sup> and Greenwood Avenue and shows the driver’s perspective. Figure 3.8 shows the intersection as a pedestrian crossing Greenwood Avenue in the northbound direction would see it. This crossing was designed to be a two-stage crossing with the pedestrian pushing the button to cross from the sidewalk to the median and then pushing a second push button to continue from the median to the other side of the street.

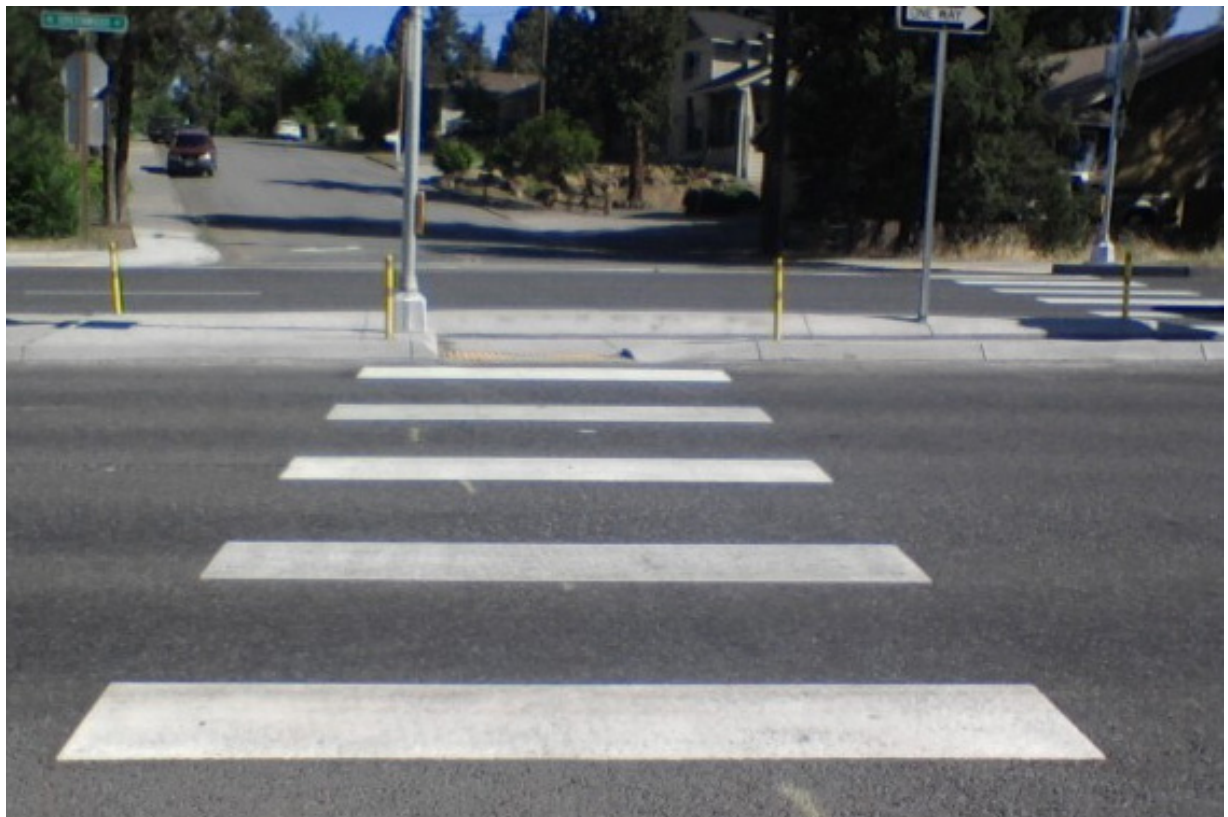
Figure 3.8: Pedestrian's perspective of RRFB crossing at Greenwood Avenue and NE 12<sup>th</sup> Street
