**METHODS FOR STRENGTHENING  
REINFORCED CONCRETE BRIDGE  
GIRDERS CONTAINING POORLY  
DETAILED FLEXURAL STEEL USING  
NEAR-SURFACE MOUNTED  
METALLICS  
Final Report Appendices A**

**SPR 750**

Oregon Department of Transportation

### **EXPERIMENTAL DATA for IT SPECIMENS**

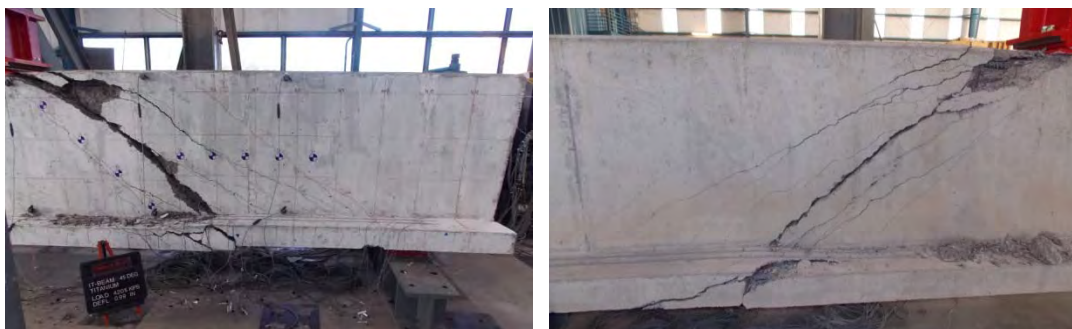
Figure A.8 – Specimen IT.45.Ld3(10).Ti front and back failure photographs

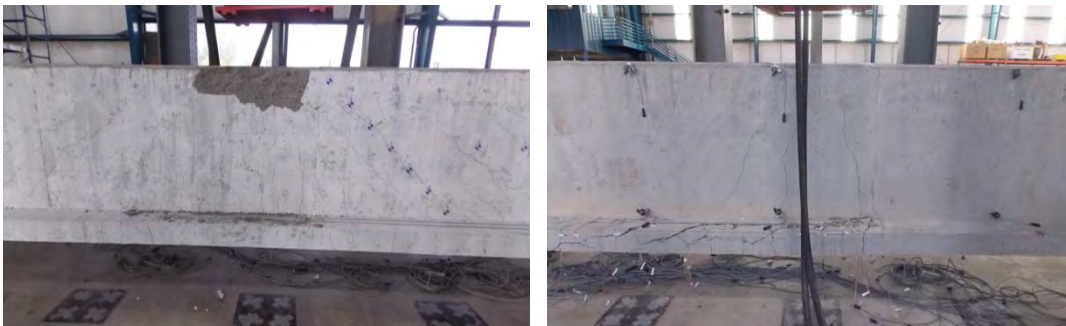
Figure A.32 – Specimen IT.45.Ld3(6).Ti front and back failure photographs

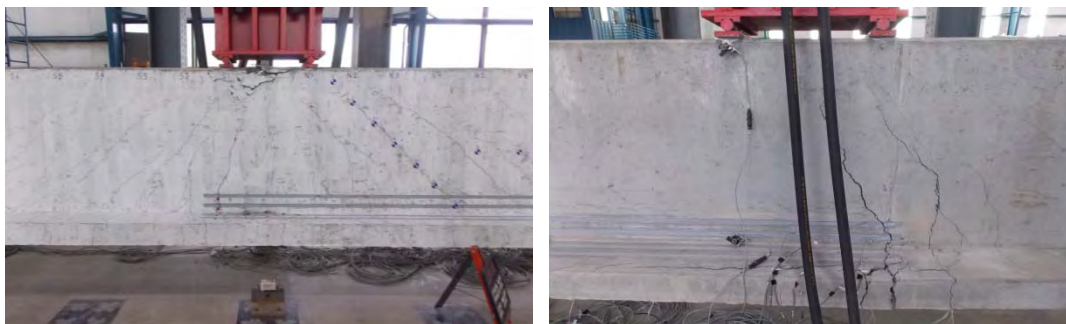
Figure A.57 – Specimen IT.45.Ld3(6).SS front and back failure photographs

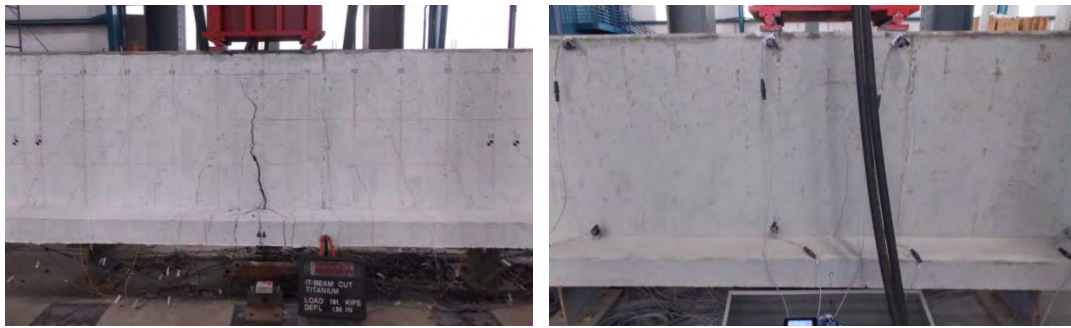
Figure A.82 – Specimen IT.0.0(6).Ti front and back failure photographs
