**METHODS FOR STRENGTHENING  
REINFORCED CONCRETE BRIDGE  
GIRDERS CONTAINING POORLY  
DETAILED FLEXURAL STEEL USING  
NEAR-SURFACE MOUNTED  
METALLICS**  
**Final Report Appendices B-D**

**SPR 750**

Oregon Department of Transportation

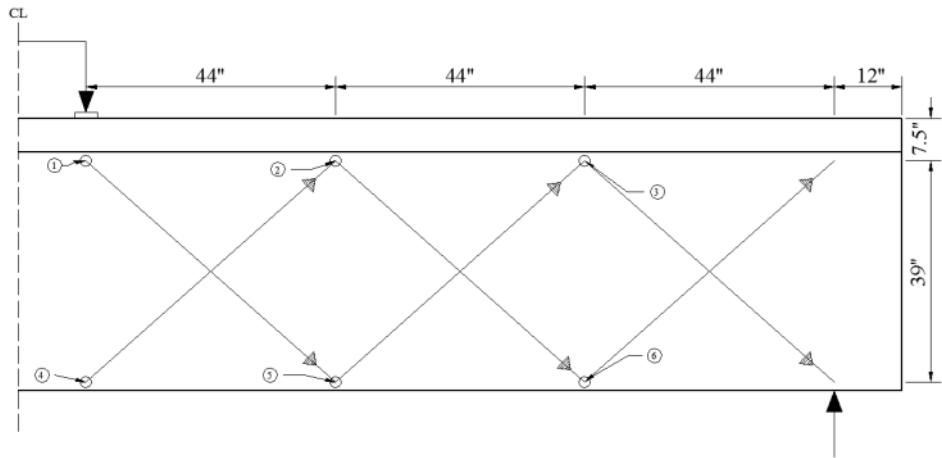
Figure B.1 Diagonal displacement sensor numbering on North side of specimen  
T.45.Ld3(10).Ti, T.45.Ld3(6).Ti and T.45.Ld3(6).SS

Diagonal Displacement Sensors: Diagonal displacement sensors were used to measure the change in crack widths crossing the sensor. The diagonal displacement sensors were mechanically attached to the stem of the specimens. Brass wire was strung from the diagonal displacement sensor to an opposing point. Two diagonal displacement sensors were placed over a specified length to measure compression and tension in the section. The sensors were numbered and installed according to Figure B.1 and Figure B.2 with the arrow indicating the direction of measurement.

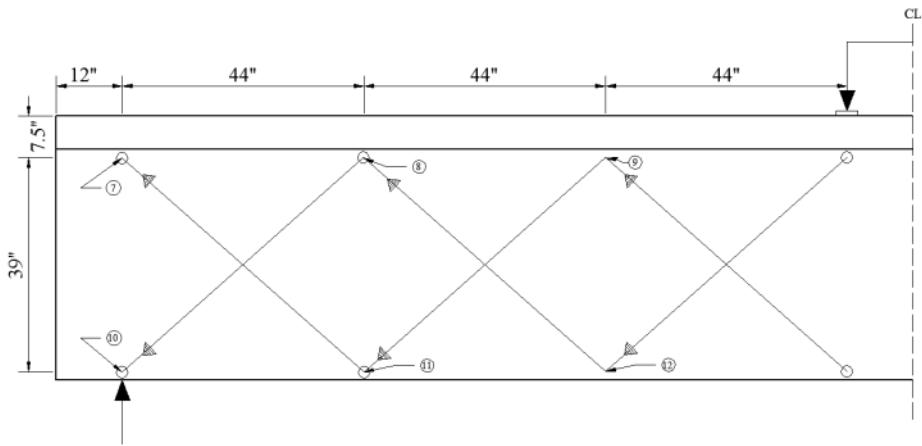
Figure B.2 Diagonal displacement sensor numbering on South side of specimen  
T.45.Ld3(6).Ti and T.45.Ld3(6).SS

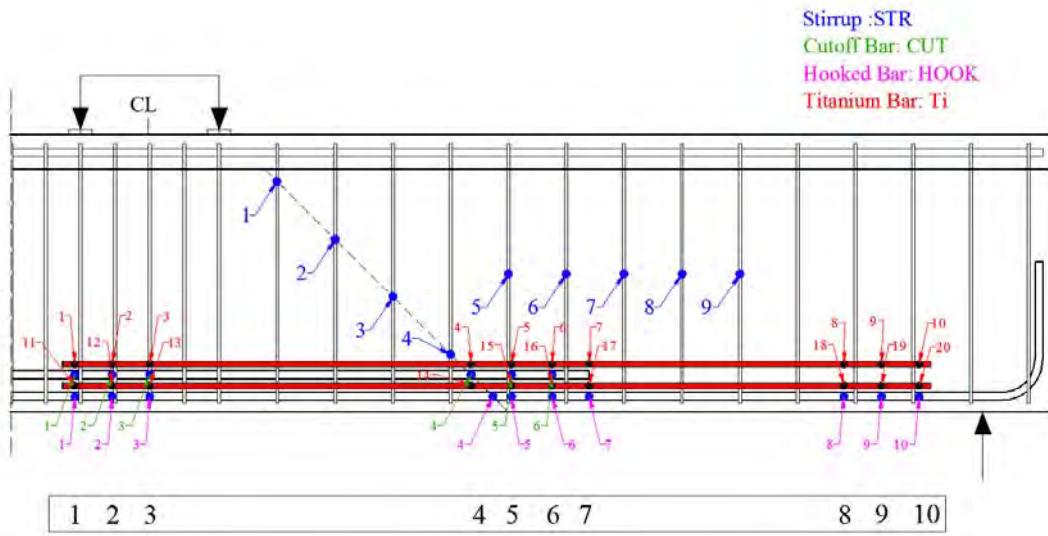
Figure B.3 - Specimen T.45.Ld3(10).Ti Strain gage labeling convention

**Strain Gages:** Stain gages were adhered to longitudinal reinforcing steel, NSM materials, and stirrups legs. Along the longitudinal reinforcing steel and NSM materials strain gages were located at the termination of the NSM material and the termination of the cutoff steel reinforcing bar. Stirrup strain gages were implemented on one leg along the preformed diagonal crack and at mid-height. The labeling convention of the strain gages can be found in Figure B.3 through Figure B.5. The strain gage location on the stainless steel NSM is coincident with the titanium on the top and bottom bars (bars 1 and 4). However, the label number for the stainless steel NSM materials are opposite of the titanium NSM material. A cross section is provided in Figure B.6 for the NSM titanium and stainless steel internal sensor configuration.

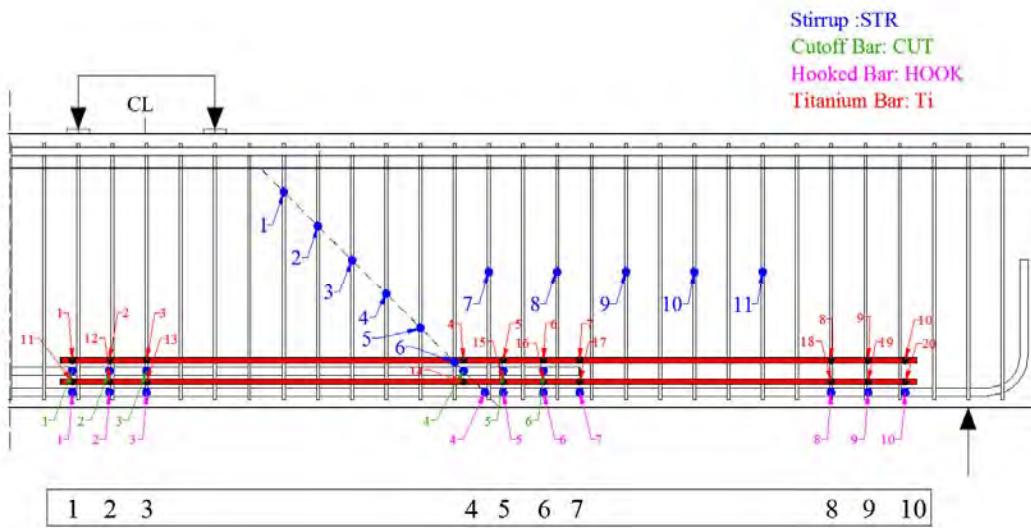
Figure B.4 - Specimen T.45.Ld3(6).Ti Strain gage labeling convention

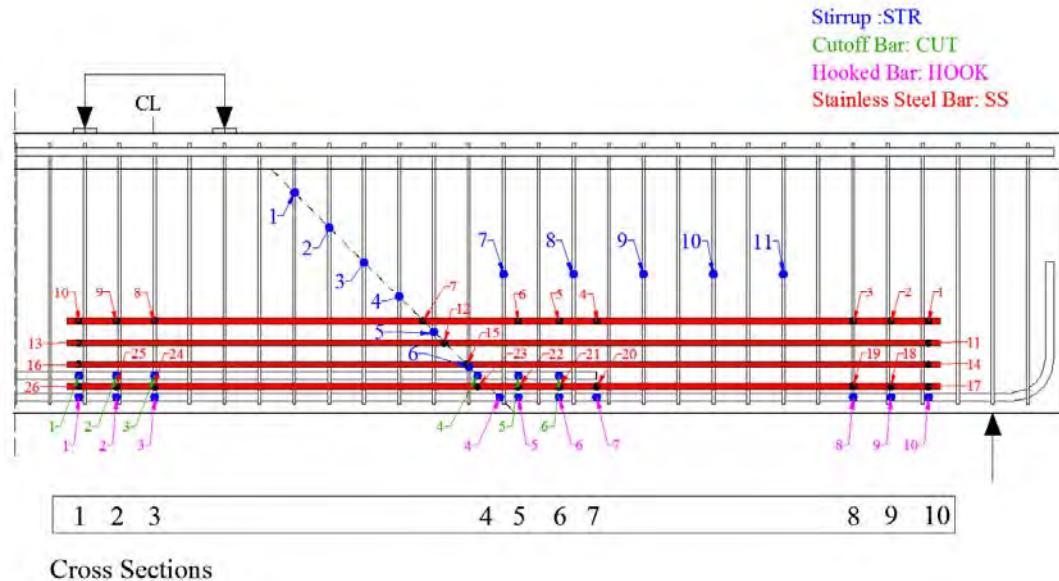
Figure B.5 - Specimen T.45.Ld3(6).SS Strain gage labeling convention

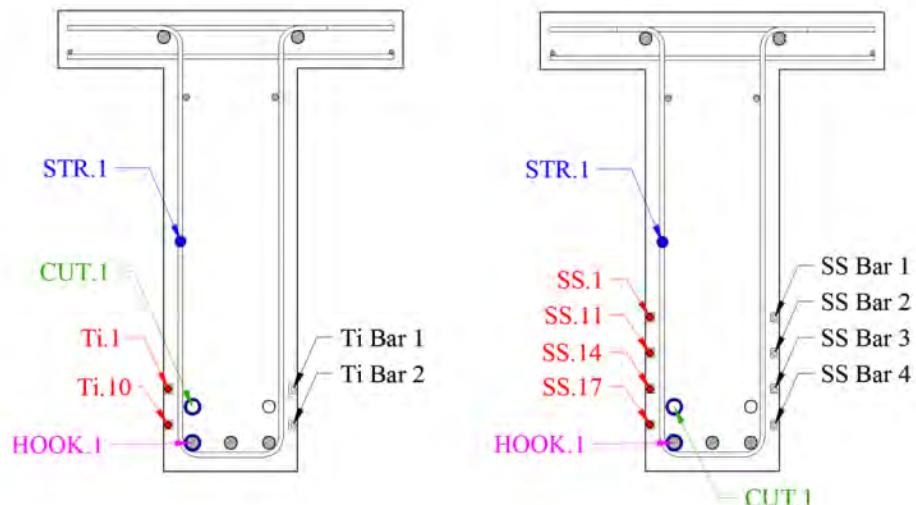
Figure B.6 - Cross section for internal instrumentation for T.45.Ld3(10).Ti and T.45.Ld3(6).Ti (left) and T.45.Ld3(6).SS (right)

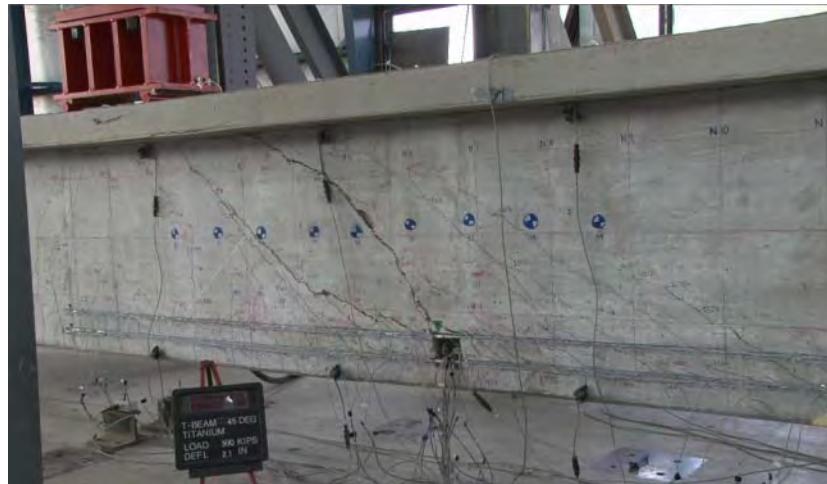
Figure B.7 - Specimen T.45.Ld3(10).Ti at failure

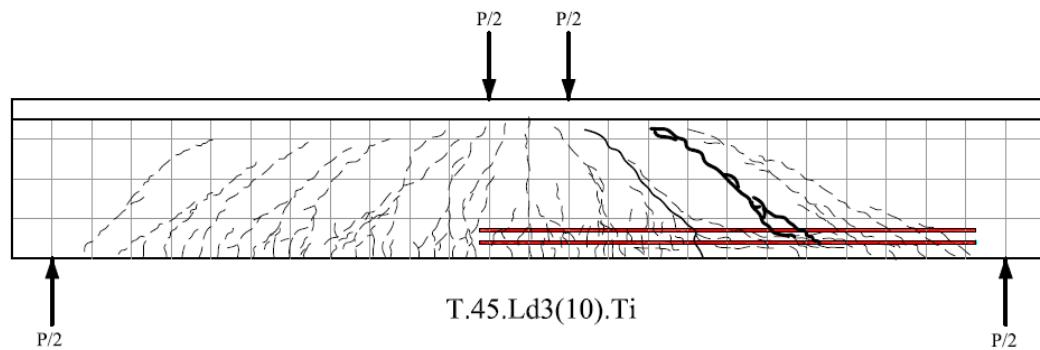
Figure B.8 - Specimen T.45.Ld3(10).Ti crack map

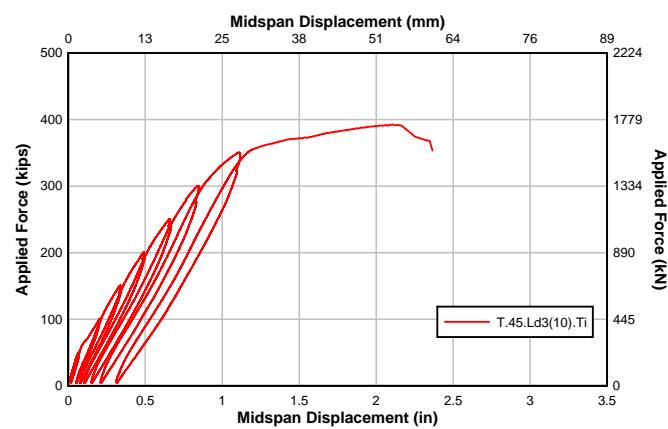
Figure B.9 - Specimen T.45.Ld3(10).Ti Load displacement curve

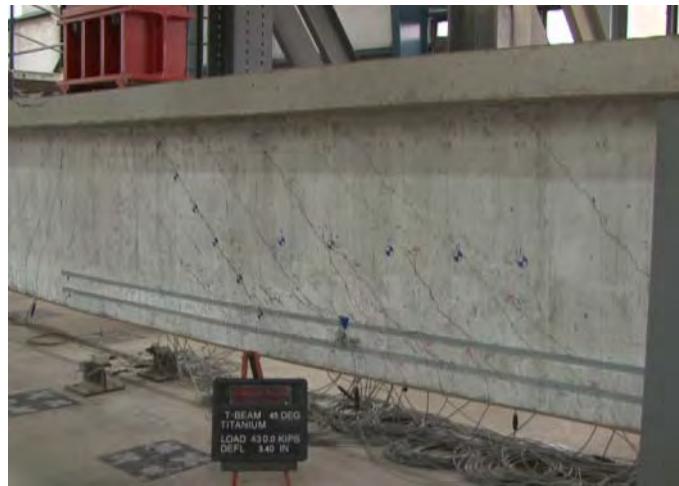
Figure B.31 - Specimen T.45.Ld3(6).Ti at failure

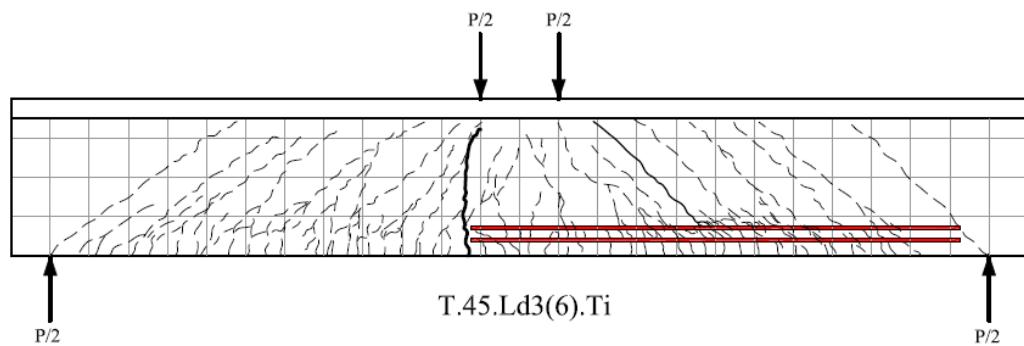
Figure B.32 - Specimen T.45.Ld3(6).Ti crack map

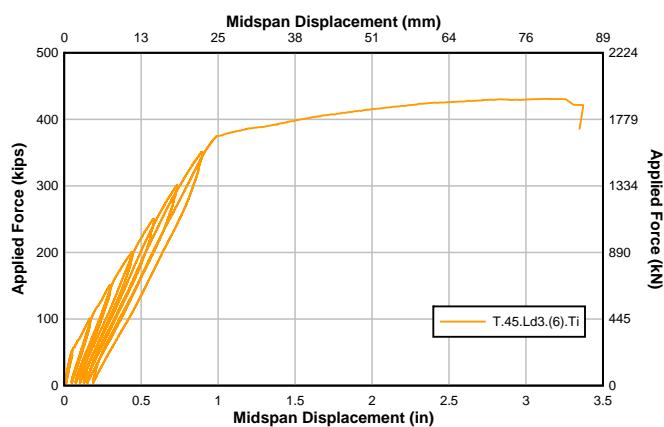
Figure B.33 - Specimen T.45.Ld3(6).Ti Load displacement curve

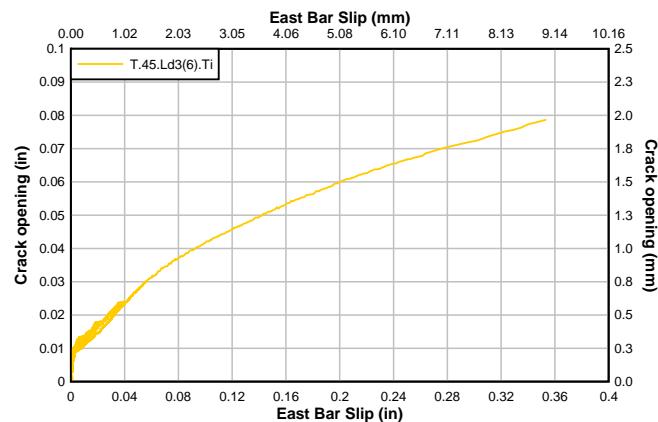
Figure B.35 - T.45.Ld3(6).Ti Crack opening vs cutoff bar slip

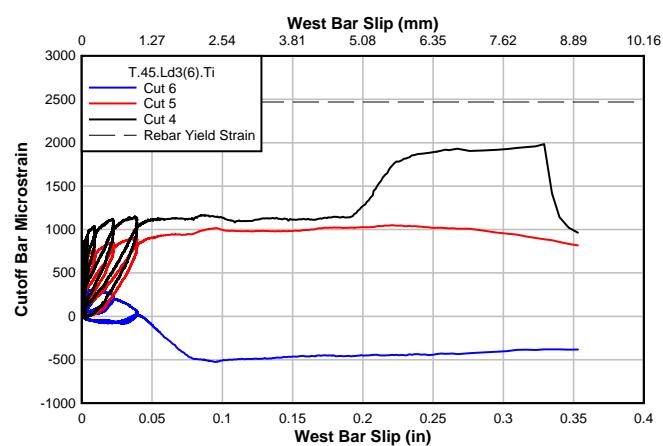
Figure B.36 - T.45.Ld3(6).Ti Slip and cutoff bar strain

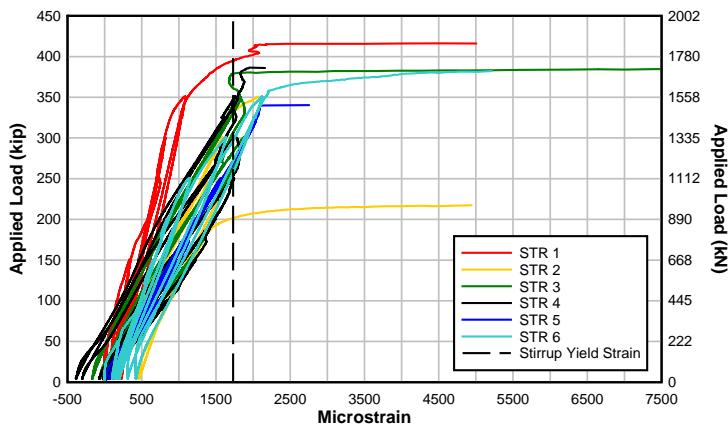
Figure B.37 - T.45.Ld3(6).Ti Strain in stirrups along diagonal crack

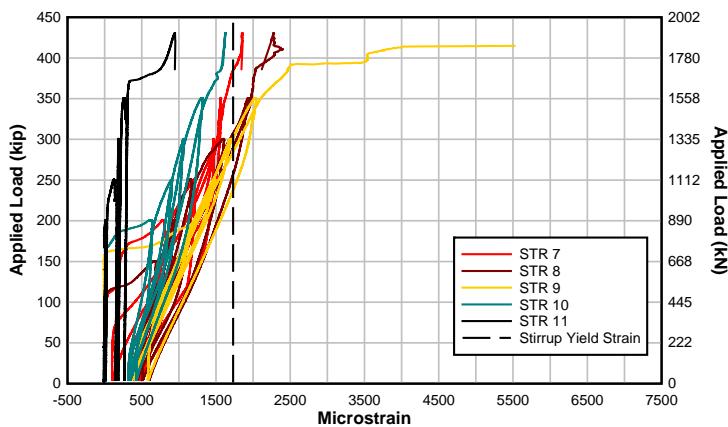
Figure B.38 - T.45.Ld3(6).Ti Strain in stirrups mid height

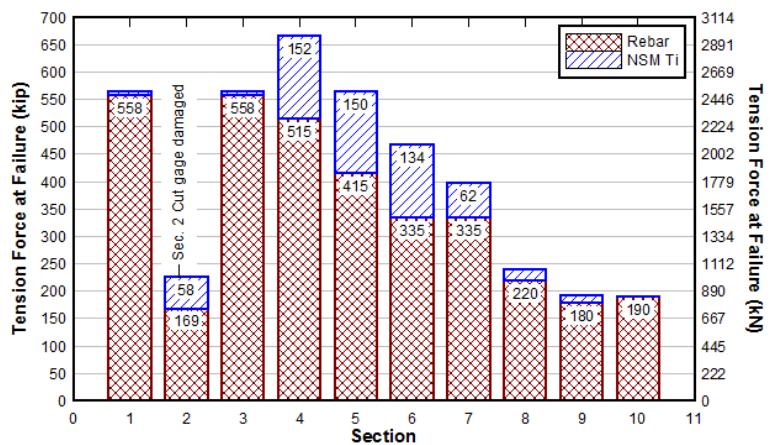
Figure B.55 - T.45.Ld3(6).Ti Steel reinforcing bar vs NSM bar maximum tension force

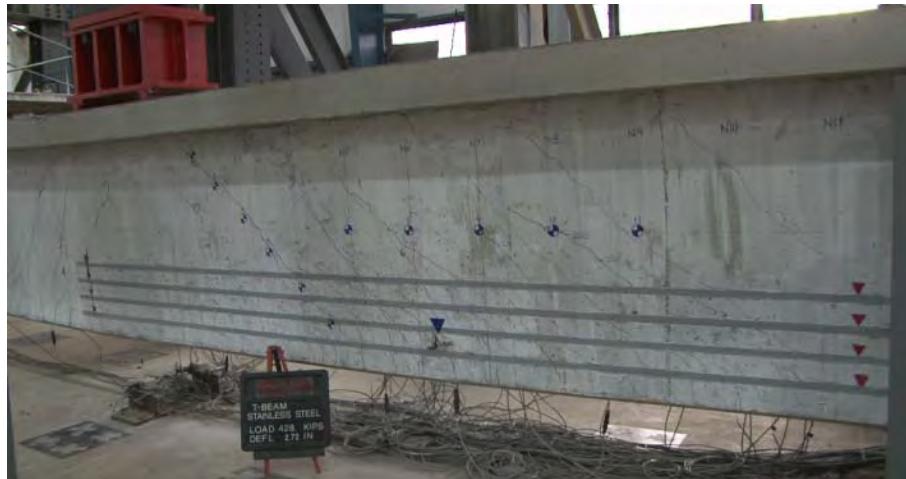
Figure B.56 - Specimen T.45.Ld3(6).SS

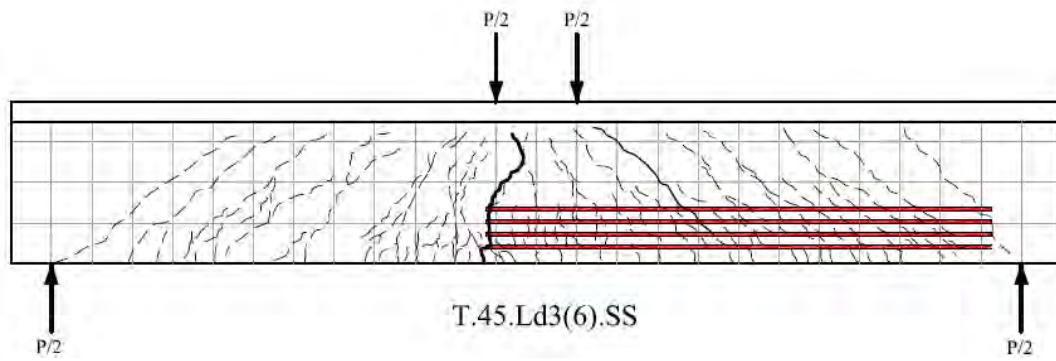
Figure B.57 - Specimen T.45.Ld3(6).SS crack map

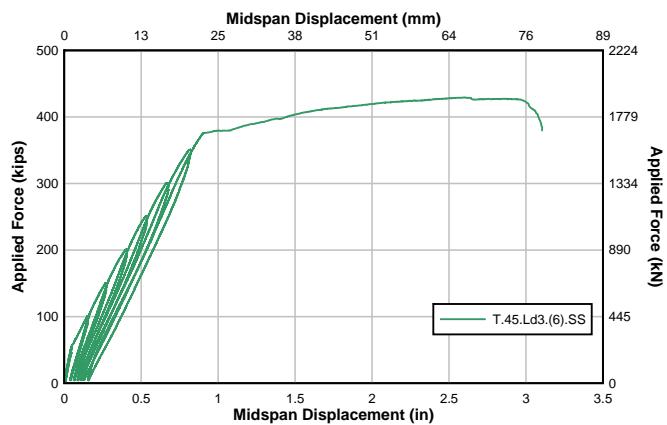
Figure B.58 - Specimen T.45.Ld3(6).SS Load displacement curve

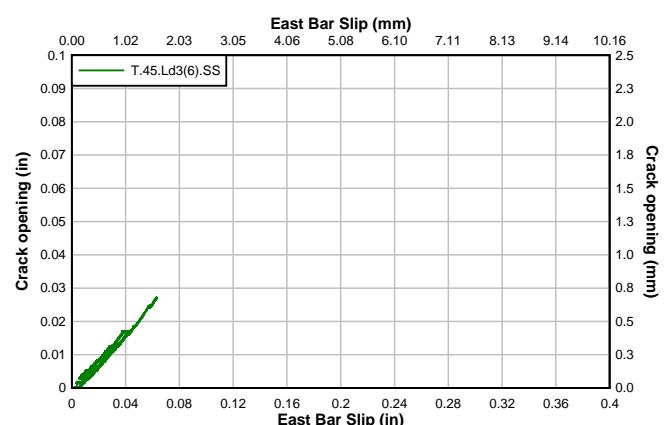
Figure B.60 - T.45.Ld3(6).SS Crack opening and cutoff bar slip

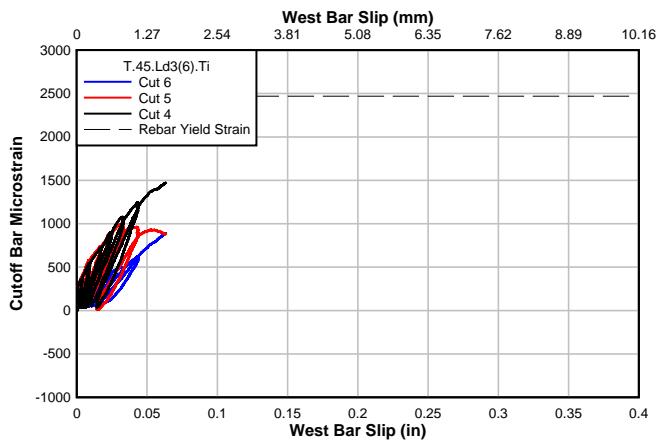
Figure B.61 - T.45.Ld3(6).SS Slip and cutoff bar strain

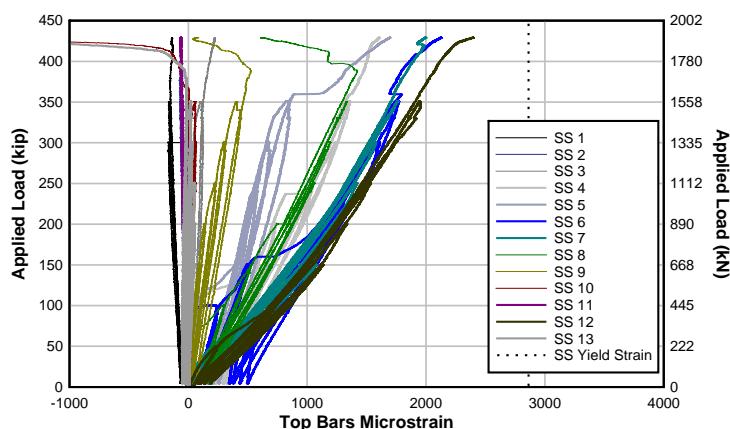
Figure B.66 - T.45.Ld3(6).SS Strain in stainless steel bar 1 & 2

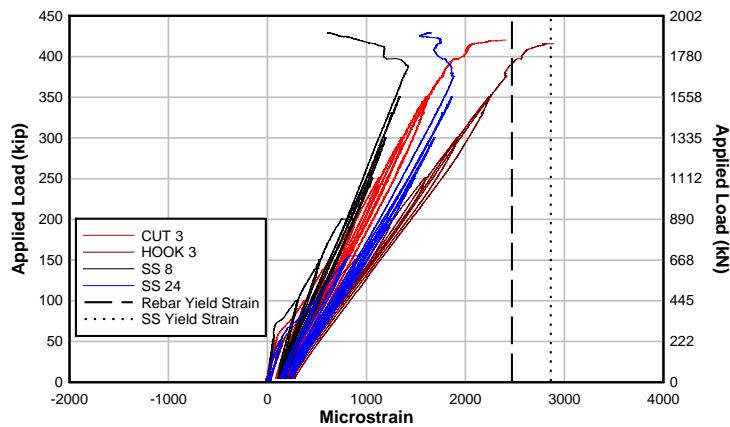
Figure B.70 - T.45.Ld3(6).SS Section 3 strain

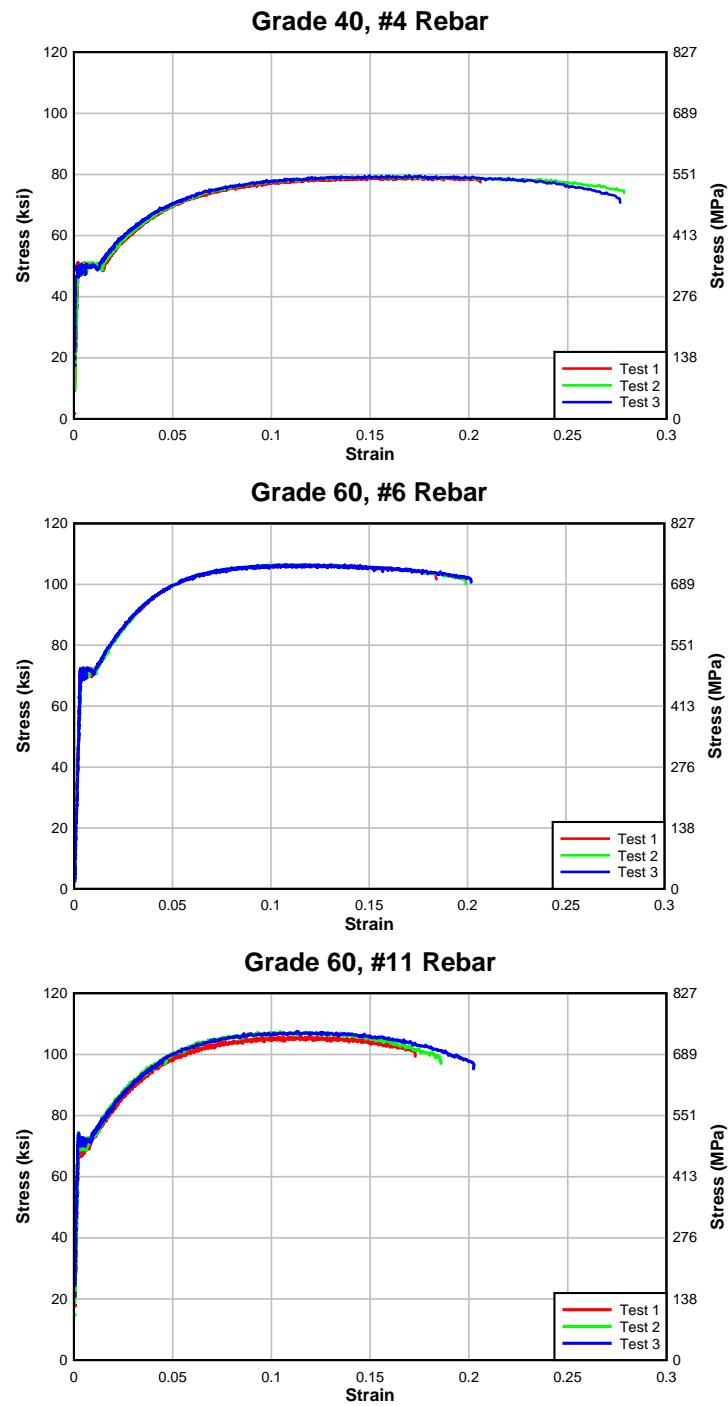
Figure C.1 – Stress-strain curves for steel reinforcement.

A 110 kip (489 kN) universal testing machine (UTM) was used for the steel and NSM materials tensile testing. Testing was performed under displacement control and the coupons were loaded at a rate of 0.001 in/sec (0.254 mm/sec) until past visible yield. After yielding, the loading rate was increased to 0.003 in/sec (0.0762 mm/sec). An extensometer measured the strains over the 2 in. (50.8 mm) gage length. To prevent damage, the extensometer was removed before rupture of the bars.

Three coupons each of steel, titanium, and stainless steel were pulled until rupture to measure the yield and ultimate strength of each material. The actual values of yield and ultimate were determined from averaging each set of three tests. The longitudinal steel was Grade 60 (Grade 420), the transverse steel was Grade 40 (Grade 280) and the stainless steel was Grade 75 (Grade 520). The titanium did not have a specified grade. The coupon stress was determined by dividing the applied load by the bar area. The stress-strain diagrams for each the steel reinforcing and NSM materials are shown in below in Figures C.1 and C.2, respectively. Because stainless steel and titanium do not have well-defined yield plateaus, the yield stresses were identified using the 0.2% offset method. Table C.2 shows a summary of the coupon data including yield stress, ultimate strength, and ultimate elongation.

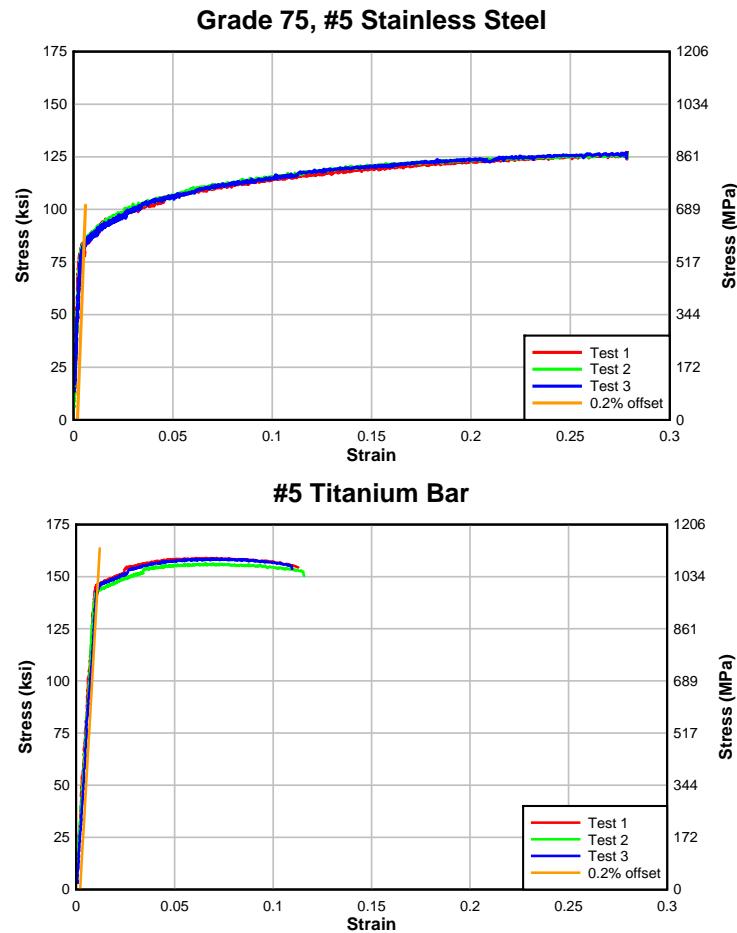
Figure C.2 – Stress-strain curves for NSM reinforcement.

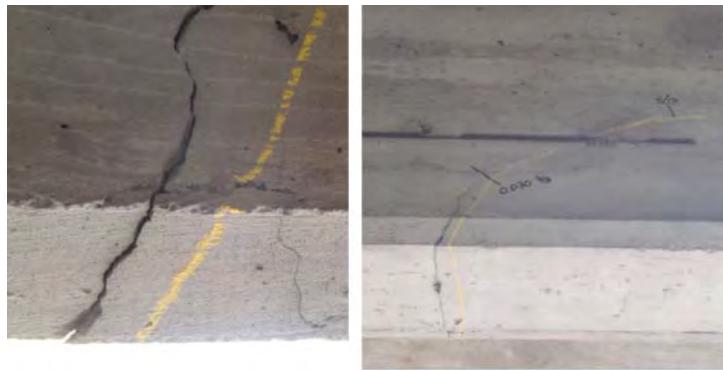
Figure D.3a – View of haunch transition on interior girder of span 1 (right) and crack with vertical offset on interior girder of span 1(left) (ODOT 2013)

The Mosier Bridge is a four span reinforced concrete deck girder (RCDG) bridge. The original three spans were built in 1953 and the bridge was lengthened in 1959 (ODOT, 2013). After the bridge inspection identified a 0.03 in. (0.762 mm) wide crack in the North span interior girder, the bridge was shored. Figure D.3a illustrates the observed cracks with vertical offset and Figure D.3b shows the reinforcing steel details superimposed over the image of the crack beam span.

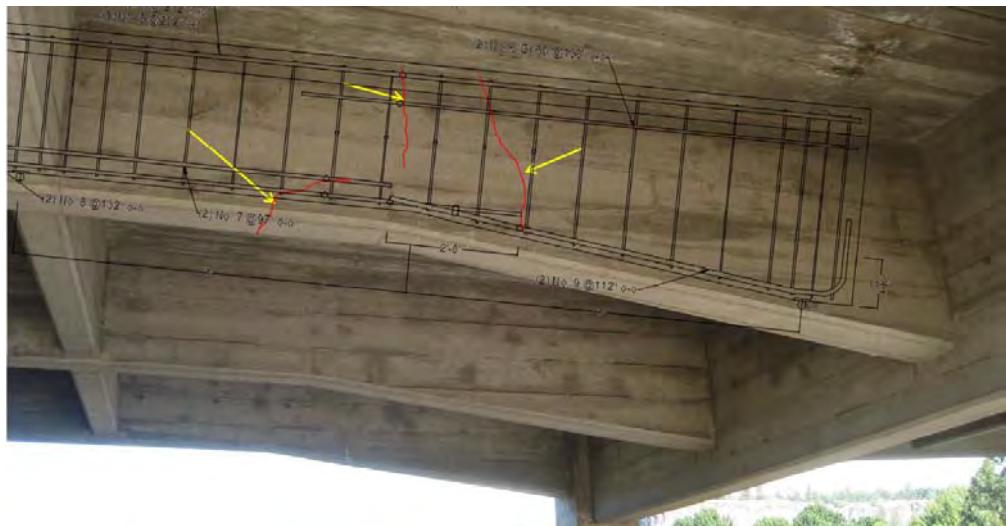
Figure D.3b – Overlay of reinforcing steel details on image of cracked girder.

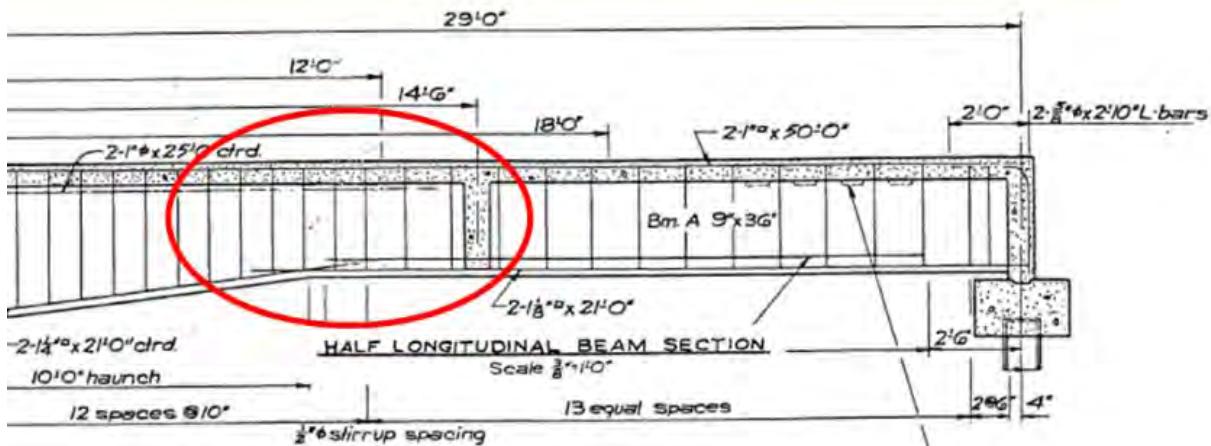
Figure D.4 – As-built elevation drawing of Mosier Bridge with highlighted critical section (ODOT 2013)

The haunch intersection with vertical offset cracks in the Mosier Bridge is highlighted in Figure D.4. Beam A in Figure D.5 is the smaller, constant cross section in Mosier specimens for 9 ft (2.74 m). The Mosier specimen transitions to Haunch AB in the remaining 9 ft (2.74 m).

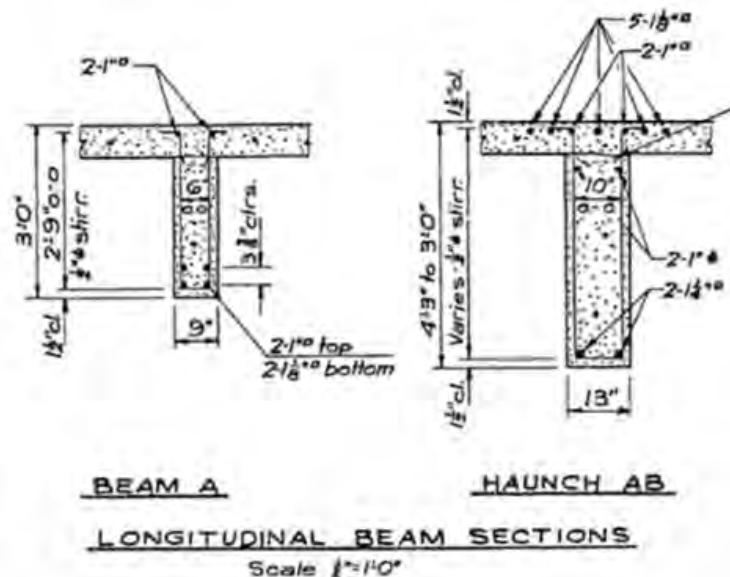
Figure D.5 – As-built cross section of Mosier Bridge span 1 interior girder (ODOT 2013)

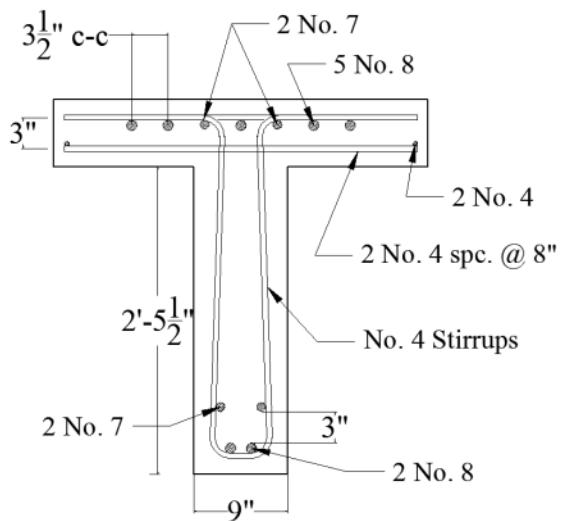
Figure D.6 – Cross section at South end of Mosier specimen.

All specimens had identical longitudinal reinforcing steel. Longitudinal reinforcing steel in the web consisted of two #7 (22M) and two #8 (25M) bars on the South half and two #9 (29M) bars through the North half. Two #6 (19M) steel reinforcing bars were located in the upper stem on the North end. All longitudinal reinforcing steel bars were adequately anchored past the support locations. To resist negative moments, the Mosier specimens had two #7 (22M) and five #8 (25M) steel reinforcing bars in the flange terminating at various lengths. Double-legged, open #4 (13M) stirrups were spaced 12 in. (305 mm) on center throughout midspan in Mosier 1 and Mosier 2. Mosier 3 decreased the stirrup spacing before the NSM titanium strengthening initiated. Figure D.6 through Figure D.12 display the cross section, elevation, and plan drawings for the Mosier specimens built in this experimental program.

The cross section drawings show the longitudinal reinforcing steel and NSM titanium for applicable specimens. The cross section at midspan was congested with four steel reinforcing bars in close proximity. The most deficient detail in the Mosier specimens was the overlapping of the #8 (25M) and #9 (29M) bars at midspan. While the as-built drawing suggested more overlap, in reality the two bars are developing simultaneously at the point of maximum moment. Mosier 3 decreased stirrup spacing and terminated the NSM titanium bars at slightly different locations than Mosier 2. The upper and lower NSM titanium bars were shifted 1 in. (25.4 mm) relative to each other.

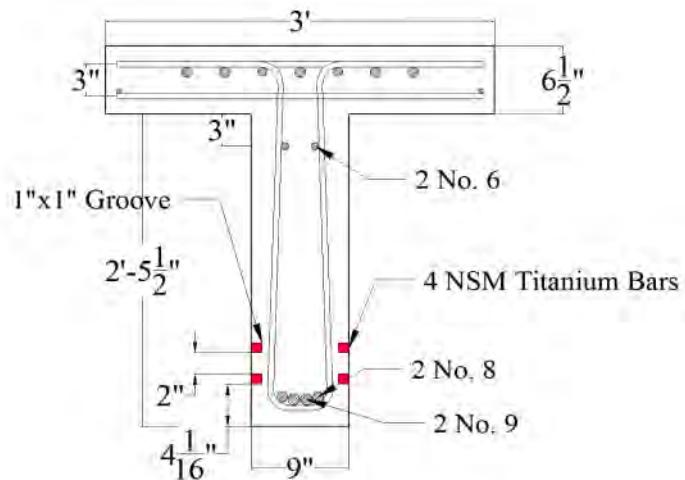
Figure D.7 - Cross section at midspan of Mosier specimen with NSM Titanium.

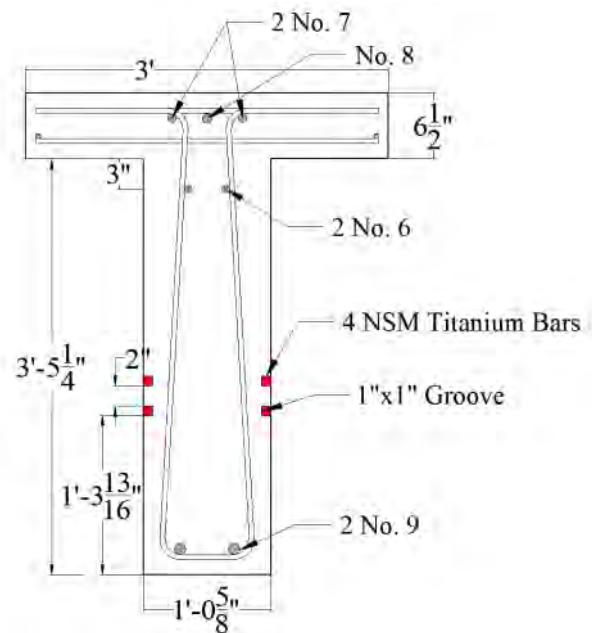
Figure D.8 - Cross section at North end of Mosier specimen with NSM Titanium.

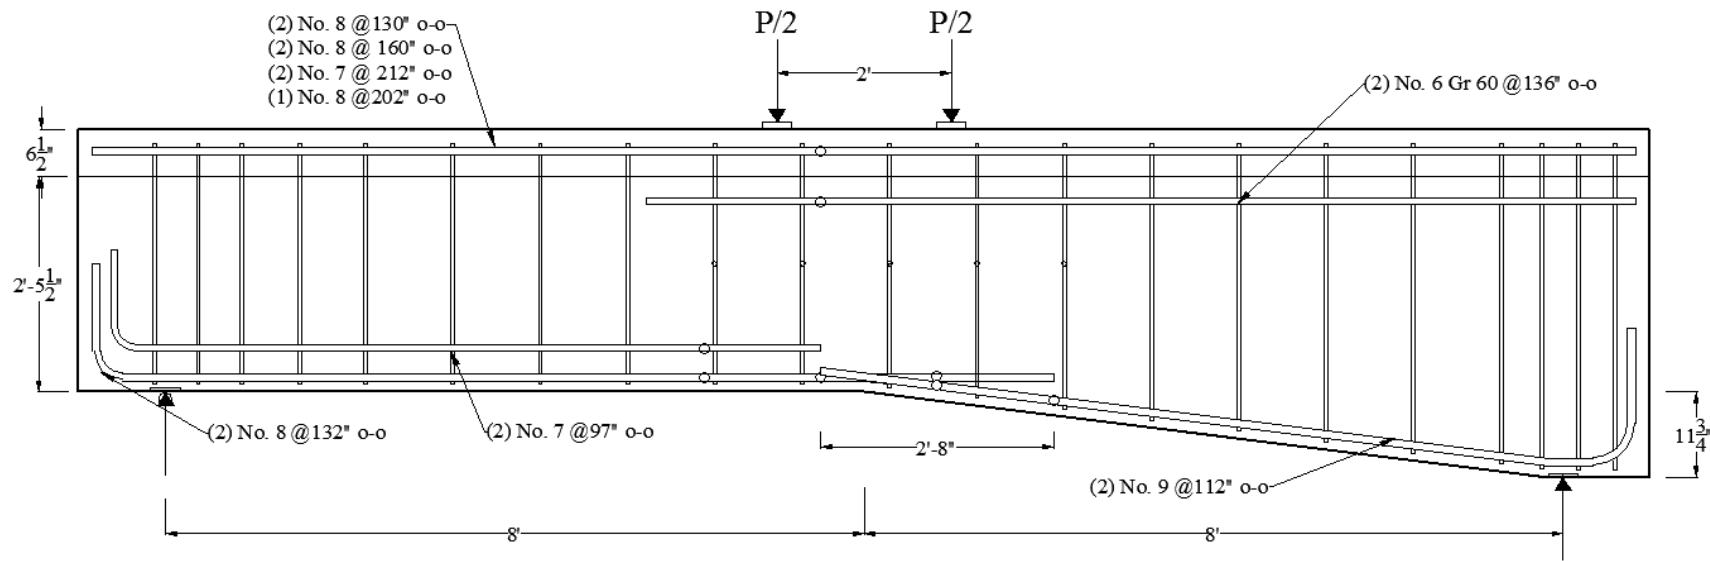
Figure D.9 - Elevation of Mosier 1

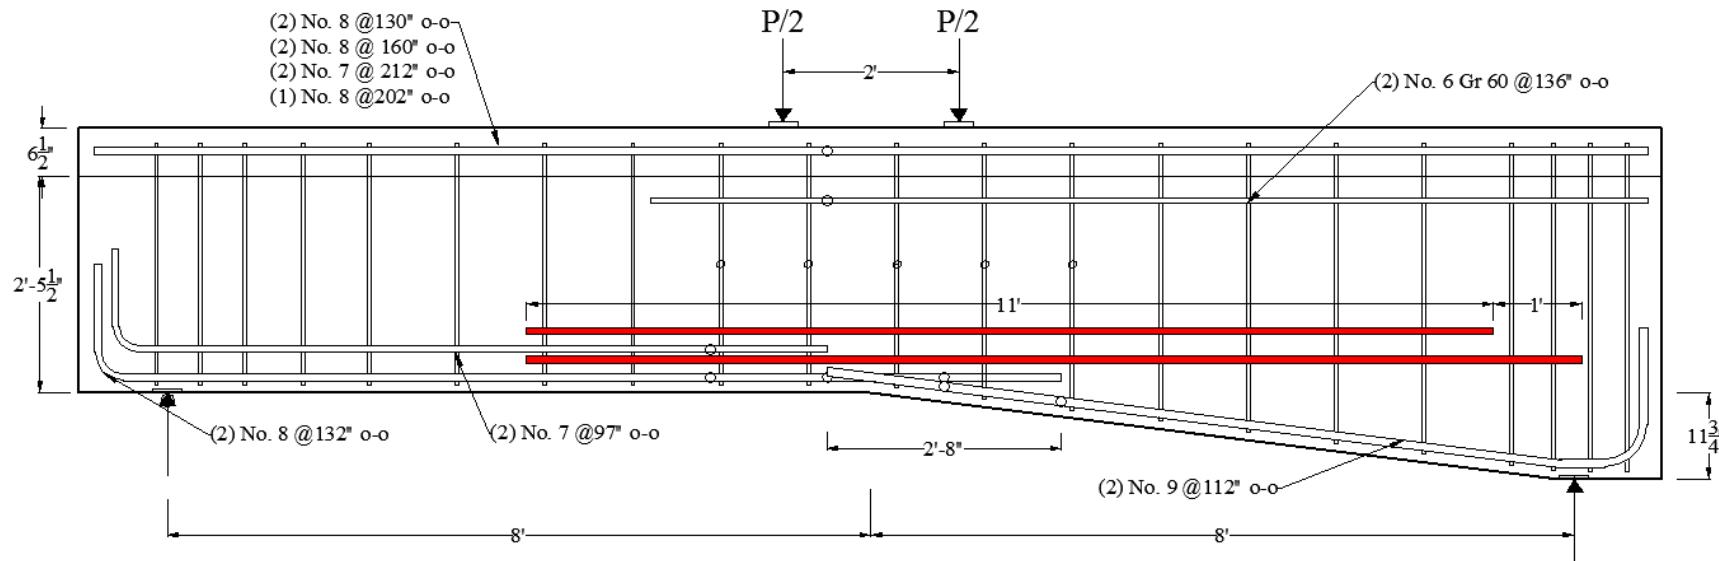
Figure D.10 - Elevation of Mosier 2 with NSM titanium

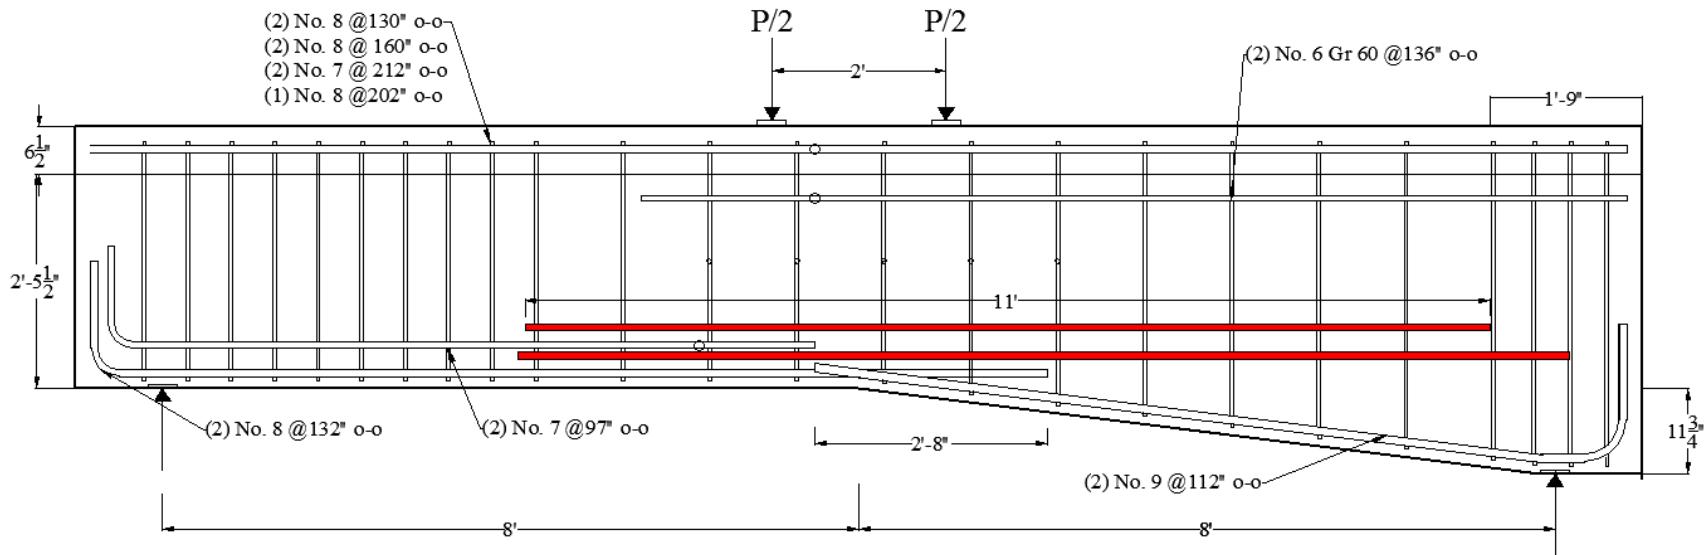
Figure D.11 - Elevation of Mosier 3 with NSM titanium

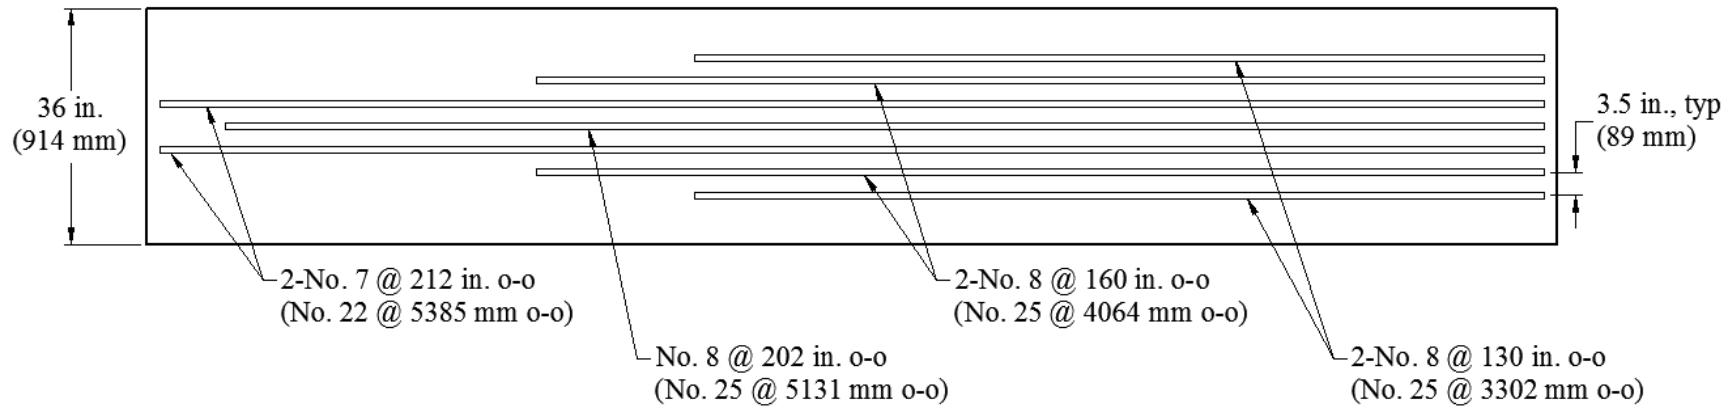
Figure D.12 Plan view of steel in deck of all Mosier specimens.

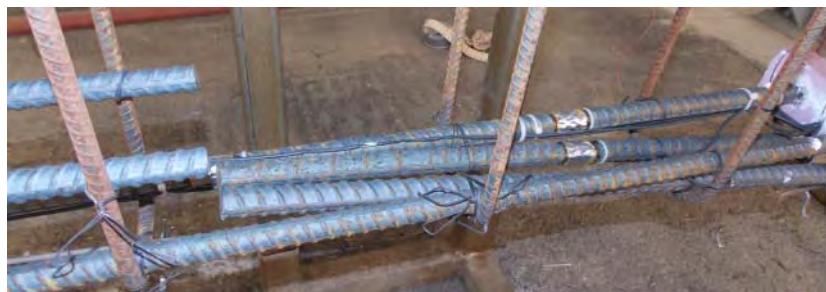
Figure D.13 - Midspan reinforcing steel terminations for Mosier specimens

The longitudinal bars were cut to length and bent on site using a bar bending machine. Stirrups of increasing height were ordered from a local reinforcing bar fabricator. To create the steel reinforcing cage, stirrups spaced 12 in. (305 mm) apart or tighter were hung from the steel reinforcing bars in the deck. Two #8 (25M) steel reinforcing bars were tied to the stirrups for the lower layer of flexural reinforcement on the South half of the Mosier specimens. Similarly, two #9 (29M) steel reinforcing bars were tied to the tapered stirrups as the flexural reinforcement on the North half. At midspan the two #9 (29M) steel reinforcing bars intersected the two #8 (25M) steel reinforcing bars as shown in Figure D.12. The cutoff layer of #7 (22M) steel reinforcing bars were spaced 3 in. (76.2 mm) clear from the top of the #7 (22M) layer. Several 1.5 in. (38 mm) wide spacers were attached to the stirrup legs and longitudinal steel to provide sufficient cover. Figure D.13 pictures the completed reinforcing steel cage for Mosier 1.

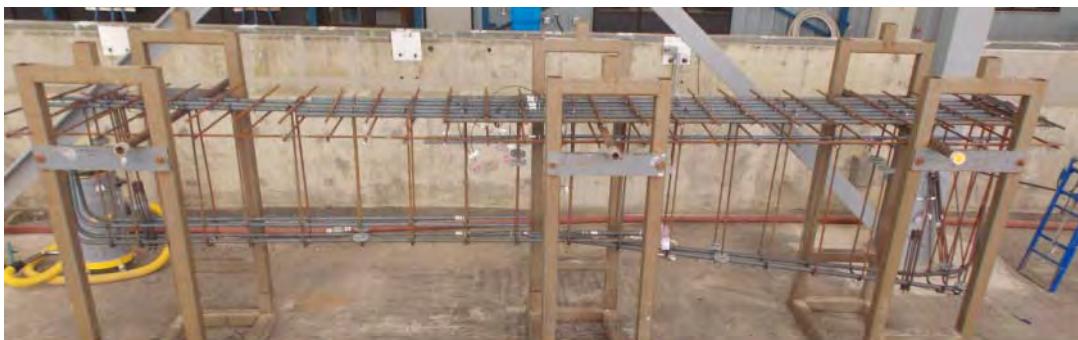
Figure D.14 - Mosier 1 reinforcing steel cage

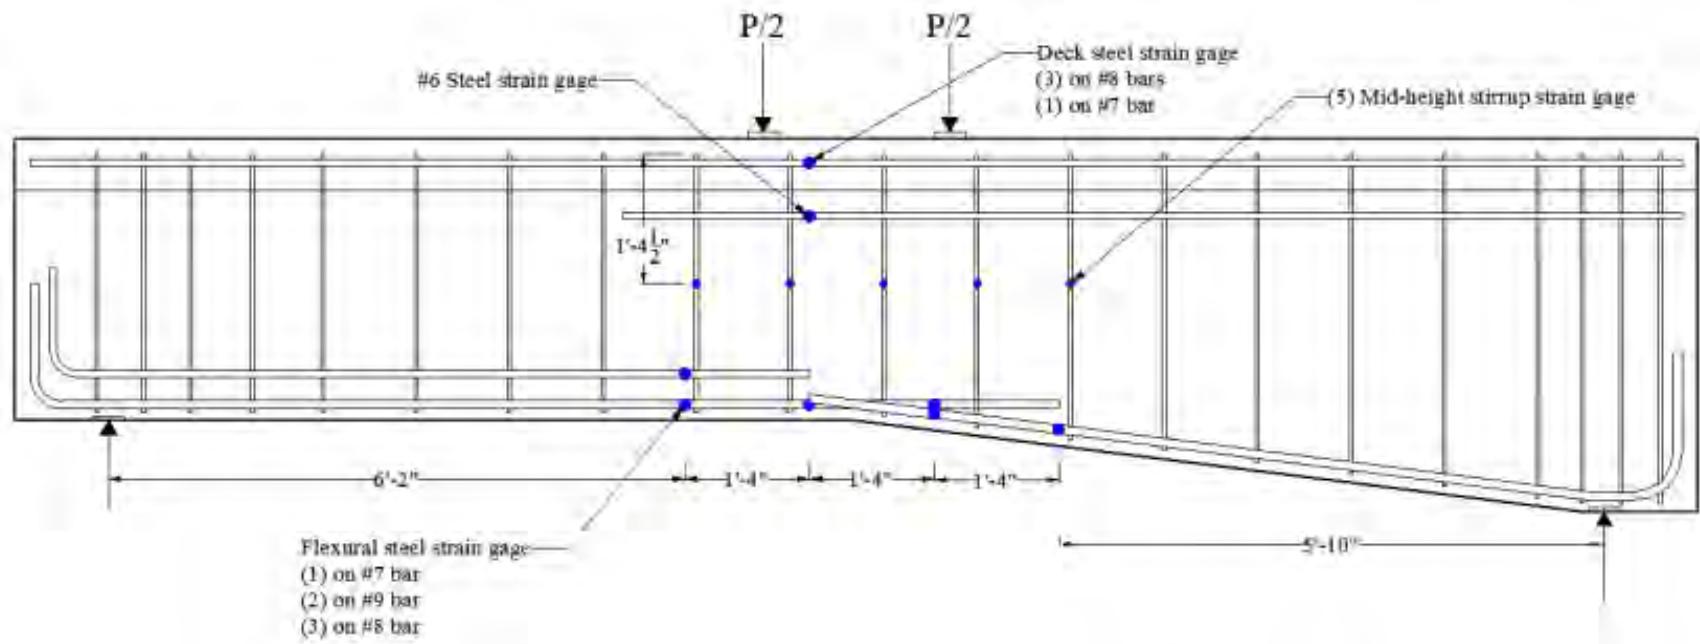
Figure D.15 - Internal sensor array of Mosier 1.

The internal steel reinforcing bars were instrumented with strain gages prior to tying the reinforcing bar cage. Strain gages were at several locations along the length of the Mosier specimens. All specimens had identical strain gage locations to enable an accurate comparison between the control and strengthened specimens. A total of six strain gages were applied to the flexural tension steel. Four strain gages were applied to different reinforcing steel bars in the deck. One strain gage was applied to the #6 (19M) reinforcing steel bar at midspan. Five strain gages were applied to one leg of the transverse reinforcing steel at mid-height to measure the shear force at midspan. Strain gages were applied to the NSM titanium at coincident locations as the internal reinforcing steel and the end of the NSM titanium bars. Locations of the strain gages on the internal reinforcing steel and NSM titanium are shown in Figure D.15 through Figure D.17.

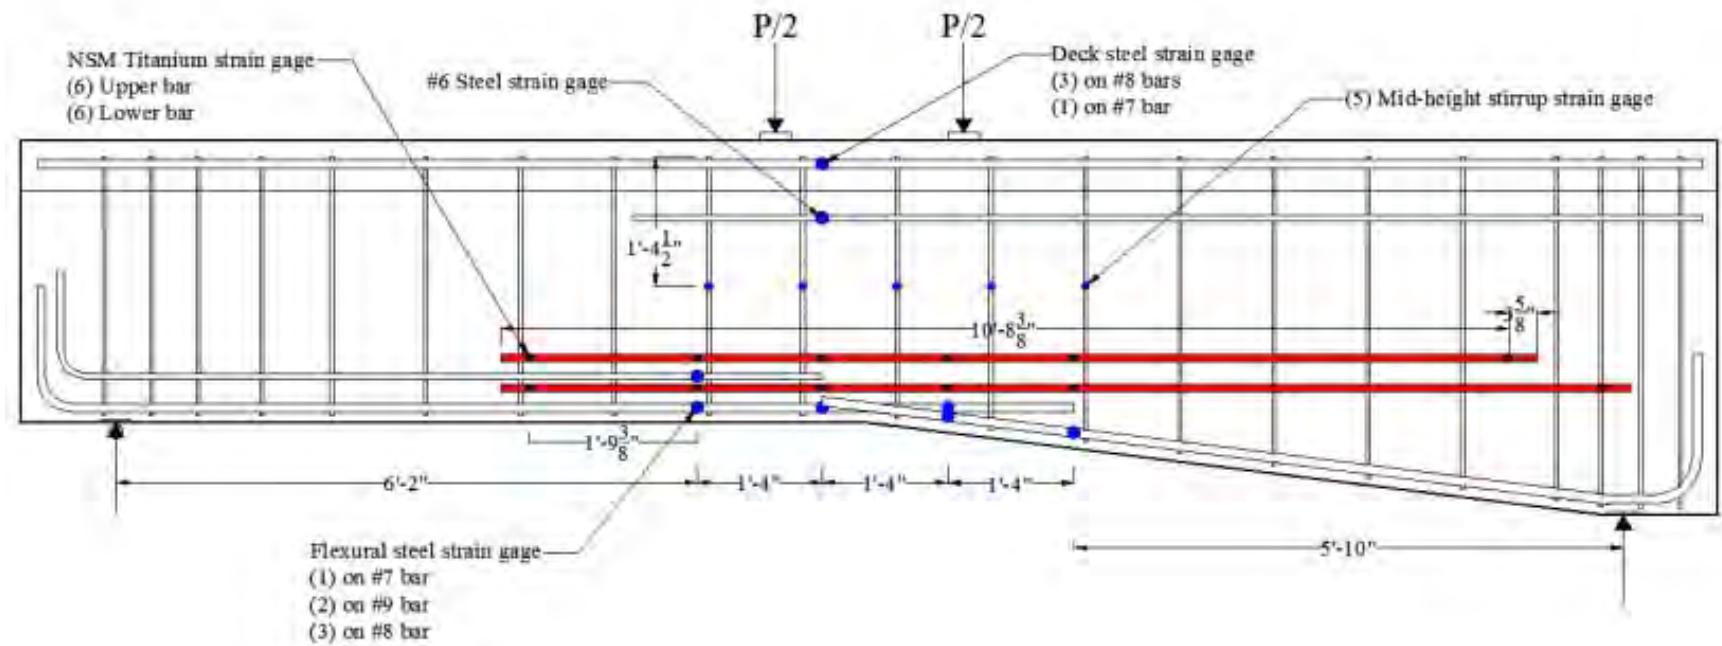
Figure D.16 - Internal sensor array of Mosier 2.
