**METHODS FOR STRENGTHENING  
REINFORCED CONCRETE BRIDGE  
GIRDERS CONTAINING POORLY  
DETAILED FLEXURAL STEEL USING  
NEAR-SURFACE MOUNTED  
METALLICS**  
**Final Report Appendices B-D**

**SPR 750**

Oregon Department of Transportation

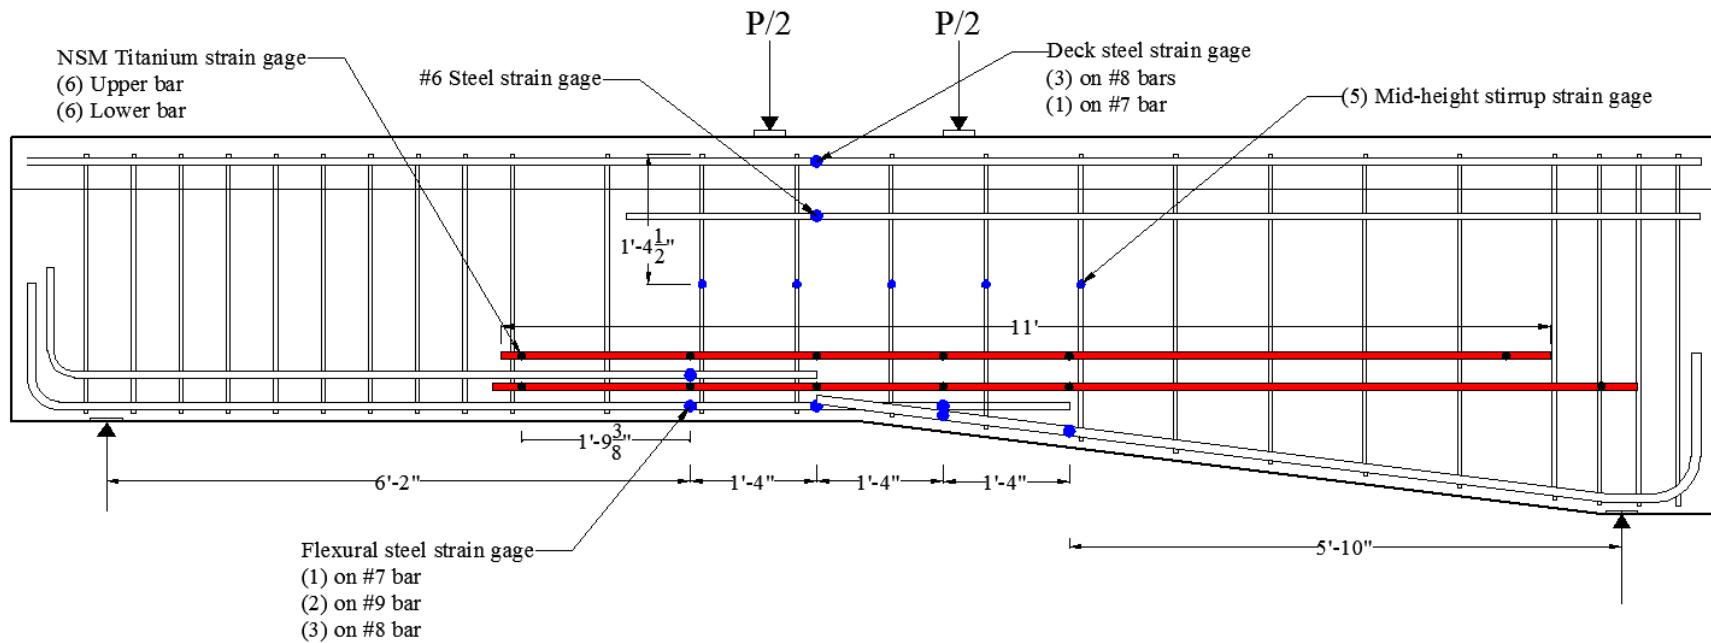
Figure D.17 - Internal sensor array of Mosier 3.

The internal steel reinforcing bars were instrumented with strain gages prior to tying the reinforcing bar cage. Strain gages were at several locations along the length of the Mosier specimens. All specimens had identical strain gage locations to enable an accurate comparison between the control and strengthened specimens. A total of six strain gages were applied to the flexural tension steel. Four strain gages were applied to different reinforcing steel bars in the deck. One strain gage was applied to the #6 (19M) reinforcing steel bar at midspan. Five strain gages were applied to one leg of the transverse reinforcing steel at mid-height to measure the shear force at midspan. Strain gages were applied to the NSM titanium at coincident locations as the internal reinforcing steel and the end of the NSM titanium bars. Locations of the strain gages on the internal reinforcing steel and NSM titanium are shown in Figure D.15 through Figure D.17.

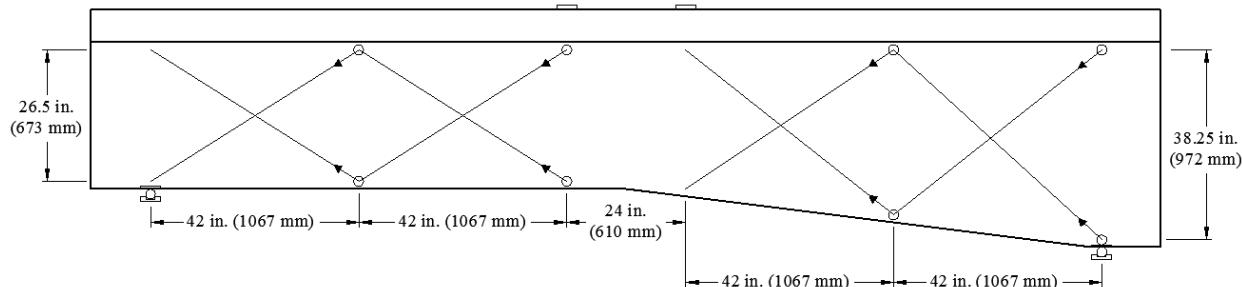
Figure D.18 - Typical specimen diagonal displacement sensor layout.

Pairs of diagonal displacement sensors were used to measure crack width over regions of the beam. Each displacement sensor had a calibrated range of 1 in. (25.4 mm). The sensors were attached to small threaded rods epoxied in the web. The configuration of a typical diagonal displacement setup for the Mosier specimens is shown in Figure D.18.

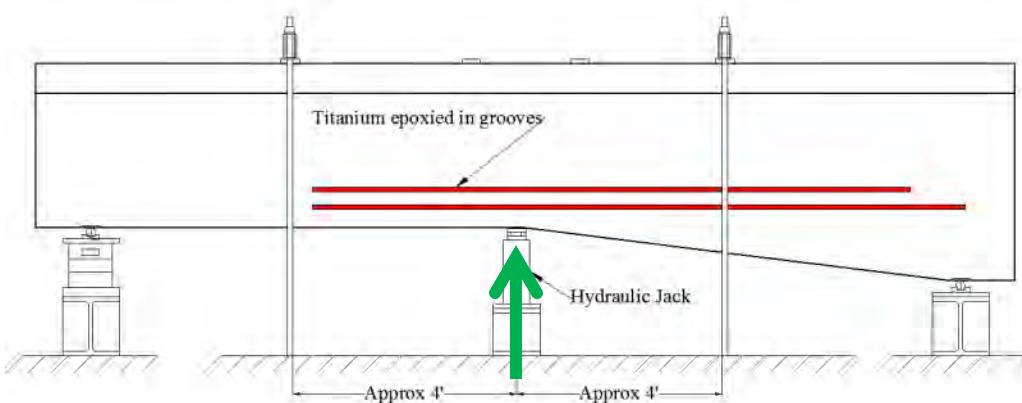
Figure D.19a - Configuration for inducing dead load stresses and NSM installation.

To induce positive four-point bending, a reaction frame was anchored into the strong floor and held the servo-hydraulic load-controlled actuator. The actuator had a 500 kip (2224 kN) capacity and a 30 in. (762 mm) stroke. The actuator force was distributed through a spreader beam creating a 2 ft (610 mm) constant moment region at midspan shown in Figure D.19b. The specimen had a M/V ratio of approximately 4.1 ft (1.25 m), which corresponded closely to the computed M/V ratio in the bridge of 3.6 ft (1.10 m). All reaction points distributed the load from a 4 in. (101.6 mm) plate on a 2 in. (50.8 mm) diameter captive roller. Loading plates at midspan were leveled with a high strength grout. Prior to testing, the actuator was plumbed, and loading plates were shimmed if necessary.

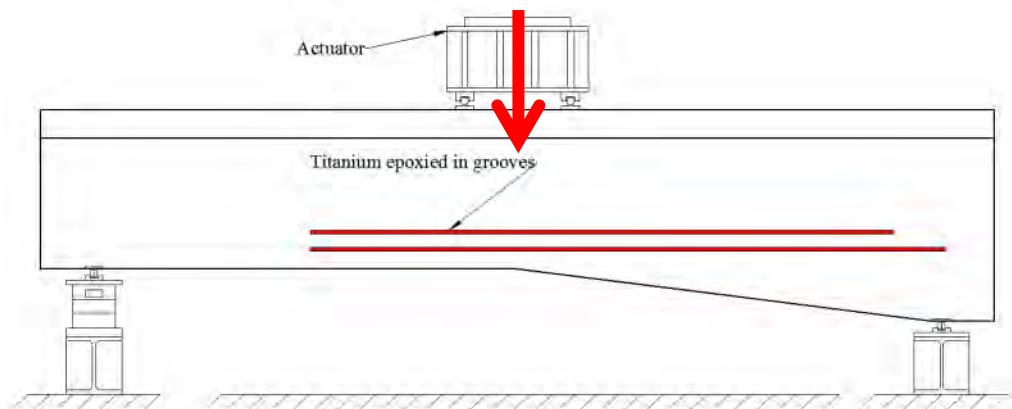
Figure D.19b - Configuration for applying actuator force representing live loads.

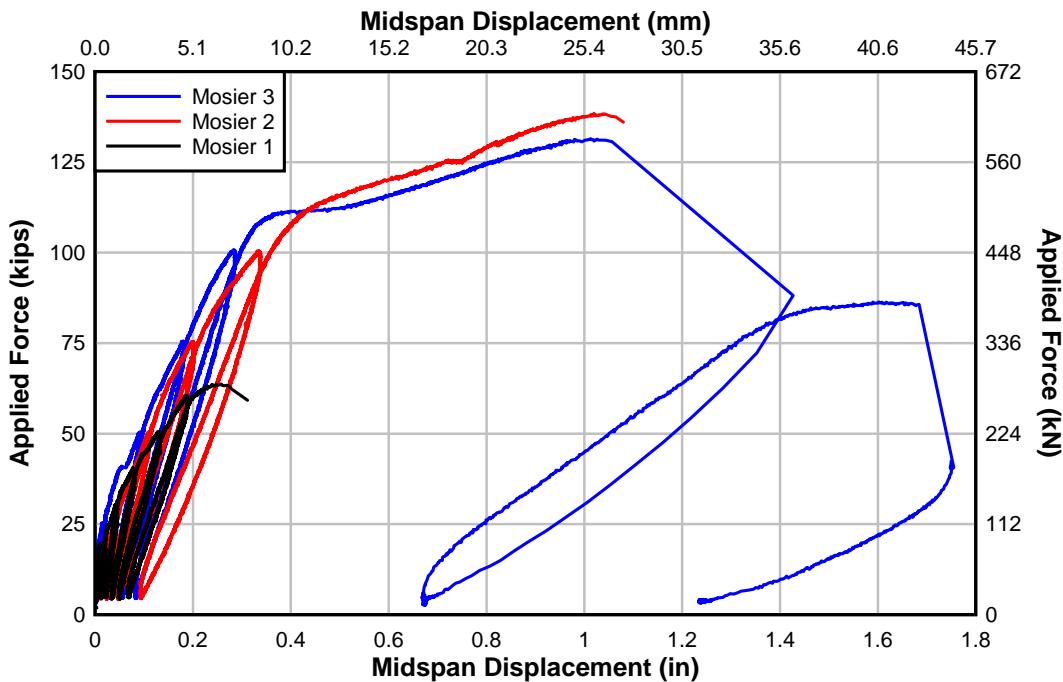
Figure D.20 - Mosier specimens applied load and measured displacement response.

The load and displacement response describes the overall behavior of the specimens. Load deformation responses for the NSM-retrofitted and baseline Mosier specimens are shown in Figure D.20. Mosier 1 was loaded in 10 kip (44.5 kN) increments, then unloaded, and then proceeded to the next load step until eventual failure. Mosier 2 and Mosier 3, the NSM titanium specimens, had a larger predicted capacity and was loaded in 25 kip (111 kN) increments, unloaded to 5 kips (22.2 kN), and then proceeded to the next load step until failure.

Mosier 2 and Mosier 3 specimens increased the baseline specimen load capacity by 74.7 kip (332 kN) and 67.8 kip (302 kN) respectively. The deflection of the strengthened specimens increased by 0.762 in. (19.3 mm) and 0.752 in. (19.1 mm) compared to the baseline for Mosier 2 and Mosier 3 respectively. Mosier 2 had a slightly lower stiffness than Mosier 3 because initial cracking of the concrete and slip of the cutoff reinforcing steel bars occurred prior to testing. The load was being carried by the NSM titanium that had a much lower modulus of elasticity. Mosier 3 maintained a composite section which lead to a stiffer response until the specimen became inelastic. Once inelastic, at approximately 109 kips (484 kN), Mosier 3 experienced a significant slip of the internal reinforcing which damaged the bond of the NSM titanium alloy bars. The damaged bond of the NSM titanium bars contributed to the slight decrease in ultimate capacity compared to Mosier 2.

Mosier 3 exhibited a significant amount of reserve capacity after failure. This reserve capacity is seen as the last load cycle upon which Mosier 3 achieved a load of 88 kips (391 kN). The reserve capacity indicates that the NSM titanium alloy bars with mechanical anchorages could sustain loads above the factored demands after bond rupture along the length that occurred at peak load.

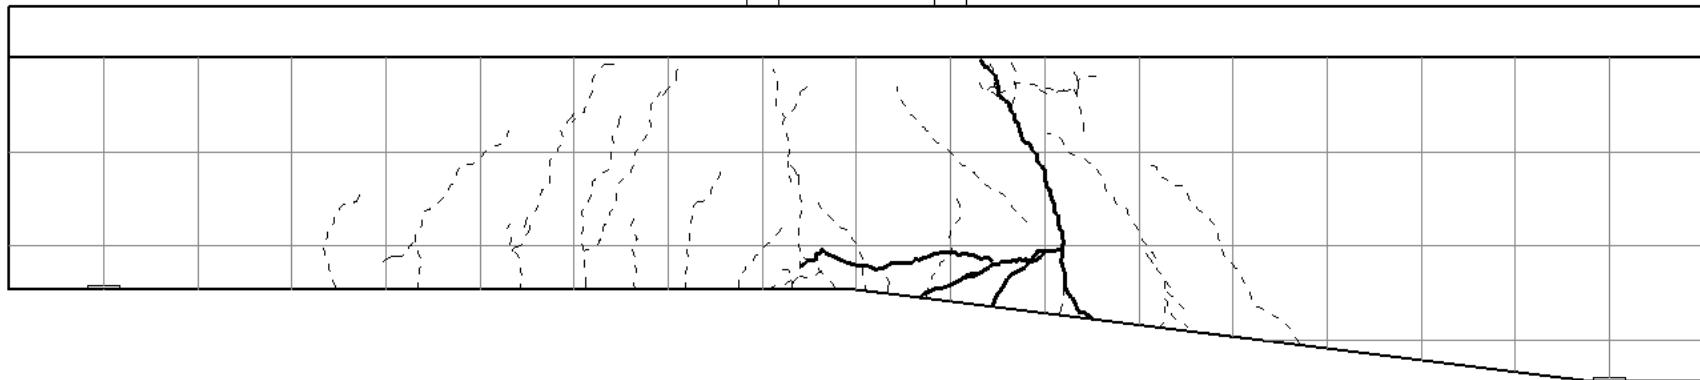
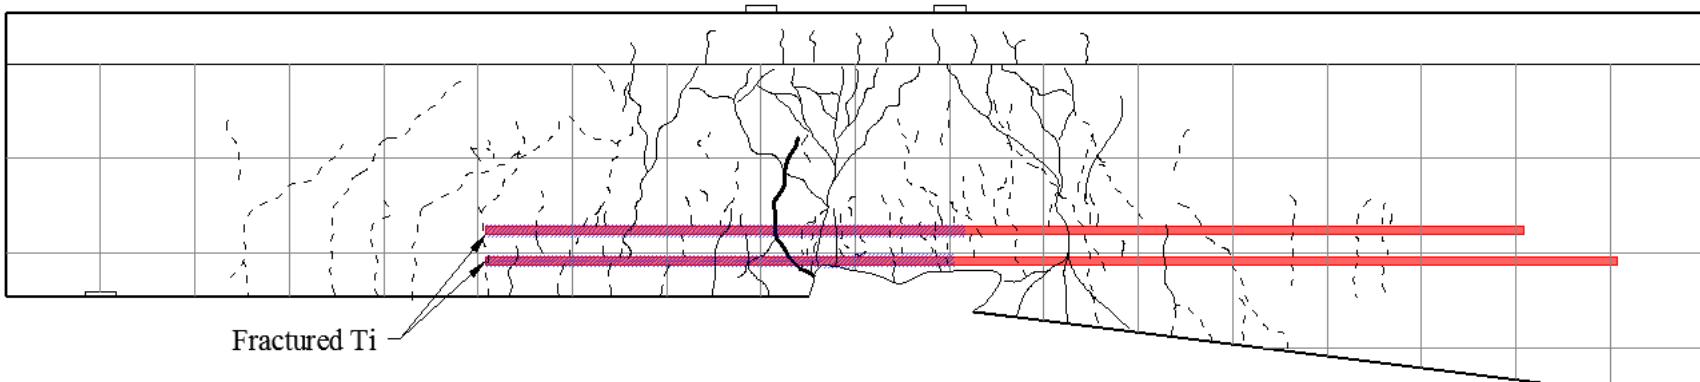
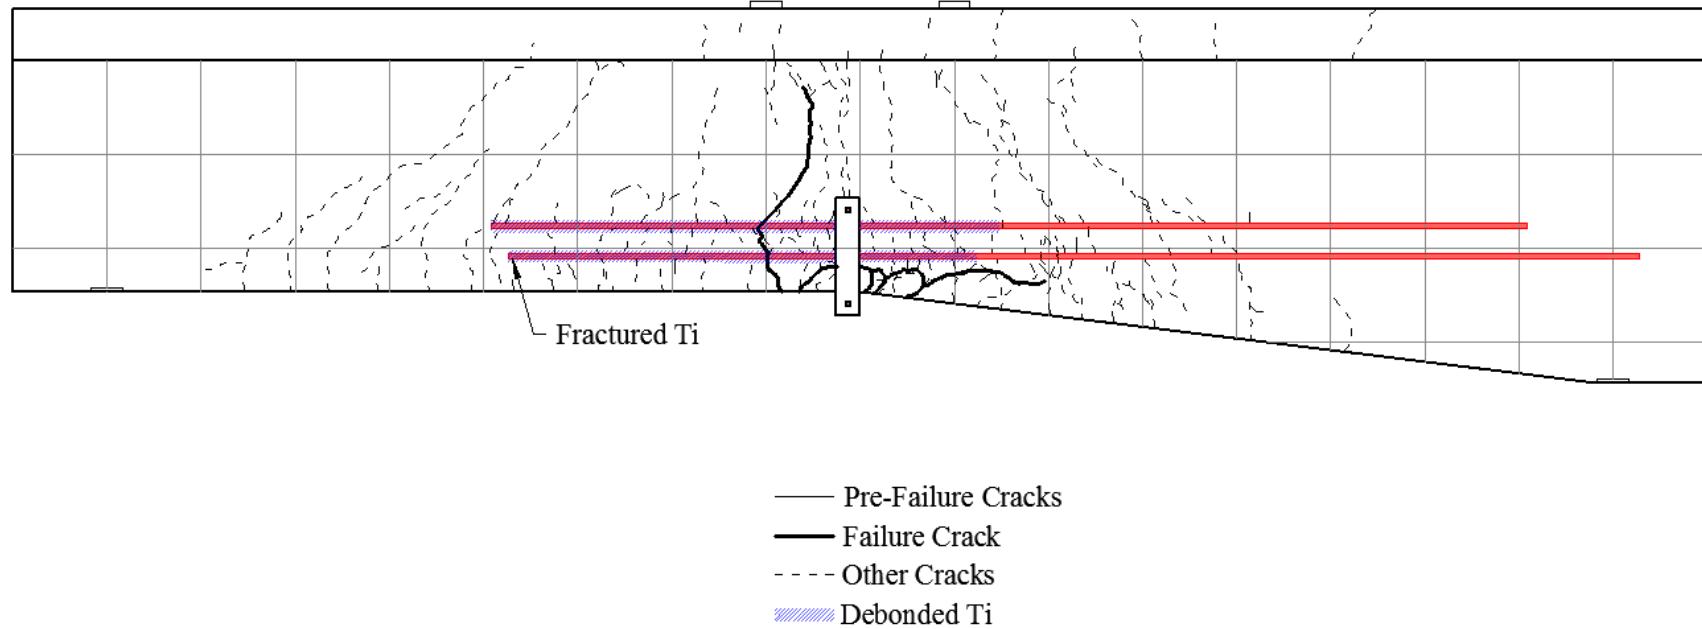
Figure D.21- Cracks observed on Mosier specimens.

Concrete crack initiation and propagation was monitored throughout the test. After each load cycle, the load was decreased and then held to minimize creep effects. During this time, the specimens were inspected and cracks were measured and highlighted. Digital pictures were taken at each load step to record the cracked condition. The crack patterns at failure are shown in for each specimen in Figure D.21. Digital photographs at failure are shown in Figures D.22 through D.24.

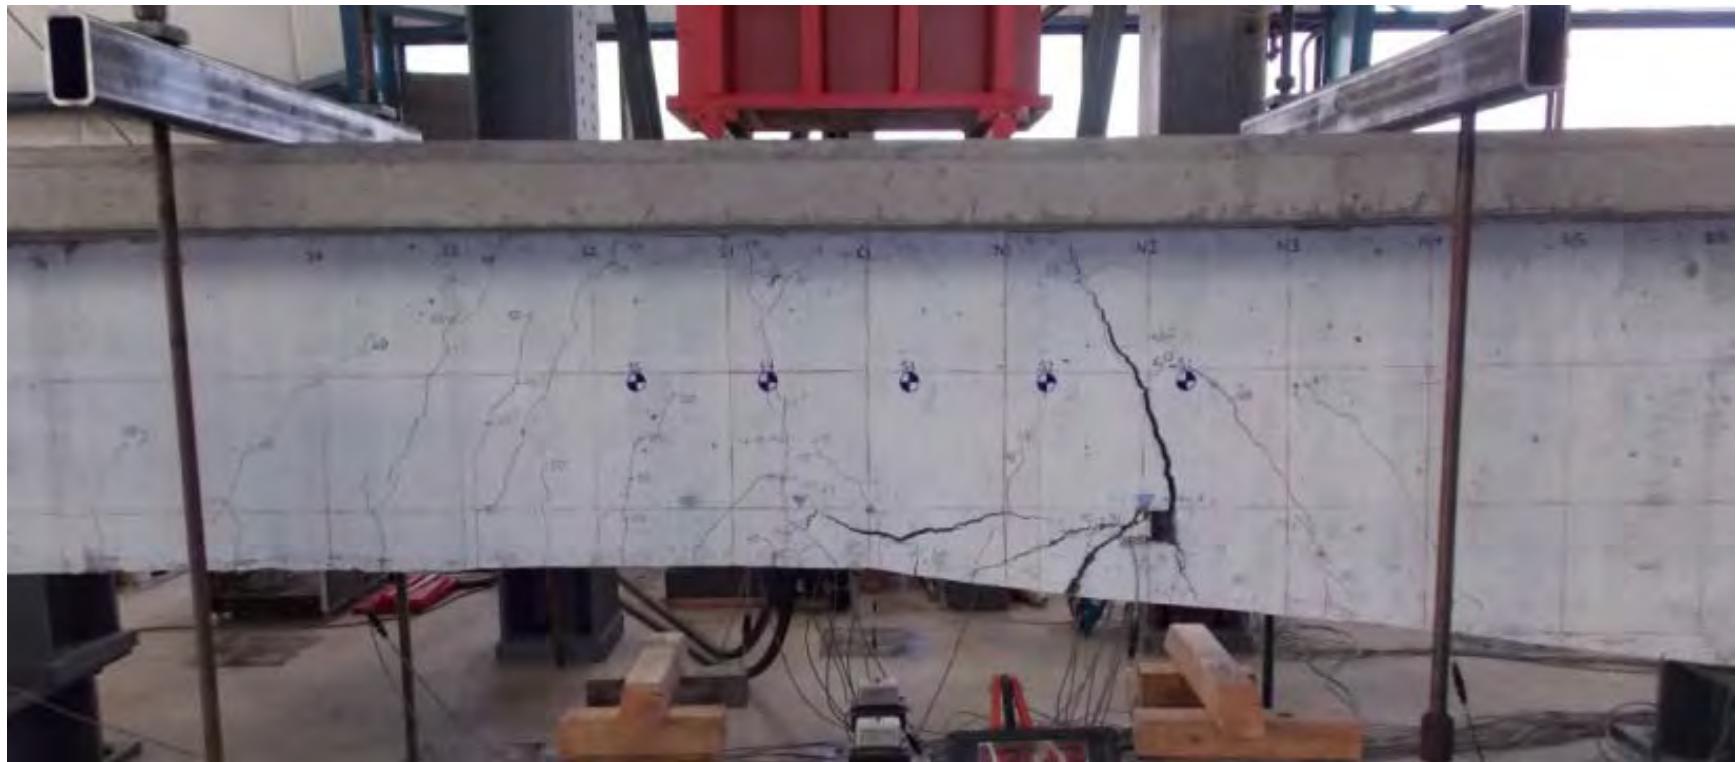
Figure D.22 - Mosier 1 failure photograph.

The Mosier 1 specimen failed in flexure and exhibited similar cracking patterns to the cracks observed in the Mosier Bridge. Mosier 2 and Mosier 3 specimens failed in flexure after debonding of the NSM titanium alloy bars. The debonding, or delamination, of the NSM titanium alloy bars initiated at midspan and propagated to the embedded NSM hook ends. After delamination of the NSM titanium bars, three out of the four titanium hooks fractured on the South end of Mosier 2. During failure of Mosier 3, all NSM titanium hooks remained intact at initial failure. After reloading and achieving the reserve capacity, one hook fractured and one hook was dislodged on the south end of Mosier 3. Chevron cracks, typical of anchorage failures, appeared near failure in all specimens. The chevron cracks were constrained by the NSM titanium. The NSM titanium strengthened specimens experienced distributed cracking over the constant moment region to the end of the NSM titanium bars in the south end of the specimen. Longitudinal cracks along the epoxy-concrete interface coincided with the abrupt debonding failure of specimens Mosier 2 and Mosier 3. The widespread extent of macro cracking in the concrete and around the epoxy provided visual indication of distress prior to failure. An example close-up view of the cracking around the NSM-titanium alloy bars prior to bond rupture is shown in Figure D.25.

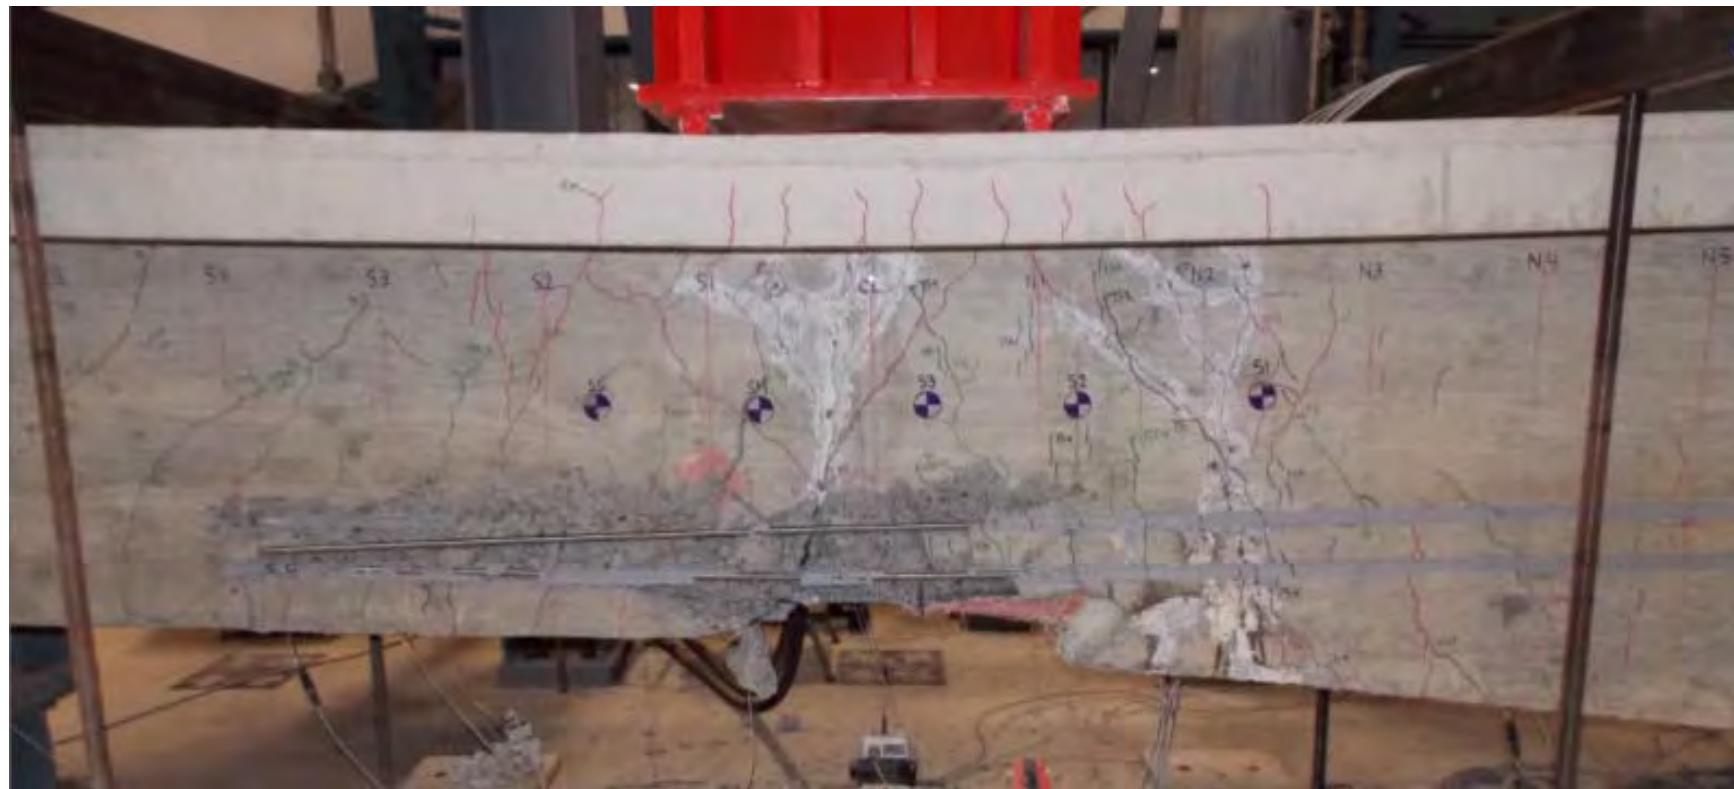
Figure D.23 - Mosier 2 failure photograph.

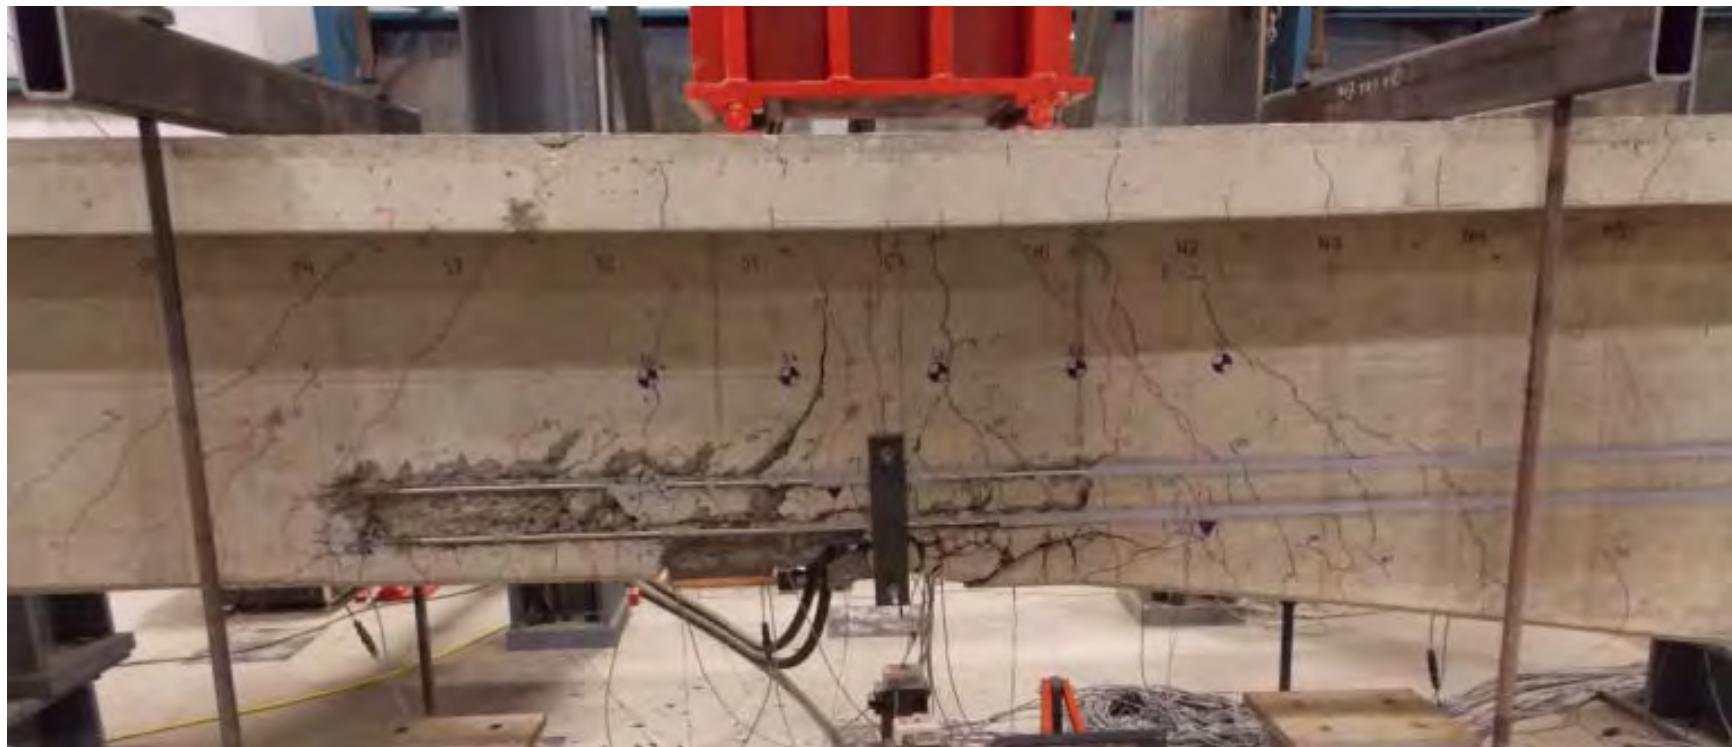
Figure D.24 - Mosier 3 failure photograph.

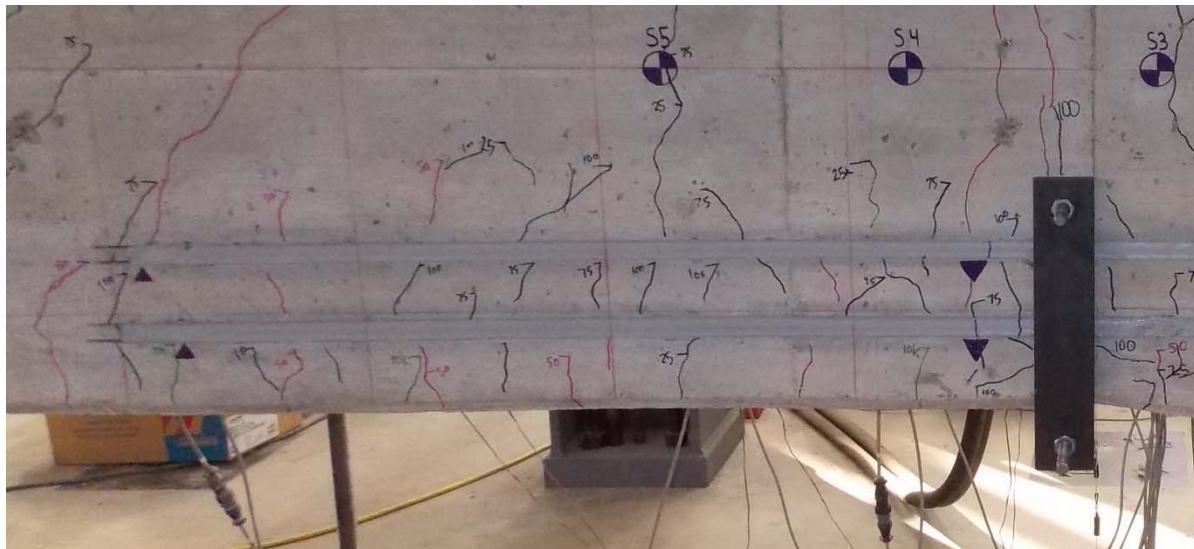
Figure D.25 – Close-up view of cracking around the NSM-titanium alloy bars prior to bond rupture.

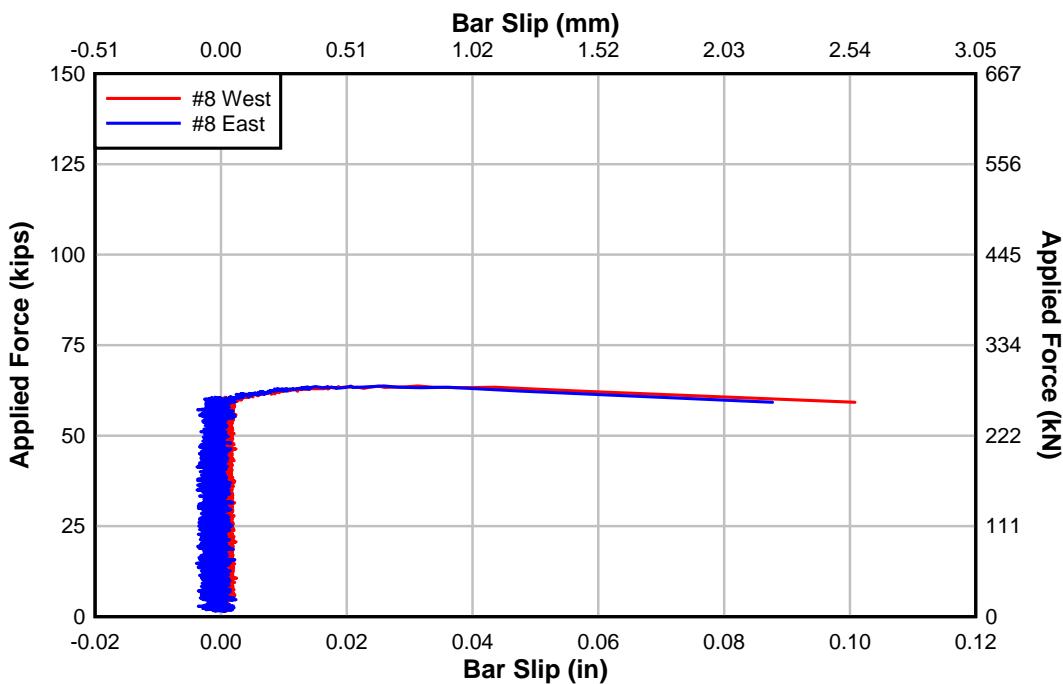
Figure D.26 – Slip response of #8 Steel reinforcing bars in Mosier 1.

As the applied load increased, the internal reinforcing steel bars slipped regardless of the failure mode or location. Cutoff reinforcing bar slip sensors installed near the block-out on the #8 (25M) bars measured the reinforcing bar slip with respect to load in Figure D.26.

The East and West #8 (25M) steel reinforcing bars had similar rates of slip throughout the test. Significant slips did not occur in the #8 (25M) steel reinforcing bar until near failure loads. Near the failure load, chevron cracking developed around the #8 (25M) bar.

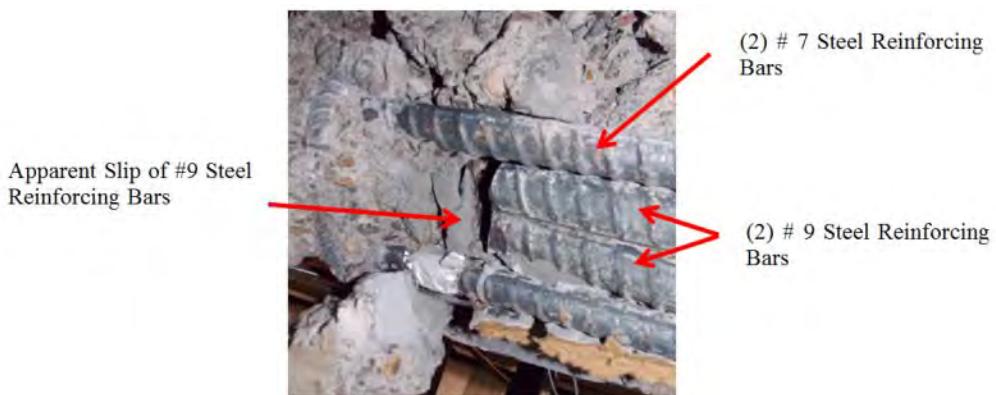
Figure D.27 - Apparent slip of # 9 Steel Reinforcing Bars in Mosier 2.

Slip of the #8 (25M) steel reinforcing bar was not recorded in the Mosier 2 and Mosier 3 specimens so as to not disrupt the bond along the NSM bars. However, apparent slip of the #9 (29M) steel reinforcing bars is shown Figure D.27 for Mosier 2 and Figure D.28 for Mosier 3.

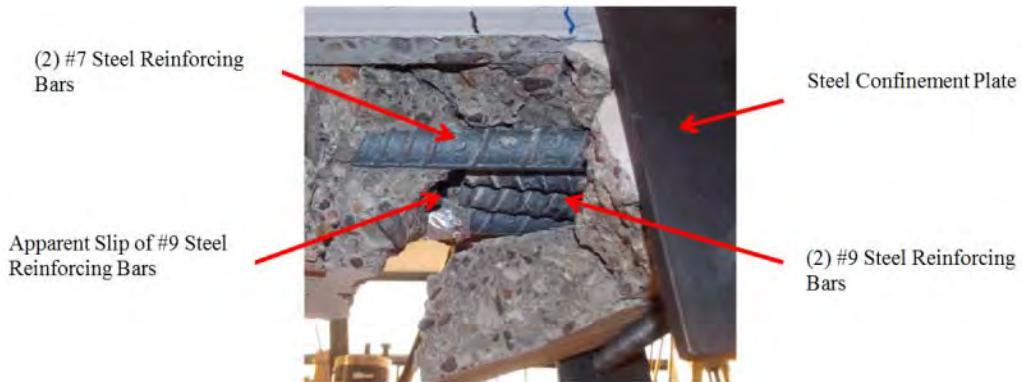
Figure D.28 - Apparent slip of #9 Steel Reinforcing Bars in Mosier 3.

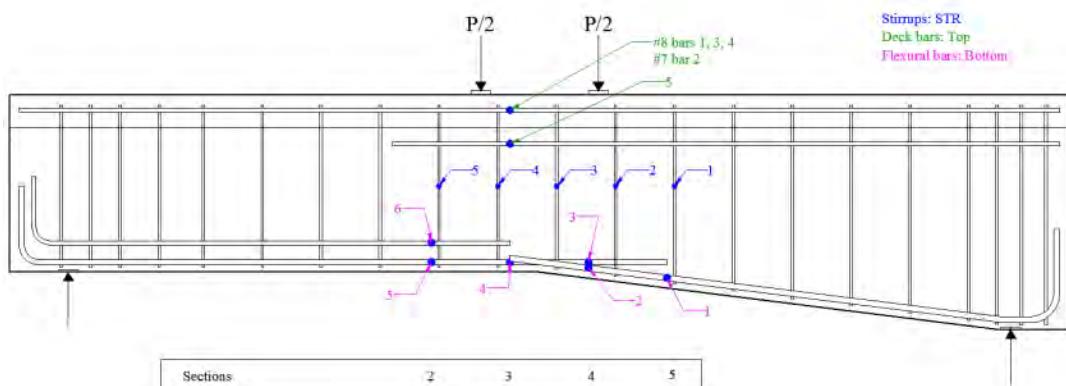
Figure D.29 - Strain gage configuration for Mosier 1.

Top, bottom, and NSM bar strains were plotted at each instrumented cross section. This comparison illustrates the interaction between the NSM bar and developing cutoff bar. The section labels start from the southernmost strain gage location on the NSM titanium bar. Therefore, section 1 on Mosier 1 does not exist. A guide for the sections is shown in Figure D.29. Strains for materials at cross sections along the length of the specimen are found for Mosier 1 in Figure D.30 through Figure D.33.

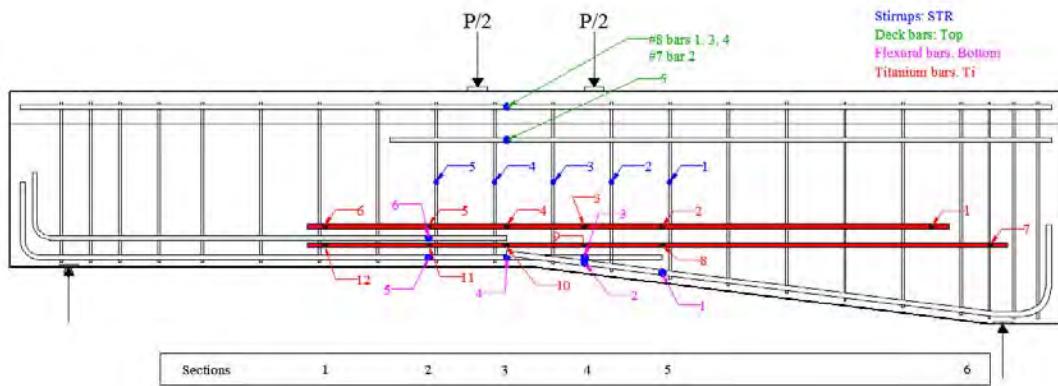
Figure D.34 - Strain gage configuration for Mosier 2 and Mosier 3.

A guide for the instrumented sections in Mosier 2 is shown in Figure D.34. Sectional strains for Mosier 2 are shown in Figure D.35 through Figure D.40. Note that the yield strain for the titanium alloy bars is  $9000 \mu\epsilon$  and the strain gages applied to the bars are only rated to provide strains to  $3000 \mu\epsilon$ .

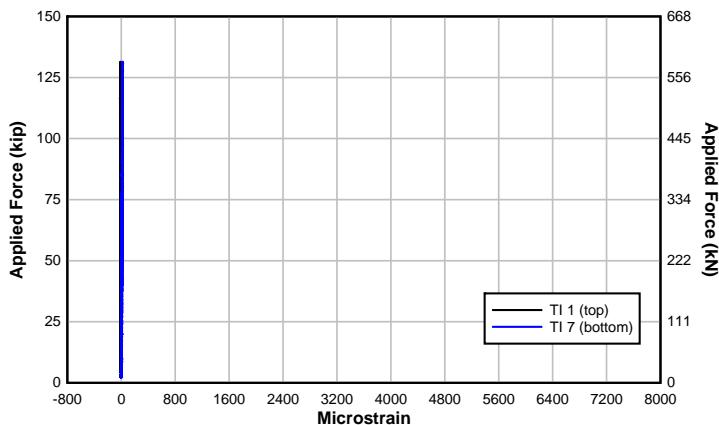
Figure D.46 - Mosier 3 Section 6.

Strains in the NSM titanium were negligible at the North end hook locations. The south end of the NSM titanium hooks had very linear strain until failure. Strain reversal in the #9 (29M) steel reinforcing bars indicated bar slip in the NSM titanium specimens. The strain reversal in the #7 (25M) was due to bar slip and neighboring bar slip of the #9 (29M) steel reinforcing bar.

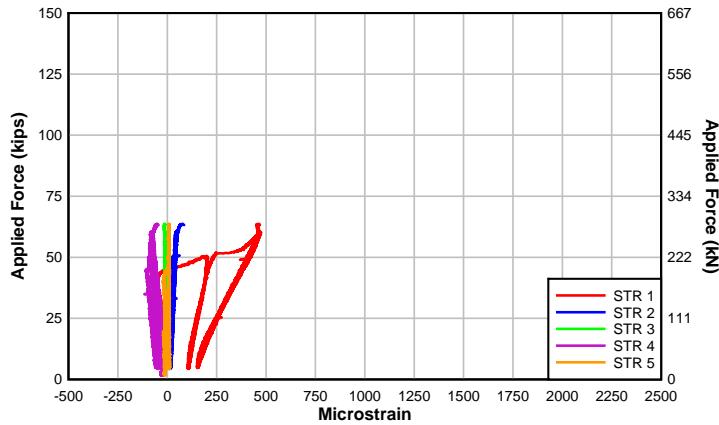
Figure D.47 - Mosier 1 Stirrup strains.

Midheight stirrup strains are shown in Figure D.47 through Figure D.49 for the Mosier specimens. The NSM titanium strengthened specimens exhibit much larger strains than Mosier 1 due to the increased flexural strength provided by the NSM titanium bars. Yield strain for the stirrups was around 1731 microstrain, which means that none of the stirrups reached yield.

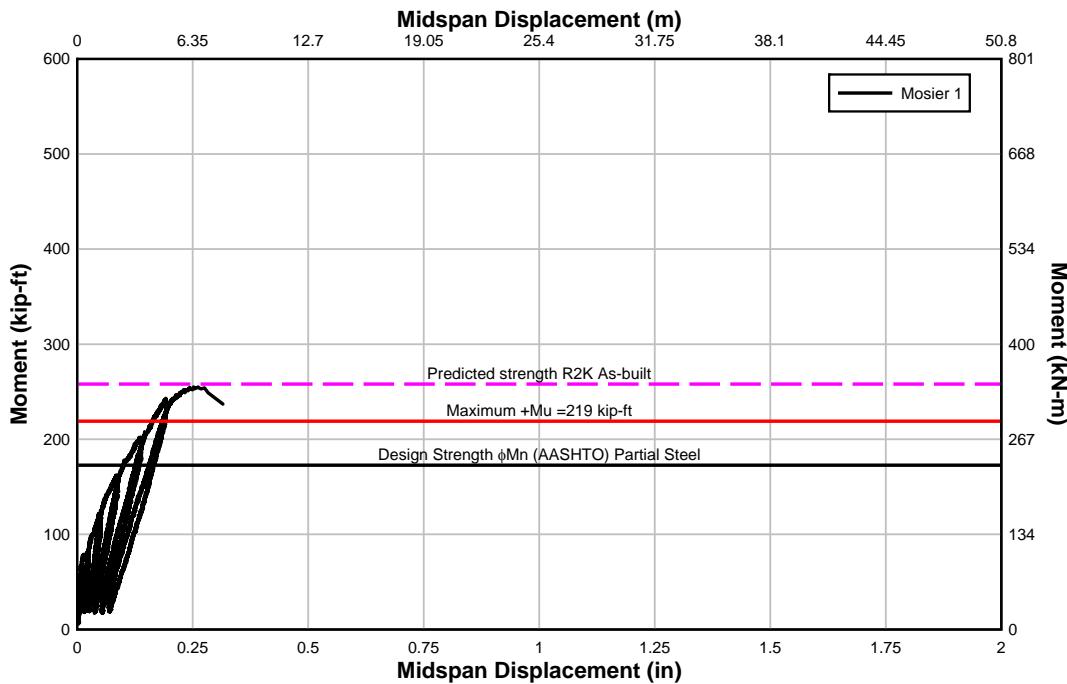
Figure D.50 - Mosier 1 predicted and experimental capacities.

strengthening. The design intent of the Mosier specimens was to strengthen the baseline specimen, Mosier 1, to a level above the required design strength,  $M_u$ . The moment capacity of Mosier 1 was computed using AASHTO-LRFD and Response 2000 and is shown relative to the experimentally observed response in Figure D.50. In the R2K analysis, the partial contribution of the poorly detailed reinforcing steel at midspan was included based on the available development length relative to the computed development length using ACI 318 complex approach. The R2K predicted flexural capacity of Mosier 1 was within 3 kip-ft (4 kN-m) of the observed value and shows that the partially developed steel should be included in the analysis.

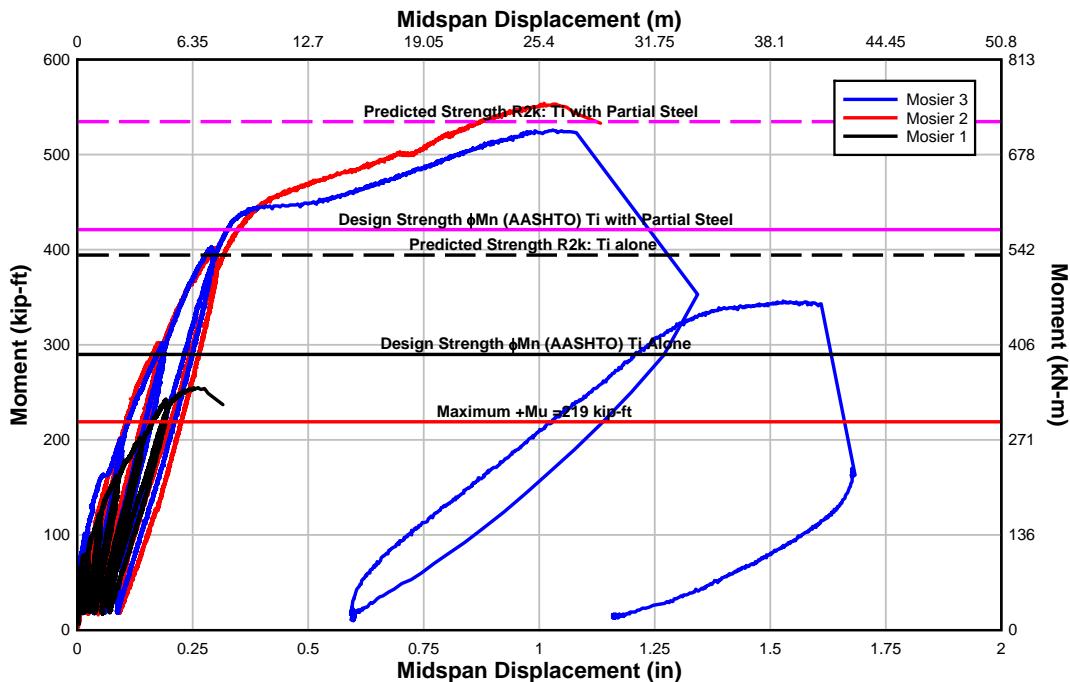
Figure D.51 - Mosier specimens predicted and experimental capacities.

The strengths of the NSM strengthened specimens were also predicted using AASHTO and R2K and are shown in Figure D.51 relative to the experimental results. The solid lines show the AASHTO predictions with and without the partial contribution of reinforcing steel at midspan. The dashed lines represent the R2K flexural capacities with and without partial contribution of reinforcing steel at midspan. As seen in the figure, improved predictions for member strength were achieved when the partially developed internal steel was used in the analysis.
