**SHEAR CAPACITY ASSESSMENT  
OF CORROSION-DAMAGED  
REINFORCED CONCRETE  
BEAMS**

**Final Report**

**SPR 326**

**December 2003**

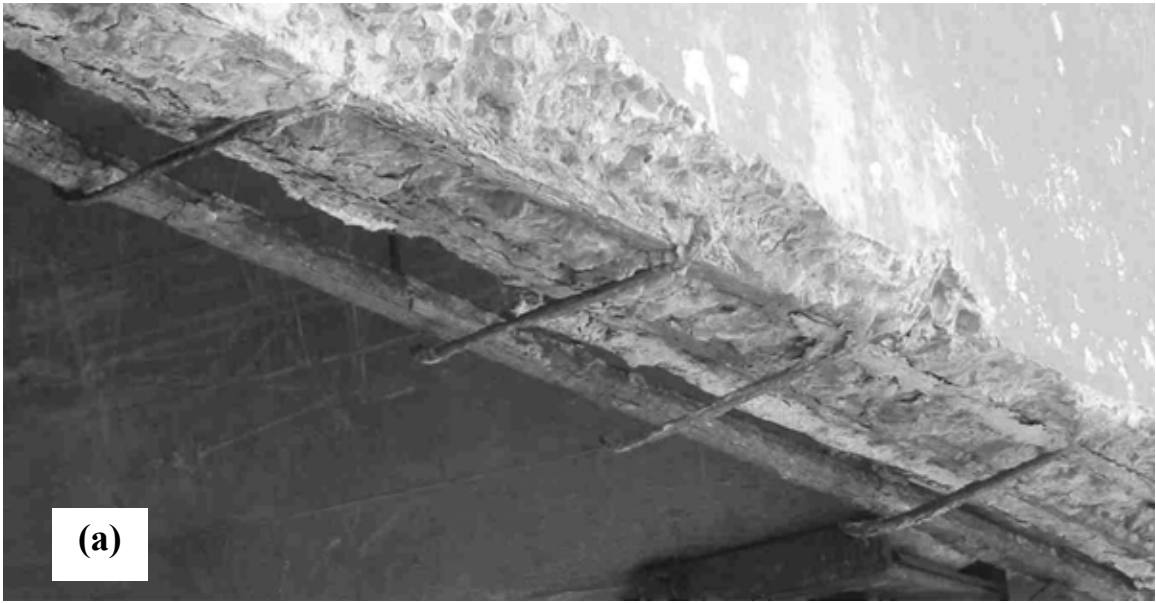
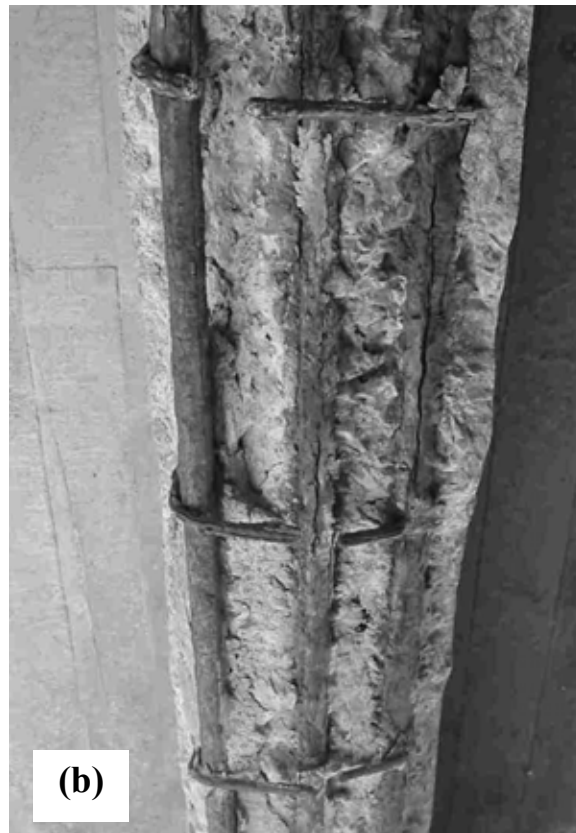
Figure 1.5: Broken shear stirrups along base of reinforced concrete deck girders on the Spencer Creek Bridge: (a) south span; (b) north span. There were no broken shear stirrups in the central span.

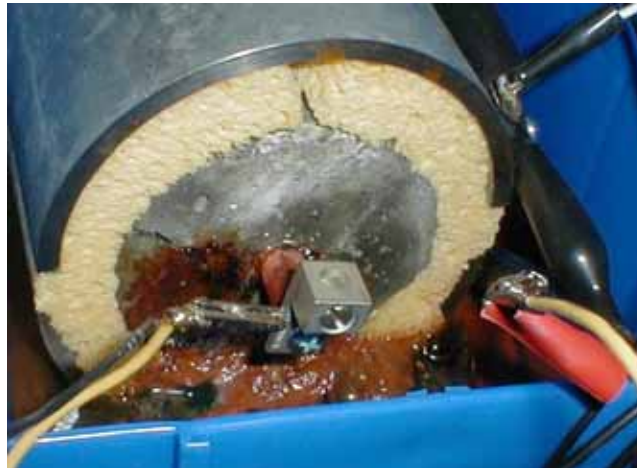
Figure 2.3: Accelerated corrosion of reinforcing steel in a small concrete cylinder. Wetted sponges surround the concrete cylinder and provide electrical contact to steel anodes surrounding the entire assembly.

The accelerated corrosion process was examined with much smaller samples prior to its use on the beam samples. These smaller samples consisted of 6-inch (15 cm) long, 3-inch (7.6 cm) diameter concrete cylinders. In the center of each was a #4 rebar, machined to a 0.413-inch (1.05 cm) diameter. The rebar protruded from each end of the concrete cylinder. The concrete had a  $\text{Cl}^-$  level of 5 lb/yd<sup>3</sup> (3.0 kg/m<sup>3</sup>). After curing for 28 days, the cylinders were placed inside a galvanized steel 4-inch (10 cm) I.D. clamshell. Sponges were cut and placed between the concrete cylinder and the clamshell. Rubber spacers were located at each end of the cylinder to prevent the severe compression of the bottom sponge. Leads were attached to the rebar and clamshells for passing current from the negatively charged clamshell to the positively charged rebar. The voltage drop across the cell was also measured. The sponges were kept moist. This arrangement is shown in Figure 2.3.

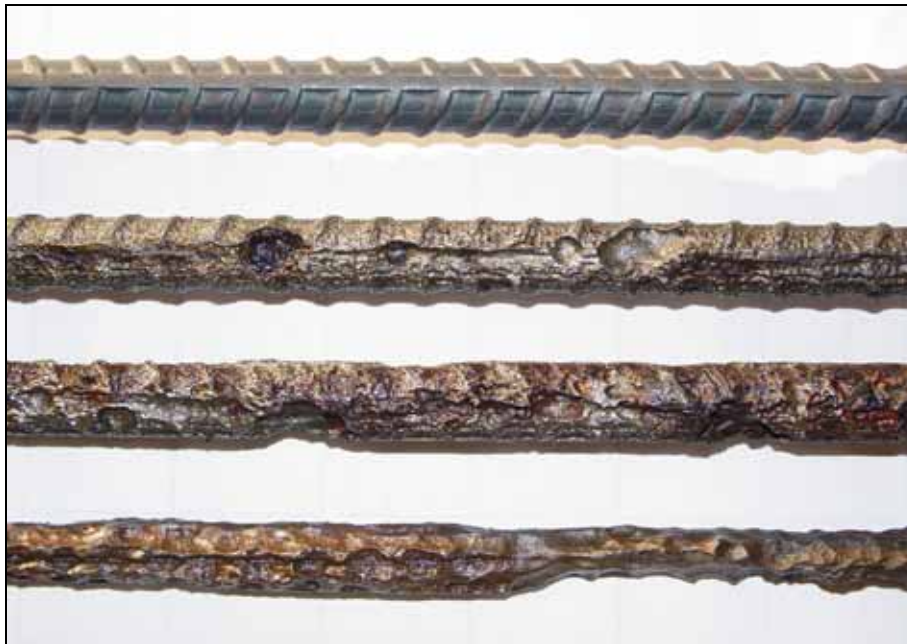
Figure 4.1: Different levels of corrosion on reinforcing steel removed from test beams  
(From top to bottom: A -Original, B - Light, C - Moderate, D - Severe)

Figure 4.1 shows typical beam stirrups for the corresponding damage states after cleaning in accordance with ASTM G1-99 (2001). All damage states exhibited significant areas of pitting. The damage for light corrosion (damage state B) was generally only localized section-loss. The same was observed for the moderate corrosion (damage state C), as well as some uniform section-loss. The severe corrosion (damage state D) showed significant localized and uniform section-loss, and in some cases complete section-loss was observed.

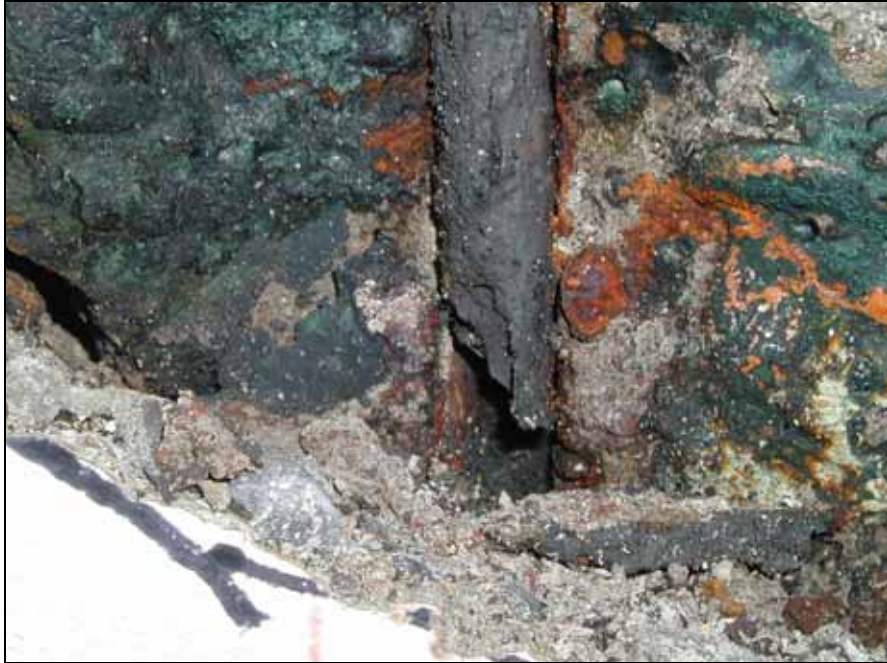
Figure 4.3: Completely corroded shear stirrup in bottom third of beam where shear crack formed

Figure 4.3 shows an area of complete section-loss at a concrete diagonal crack location. Shear stirrup fracture always occurred at areas of significant localized section-loss, as shown in Figure 4.4.

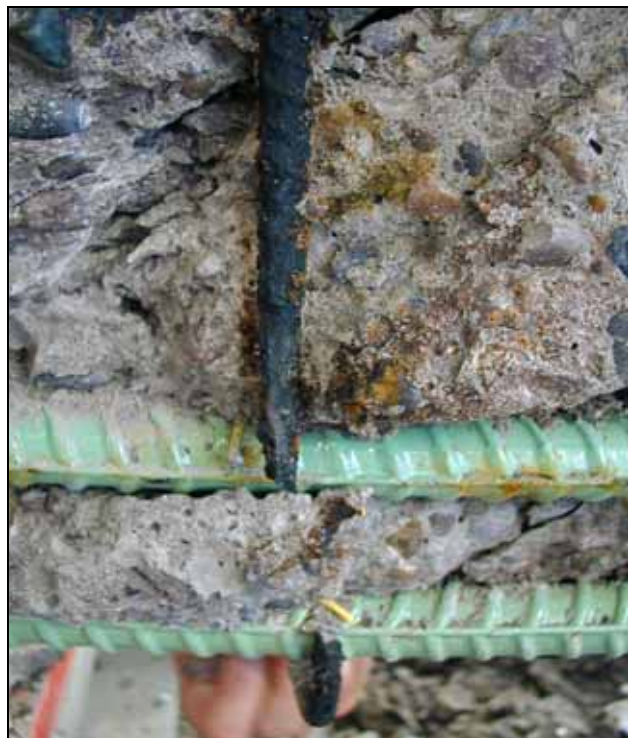
Figure 4.4: Fractured shear stirrup near flexural tension steel
