**EVALUATION OF ADJACENT
AC AND CRC
PAVEMENT LANES**

Final Report

**FHWA Experimental Feature
Project No. OR 89-04**

February 1995

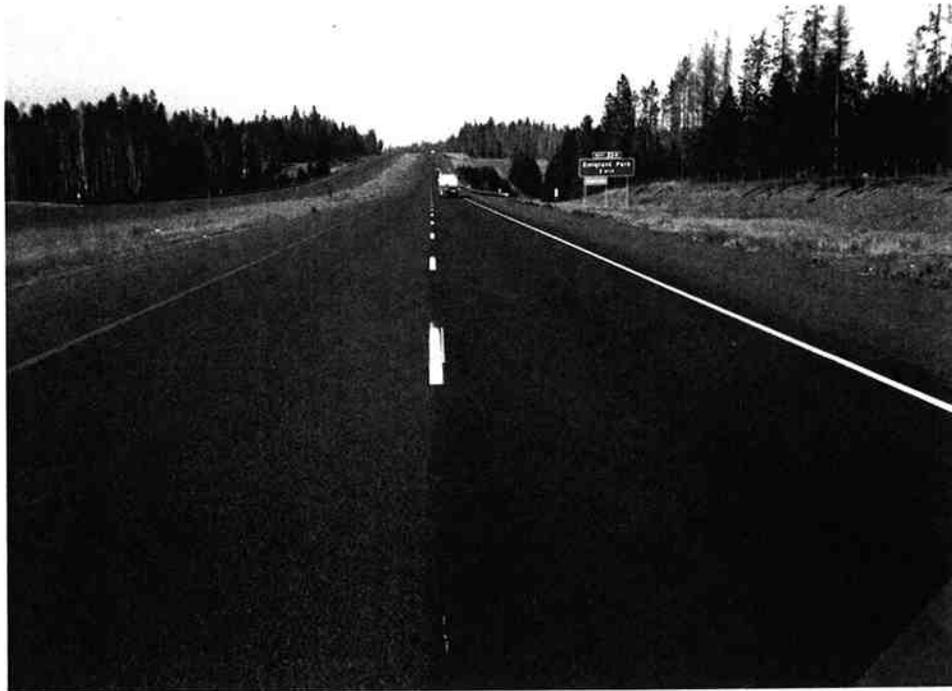
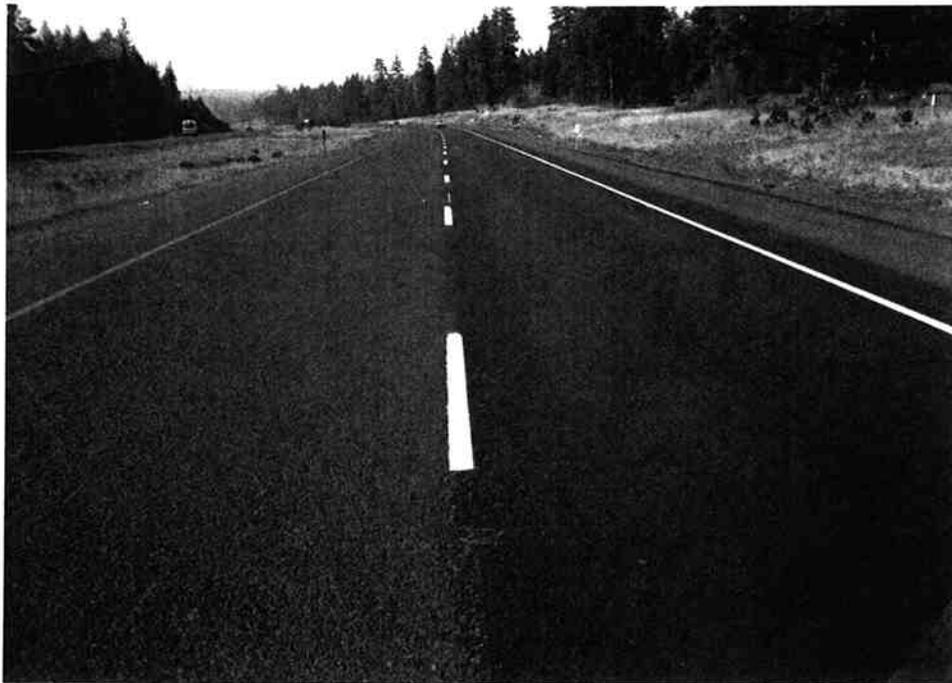
Figure 2.2 Typical Pavement Condition Prior to Construction

the "E" mix, and loss of the recycled mix. The deterioration continued at an accelerating rate, aided by increased truck volumes and axle loads. In 1986, maintenance costs for this section of highway increased dramatically to an estimated \$130,000 per year. Typical pavement conditions prior to construction are shown in Figure 2.2.

a) 1986 Pavement Condition at MP 236.5 (WB) (within test section)

b) 1986 Pavement Condition at MP 231.0 (WB) (within control section)

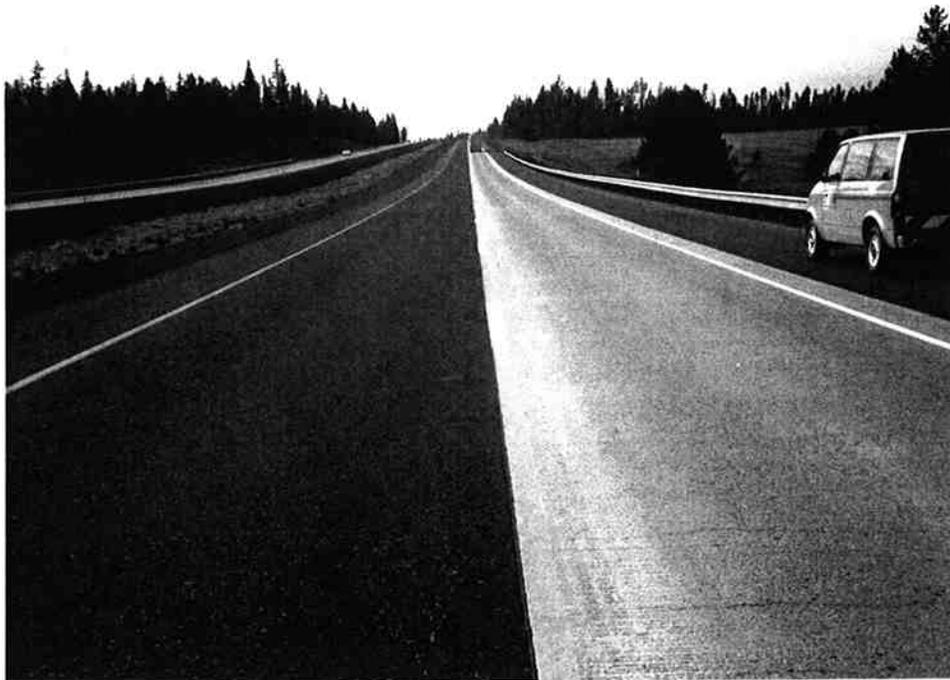
Figure 4.1 Typical Pavement Condition

The typical pavement condition is shown in Figure 4.1. The measured ruts (less than ¼-inch) on the AC lane were about the same for 1991 and 1992. In most areas, these ruts were unnoticeable. The ruts on the CRC lane were in a range of 0 to 1/16-inch, and there were no increases in rutting depths from 1991 to 1994.

a) AC/CRC Pavement Condition in May 1991 at MP 236.37

b) AC/CRC Pavement Condition in May 1992 at MP 236.37

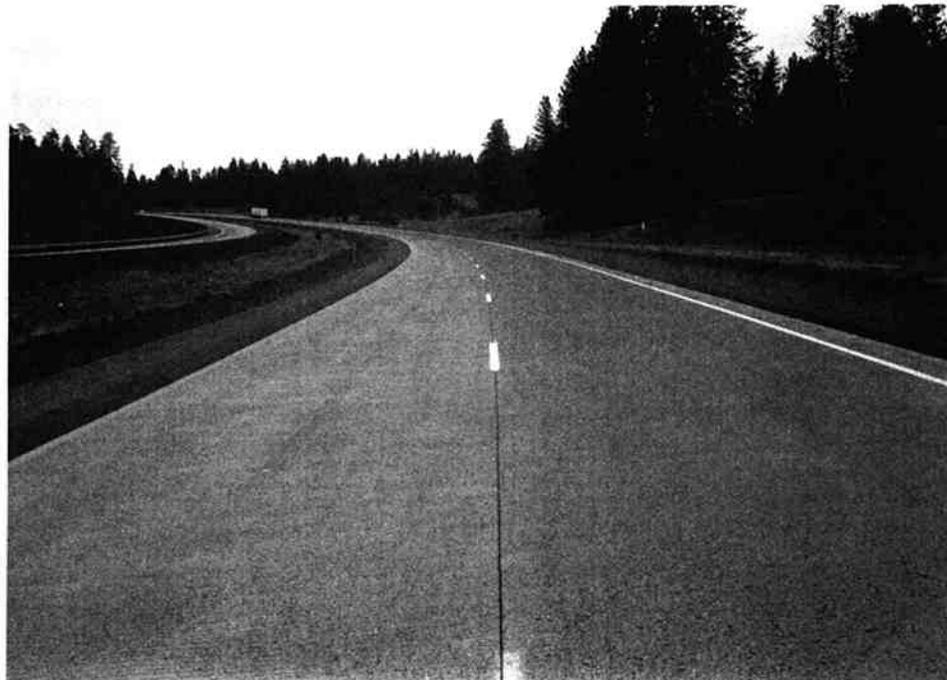
Figure 4.6 Typical Pavement Condition

The rutting in both CRC lanes is approximately 0 to 1/16-inch, as shown in Figure 4.6. The cracking pattern (Figure 4.7) and number of cracks per 100-foot section for both lanes in the control section are the same as in the CRC lane of the test section. The cracking in the CRC section is expected and not necessarily an indication of distress.

a) CRC Pavement Condition in May 1991 at MP 231.82

b) CRC Pavement Condition in May 1992 at MP 231.82
