OREGON DEPARTMENT OF TRANSPORTATION

AGGREGATE SITES

DISTRICT 12

JUNE 2002

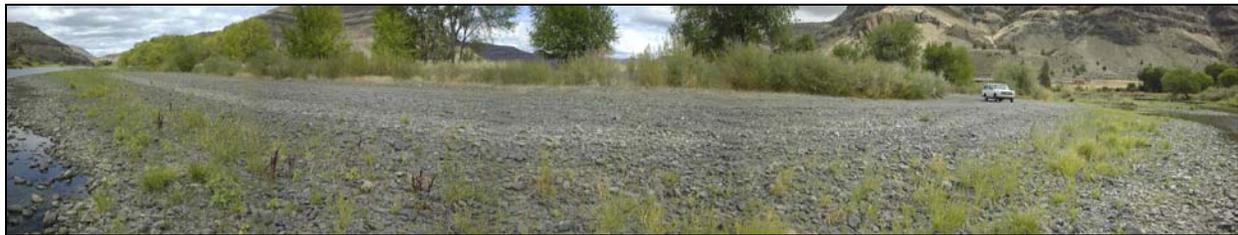
County	Site Name			Dist	Hwy	Mile Pt	TWP	RGE	Sect
Grant				12	0005	105.5	09S	26.0E	30
File ID		Source #	Date Visited	Map #			Type of Site		
05277, 27686		12-001-5	09/12/2000	1R-2-491			Gravel		
Latitude	Longitude	Elev. (m)	Acreage	Pit Size		DOGAMI Permit #			
44 45'22.38000"	119 38'21.97000"	609	6.42	NA					
Comments									
Lat. and Long. acquired using Terrain Navigator Software									
Rock Type		Unit	Color	Weathering			Jointing		
Metamorphic/Igneous Gravel		Qal	NA	NA			NA		
Quality			Hardness	lbs./cu ft.	Reserve (cy)	Reserve (Tons)			
NA			NA	120	24,000	38,880			
Potentially Significant Site	Why			Open/Closed	Direction				
No	NA			Closed	Adjacent to the John Day River				
Adjacent Land Use									
Ranching/Orchards/Kimberly, OR is adjacent									
Remarks									
This site is located adjacent to and south of Highway 19. The North Fork of the John Day River meets the main stem of the John Day River here. The gravel is composed of cobble (60%), pebble (10%), and sand (30%) sizes. The site is above the river level about 6 feet and below the highway about 8 feet. The ground is being used for a waste site. There is no gate. The property is being used for river access. Possible mitigation site.

View of the gravel site located adjacent to and south of Highway 19.

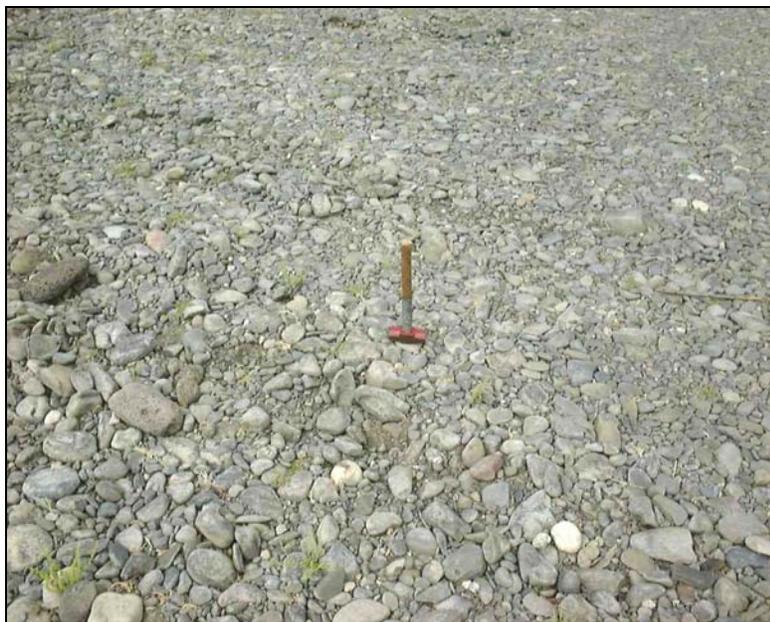
Close-up view of the gravel at this site composed primarily of cobble size material.

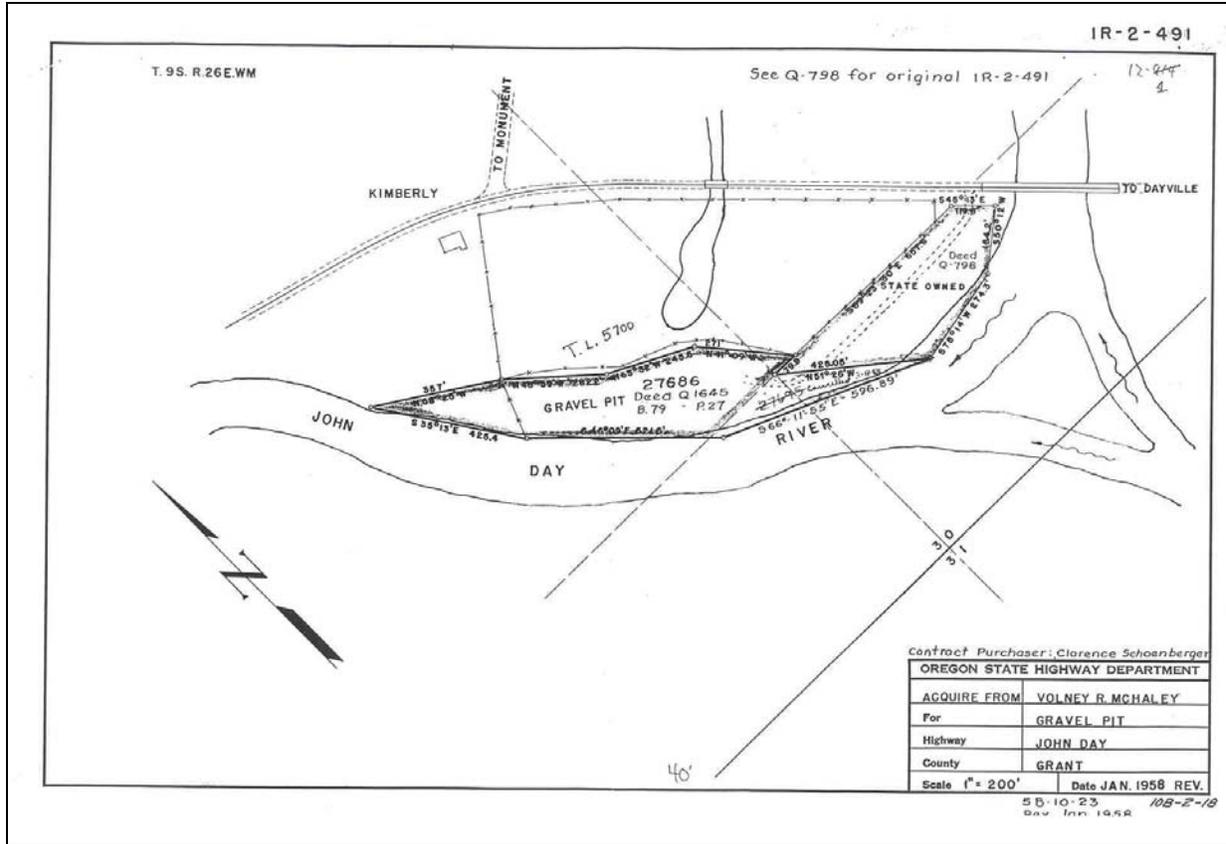
Aerial view of the gravel site located at the confluence of the North Fork of the John Day River with the main stem of the John Day River.

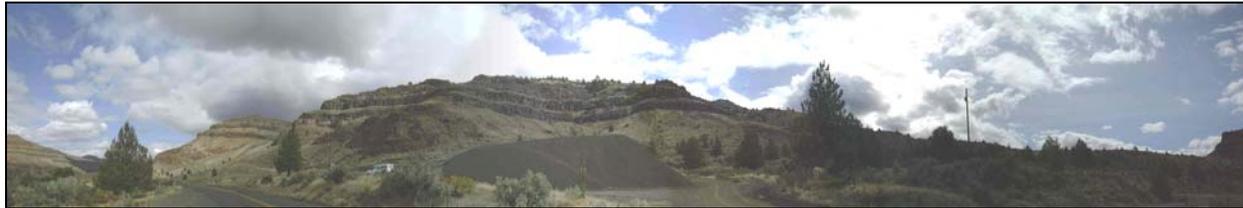
County	Site Name			Dist	Hwy	Mile Pt	TWP	RGE	Sect
Grant	Rose and Bone Creek Quarry			12	0005	106	09S	26.0E	30, 31
File ID		Source #	Date Visited		Map #		Type of Site		
34098		12-002-5	09/19/2000		1R-5-1531		Quarry		
Latitude	Longitude	Elev. (m)	Acreage	Pit Size	DOGAMI Permit #				
44 45'00.12667"	119 38'13.11455"	565.598	113.77	Unknown					
Comments									
GPS acquired at the site.									
Rock Type	Unit	Color		Weathering		Jointing			
Basalt	Tcp	Olive Black (5Y 2/1)		Decomposing to Slight		Highly Fractured			
Quality			Hardness	lbs./cu ft.	Reserve (cy)		Reserve (Tons)		
Poor to Good			R3	170	50,000		100,000		
Potentially Significant Site	Why			Open/Closed	Direction				
No				Closed	To the west about 150 meters is the John Day River				
Adjacent Land Use									
Open space/Fruit Orchards/Ranching.									
Remarks									
This site is adjacent to and east of Highway 19 just outside of Kimberly, OR. The rock is a medium to fine-grain highly fractured basalt. There are multiple flows with some decomposition and others that have slight weathering. This makes it very difficult to mine and to use for AC. Good for fill material. The terrain is gradual at the southern portion and vertical cliffs (300 ft. plus) at the middle and northern part of the site. There is no screening and plenty of room to work. There is no gate but we do have a sign up.

View looking to the east at the large (113.77 acres) quarry site located just outside of Kimberly, OR off of Highway 19.

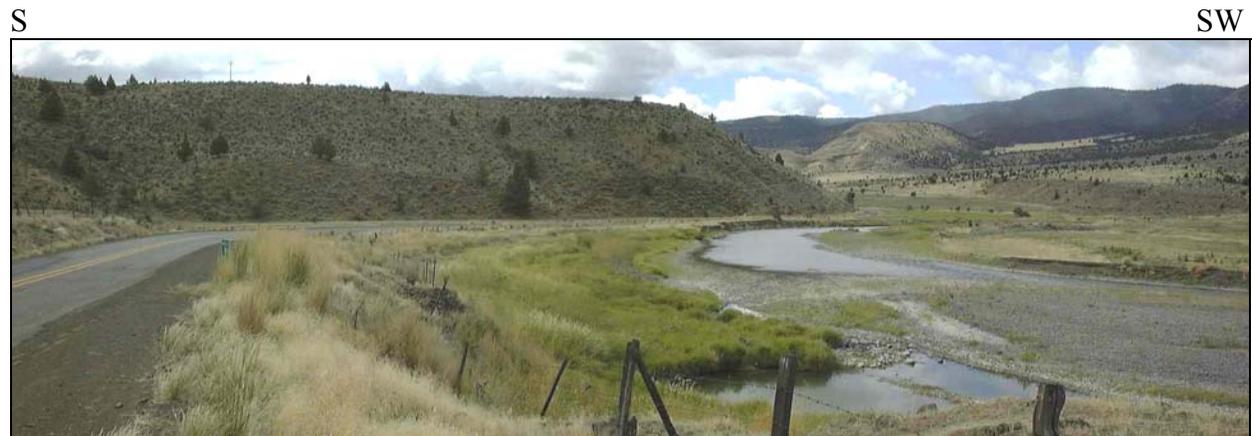
County	Site Name			Dist	Hwy	Mile Pt	TWP	RGE	Sect
Grant				12	0005	111.3	10S	26.0E	19
File ID		Source #	Date Visited	Map #			Type of Site		
11183		12-003-5	09/19/2000	1R-2-1424			Gravel		
Latitude	Longitude	Elev. (m)	Acreage	Pit Size		DOGAMI Permit #			
44 41'06.61000"	119 38'51.53000"	609	7.5	NA					
Comments									
Lat. and Long. acquired using Terrain Navigator Software									
Rock Type	Unit	Color		Weathering			Jointing		
Igneous Gravel	Qal	NA		NA			NA		
Quality			Hardness	lbs./cu ft.	Reserve (cy)	Reserve (Tons)			
Good			NA	120					
Potentially Significant Site	Why			Open/Closed	Direction				
No	NA			Closed	Adjacent to the John Day River				
Adjacent Land Use									
Ranching/Open space									
Remarks									
This site is adjacent to and west of Highway 19. The river has consumed most of the ground due to the location of this site. The ground was situated on the outside of the river radius and is all but gone. The road is about 6 feet above the river level.

View of the gravel site located adjacent to and west of Highway 19.

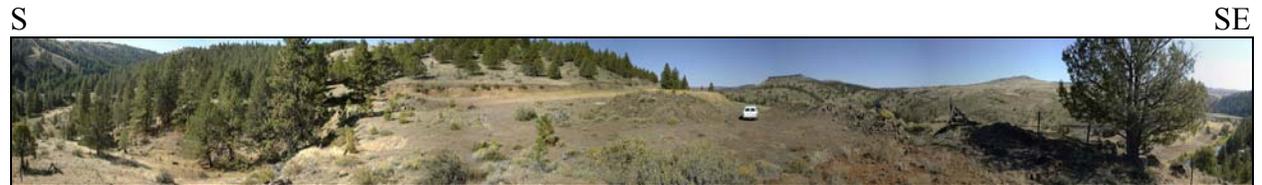
County	Site Name				Dist	Hwy	Mile Pt	TWP	RGE	Sect
Grant	Powell Quarry				12	0028	78.2	08S	31.0E	30
File ID		Source #	Date Visited	Map #			Type of Site			
07245		12-015-5	09/14/2000	1R-2-855			Stock Pile Site			
Latitude	Longitude	Elev. (m)	Acreage	Pit Size	DOGAMI Permit #					
44 50'17.66044"	119 02'26.51306"	945.961	10.28	NA						
Comments										
GPS acquired in the pit.										
Rock Type	Unit	Color		Weathering			Jointing			
Basalt	Tcp	NA		NA			NA			
Quality			Hardness	lbs./cu ft.	Cubic Yards	Reserve (Tons)				
NA			NA	150						
Potentially Significant Site	Why	Open/Closed	Direction							
No	NA	Closed	East and down about 200 feet is the North Middle Fork of the John Day River.							
Adjacent Land Use										
Open space										
Remarks										
This site is located east of and adjacent to Highway 395. The ground is flat next to the highway but slopes away very steeply down to the river below. This site is used as a waste rock area. With the proximity to the North Middle Fork of the John Day River and the steepness of the terrain I feel this is the best use of the site.

View looking north at the stock pile site located east of and adjacent to Highway 395.

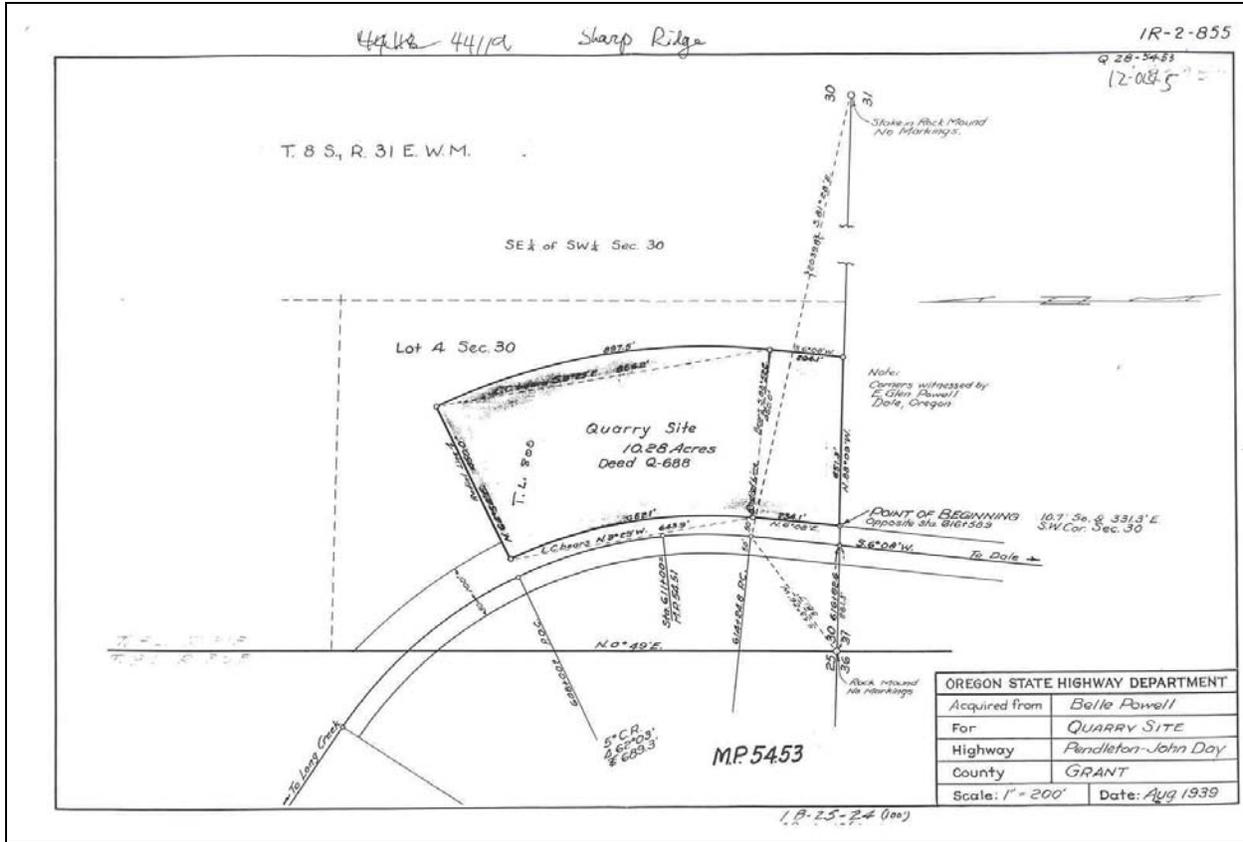
Aerial view of the stock pile site located adjacent to and west of Highway 395.

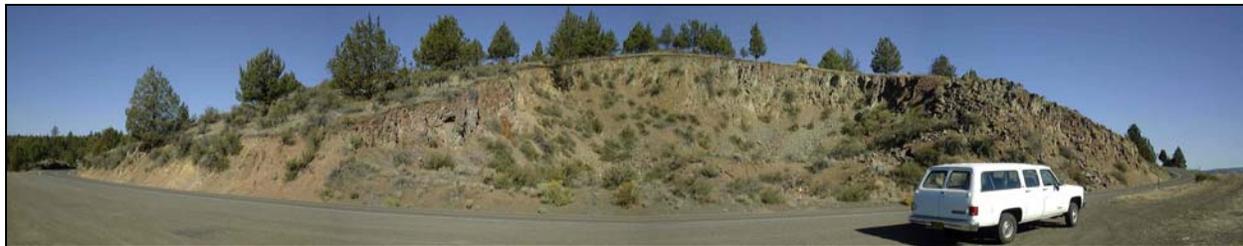
County	Site Name		Dist	Hwy	Mile Pt	TWP	RGE	Sect
Grant			12	0028	81.7	08S	30.0E	35, 36
File ID		Source #	Date Visited		Map #		Type of Site	
01695		12-016-5	09/14/2000		1R-1-1370		Quarry	
Latitude	Longitude	Elev. (m)	Acreage	Pit Size		DOGAMI Permit #		
44 49'45.63465"	119 03'48.12483"	1192.635	2.18	<1				
Comments								
GPS acquired in the pit.								
Rock Type		Unit	Color		Weathering		Jointing	
Basalt		Tcp	NA		Moderate to Decomposing		Highly Fractured	
Quality			Hardness	lbs./cu ft.	Reserve (cy)	Reserve (Tons)		
Poor to Fair			R3-	155	20,000	30,000		
Potentially Significant Site		Why			Open/Closed	Direction		
No		NA			Closed	NA		
Adjacent Land Use								
Open space								
Remarks								
This site is located west of and adjacent to Highway 395. The rock is a fine-grain decomposing basalt. There is no screening and no room to work. You can rip the material. The pit face is tall and all of the work in the future should be from the top down. The terrain is vertical along the highway and flat on top.

View looking west across Highway 395 at the small quarry site.

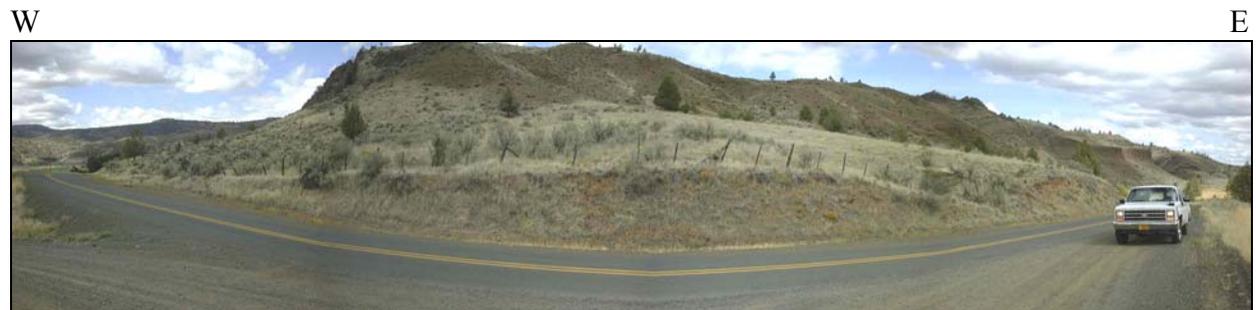
County	Site Name			Dist	Hwy	Mile Pt	TWP	RGE	Sect
Grant				12	0402	5.2	09S	26.0E	15
File ID		Source #	Date Visited	Map #			Type of Site		
08461		12-027-5	09/19/2000	1R-2-1030			Raw Land		
Latitude	Longitude	Elev. (m)	Acreage	Pit Size		DOGAMI Permit #			
44 47'27.69000"	119 34'27.59000"	609	1.95	NA					
Comments									
Lat. and Long. acquired using Terrain Navigator Software									
Rock Type	Unit	Color		Weathering			Jointing		
Colluvium	NA	NA		NA			NA		
Quality			Hardness	lbs./cu ft.	Reserve (cy)	Reserve (Tons)			
NA			NA	120					
Potentially Significant Site	Why	Open/Closed	Direction						
No	NA	Closed	To the south about 200 meters is the North Middle Fork of the John Day River.						
Adjacent Land Use									
Open space									
Remarks									
This site is located adjacent to and north of the Kimberly Long Creek Highway (402). It is just east of the County Road. This is raw land with no past visible disturbance. Most of the ground is composed of soils and minor basalts. The material would be used for fill only. There is no screening and very limited room to work.

View looking to the north at the small raw land site located along Highway 402.

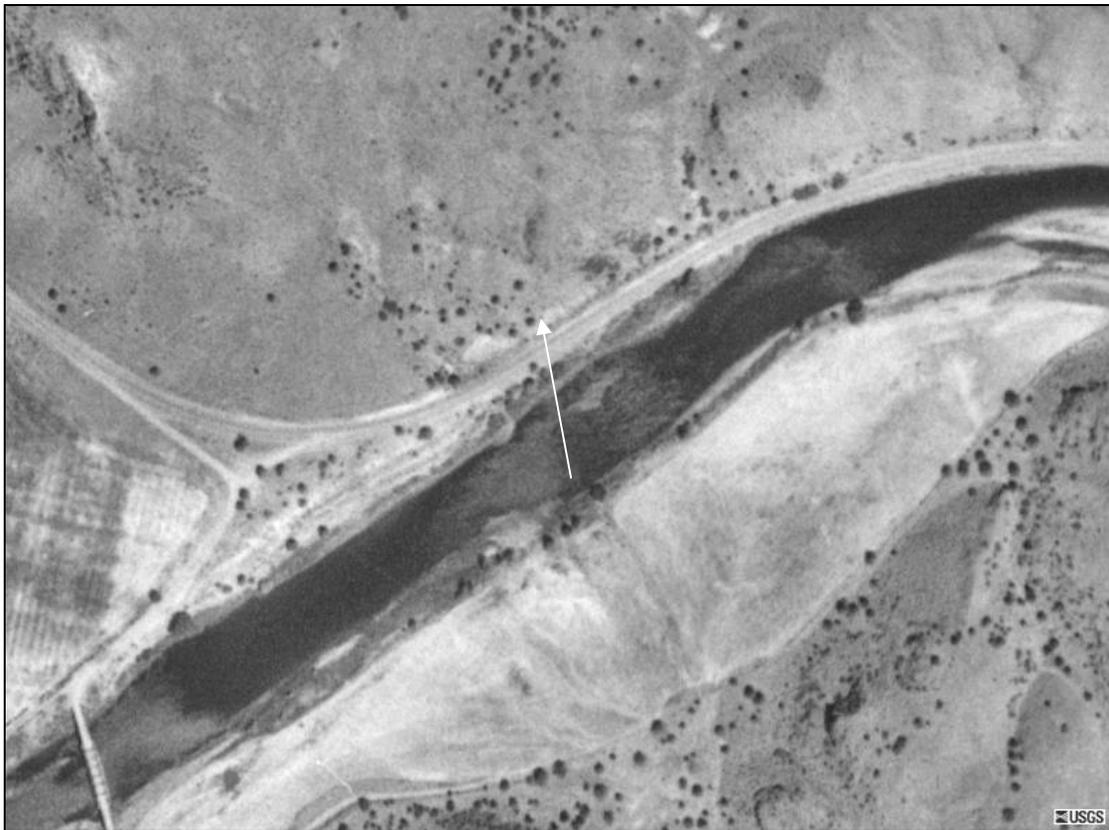
Aerial view of the small raw land site located along Highway 402.

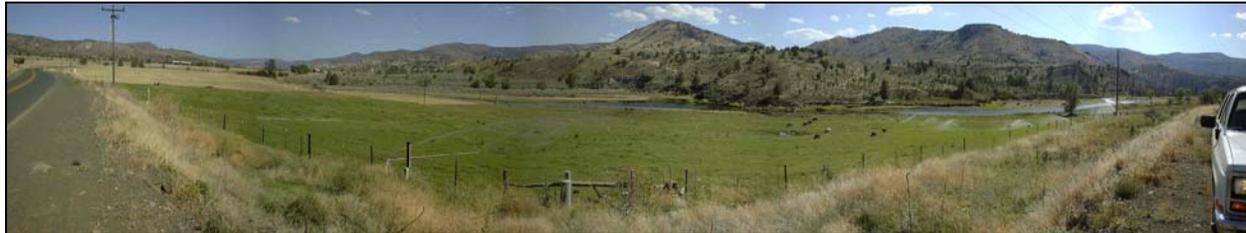
County	Site Name	Dist	Hwy	Mile Pt	TWP	RGE	Sect	
Grant		12	0402	6.6	09S	26.0E	12, 13	
File ID		Source #	Date Visited	Map #		Type of Site		
12888, 12887		12-028-5	09/14/2000	1R-2-1632		Gravel		
Latitude	Longitude	Elev. (m)	Acreage	Pit Size	DOGAMI Permit #			
44 47'50.11000"	119 32'54.05000"	609	13.62	NA				
Comments								
Lat. and Long. acquired using Terrain Navigator Software								
Rock Type	Unit	Color	Weathering		Jointing			
Gravel	Qal	NA	NA		NA			
Quality			Hardness	lbs./cu ft.	Reserve (cy)	Reserve (Tons)		
Good			NA	120				
Potentially Significant Site	Why			Open/Closed	Direction			
No	NA			Closed	NA			
Adjacent Land Use								
Ranching adjacent								
Remarks								
This site is located south of the Kimberly Long Creek Highway (402) about 450 meters. The ground is on both sides of the North Middle Fork of the John Day River. The easement has been fenced and is not evident anymore. Most of the property is on the south side of the river where there is no access. The ground is long and narrow. We might have some form of agreement with the Oregon Department of Fish and Wildlife about this site. Possible mitigation site?

View of the gravel site located north of Highway 402 about 450 meters.

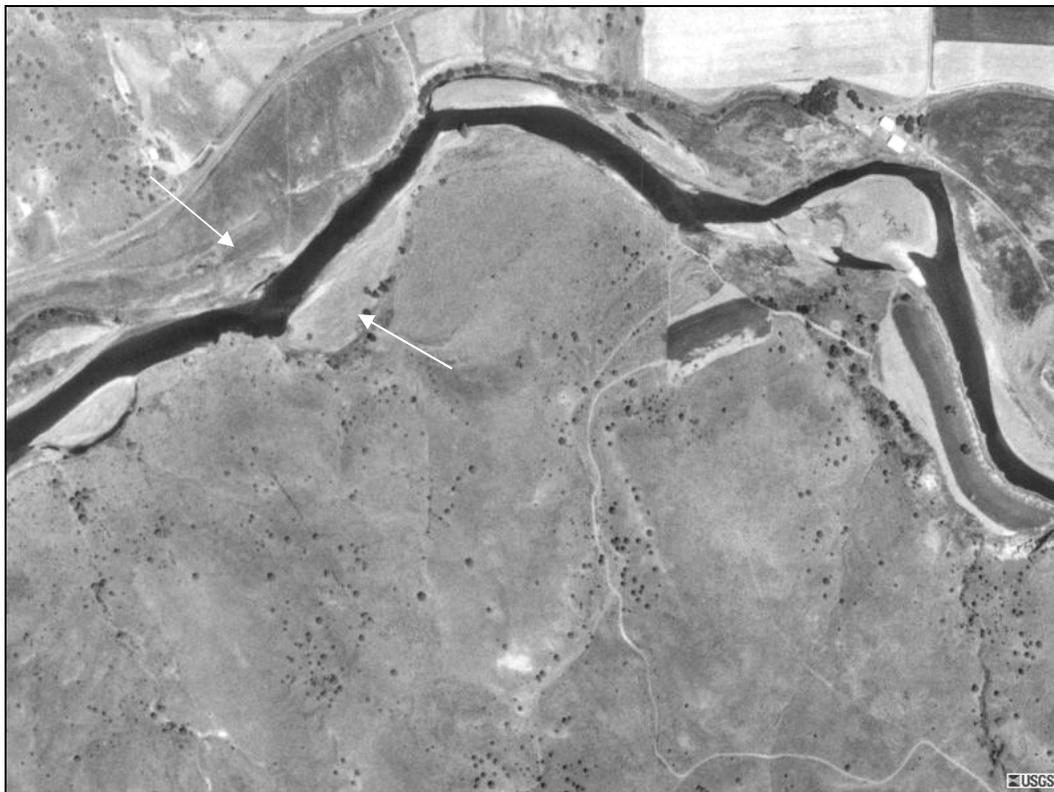
Aerial view of the gravel site that is on either side of the North Middle Fork of the John Day River.

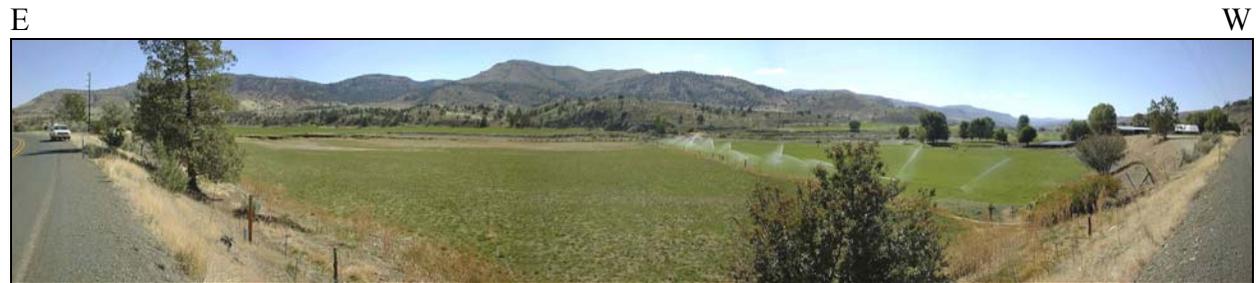
County	Site Name	Dist	Hwy	Mile Pt	TWP	RGE	Sect	
Grant		12	0402	10	09S	27.0E	04, 09	
File ID		Source #	Date Visited		Map #		Type of Site	
12896		12-029-5	09/14/2000		1R-2-1634		Gravel	
Latitude	Longitude	Elev. (m)	Acreage	Pit Size	DOGAMI Permit #			
44 48'36.63000"	119 29'17.23000"	609	8.2	NA				
Comments								
Lat. and Long. acquired using Terrain Navigator Software								
Rock Type	Unit	Color		Weathering		Jointing		
Gravel	Qal	NA		NA		NA		
Quality			Hardness	lbs./cu ft.	Reserve (cy)	Reserve (Tons)		
NA			NA	120				
Potentially Significant Site	Why		Open/Closed		Direction			
No	NA		Closed		In the North Middle Fork of the John Day River			
Adjacent Land Use								
Ranching adjacent								
Remarks								
This site is south of the Kimberly Long Creek Highway (402) about 450 meters. Conversation with W. Walker, the adjacent property owner, showed me the easement and the boundary lines. He also informed me that he would buy the ground, or trade for some property up by the highway. He has about 20,000 cubic yards of gravel there. The river moved during the flood of 1996 and we lost the lions share of the ground. The site might have mitigation potential.

View of the gravel site located south of Highway 402 about 450 meters.

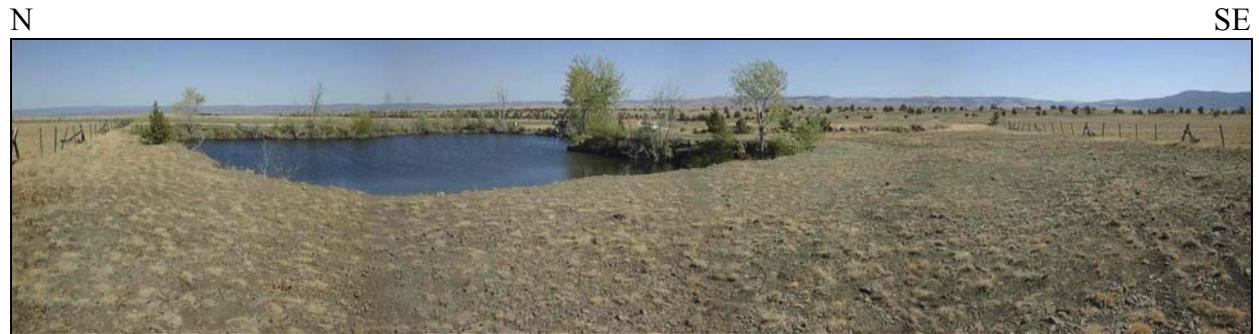
County	Site Name			Dist	Hwy	Mile Pt	TWP	RGE	Sect
Grant				12	0402	30.5	10S	29.0E	01
File ID		Source #	Date Visited	Map #			Type of Site		
23619		12-033-5	09/14/2000	1R-5-737			Quarry		
Latitude	Longitude	Elev. (m)	Acreage	Pit Size		DOGAMI Permit #			
44 44'07.83664"	119 10'51.20736"	1285.492	5.63	<2					
Comments									
GPS acquired on site.									
Rock Type	Unit	Color		Weathering			Jointing		
Basalt	Tcp	NA		NA			NA		
Quality			Hardness	lbs./cu ft.	Reserve (cy)	Reserve (Tons)			
Fair			NA	155	96,000	144,000			
Potentially Significant Site	Why			Open/Closed	Direction				
No	NA			Closed	NA				
Adjacent Land Use									
Open space									
Remarks									
This site is adjacent to and south of the Kimberly Long Creek Highway (402). There is a small pond at the west end of the site. It gets stocked every fall with trout by ODFW. The rest of the ground is used as a stock pile site. There is no screening and plenty of room to work. The terrain is flat. The water table is about 3 to 5 feet below the surface here. We would need to de-water at this location if we wish to remove more material and acquire additional area for staging (crusher and stockpiles).

View of the small pond that is stocked by ODFW that is located on the quarry site.

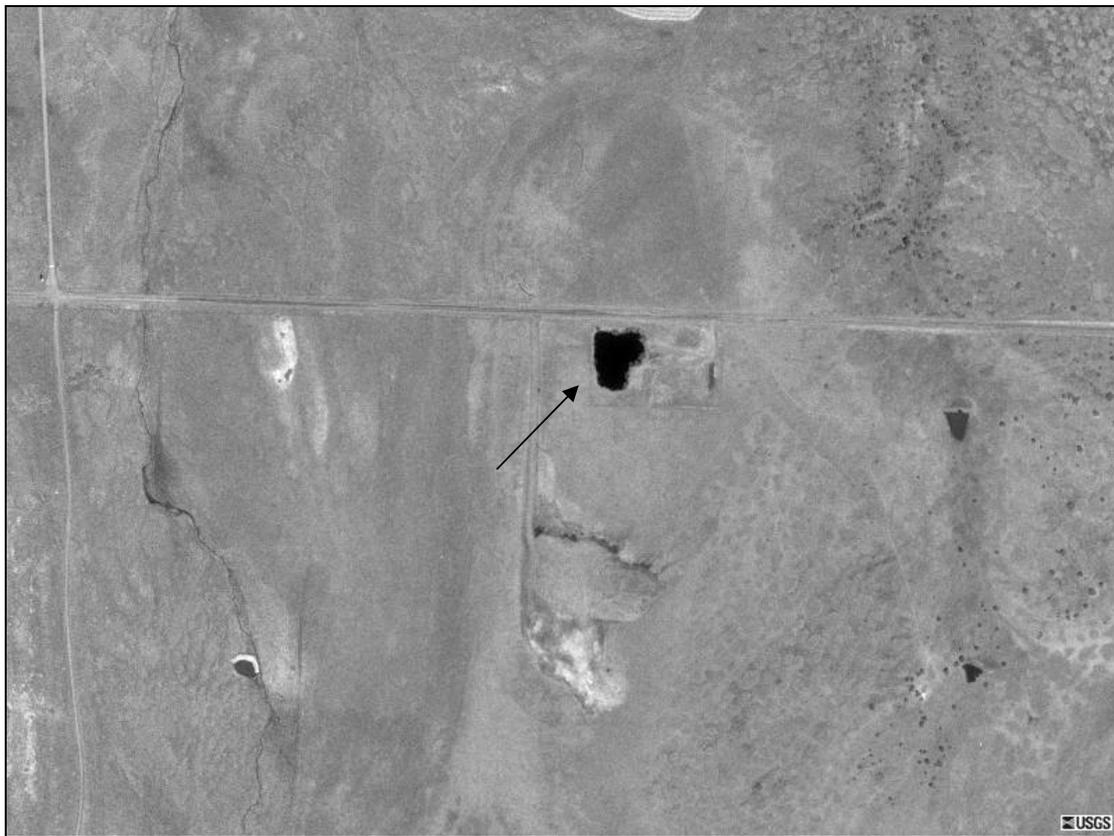
Aerial view of the quarry site adjacent to Highway 402, which has a small pond on the site.

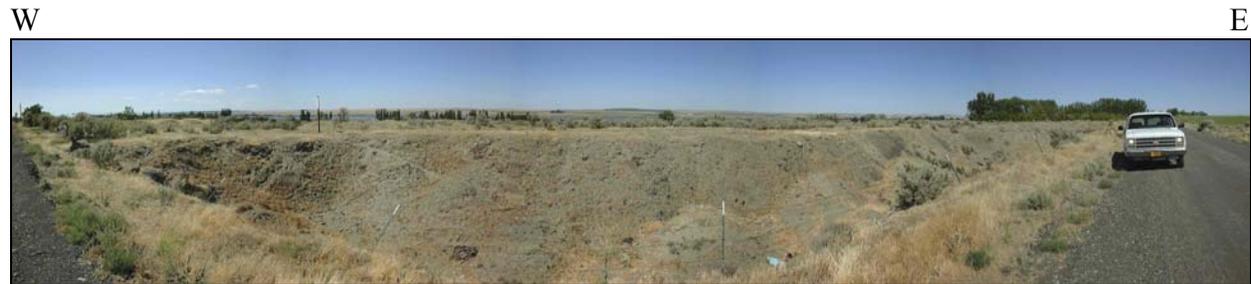
County	Site Name			Dist	Hwy	Mile Pt	TWP	RGE	Sect
Morrow				12	0002	175.98	05N	27.0E	20
File ID		Source #	Date Visited	Map #			Type of Site		
Q0173, Q0127		25-005-5	07/27/2000	1R-1-496, 1R-1-563			Stock Pile Site		
Latitude	Longitude	Elev. (m)	Acreage	Pit Size	DOGAMI Permit #				
45 53'51.03237"	119 27'40.07583"	99.716	10.34	<2					
Comments									
GPS acquired along East Oregon Lane adjacent to the pit.									
Rock Type	Unit	Color	Weathering			Jointing			
NA	Qgs	NA	NA			NA			
Quality			Hardness	lbs./cu ft.	Reserve (cy)	Reserve (Tons)			
NA			NA	0					
Potentially Significant Site	Why			Open/Closed	Direction				
No	NA			NA	NA				
Adjacent Land Use									
Rural residential									
Remarks									
This site is located north and adjacent of Oregon Lane. The ground is used as a waste site now. The site is depleted of any material.									
202B	203B	211	206 Fine	206 Coarse	208 F	208 F Ht.	208 C	208 C Ht.

View of the depleted site off of East Oregon Lane that is now used as a stock pile site.

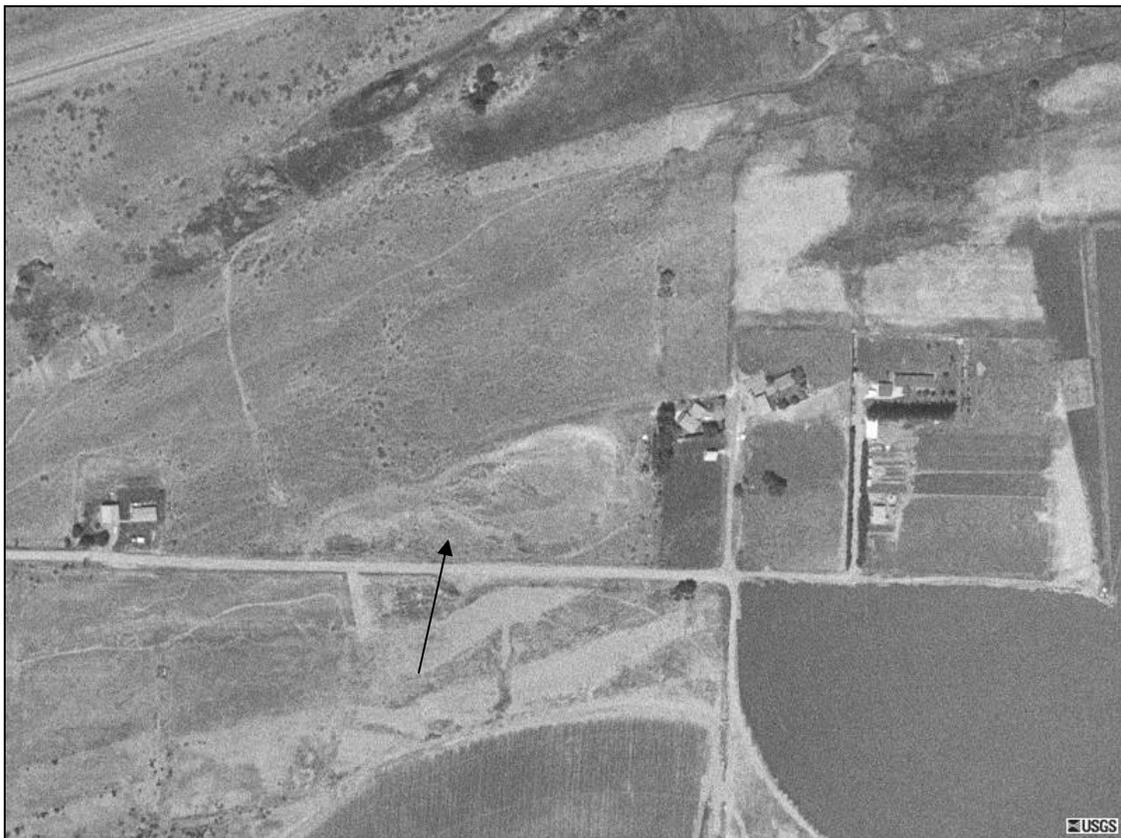
Aerial view of the stock pile site located adjacent to East Oregon Lane.

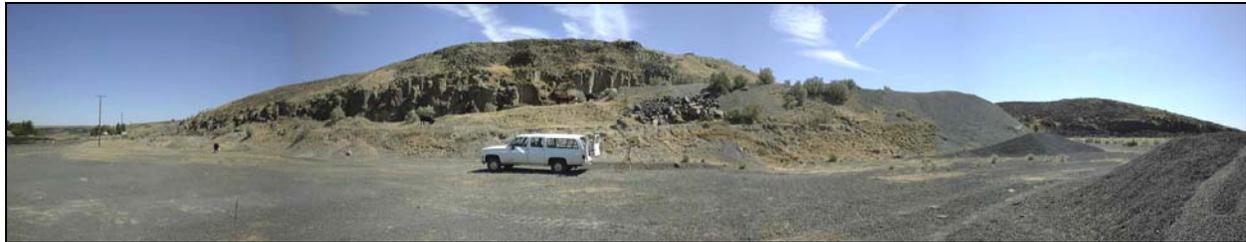
County	Site Name	Dist	Hwy	Mile Pt	TWP	RGE	Sect	
Morrow	Morgan Quarry	12	0052	9.65	02N	23.0E	07, 06	
File ID		Source #	Date Visited	Map #		Type of Site		
Q0136, Q0121		25-007-5	07/25/2000	1R-1-582, 1R-1-568		Quarry		
Latitude	Longitude	Elev. (m)	Acreage	Pit Size	DOGAMI Permit #			
45 40'31.58364"	119 58'40.55332"	154.691	4.72	<2				
Comments								
GPS acquired in the pit.								
Rock Type	Unit	Color	Weathering		Jointing			
Basalt	Tcs	Medium Dark Grey (N4)	Fresh to Slight		Massive to Moderately Fractured			
Quality			Hardness	lbs./cu ft.	Reserve (cy)	Reserve (Tons)		
Good			R3+	165	70,000	155,925		
Potentially Significant Site	Why			Open/Closed	Direction			
No	NA			Closed	West about 400 meters is Willow Creek			
Adjacent Land Use								
Farming/ house to the north approximately 400 meters								
Remarks								
This site is adjacent to Highway 74. The rock is a massive fractured fine-grain basalt. There is no screening from the highway and some room to work. You would need to drill and blast, but you could also rip. The terrain is gradual. Very limited staging area.

View of the quarry site located adjacent to Highway 74.

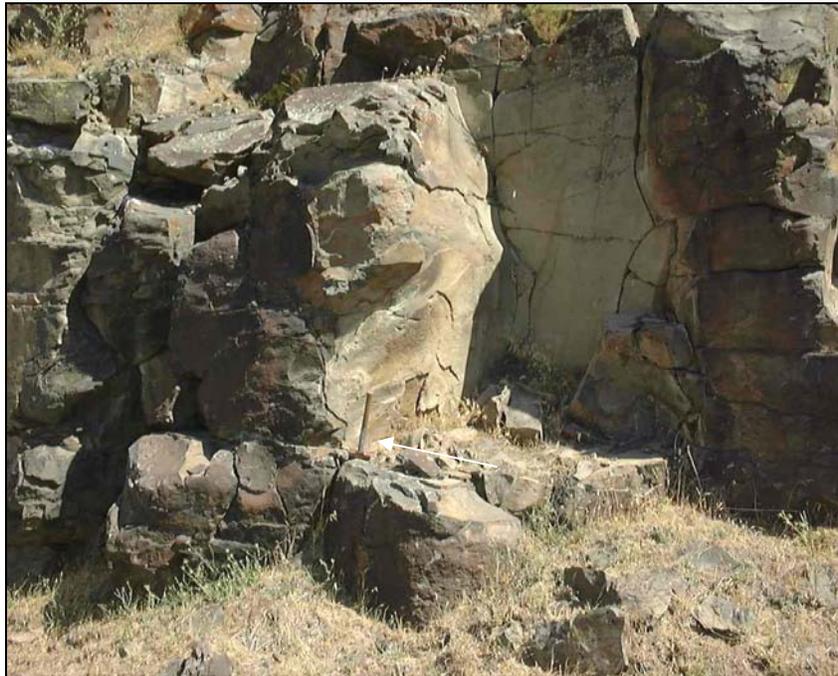
Close-up view of the massively fractured basalt found at this site.

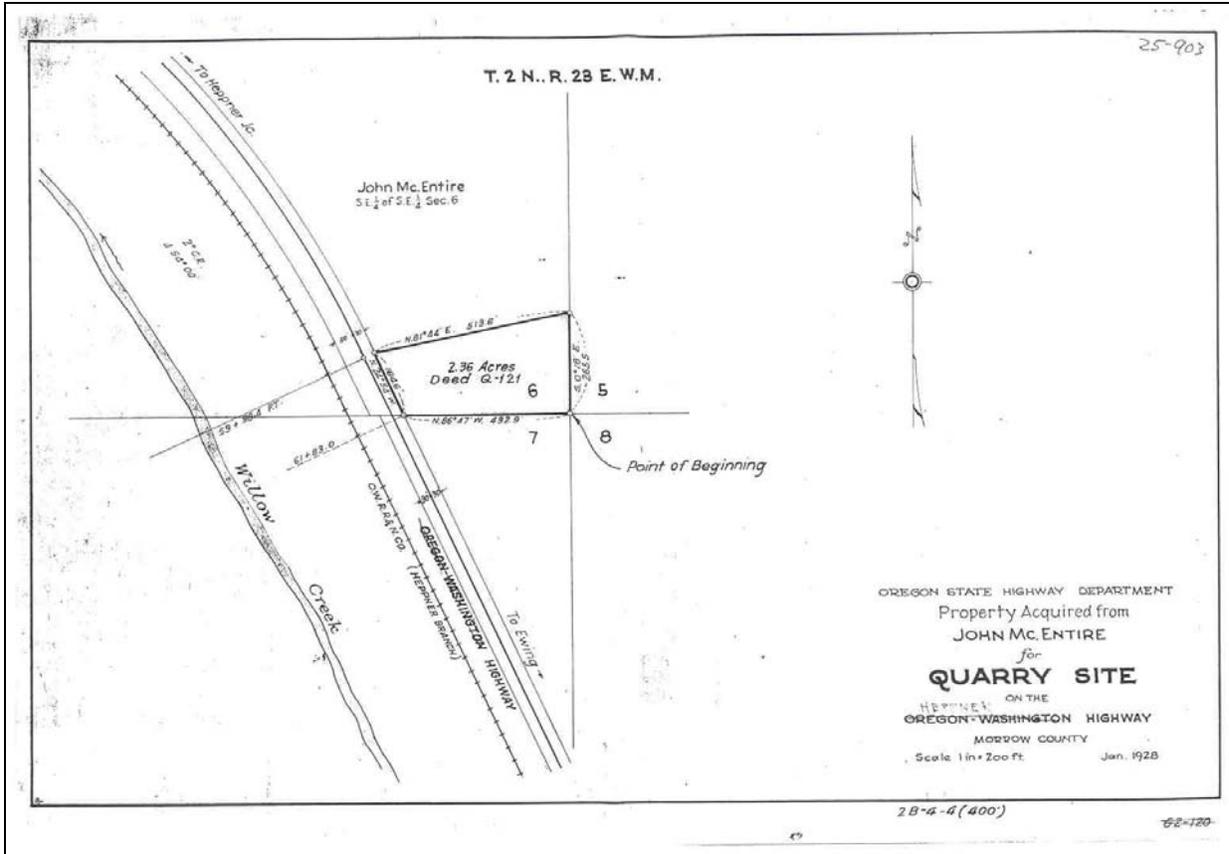
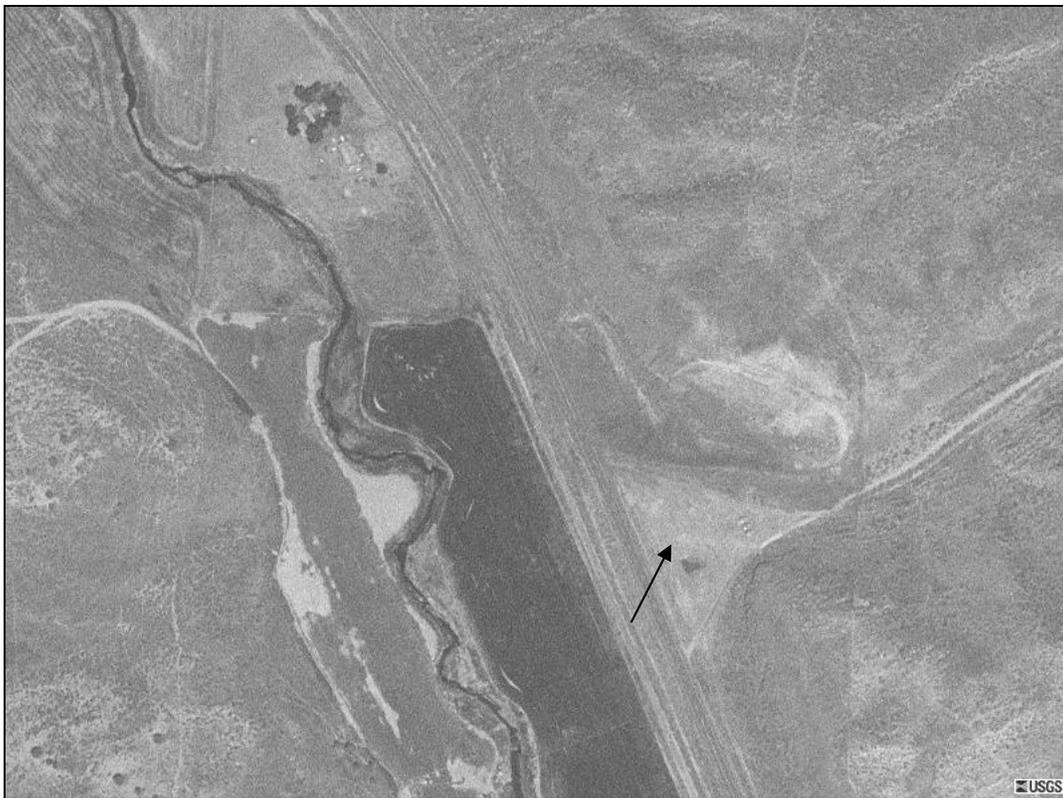
Aerial view of the quarry site that is adjacent to Highway 74.

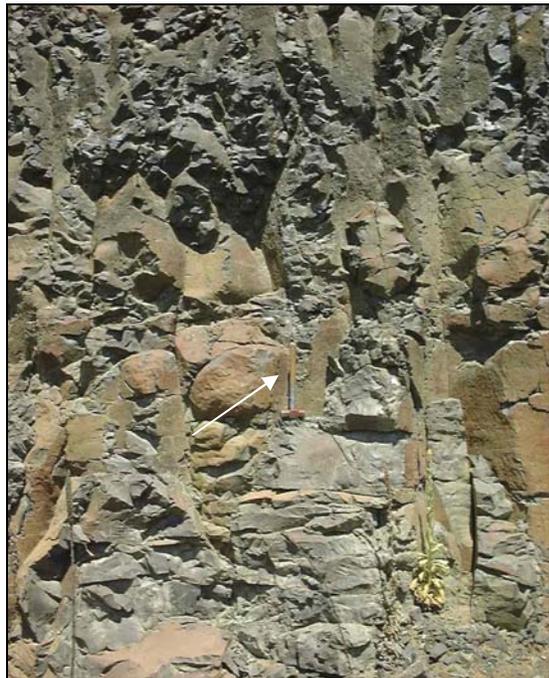
Close-up view of the fine-grain highly fractured rock.

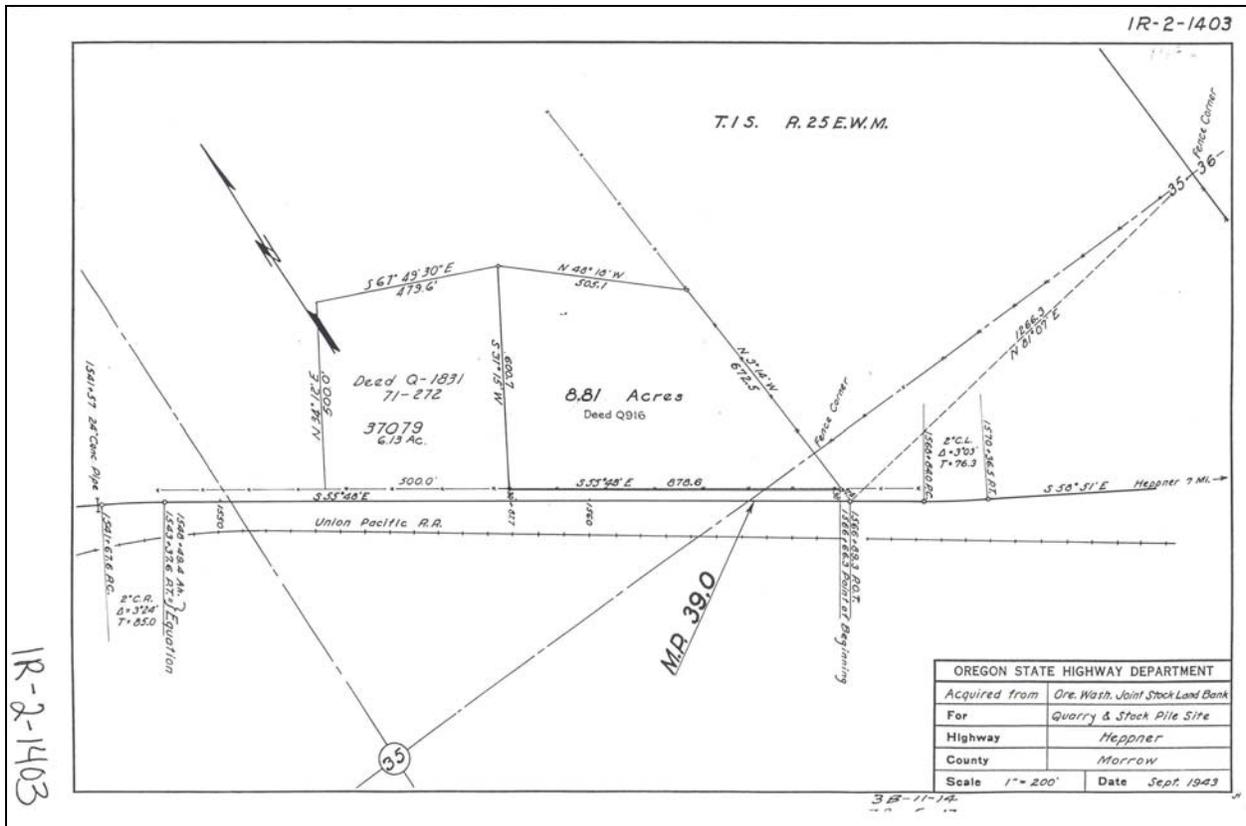
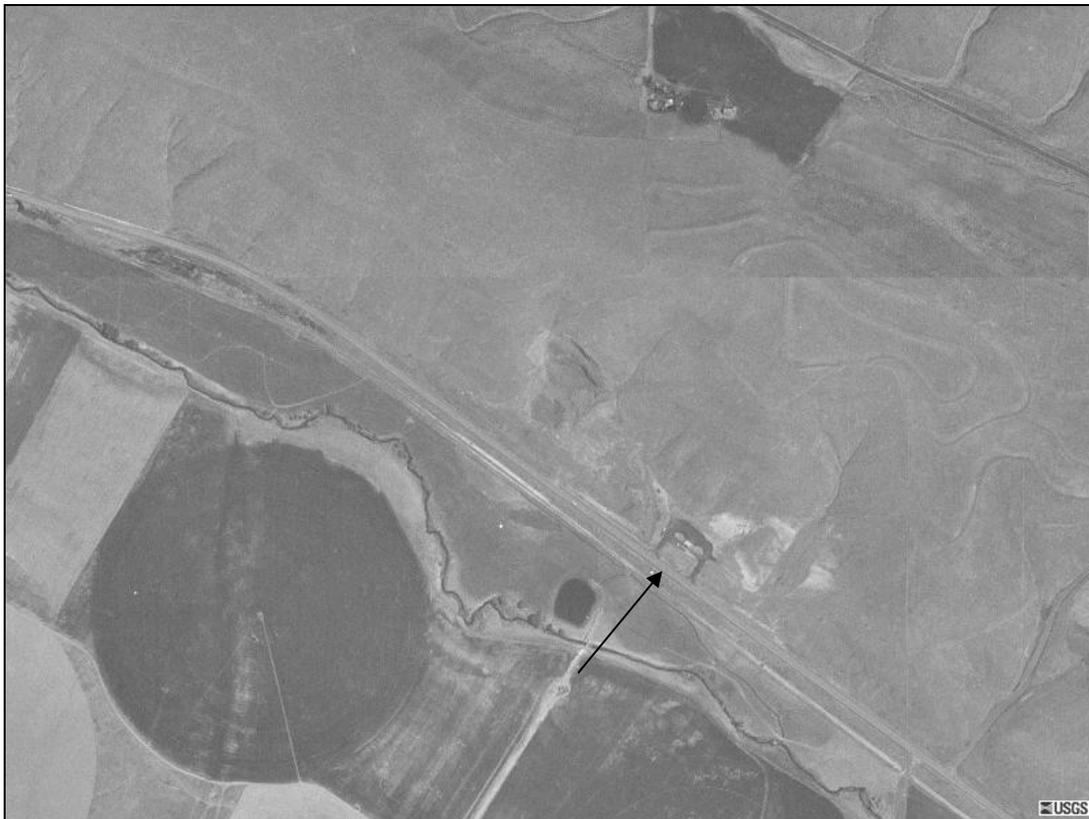
Aerial view of the quarry site located east of Lexington, OR on Highway 74.

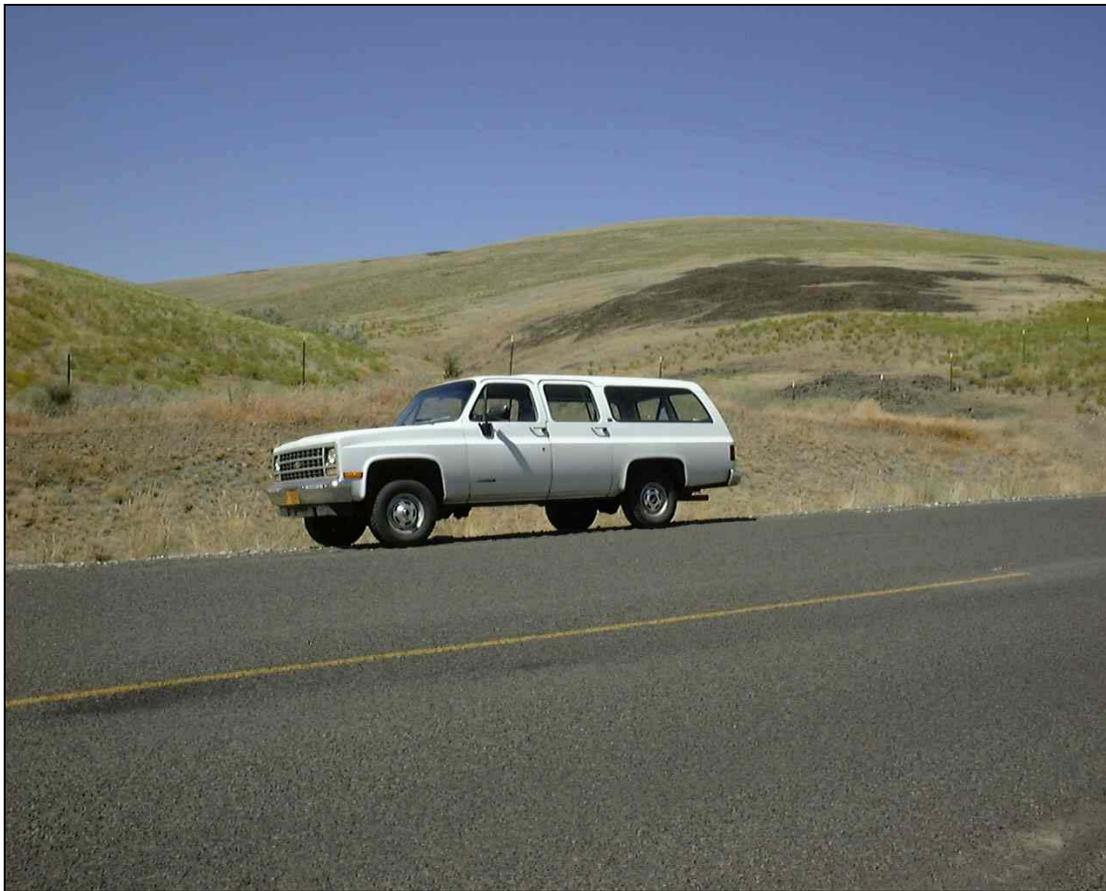
County	Site Name				Dist	Hwy	Mile Pt	TWP	RGE	Sect
Morrow	Barratt Quarry				12	0052	47.9	02S	26.0E	25
File ID		Source #	Date Visited	Map #			Type of Site			
01393		25-011-5	07/25/2000	1R-1-1338			Raw Land			
Latitude	Longitude	Elev. (m)	Acreage	Pit Size	DOGAMI Permit #					
45 21'41.52000"	119 31'39.64000"	668	4	NA						
Comments										
Lat. and Long. acquired using Terrain Navigator Software										
Rock Type	Unit	Color		Weathering			Jointing			
Basalt	Tcg	NA		NA			NA			
Quality			Hardness	lbs./cu ft.	Reserve (cy)	Reserve (Tons)				
Good			NA	120	65,000	105,300				
Potentially Significant Site	Why			Open/Closed	Direction					
No	NA			NA	NA					
Adjacent Land Use										
Farming and Ranching										
Remarks										
This site is located north of and adjacent to Highway 74, just east of Heppner. The site has no prior disturbance and has been fenced. There is no access to this site and our stock pile site across the highway. There is no screening and limited room to work. The terrain is gradual with a dry draw bisecting the property.

View of the raw land site located north of and adjacent to Highway 74.

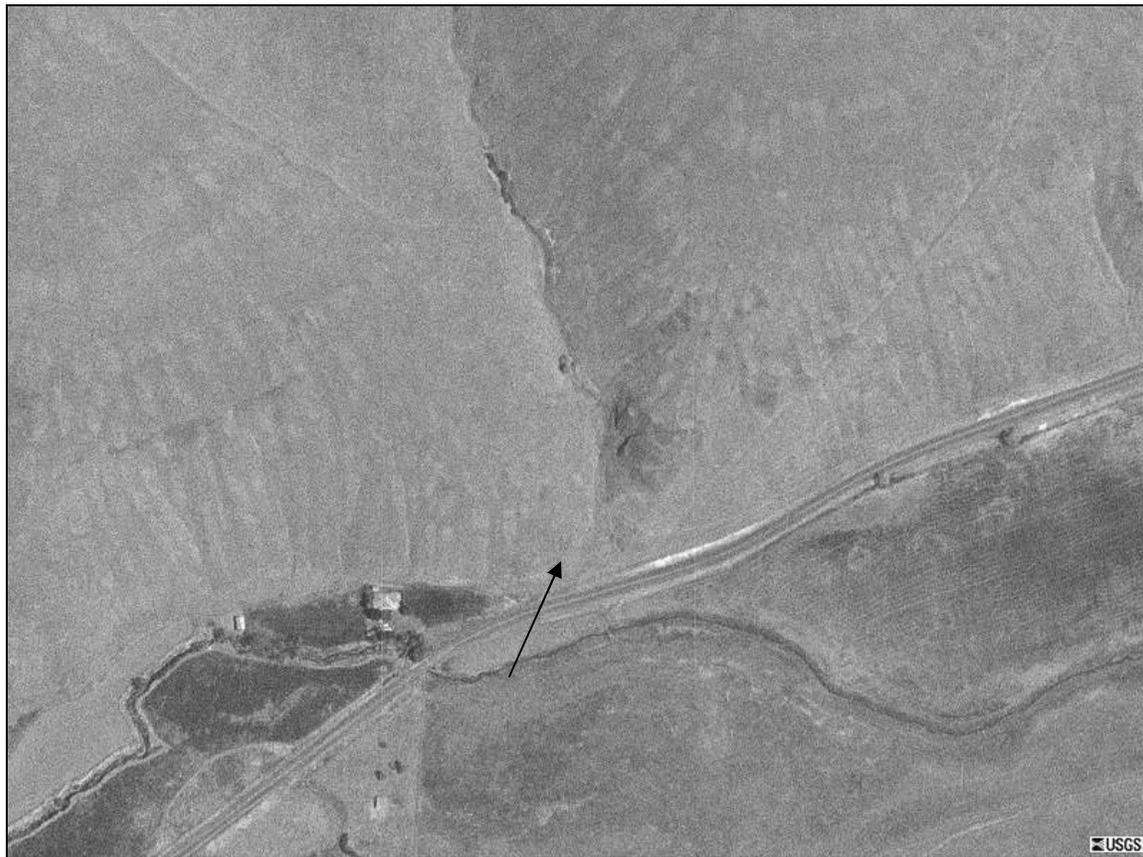
Aerial view of the raw land site located just north of Highway 74.

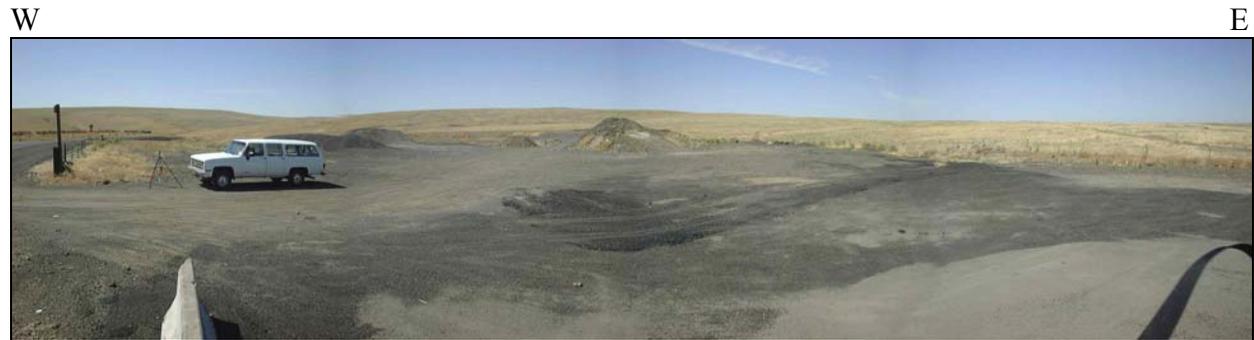
County	Site Name			Dist	Hwy	Mile Pt	TWP	RGE	Sect
Morrow				12	0052	57.5	02S	28.0E	21
File ID		Source #	Date Visited	Map #			Type of Site		
08913		25-012-5	07/25/2000	1R-2-1123			Quarry		
Latitude	Longitude	Elev. (m)	Acreage	Pit Size		DOGAMI Permit #			
45 22'42.17652"	119 20'49.56102"	977.295	9.52	<3		25-0063			
Comments									
GPS acquired at access point.									
Rock Type	Unit	Color		Weathering			Jointing		
Basalt	Tcg	NA		NA			NA		
Quality			Hardness	lbs./cu ft.	Reserve (cy)	Reserve (Tons)			
Good			NA	155	100,000	209,250			
Potentially Significant Site	Why			Open/Closed	Direction				
No	NA			Closed	NA				
Adjacent Land Use									
Open space									
Remarks									
This site is located north of and adjacent to Highway 74. The ground appears to have been reclaimed sometime in the past. All or part, I could not tell. The rest of the ground is used for a stockpile and waste rock site. If half was reclaimed, then we could use up to 4.0 acres at a depth of 30 plus feet. The terrain is fairly flat. This site is at the top of the grade along Highway 74. This is good for embankment material only.

View looking north at the stock pile sites that are adjacent to Highway 74.

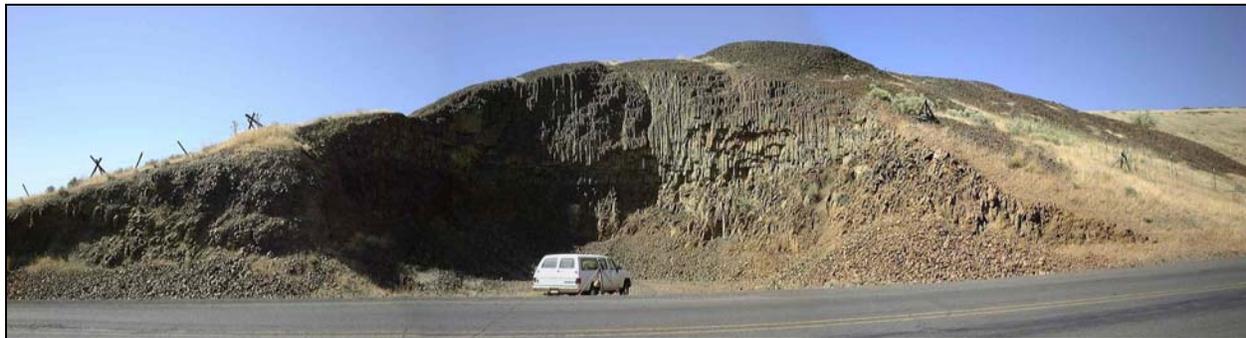
County	Site Name				Dist	Hwy	Mile Pt	TWP	RGE	Sect
Morrow	Hughes Quarry				12	0052	62.4	02S	28.0E	13
File ID		Source #	Date Visited	Map #			Type of Site			
Q0083		25-013-5	07/25/2000	1R-1-508			Quarry			
Latitude	Longitude	Elev. (m)	Acreage	Pit Size	DOGAMI Permit #					
45 23'56.39988"	119 16'38.10549"	773.855	4.72	<1						
Comments										
GPS acquired in the pit.										
Rock Type	Unit	Color		Weathering			Jointing			
Basalt	Tcg			Slight to Fresh			Highly Fractured			
Quality			Hardness	lbs./cu ft.	Reserve (cy)	Reserve (Tons)				
Good			R3	155						
Potentially Significant Site	Why			Open/Closed	Direction					
No	NA			Closed	NA					
Adjacent Land Use										
Open space										
Remarks										
This site is located adjacent to Highway 74 on a very sharp corner. The site is too small and in a difficult location for aggregate removal. The maximum area here for aggregate would be 2 acres not the 4.72. There is no room to work and no screening from the highway. This site is on the outside radius of a 20 mile per hour corner and would pose a danger. The terrain is moderately steep and sloping a multitude of different directions.

View of the quarry site located adjacent to Highway 74 on a very sharp corner.
