OREGON DEPARTMENT OF TRANSPORTATION

AGGREGATE SITES

DISTRICT 12

JUNE 2002

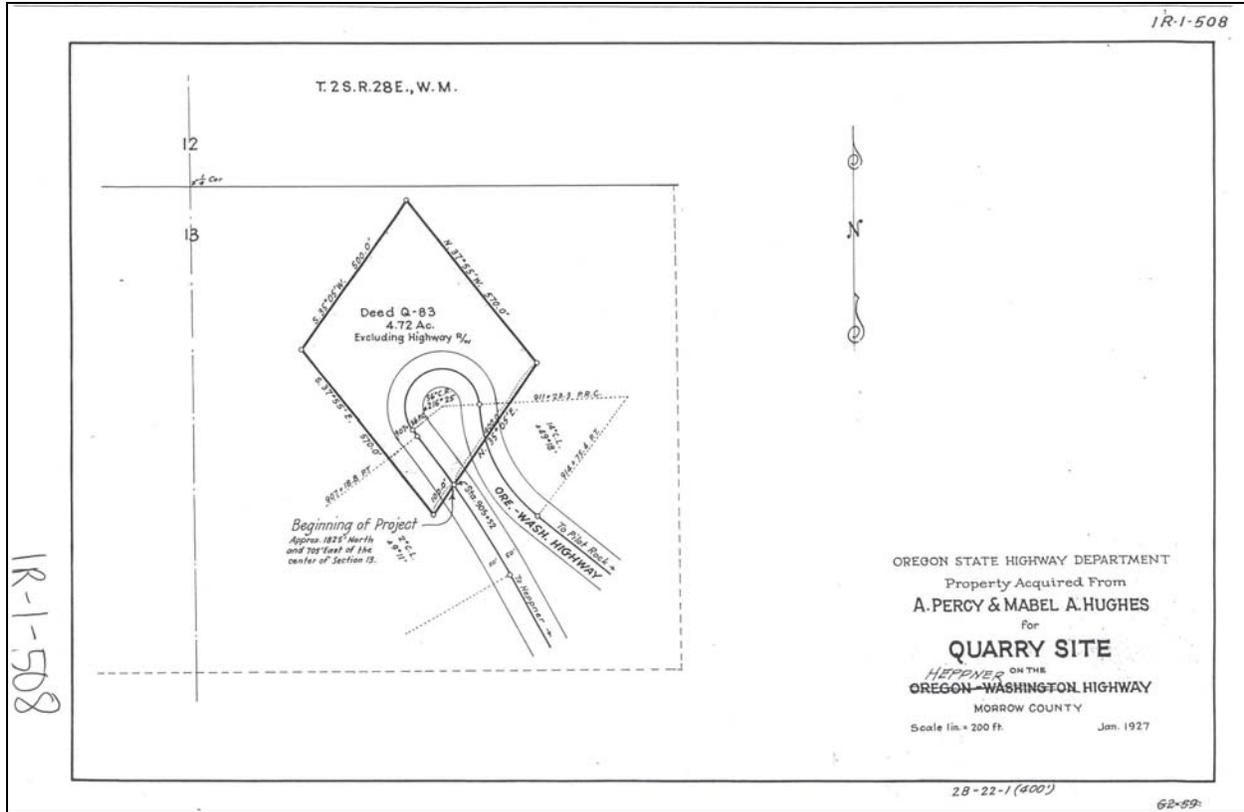
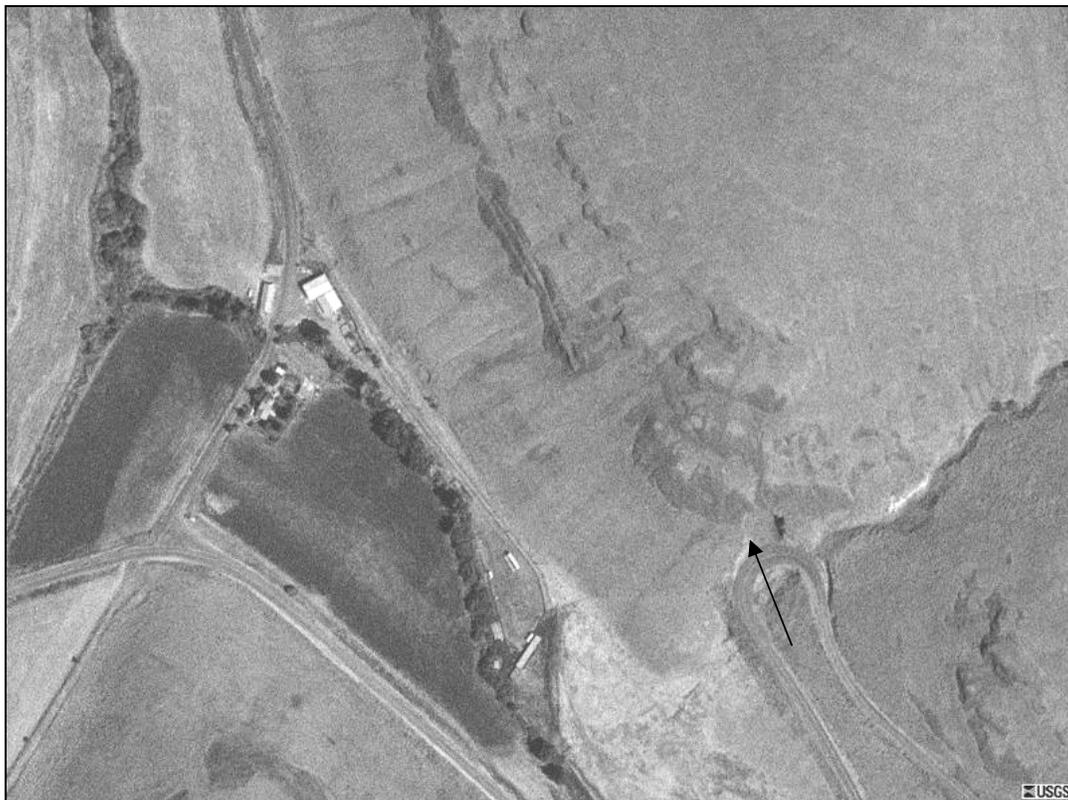
Close-up view of the highly fractured quarry face.

Aerial view of the small quarry site located on Highway 74 on a very sharp corner.

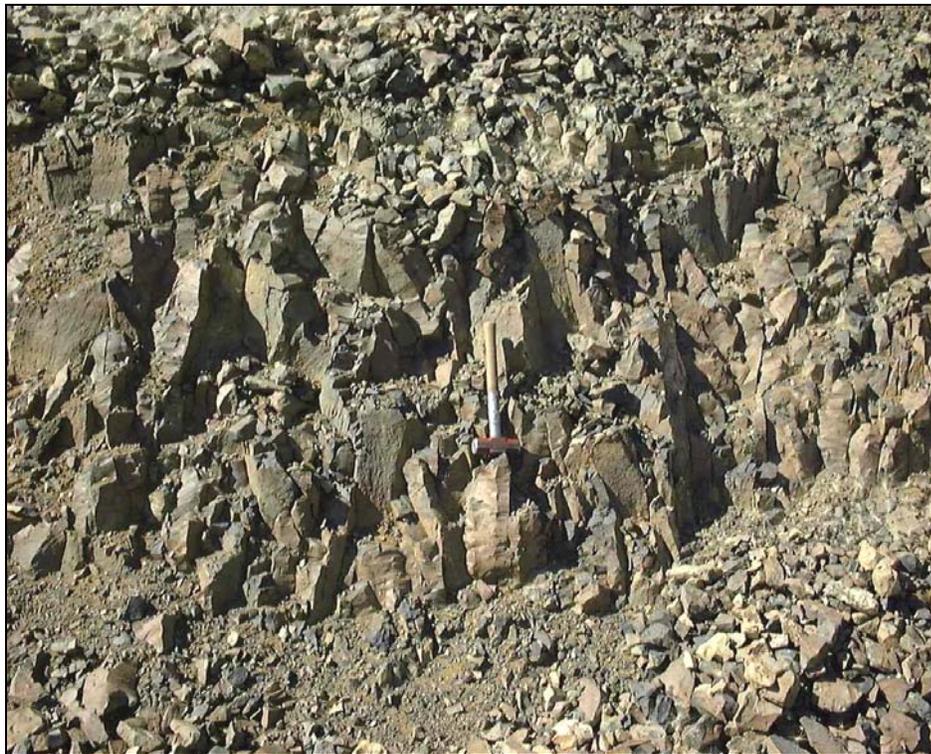
Close-up view of the highly fractured basalt found at this quarry site.

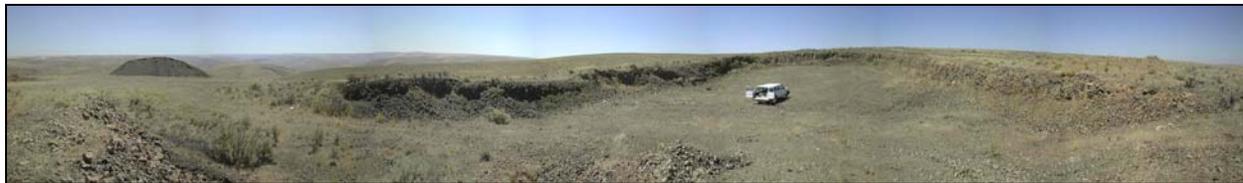
County	Site Name				Dist	Hwy	Mile Pt	TWP	RGE	Sect
Morrow					12	0300	54.8	03S	23.0E	31
File ID		Source #	Date Visited	Map #		Type of Site				
42140		25-016-5	07/26/2000	1R-4-308		Quarry				
Latitude	Longitude	Elev. (m)	Acreage	Pit Size	DOGAMI Permit #					
45 15'49.46562"	119 59'38.73370"	795.334	189	<2						
Comments										
GPS acquired in the pit.										
Rock Type	Unit	Color		Weathering		Jointing				
Basalt	Tcg	Medium Dark Grey (N4)		Slight		Highly Fractured				
Quality			Hardness	lbs./cu ft.	Reserve (cy)	Reserve (Tons)				
Good to Fair			R3-	169	1,000,000	1,500,000				
Potentially Significant Site	Why			Open/Closed	Direction					
No	USA ground			Closed	NA					
Adjacent Land Use										
Open space										
Remarks										
This site is south of Hale Ridge Road off of Highway 206. The rock is a medium-grain highly fractured basalt. There is ample room to work and good screening from the highway. You can rip the rock. The ground slopes away from the county road and can be up to a twenty degree incline. USA ground.

View of the 189 acre quarry site located south of Hale Ridge Road and off of Highway 206.

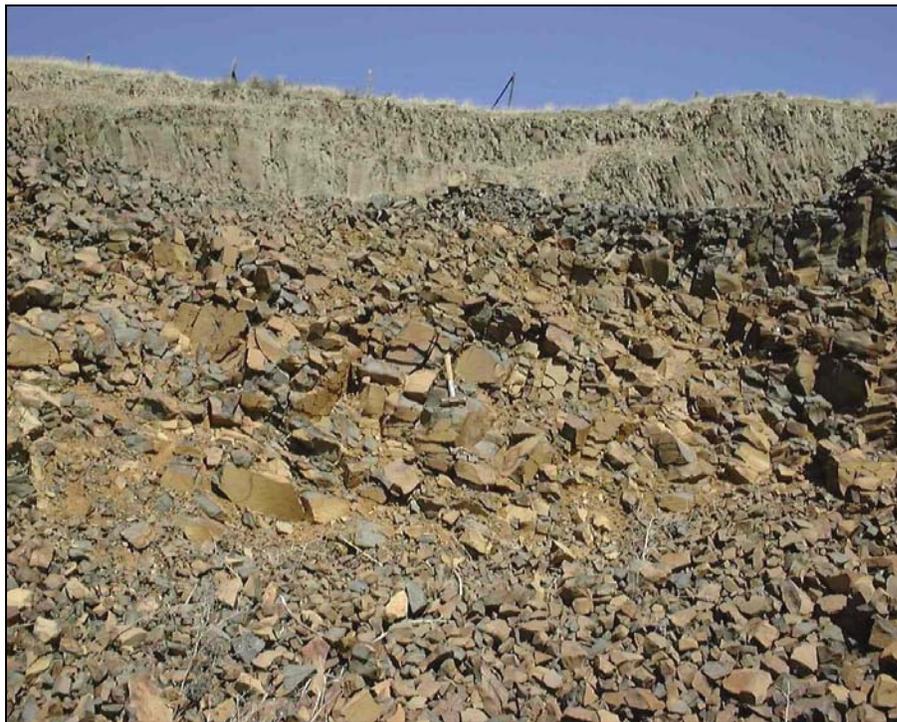
View of the highly fractured basalt found at this large quarry site.

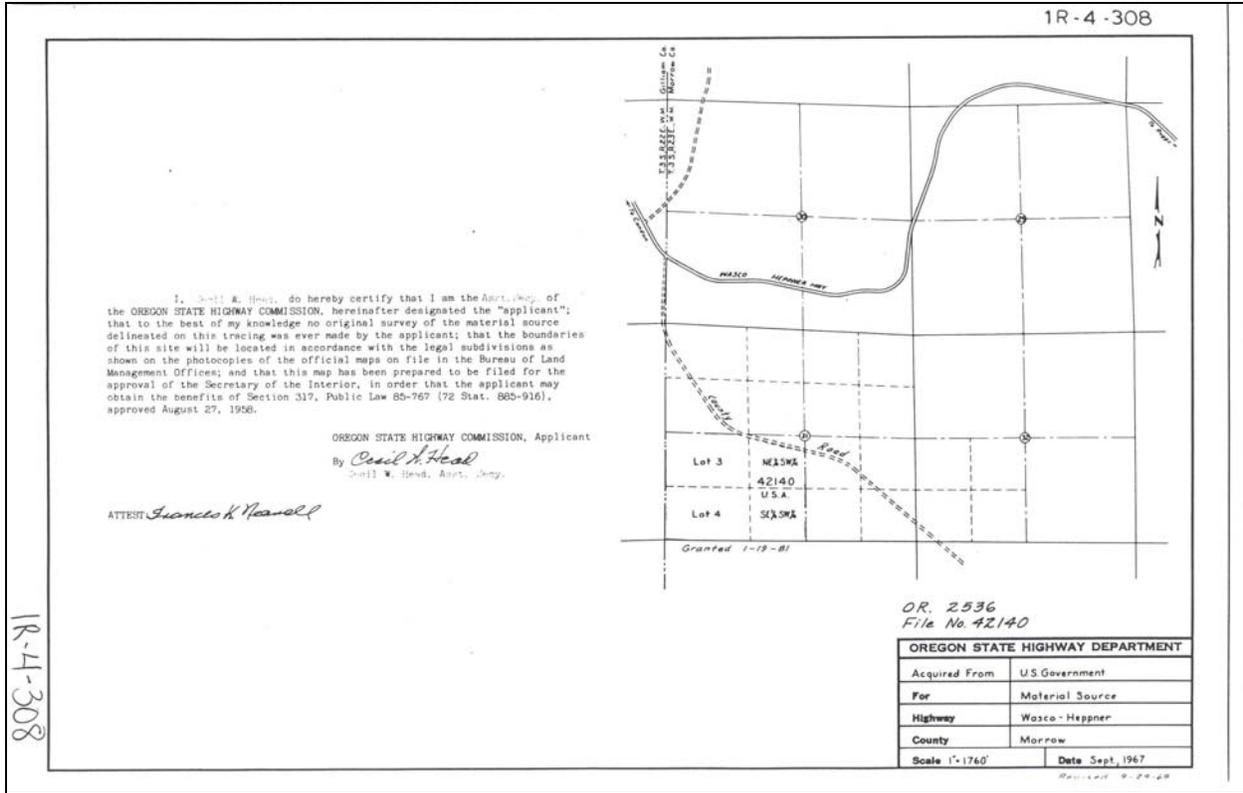
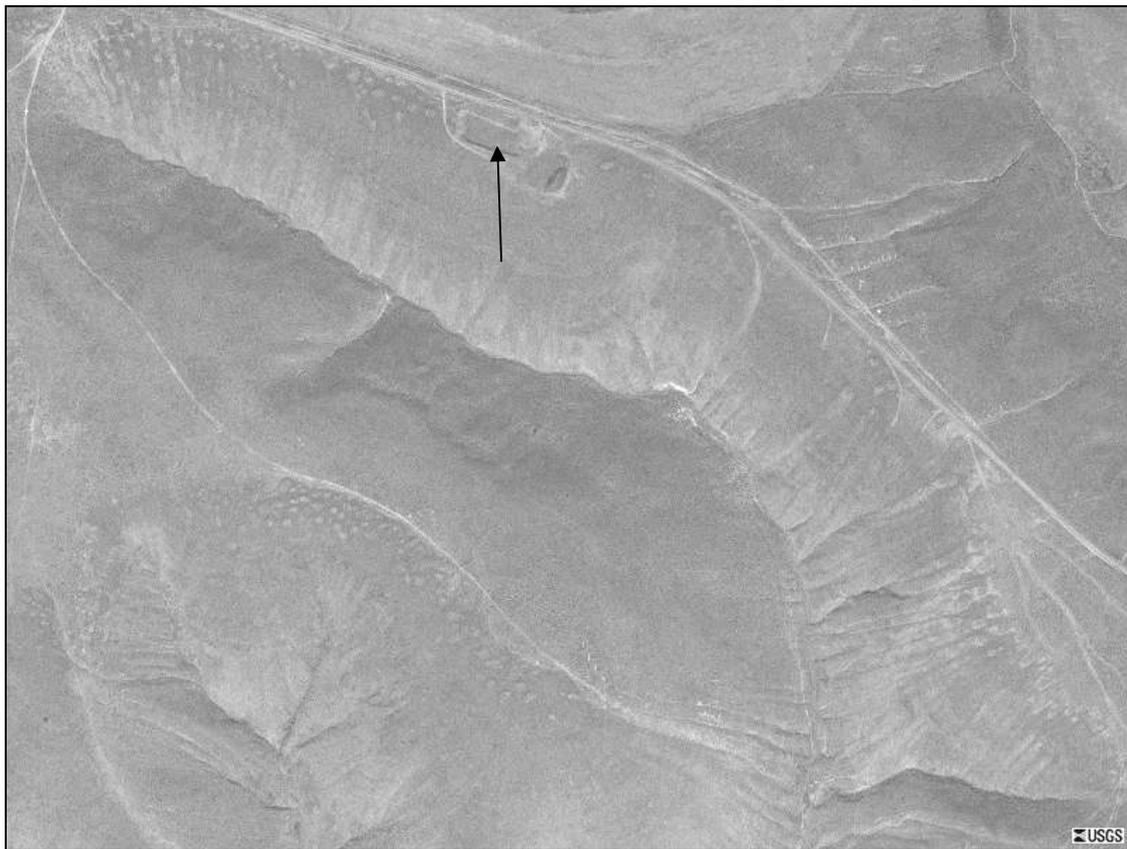
Aerial view of the 189 acre quarry site located off of Highway 206.

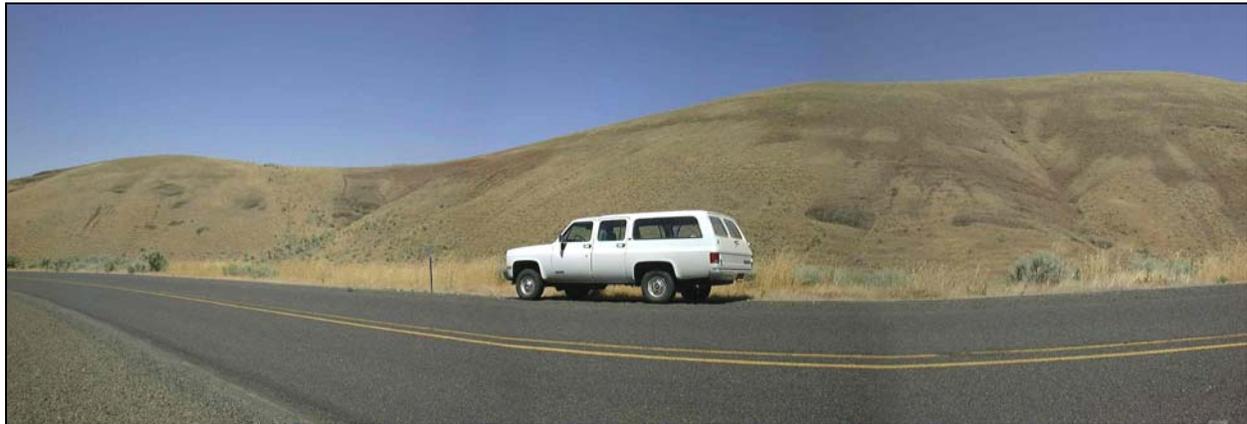
View from Highway 206 looking at the raw land site.

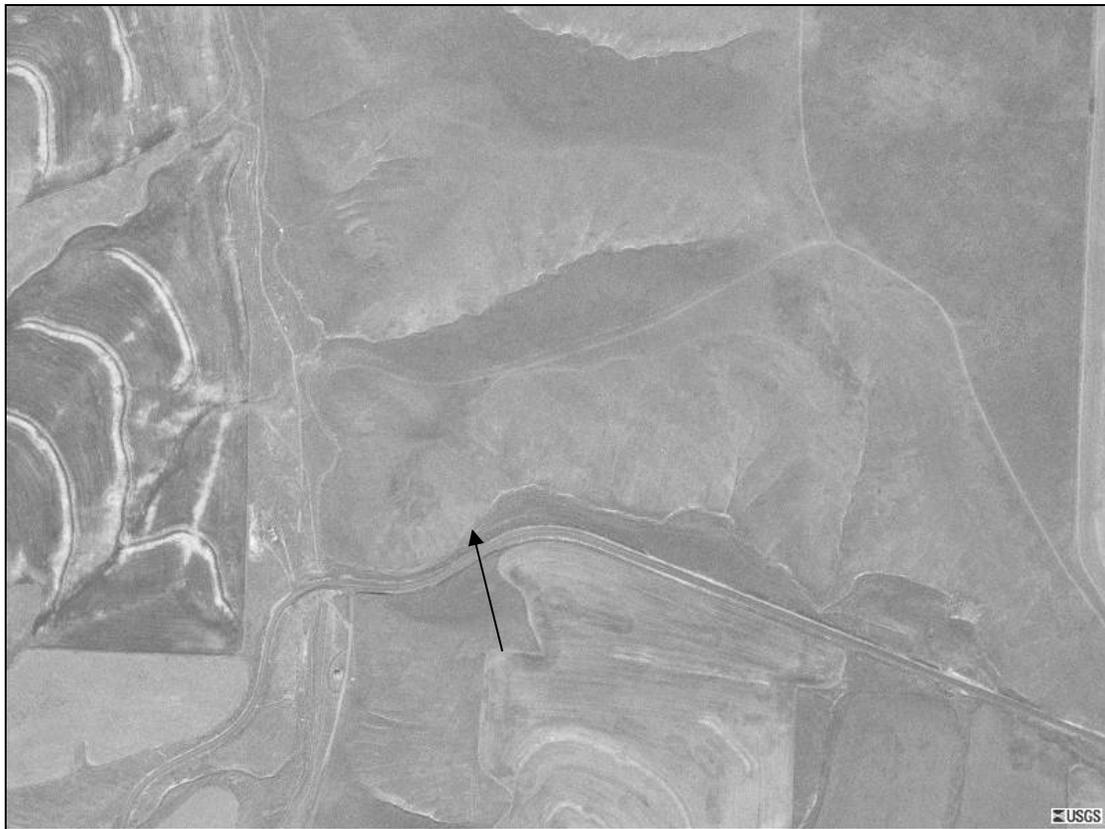
Aerial view of the raw land site located north of Highway 206.

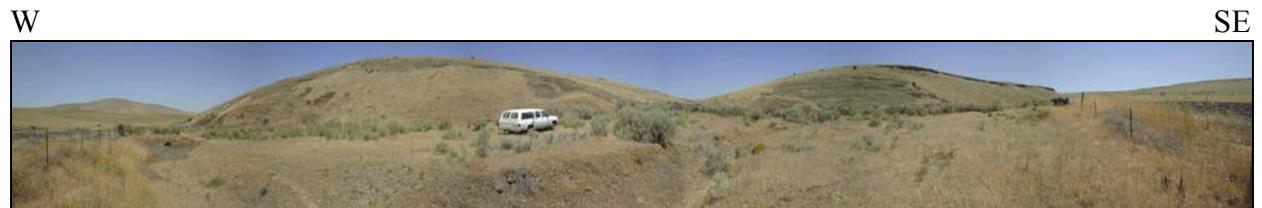
County	Site Name				Dist	Hwy	Mile Pt	TWP	RGE	Sect
Morrow					12	0300	60.3	03S	23.0E	26
File ID		Source #	Date Visited	Map #		Type of Site				
11768, 11770		25-018-5	07/25/2000	1R-2-1507		Quarry				
Latitude	Longitude	Elev. (m)	Acreage	Pit Size	DOGAMI Permit #					
45 16'41.10469"	119 54'55.01673"	695.484	8.06	NA						
Comments										
GPS acquired on site.										
Rock Type	Unit	Color		Weathering		Jointing				
Basalt	Tcg	Medium Dark Grey (N4)		Slight		Highly Fractured				
Quality			Hardness	lbs./cu ft.	Reserve (cy)	Reserve (Tons)				
Good			R3	155	95,000	142,500				
Potentially Significant Site	Why			Open/Closed	Direction					
No	NA			NA	NA					
Adjacent Land Use										
Open space										
Remarks										
This site is adjacent to and north of Highway 206. There are a few cat cuts and that is all of the disturbed ground here. Most of the ground is natural or reclaimed. There is no screening and some room to work. You can rip the material into (20cm) dice rock. There is a dry draw on the site that bisects the ground. Gradual rolling terrain.

View of the quarry site located adjacent to and north of Highway 206.

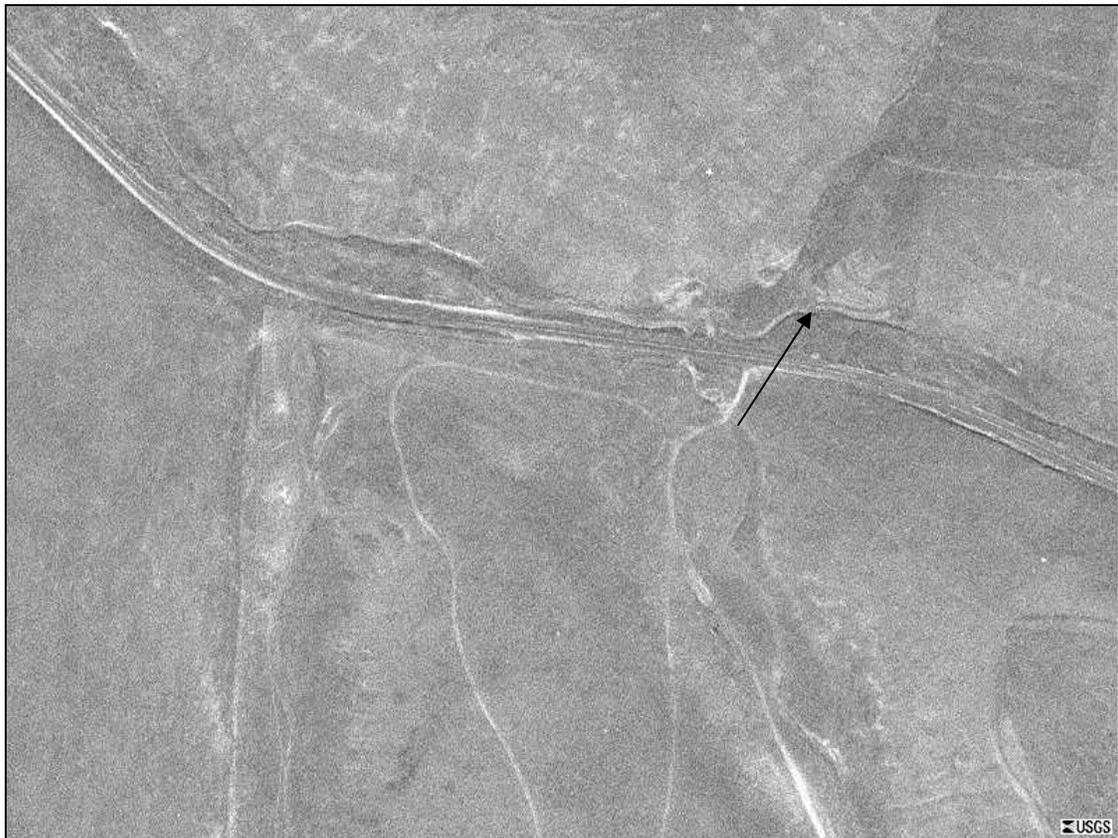
Aerial view of the quarry site located north of Highway 206.

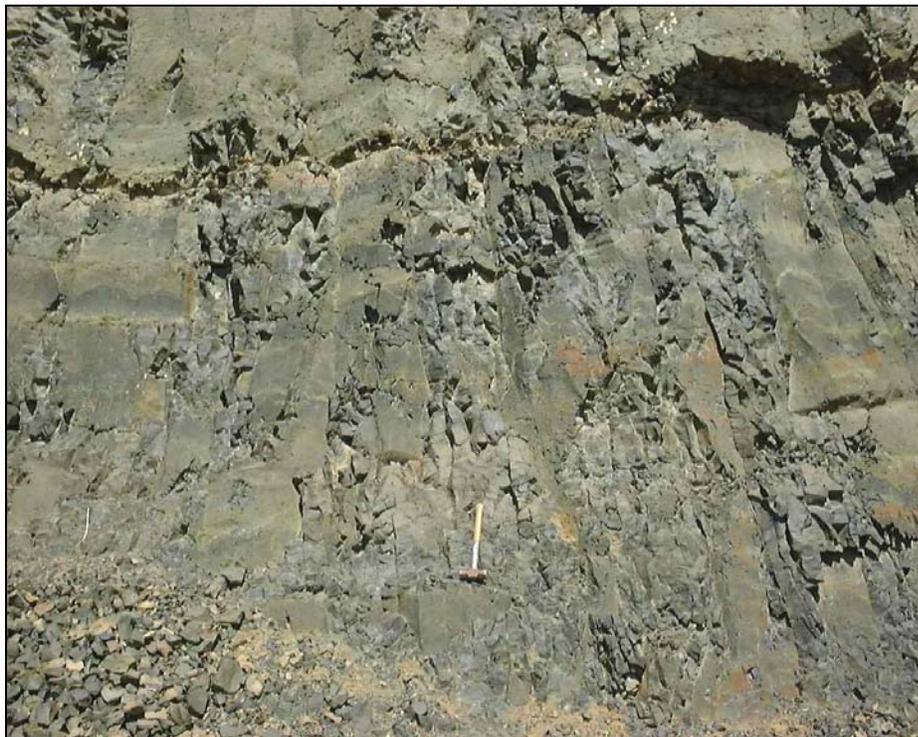
Close-up view of the fine-grain slightly vesicular, highly fractured basalt found at the quarry.

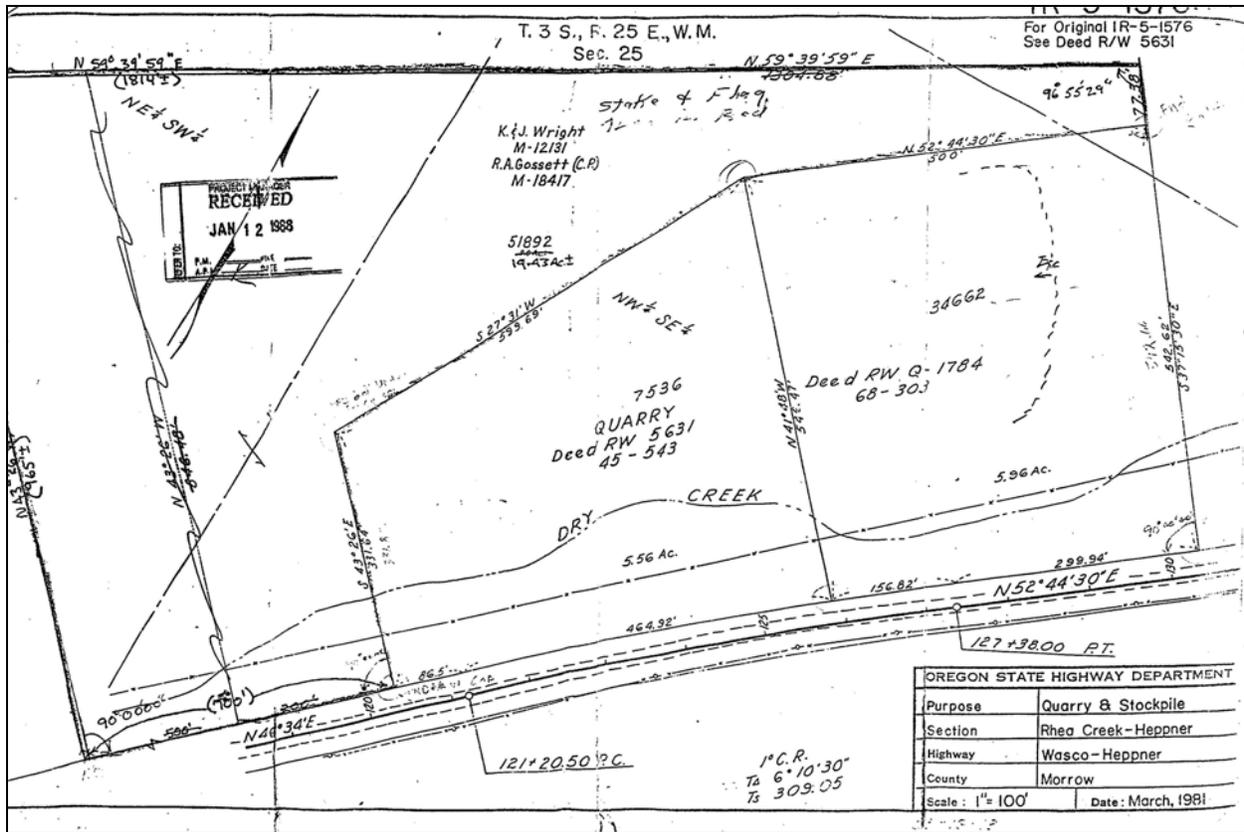
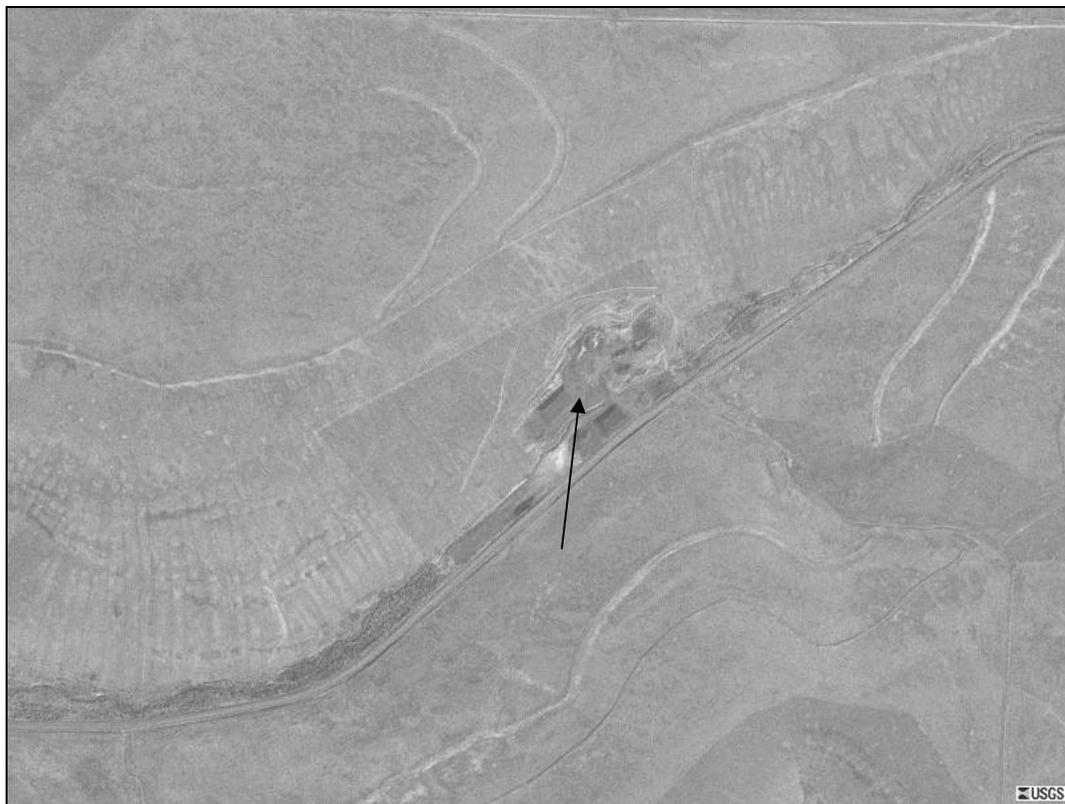
Aerial view of the quarry site located north of Highway 206.

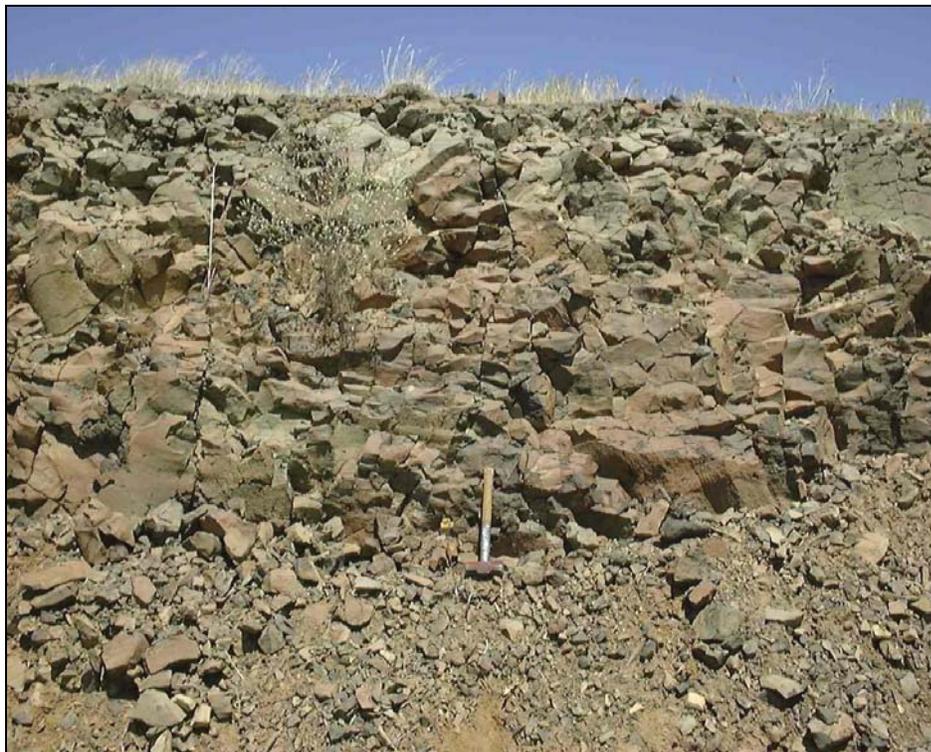
Close-up view of the highly fractured basalt found at this location.

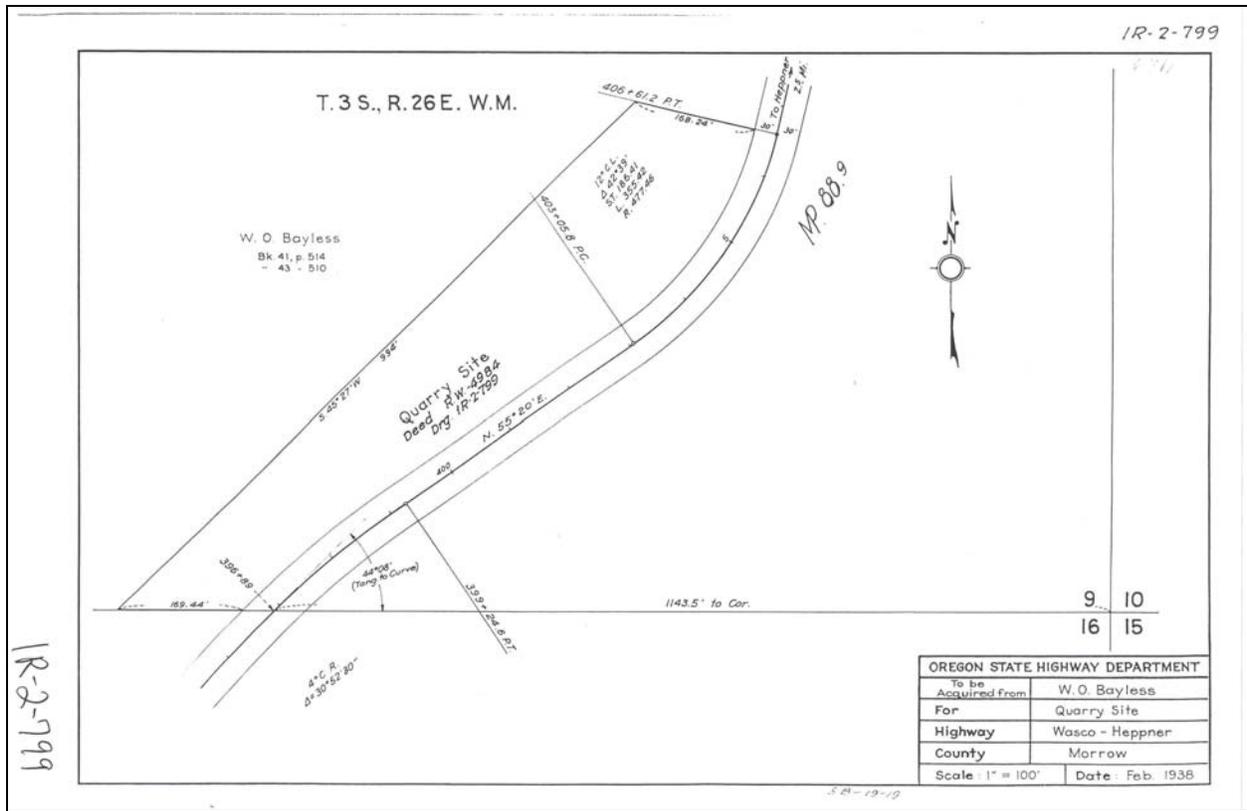
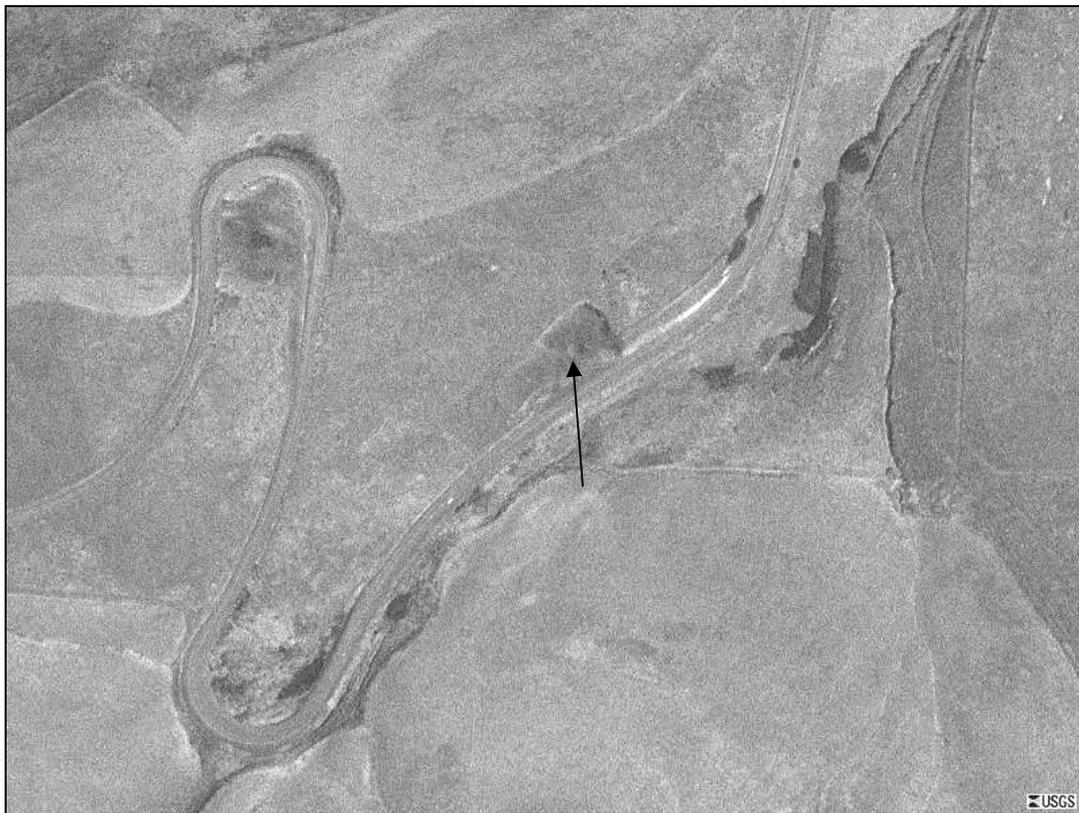
Aerial view of the long and narrow quarry site located adjacent to Highway 206.

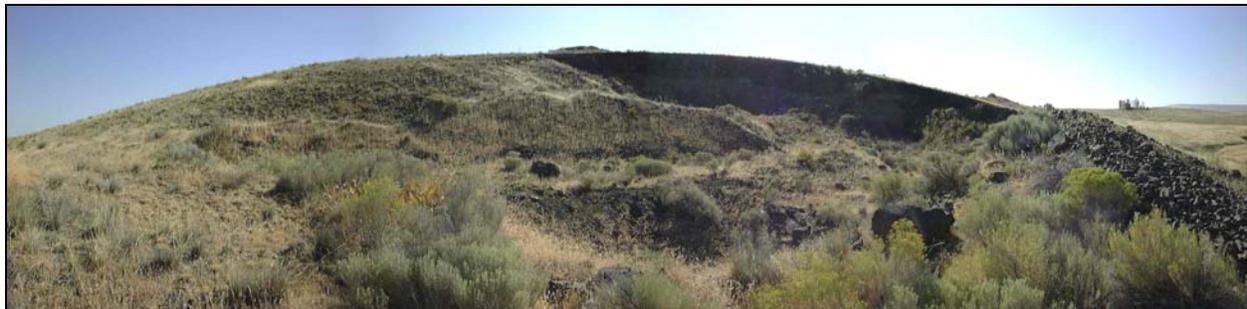
County	Site Name				Dist	Hwy	Mile Pt	TWP	RGE	Sect
Morrow					12	0320	9.98	01N	26.0E	20
File ID		Source #	Date Visited	Map #		Type of Site				
03229, 03230		25-021-5	07/26/2000	1R-1-1556		Quarry				
Latitude	Longitude	Elev. (m)	Acreage	Pit Size	DOGAMI Permit #					
45 33'01.76661"	119 35'53.94935"	378.188	6.28	<1						
Comments										
GPS acquired next to the pit.										
Rock Type	Unit	Color		Weathering		Jointing				
Basalt	Tcw	Medium Dark Grey (N4)		Slight		Highly Fractured				
Quality			Hardness	lbs./cu ft.	Reserve (cy)	Reserve (Tons)				
Good to Fair			R3-	166	65,000	145,665				
Potentially Significant Site	Why			Open/Closed	Direction					
No	NA			Closed	NA					
Adjacent Land Use										
Farming and one home 500 meters to the east.										
Remarks										
This is a small site southeast of Highway 207. The access to the site is not there any more (wheat field). I visited the site via private drive. The rock is a fine-grain highly fractured slightly weathered basalt. Some of the basalt is vesicular and the upper 10 to 15 feet will have stronger weathering. There is limited room to work and limited screening. You can rip the material. The terrain is fairly flat.

View of the small quarry site located southeast of Highway 207.

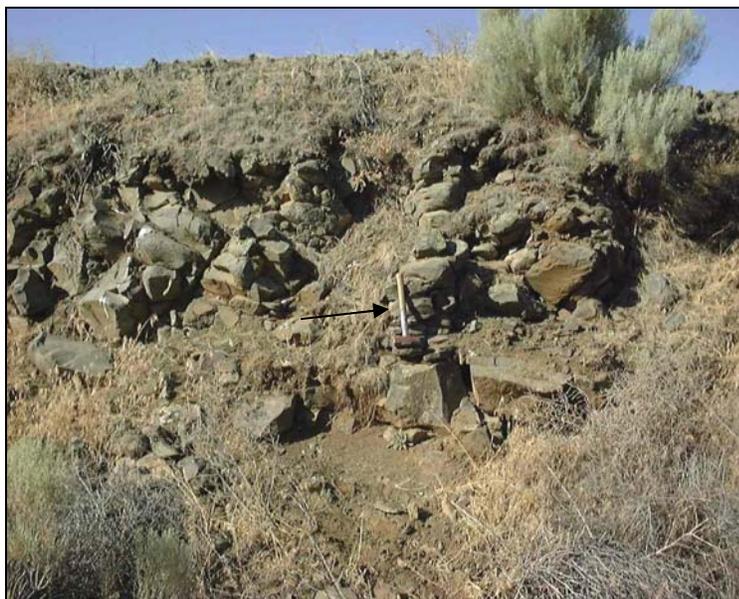
Close-up view of the material found at this site.

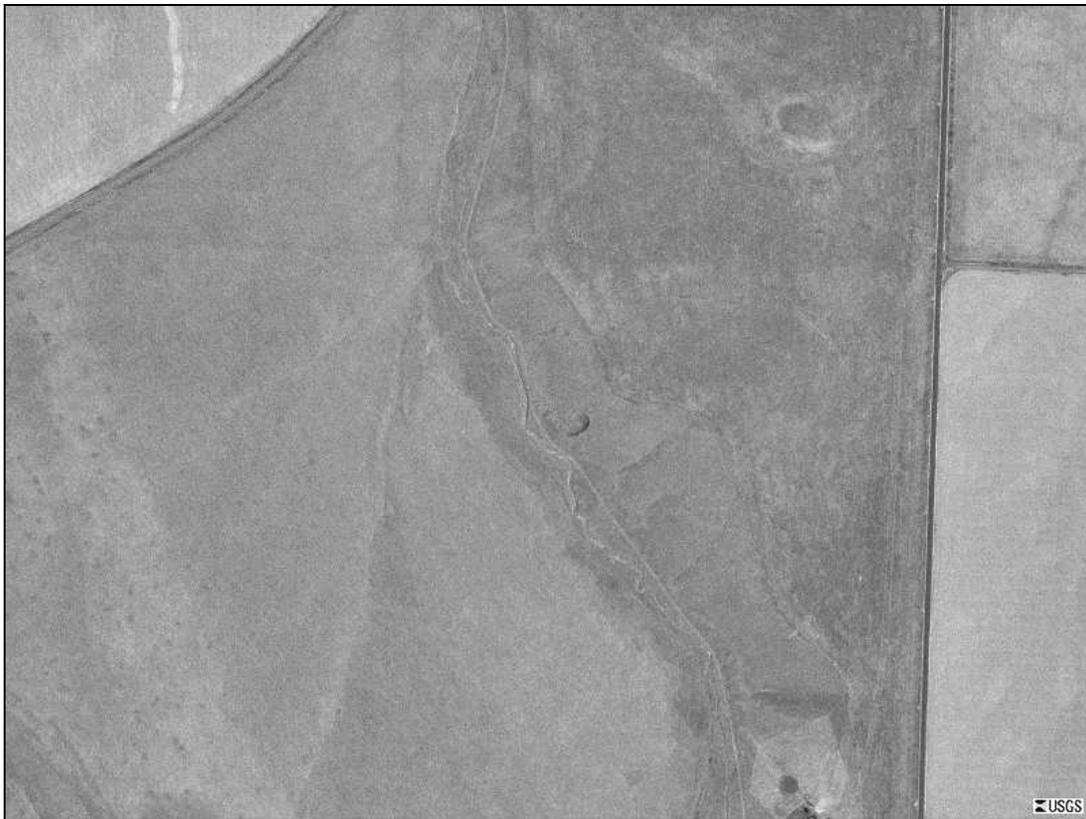
Aerial view of the quarry site located east of Highway 207.

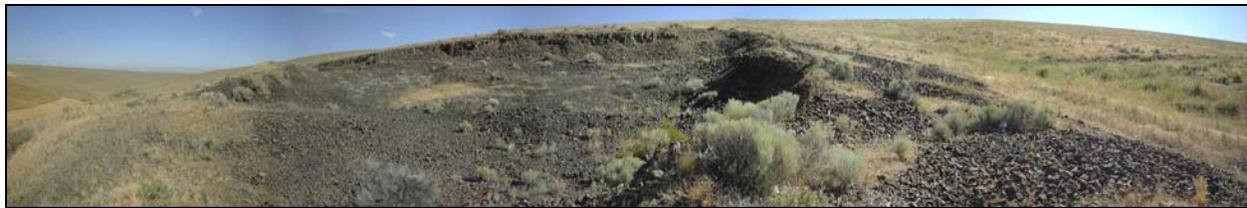
County	Site Name				Dist	Hwy	Mile Pt	TWP	RGE	Sect
Morrow					12	0321	7	04S	25.0E	27
File ID		Source #	Date Visited	Map #		Type of Site				
11151		25-022-5	07/27/2000	1R-2-1410		Quarry				
Latitude	Longitude	Elev. (m)	Acreage	Pit Size	DOGAMI Permit #					
45 11'17.68504"	119 41'47.53334"	1018.523	6	<1						
Comments										
GPS acquired at access gate.										
Rock Type	Unit	Color		Weathering			Jointing			
Basalt	Tcg	Medium Dark Grey (N4)		Fresh			Highly Fractured			
Quality			Hardness	lbs./cu ft.	Reserve (cy)	Reserve (Tons)				
Good			R3+	169	100,000	228,150				
Potentially Significant Site	Why			Open/Closed	Direction					
No	NA			Closed	NA					
Adjacent Land Use										
Open space/Farming										
Remarks										
This site is adjacent to and east of Highway 207. The rock is a fine-grain highly fractured basalt. The site has very limited room to work and no screening. You can rip the material into cobble size pieces. The terrain slopes up from the road about 10 degrees.

View of the quarry site.

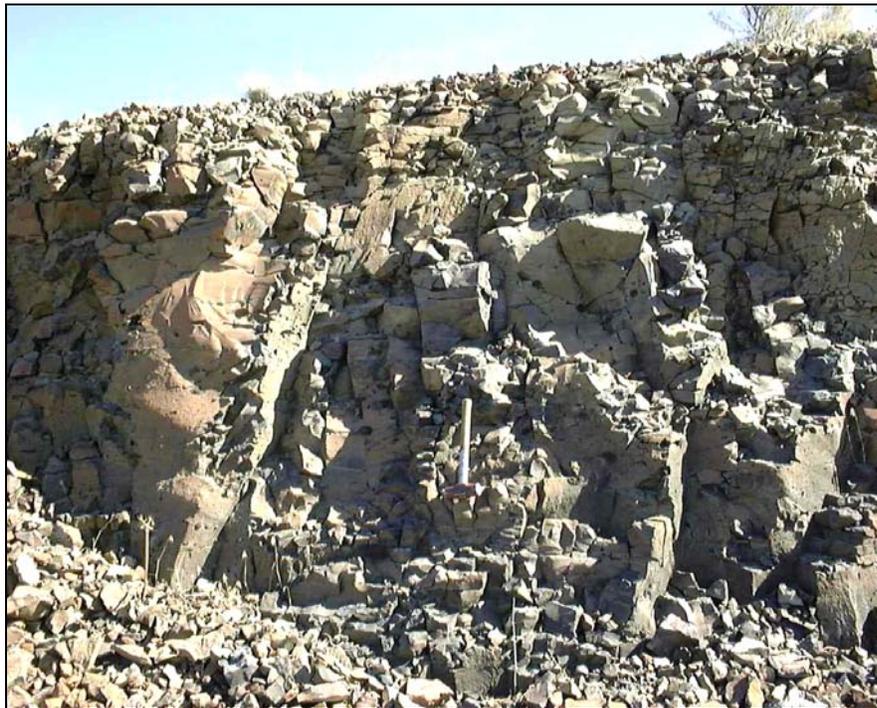
Close-up view of the highly fractured pit face at the quarry site.

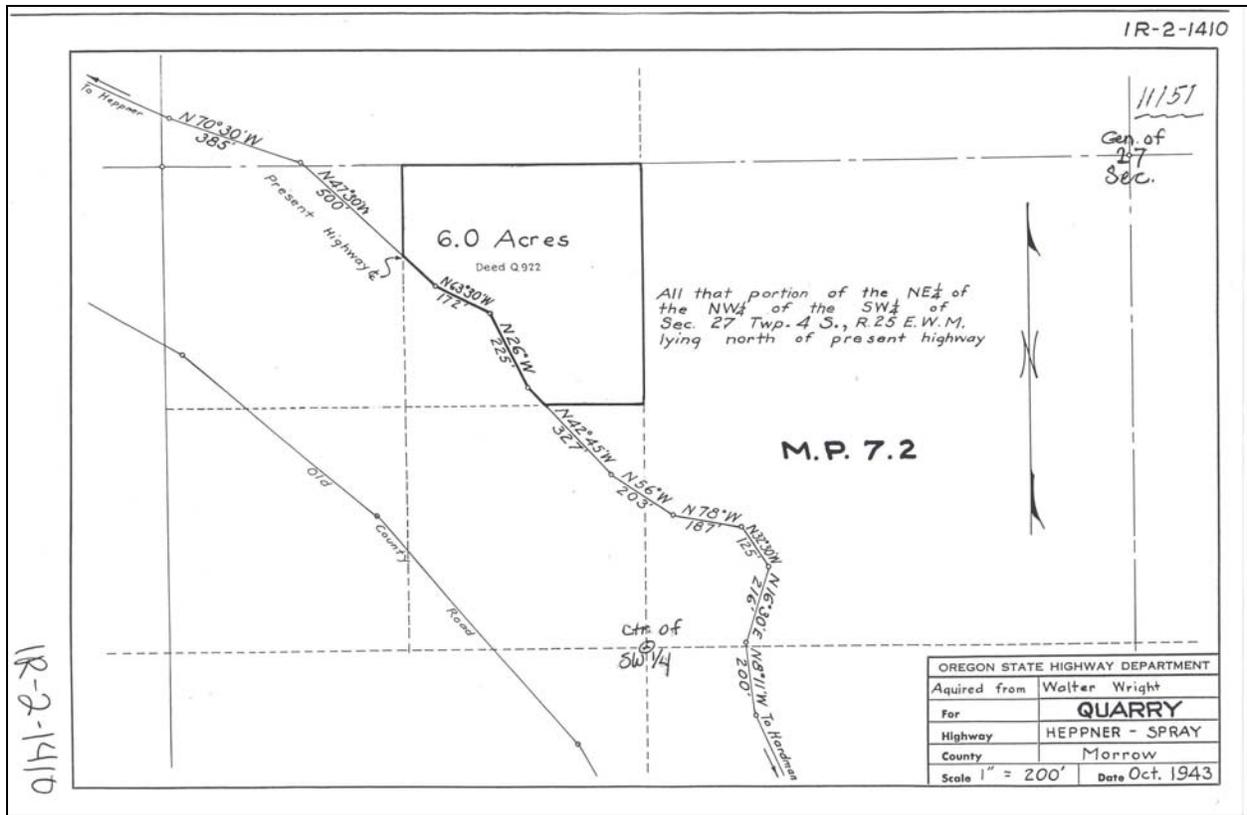
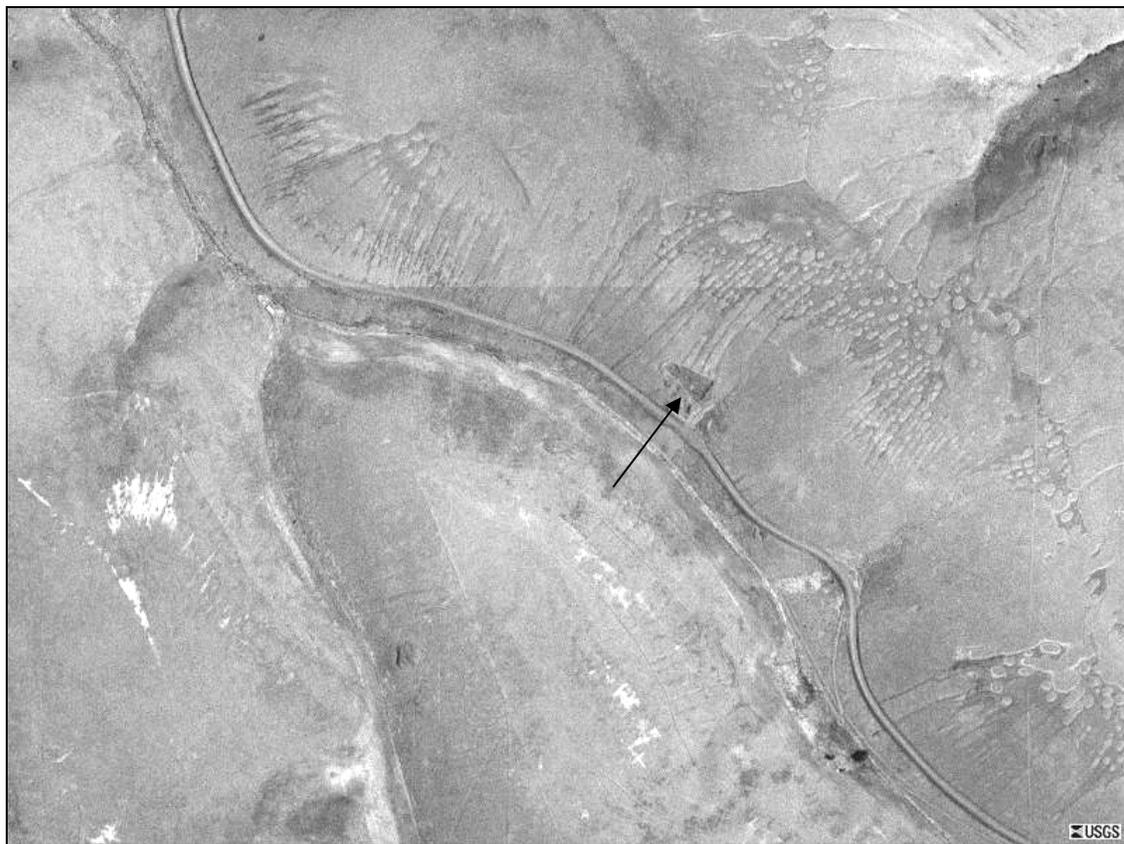
Aerial view of the quarry site located north of Highway 207.

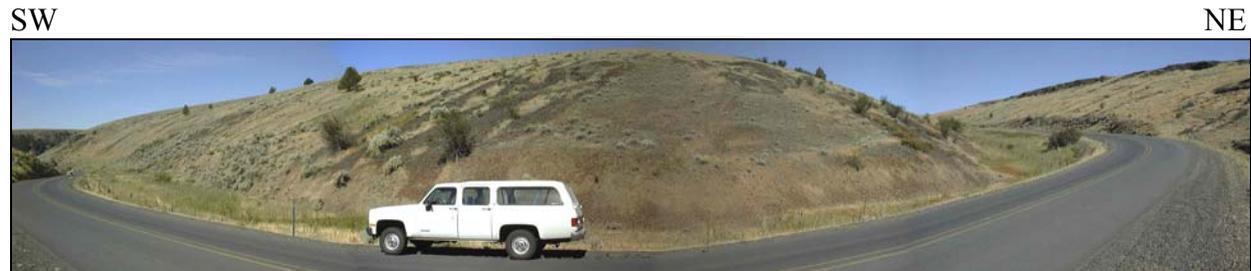
County	Site Name				Dist	Hwy	Mile Pt	TWP	RGE	Sect
Morrow	Cecil Quarry				12	0321	10.2	05S	25.0E	11
File ID		Source #	Date Visited	Map #			Type of Site			
15877		25-023-5	07/27/2000	1R-2-1978			Raw Land			
Latitude	Longitude	Elev. (m)	Acreage	Pit Size	DOGAMI Permit #					
45 09'10.47000"	119 40'23.13000"	1039	4.19	NA						
Comments										
Lat. and Long. acquired using Terrain Navigator Software										
Rock Type	Unit	Color		Weathering			Jointing			
Basalt	Tcg	NA		NA			NA			
Quality			Hardness	lbs./cu ft.	Reserve (cy)	Reserve (Tons)				
Good			NA	120						
Potentially Significant Site	Why			Open/Closed	Direction					
No	NA			Closed	NA					
Adjacent Land Use										
Open space										
Remarks										
This a long narrow site west of Highway 207. Right of Way has removed most of the ground and there is no access to this site from the highway. The terrain slopes up from the highway about 20 degrees. There would be no room to work and no screening from the highway. The highway is situated above the site.

View of the raw land site looking west across Highway 207.

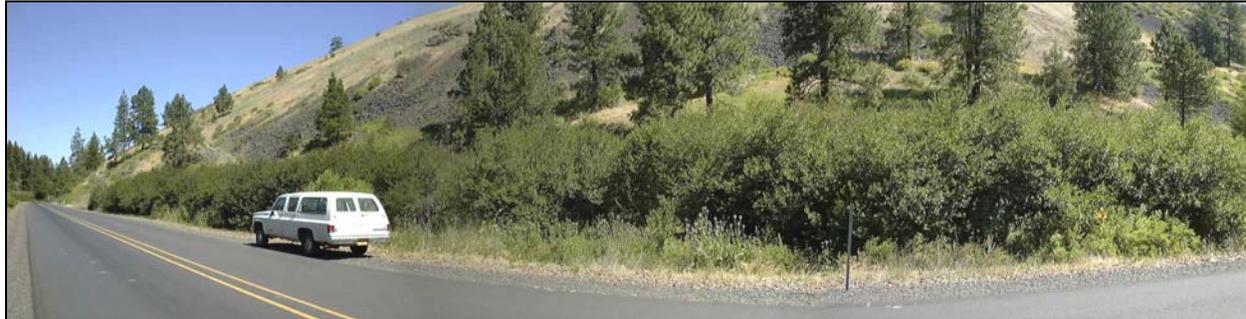
County	Site Name			Dist	Hwy	Mile Pt	TWP	RGE	Sect
Morrow				12	0321	13.98	05S	26.0E	19
File ID		Source #	Date Visited	Map #			Type of Site		
15878		25-025-5	07/27/2000	1R-2-1980			Raw Land		
Latitude	Longitude	Elev. (m)	Acreage	Pit Size		DOGAMI Permit #			
45 07'00.30000"	119 37'53.82000"	1035	2.29	NA					
Comments									
Lat. and Long. acquired using Terrain Navigator Software									
Rock Type	Unit	Color		Weathering			Jointing		
Basalt	Tcg	NA		NA			NA		
Quality			Hardness	lbs./cu ft.	Reserve (cy)	Reserve (Tons)			
NA			NA	120					
Potentially Significant Site	Why			Open/Closed	Direction				
No	NA			Closed	Adjacent to Rock Creek				
Adjacent Land Use									
Open Space/Ranch across the highway to the southwest about 400 meters									
Remarks									
This is a narrow and small site adjacent to the north of Highway 207. The material was removed from the talus slope in the past. This site is all over grown with vegetation and has a wetland environment at the base of the slope, next to the creek. This site has mitigation potential. There is no screening from the highway and no room to work.

View of the raw land site with a small disturbance that is adjacent to Highway 207.

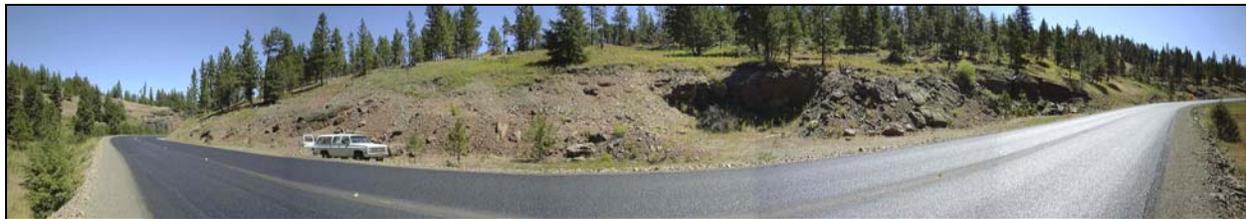
View looking east across Highway 207 at the quarry site.

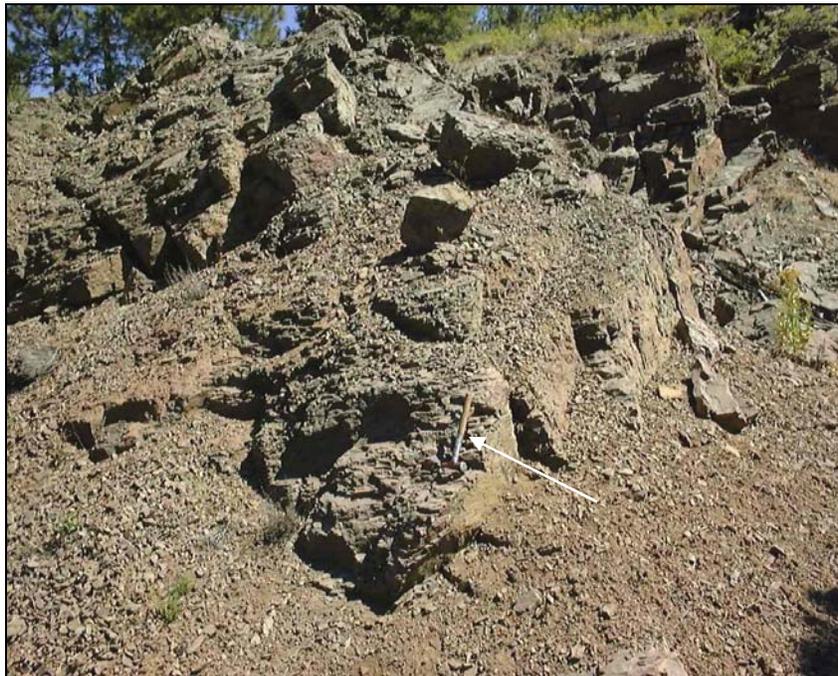
County	Site Name				Dist	Hwy	Mile Pt	TWP	RGE	Sect
Morrow					12	0321	17.5	06S	26.0E	06
File ID		Source #	Date Visited	Map #		Type of Site				
24724		25-026-5	07/27/2000	1R-5-871		Quarry				
Latitude	Longitude	Elev. (m)	Acreage	Pit Size	DOGAMI Permit #					
45 04'30.46406"	119 39'15.78160"	1120.114	5.63	<1						
Comments										
GPS acquired in the pit.										
Rock Type	Unit	Color		Weathering		Jointing				
Pyroclastics	Tsfj	Light Olive Grey (5Y 5/2)		Decomposing		Highly Fractured				
Quality			Hardness	lbs./cu ft.	Reserve (cy)	Reserve (Tons)				
Poor			R2-	151						
Potentially Significant Site	Why			Open/Closed	Direction					
No	NA			Closed	NA					
Adjacent Land Use										
Open space										
Remarks										
This site is adjacent to and east of Highway 207. The material is a fine-grained decomposing pyroclastic rock. The rock breaks into very small pieces. There would be a lot of fines from this rock and I would not recommend its use for anything. County records only show us as the owners for the Right of Way along this stretch of road.

Close-up view of the pyroclastic rock found at this site.

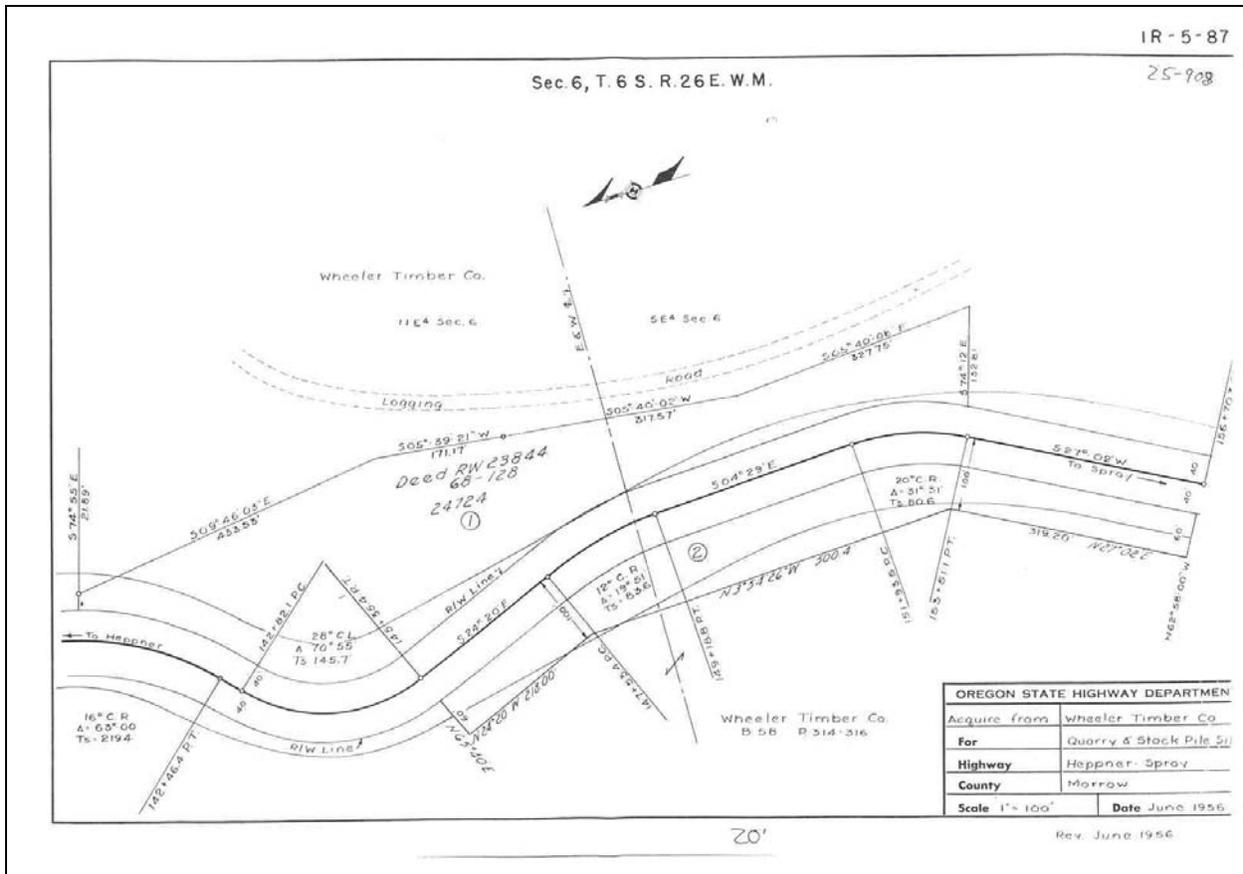
Aerial view of the quarry site located adjacent to and east of Highway 207.
