OREGON DEPARTMENT OF TRANSPORTATION

AGGREGATE SITES

DISTRICT 12

JUNE 2002

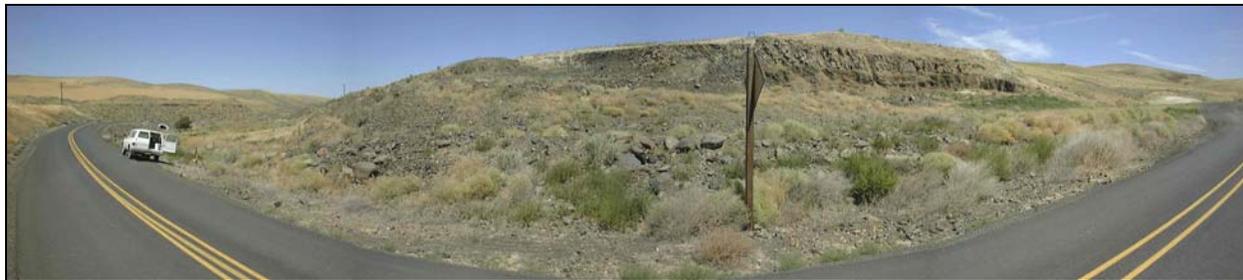
View of the quarry site along Morgan East Road.

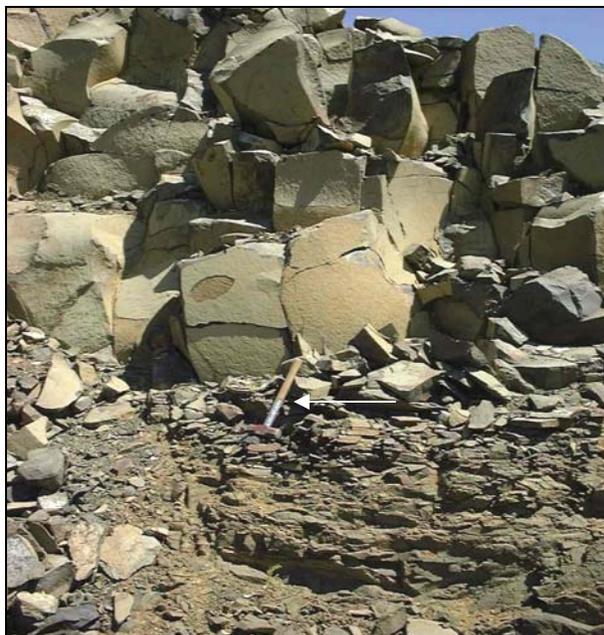
County	Site Name				Dist	Hwy	Mile Pt	TWP	RGE	Sect
Morrow					12	0052	19.3	01N	23.0E	22
File ID		Source #	Date Visited		Map #			Type of Site		
Q0144		25-031-5	07/25/2000		1R-1-567			Quarry		
Latitude		Longitude	Elev. (m)	Acreage	Pit Size		DOGAMI Permit #			
45 33'13.01616"		119 55'05.55596"	247.143	7.89	<5		25-0047			
Comments										
GPS acquired along the County Road and the pit.										
Rock Type		Unit	Color		Weathering			Jointing		
Basalt		Tcw	Medium Dark Grey (N4)		Fresh to Decomposing			Massive to Highly Fractured		
Quality				Hardness	lbs./cu ft.	Reserve (cy)		Reserve (Tons)		
Good to Fair				R3+	162	100,000		218,700		
Potentially Significant Site		Why			Open/Closed		Direction			
No		NA			Closed		West about 400 meters is Willow Creek			
Adjacent Land Use										
Open space/Farming										
Remarks										
This site is adjacent to the east along Highway 74 and Morgan East Road. There is no access to the quarry by vehicle anymore. The basalt here is composed of variable flows, with some being fine-grain excellent rock, and others that are a decomposing vesicular. You can rip the material. There is some room to work, but limited screening. The terrain is gradual. Most of the rock is good quality material.

Close-up view of the massive to highly fractured basalt found at this site.

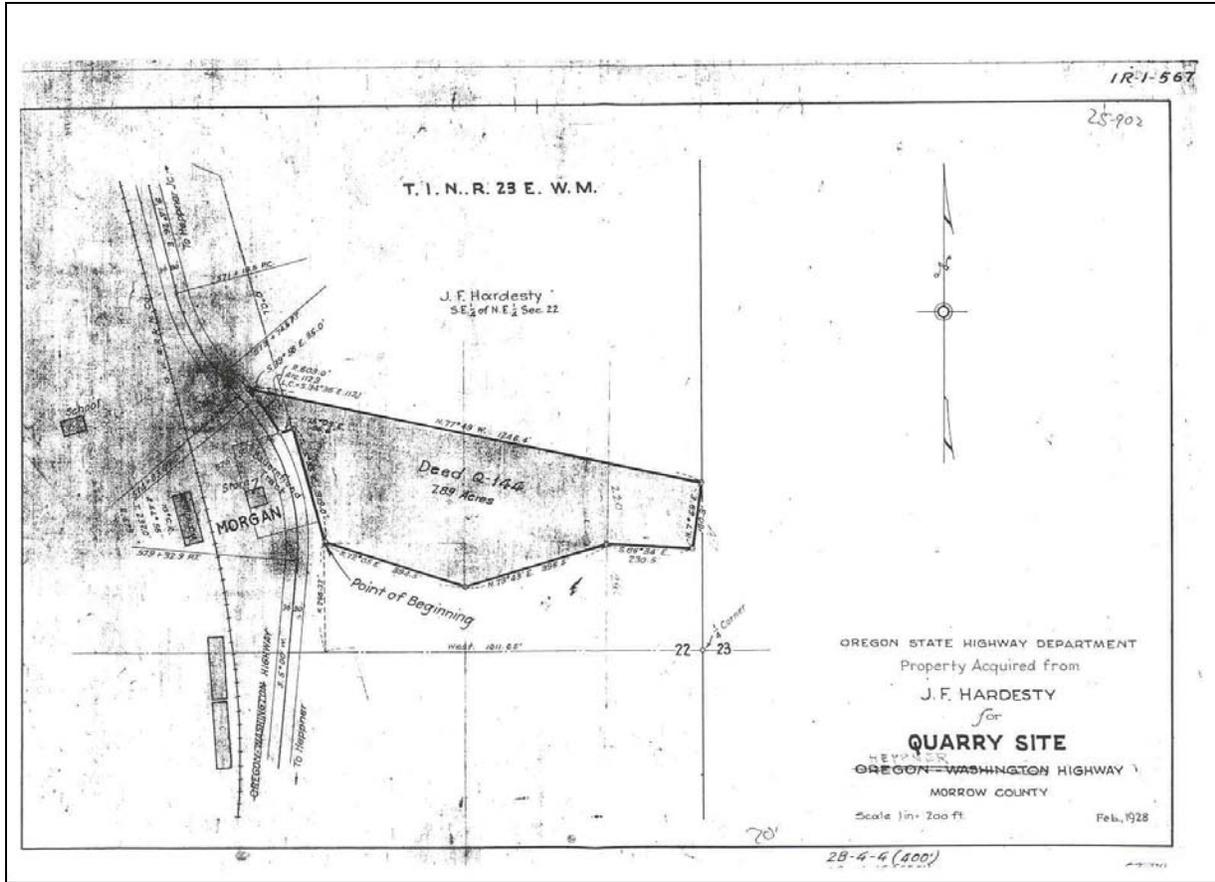
Aerial view of the quarry site located off of Morgan East Road.

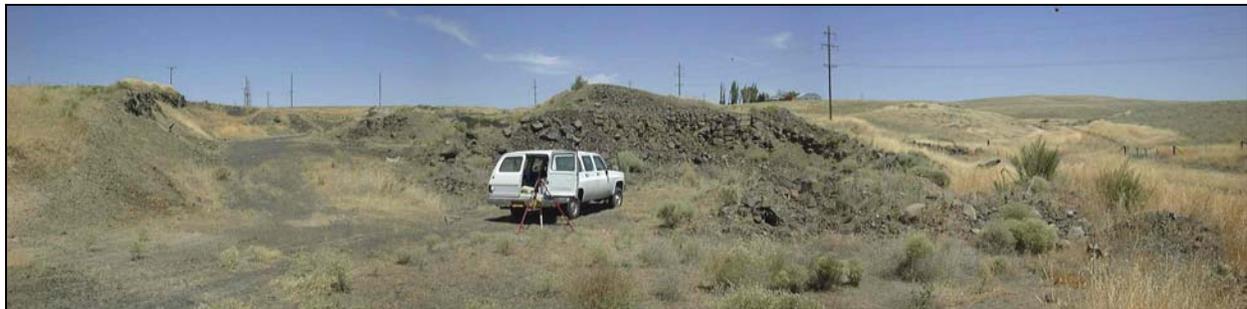
View of the quarry site located just north of Lexington, OR and adjacent to and east of Highway 207.

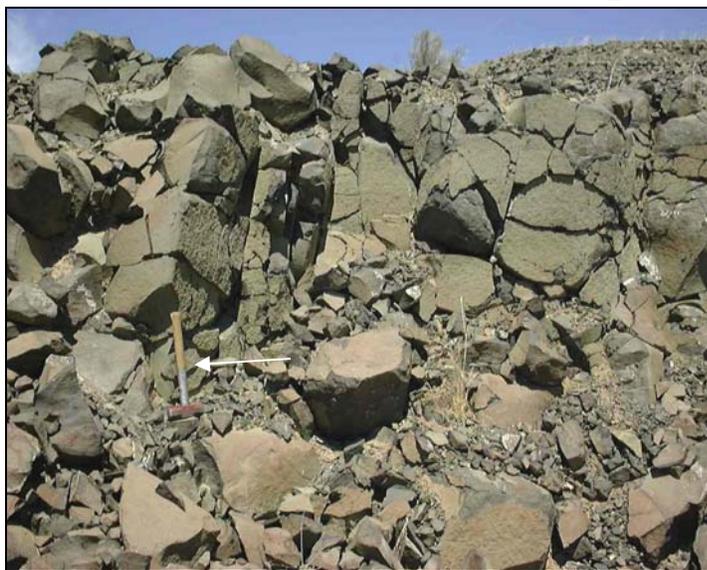
County	Site Name		Dist	Hwy	Mile Pt	TWP	RGE	Sect
Morrow			12	0320	0.5	01S	25.0E	27, 26
File ID	Source #	Date Visited	Map #			Type of Site		
11154A, 11154, 18716	25-035-5	07/25/2000	1R-2-1522, 1R-5-212, 1R-2-1408, 1R-5-212			Quarry		
Latitude	Longitude	Elev. (m)	Acreage	Pit Size	DOGAMI Permit #			
45 27'15.47706"	119 40'40.20044"	481.83	11.6	<2				
Comments								
GPS acquired in the first pit.								
Rock Type	Unit	Color		Weathering		Jointing		
Basalt	Tcg	Medium Dark Grey (N4)		Slight		Massive to Highly Fractured		
Quality			Hardness	lbs./cu ft.	Reserve (cy)	Reserve (Tons)		
Good			R3	175	100,000	150,000		
Potentially Significant Site	Why			Open/Closed	Direction			
No	NA			Closed	NA			
Adjacent Land Use								
Farming/open space/one home to the northeast approximately 500 meters								
Remarks								
This site is just north of the town of Lexington and adjacent to the east of Highway 207. The rock is a fine-grain highly fractured, slightly weathered basalt. Some of the rock can be massive. The top five to six feet can have stronger weathering. The ground is used for waste rock now. Also, the site is below the highway on gradually sloping terrain. There is no screening, but room to work.

Close-up view of the massive to highly fractured basalt found at this site.

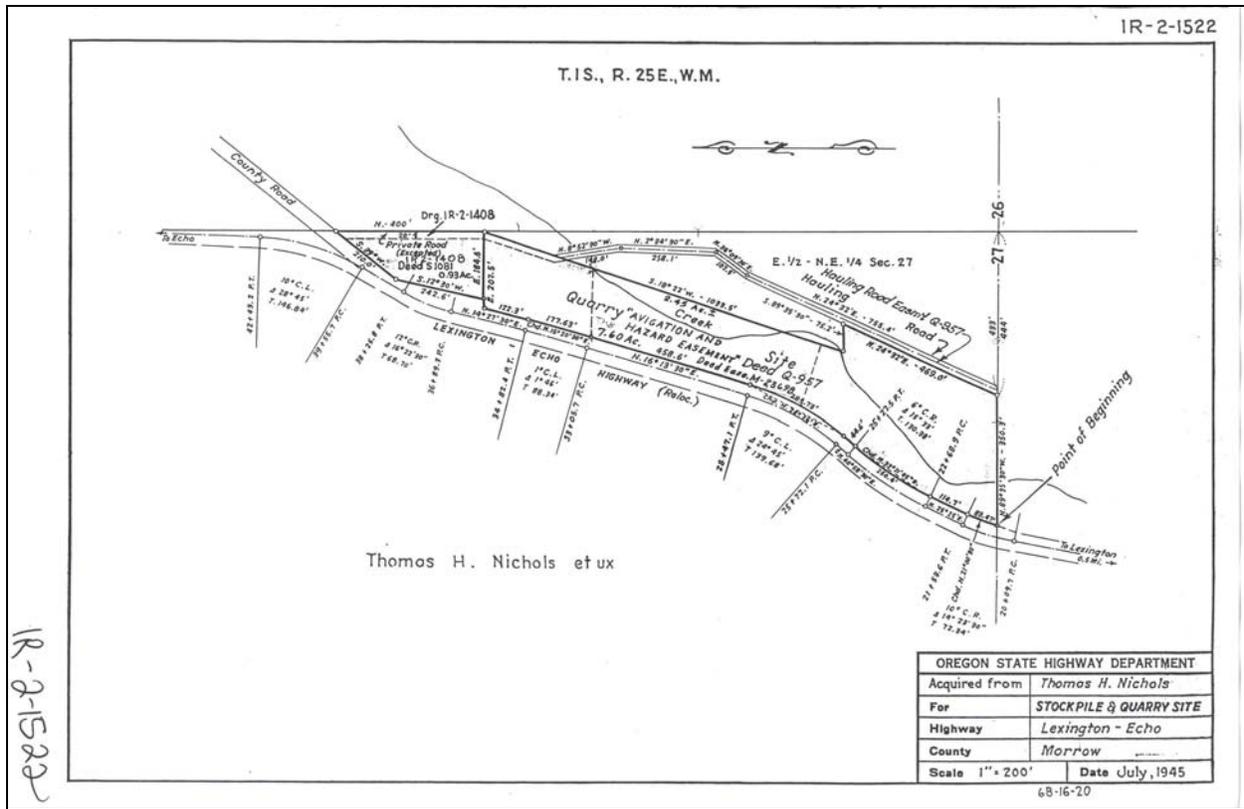
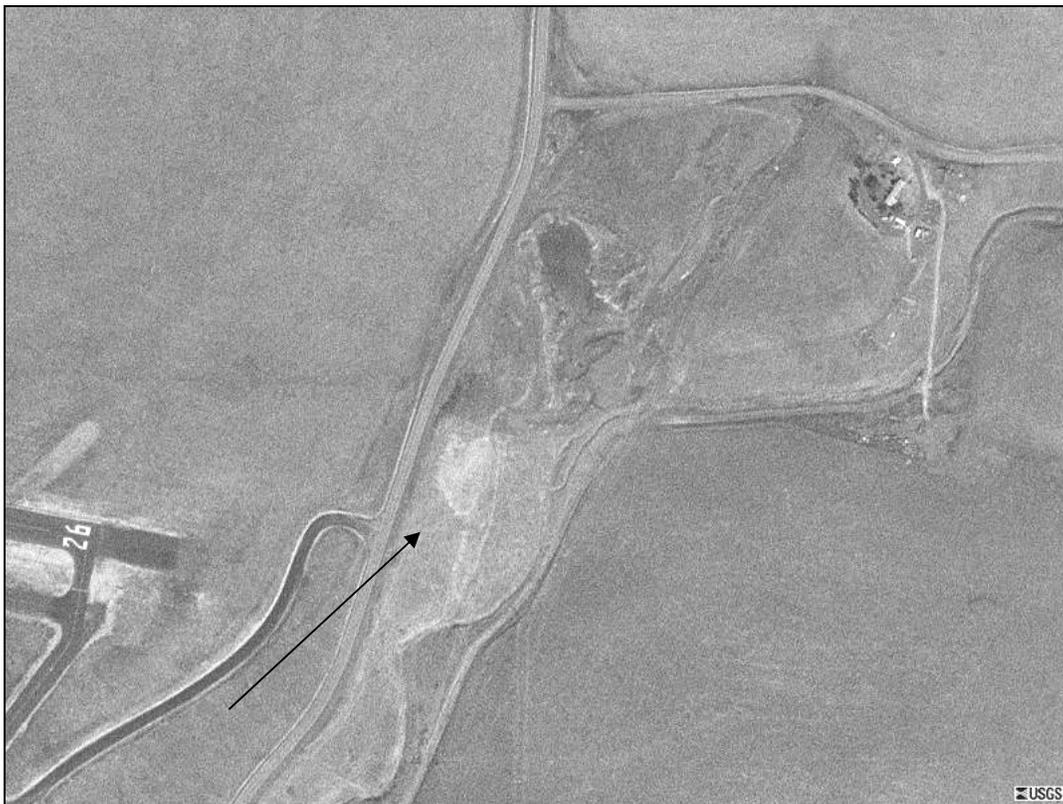
Aerial view of the quarry site located adjacent to and east of Highway 207.

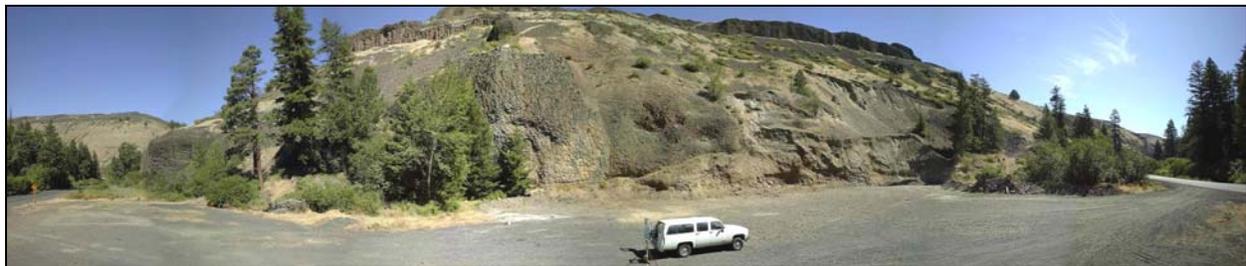
County	Site Name			Dist	Hwy	Mile Pt	TWP	RGE	Sect
Morrow				12	0321	11.61	05S	25.0E	14
File ID		Source #	Date Visited	Map #			Type of Site		
15875		25-042-5	07/27/2000	1R-2-1979			Quarry		
Latitude	Longitude	Elev. (m)	Acreage	Pit Size		DOGAMI Permit #			
45 08'06.98989"	119 39'59.28198"	973.164	5.6	<1		25-0064			
Comments									
GPS acquired in the pit.									
Rock Type	Unit	Color		Weathering			Jointing		
Basalt	Tcg	NA		NA			NA		
Quality			Hardness	lbs./cu ft.	Reserve (cy)	Reserve (Tons)			
NA			NA	155					
Potentially Significant Site	Why			Open/Closed	Direction				
No	NA			Closed	South about 100 meters is Rock Creek				
Adjacent Land Use									
Open space									
Remarks									
This site is adjacent to and north of Highway 207. The basalt is being removed from a talus slope at the base of a 300 plus foot slope/cliff. I strongly recommend that we stop removing material from this site. Every time we remove material from the toe of the slope we jeopardize the next persons safety. A second bench has been constructed above the base of the site. This is very dangerous and should stop immediately. We can use the ground for a waste/stock pile/stage area.

View of the quarry site that is located adjacent to and north of Highway 207.

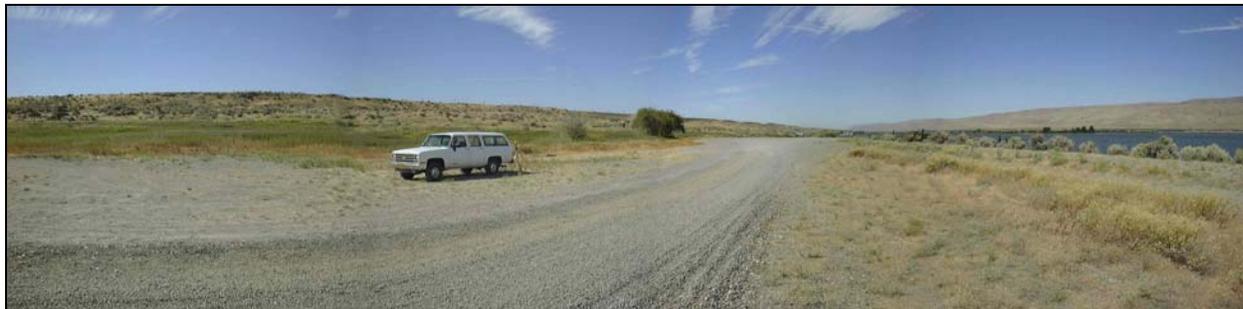
County	Site Name				Dist	Hwy	Mile Pt	TWP	RGE	Sect
Morrow					12	0002	0	04N	23.0E	20
File ID		Source #	Date Visited	Map #		Type of Site				
17481		25-901-5	07/25/2000	1R-5-127		Raw Land				
Latitude	Longitude	Elev. (m)	Acreage	Pit Size	DOGAMI Permit #					
45 48'41.98090"	119 58'07.49457"	84.647	84.4	NA						
Comments										
GPS acquired at the boat ramp.										
Rock Type	Unit	Color	Weathering		Jointing					
Basalt	Ts	NA	NA		NA					
Quality			Hardness	lbs./cu ft.	Reserve (cy)	Reserve (Tons)				
Good			NA	120	160,000	259,200				
Potentially Significant Site	Why			Open/Closed	Direction					
No	USA Ground			Closed	Adjacent to the Columbia River					
Adjacent Land Use										
Park/Boat ramp										
Remarks										
This site is north of I-84 and south of the Columbia River. There is a boat ramp and primitive camp ground on the site now. The rock is a heterogeneous mix of size and lithology. There are minor amounts of gravel with Columbia River Basalts below to depth. You would have a choice to remove gravel or basalt. The Rail line bisects the ground also. USA property

View of the raw land site north of I-84 and south of the Columbia River.

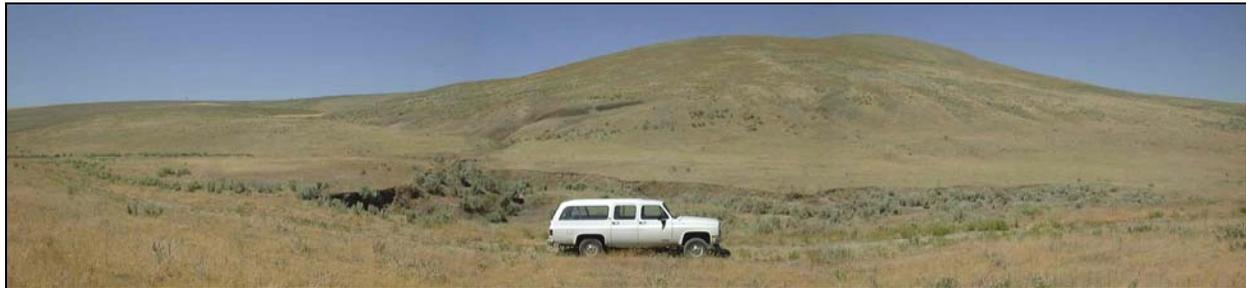
County	Site Name			Dist	Hwy	Mile Pt	TWP	RGE	Sect
Morrow				12	0300	59.60	03S	23.0E	27
File ID		Source #	Date Visited	Map #			Type of Site		
08932		25-905-5	07/02/2000	1R-2-1130			Raw Land		
Latitude	Longitude	Elev. (m)	Acreage	Pit Size		DOGAMI Permit #			
45 16'22.31000"	119 55'59.20000"	729	3.81	NA					
Comments									
Lat. and Long. acquired using Terrain Navigator Software									
Rock Type	Unit	Color		Weathering			Jointing		
Basalt	Tcg	NA		NA			NA		
Quality			Hardness	lbs./cu ft.	Reserve (cy)	Reserve (Tons)			
Poor			NA	120					
Potentially Significant Site	Why			Open/Closed	Direction				
No	NA				NA				
Adjacent Land Use									
Remarks									
This is raw land south of Highway 206 about .75 miles. This would be a borrow site of no importance. There are small exposes of basalt to the west, but I am not sure if it is on our ground. The material in the draw is composed of silt and sand. The terrain is flat. Site should be surplused.

View of the raw land site approximately 0.75 miles south of Highway 206.

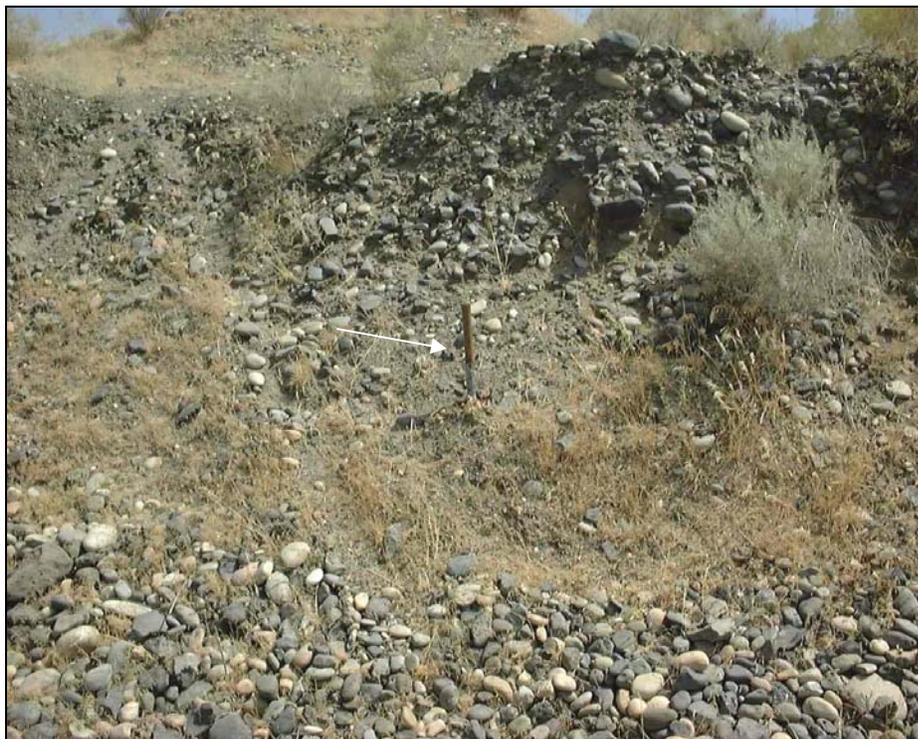
Close-up view of the gravel at this quarry site.

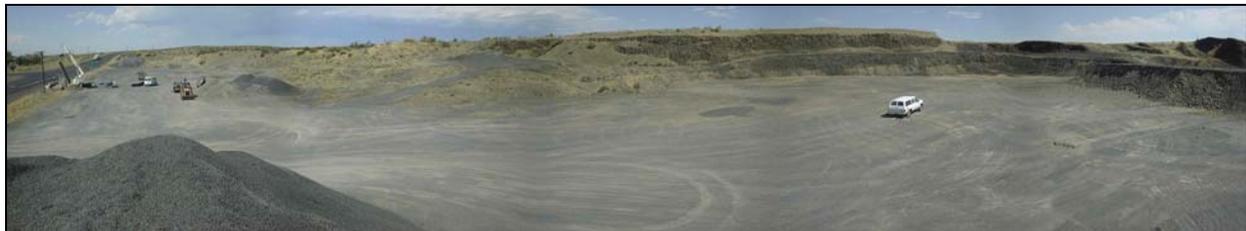
View of the large quarry site near the junction of U.S. Highway 730 and Highway 207.

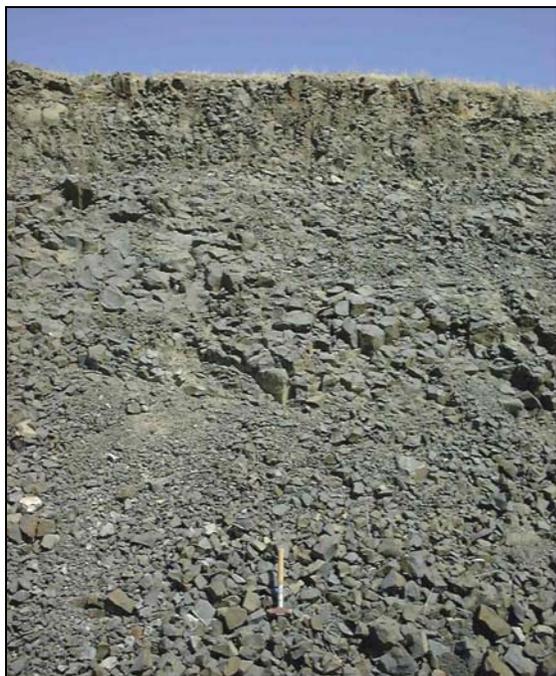
County	Site Name				Dist	Hwy	Mile Pt	TWP	RGE	Sect
Umatilla					12	0002	190	05N	29.0E	22
File ID		Source #	Date Visited	Map #		Type of Site				
Q0225, Q0268		30-003-5	08/10/2000	1R-1-675		Quarry				
Latitude	Longitude	Elev. (m)	Acreage	Pit Size	DOGAMI Permit #					
45 54'11.30330"	117 10'21.81555"	131.95	70	<4	30-0033					
Comments										
GPS acquired in the pit.										
Rock Type	Unit	Color		Weathering		Jointing				
Basalt	Tcs	Medium Dark Grey (N4)		Fresh		Highly Fractured				
Quality			Hardness	lbs./cu ft.	Reserve (cy)	Reserve (Tons)				
Good to Very Good			R3-	177	1,500,000	3,584,250				
Potentially Significant Site	Why			Open/Closed	Direction					
No	USA Ground			Closed	NA					
Adjacent Land Use										
Open space										
Remarks										
This site is adjacent to and north of U.S. Highway 730 and the junction with Highway 207. The rock is a brittle, fine-grain, highly fractured basalt. There is no screening and ample room to work. You can rip the basalt but should drill and blast. The terrain is fairly flat with no overburden. This is BLM ground.

Close-up view of the highly fractured basalt found at this site.

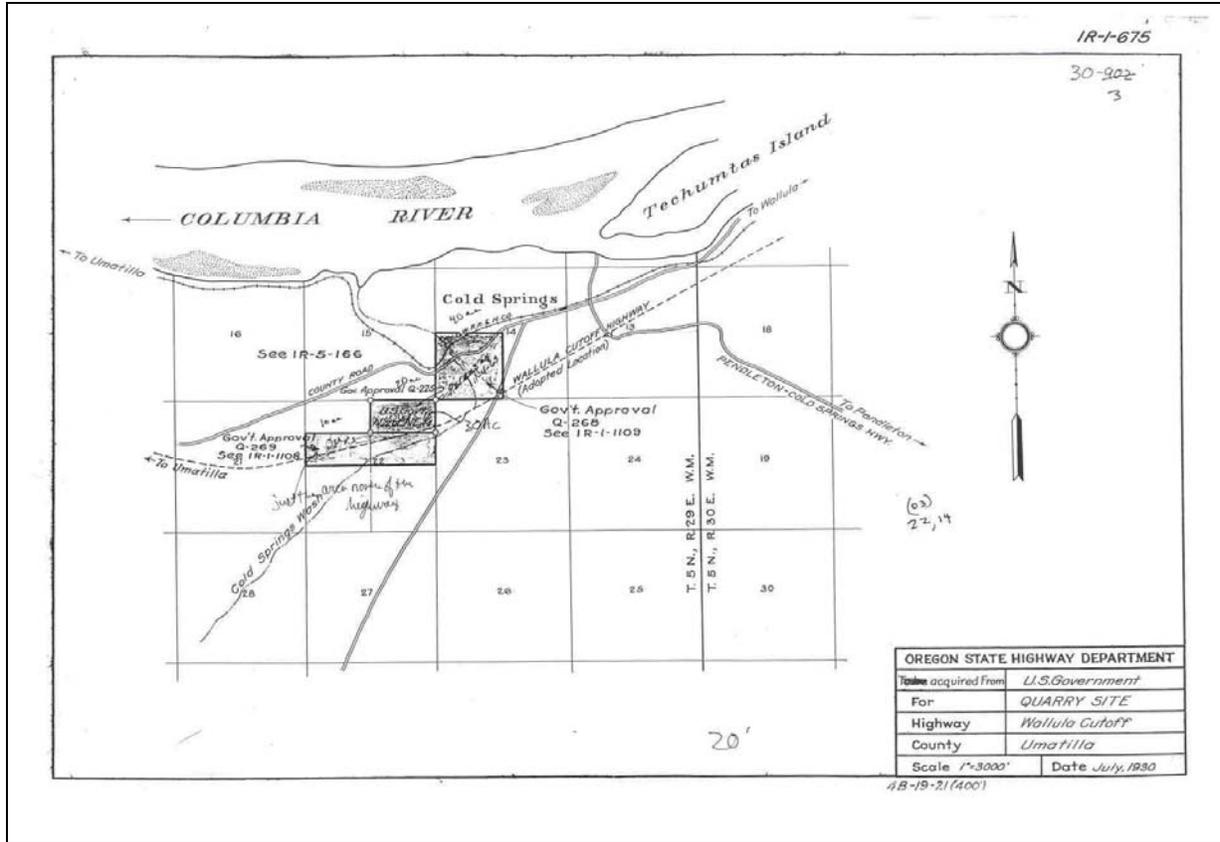
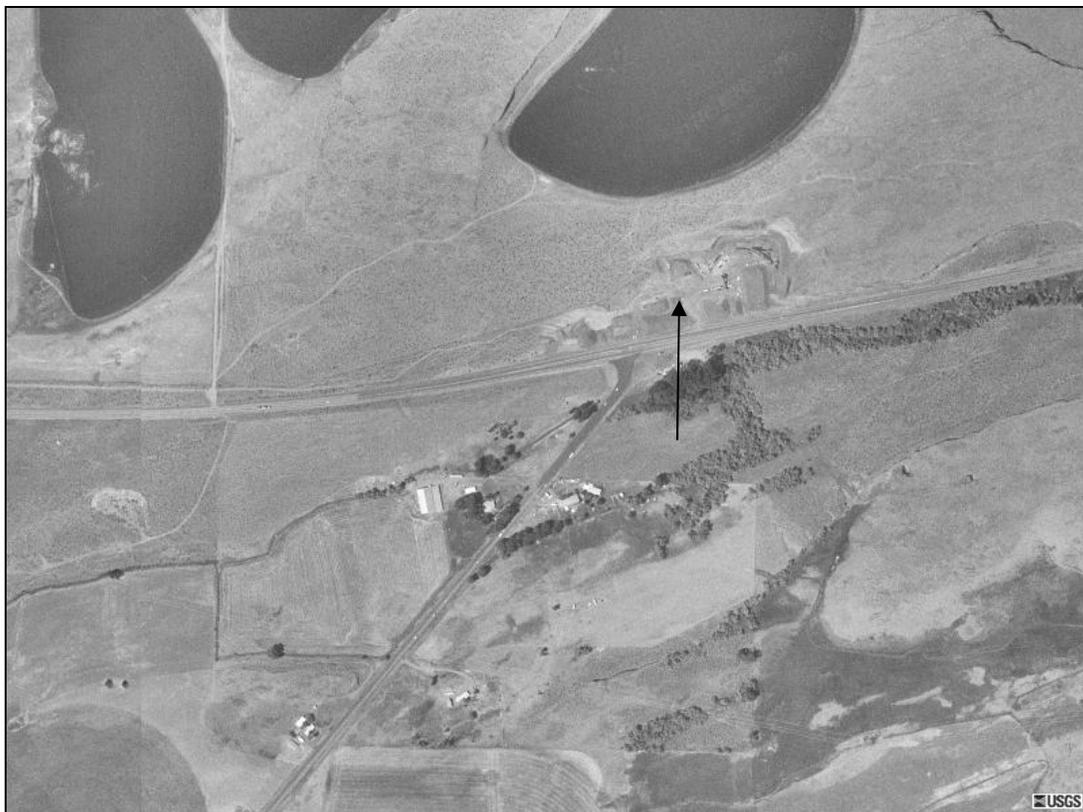
Aerial view of the large quarry site at the junction of U.S. Highway 730 and Highway 207.

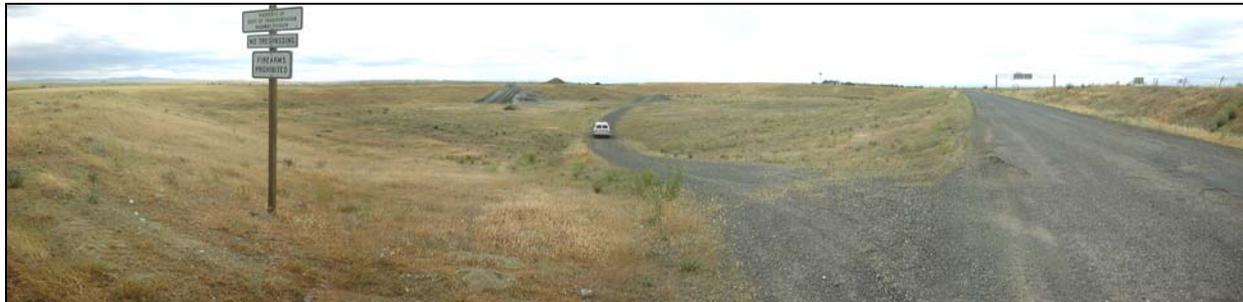
View of the borrow site located south of I-84 about 100 meters.

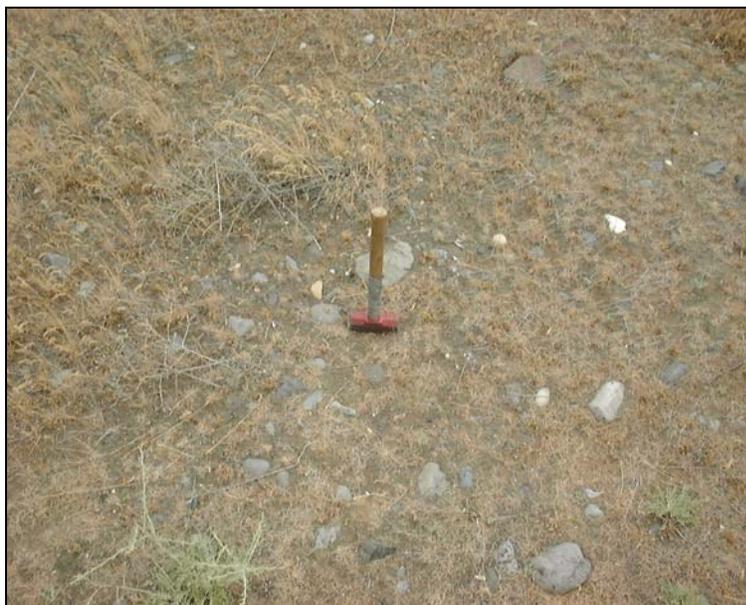
Close-up view of the material found at the borrow site located near I-84.

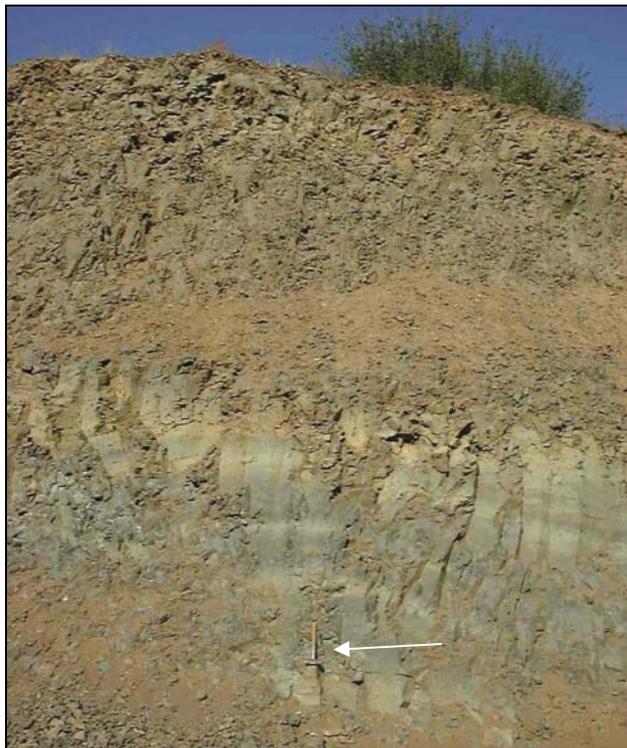
Close-up view of the pit face at this site.

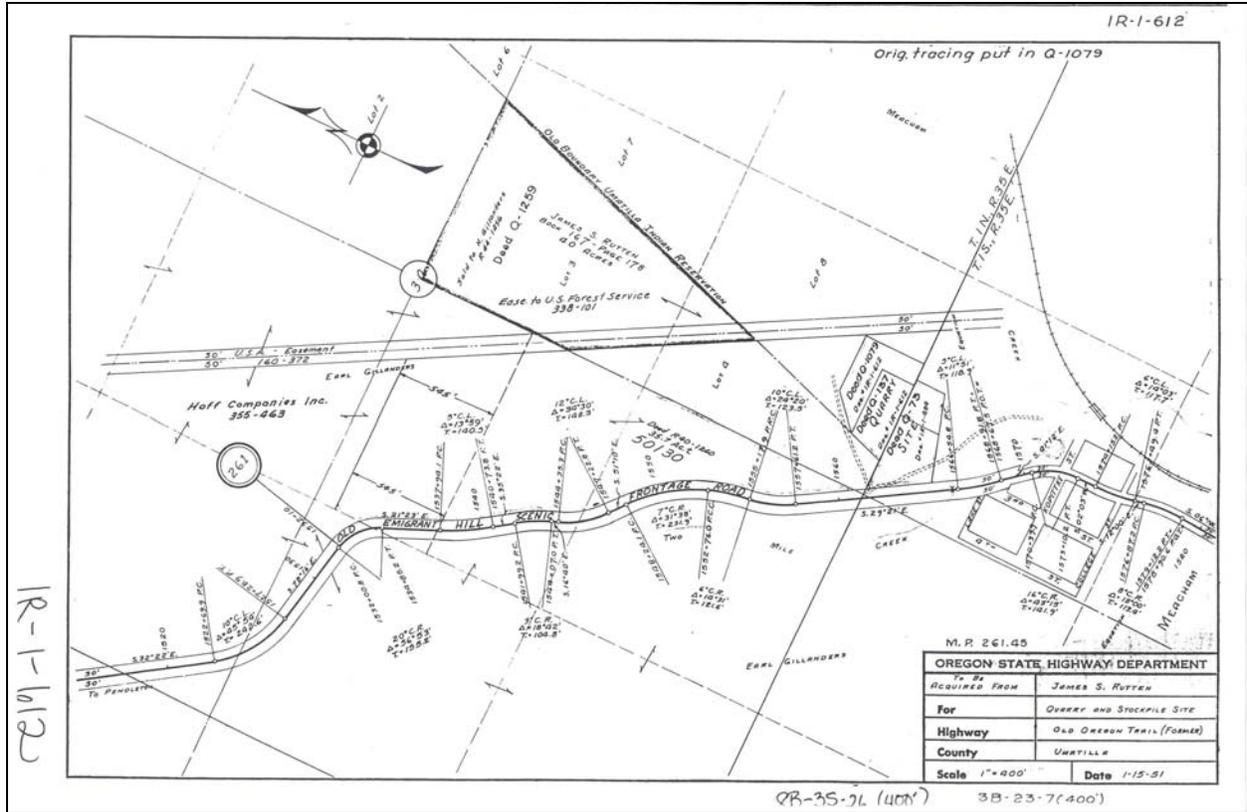
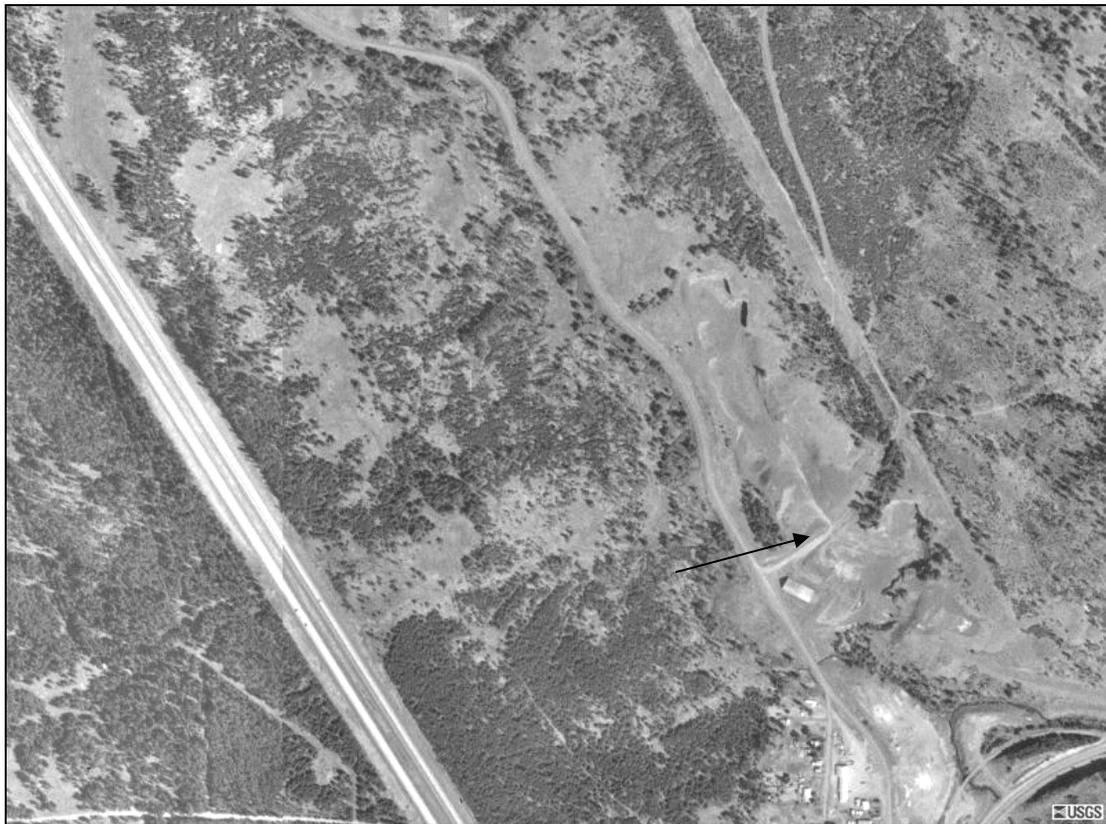
Aerial view of the quarry site located north of Meacham, OR.

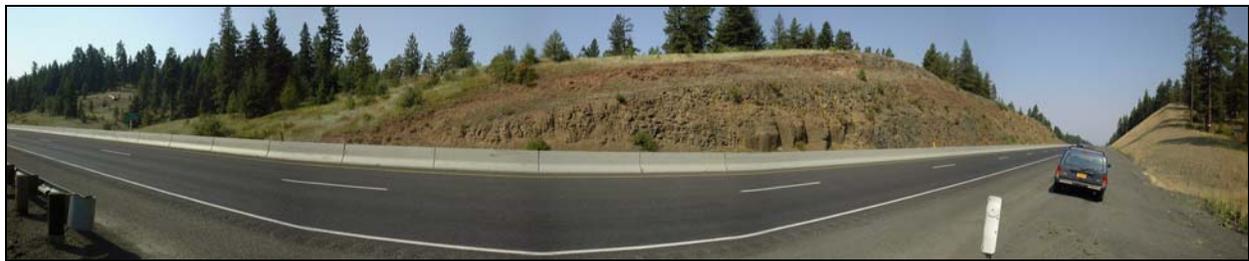
View of the raw land site looking across I-84.

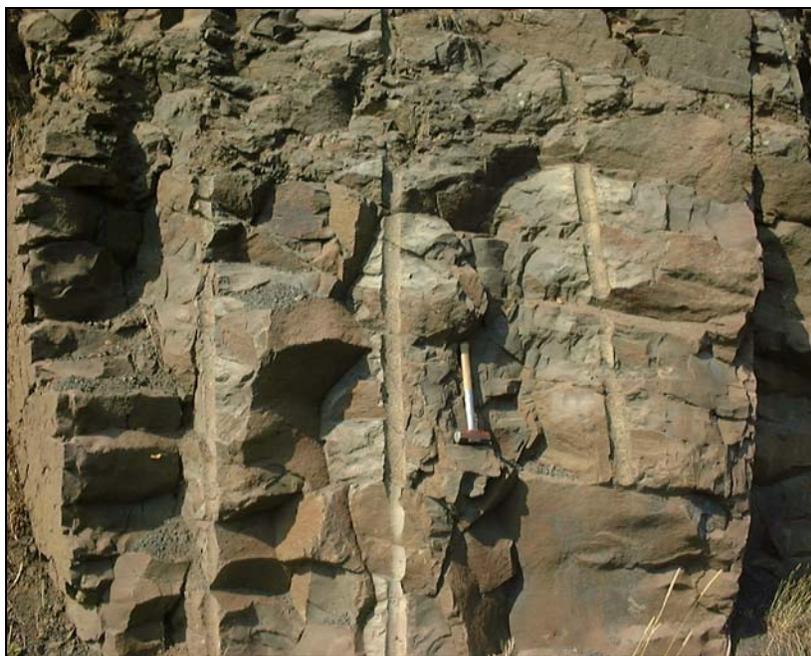
County	Site Name				Dist	Hwy	Mile Pt	TWP	RGE	Sect
Umatilla					12	0006	243.7	01S	35.0E	24, 25
File ID		Source #	Date Visited	Map #		Type of Site				
24089		30-016-5	08/17/2000	1R-5-803		Raw Land				
Latitude	Longitude	Elev. (m)	Acreage	Pit Size	DOGAMI Permit #					
45° 27' 37.43000"	118°23'07.90000"	1298	36.82	NA						
Comments										
Lat. and Long. acquired using Terrain Navigator Software										
Rock Type	Unit	Color		Weathering		Jointing				
Basalt	Tcg	Medium Grey (N5)		Slight		Highly Fractured				
Quality			Hardness	Lbs./cu ft.	Reserve (cy)	Reserve (Tons)				
Good			R3	160	1,000,000	1,500,000				
Potentially Significant Site	Why			Open/Closed	Direction					
Yes	NA			Closed	NA					
Adjacent Land Use										
Open space										
Remarks										
This site is adjacent to and west of I-84. This site has no past disturbance with no developed access. The source number could have come from the roadcut at this location. The rock is a fine-grain moderately fractured basalt. There could be room to work, with limited screening from the highway. The ground is bound by pipelines on both the east and west sides.

Close-up view of the rock wall at the site that is adjacent to I-84.

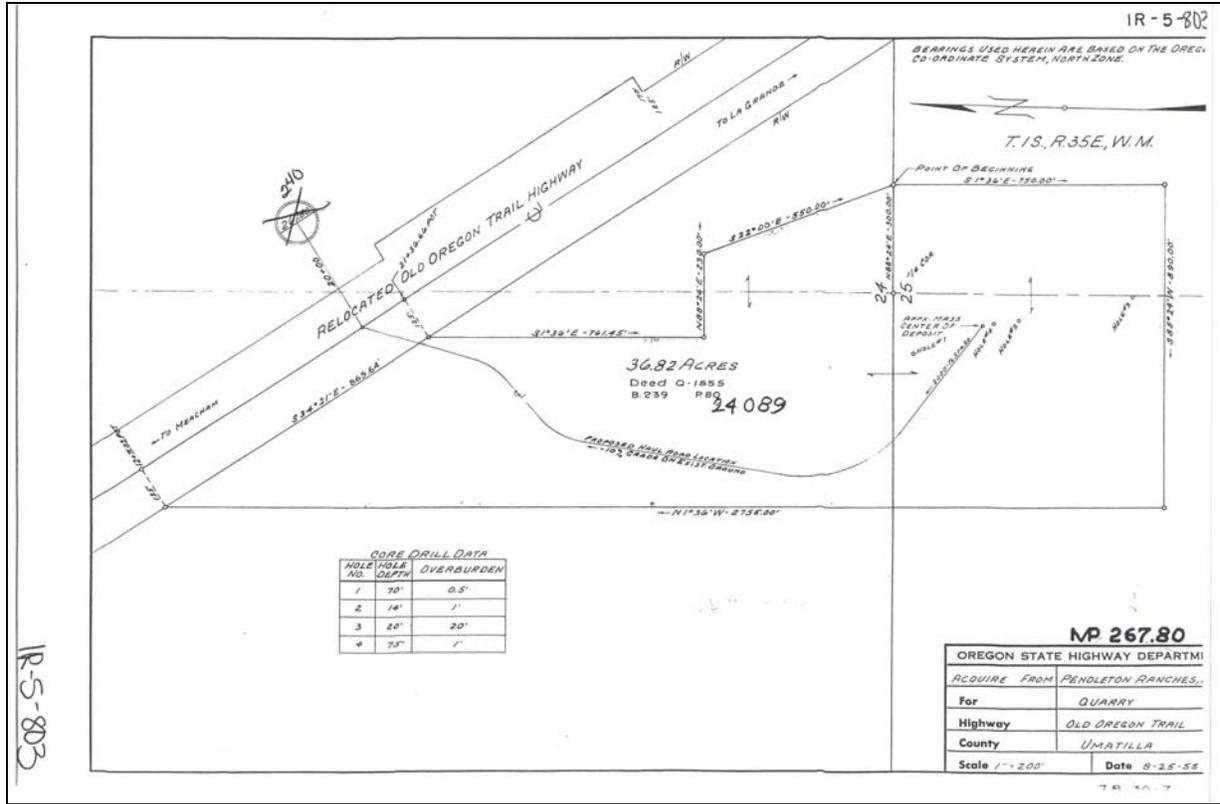
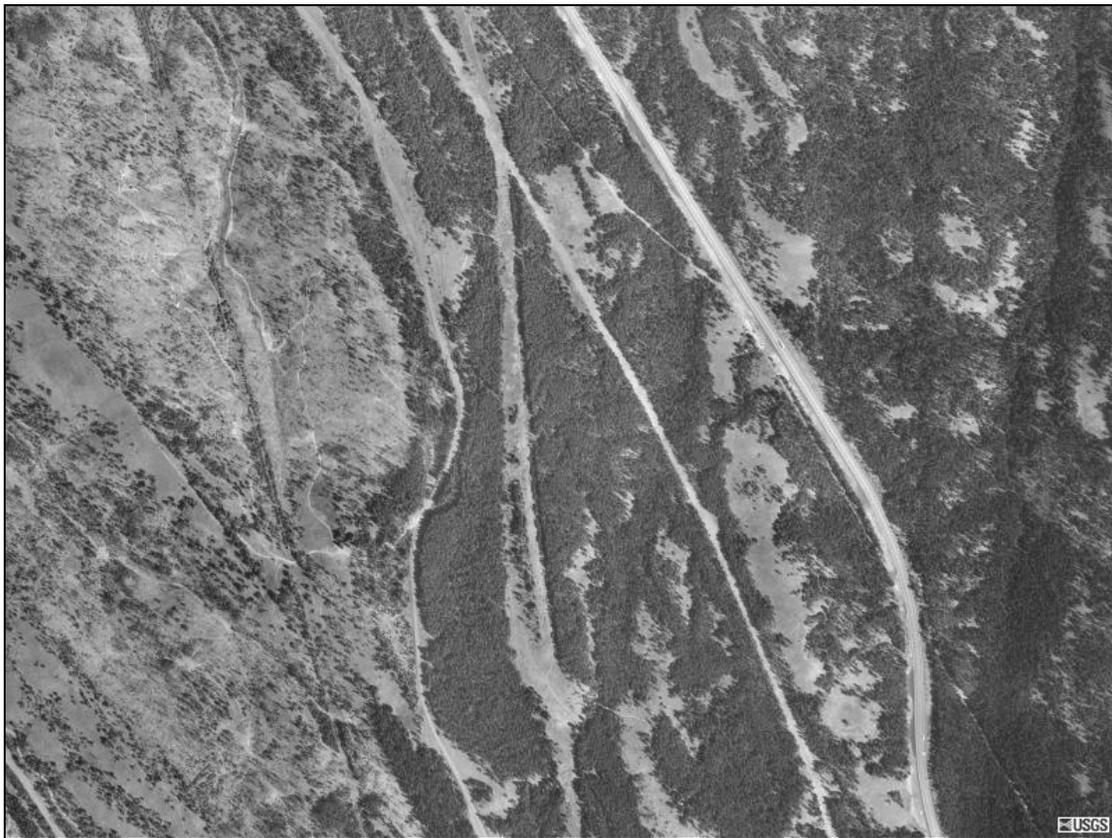
Aerial view of the raw land site located south of I-84.

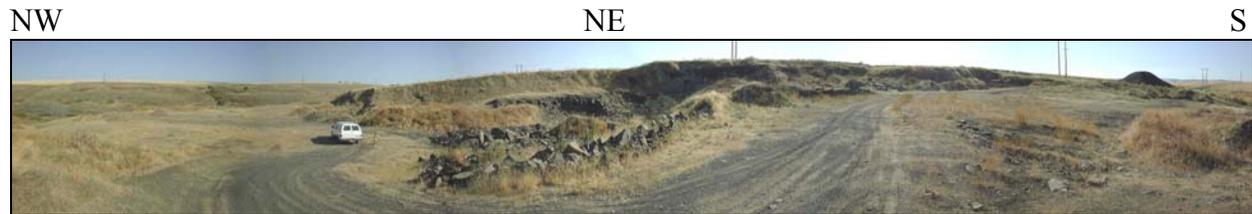
View of the quarry site located north of Highway 11 off of the Helix Highway.

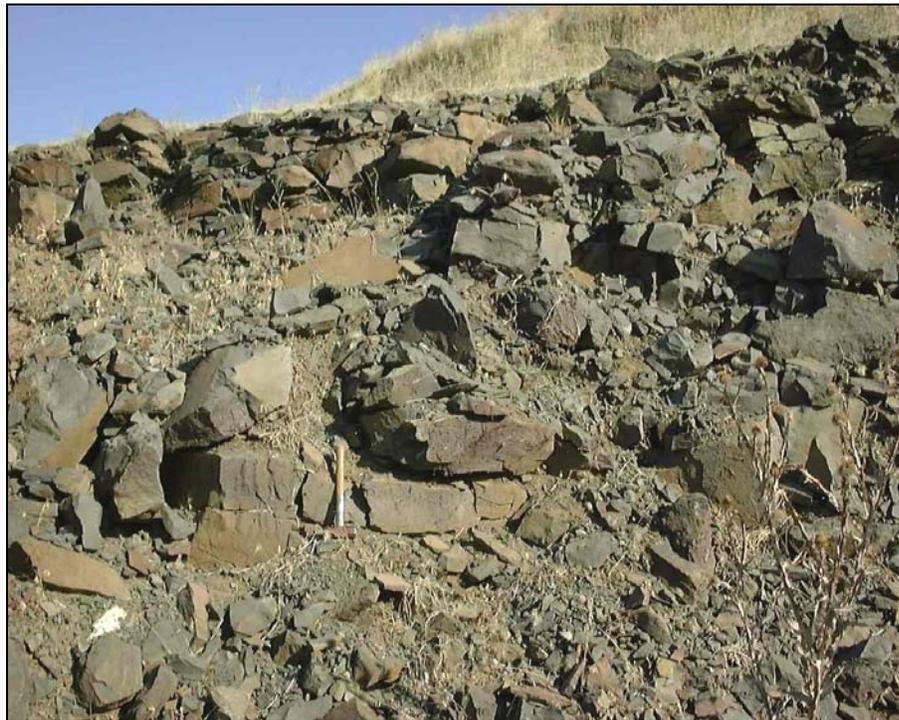
County	Site Name				Dist	Hwy	Mile Pt	TWP	RGE	Sect
Umatilla					12	0335	6.4	03N	33.0E	23
File ID		Source #	Date Visited	Map #		Type of Site				
07737, 26247, 25987		30-017-5	08/09/2000	1R-5-984, 1R-2-926		Quarry				
Latitude	Longitude	Elev. (m)	Acreage	Pit Size	DOGAMI Permit #					
45 43'29.41768"	118 39'14.08174"	424.956	8.56	<5						
Comments										
GPS acquired in the pit.										
Rock Type	Unit	Color		Weathering			Jointing			
Basalt	Tcw	Medium Grey (N5)		Slight			Highly Fractured to Massive			
Quality			Hardness	lbs./cu ft.	Reserve (cy)	Reserve (Tons)				
Fair to Good			R3-	170	160,000	367,200				
Potentially Significant Site	Why			Open/Closed	Direction					
No	NA			Closed	West about 200 meters is Wild Horse Creek					
Adjacent Land Use										
Farming										
Remarks										
This site is adjacent to and east of the Helix Highway, and north of Highway 11. The rock is a fine-grain highly fractured basalt. There is no screening with ample room to work here. The ground is used for waste material and stockpiling. The gate was open and it appears the public is dumping trash here. There are power lines adjacent to the east. The terrain is comprised of gradual rolling hills of about 3 degrees.

Close-up view of the fine-grain, highly fractured basalt found at this quarry site.

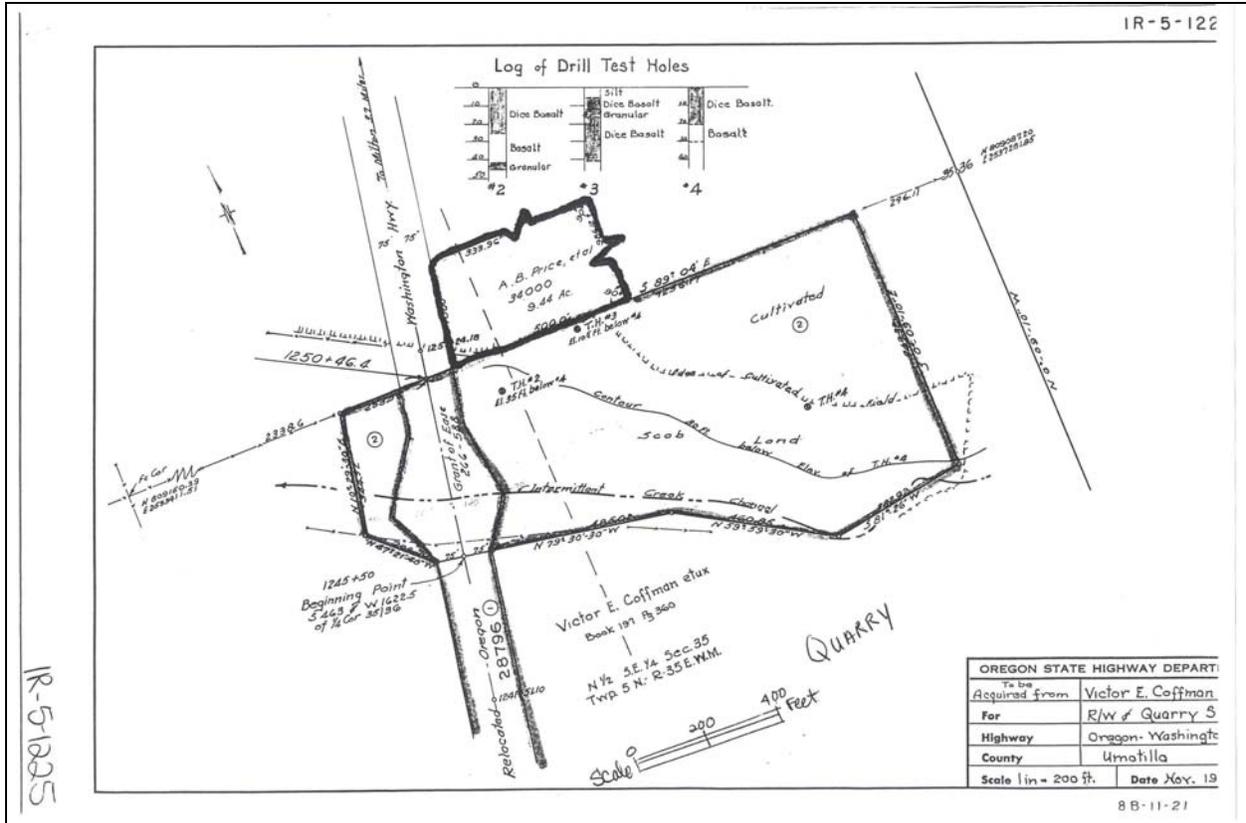
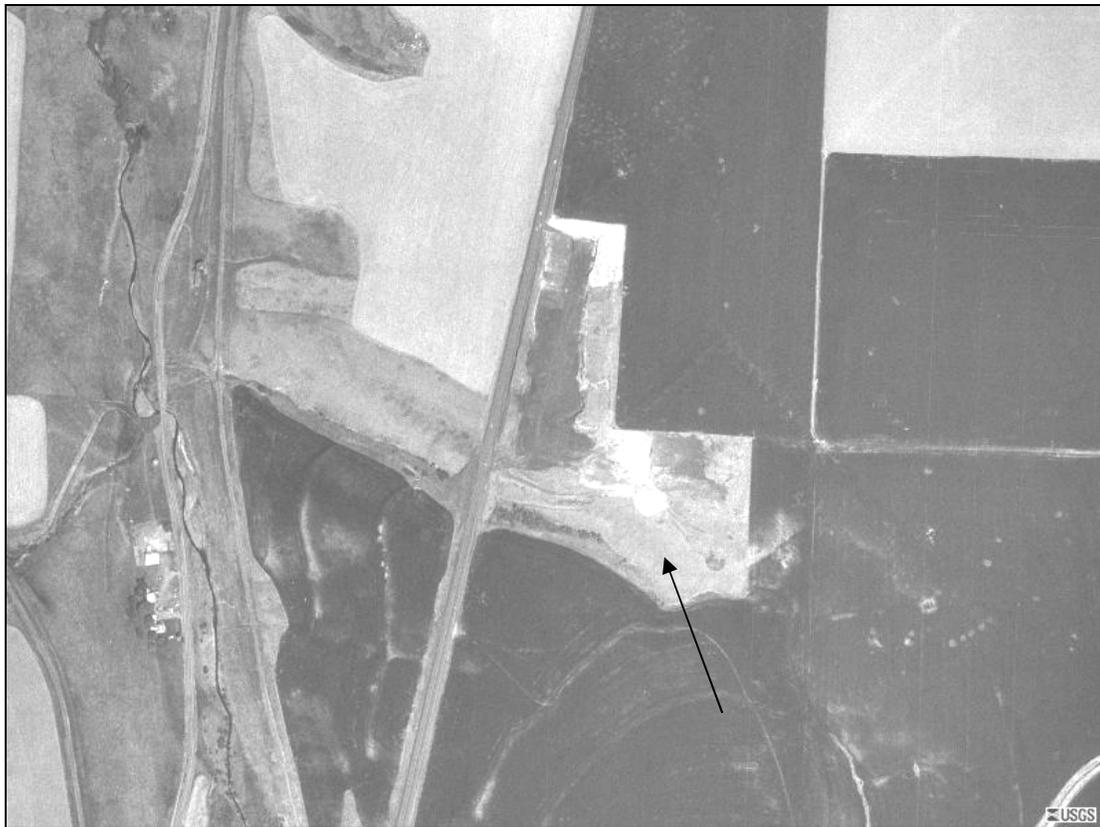
Close-up view of the highly fractured basalt found at this quarry site.

Aerial view of the quarry site located adjacent to Highway 11.

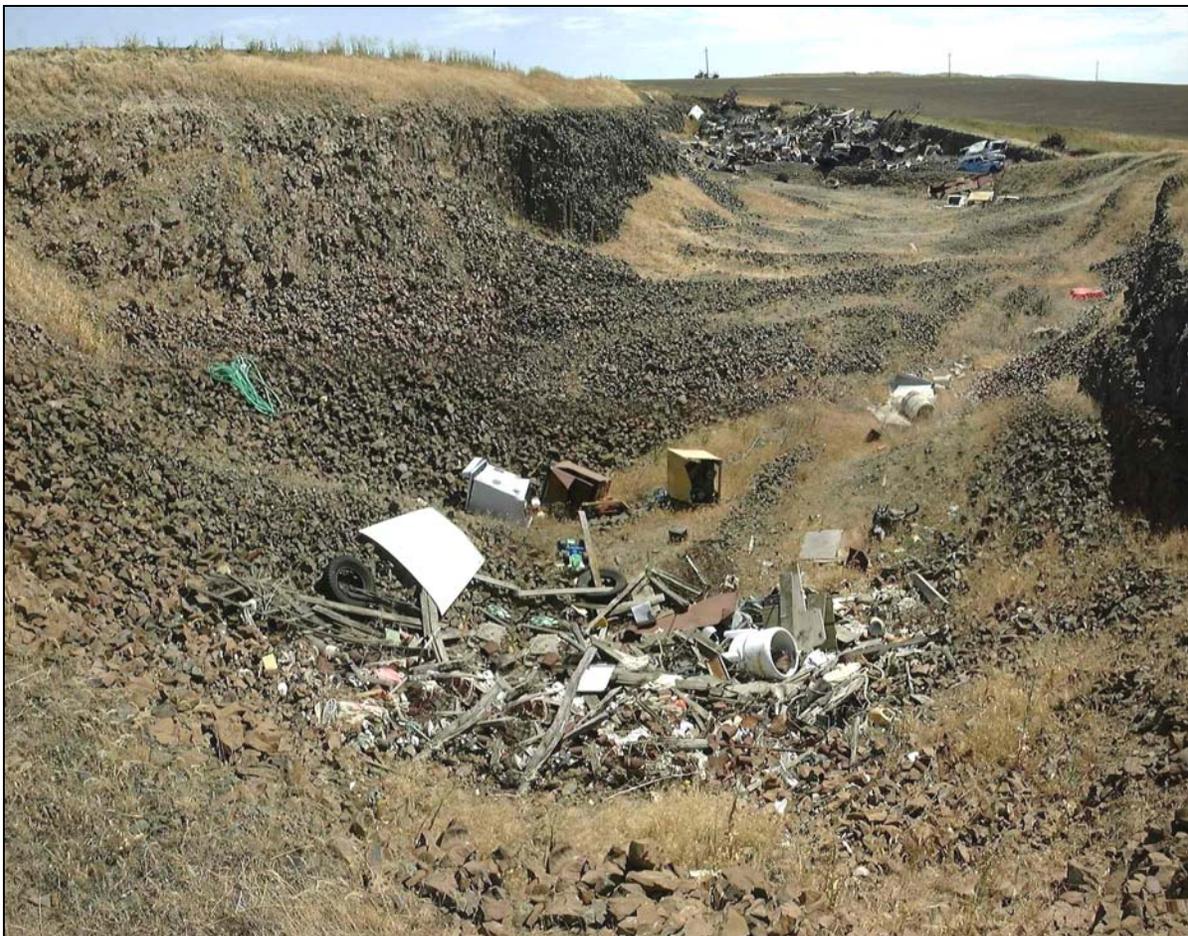
County	Site Name				Dist	Hwy	Mile Pt	TWP	RGE	Sect
Umatilla					12	0008	25.1	05N	35.0E	35
File ID		Source #	Date Visited	Map #		Type of Site				
10911		30-020-5	08/09/2000	1R-1-1024		Quarry				
Latitude	Longitude	Elev. (m)	Acreage	Pit Size	DOGAMI Permit #					
45 52'18.33000"	118 23'59.60000"	487	3.4	<1						
Comments										
Lat. and Long. acquired using Terrain Navigator Software										
Rock Type	Unit	Color		Weathering			Jointing			
Basalt	Tcw	Medium Dark Grey (N4)		Slight to Fresh			Highly Fractured			
Quality			Hardness	lbs./cu ft.	Reserve (cy)	Reserve (Tons)				
Good			R3	155	60,000	125,550				
Potentially Significant Site	Why			Open/Closed	Direction					
No	NA			Closed	NA					
Adjacent Land Use										
Farming										
Remarks										
This site is located west of Highway 11 about 150 meters. The easement has been blocked and this site is being used for a land fill. There is no screening and little room to work at this location. The quarry is located in the middle of a wheat field. This property is very close to 30-019-5 and has the same type of rock.

View of the small quarry site that is located in the middle of a wheat field.

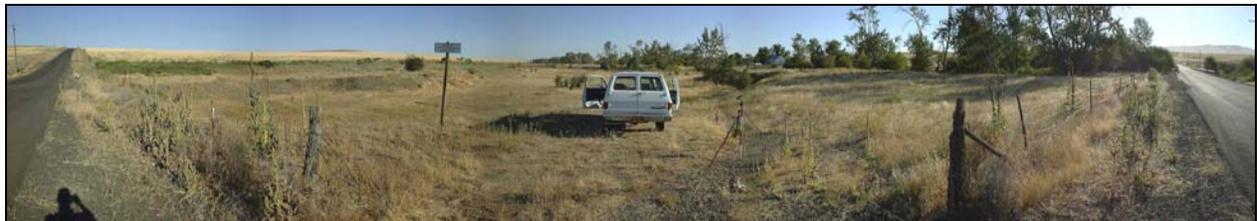
View of the gravel site located north of Spring Creek Road.
