OREGON DEPARTMENT OF TRANSPORTATION

AGGREGATE SITES

DISTRICT 12

JUNE 2002

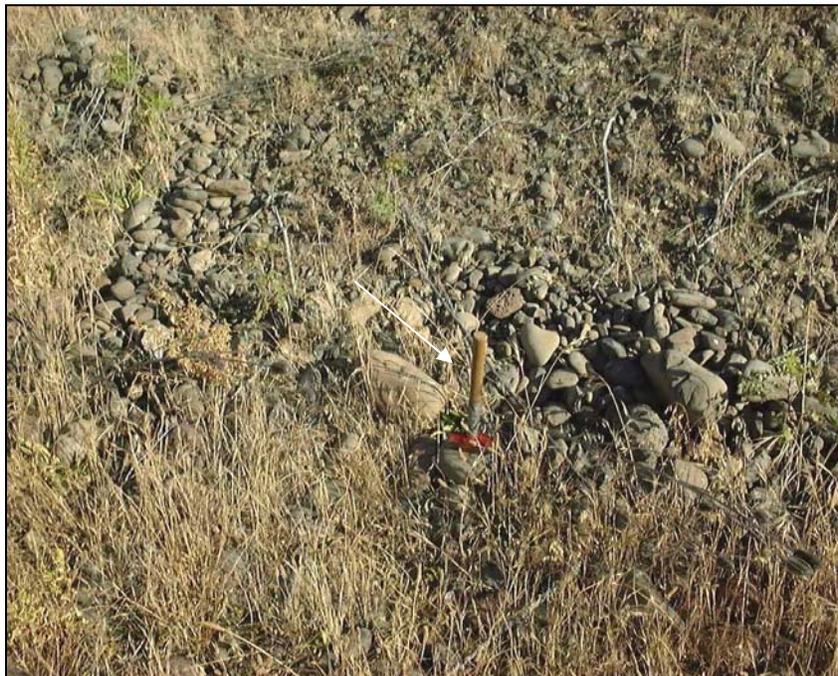
County	Site Name				Dist	Hwy	Mile Pt	TWP	RGE	Sect
Umatilla					12	0028	10.2	01N	32.0E	23
File ID		Source #	Date Visited	Map #		Type of Site				
24243		30-023-5	08/08/2000	1R-5-834		Gravel				
Latitude	Longitude	Elev. (m)	Acreage	Pit Size	DOGAMI Permit #					
45 33'05.14750"	118 46'27.00038"	413.673	10.08	<3						
Comments										
GPS acquired in the pit.										
Rock Type	Unit	Color	Weathering		Jointing					
Volcanic Gravel	Qal	NA	NA		NA					
Quality			Hardness	lbs./cu ft.	Reserve (cy)	Reserve (Tons)				
Fair to Good			NA	120	65,000	105,300				
Potentially Significant Site	Why			Open/Closed	Direction					
No	NA			Closed	Adjacent to the east is McKay Creek.					
Adjacent Land Use										
Farming/ one residence to the northeast approximately 400 meters										
Remarks										
This site is adjacent to and north of Spring Creek Road. The material is composed of a mix of volcanic gravel of varying sizes and shapes. Major portion of the material has been removed. There is a small area near the creek still remaining. It appears that the material is composed of sand around 50%, and gravel around 50% by volume. The terrain is flat with good access.

Close-up view of the material found at this site, composed of a mix of volcanic gravel of varying sizes.

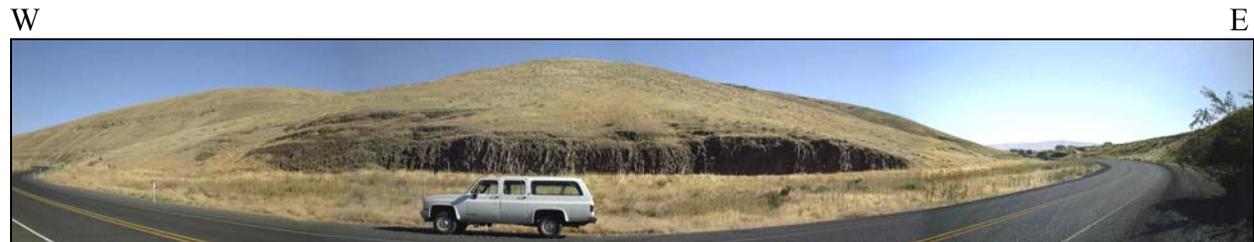
County	Site Name				Dist	Hwy	Mile Pt	TWP	RGE	Sect
Umatilla					12	0028	17.9	01S	32.0E	19
File ID		Source #	Date Visited	Map #			Type of Site			
25121		30-024-5	08/08/2000	1R-5-899			Quarry			
Latitude	Longitude	Elev. (m)	Acreage	Pit Size	DOGAMI Permit #					
45 27'57.74000"	118 52'07.66000"	548	12.36	NA						
Comments										
Lat. and Long. acquired using Terrain Navigator Software										
Rock Type	Unit	Color		Weathering			Jointing			
Basalt	Tcg	NA		Slight			Highly Fractured			
Quality			Hardness	lbs./cu ft.	Reserve (cy)	Reserve (Tons)				
Good to Fair			R3-	155	160,000	334,800				
Potentially Significant Site	Why			Open/Closed	Direction					
No	NA			Closed	NA					
Adjacent Land Use										
Open Space										
Remarks										
This is an old quarry site along Highway 395 south of Pilot Rock. There is no developed access to the site. The ground is on the north side of the road radius. There is no screening and limited room to work. The terrain is a gradual slope of about 10 degrees. This property would have limited site line along this curvy section of the highway.

View of the old quarry site looking across Highway 395.

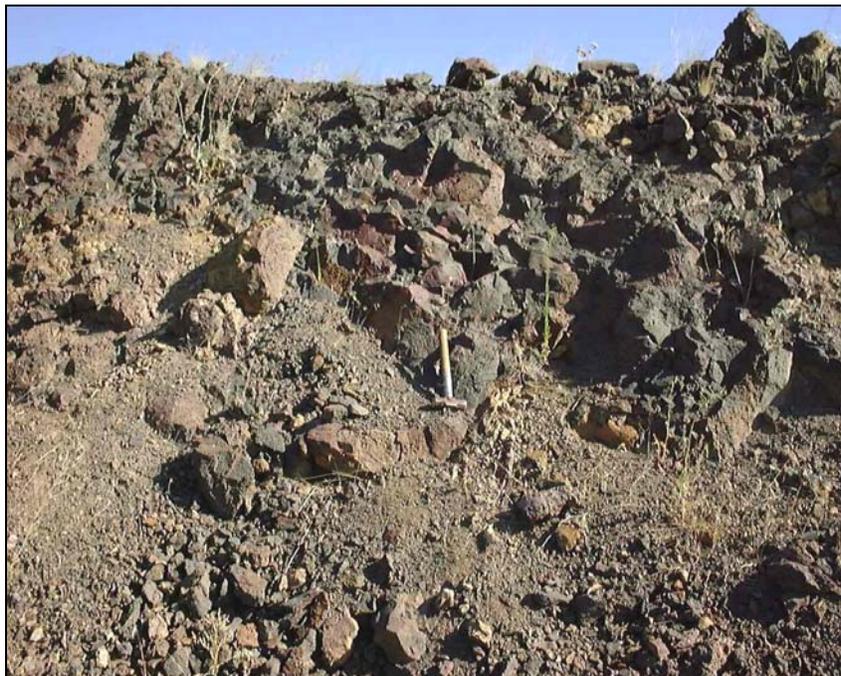
County	Site Name				Dist	Hwy	Mile Pt	TWP	RGE	Sect
Umatilla	Nye Junction Quarry				12	0028	23.8	01S	31.0E	19
File ID		Source #	Date Visited	Map #		Type of Site				
00061, 35378		30-026-5	08/08/2000	1R-5-1674		Quarry				
Latitude	Longitude	Elev. (m)	Acreage	Pit Size	DOGAMI Permit #					
45 27'36.47191"	118 59'01.78173"	711.367	26	<2	30-0090					
Comments										
GPS acquired in the pit.										
Rock Type	Unit	Color		Weathering		Jointing				
Basalt	Tcg	Medium Dark Grey (N4)		Slight		Highly Fractured				
Quality			Hardness	lbs./cu ft.	Reserve (cy)	Reserve (Tons)				
Fair			R3	173	400,000	934,200				
Potentially Significant Site	Why			Open/Closed	Direction					
Yes	Maintenance yard/Large amount of ground			Closed	NA					
Adjacent Land Use										
Open space										
Remarks										
This site is located at the junction of Highway 74 and Highway 395. There is a sanding shed here at this location. The ground is used for a waste site/quarry. Some small disturbances at this site. The rock is slightly weathered and is very vesicular basalt. You can rip the material. There is plenty of room to work, with no screening. The terrain is gradual with little overburden.

Close-up view of the slightly weathered and very vesicular basalt found at this site.

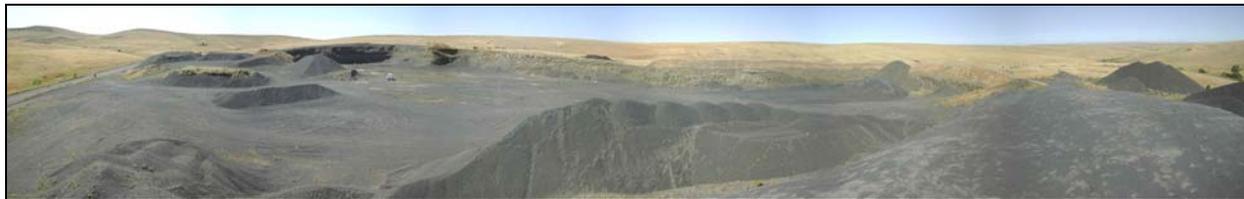
County	Site Name				Dist	Hwy	Mile Pt	TWP	RGE	Sect
Umatilla					12	0028	34.6	03S	30.5E	12
File ID		Source #	Date Visited	Map #		Type of Site				
Q0172, 10767		30-027-5	08/08/2000	1R-1-624		Quarry				
Latitude	Longitude	Elev. (m)	Acreage	Pit Size	DOGAMI Permit #					
45 18'51.18689"	119 00'10.78107"	1082.129	11.27	<12	30-0097					
Comments										
GPS acquired in the pit.										
Rock Type	Unit	Color		Weathering		Jointing				
Basalt	Tcg	Medium Dark Grey (N4)		Fresh to Slight		Highly Fractured				
Quality			Hardness	lbs./cu ft.	Reserve (cy)	Reserve (Tons)				
Good			R3	175	300,000	708,750				
Potentially Significant Site	Why			Open/Closed	Direction					
Yes	Large ground near the summit of Highway 395			Closed	NA					
Adjacent Land Use										
Open space/Farming										
Remarks										
This site is adjacent to and west of Highway 395. This is a fine-grain, slightly vesicular, highly fractured basalt. There is no screening from the highway but ample room to work. The ground is flat and just about road level. You can rip the material. The pit is to the boundaries and the pit floor would need to be lowered if we want to pull any more material out. Multiple stock piles of crushed rocks (approximately 2000 cubic yards).

View of the quarry site located adjacent to and west of Highway 395.

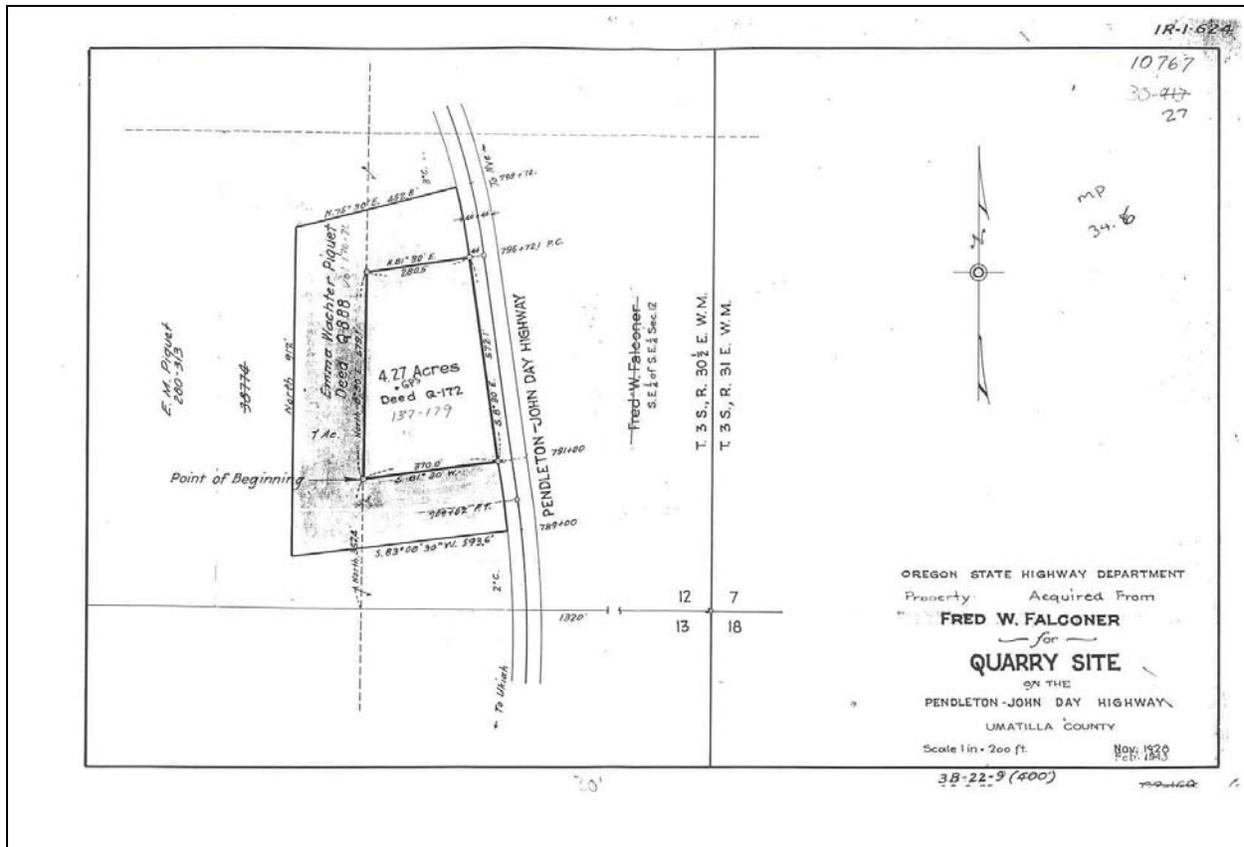
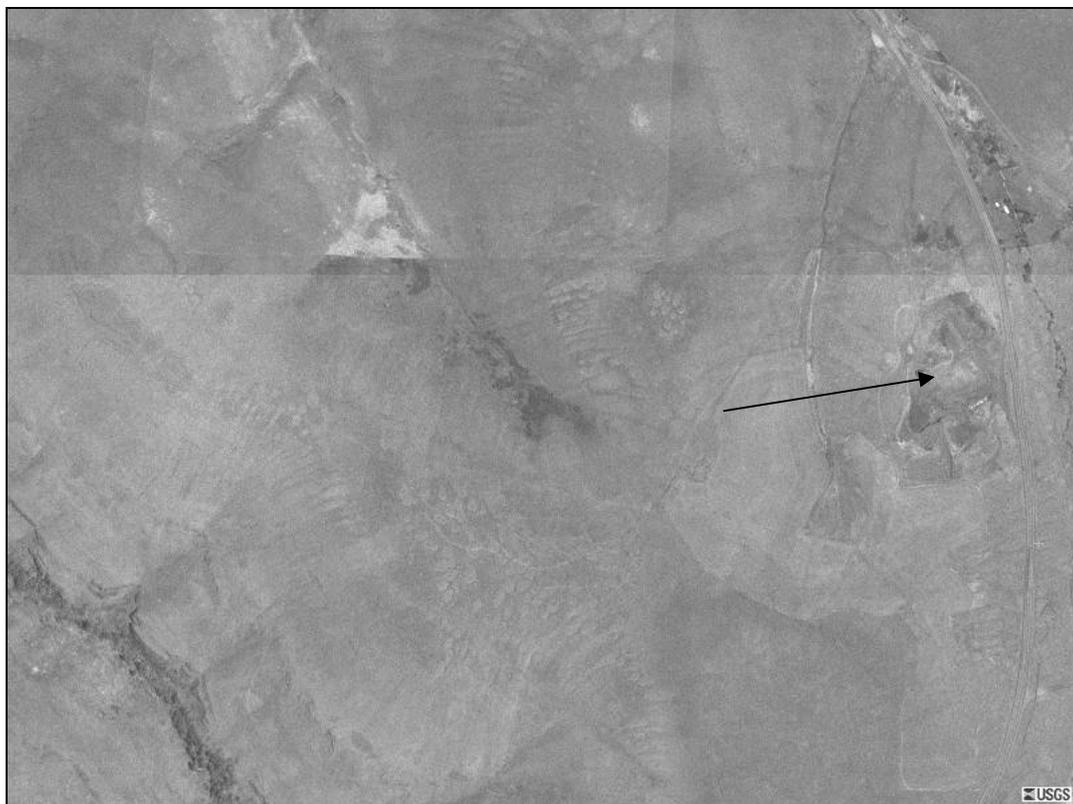
Close-up view of the fine-grain, slightly vesicular, highly fractured basalt found at the site.

Aerial view of the quarry site that is located adjacent to and west of Highway 395.

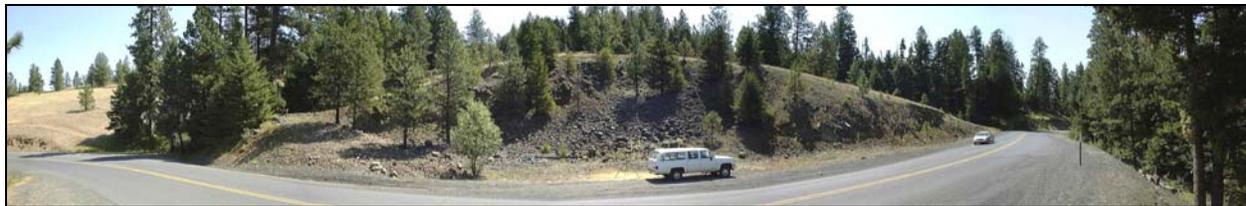
View of the small road cut site along Highway 395 near Battle Mountain State Park.

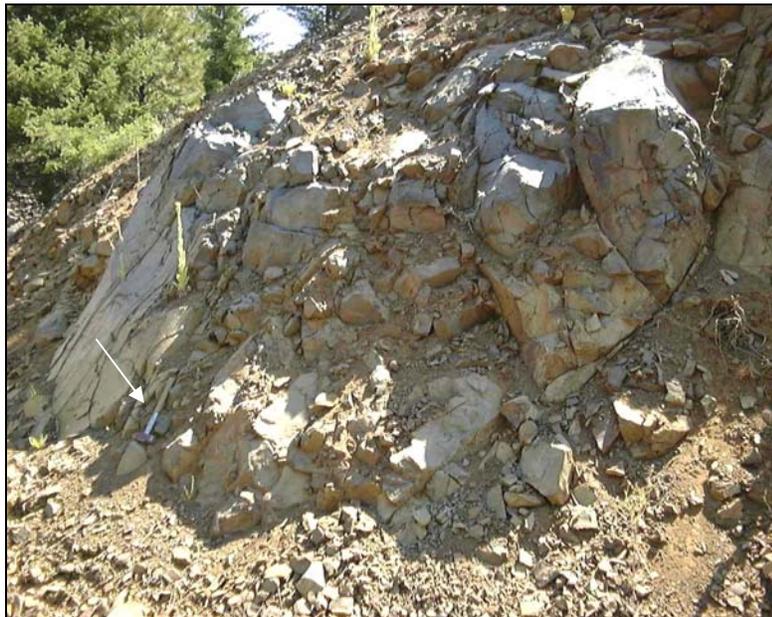
County	Site Name			Dist	Hwy	Mile Pt	TWP	RGE	Sect
Umatilla				12	0028	39.1	03S	31.0E	29
File ID		Source #	Date Visited	Map #			Type of Site		
Q0172		30-028-5	08/08/2000	1R-1-624			Road Cut		
Latitude	Longitude	Elev. (m)	Acreage	Pit Size		DOGAMI Permit #			
45 16'46.16040"	118 58'15.94613"	1268.948	4.27	NA					
Comments									
GPS acquired at turn-out.									
Rock Type	Unit	Color		Weathering			Jointing		
Basalt	Tcg	Olive Grey (5Y 4/1)		Slight to Moderate			Highly Fractured		
Quality			Hardness	lbs./cu ft.	Reserve (cy)	Reserve (Tons)			
Fair to Poor			R3-	165	60,000	133,650			
Potentially Significant Site	Why			Open/Closed	Direction				
No	NA			NA	NA				
Adjacent Land Use									
Open Space/State Park adjacent to the north									
Remarks									
This is a small road cut along Highway 395. The rest of the ground is raw land. The site is long and narrow. The rock exposed is of little value for AC. Maintenance might use the material for shoulder or fill. The property is very close to Battle Mountain State Park.

Close-up view of the material at the road cut.

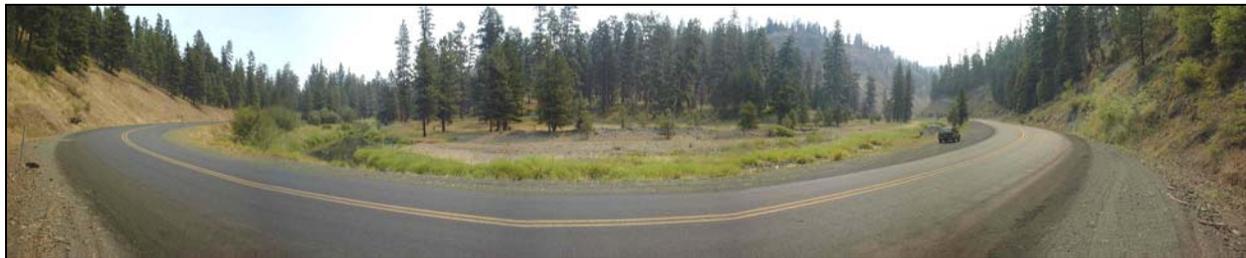
County	Site Name				Dist	Hwy	Mile Pt	TWP	RGE	Sect
Umatilla					12	0028	51	05S	31.0E	21
File ID		Source #	Date Visited	Map #			Type of Site			
10609		30-029-5	08/08/2000	1R-2-1319			Raw Land			
Latitude	Longitude	Elev. (m)	Acreage	Pit Size		DOGAMI Permit #				
45 07'26.53000"	118 58'30.68000"	1036	50	NA		20-0020				
Comments										
Lat. and Long. acquired using Terrain Navigator Software										
Rock Type	Unit	Color		Weathering			Jointing			
Igneous Gravel	Qal	NA		NA			NA			
Quality			Hardness	lbs./cu ft.	Reserve (cy)	Reserve (Tons)				
Unknown			NA	120						
Potentially Significant Site	Why			Open/Closed	Direction					
No	NA			NA	Camas Creek bisects the ground					
Adjacent Land Use										
Open space/State Park										
Remarks										
This site is located on the east side of Highway 395. There is no access to the property. This is raw land on either side of Camas Creek with the east side controlling at least 99%. This ground is difficult to get to with the location of the creek and the highway. There is a State Park adjacent to the site. There have been land use issues associated with this site.

View looking east across Highway 395 at the large raw land site.

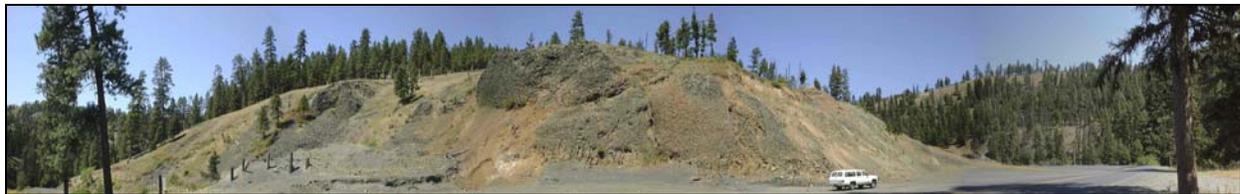
County	Site Name				Dist	Hwy	Mile Pt	TWP	RGE	Sect
Umatilla					12	0028	52	05S	31.0E	28
File ID		Source #	Date Visited		Map #			Type of Site		
10491		30-030-5	08/08/2000		10B-4-26			Quarry		
Latitude	Longitude	Elev. (m)	Acreage	Pit Size	DOGAMI Permit #					
45 06'42.71000"	118 50'22.06000"	1033	13.69	NA						
Comments										
Lat. and Long. acquired using Terrain Navigator Software										
Rock Type	Unit	Color		Weathering			Jointing			
Basalt	Tcg	Medium Dark Grey (N4)		Fresh to Slight			Highly Fractured			
Quality			Hardness	lbs./cu ft.	Reserve (cy)	Reserve (Tons)				
Good			R3+	172	1,000,000	1,500,000				
Potentially Significant Site	Why			Open/Closed	Direction					
No	NA			NA	Camas Creek is adjacent to the south					
Adjacent Land Use										
Open space										
Remarks										
This site is adjacent to the north and south of Highway 395. The rock is a fine-grain, highly fractured, slightly vesicular basalt. There is no screening, but limited room to work. Most of the removal of aggregate has been from the bottom of the hill. I strongly suggest that we work from the top down. The terrain is quite steep. The site is on a blind radius.

View looking north at the quarry site that is located north and south of Highway 395 on a corner.

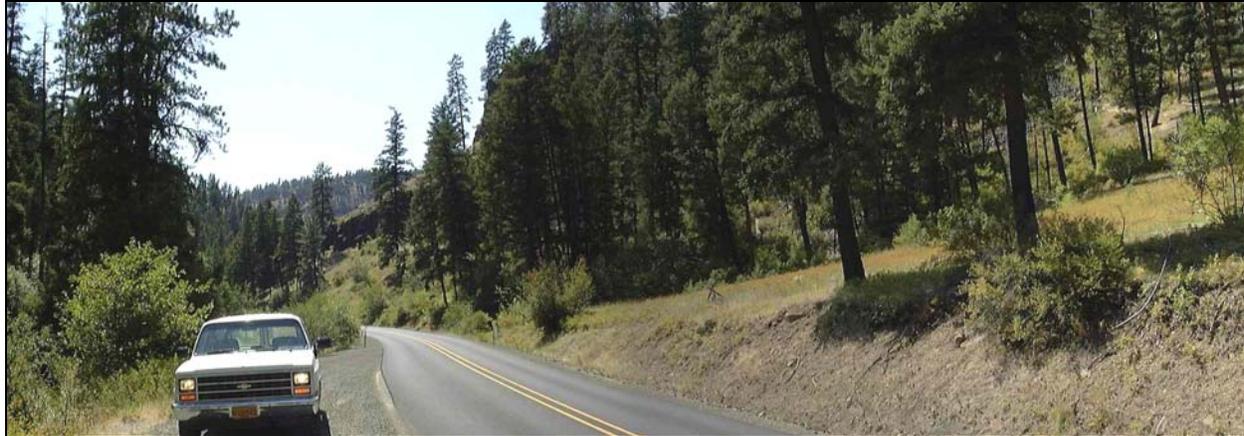
View of the raw land site located adjacent to the north of Highway 395.

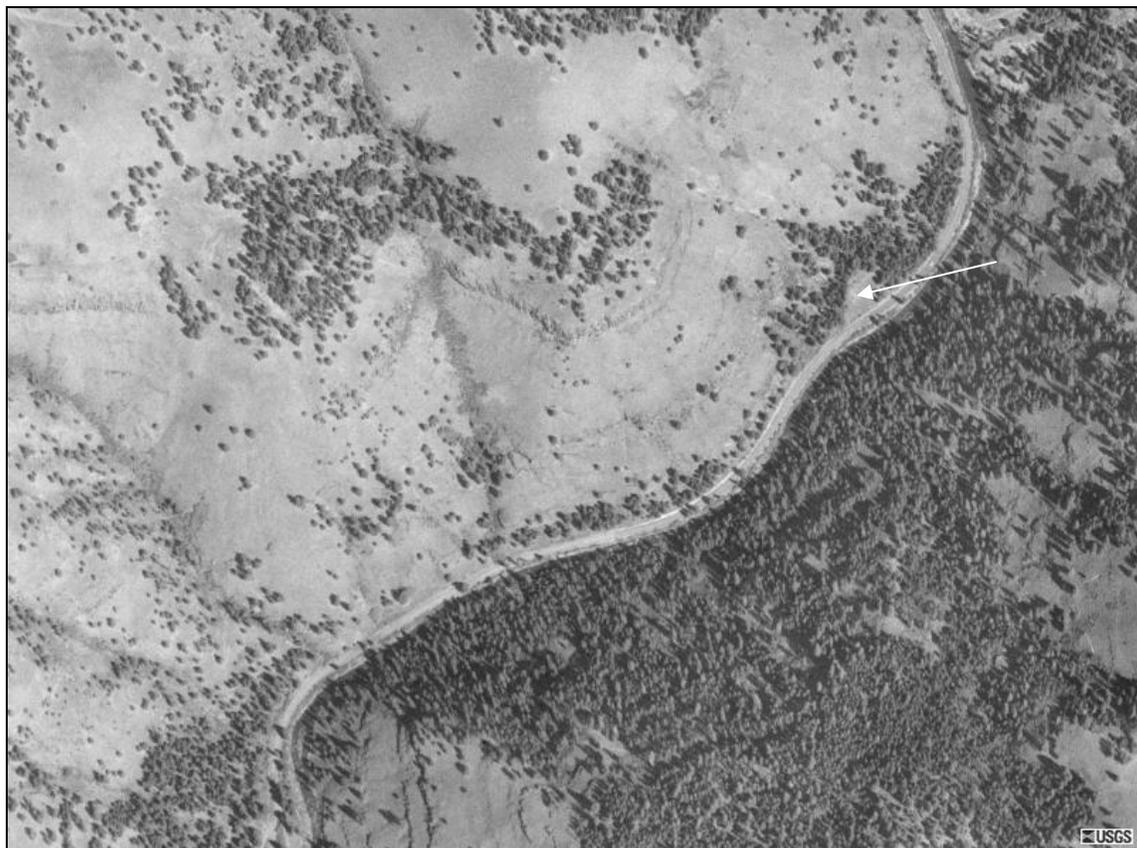
Aerial view of the raw land site located north of Highway 395.

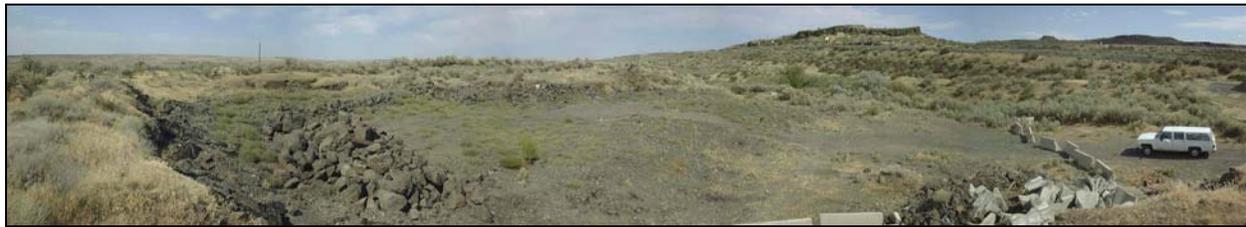
County	Site Name			Dist	Hwy	Mile Pt	TWP	RGE	Sect
Umatilla				12	0036	1	05N	29.0E	13
File ID		Source #	Date Visited	Map #			Type of Site		
RW1114		30-032-5	08/09/2000	1R-5-533			Quarry		
Latitude	Longitude	Elev. (m)	Acreage	Pit Size		DOGAMI Permit #			
45 54'55.62451"	119 07'56.73148"	124.922	133.27	<1					
Comments									
GPS acquired in the pit.									
Rock Type	Unit	Color		Weathering			Jointing		
Basalt	Tcw	NA		NA			NA		
Quality			Hardness	lbs./cu ft.	Reserve (cy)		Reserve (Tons)		
Good to Fair			NA	155	320,000		669,600		
Potentially Significant Site	Why			Open/Closed		Direction			
Yes	Large acreage			Closed		North about 600 meters is the Columbia River			
Adjacent Land Use									
Open space									
Remarks									
This site is located at the junction of the Cold Springs Highway and Highway 730. We own 109.53 acres of land along Highway 730. I evaluated the quarry site (23.74 acres) at the junction. This site has a thin intermittent basalt flow exposed with terrace gravel all around. The gravel is a heterogeneous mix of lithology and size. The gravel is about 50% and sand 50% by volume. The gravel is most likely thin and is not of much consequence. The basalt is a fine-grain, moderately fractured rock. You can rip the basalt and could get rip rap. There is no screening with room to work. The terrain is fairly flat. Part of the ground is BLM controlled.

View of the pit on the large quarry site located at the junction of Highway 37 and U.S. Highway 730.

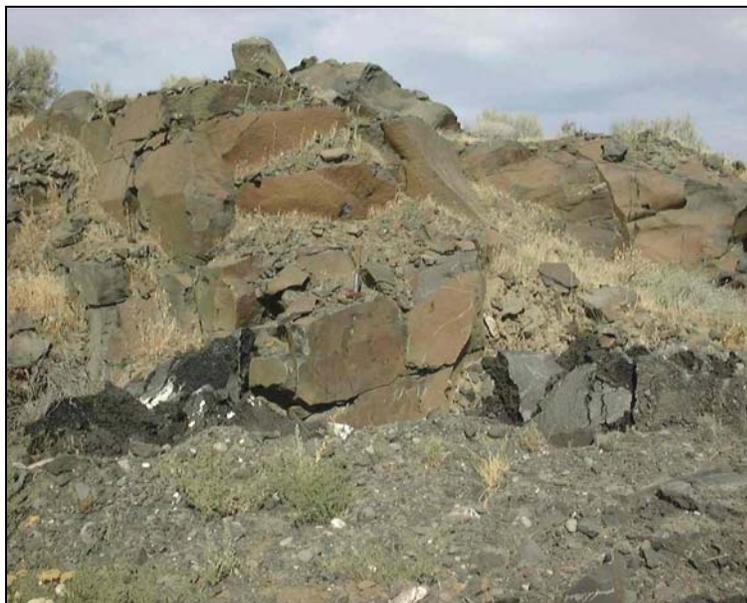
Close-up view of the rock found in the pit at this site.

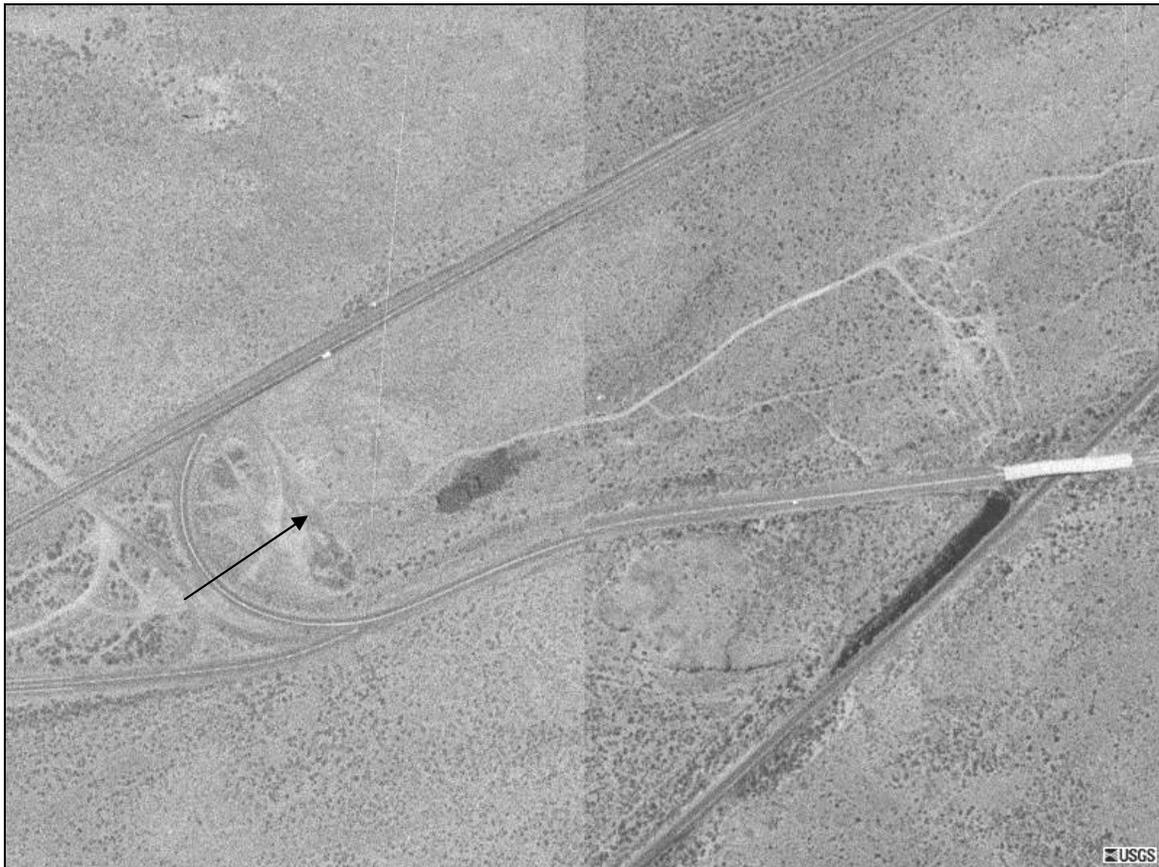
Aerial view of the large quarry site located at the junction of Highway 37 and U.S. Highway 730.

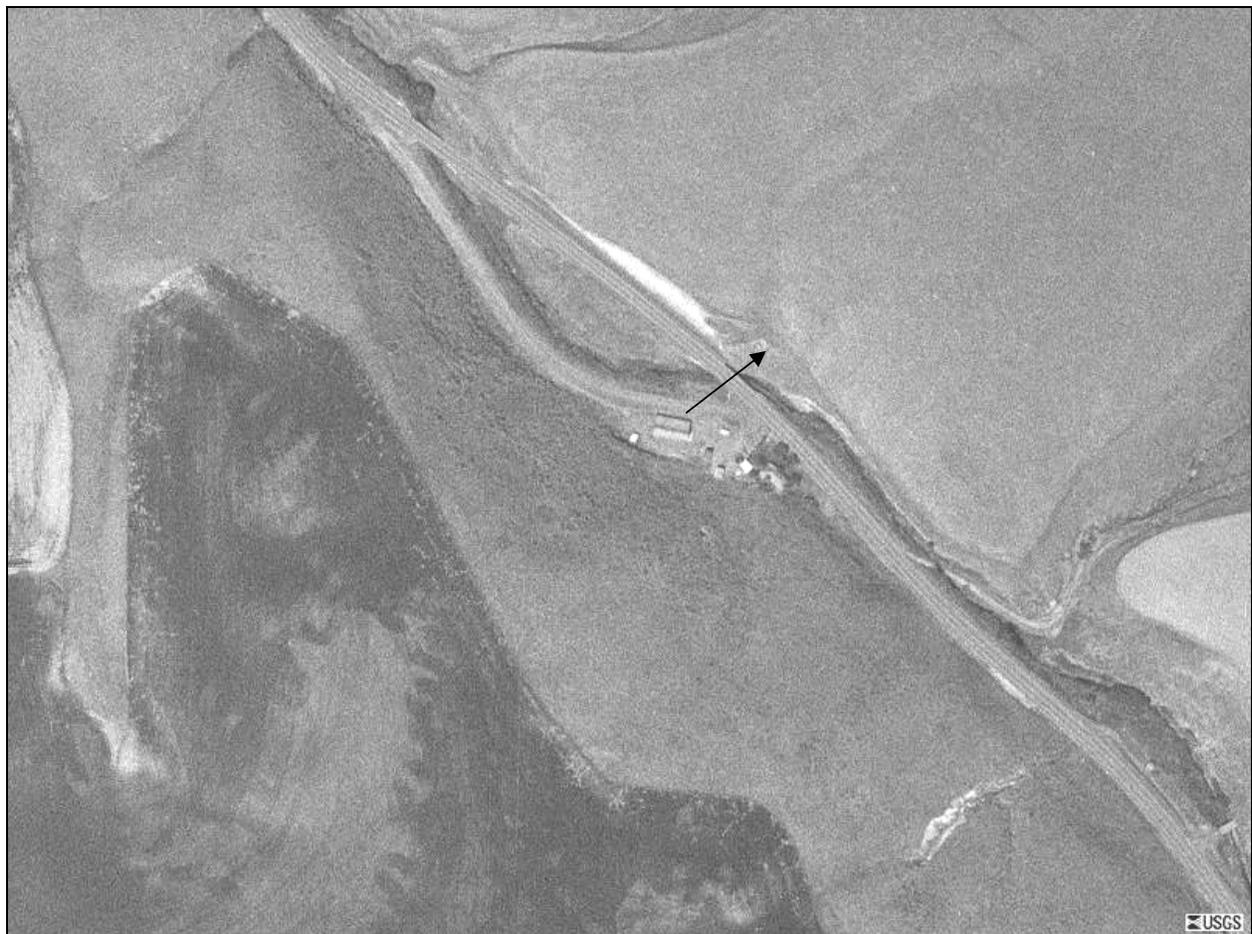
County	Site Name				Dist	Hwy	Mile Pt	TWP	RGE	Sect
Umatilla					12	0036	15.6	04N	31.0E	02
File ID		Source #	Date Visited	Map #			Type of Site			
01761		30-033-5	08/10/2000	1R-1-1388			Raw Land			
Latitude	Longitude	Elev. (m)	Acreage	Pit Size	DOGAMI Permit #					
45 51'00.76000"	118 53'53.32000"	364	2.12	NA						
Comments										
Lat. and Long. acquired using Terrain Navigator Software										
Rock Type	Unit	Color		Weathering			Jointing			
NA	Tcw	NA		NA			NA			
Quality			Hardness	lbs./cu ft.	Reserve (cy)	Reserve (Tons)				
NA			NA	120						
Potentially Significant Site	Why			Open/Closed	Direction					
No	NA			Closed	Adjacent to the Middle Fork Cold Springs					
Adjacent Land Use										
Open space/Farming										
Remarks										
This site is adjacent to the north on Highway 37. The ground is just a wide spot for a stockpile or staging area. There is no aggregate value here.										
202B	203B	211	206 Fine	206 Coarse	208 F	208 F Ht.	208 C	208 C Ht.

Aerial view of the small raw land site that is adjacent to and north of Highway 37.

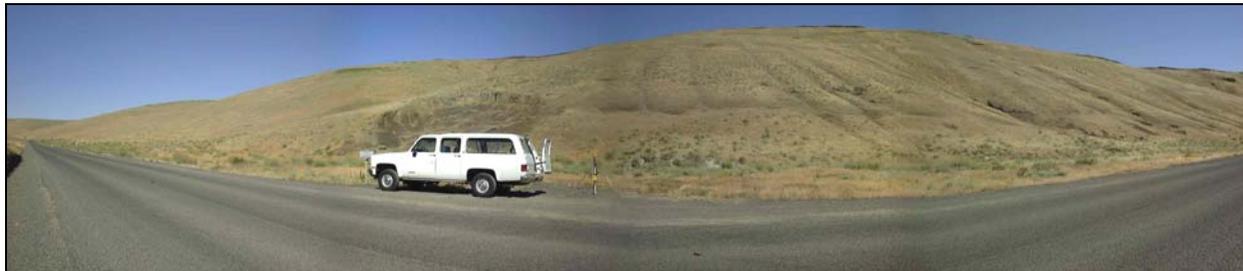
County	Site Name				Dist	Hwy	Mile Pt	TWP	RGE	Sect
Umatilla					12	0052	74.6	01S	30.0E	31
File ID		Source #	Date Visited	Map #		Type of Site				
18790		30-035-5	08/08/2000	1R-1-498		Quarry				
Latitude	Longitude	Elev. (m)	Acreage	Pit Size	DOGAMI Permit #					
45 26'16.11901"	119 08'10.16553"	737.349	19.25	<1						
Comments										
GPS acquired along Highway 74 and the access point.										
Rock Type	Unit	Color		Weathering			Jointing			
Basalt	Tcg	Medium Dark Grey (N4)		Fresh			Highly Fractured			
Quality			Hardness	lbs./cu ft.	Reserve (cy)	Reserve (Tons)				
Good			R3	162	200,000	437,400				
Potentially Significant Site	Why			Open/Closed	Direction					
No	NA			Closed	NA					
Adjacent Land Use										
Open space										
Remarks										
This is adjacent to and northwest of Highway 74 near the county line. There is a small disturbance at this location. The rock is a fine-grain highly fractured basalt. There is some room to work, but no screening. The terrain has a slope of approximately 20 to 25 degrees. Little to no overburden. We would need to develop the access to this site. You can rip the material.

View of the quarry site located adjacent to and northwest of Highway 74.

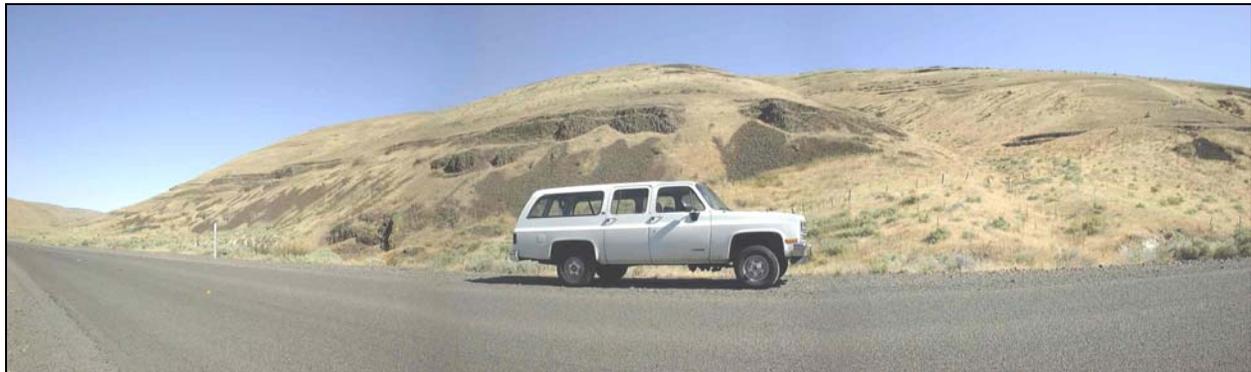
County	Site Name			Dist	Hwy	Mile Pt	TWP	RGE	Sect
Umatilla				12	0052	79.7	01S	30.0E	22
File ID		Source #	Date Visited	Map #			Type of Site		
18792		30-036-5	08/08/2000	1R-5-224			Raw Land		
Latitude	Longitude	Elev. (m)	Acreage	Pit Size		DOGAMI Permit #			
45 27'29.76000"	119 03'59.66000"	679	6.9	NA					
Comments									
Lat. and Long. acquired using Terrain Navigator Software									
Rock Type	Unit	Color		Weathering			Jointing		
Basalt	Tcg	Medium Dark Grey (N4)		NA			NA		
Quality			Hardness	lbs./cu ft.	Reserve (cy)	Reserve (Tons)			
Good			NA	120	145,000	234,900			
Potentially Significant Site	Why			Open/Closed	Direction				
No	NA			Closed	NA				
Adjacent Land Use									
Open space									
Remarks									
This is raw land adjacent to and north of Highway 74. There is no access to this site. The rock here is a fine-grain basalt. The terrain is fairly steep at about 35 degrees. There would be no screening and limited room to work.

View of the raw land site that is adjacent to and north of Highway 74.

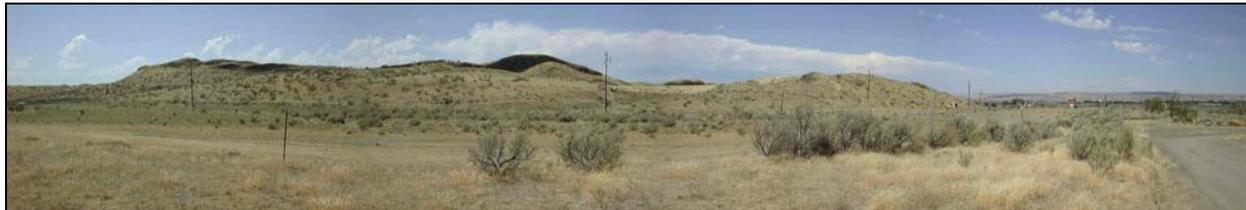
County	Site Name			Dist	Hwy	Mile Pt	TWP	RGE	Sect
Umatilla				12	0054	2.7	05N	28.0E	28
File ID		Source #	Date Visited	Map #			Type of Site		
Q0433		30-038-5	08/10/2000	1R-1-1476			Raw Land		
Latitude	Longitude	Elev. (m)	Acreage	Pit Size		DOGAMI Permit #			
45 53'06.12000"	119 18'27.75000"	151	40	NA					
Comments									
Lat. and Long. acquired using Terrain Navigator Software									
Rock Type	Unit	Color		Weathering			Jointing		
Basalt	Tcs	NA		NA			NA		
Quality			Hardness	lbs./cu ft.	Reserve (cy)	Reserve (Tons)			
Fair to Good			NA	120	600,000	972,000			
Potentially Significant Site	Why			Open/Closed	Direction				
No	USA Ground			Closed	NA				
Adjacent Land Use									
Industrial									
Remarks									
This site is located west of Highway 395 about 1000 meters in Umatilla, OR. This property is owned by the USA. I had no access to this site to evaluate the ground. The easement is not evident anymore. This property is part of Umatilla Butte.

View of the 40 acre site that is part of the Umatilla Butte and is located west of Highway 395.

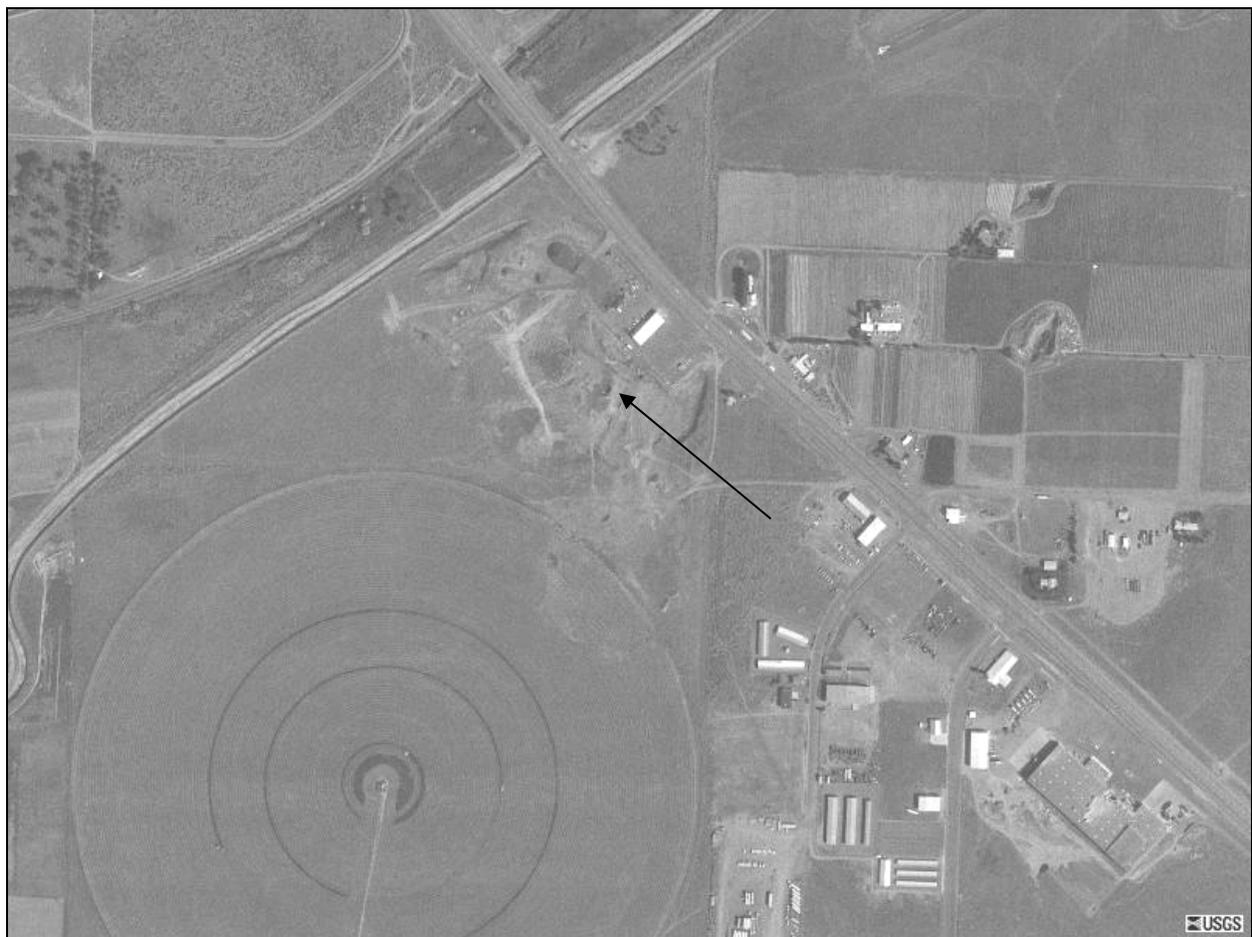
County	Site Name				Dist	Hwy	Mile Pt	TWP	RGE	Sect
Umatilla	Hermiston Maintenance Shop				12	0054	7.1	04N	28.0E	14
File ID		Source #	Date Visited	Map #		Type of Site				
02287, 27880		30-040-5	08/10/2000	1R-1-1477		Maintenance Yard				
Latitude		Longitude		Elev. (m)	Acreage	Pit Size		DOGAMI Permit #		
45 49'19.14000"		119 16'11.80000"		183	33.7	NA				
Comments										
Lat. and Long. acquired using Terrain Navigator Software										
Rock Type		Unit	Color		Weathering			Jointing		
NA		Qgs	NA		NA			NA		
Quality				Hardness	lbs./cu ft.		Reserve (cy)		Reserve (Tons)	
NA				NA	0					
Potentially Significant Site		Why			Open/Closed		Direction			
No		NA			NA		NA			
Adjacent Land Use										
Industrial										
Remarks										
This is the Maintenance Yard on Highway 207 in Hermiston. The excess ground is being used for a waste site and bone yard.										
202B	203B	211	206 Fine	206 Coarse	208 F	208 F Ht.	208 C	208 C Ht.

Aerial view of the Hermiston Maintenance Yard located along Highway 207.

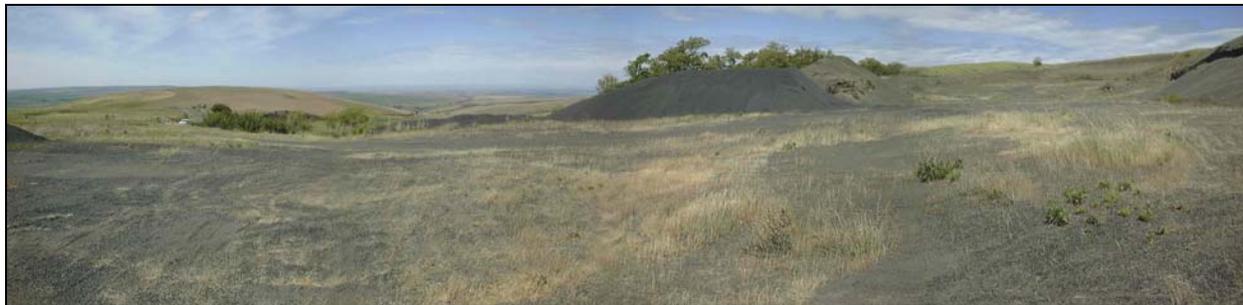
County	Site Name				Dist	Hwy	Mile Pt	TWP	RGE	Sect
Umatilla	Weston Pit				12	0330	2.2	04N	35.0E	24
File ID		Source #	Date Visited	Map #		Type of Site				
29427		30-043-5	06/06/2001	10C-34-6		Quarry				
Latitude	Longitude	Elev. (m)	Acreage	Pit Size	DOGAMI Permit #					
45 48'30.54245"	118 23'25.03590"	779.638	10.35	<4	30-0061					
Comments										
GPS acquired at the access gate.										
Rock Type	Unit	Color		Weathering		Jointing				
Basalt	Tcg	Medium Dark Grey (N4)		Moderate to Slight		Highly Fractured				
Quality			Hardness	lbs./cu ft.	Reserve (cy)	Reserve (Tons)				
Fair to Good			R2+ to R3	180	1,000,000	1,500,000				
Potentially Significant Site	Why			Open/Closed	Direction					
Yes	Acreage on State Highway.			Closed	NA					
Adjacent Land Use										
Farming										
Remarks										
This site is located adjacent to and south of Highway 204. The rock here is a weathered, highly fractured, fine-grain basalt that has minor vesicular structure. There is room to work with good screening. You can rip the material. The terrain is gradual. This site is used as a stockpile site. There is a locked gate at this location, but no sign. 100,000 cubic yards have been removed to date.

View looking north across the quarry site located adjacent to and south of Highway 204.

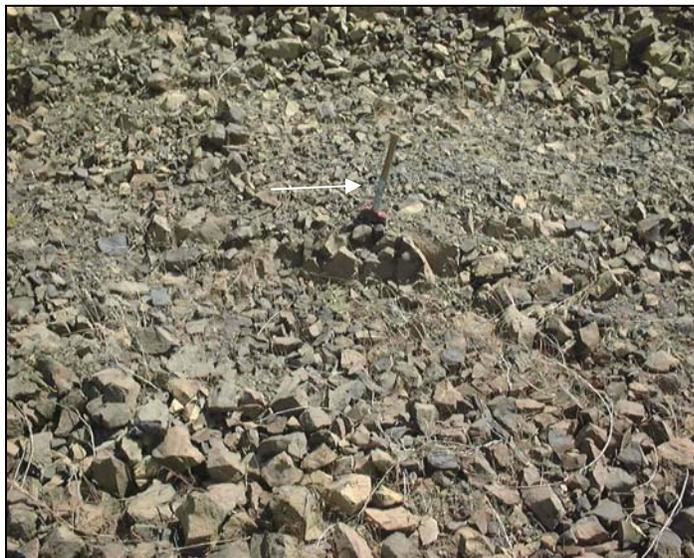
Close-up view of the basalt found at this site.

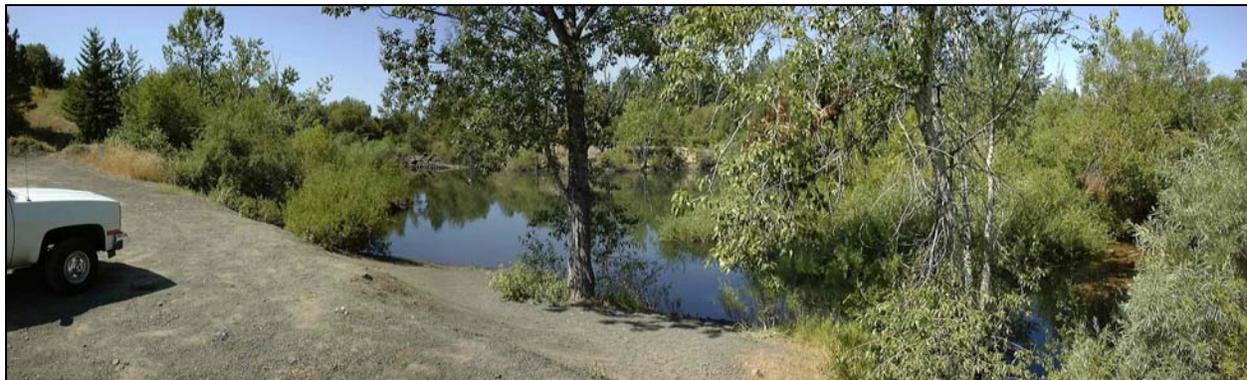
County	Site Name				Dist	Hwy	Mile Pt	TWP	RGE	Sect
Umatilla					12	0330	11.3	04N	37.0E	30
File ID		Source #	Date Visited	Map #		Type of Site				
12272		30-044-5	08/09/2000	1R-2-1550		Maintenance Yard				
Latitude	Longitude	Elev. (m)	Acreage	Pit Size		DOGAMI Permit #				
45 47'24.72000"	118 14'48.47000"	1145	5.23	NA						
Comments										
Lat. and Long. acquired using Terrain Navigator Software										
Rock Type	Unit	Color		Weathering			Jointing			
NA	Tcg	NA		NA			NA			
Quality			Hardness	lbs./cu ft.		Reserve (cy)	Reserve (Tons)			
NA			NA	0						
Potentially Significant Site	Why			Open/Closed		Direction				
NA	NA			NA		NA				
Adjacent Land Use										
Rural residential										
Remarks										
This site is adjacent to the south of Highway 204. There is a Maintenance sanding shed and storage building at this location. There is a small pond (30 meters by 70 meters) west and adjacent to the sanding shed that is stock by ODFW for public fishing.

View of Weston Pond, which occupies the old pit at this site and is stocked with fish by ODFW.

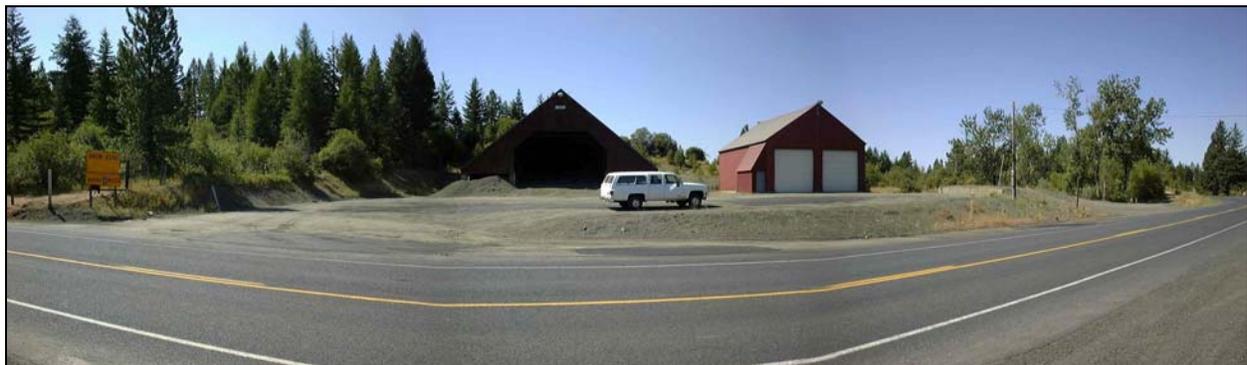
View looking south across Highway 204 at the sanding shed and maintenance storage building located at this site.

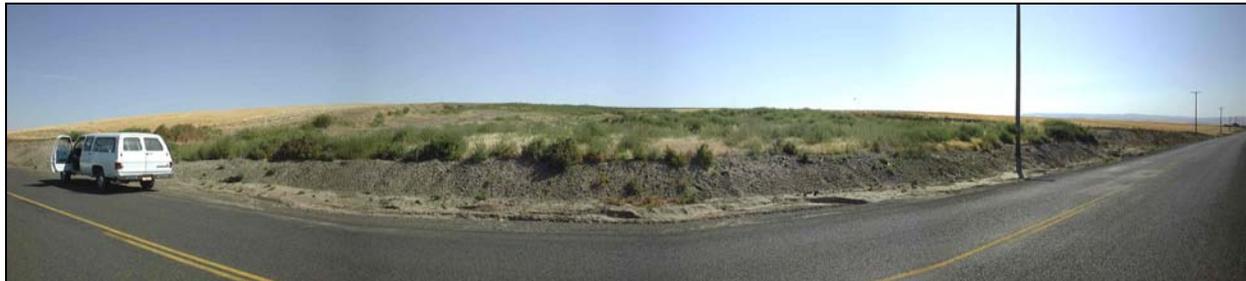
County	Site Name				Dist	Hwy	Mile Pt	TWP	RGE	Sect
Umatilla					12	0334	14.48	04N	34.0E	10
File ID		Source #	Date Visited	Map #			Type of Site			
09754		30-049-5	08/09/2000	1R-2-1223			Quarry			
Latitude	Longitude	Elev. (m)	Acreage	Pit Size	DOGAMI Permit #					
45 50'21.72000"	118 33'16.98000"	578	3.54	NA						
Comments										
Lat. and Long. acquired using Terrain Navigator Software										
Rock Type	Unit	Color		Weathering			Jointing			
Basalt	Tcw	NA		NA			NA			
Quality			Hardness	lbs./cu ft.	Reserve (cy)	Reserve (Tons)				
NA			NA	155						
Potentially Significant Site	Why			Open/Closed	Direction					
No	NA			NA	NA					
Adjacent Land Use										
Farming										
Remarks										
This site is located east of and adjacent to Gerking Flat Road. This site looks as if it has been reclaimed. There is no screening with limited room to work. The terrain has a very gradual slope up from the road. Part of the ground is within the Q1 geological unit with basalts below. The mile point from the 1R map is wrong.

View looking east across Gerking Flat Road at the reclaimed quarry site.

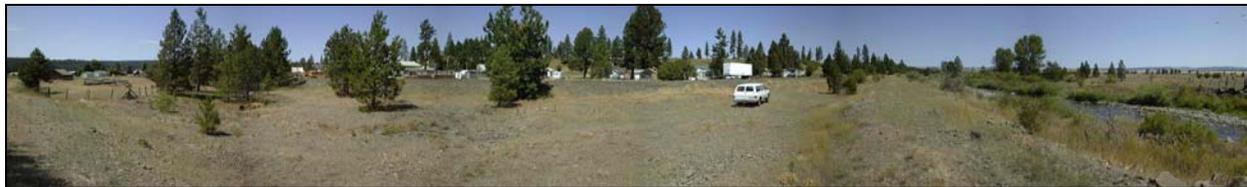
County	Site Name				Dist	Hwy	Mile Pt	TWP	RGE	Sect
Umatilla	Leverance Quarry				12	0341	1.6	05S	31.0E	14
File ID		Source #	Date Visited	Map #		Type of Site				
24463		30-051-5	08/08/2000	1R-5-842		Gravel				
Latitude	Longitude	Elev. (m)	Acreage	Pit Size	DOGAMI Permit #					
45 08'03.65293"	118 55'38.86710"	1024.992	7.55	NA						
Comments										
GPS acquired between the creek and Highway 244.										
Rock Type	Unit	Color	Weathering			Jointing				
Igneous Gravel	Qal	NA	NA			NA				
Quality			Hardness	lbs./cu ft.	Reserve (cy)	Reserve (Tons)				
Good			NA	120						
Potentially Significant Site	Why			Open/Closed	Direction					
No	NA			Closed	Camas Creek bisects the property					
Adjacent Land Use										
In the town of Ukiah										
Remarks										
This site is located on the east end of Ukiah and adjacent to the south of Highway 244. The property is on both sides of the creek. The gravel is composed of small boulder to cobble size material with very little sand. There is a small dike (levee) on our ground running the length of the creek. The ground is 4 to 6 feet below the highway and 2 to 3 feet above the creek.

View of the gravel site located east of Ukiah, OR and south of Highway 244.

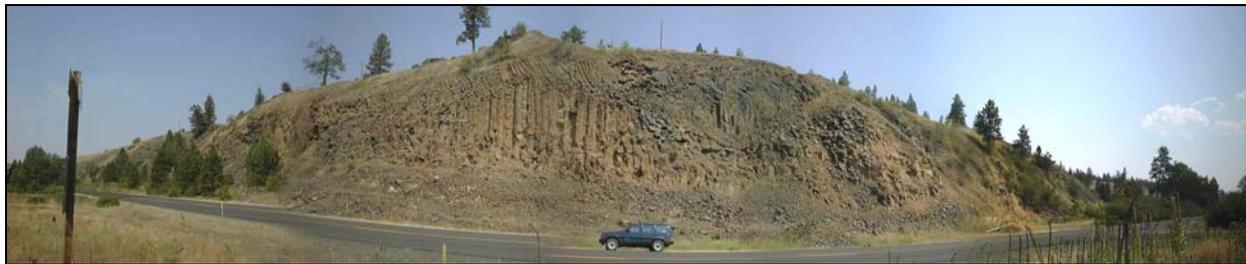
County	Site Name				Dist	Hwy	Mile Pt	TWP	RGE	Sect
Umatilla					12	0341	6	05S	32.0E	04
File ID		Source #	Date Visited	Map #		Type of Site				
24468		30-052-5	08/17/2001	1R-5-945		Quarry				
Latitude	Longitude	Elev. (m)	Acreage	Pit Size	DOGAMI Permit #					
45 09'31.76000"	118 50'34.90000"	1097	6.51	NA						
Comments										
Lat. and Long. acquired using Terrain Navigator Software										
Rock Type	Unit	Color		Weathering		Jointing				
Basalt	Tcg	Medium Grey (N5)		Slight		Moderate Fracture to Massive				
Quality			Hardness	lbs./cu ft.	Reserve (cy)		Reserve (Tons)			
Good			R3+	184	200,000		300,000			
Potentially Significant Site	Why		Open/Closed		Direction					
No	Too Small		Closed		To the south approximately 100 meters is Camas Creek					
Adjacent Land Use										
Open Space										
Remarks										
This site is located north of and adjacent to Highway 244. The rock here is a fine-grain basalt. There is no room to work and no screening from the highway. The terrain is steep and all work should proceed from the top down. There is a stock pile site across the highway from this quarry.

View of the quarry site located adjacent to and north of Highway 244.

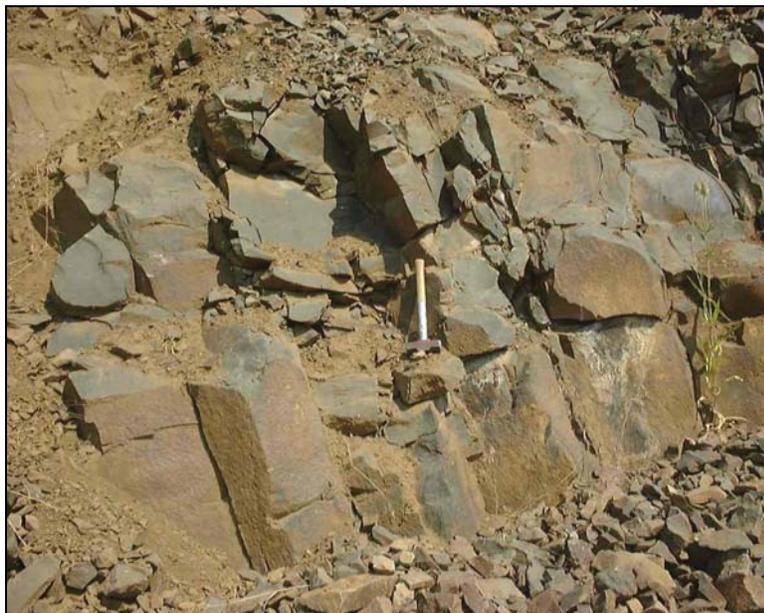
Close-up view of the fine-grain basalt that comprises the quarry wall.

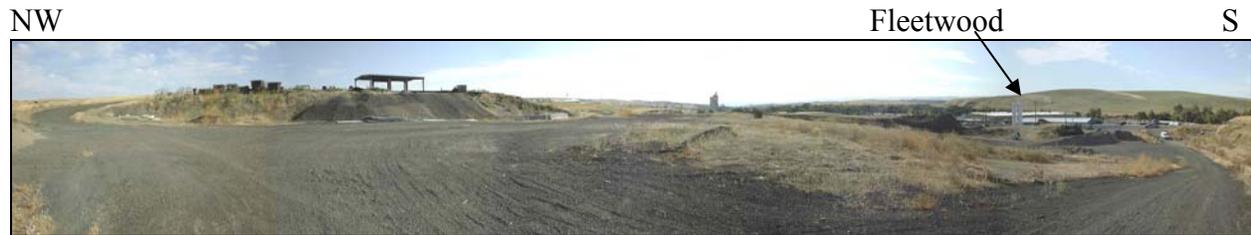
County	Site Name				Dist	Hwy	Mile Pt	TWP	RGE	Sect
Umatilla	Brogoitti Quarry				12	0006	207.7	02N	32.0E	08
File ID		Source #	Date Visited	Map #			Type of Site			
22924		30-076-5	08/10/2000	1R-5-644			Quarry			
Latitude	Longitude	Elev. (m)	Acreage	Pit Size		DOGAMI Permit #				
45 40'11.93433"	118 50'51.79457"	310.089	7.24	NA						
Comments										
GPS acquired at the locked gate.										
Rock Type	Unit	Color		Weathering			Jointing			
Basalt	Tcw	Olive Grey (5Y 4/1)		Slight			Moderately Fractured			
Quality			Hardness	lbs./cu ft.	Reserve (cy)		Reserve (Tons)			
Fair			R3-	155	20,000		41,850			
Potentially Significant Site	Why	Open/Closed		Direction						
No	NA	Closed		To the south about 800 meters is the Umatilla River						
Adjacent Land Use										
Industrial										
Remarks										
This property is a Maintenance bone-yard/waste/stock pile site. There is approximately 20,000 cubic yards of medium-grain moderately fractured basalt left. You can rip the material. There is no screening with room to work. There is minor rip rap at this site.

View of the Maintenance bone yard, waste rock and stock pile site.

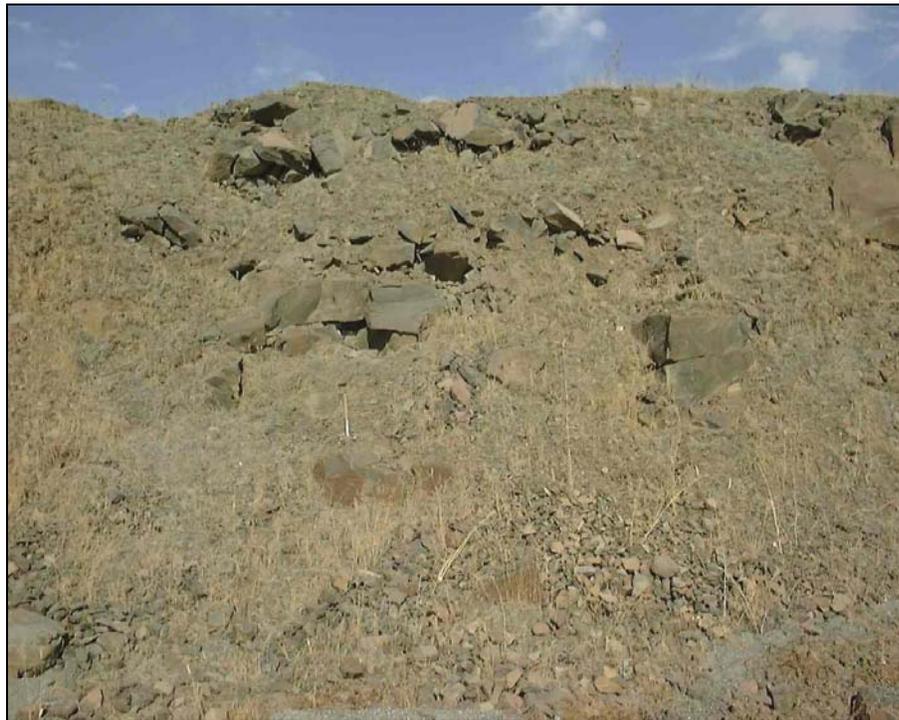
Close-up view of the rock found at this site.
