OREGON DEPARTMENT OF TRANSPORTATION

AGGREGATE SITES

DISTRICT 12

JUNE 2002

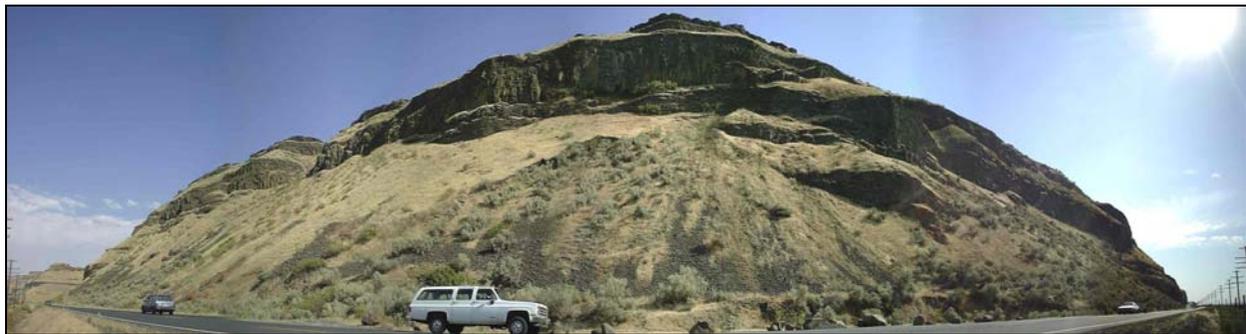
County	Site Name			Dist	Hwy	Mile Pt	TWP	RGE	Sect
Umatilla				12	0002	209	06N	30.0E	25
File ID		Source #	Date Visited	Map #			Type of Site		
Q0293		30-903-5	08/09/2000	1R-1-1160			Raw Land		
Latitude	Longitude	Elev. (m)	Acreage	Pit Size		DOGAMI Permit #			
45 58'12.90000"	119 00'26.49000"	119	40	NA					
Comments									
Lat. and Long. acquired using Terrain Navigator Software									
Rock Type	Unit	Color		Weathering			Jointing		
Basalt	Tcs	NA		NA			NA		
Quality			Hardness	lbs./cu ft.	Reserve (cy)	Reserve (Tons)			
Good to Fair			NA	120	100,000	150,000			
Potentially Significant Site	Why	Open/Closed	Direction						
No	USA ground	Closed	To the north about 100 meters across Highway 730 is the Columbia River						
Adjacent Land Use									
Open space									
Remarks									
This site is adjacent and south of Highway 730. This is raw land owned by the US government. The terrain has vertical cliffs composed of multiple lava flows. There would be no screening or room to work at this location.

View of the raw land site located south of U.S. Highway 730.

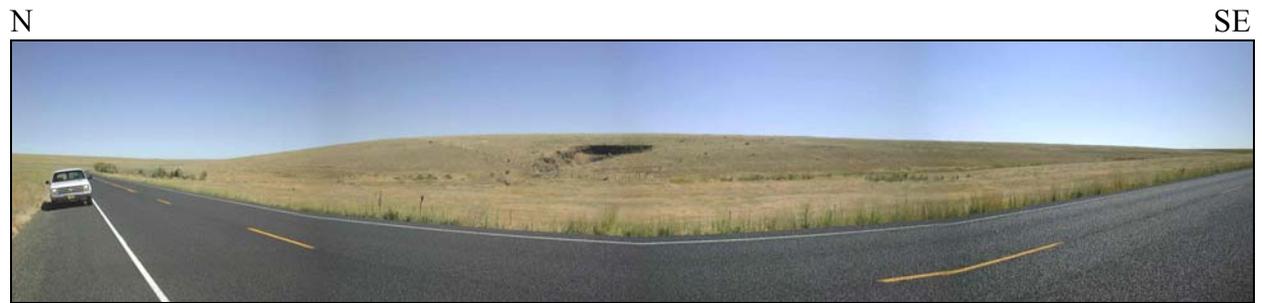
County	Site Name				Dist	Hwy	Mile Pt	TWP	RGE	Sect
Umatilla	McCoy Quarry				12	0028	0	02S	31.0E	06
File ID		Source #	Date Visited	Map #		Type of Site				
Q0053		30-906-5	08/08/2000	1R-1-463		Quarry				
Latitude	Longitude	Elev. (m)	Acreage	Pit Size	DOGAMI Permit #					
45 25'06.51000"	118 59'35.07000"	852	2.81	<1						
Comments										
GPS of the general area acquired using Terrain Navigator Software.										
Rock Type	Unit	Color		Weathering			Jointing			
Basalt	Tcg	NA		NA			NA			
Quality			Hardness	lbs./cu ft.	Reserve (cy)	Reserve (Tons)				
NA			NA	155	30,000	62,775				
Potentially Significant Site	Why			Open/Closed	Direction					
No	NA			NA	NA					
Adjacent Land Use										
Open space										
Remarks										
This site is located east of Highway 395 about 150 meters. It appears that this site was on the old alignment. There is a small pit less than one acre in size. The terrain is fairly flat with some overburden. There is no access to this site anymore. If we wish to use this ground in the future we will need to develop an access. This is a small amount of ground for a quarry site. This site will need a current survey to locate the boundaries.

View looking east across Highway 395 at the small quarry site.

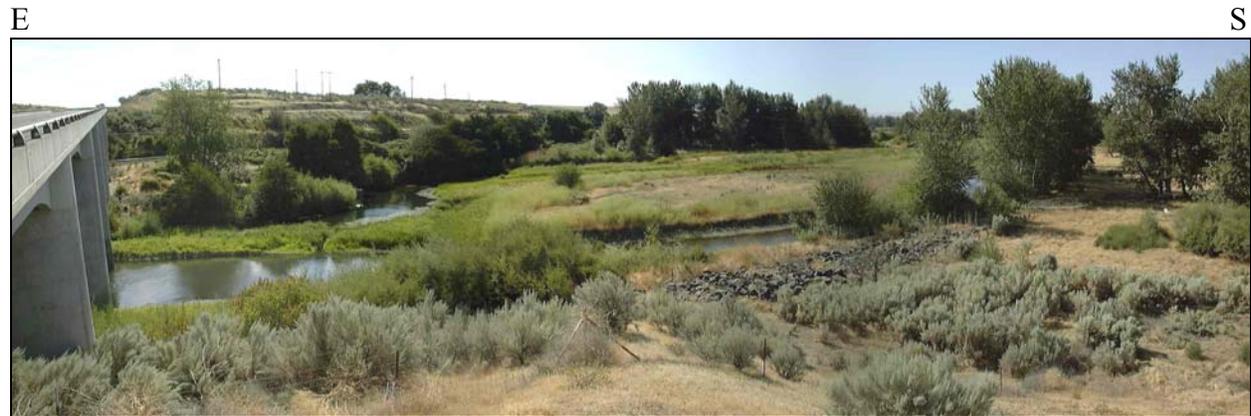
County	Site Name			Dist	Hwy	Mile Pt	TWP	RGE	Sect
Umatilla	Boardman Stanfield Gravel Pit			12	0006	0	03N	29.0E	05
File ID		Source #	Date Visited	Map #			Type of Site		
08832, 08832A		30-919-5	08/10/2000	1R-2-1114			Gravel		
Latitude	Longitude	Elev. (m)	Acreage	Pit Size		DOGAMI Permit #			
45 45'49.61000"	119 12'43.82000"	190	9.8	NA					
Comments									
Lat. and Long. acquired using Terrain Navigator Software									
Rock Type	Unit	Color		Weathering			Jointing		
Gravel	Qal	NA		NA			NA		
Quality			Hardness	lbs./cu ft.	Reserve (cy)	Reserve (Tons)			
NA			NA	120					
Potentially Significant Site	Why			Open/Closed	Direction				
No	NA			NA	Umatilla River bisects the ground				
Adjacent Land Use									
Farming/Open Space									
Remarks									
This site is within the Umatilla River under Interstate 84. There is no access to the site any more. This site has mitigation potential.									
202B	203B	211	206 Fine	206 Coarse	208 F	208 F Ht.	208 C	208 C Ht.

View of the gravel site in the Umatilla River under I-84 eastbound.

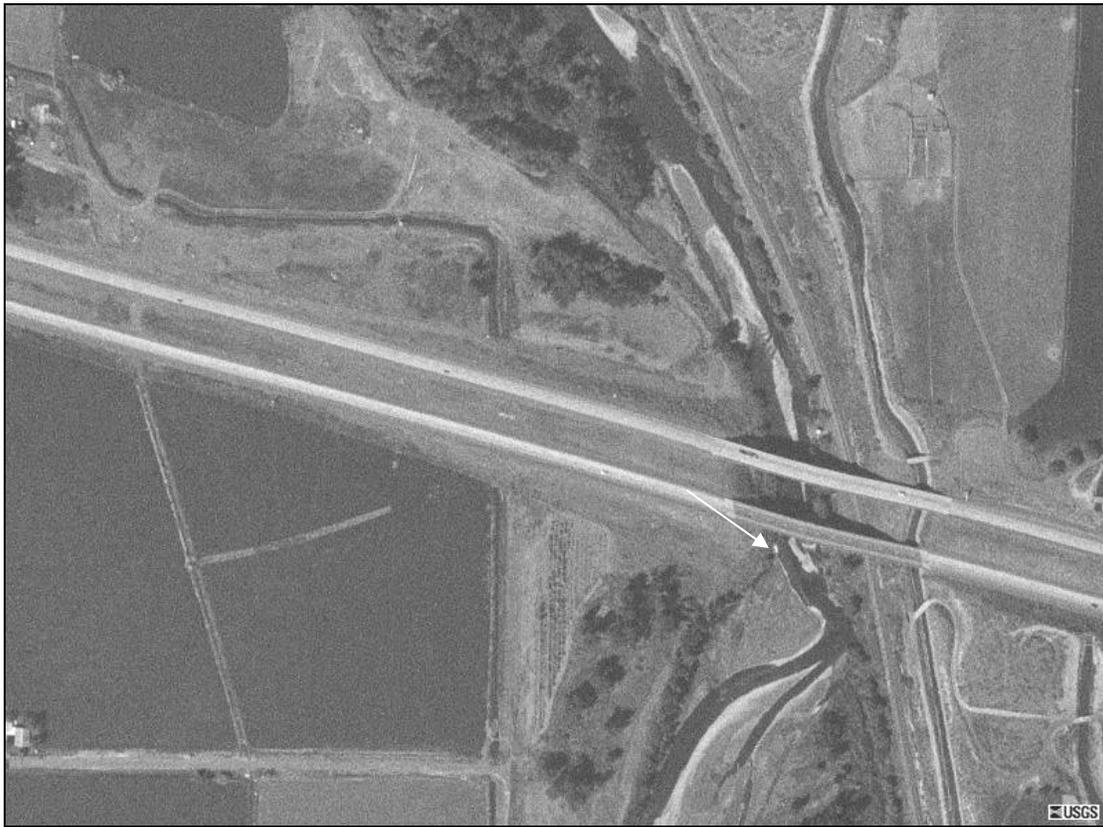
Aerial view of the gravel site within the Umatilla River.

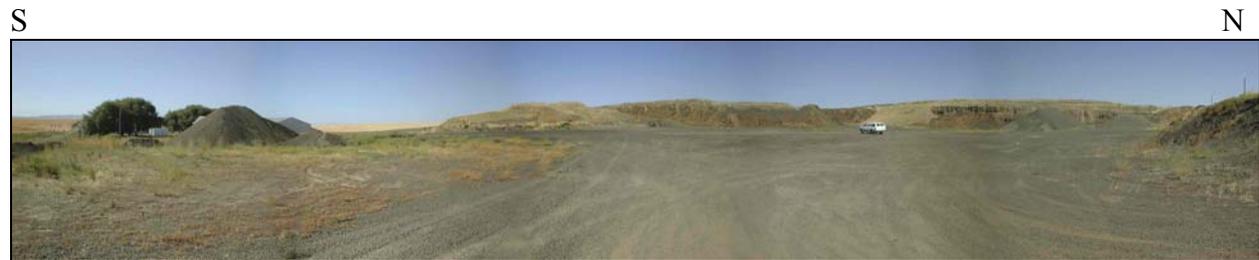
County	Site Name				Dist	Hwy	Mile Pt	TWP	RGE	Sect
Umatilla	Catron Pit				12	0334	14.7	04N	34.0E	22
File ID		Source #	Date Visited	Map #			Type of Site			
13409		30-921-5	08/09/2000	1R-2-1758			Quarry			
Latitude	Longitude	Elev. (m)	Acreage	Pit Size	DOGAMI Permit #					
45 48'40.79044"	118 32'59.65309"	511.867	2.73	<6	30-0004					
Comments										
GPS acquired in the pit.										
Rock Type	Unit	Color		Weathering			Jointing			
Basalt	Tcw	Medium Light Grey (N6)		Moderate			Highly Fractured			
Quality			Hardness	lbs./cu ft.	Reserve (cy)	Reserve (Tons)				
Fair to Good			R2	188	100,000	150,000				
Potentially Significant Site	Why			Open/Closed	Direction					
No	NA			Closed	NA					
Adjacent Land Use										
Farming										
Remarks										
This site is adjacent to and west of Gerking Flat Road. The rock is a fine-grain, highly fractured basalt. There is heavy iron staining within the basalt at this location. There is no screening but ample room to work. The pit floor is at the gravel road level now. If we want more aggregate we will need to lower the pit floor. If we lowered the pit another 20 feet we could get about 160,000 cubic yards of material.

View of the quarry site located adjacent to and west of Gerking Flat Road. The disturbance is much larger than the 2.73 acres that ODOT owns.

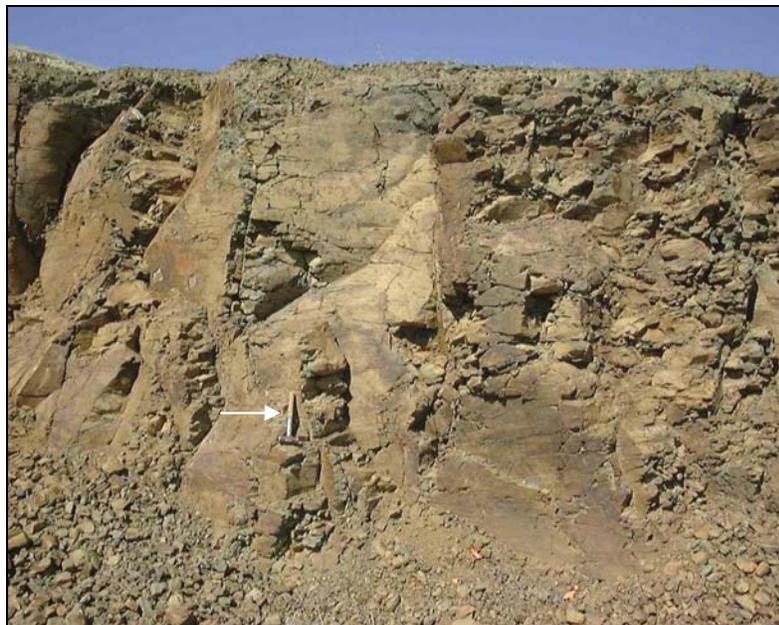
Close-up view of the pit face.

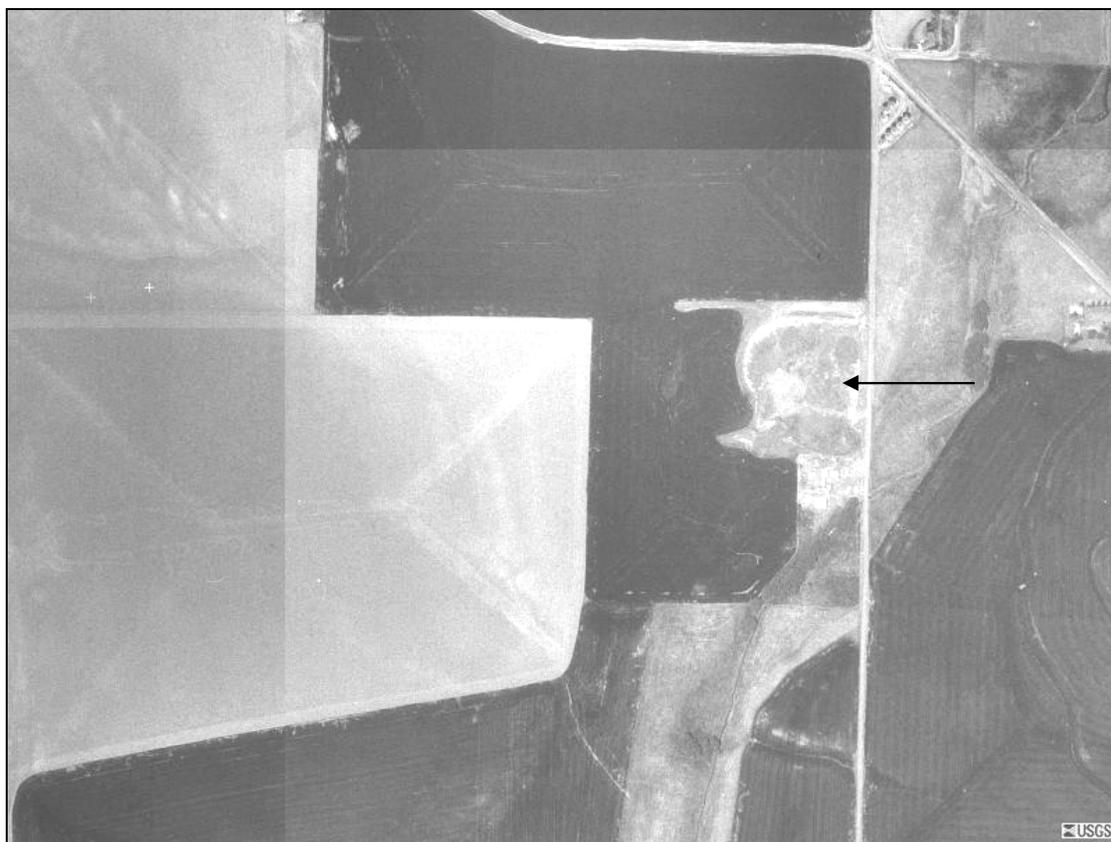
Aerial view of the quarry site located adjacent to and west of Gerking Flat Road.

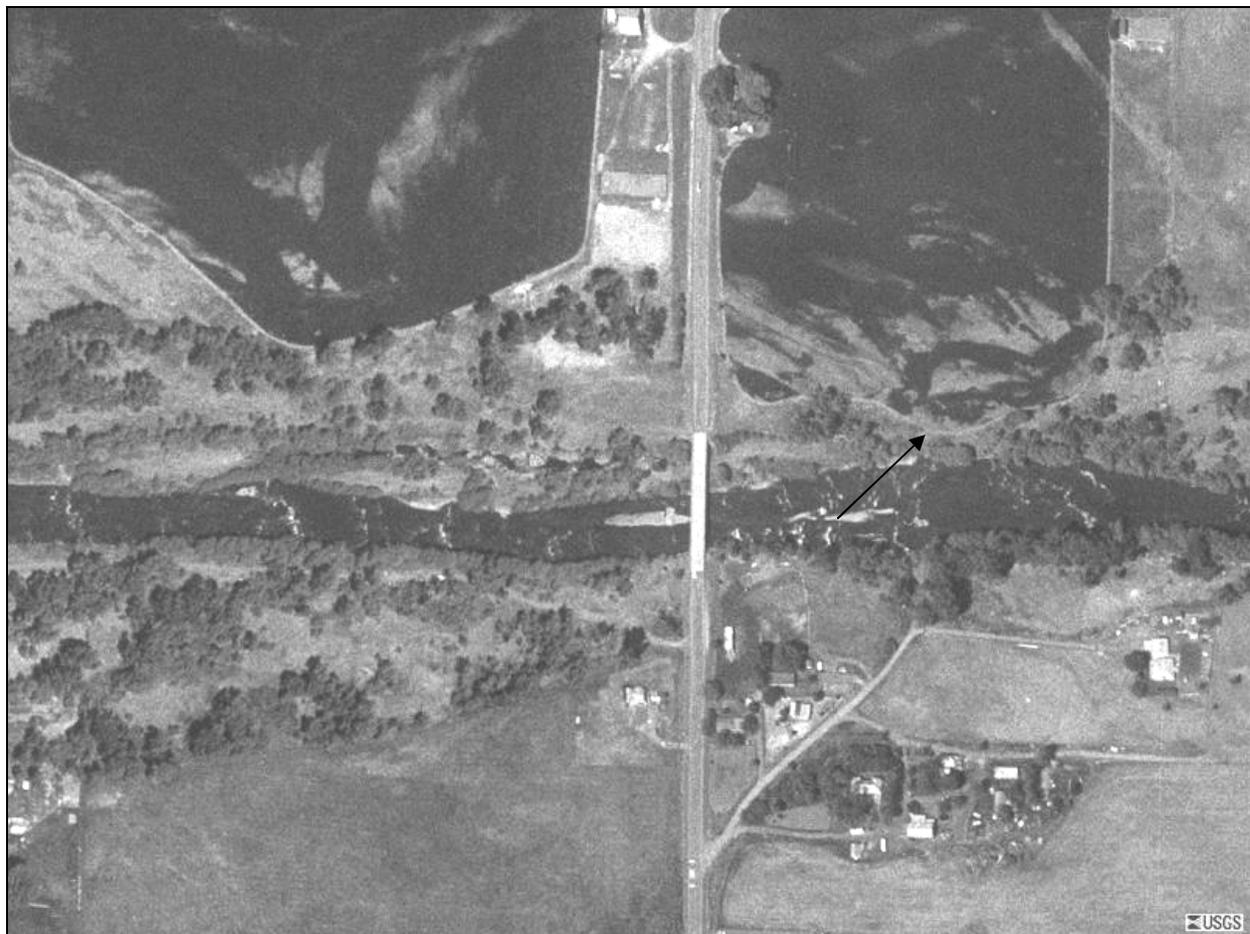
County	Site Name	Dist	Hwy	Mile Pt	TWP	RGE	Sect
Umatilla		12	0008	0	02N	33.0E	03, 10
File ID		Source #	Date Visited	Map #		Type of Site	
06223, 06224		30-926-5	08/09/2000	1R-2-577		Gravel	
Latitude	Longitude	Elev. (m)	Acreage	Pit Size	DOGAMI Permit #		
45 40'30.30000"	118 40'55.12000"	396	4.21	NA			
Comments							
Lat. and Long. acquired using Terrain Navigator Software							
Rock Type	Unit	Color	Weathering		Jointing		
Alluvium	Qal	NA	NA		NA		
Quality			Hardness	lbs./cu ft.	Reserve (cy)	Reserve (Tons)	
NA			NA	120			
Potentially Significant Site	Why			Open/Closed	Direction		
No	NA			Closed	Adjacent is the Umatilla River		
Adjacent Land Use							
Rural residential							
Remarks							
This site is east of the Umatilla Mission Highway and north of the Umatilla River on the old alignment. This site could have mitigation potential.							
202B	203B	211	206 Fine	206 Coarse	208 F	208 F Ht.	208 C
Material Use

Aerial view of the gravel site located north of the Umatilla River.

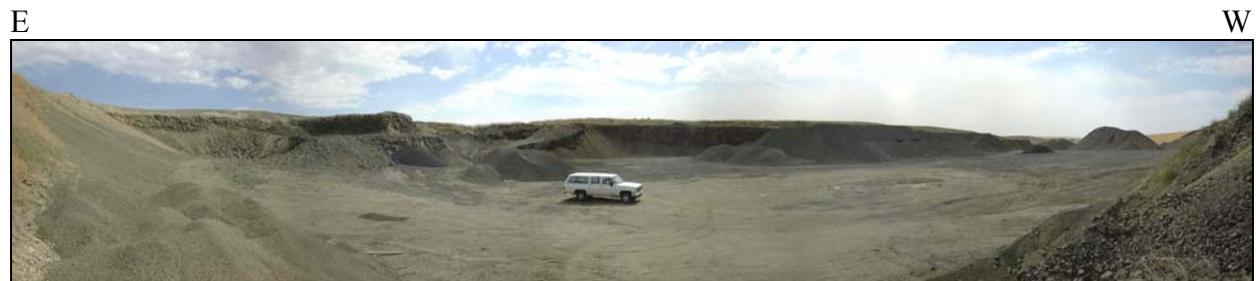
County	Site Name				Dist	Hwy	Mile Pt	TWP	RGE	Sect
Umatilla	Struve (HASCOM)				12	0334	2.0	04N	32.0E	23
File ID		Source #	Date Visited	Map #		Type of Site				
13446, 32303, 38342		30-999-5	08/09/2000	1R-2-1702		Quarry				
Latitude	Longitude	Elev. (m)	Acreage	Pit Size	DOGAMI Permit #					
45 48'58.05000"	118 46'58.03000"	487	13.66	<4	30-0067					
Comments										
Lat. and Long. acquired using Terrain Navigator Software										
Rock Type	Unit	Color		Weathering		Jointing				
Basalt	Tcw	Medium Dark Grey (N4)		Slight		Highly Fractured				
Quality			Hardness	lbs./cu ft.	Reserve (cy)	Reserve (Tons)				
Good			R3	155	50,000	75,000				
Potentially Significant Site	Why			Open/Closed	Direction					
No	NA			Closed	NA					
Adjacent Land Use										
Farming										
Remarks										
This site is adjacent to and north of Highway 37. The material is composed of a fine-grain, highly fractured basalt. The quarry is almost depleted of aggregate after this site was used for the paving of Highway 37 during the year 2000. There is a large amount of stock pile material left over. There is room to work with limited screening. You could rip the rock.

View looking south at the quarry site located north of Highway 37.

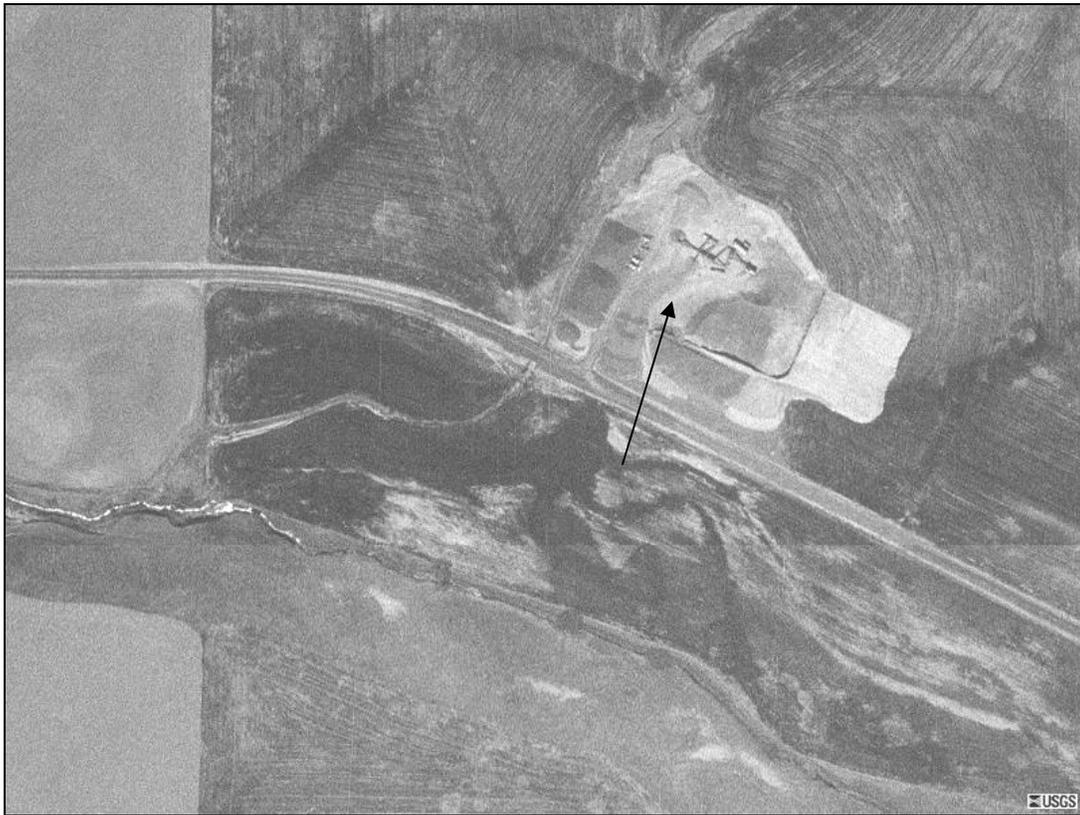
Aerial view of the quarry site located north of Highway 37.

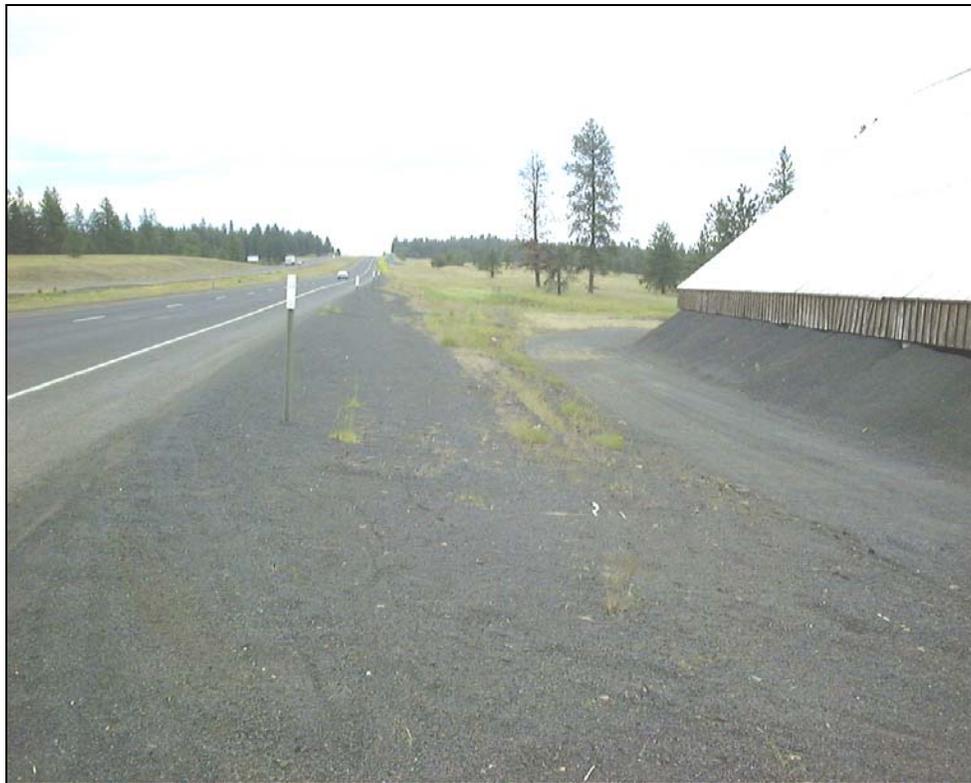
County	Site Name				Dist	Hwy	Mile Pt	TWP	RGE	Sect
Union					12	0006	249.0	02S	36.0E	26
File ID		Source #	Date Visited	Map #		Type of Site				
04952		31-001-5	08/15/2000	1R-1-1783		Maintenance Yard				
Latitude		Longitude	Elev. (m)	Acreage	Pit Size	DOGAMI Permit #				
45 21'46.67000"		118 16'29.17000"	1097	9.27	NA					
Comments										
Lat. and Long. acquired using Terrain Navigator Software										
Rock Type	Unit	Color		Weathering			Jointing			
NA	Tcg	NA		NA			NA			
Quality			Hardness	lbs./cu ft.	Reserve (cy)	Reserve (Tons)				
NA			NA	0						
Potentially Significant Site	Why				Open/Closed	Direction				
NA	NA				NA	NA				
Adjacent Land Use										
Open space										
Remarks										
This site is adjacent to and south of Interstate 84. It appears this ground is being used for one of our sanding sheds and a stock pile site.										
202B	203B	211	206 Fine	206 Coarse	208 F	208 F Ht.	208 C	208 C Ht.

View of the sanding shed located south of I-84.

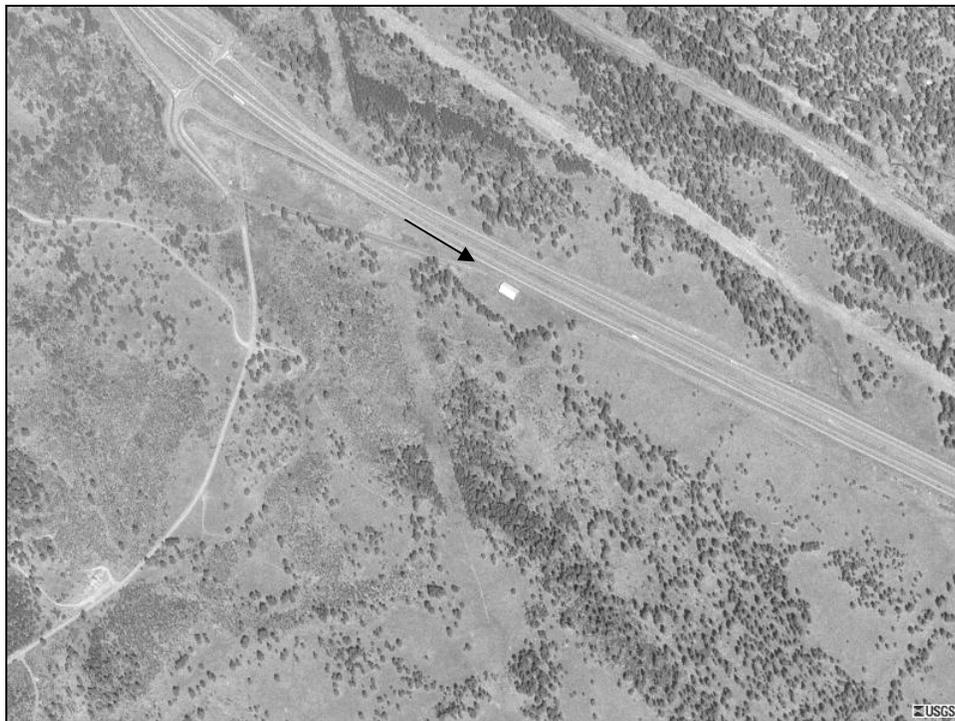
Aerial view of the sanding shed and stockpile site located adjacent to I-84.

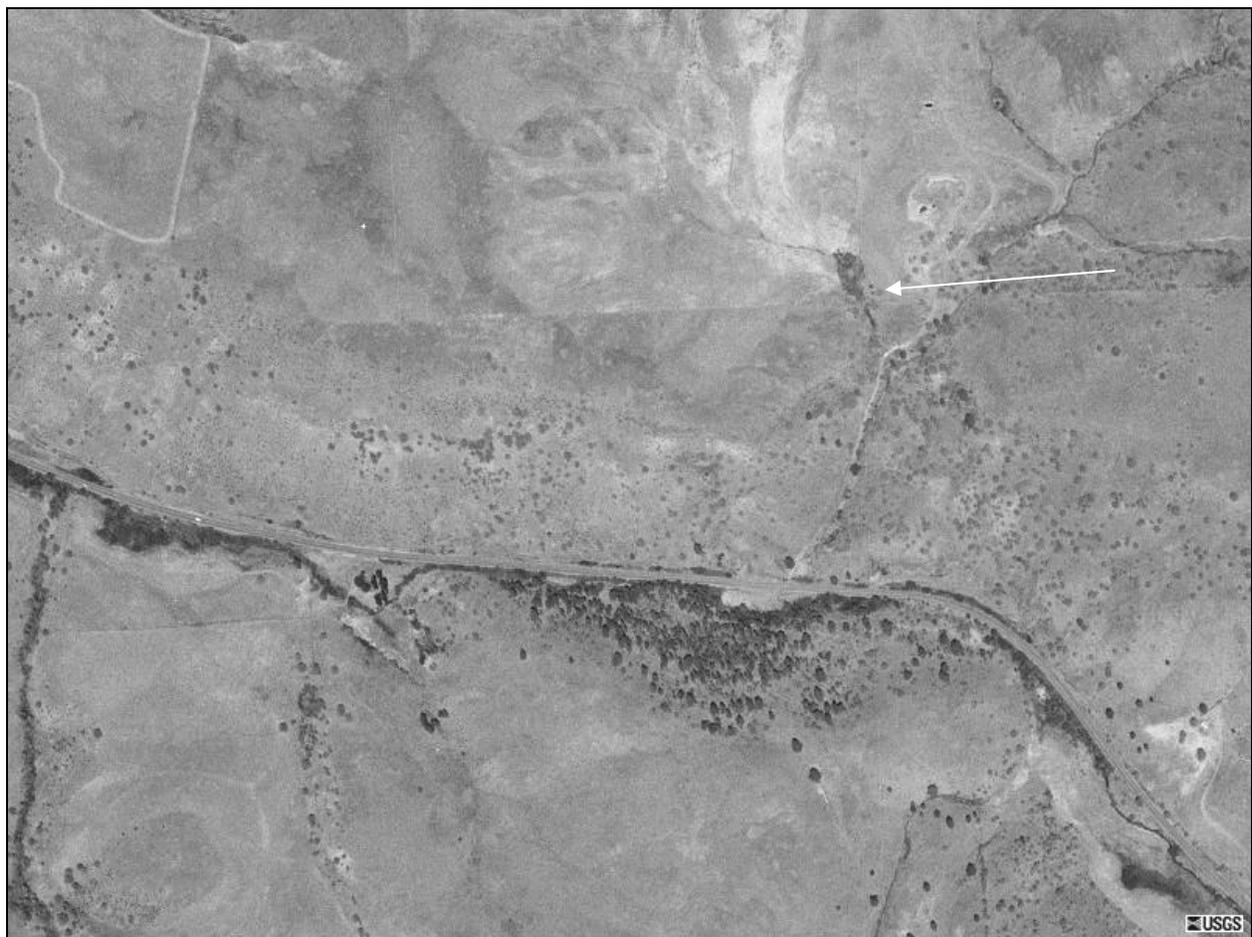
County	Site Name				Dist	Hwy	Mile Pt	TWP	RGE	Sect
Wheeler					12	0005	61.59	06S	21.0E	35
File ID		Source #	Date Visited	Map #			Type of Site			
03760		35-003-5	06/14/2000	1R-1-1619			Raw Land			
Latitude	Longitude	Elev. (m)	Acreage	Pit Size		DOGAMI Permit #				
44 59'33.15000"	120 09'50.25000"	960	5.35	NA						
Comments										
Lat. and Long. acquired using Terrain Navigator Software										
Rock Type	Unit	Color		Weathering			Jointing			
Basalt	Tc	NA		NA			NA			
Quality			Hardness	lbs./cu ft.	Reserve (cy)	Reserve (Tons)				
NA			NA	150	80,000	162,000				
Potentially Significant Site	Why			Open/Closed	Direction					
No	NA			Closed	NA					
Adjacent Land Use										
Open space										
Remarks										
This site is north of Highway 19 approximately 1300 feet. The access is not evident anymore and I did not hike in to evaluate the ground. The quantity is based on past records.										
202B	203B	211	206 Fine	206 Coarse	208 F	208 F Ht.	208 C	208 C Ht.

Aerial view of the raw land site located north of Highway 19 approximately 1300 feet.

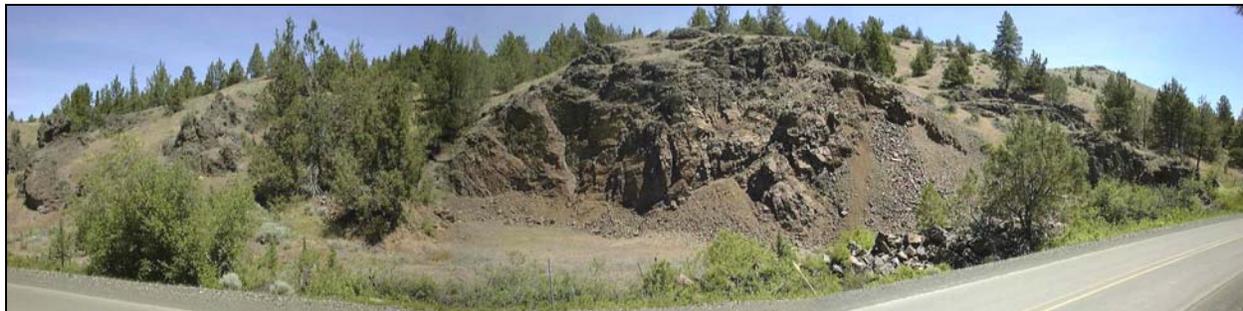
County	Site Name				Dist	Hwy	Mile Pt	TWP	RGE	Sect
Wheeler					12	0005	61.7	07S	21.0E	02
File ID		Source #	Date Visited	Map #		Type of Site				
15907, 15906		35-004-5	06/14/2000	1R-2-1990		Quarry				
Latitude	Longitude	Elev. (m)	Acreage	Pit Size	DOGAMI Permit #					
44 59'20.85705"	120 9'52.59578"	890.7	4.3	<1						
Comments										
GPS acquired at the access point and Highway 19.										
Rock Type	Unit	Color		Weathering		Jointing				
Andesite	Tca	Olive Grey (5Y 4/1)		Slight		Highly Fractured				
Quality			Hardness	lbs./cu ft.	Reserve (cy)	Reserve (Tons)				
Fair to Good			R3+	160	70,000	151,200				
Potentially Significant Site	Why			Open/Closed	Direction					
No	NA			Closed	Adjacent to Butte Creek					
Adjacent Land Use										
Open space										
Remarks										
This site is located adjacent to and north of Highway 19. The rock is a fine-grain, platy andesite with interfingering debris flows. There is moderate amount of rip rap at this site. There is no screening from the highway and limited room to work. You will need to work from the top down here as the cliffs are very dangerous to work around. You might be able to rip the material, but I suggest shooting the rock.

View of the quarry site looking across Highway 19 to the north.

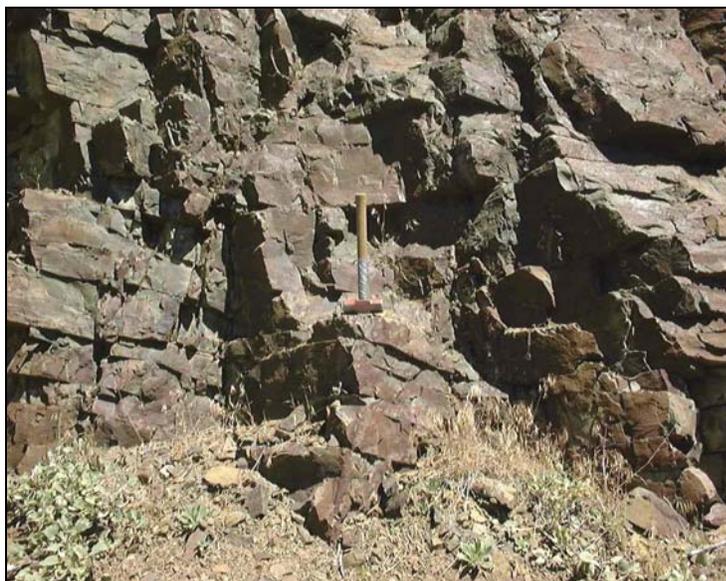
Close-up view of the highly fractured andesite that comprises the quarry face.

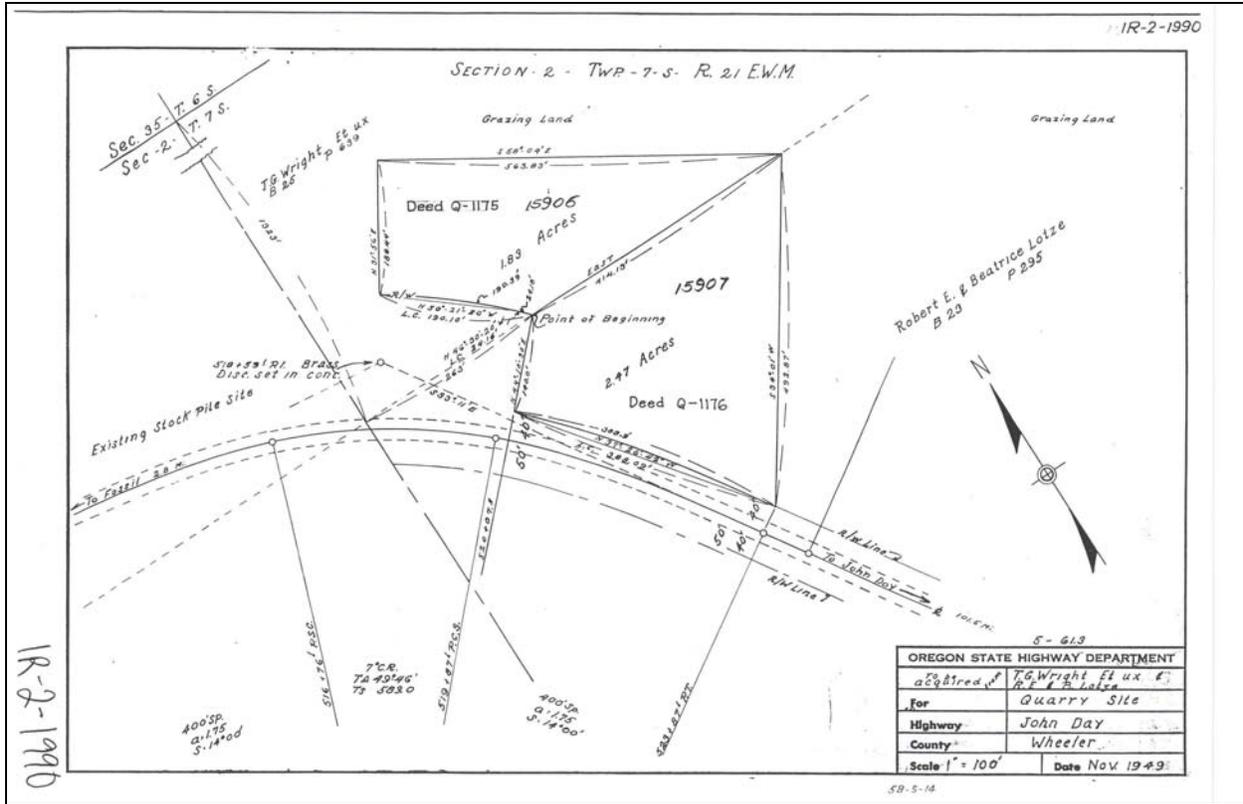
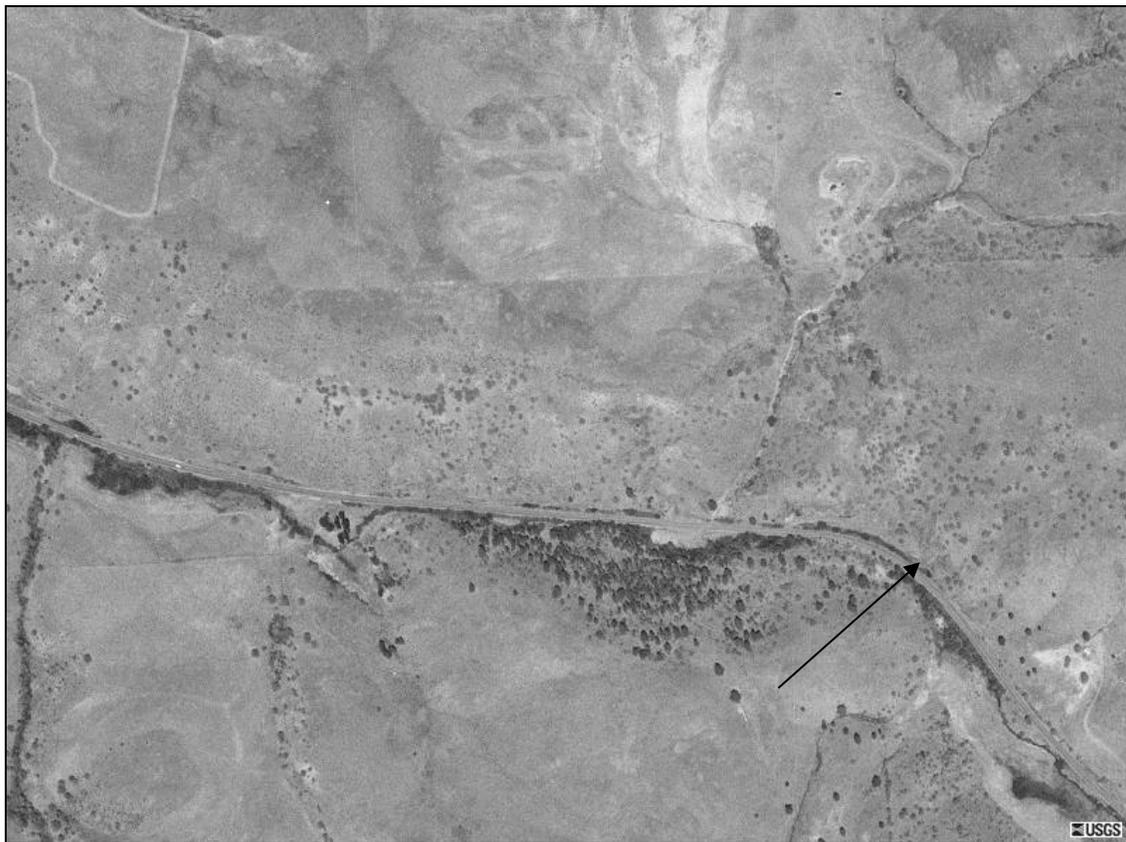
Aerial view of the quarry site located north of Highway 19.

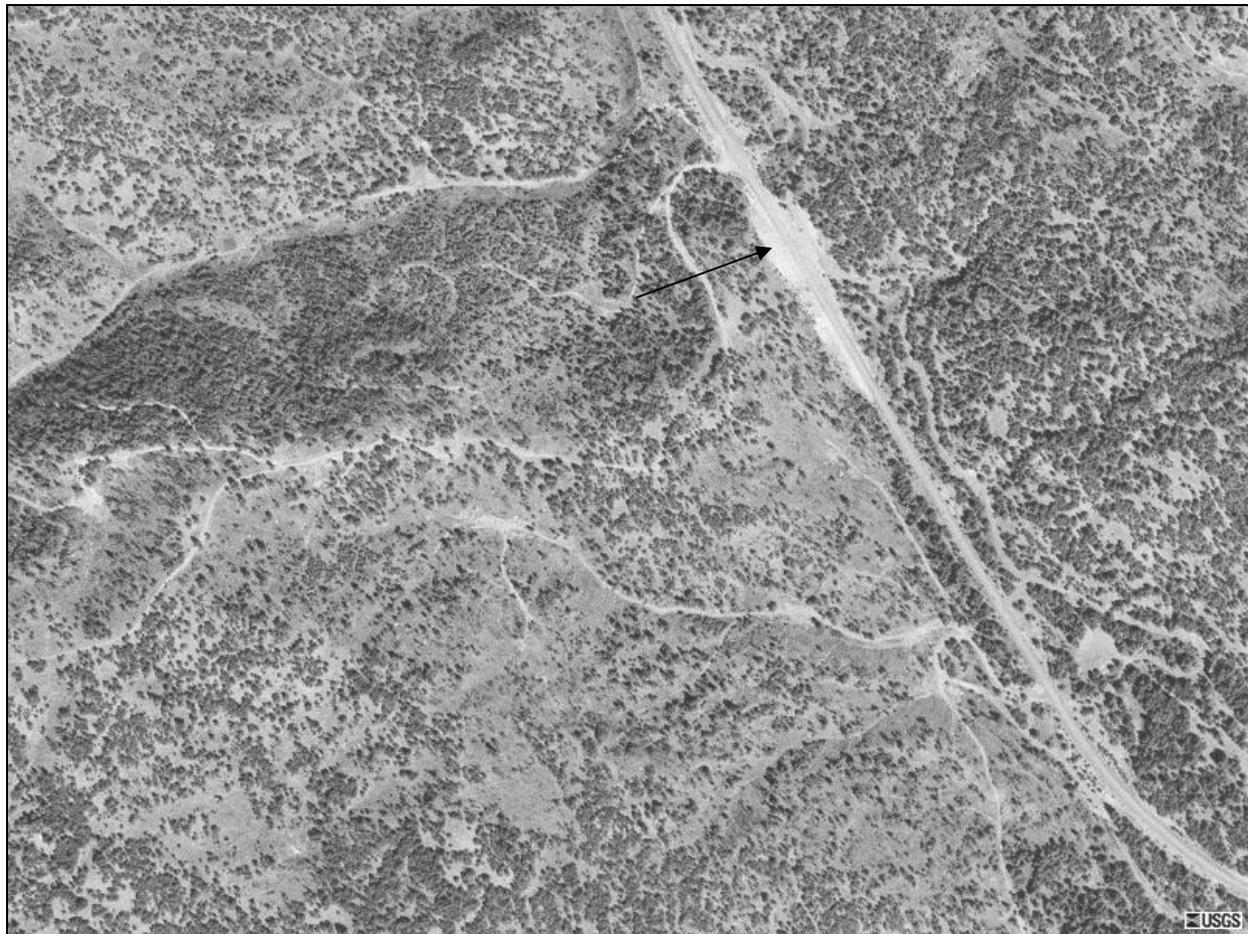
County	Site Name			Dist	Hwy	Mile Pt	TWP	RGE	Sect
Wheeler				12	0005	68.9	08S	22.0E	04
File ID		Source #	Date Visited	Map #			Type of Site		
01729		35-005-5	06/13/2000	1R-1-1378			Raw Land		
Latitude	Longitude	Elev. (m)	Acreage	Pit Size		DOGAMI Permit #			
44 54'17.56000"	120 06'26.02000"	1216	3.34	NA					
Comments									
Lat. and Long. acquired using Terrain Navigator Software									
Rock Type	Unit	Color		Weathering			Jointing		
Debris Flow	Tca	NA		NA			NA		
Quality			Hardness	lbs./cu ft.	Reserve (cy)	Reserve (Tons)			
Poor			R2	120					
Potentially Significant Site	Why			Open/Closed	Direction				
No	NA			Closed	NA				
Adjacent Land Use									
Open space									
Remarks									
This site has been consumed by the new alignment of Highway 19 and is right-of-way now at the summit. The rock here is of poor quality and has little to no value for highway construction.									
202B	203B	211	206 Fine	206 Coarse	208 F	208 F Ht.	208 C	208 C Ht.

Aerial view of the raw land site which is now right-of-way for Highway 19.

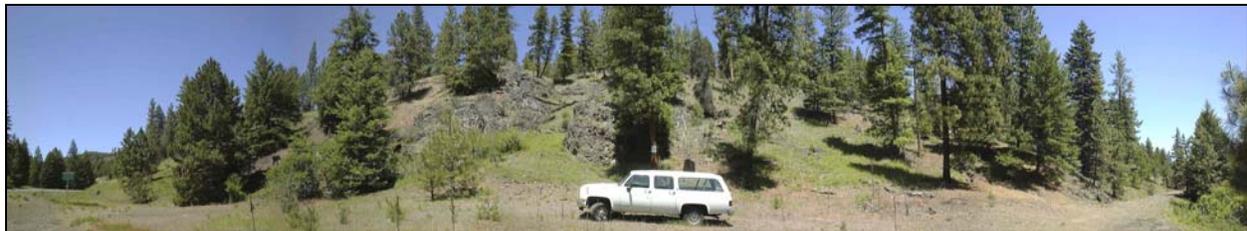
View of the raw land site along the old alignment of Highway 19.

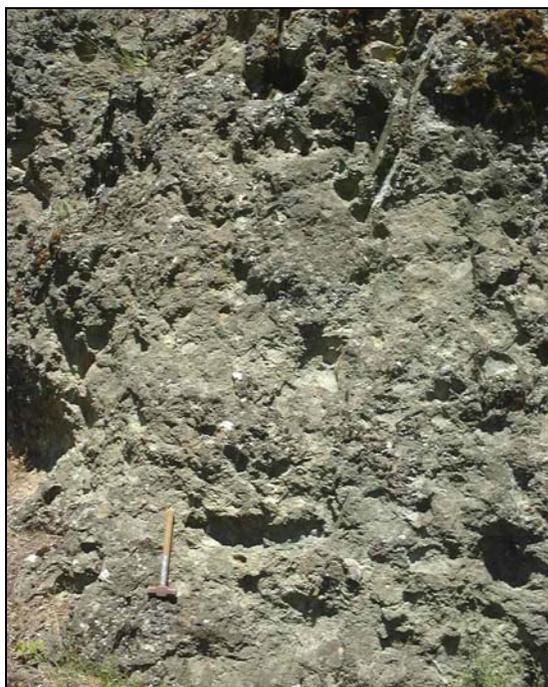
Close-up view of the poor quality debris flow.

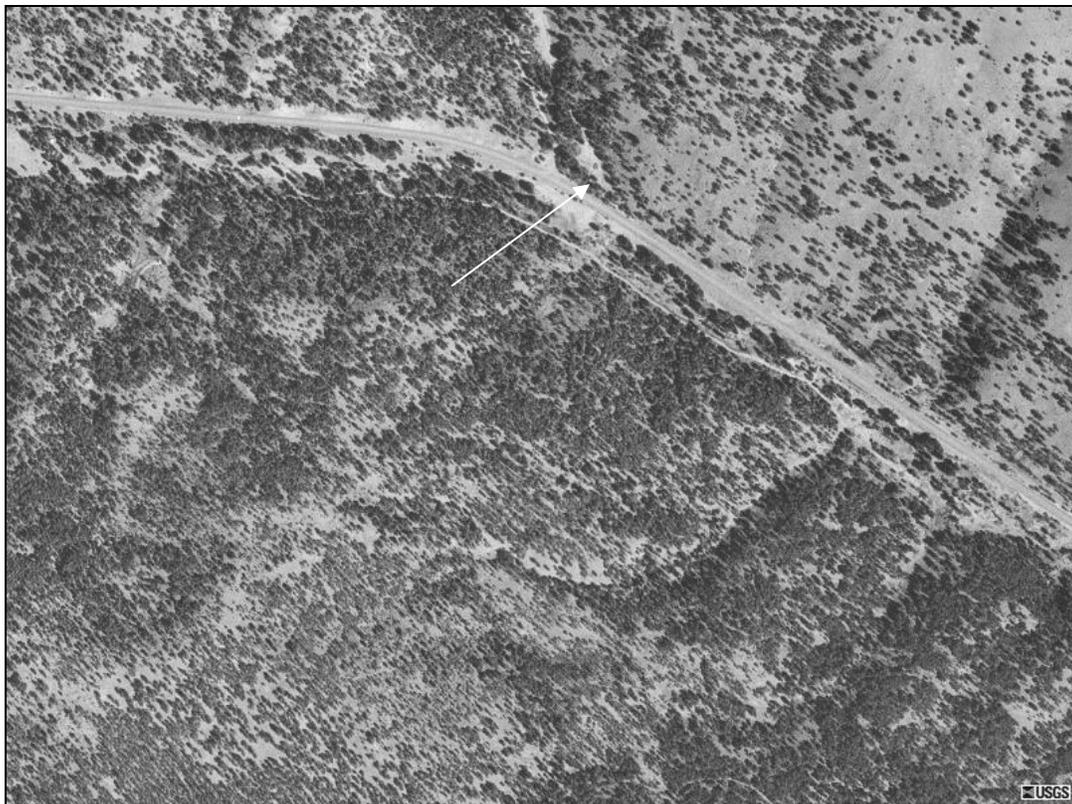
Aerial view of the raw land site located along Highway 19.

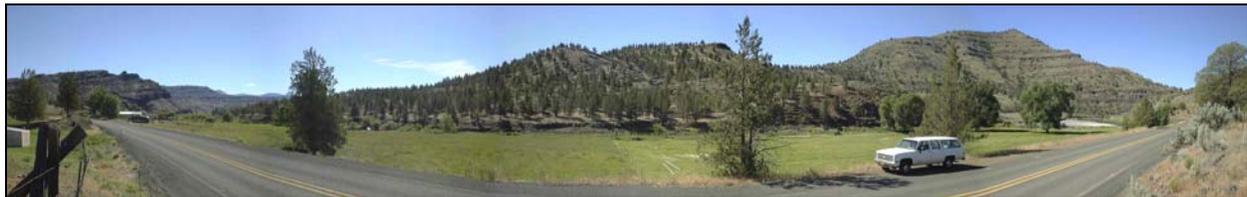
County	Site Name			Dist	Hwy	Mile Pt	TWP	RGE	Sect
Wheeler				12	0005	90.1	08S	24.0E	35
File ID		Source #	Date Visited	Map #			Type of Site		
03016, Q0435		35-009-5	06/13/2000	1R-1-1534, 1R-1-1509, 4B-25-14			Raw Land		
Latitude	Longitude	Elev. (m)	Acreage	Pit Size		DOGAMI Permit #			
44 49'50.95000"	119 49'38.41000"	548	48.12	NA					
Comments									
Lat. and Long. acquired using Terrain Navigator Software									
Rock Type	Unit	Color	Weathering			Jointing			
Volcanic Gravel	Qal	NA	NA			NA			
Quality			Hardness	lbs./cu ft.	Reserve (cy)	Reserve (Tons)			
Fair to Good			NA	120	755,000	1,223,100			
Potentially Significant Site	Why			Open/Closed	Direction				
No	Part is USA Ground			Closed	On either side of the John Day River				
Adjacent Land Use									
Open Space/Ranching									
Remarks									
This site is raw land with no visible disturbances. It is adjacent to and south of Highway 19 and on either side of the John Day River. The ground is being used for livestock grazing and irrigation by the adjacent property owner. The property is 10 feet below the highway and 6 feet above the river. There is no screening and ample room to work. The ground on the south side of the river has no access. The lithology is a basalt within the Columbia River group. The terrain varies from flat to a moderate slope of about 10 degrees.

View of the raw land site looking south across Highway 19.

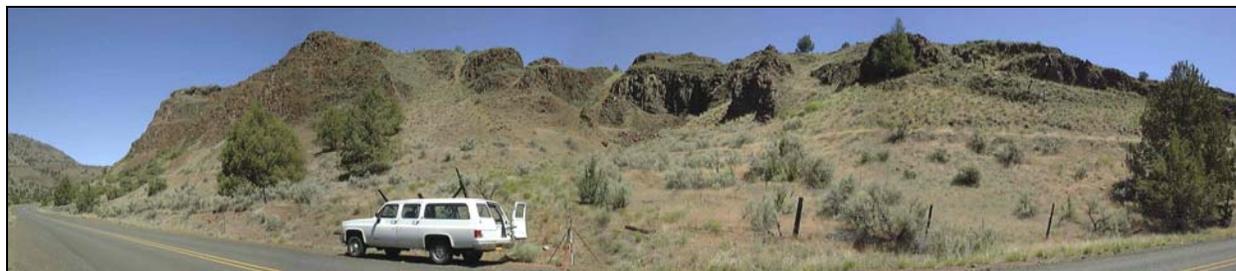
County	Site Name				Dist	Hwy	Mile Pt	TWP	RGE	Sect
Wheeler					12	0005	102.9	09S	25.0E	23
File ID		Source #	Date Visited	Map #		Type of Site				
06439		35-010-5	06/13/2000	1R-2-731		Quarry				
Latitude	Longitude	Elev. (m)	Acreage	Pit Size	DOGAMI Permit #					
44 46'39.60032"	119 40'49.57058"	559.702	3.86	<1						
Comments										
GPS acquired at access point.										
Rock Type	Unit	Color		Weathering		Jointing				
Basalt	Tcp	Medium Dark Grey (N4)		Slight to Moderate		Highly Fractured				
Quality		Hardness		lbs./cu ft.	Reserve (cy)	Reserve (Tons)				
Poor to Good		R2+ to R3+		170	60,000	137,700				
Potentially Significant Site	Why	Open/Closed		Direction						
No	NA	Closed		South across Highway 19 about 200 meters is the John Day River						
Adjacent Land Use										
Open space/one ranch to the east approximately 350 meters										
Remarks										
This site is adjacent to and north of Highway 19. The rock is a medium-grain basalt that has varying igneous lithologies mixed together. Some of the rock is a fine-grain good quality basalt and some is a poor quality basalt. There is no screening from the highway and no room to work. This site has moderately steep terrain. There is a moderate amount of staining and secondary mineral alteration.

View of the quarry site located adjacent to and north of Highway 19.

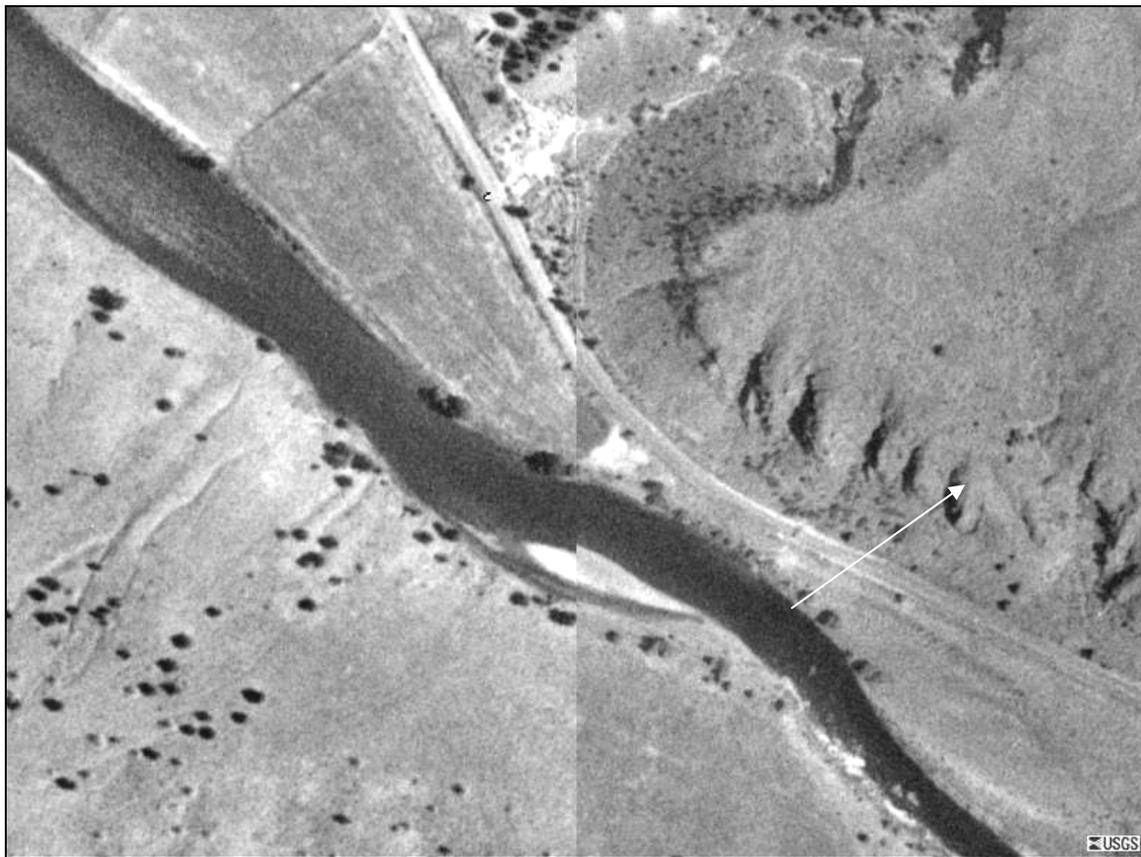
35-010-5

Close-up view of the medium grain basalt found at this quarry site.

Aerial view of the quarry site that is located north of Highway 19.

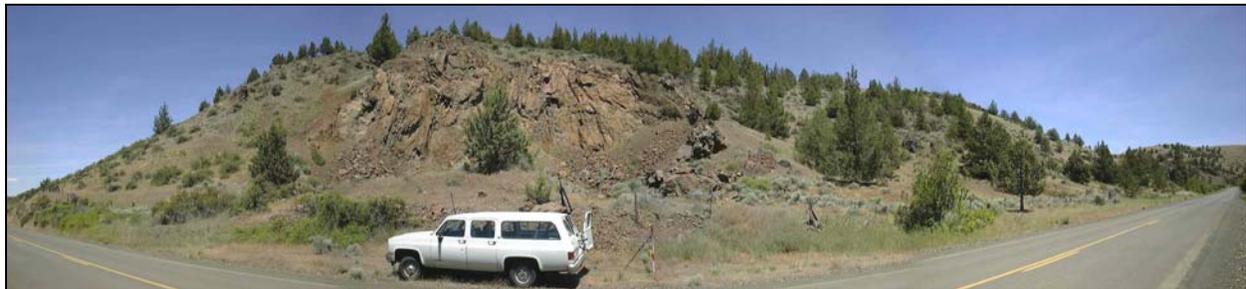
View looking north across Highway 19 at the quarry site.

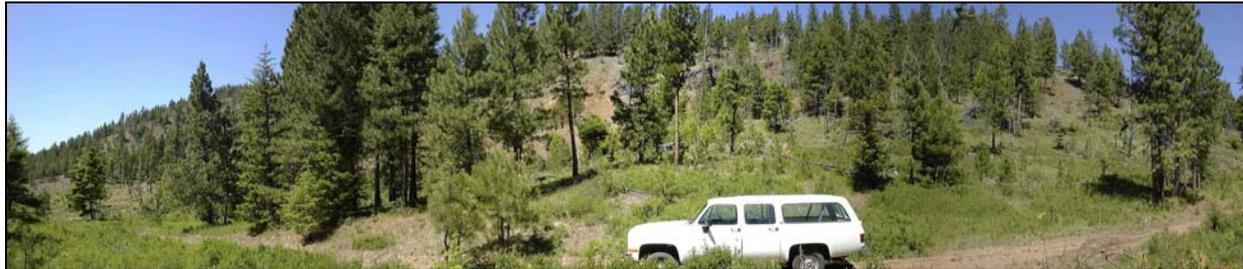
View of the raw land site located east of Highway 19 about 1200 meters.

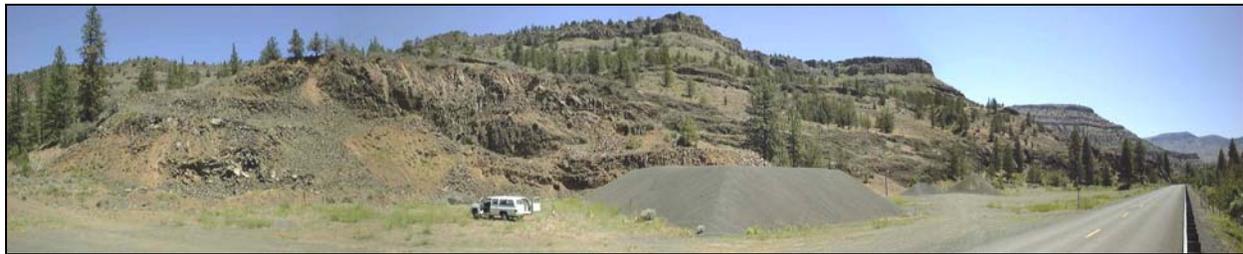
County	Site Name				Dist	Hwy	Mile Pt	TWP	RGE	Sect
Wheeler	Mortimer Ranch				12	0005	75.64	08S	22.0E	36
File ID		Source #	Date Visited	Map #		Type of Site				
06435, 26855		35-039-5	06/13/2000	1R-2-735		Quarry				
Latitude	Longitude	Elev. (m)	Acreage	Pit Size	DOGAMI Permit #					
44 49'46.91957"	120 01'49.69147"	661.933	5.73	<5	35-0016					
Comments										
GPS acquired in the pit.										
Rock Type	Unit	Color		Weathering		Jointing				
Basalt	Tcp	Greenish Black (5G 2/1)		Slight		Moderately Fractured				
Quality			Hardness	lbs./cu ft.	Reserve (cy)	Reserve (Tons)				
Good to Fair			R3	177	95,000	227,003				
Potentially Significant Site	Why	Open/Closed	Direction							
No	NA	Closed	West across Highway 19 about 150 meters is Service Creek							
Adjacent Land Use										
Open space/one ranch to the northwest about 700 meters										
Remarks										
This site is located adjacent to and east of Highway 19. The rock is a fine-grain basalt with minor intermixed poor quality basalts. Some of the layers are decomposing, otherwise you have a good hard basalt. There is no screening with plenty of room to work. You can rip the rock. This property is also used as a stock pile site. The quarry face is about 30 to 40 feet tall. The terrain is moderately steep, about 10 degrees. This site is getting close to being depleted. The property is along the old highway alignment.

View of the quarry site located adjacent to and east of Highway 19.

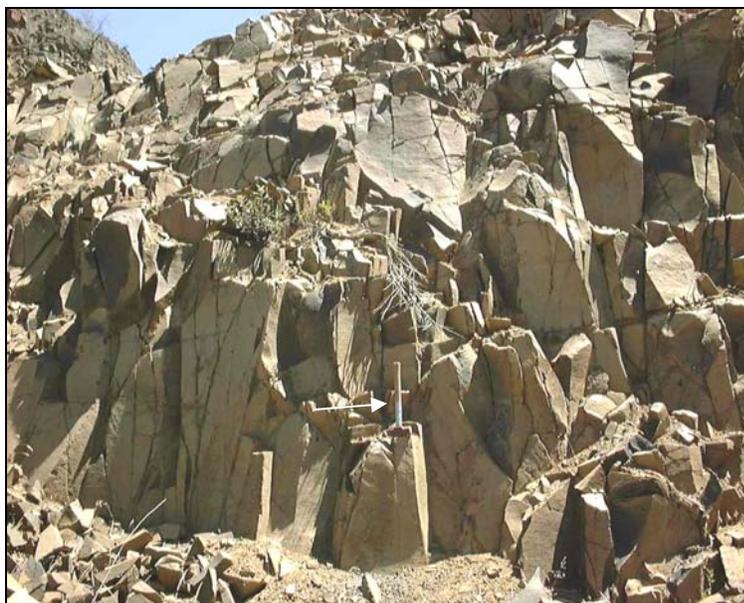
View of the quarry face and the fine-grain basalt.

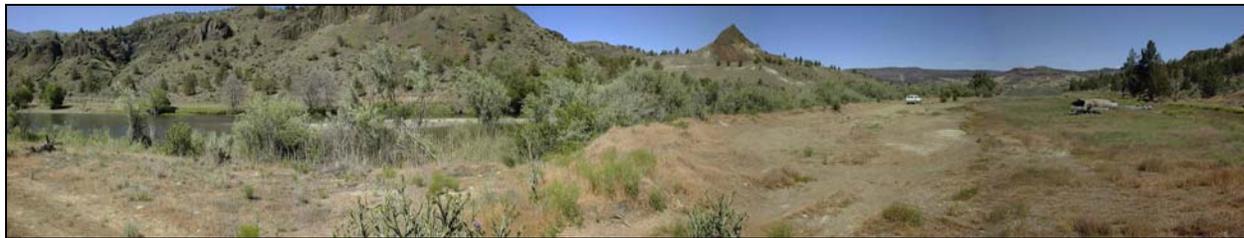
View of the gravel site that is now used as a stock pile site.
