OREGON DEPARTMENT OF TRANSPORTATION

AGGREGATE SITES

DISTRICT 12

JUNE 2002

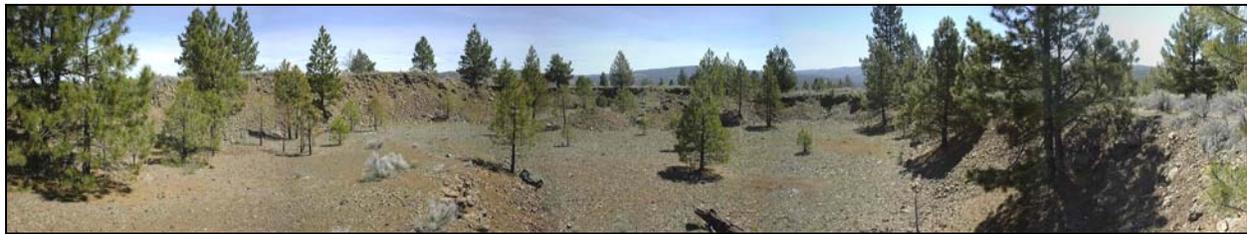
County	Site Name				Dist	Hwy	Mile Pt	TWP	RGE	Sect
Wheeler					12	0005	62.650	06S	22.0E	33
File ID		Source #	Date Visited	Map #		Type of Site				
13515		35-903-5	06/14/2000	1R-2-1710		Quarry				
Latitude	Longitude	Elev. (m)	Acreage	Pit Size	DOGAMI Permit #					
45 00'04.72662"	120 06'02.48815"	1209.013	9.05	<2						
Comments										
GPS acquired in the first pit.										
Rock Type	Unit	Color		Weathering		Jointing				
Basalt	Tca	Olive Grey (5Y 4/1)		Moderate to Slight		Highly Fractured				
Quality			Hardness	lbs./cu ft.	Reserve (cy)	Reserve (Tons)				
Fair			R3	166	220,000	493,020				
Potentially Significant Site	Why			Open/Closed	Direction					
No	NA			Closed	NA					
Adjacent Land Use										
Open space										
Remarks										
This site is about 4 miles east of Highway 19 on Kinzua Lane. The rock is a fine-grain basalt that is highly fractured. There is some moderate weathering with heavy staining. There is good screening and plenty of room to work. You can rip the rock. There is little to no overburden.

View of the quarry site located 4 miles east of Highway 19 on Kinzua Lane.

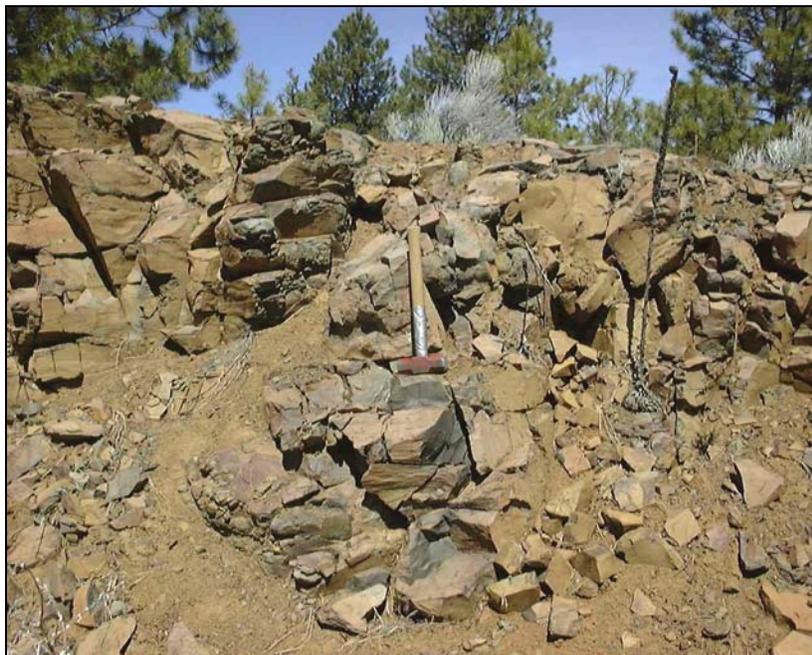
Close-up view of the highly fractured basalt found at the site.

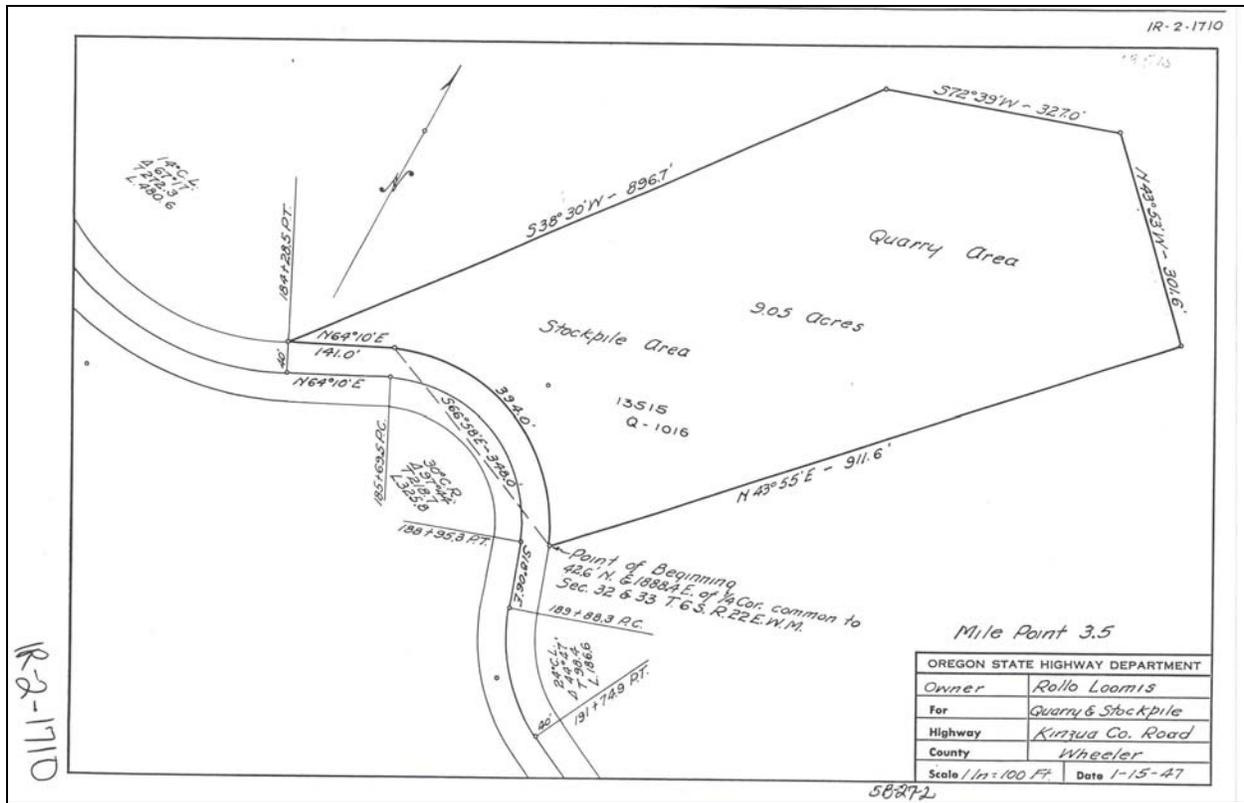
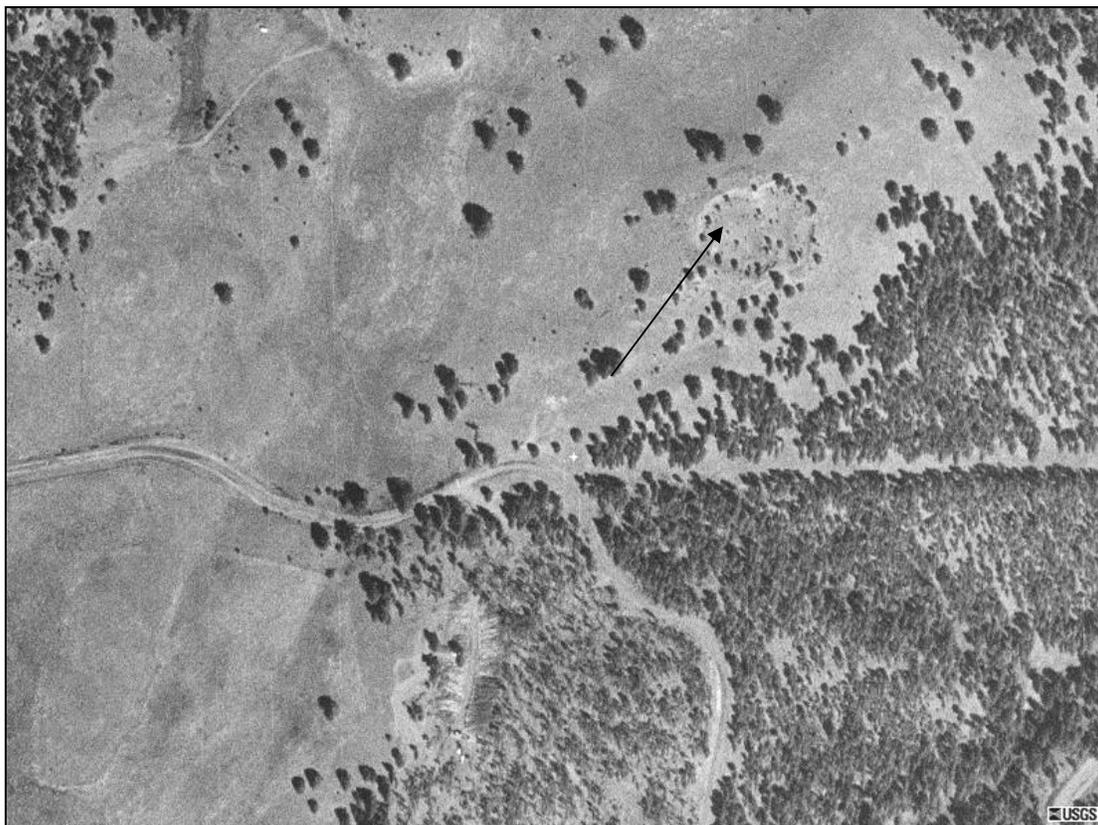
Aerial view of the quarry site located along Kinzua Lane, 4 miles east of Highway 19.
