## List of Sites in District 2C

County	Site Name			Dist	Hwy	Mile Pt	TWP	RGE	Sect
Clackamas	Estacada Maintenance Yard			02C	0171	22	03S	04.0E	17
File ID		Source #	Date Visited	Map #			Type of Site		
22385, 43797		03-002-1	2/04/1999	1R-5-599			Stock Pile Site		
Latitude	Longitude	Elev. (m)	Acreage	Pit Size		DOGAMI Permit #			
45°18'18.22215"	122°20'36.58673"	133.279	8.23	NA					
Comments									
GPS acquired at the locked gate to this site.									
Rock Type	Unit	Color		Weathering			Jointing		
NA	NA	NA		NA			NA		
Quality			Hardness	lbs./cu ft.	Reserve (cy)	Reserve (Tons)			
NA			NA	0					
Potentially Significant Site	Why			Open/Closed	Direction				
No	Stock pile/Maintenance site.			Closed	NA				
Adjacent Land Use									
Residential/Rural									
Remarks									
This is a Maintenance Stock Pile and Waste/Bone Yard site. It is located on Highway 211/224 just north of Estacada. This site is depleted of any aggregate.									
202B	203B	211	206 Fine	206 Coarse	208 F	208 F Ht.	208 C	208 C Ht.

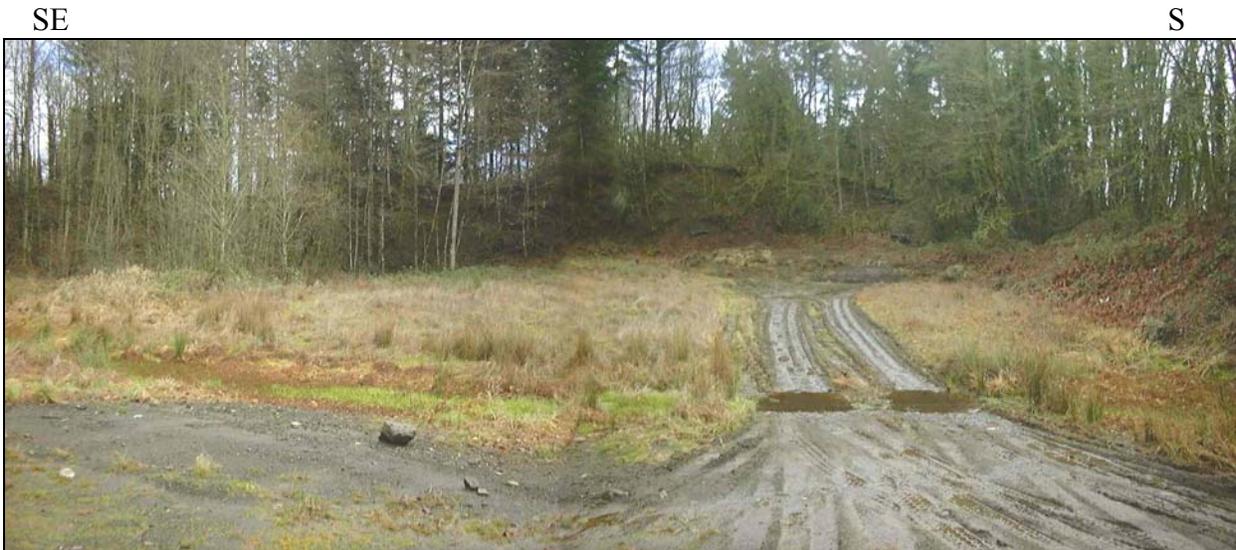
Looking south at the pit area.

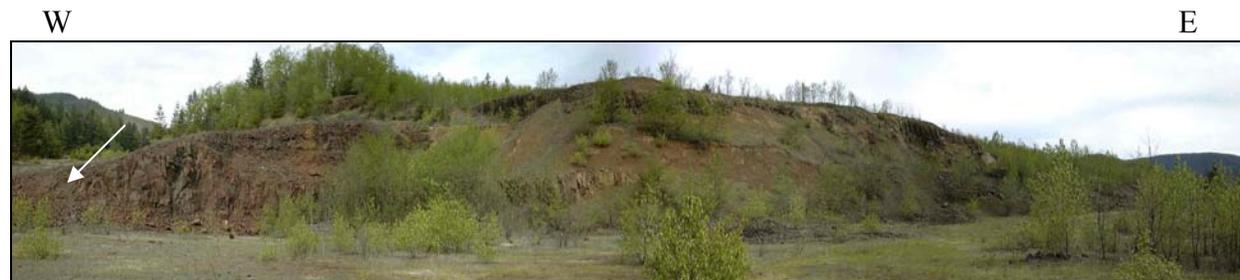
County	Site Name			Dist	Hwy	Mile Pt	TWP	RGE	Sect
Clackamas	Brightwood Quarry			02C	0026	38.06	02S	06.0E	25
File ID		Source #	Date Visited	Map #			Type of Site		
18680, 26073		03-021-1	5/06/1999	1R-1-554, 1R-5-977			Quarry		
Latitude	Longitude	Elev. (m)	Acreage	Pit Size	DOGAMI Permit #				
45°21'39.7334"	122°00'55.93769"	381.036	62.11	<20 acres	03-0201				
Comments									
GPS acquired in the pit.									
Rock Type	Unit	Color		Weathering			Jointing		
Basalt	Tfc	Medium Dark Grey (N4)		Fresh to Slight			Highly Fractured to Massive		
Quality			Hardness	lbs./cu ft.	Reserve (cy)	Reserve (Tons)			
Good to Fair			R3 to R4	170	726,000	1,666,170			
Potentially Significant Site	Why			Open/Closed	Direction				
No	This is a leased site from the BLM.			Closed	Adjacent to the Salmon River				
Adjacent Land Use									
Forest									
Remarks									
This site is about 200 meters west of Highway 26. The rock lithologies range from a fine-grain basalt/andesite to a vesicular basalt. You can rip some of the material, but most likely you would need to drill and blast the rock. This can be a large quantity of rock depending on the property boundaries. There is very good screening from the highway with plenty of room to work. We might want to think about installing a berm between the Salmon River and the pit floor at this site if we ever open it back up. Some of the aggregate should be evaluated for elongated pieces due to the fine-grain nature of the rock. This is leased ground from the BLM. The gate at the access point had no lock.

180° view looking to the north from the upper pit floor at the pit face. Arrow points to the area of the close-up image.

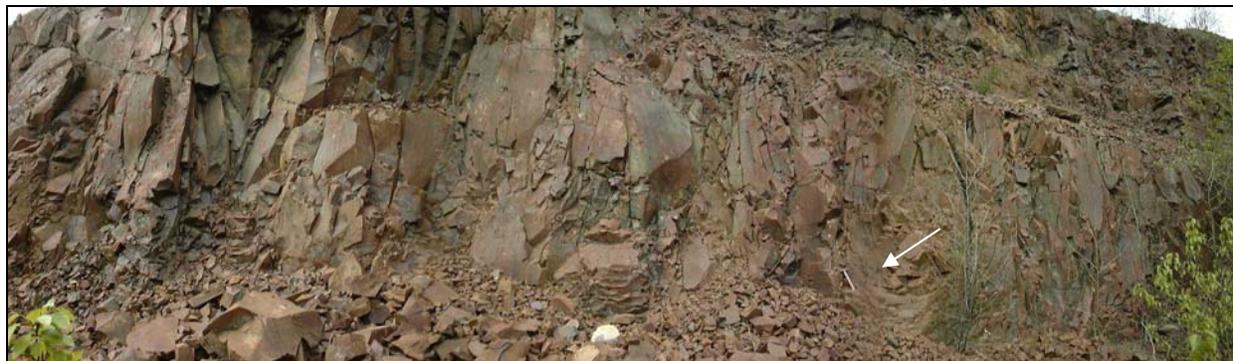
Close-up view of the pit face with the hammer for scale.

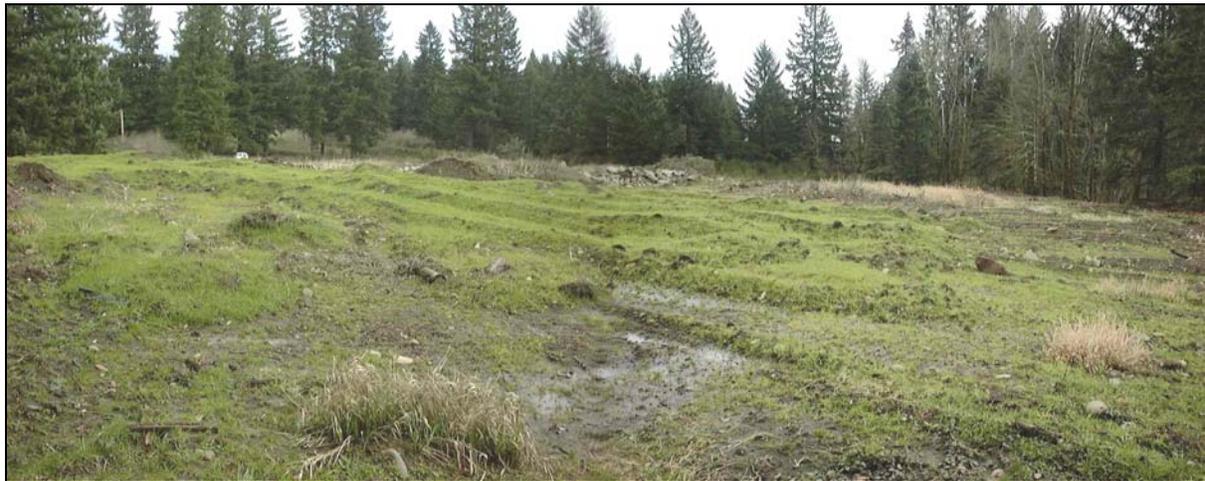
County	Site Name			Dist	Hwy	Mile Pt	TWP	RGE	Sect
Clackamas	Barton Gravel Pit			02C	0171	14.61	02S	03.0E	23
File ID		Source #	Date Visited	Map #			Type of Site		
13578, 13578A		03-070-1	2/04/1999	1R-2-1738			Stock Pile Site		
Latitude	Longitude	Elev. (m)	Acreage	Pit Size		DOGAMI Permit #			
45°23'13.81857"	122°24'30.76333"	79.789	9.08	NA					
Comments									
GPS acquired at the site.									
Rock Type	Unit	Color		Weathering			Jointing		
NA	NA	NA		NA			NA		
Quality			Hardness	lbs./cu ft.	Reserve (cy)	Reserve (Tons)			
NA			NA	0					
Potentially Significant Site	Why			Open/Closed	Direction				
No	Waste rock site			Closed	NA				
Adjacent Land Use									
Residential/Park across the road									
Remarks									
This property is used by Maintenance as a stock pile/waste rock site. The adjoining ground has some wetland mitigation potential. There is no fence or gate at this location and it is open to the public. There appears to be no aggregate value here.

Looking to the east at the stockpile site.

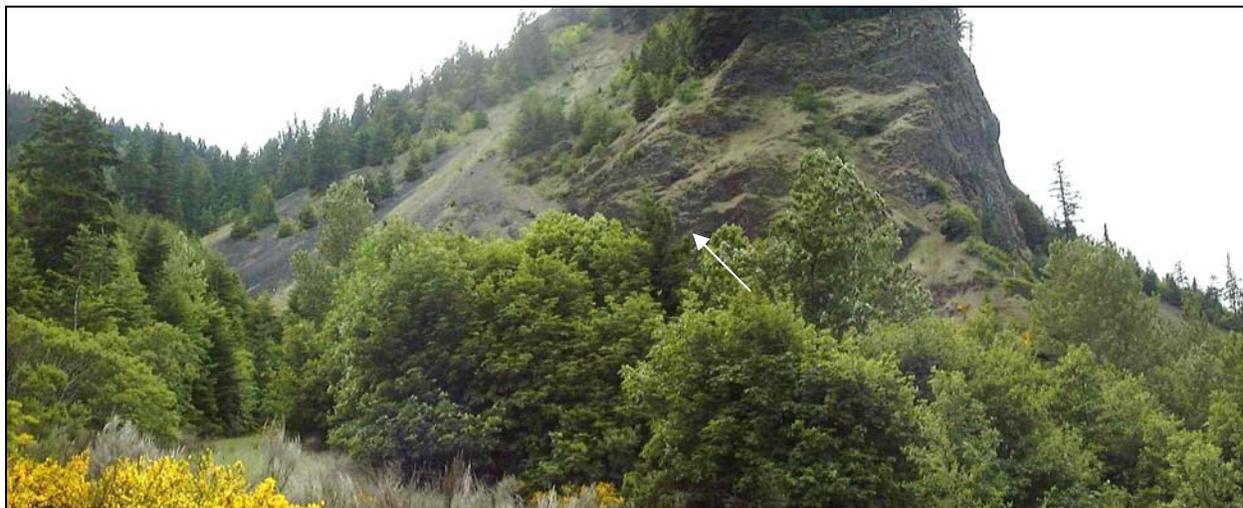
County	Site Name			Dist	Hwy	Mile Pt	TWP	RGE	Sect
Hood River	Mitchell Pit Quarry			02C	0002	0	03N	10.0E	31
File ID		Source #	Date Visited	Map #			Type of Site		
17802		14-002-1	6/02/1999	1R-5-149			Quarry		
Latitude	Longitude	Elev. (m)	Acreage	Pit Size		DOGAMI Permit #			
45°42'10.37000"	121°36'38.41000"	61	12.93	NA					
Comments									
Lat. and Long. acquired using Terrain Navigator Software									
Rock Type	Unit	Color		Weathering			Jointing		
Basalt	Tc	Medium Dark Grey (N4)		Fresh			NA		
Quality			Hardness	lbs./cu ft.	Reserve (cy)	Reserve (Tons)			
Good			R4	155	See Remarks				
Potentially Significant Site	Why			Open/Closed	Direction				
No	Small site, landlocked, limited room to work, close to state park.			Closed	North across I-84 is the Columbia River.				
Adjacent Land Use									
State Park/One residence adjacent to the east.									
Remarks									
This site is located about 100 meters south of I-84. The property is a talus slope with angular softball size basalt. There is no overburden, no room to work, and some screening. The access to this site is very limited and should be evaluated if we wish to open this site back up. The original easement was from I-84 which appears to be not available any more. This site sits within the Scenic Gorge Area. This site has approximately 65,000 cubic yards of material available if the site were open for use.

Looking southwest at the talus slope and the surrounding area.

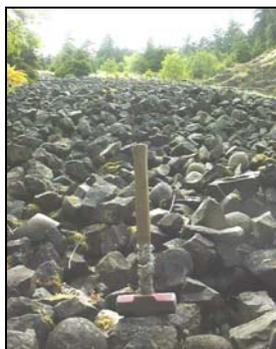
Close-up view of the talus.

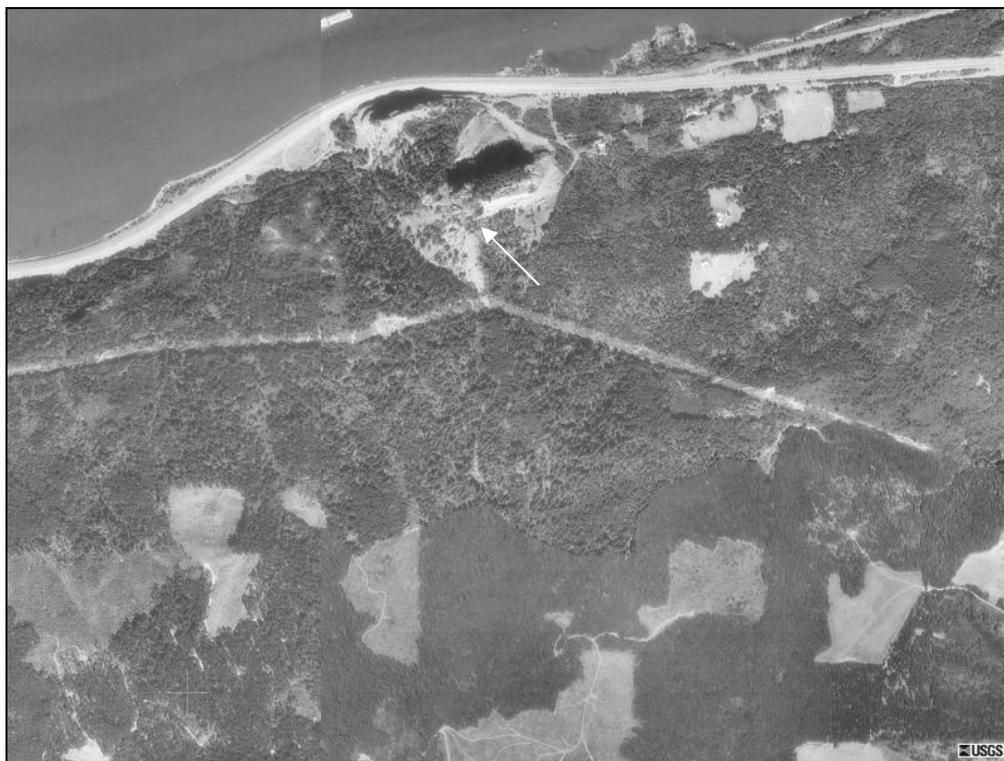
Aerial view of Mitchell Point with the talus slope on the eastside. I-84 and the Columbia River are in the upper portion of the image.

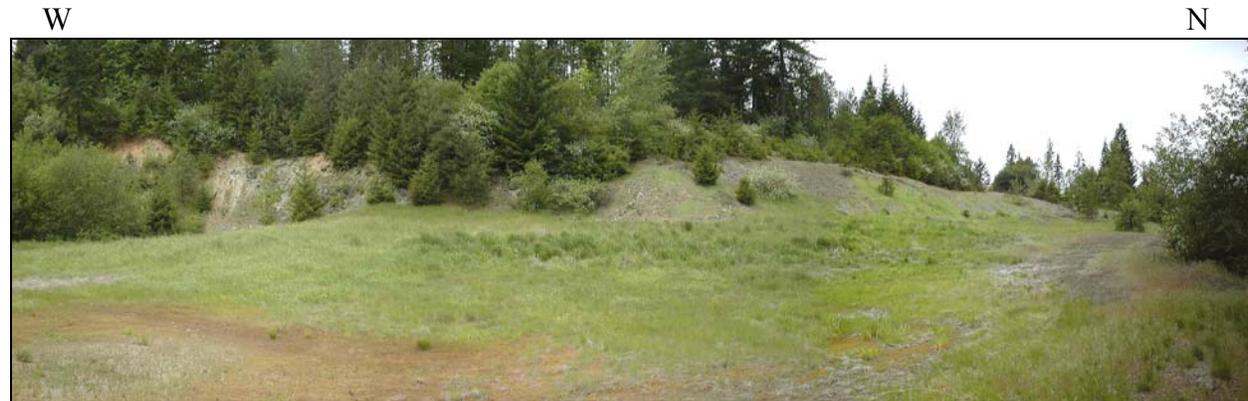
County	Site Name				Dist	Hwy	Mile Pt	TWP	RGE	Sect
Hood River	Smullen Quarry				02C	0026	80.07	01S	10.0E	09
File ID		Source #	Date Visited	Map #		Type of Site				
06321, 06321A, 58350		14-007-1	6/02/1999	1R-2-685		Gravel				
Latitude	Longitude	Elev. (m)	Acreage	Pit Size	DOGAMI Permit #					
45°29'52.73000"	121°33'48.83000"	597	6.2	NA						
Comments										
Lat. and Long. acquired using Terrain Navigator Software										
Rock Type	Unit	Color	Weathering		Jointing					
Volcanic Gravel	NA	NA	NA		NA					
Quality			Hardness	lbs./cu ft.	Reserve (cy)	Reserve (Tons)				
NA			NA	120	10,000	16,200				
Potentially Significant Site	Why			Open/Closed	Direction					
No	Depleted/Small narrow property			Closed	Adjacent to the East Fork of Hood River.					
Adjacent Land Use										
Forest/Farming										
Remarks										
The property is located at the junction of Highway 35 and the Parkdale County Road. This site has a very small amount of rock left. The gravel here is a heterogeneous mix of sizes that range from sand to boulder. The dominant size is in the boulder category. This property is better suited for a stockpile site, or waste site. The gravel is almost depleted. The ground is flat, plenty of room to work, with limited screening from the highway. There have been legal challenges in the past about this site.

Looking to the north at the reclaimed pit.

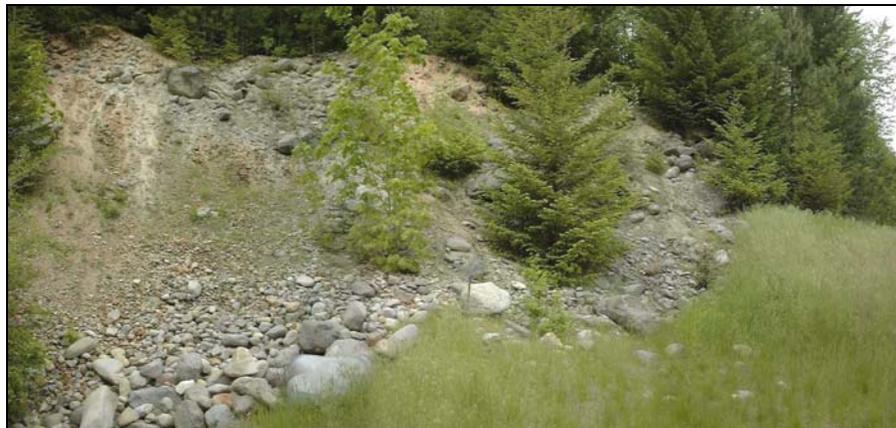
Close-up view of the volcanic boulders in the area.

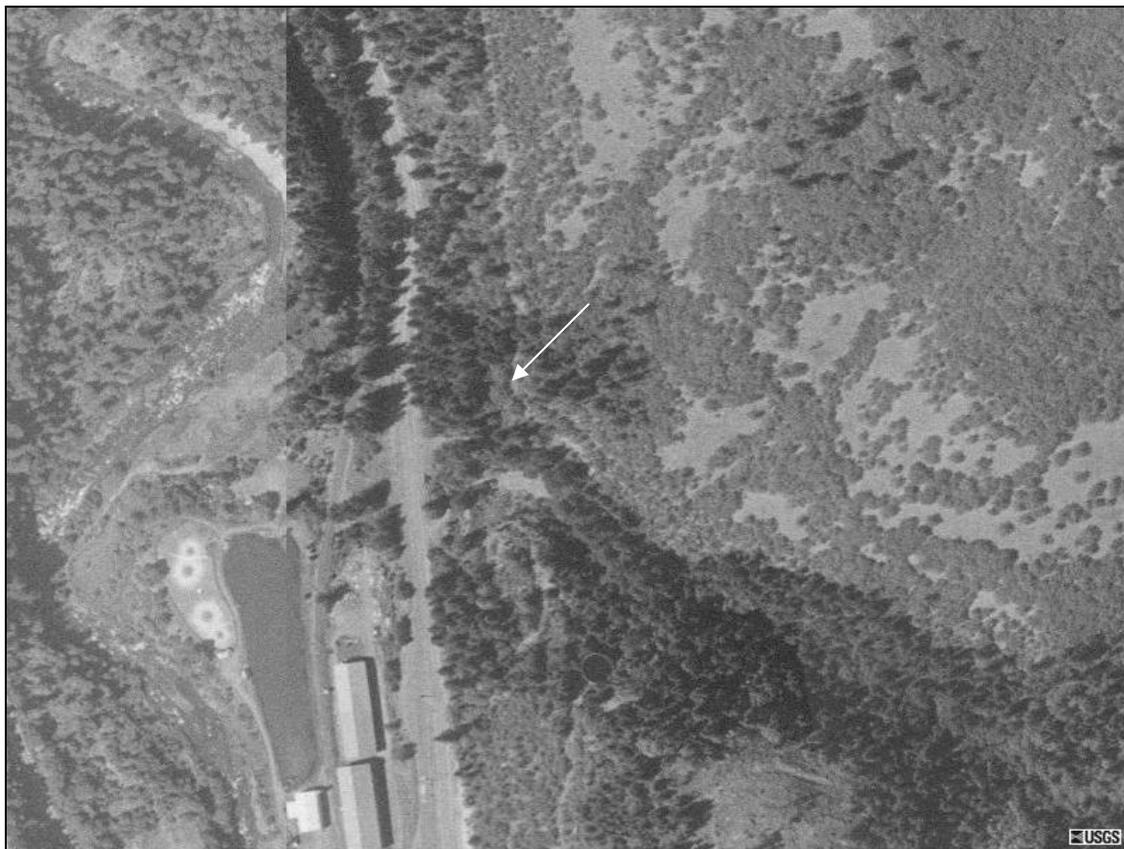
Aerial view of the site (arrow) in relationship to Highway 281.

County	Site Name				Dist	Hwy	Mile Pt	TWP	RGE	Sect
Hood River	Winans Prospect				02C	0281	11.12	01N	10.0E	06
File ID		Source #	Date Visited	Map #			Type of Site			
03296		14-011-1	6/02/1999	1R-1-1562			Raw Land			
Latitude	Longitude	Elev. (m)	Acreage	Pit Size	DOGAMI Permit #					
45°35'38.68000"	121°37'36.66000"	304	6	NA						
Comments										
Lat. and Long. acquired using Terrain Navigator Software										
Rock Type	Unit	Color		Weathering			Jointing			
NA	Tcw	NA		NA			NA			
Quality			Hardness	lbs./cu ft.	Reserve (cy)	Reserve (Tons)				
NA			NA	NA	See Remarks					
Potentially Significant Site	Why			Open/Closed	Direction					
No	Too small, ground has not been evaluated for quantity or quality.			Closed	The East Fork of Hood River is across Highway 281 to the west approximately 250 meters.					
Adjacent Land Use										
Forest										
Remarks										
This site was not found along Highway 281. The Right of Way map does not show enough information to locate this property in the field. I was in close proximity to this site and feel that there would be some overburden, no room to work, and no screening from the road. I have calculated that there could be up to 60,000 cubic yards of material at this location if it were open for use. There is a better quarry site for aggregate production a couple of miles to the south. This site has some timber value and plenty of overburden.

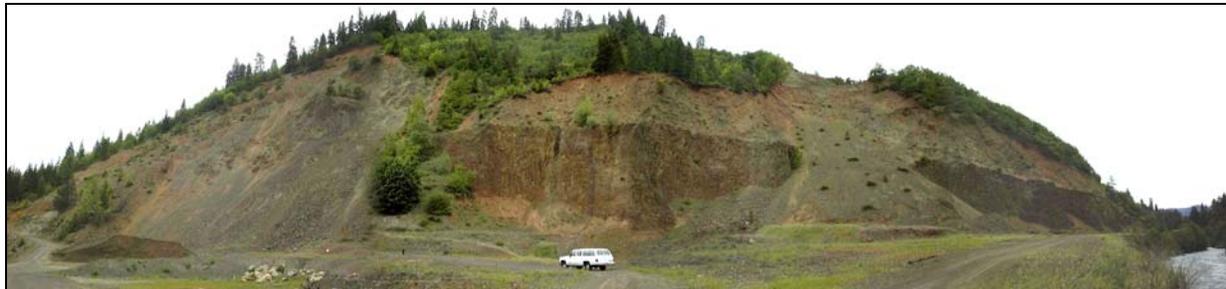
Remarks									
This site is located east of the Hood River Highway about 100 meters. The rock is a fine-grain moderately vesicular basalt that is highly fractured with some oxidized zones. The overburden/oxidized zone could be up to 15 feet thick, with the average thickness approximately 6 feet. This is in an area of very steep terrain and care should be used to develop this site from the top down. You could rip the oxidized zone, but the best results would be from drilling and blasting the rock. There is plenty of room to work, with limited to no screening from the highway. This site is used by the Forest Service and Hood River County. There have been past conflicts with the County about this site. Notes about the rock indicate that the soil content is great enough to require two washings to reduce the PI and the LL. It might be important to install a berm adjacent to the East Fork of the Hood River. This would help to keep the fines out of the stream.

Looking to the northeast at the pit floor and the pit wall. East Fork of the Hood River is in the lower right corner of the image.

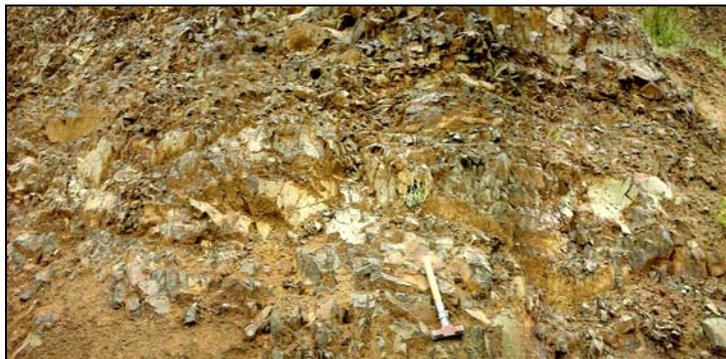
Close-up view of the fracture pattern with the hammer for scale.

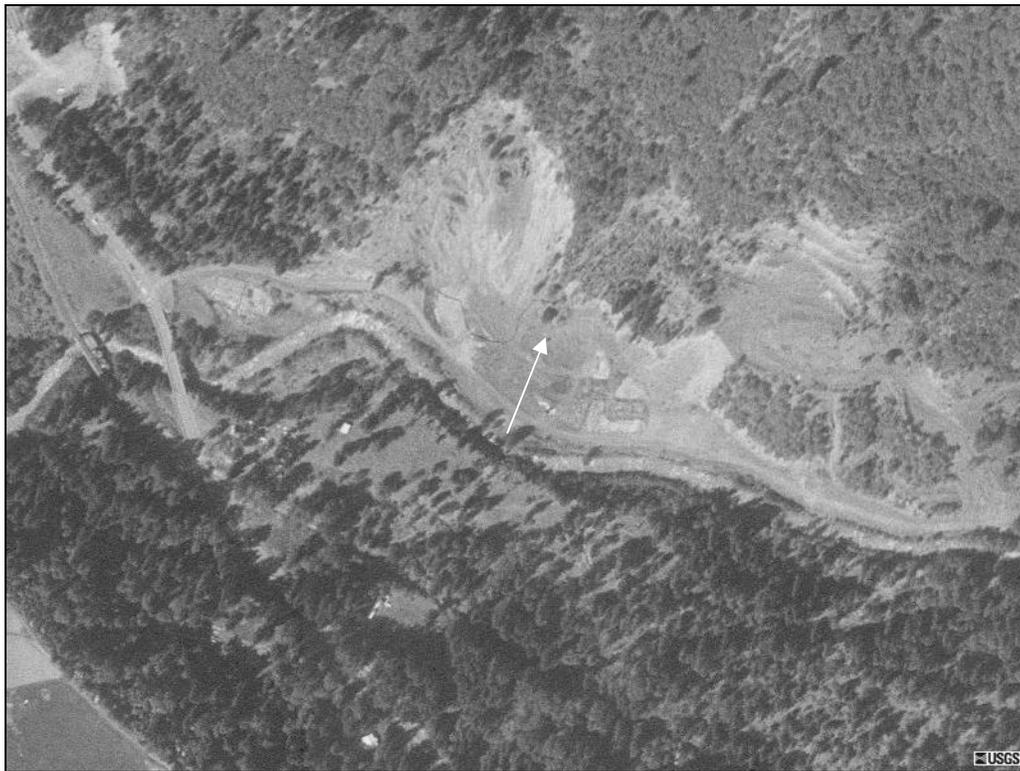
Aerial view of the quarry site located center of the image.  
Sinuous line is the trace of the river.

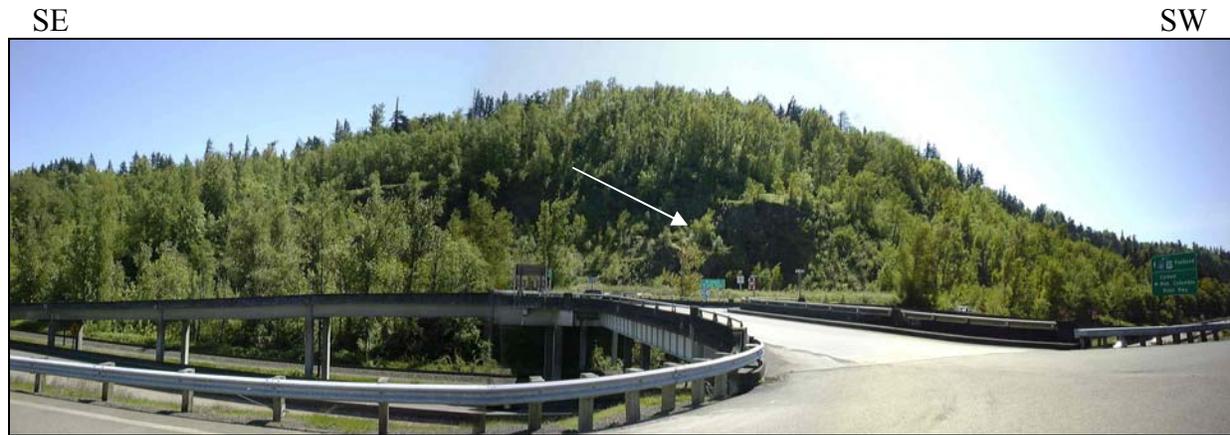
This site is adjacent to the town of Corbett. The quarry is within the Scenic Gorge Area. The texture of the rock is a fine-grain basalt that is moderately fractured. There is no screening from Interstate 84 and limited room to work at this location. You might be able to rip the material but most likely you would need to drill and blast the rock. The rock should be removed from the top down to efficiently utilize this site. The terrain is very steep at the northern limits of the property with the upper portion being flat. The small pit that is there now has concrete barriers along the road to keep vehicles out. It appears someone has been using the pit as a waste site. There could be up to 500,000 cubic yards of material at this location if it were open for use. The quarry is overgrown with vegetation.										
202B	203B	211	206 Fine	206 Coarse	208 F	208 F Ht.	208 C	208 C Ht.

Looking to the south at the small pit (center right) adjacent to I-84.

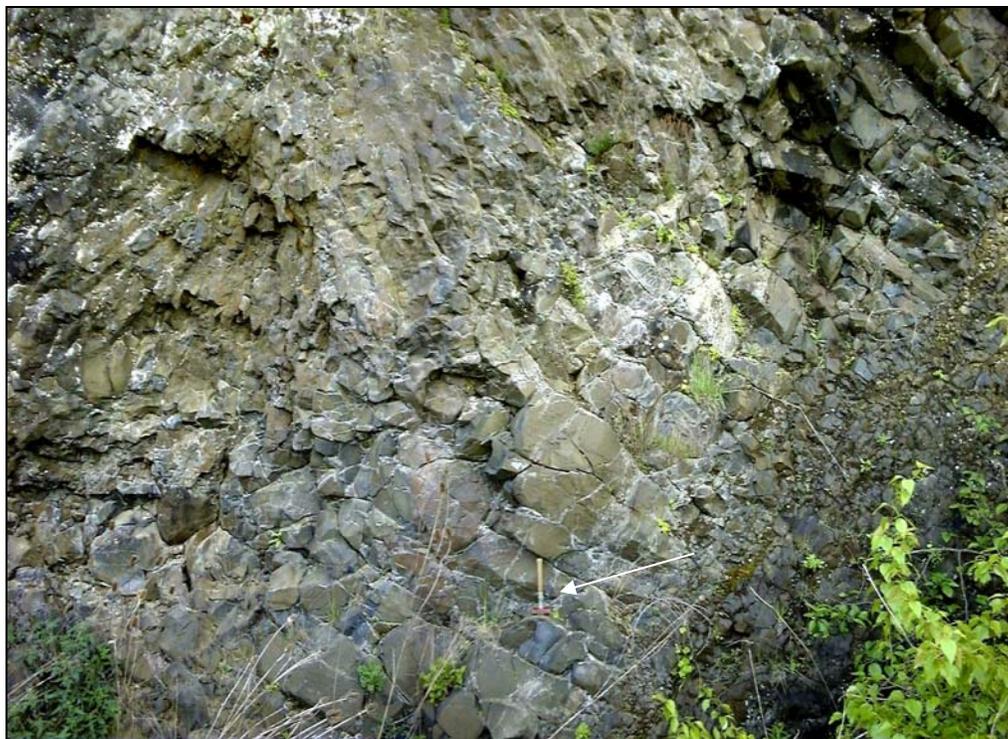
Close-up view of the jointing pattern at the pit face, hammer for scale.

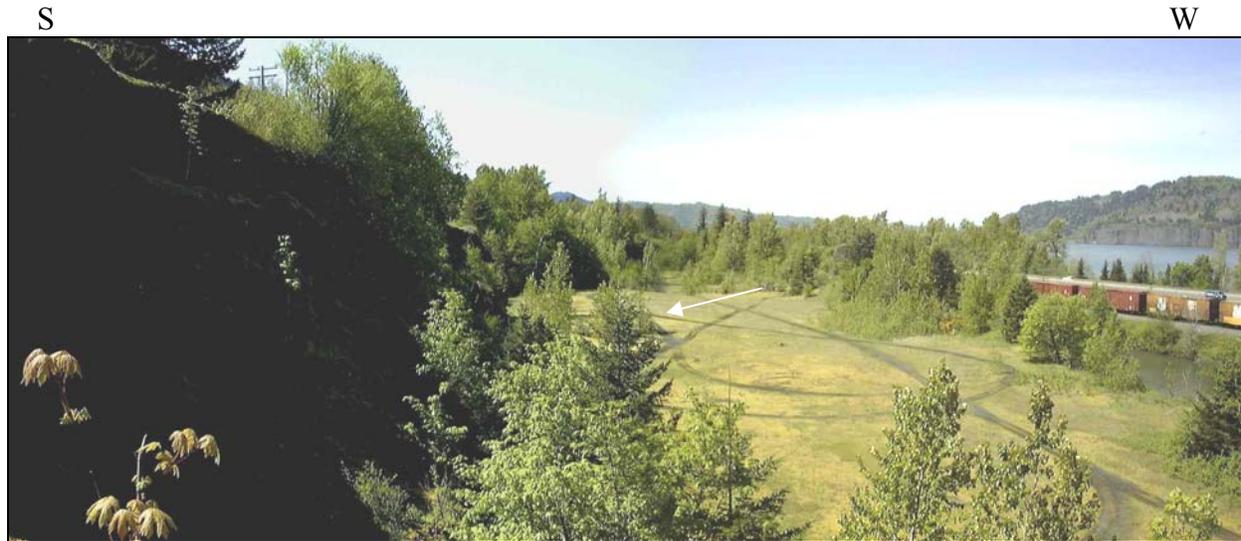
County	Site Name			Dist	Hwy	Mile Pt	TWP	RGE	Sect
Multnomah	Coopey Creek Quarry			02C	0002	27.83	01N	05.0E	14
File ID		Source #	Date Visited	Map #		Type of Site			
06490, 6490A		26-007-1	5/05/1999	1R-2-778		Quarry			
Latitude	Longitude	Elev. (m)	Acreage	Pit Size	DOGAMI Permit #				
45°33'58.49000"	122°09'49.39000"	61	10.84	<9 acres					
Comments									
Lat. and Long. acquired using Terrain Navigator Software									
Rock Type	Unit	Color		Weathering		Jointing			
Basalt	Tcg	NA		NA		NA			
Quality			Hardness	lbs./cu ft.	Reserve (cy)	Reserve (Tons)			
NA			NA	155					
Potentially Significant Site	Why	Open/Closed		Direction					
No	Depleted	Closed		Northwest across I-84 is the Columbia River.					
Adjacent Land Use									
Within the community of Bridal Veil.									
Remarks									
This site is depleted of rock. This site should be evaluated for possible fencing to keep people away from the cliffs adjacent to Highway 30. The bench cut is very tall and is very dangerous.

Looking to the southwest at the pit wall (left center) and the pit floor (center right).  
The Columbia River is on the right side of the image.

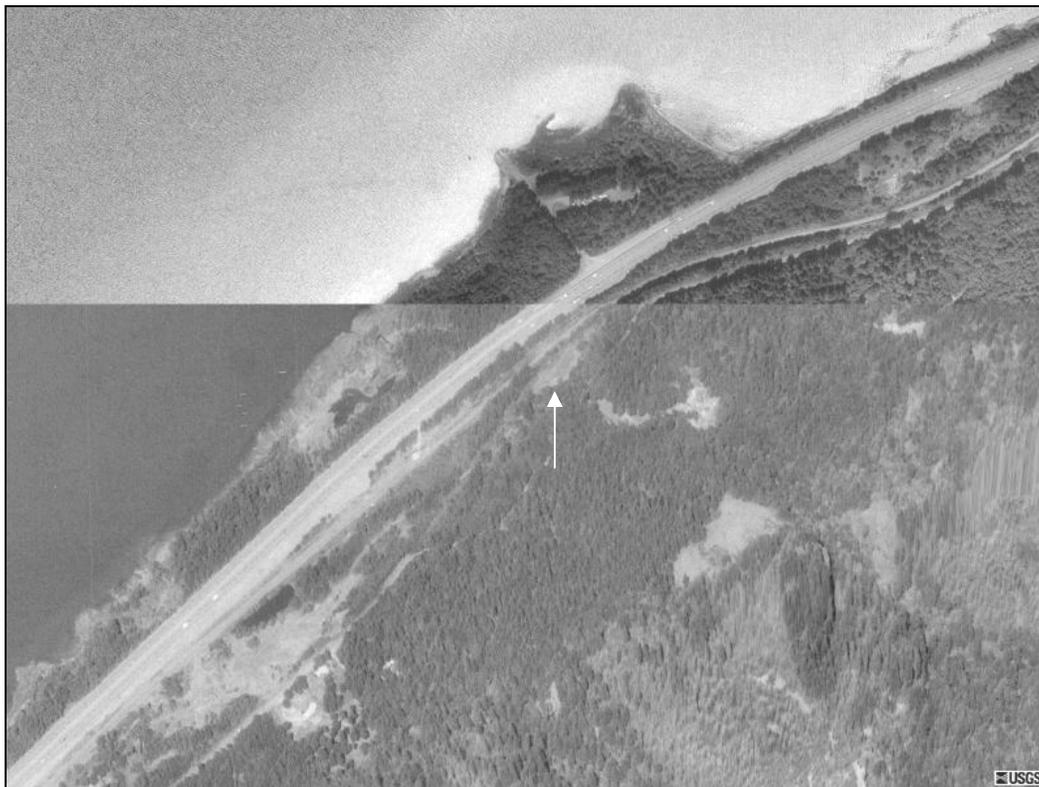
Aerial view of the pit (arrow) and the surrounding area along Highway 30.

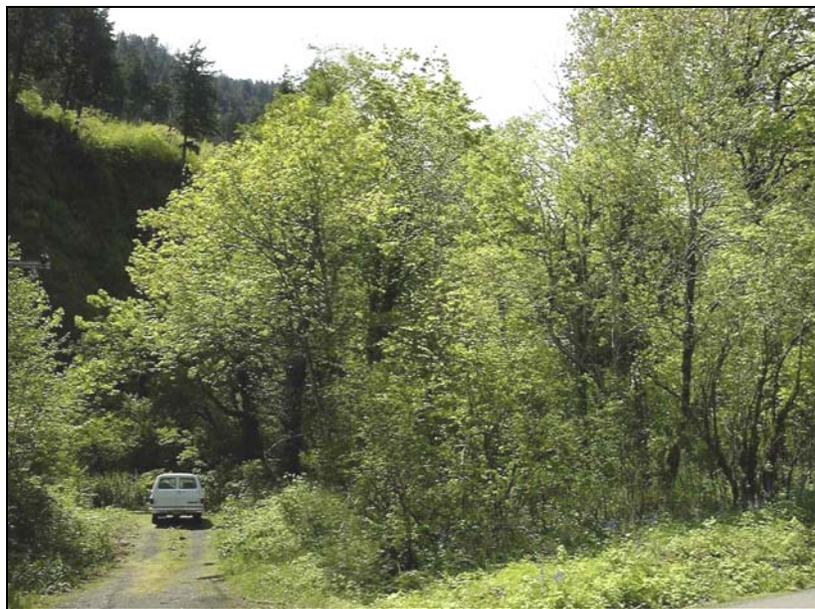
Remarks										
This site is adjacent to Benson State Park. The rock is a fine-grain basalt that is vesicular. There could be up to 5 feet of overburden at the quarry site. The ground is in an area that is very steep to vertical and all overgrown. There are limited exposures visible to view the rock here. There is ample room to work at this location with fair to good screening. The access road is a problem with it being off of Highway 30 in a tight area. This site is within the Scenic Gorge Area and removal of rock most likely would not happen. There is approximately 1,210,000 cubic yards of material at this location if it were open for use.										
202B	203B	211	206 Fine	206 Coarse	208 F	208 F Ht.	208 C	208 C Ht.		
Material Use

Looking south at the site and the surrounding area. Disturbance is back within the trees to the far right of the image.

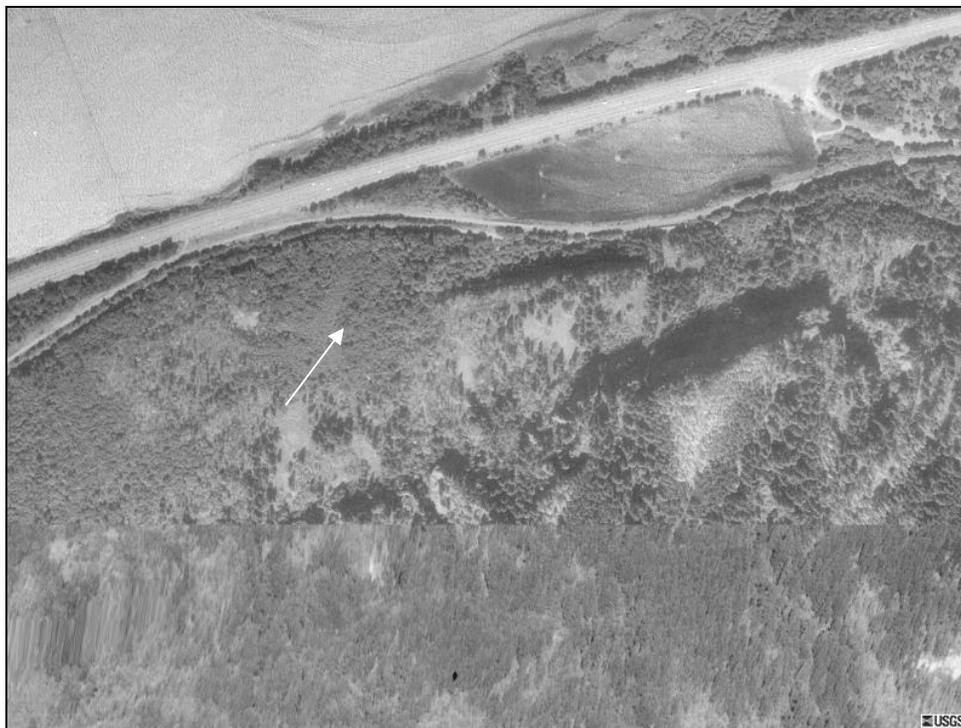
Aerial view of the property along Highway 30.  
Arrow points to the general vicinity.

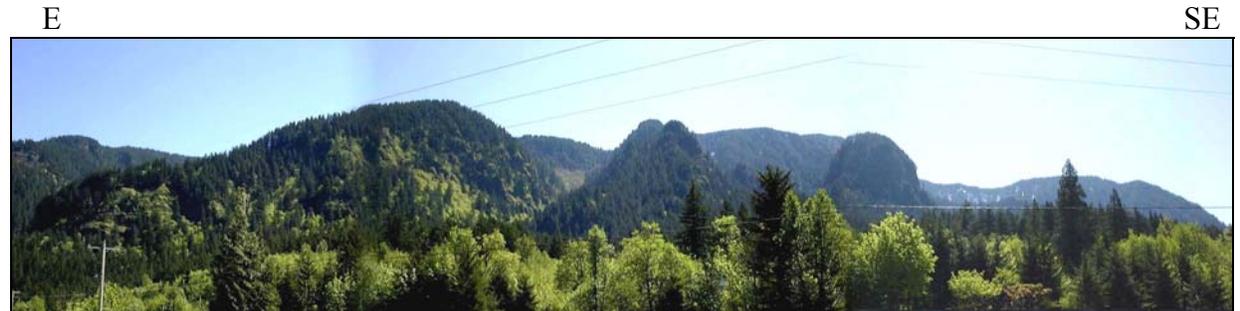
Looking to the south at the surrounding area along I-84.

County	Site Name			Dist	Hwy	Mile Pt	TWP	RGE	Sect
Multnomah	Yeon Talus Pit (Ryan Quarry)			02C	0002	38.18	02N	07.0E	31
File ID		Source #	Date Visited	Map #			Type of Site		
Q0229		26-013-1	5/05/1999	1R-1-1008			Raw Land		
Latitude	Longitude	Elev. (m)	Acreage	Pit Size		DOGAMI Permit #			
45°36'59.02000"	121°59'37.32000"	39	47.15	NA					
Comments									
Lat. and Long. acquired using Terrain Navigator Software									
Rock Type	Unit	Color		Weathering			Jointing		
Basalt	Qtba	NA		NA			NA		
Quality			Hardness	lbs./cu ft.	Reserve (cy)	Reserve (Tons)			
Unknown			NA	120	See Remarks				
Potentially Significant Site	Why			Open/Closed	Direction				
No	This property is in the National Scenic Gorge Area.			Closed	Northwest across I-84 is the Columbia River about 700 meters.				
Adjacent Land Use									
Forest/Parks									
Remarks									
This property is in the Columbia River Gorge National Scenic Area. The rock in this area is of good quality. The property is adjacent to John B. Yeon State Park. The USGS Quad shows our property as part of the State Park. Right of Way informs me that we still own the property. I am doubtful that we will be able to remove rock within the Gorge Area any time soon. There could be up to 800,000 cubic yards of material here if it were open for use. This property is on Highway 30 where it merges with I-84 and there is no screening.

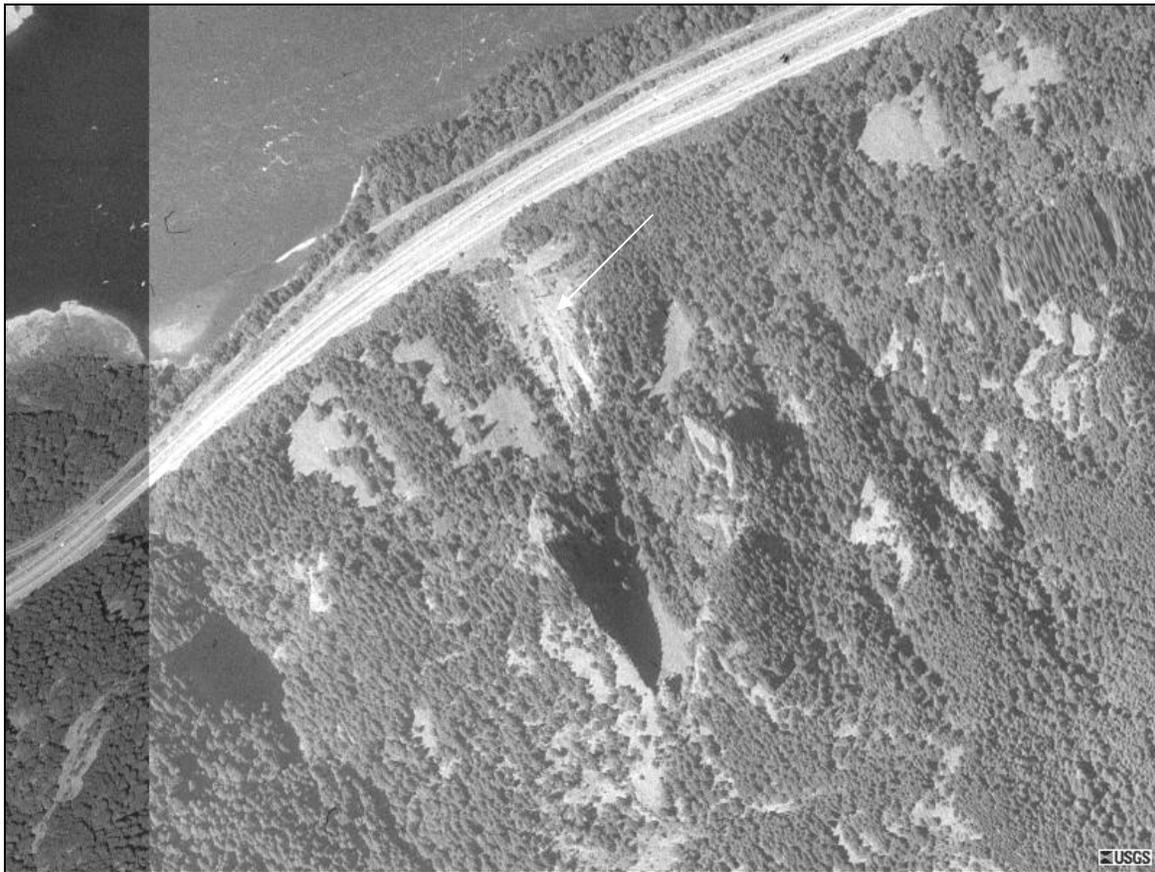
Aerial view of the terrain along I-84, the arrow shows the approximate location of the property.

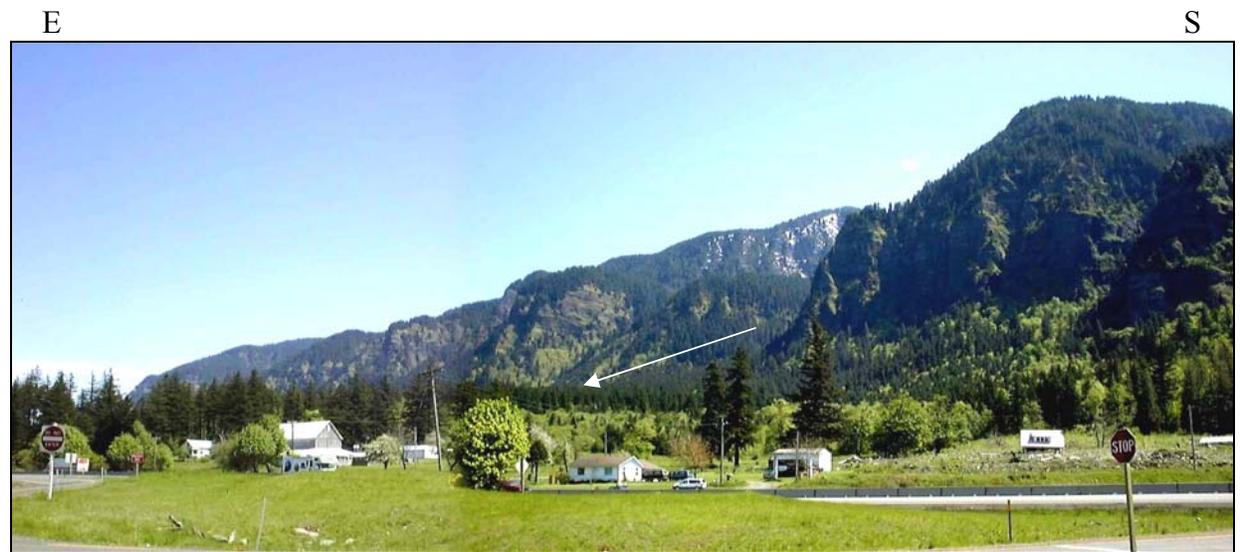
Looking to the east past Dodson, Oregon at the raw land site.  
Arrow points to the general area.

County	Site Name			Dist	Hwy	Mile Pt	TWP	RGE	Sect
Multnomah	Dodson Material Source			02C	0002	35.36	01N	06.0E	01
File ID		Source #	Date Visited	Map #			Type of Site		
47573		26-036-1	5/05/1999	1R-4-538			Raw Land		
Latitude	Longitude	Elev. (m)	Acreage	Pit Size		DOGAMI Permit #			
45°36'05.04000"	122°01'02.83000"	181	160	NA					
Comments									
Lat. and Long. acquired using Terrain Navigator Software									
Rock Type	Unit	Color	Weathering			Jointing			
Basalt	Tcg/Qtba	NA	NA			NA			
Quality			Hardness	lbs./cu ft.	Reserve (cy)	Reserve (Tons)			
Good to Fair			NA	155	See Remarks				
Potentially Significant Site	Why			Open/Closed	Direction				
No	Within the National Gorge Scenic Area			Closed	Northwest across I-84 is the Columbia River, about 1000 meters.				
Adjacent Land Use									
Forest/ State Park/ Dodson to the north about 0.5 miles.									
Remarks									
I could not find the access road to this site and I did not visit this ground.. This is approximately .5 miles south from Highway 30 and is not visible from the interstate. This ground is in an area of talus at the base of the Columbia River Gorge cliffs. The rock in the area is of good quality. There would be good screening and plenty of room to work. Vehicle access to the site would be through a residential area. The ground is situated in the Gorge Scenic Area and I feel doubtful that we could remove any rock now or in the future. There is approximately 3,870,000 cubic yards of rock available if the site were open for use.

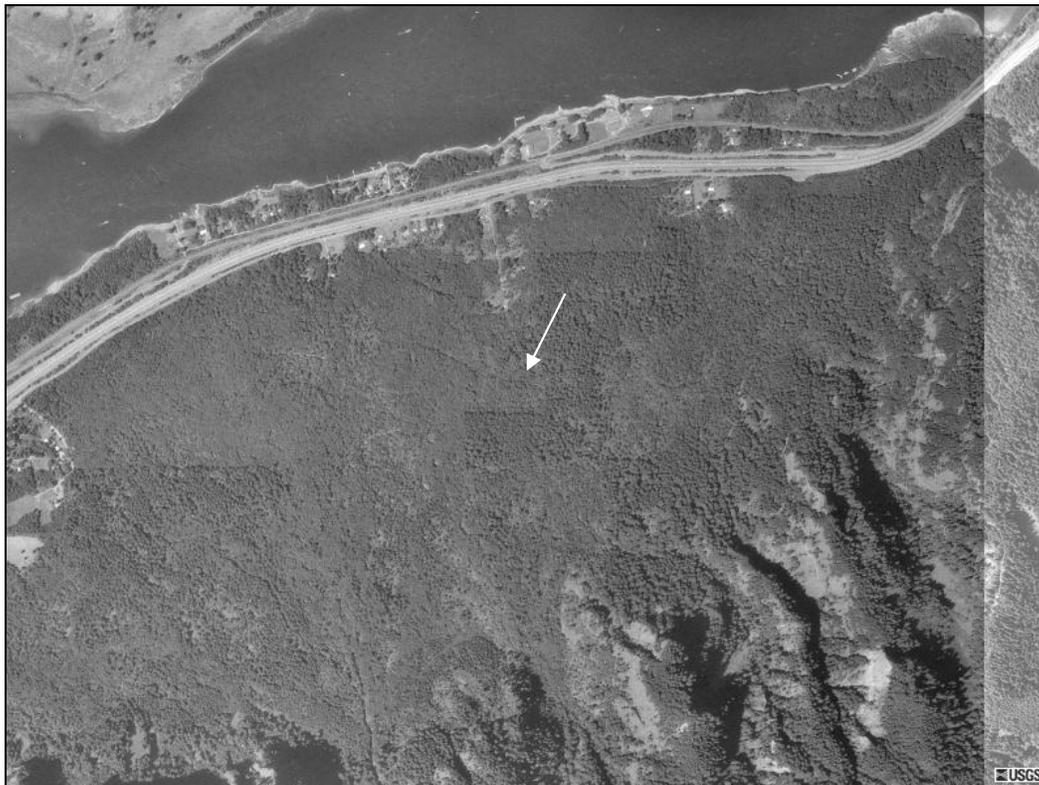
Approximate location of the site and the surrounding area.

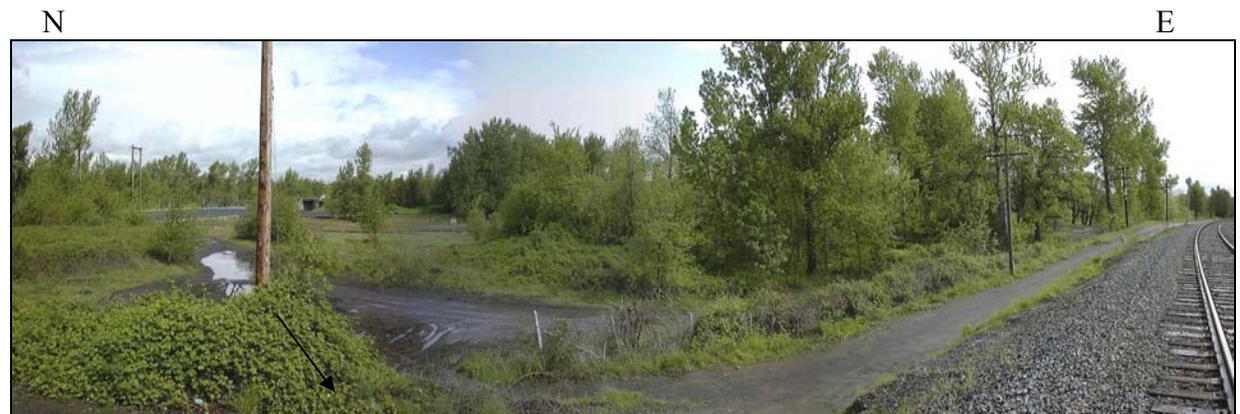
County	Site Name			Dist	Hwy	Mile Pt	TWP	RGE	Sect
Multnomah	Wilhelm Filler pit			02C	0002	17.82	01N	03.0E	25
File ID		Source #	Date Visited	Map #			Type of Site		
01823, 07694		26-045-1	5/04/1999	1R-2-959			Stock Pile Site		
Latitude	Longitude	Elev. (m)	Acreage	Pit Size		DOGAMI Permit #			
45°32'33.97000"	122°22'51.30000"	55	8.16	NA					
Comments									
Lat. and Long. acquired using Terrain Navigator Software									
Rock Type	Unit	Color		Weathering			Jointing		
NA	NA	NA		NA			NA		
Quality			Hardness	lbs./cu ft.	Reserve (cy)	Reserve (Tons)			
NA			NA	0					
Potentially Significant Site	Why	Open/Closed	Direction						
No	Depleted	Closed	West across the county road is the Sandy River approximately 100 meters.						
Adjacent Land Use									
Lewis and Clark State Park is adjacent to the south.									
Remarks									
This site is used as a stockpile site, and bone-yard adjacent to the east/west rail line in Troutdale. It appears we utilize more land than the 8 acres that is mentioned in the Right of Way database.

Looking to the northeast at the stockpile site along the rail line.

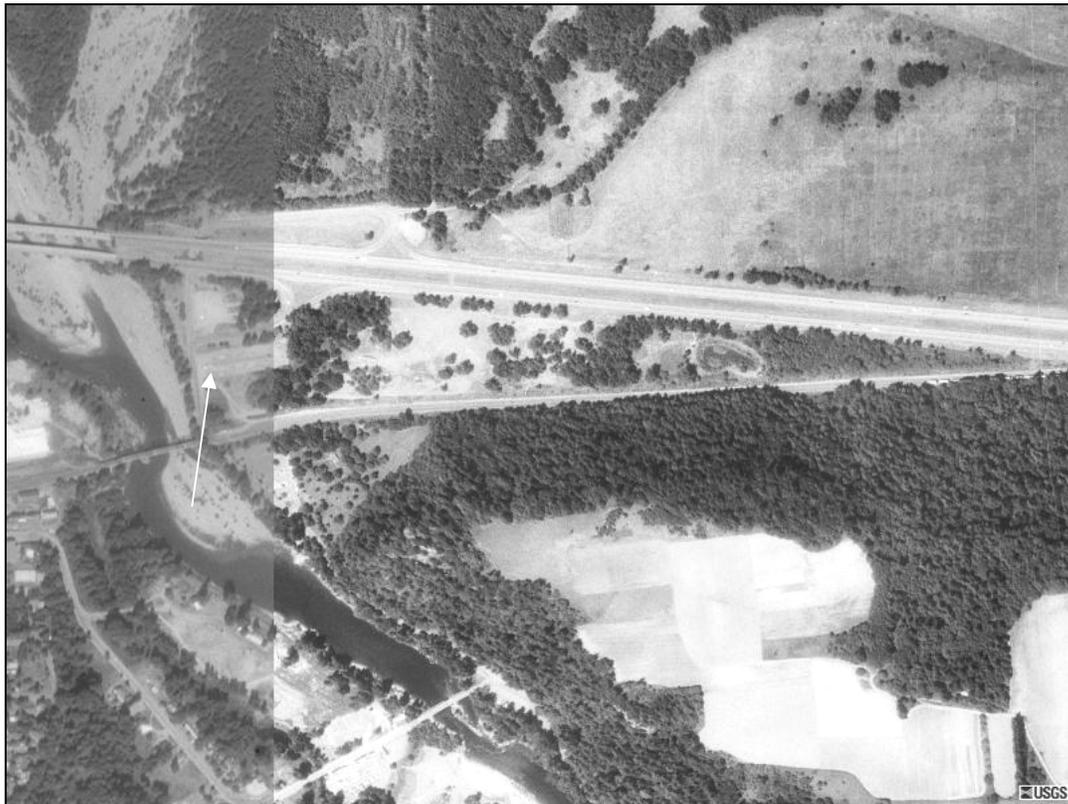
Aerial view of the stockpile site (arrow) and the surrounding area.
