**MONITORING OF
BIOENGINEERING
STABILIZATION PROJECTS**

Final Report

SPR 353

August 2009

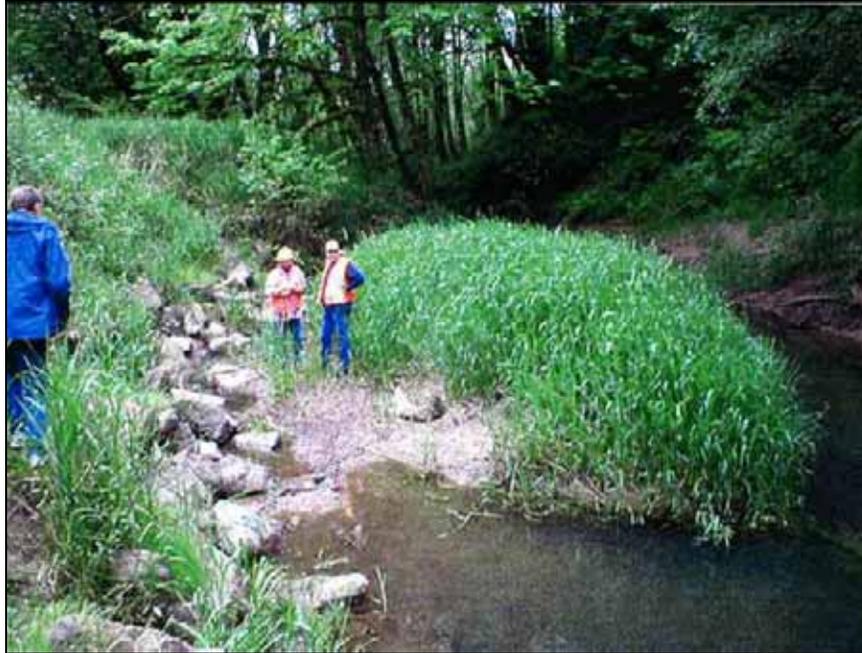
Figure 2.1: West Fork Dairy Creek looking downstream. US Route 26 is immediately to the left of the photo. Prior to remedial work at this site, the stream had begun to abandon the channel on the right of the photo and establish the new channel on the left, which was eroding away the embankment supporting the highway. This photograph was taken in May 2003.

Over time West Fork Dairy Creek eroded away the cut bank supporting the highway to the point that ODOT personnel became concerned that the stability of the road was threatened. Rather than using rip-rap armoring to halt any further erosion of the embankment, ODOT used what is here referred to as a bioengineering approach. Very large boulders were placed at the very base of the embankment to the level of normal high water (see Figure 2.1). Above the level of normal high water the embankment was built out slightly with soil material covered with woven jute fabric. The jute fabric was anchored in place with rebar and steel plate gussets (see Figure 2.2). The embankment was then seeded and planted with cuttings of woody vegetation (see Figure 2.3). An additional feature present at the upstream edge of the bioengineering is a log that

projects obliquely into the stream and redirects some of the stream's energy away from the cut bank.

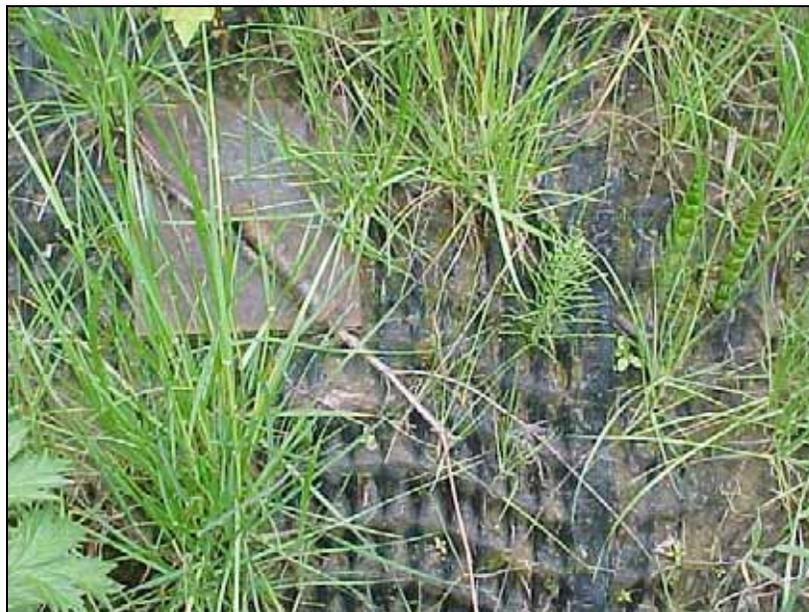
Figure 2.2: Close-up view of the soft engineering used to stabilize the embankment. Visible in this photo are a steel plate & rebar anchor along with exposed woven jute matting. This photograph was taken in May 2002.

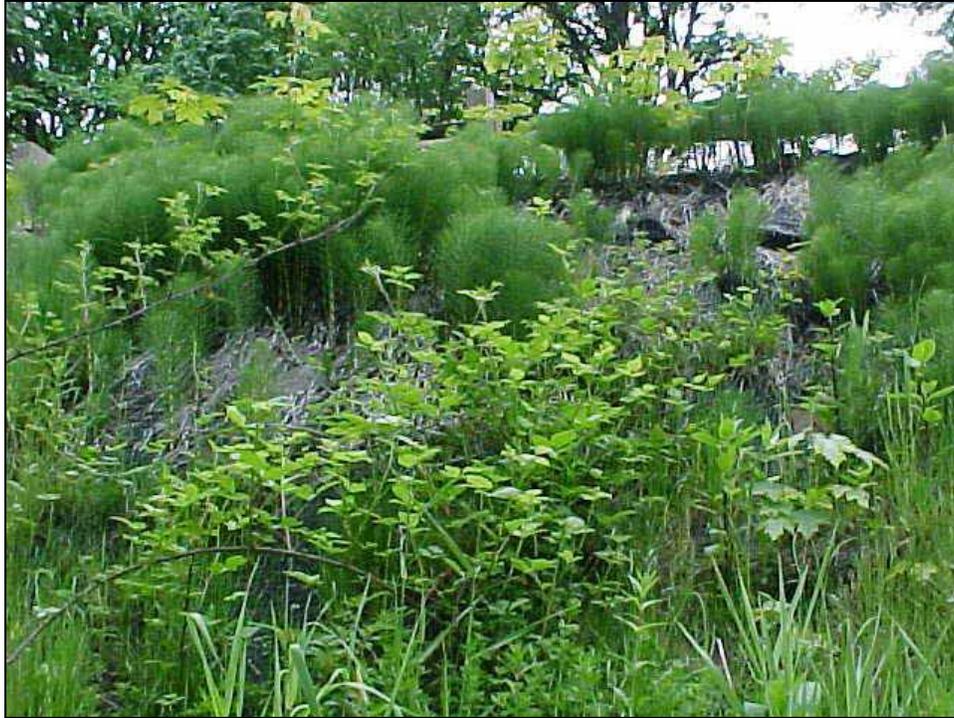
Figure 2.3: Vegetated cut bank of West Fork Dairy Creek, which also serves as the embankment supporting US Route 26. This photograph was taken in May of 2002.

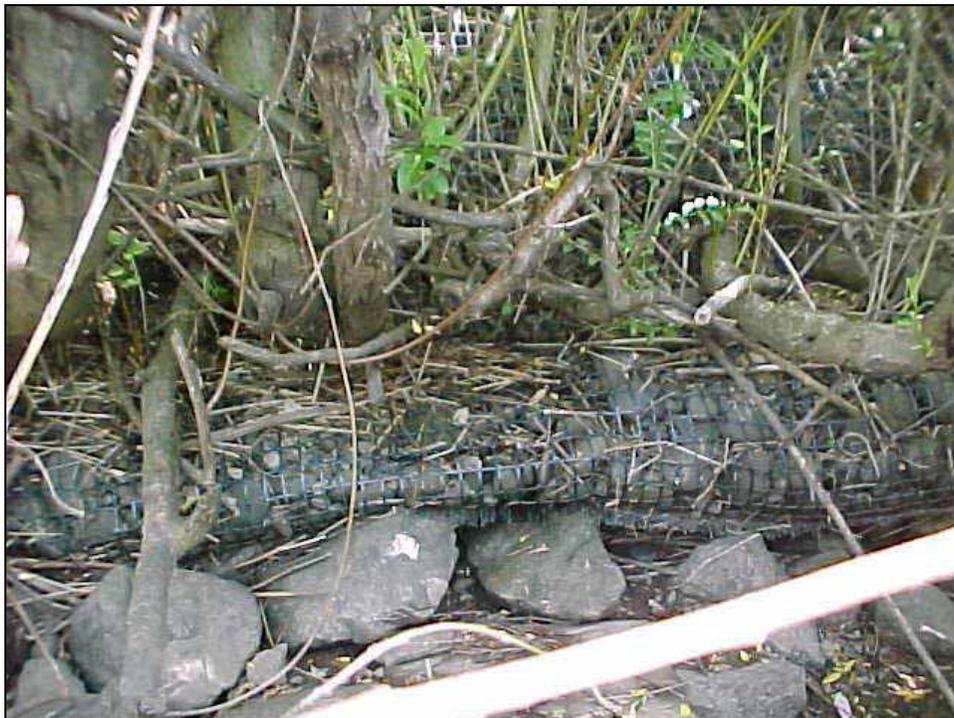
The features installed consist of the cut bank being terraced with geogrid-encased gravel planted with willows. Figure 2.4 shows a portion of the geogrid-encased gravel at the level of normal high water. Note that the very base of the terraced cut bank was armored with large cobble to small boulder-sized rip-rap. The remainder of the stream channel was reconstructed to resemble a natural meander bend with a gravel point bar. Figure 2.5 shows the nature of the realignment, and Figure 2.6 shows the details of the planned reconstruction. Figures 2.7 and 2.8 show the cut bank terraces being built. Figure 2.9 shows the bioengineered reach in 1997 after the vegetation had had a chance to get established. Note the abundance of willows. Three of the several larger canopy forming trees that were planted on the top level terrace can also be seen upon close inspection.

Figure 2.4: Small rip-rap overlain by the geogrid-enclosed gravel with woody vegetation at the Johnson Creek site

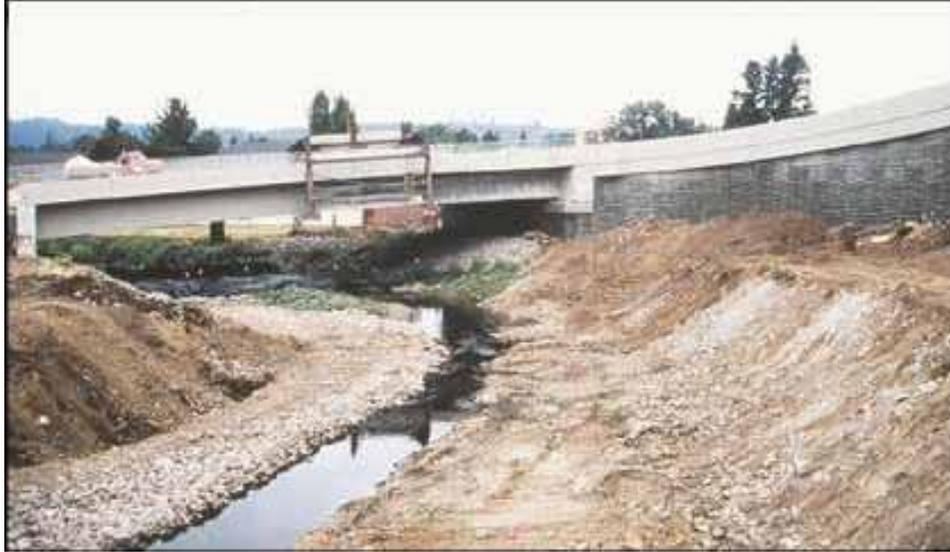
Figure 2.7: Beginning of construction of the Johnson Creek bioengineering features in 1993

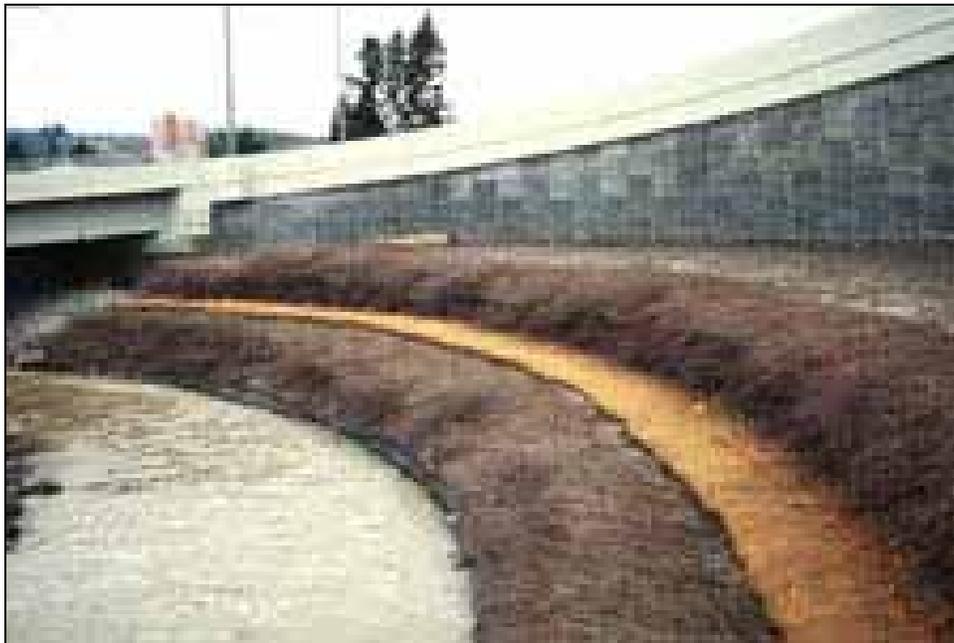
Figure 2.8: Johnson Creek bioengineering features in 1993 after construction but before planting of vegetation

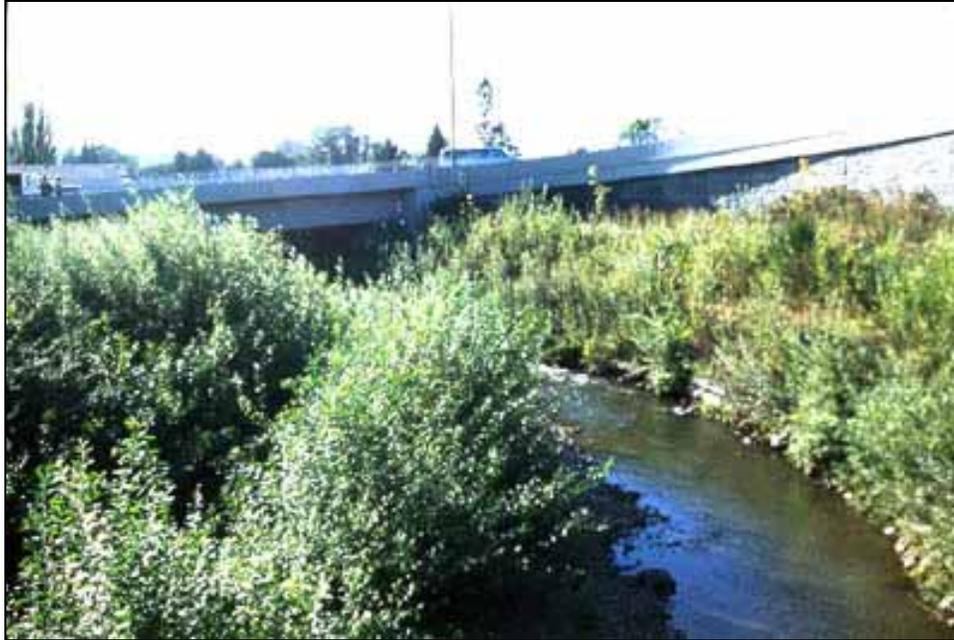
Figure 2.9: Johnson Creek bioengineering site after establishment of vegetation in late summer/early fall 1997

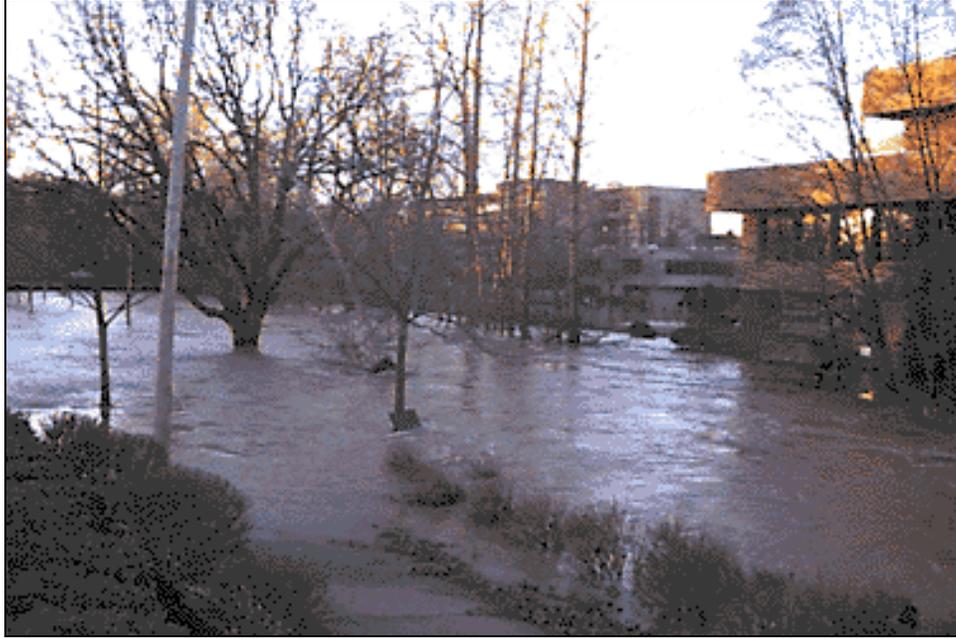
Figure 2.10: Photograph of the Shelton Ditch bioengineering site taken when the water was near its peak crest during flooding in February 1996. Photo courtesy of Jon Hazen, <http://www.oregonlink.com/flooding/>

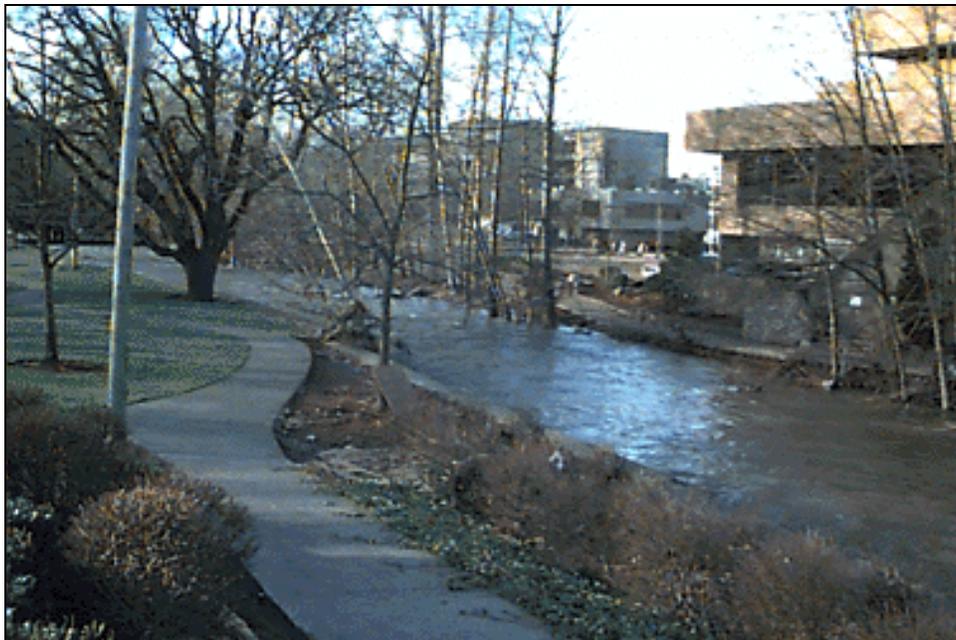
Figure 2.11: Photograph of the Shelton Ditch bioengineering site taken during flooding in February 1996 after the stream had receded back into its banks. Photograph courtesy of Jon Hazen, <http://www.oregonlink.com/flooding/>

The bioengineering features at this site are limited to simply planting riparian vegetation on the banks, as shown in Figure 2.12. Comparing Figure 2.11 with Figure 2.12, one can see some of the vegetation added between the water and the sidewalk to the right (upstream) of the row of trees. Figure 2.13 shows that modest sized rip-rap is still part of the bank protection at the site.

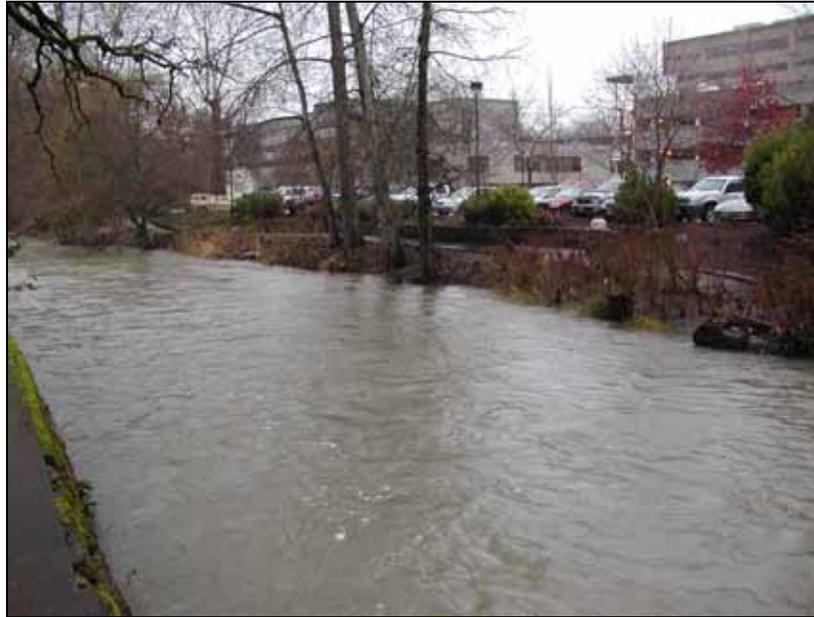
Figure 2.12: Shelton Ditch bioengineering monitoring site in January 2006. Note the brushy, woody plants on the far (north) bank in the right-hand portion of the photograph that were absent in 1996.

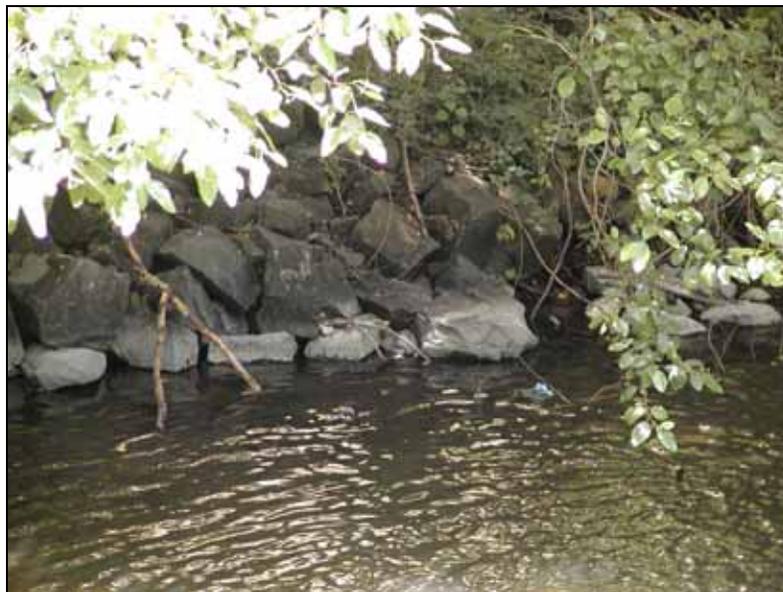
Figure 2.13: Small rip-rap protecting the northern stream bank from erosion. Photograph was taken in July 2005 at the Shelton Ditch bioengineering monitoring site.

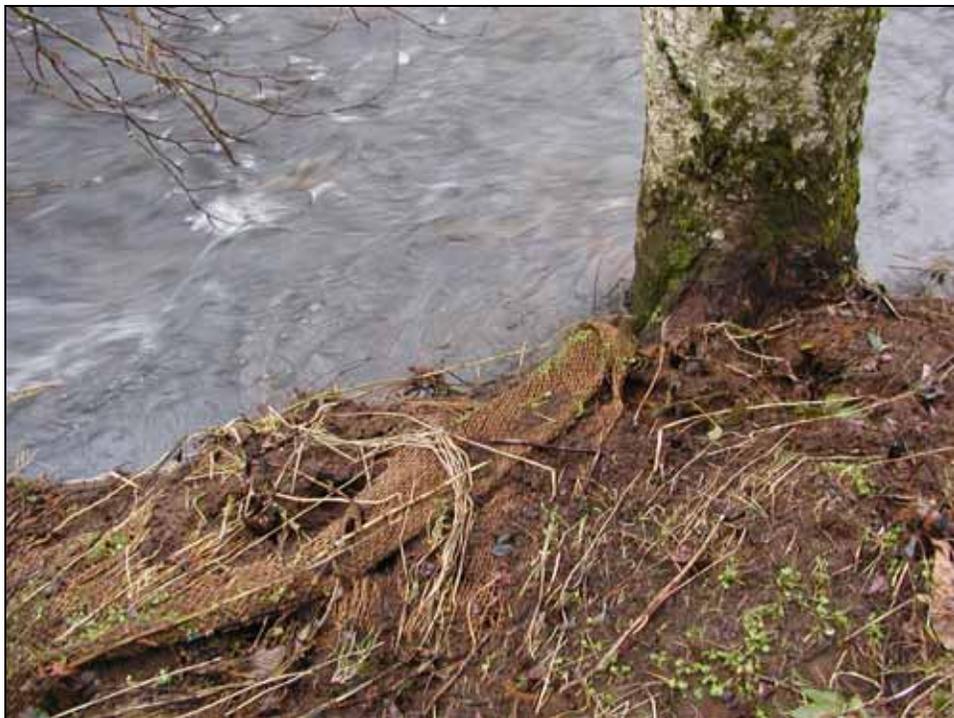
The bioengineering at this location consisted of reestablishing a broad, natural riparian habitat in areas previously disrupted by a pond and a diversion. Woven jute fabric was used to stabilize the stream banks of the traditional channel (see Figure 2.14). Large woody debris (in the form of one- to two-foot diameter logs) was placed in the stream to promote complexity (see Figure 2.15). This large woody debris was in fact the main objective of the work adjacent to the Fairview Training Center. Willows were planted along the stream banks where the pond once was (see Figure 2.16). Woody vegetation was planted in the area of the reclaimed diversion with a photodegradable plastic mat placed to control canary reed grass until vegetative shading could accomplish the same objective (see Figure 2.17).

Figure 2.14: Exposed woven jute fabric installed to stabilize stream banks at the Pringle Creek site

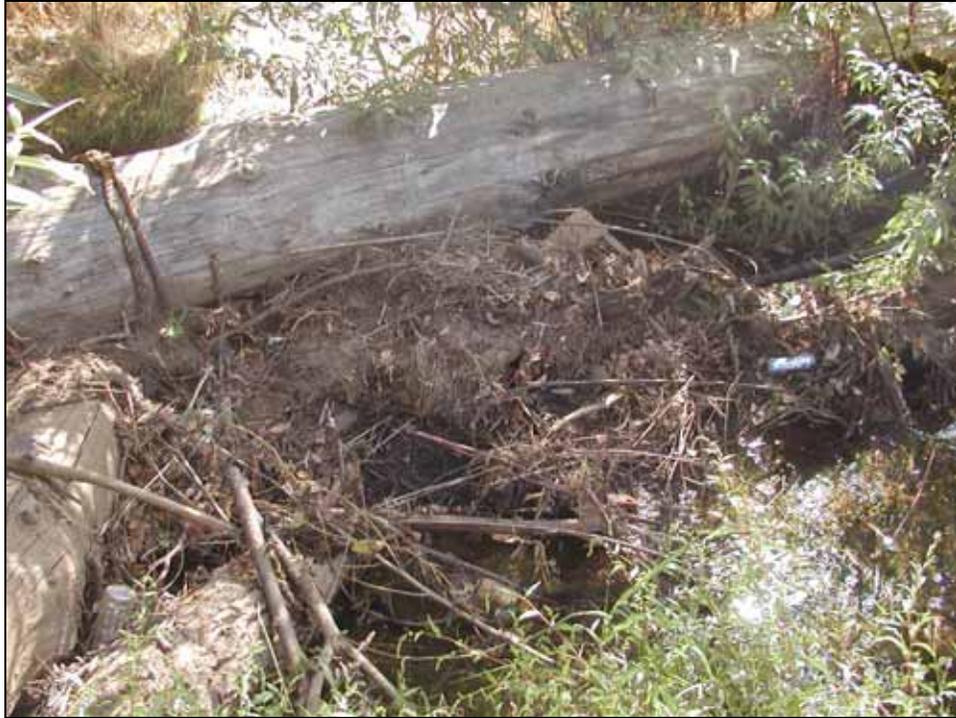
Figure 2.15: One of three artificial log jams placed in Pringle Creek to help create deeper pools for fish habitat

The objective of placing the large logs in the stream had been to create deeper pools for improved habitat for fish species such as Steelhead Trout (*White 2009*). The stream had already been through one complete wet season before monitoring was begun. No noticeable change in the size or depth of the pools around the logs was observed during monitoring. The stream seems to have adjusted itself to the presence of the logs in one wet season.

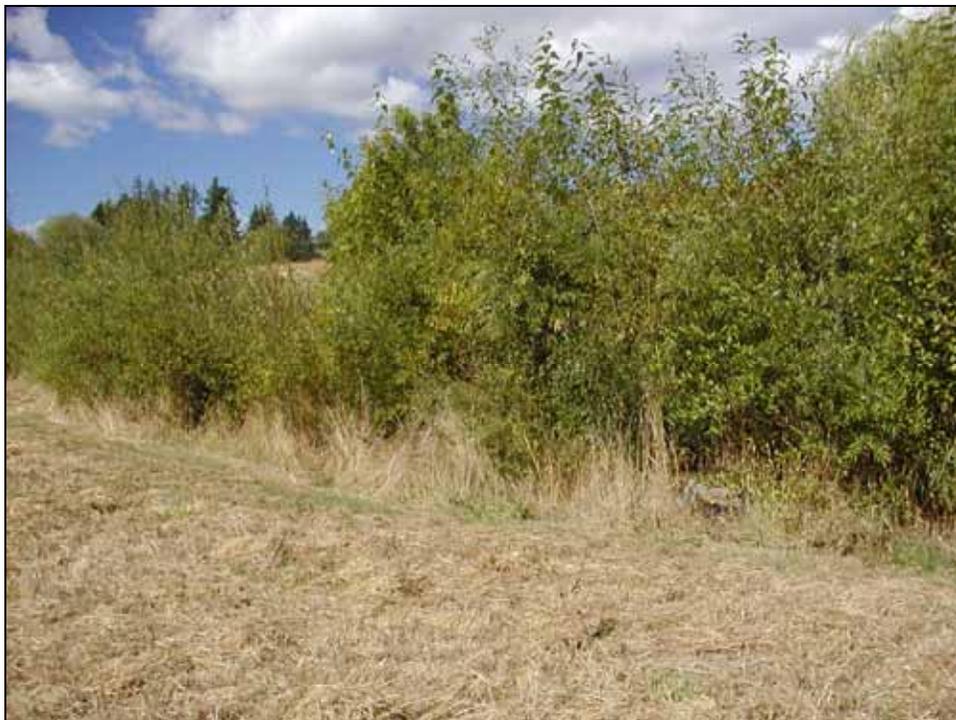
Figure 2.16: Willows planted along Pringle Creek's riparian zone in what, at one time, was an artificial pond created by a small dam

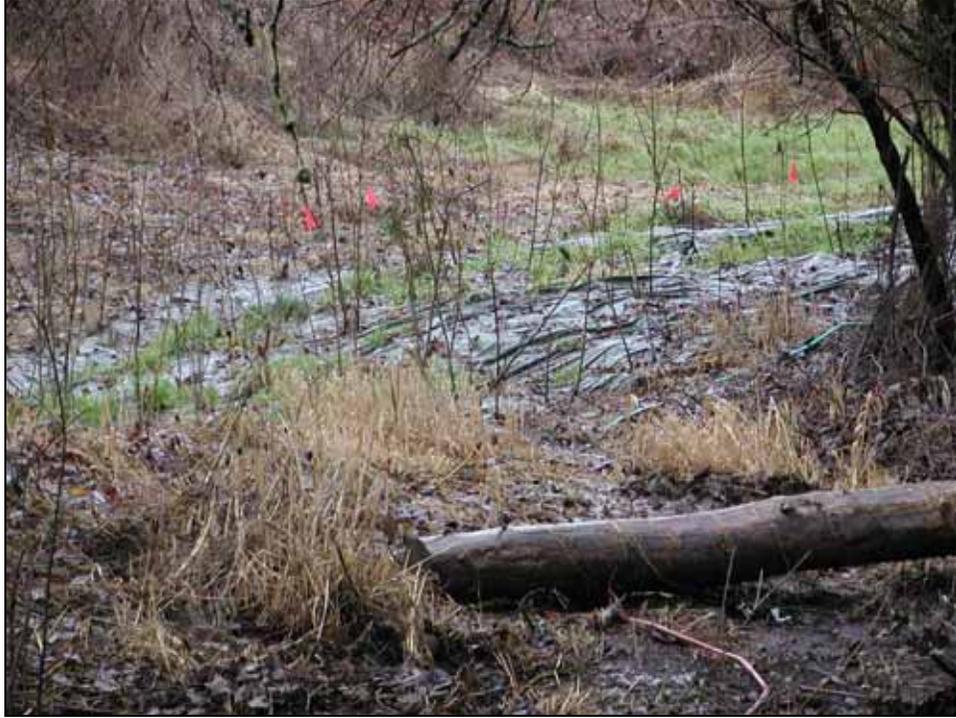
Figure 2.17: Willows planted along Pringle Creek. The black plastic is intended to inhibit the growth of canary reed grass until shading by the willows can accomplish that same objective.

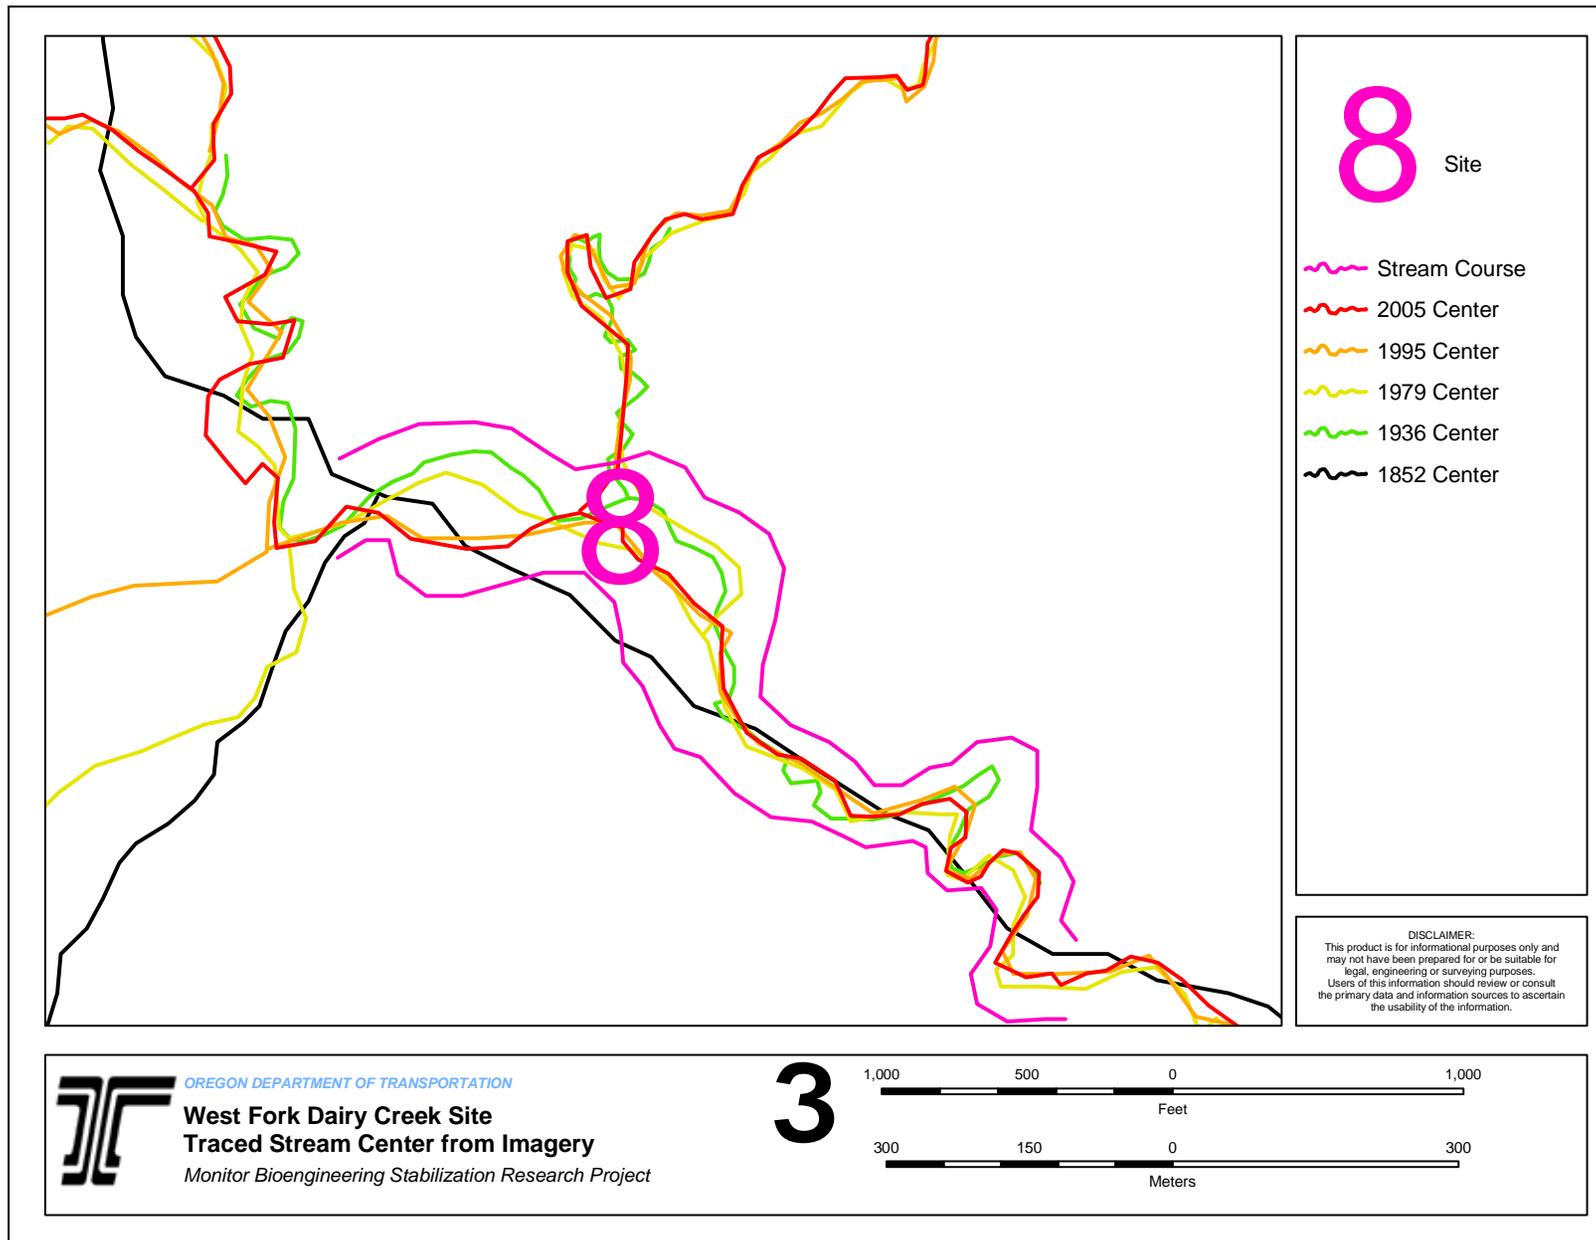
Figure 4.6 shows a map combining the trace of the apparent stream thalweg for each of the time periods.

Figure 4.6: Map of the West Fork Dairy Creek bioengineering site with the interpreted center of the stream channel as depicted on maps and imagery over historic times

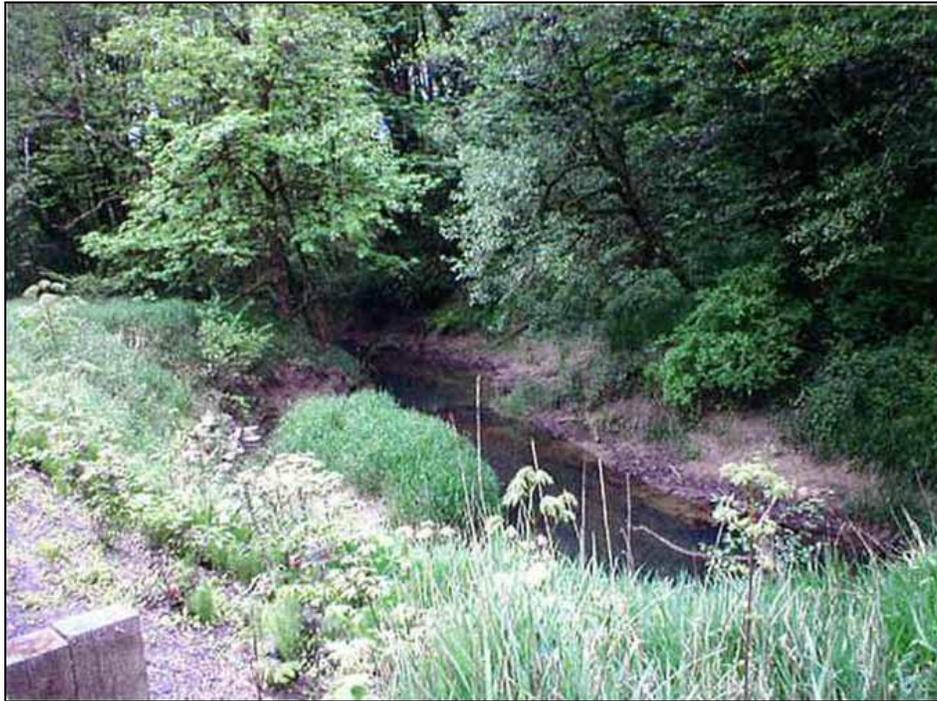
Figure 4.7: Photograph taken May 2003 showing the West Fork Dairy Creek site, looking downstream

The positions of the stream bank did not change noticeably during monitoring, as shown in Figures 4.7 through 4.17. The most noticeable differences over time were the seasonal changes in vegetation and the slow succession of vegetation over the years following construction.

The large rip-rap at the base of the slope has remained in place, and the size and form of the small islet in the stream was surprisingly consistent. The vegetation on the bioengineered slope quickly recovered following flood flows.

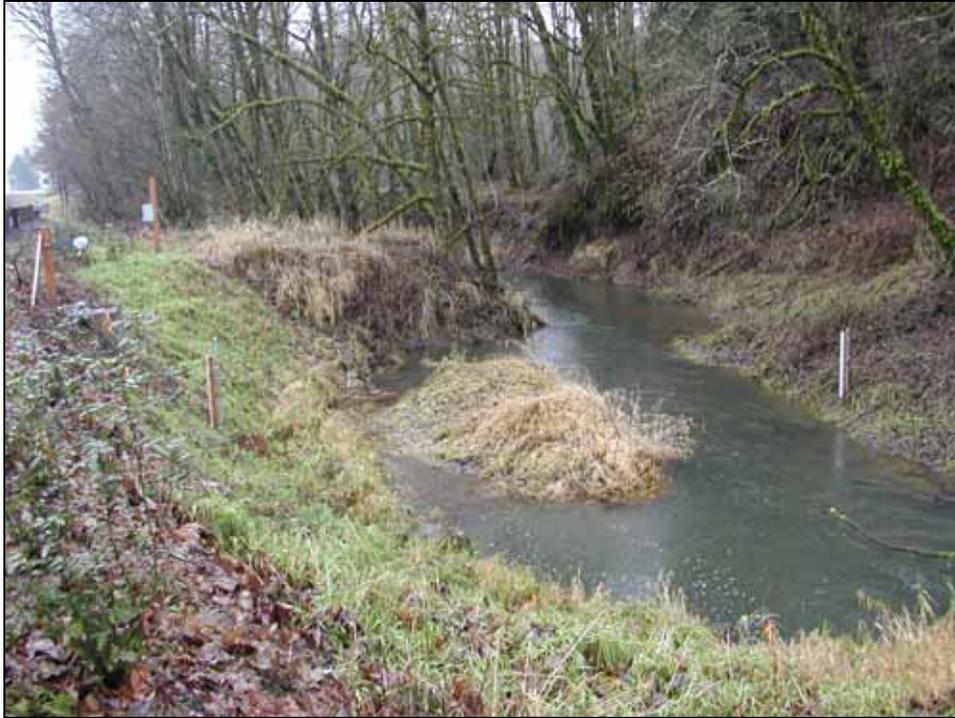
The fabric and anchors are now completely and continuously covered in vegetation. In Figure 4.8 woody plantings placed in the slope can be seen marked with orange flagging. It does not appear that any of these actually established themselves, but in Figures 4.11, 4.15, and 4.17 it can be seen that Oregon Grape and some sort of Maple tree (Bigleaf?) established themselves high on the slope.

Figure 4.8: Photograph taken December 2003 showing the West Fork Dairy Creek site, looking downstream

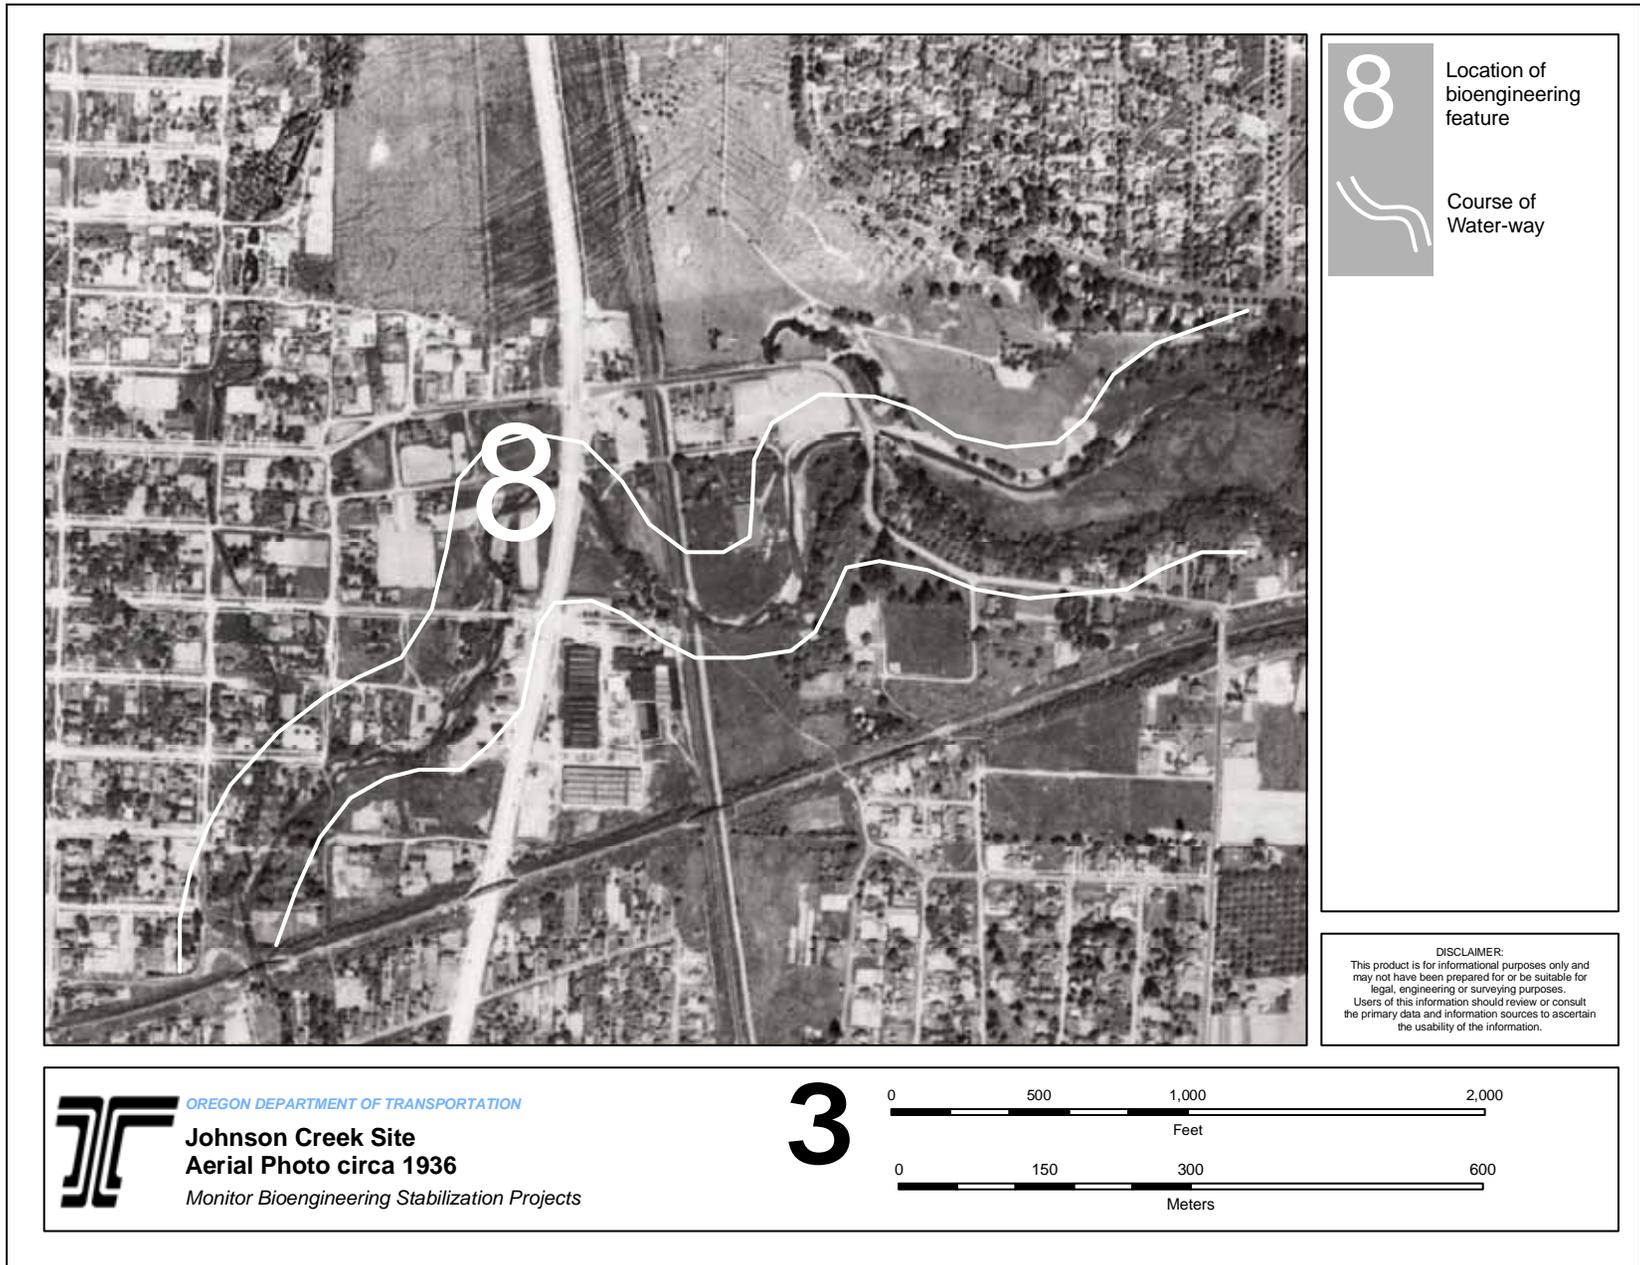
Figure 4.19 shows that in 1936 there was no longer any evidence of the lake. The wetlands appear to be dry as well. The stream channel has established itself in broad loops across the former location of the lake and wetlands. All the subsequent maps/images (Figures 4.20, 4.21, and 4.22) show the channel of Johnson Creek in essentially the same location. The changes made to its location for the construction of the new interchange do not appear to have significantly altered the stream from the course it established following whatever changes eliminated the lake and wetlands (Figure 4.23).

Figure 4.19: Map of the Johnson Creek bioengineering site as depicted in an aerial photograph dated 1936

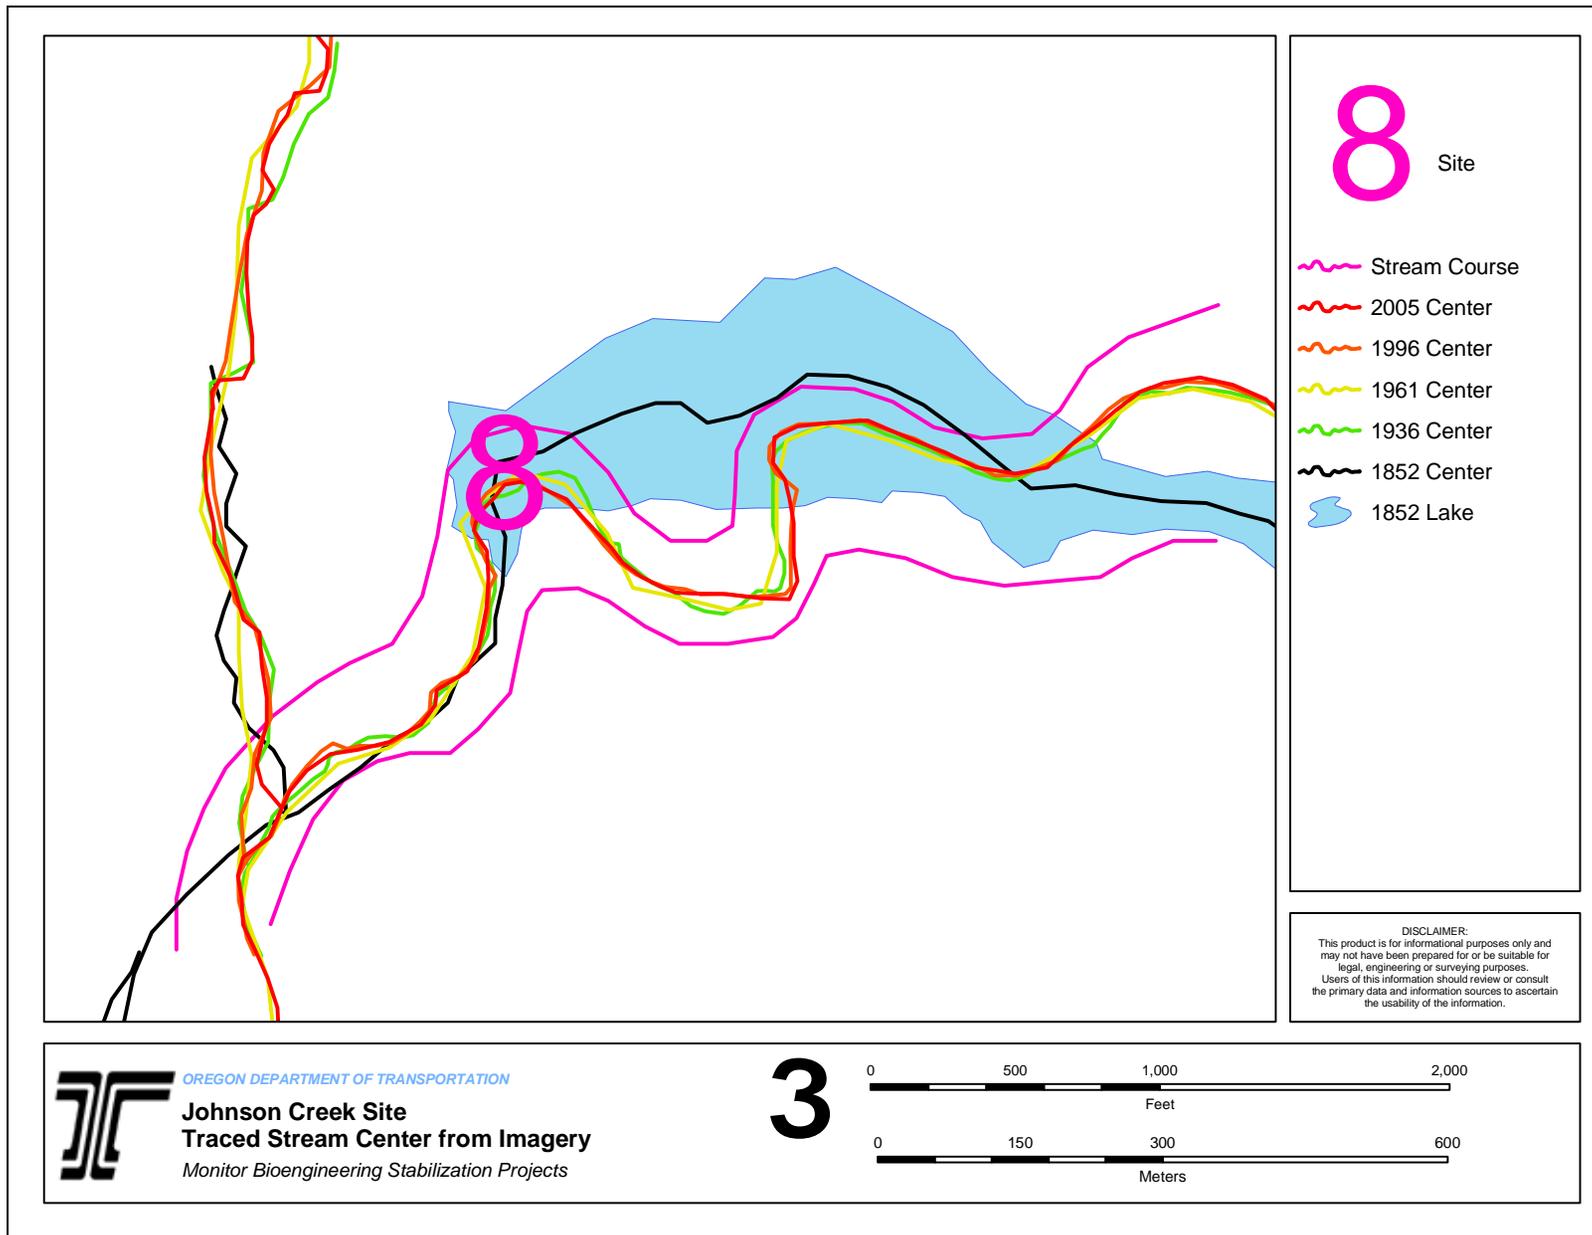
Figure 4.23: Map of the Johnson Creek bioengineering site with the interpreted center of the stream channel as depicted on maps and imagery over historic times

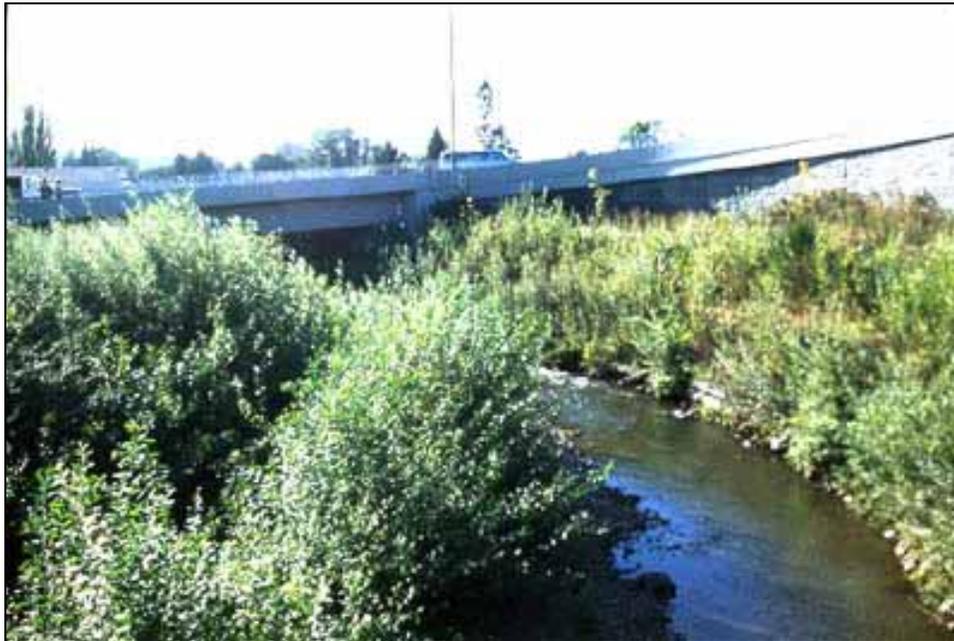
Figure 4.24: Photograph taken late summer/early fall 1997 showing the Johnson Creek site, looking downstream

The construction of the bioengineering features was better documented at this site than at the other sites, and this is also true of the monitoring. The bioengineering site was monitored as part of the original construction (*Sotir 2009*). Because of this earlier monitoring, photographs are available for a period spanning 10 years (Figures 4.24 through 4.31).

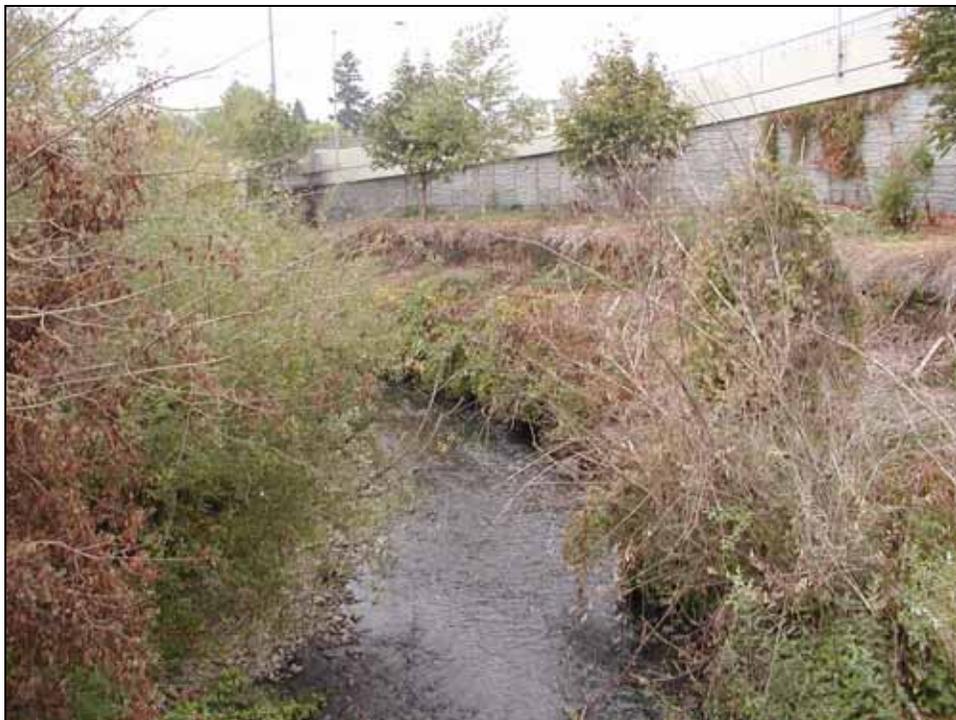
Figure 4.26: Photograph taken September 2006 showing the Johnson Creek site, looking downstream

Initially the willows planted on both the point bar and the bioengineered cut bank flourished. On the point bar they have continued to do so up to the present. On the cut bank, however, most of the willows were eventually overrun by blackberry bushes. This kept the site looking green and verdant during the growing season, but blackberries are not the vegetation that is desired at the site. In 2006 the site was mowed essentially to ground level, leaving only the few large trees at the site (see Figures 4.26, 4.27, 4.29, 4.30, and 4.31).

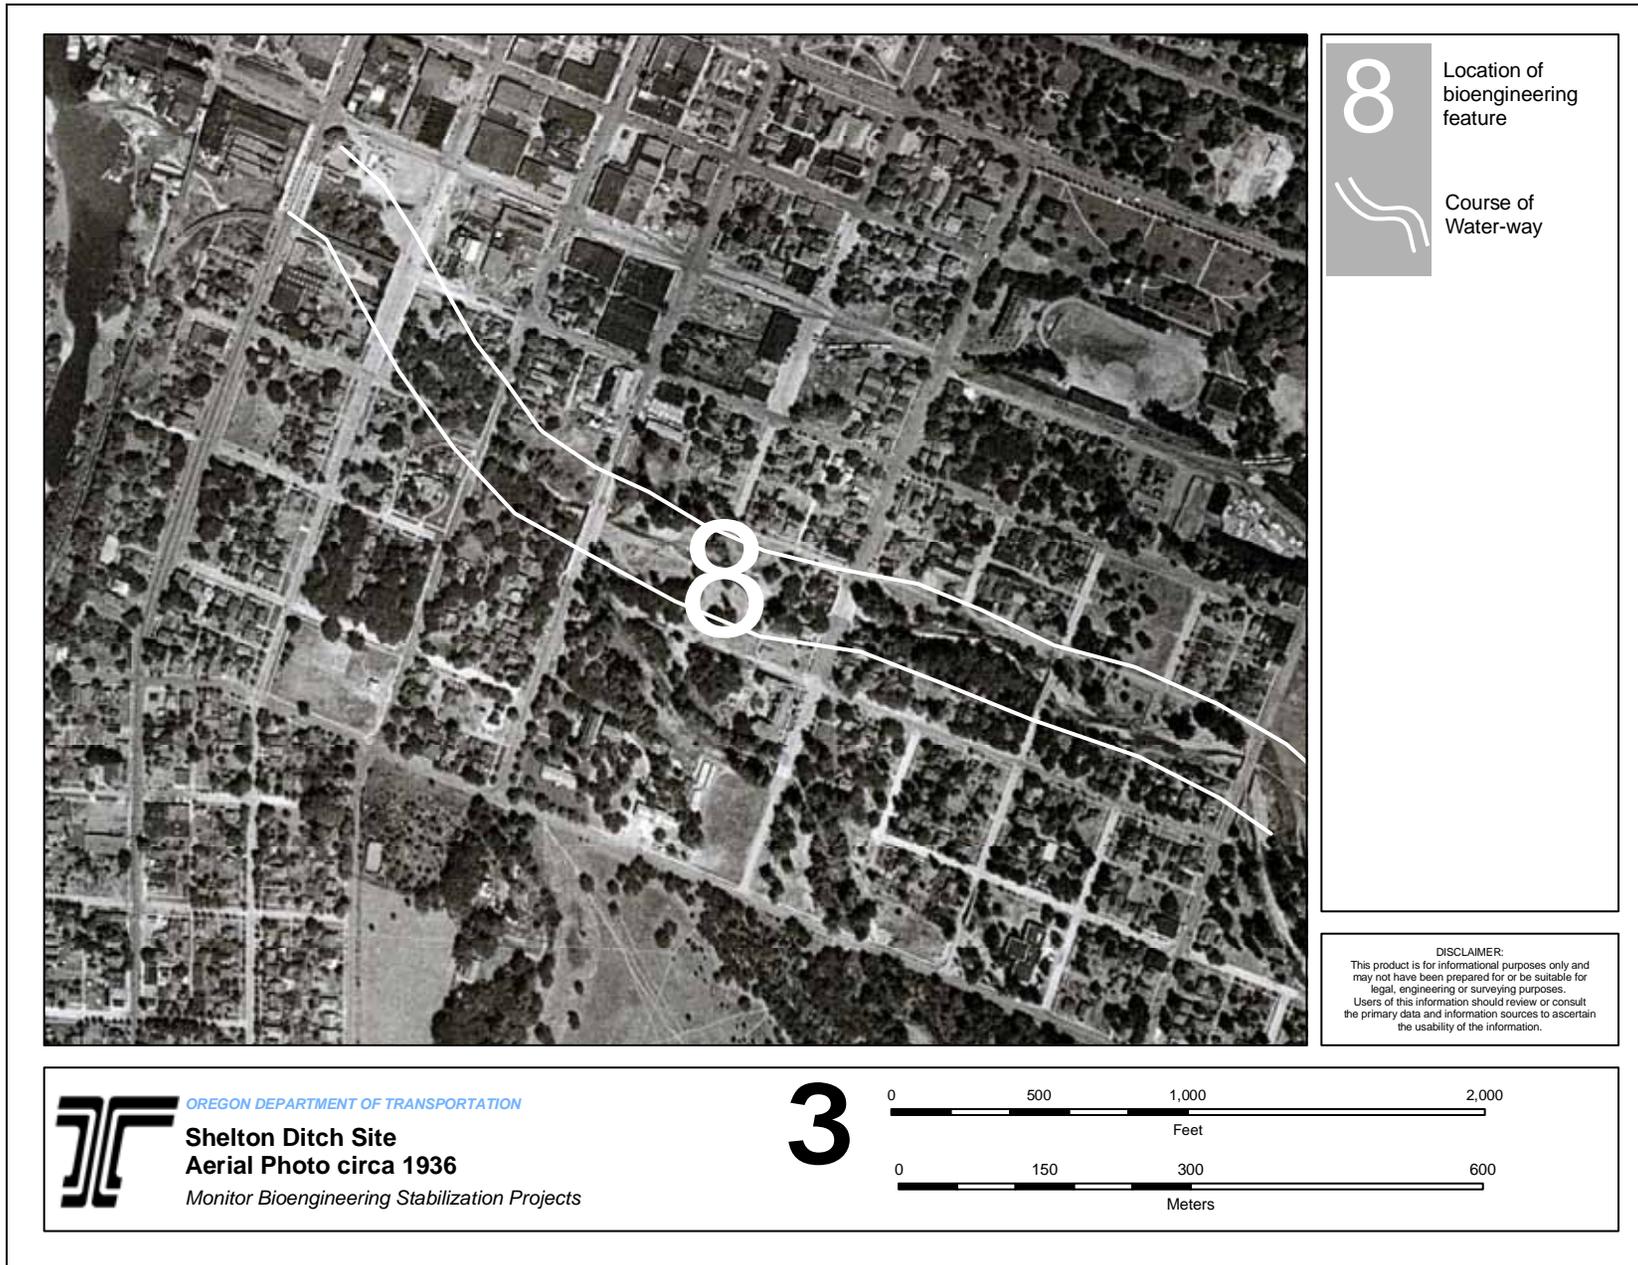
Figure 4.33: Map of the Shelton Ditch bioengineering site as depicted in an aerial photograph dated 1936

Figure 4.33 shows that in 1936 Shelton Ditch was a broad, sinuous stream with a fair degree of complexity in the vicinity of the bioengineering site. The encroachment of urbanization is evident, even though there is still a buffer of open space along most of the stream's length. The stream banks are largely free of trees and to a degree that is notably different from nearby Pringle Creek.
