**MONITORING OF
BIOENGINEERING
STABILIZATION PROJECTS**

Final Report

SPR 353

August 2009

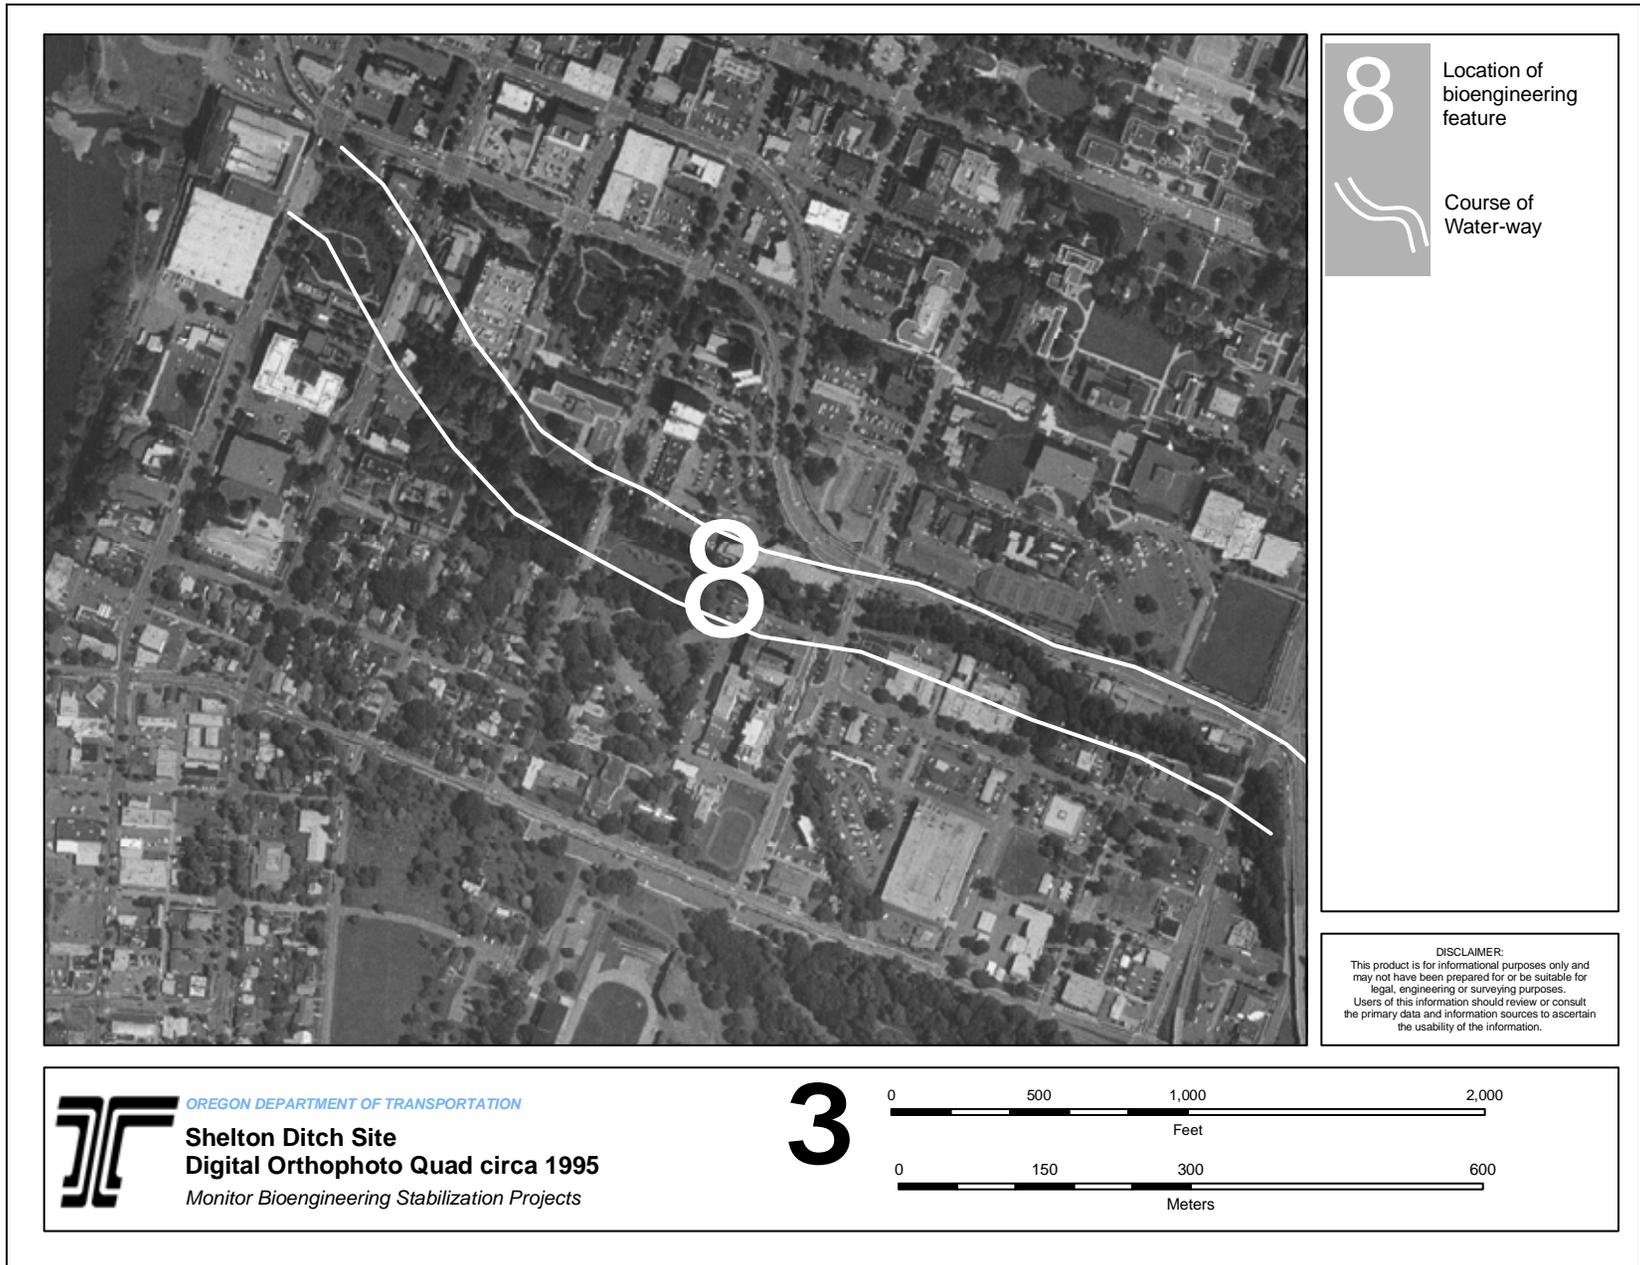
The images from 1995 (Figure 4.35) and 2005 (Figure 4.36) show that, while the stream is still straight and held to a restrictive channel, there are trees growing along and shading almost the entire length of the stream. The ironic exception to the current riparian shading is the bank of the stream within Pringle Park. Figure 4.37 shows that the location of Shelton Ditch has not changed much since the ditch was built.

Figure 4.35: Map of the Shelton Ditch bioengineering site as depicted in a digital orthophoto dated 1995

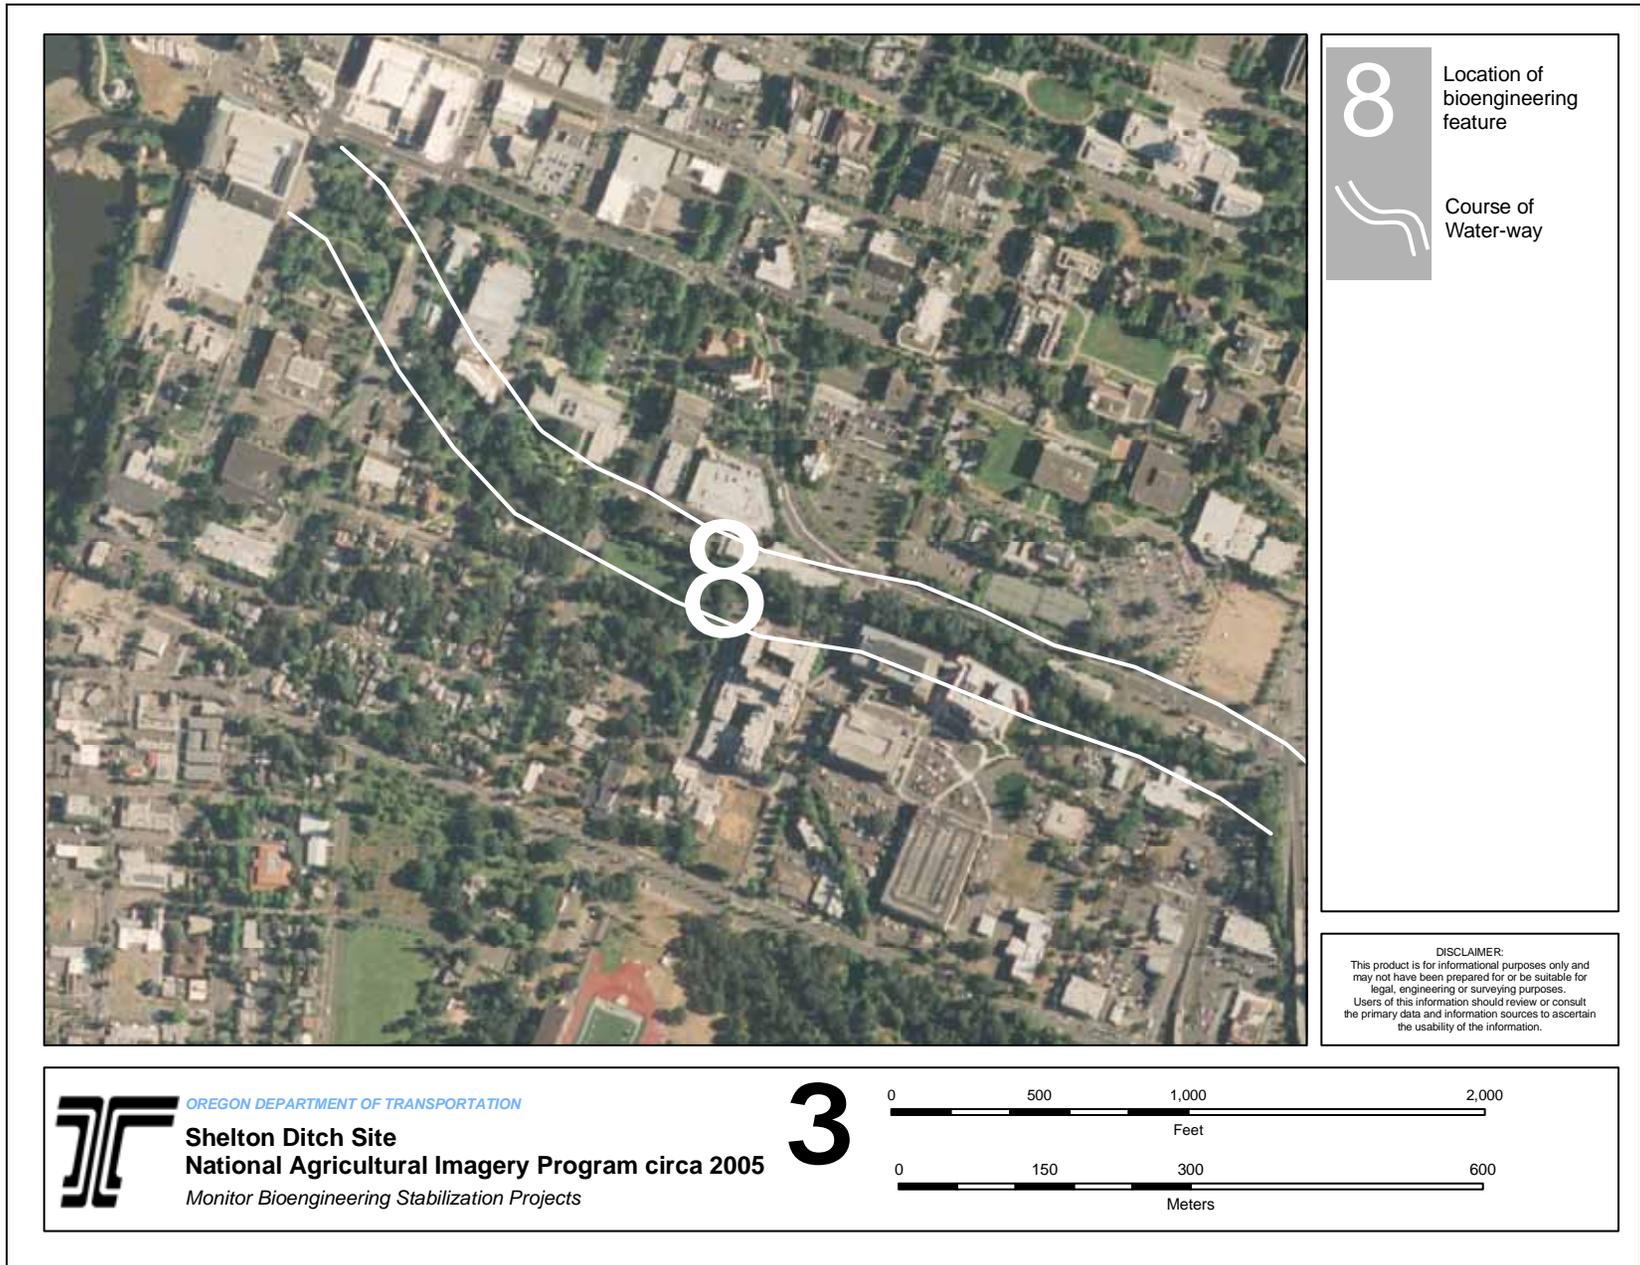
Figure 4.36: Map of the Shelton Ditch bioengineering site as depicted in a National Agricultural Imagery Program image dated 2005

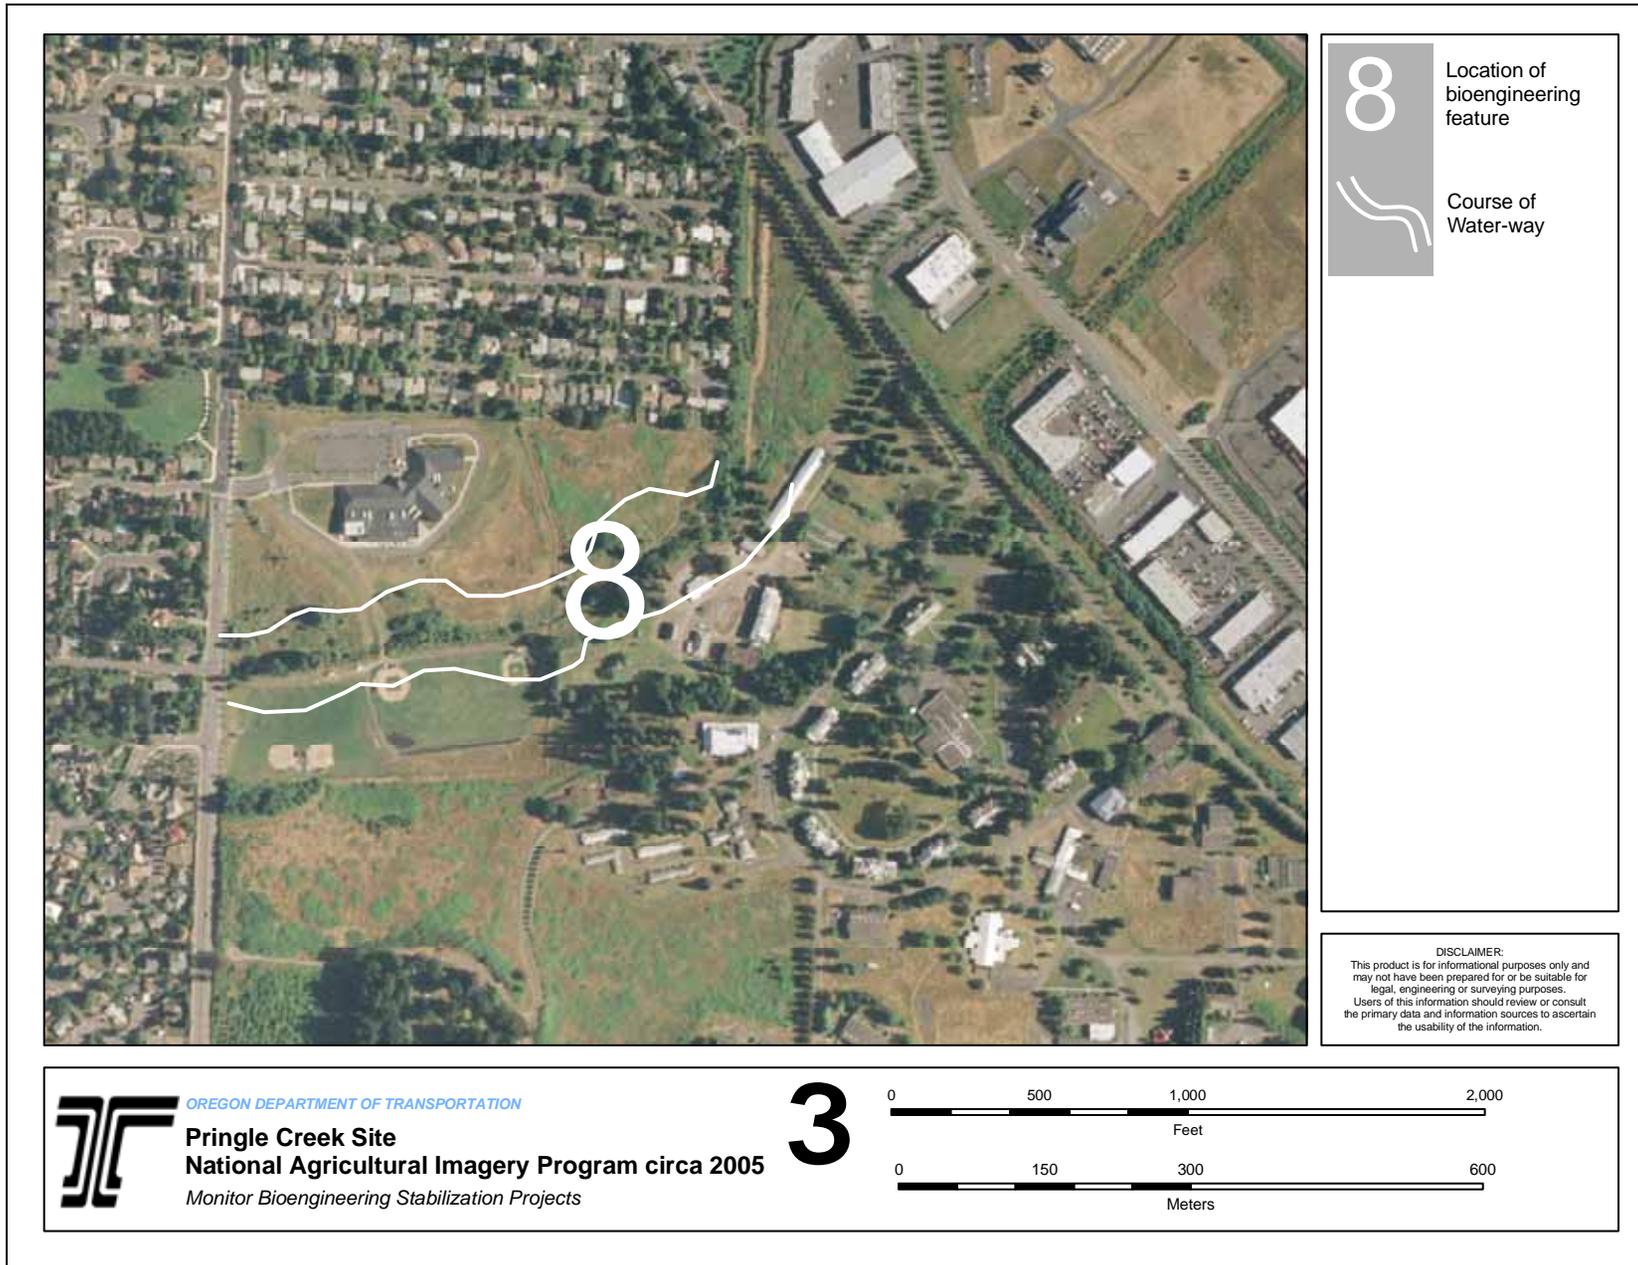
The 2005 color aerial photograph (Figure 4.42) shows willows beginning to reestablish themselves along the stream where the pond had disrupted the riparian vegetation. Figure 4.43 shows that the significant change to Pringle Creek over history was the construction and removal of the fishing pond.

Figure 4.42: Map of the Pringle Creek bioengineering site as depicted in a National Agricultural Imagery Program image dated 2005
