**DEVELOPMENT AND EVALUATION OF  
FIBER OPTIC SENSORS**

**Final Report**

**PROJECT 312**

Eric Udd  
and  
Marley Kunzler  
Blue Road Research  
276 NE 219<sup>th</sup> Avenue  
Gresham, Oregon 97030

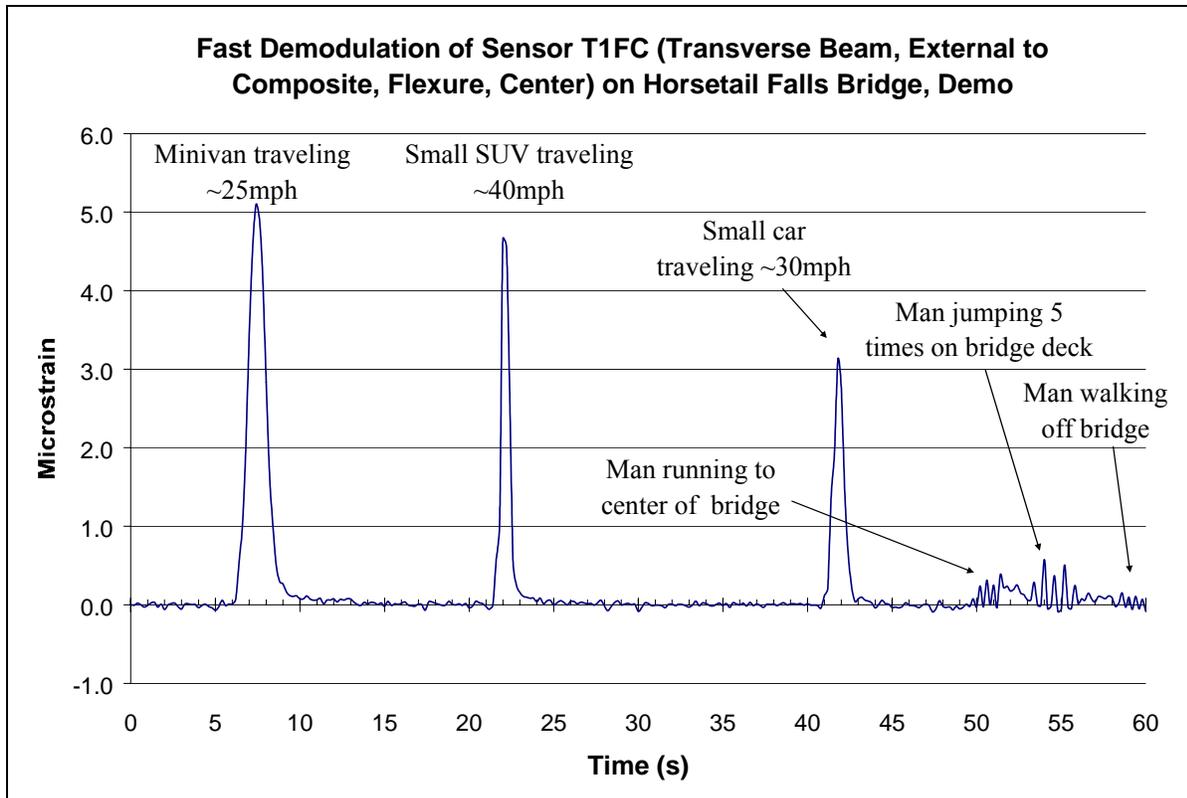
Figure 1.1: Data collected at the Horsetail Falls Bridge showing various profiles: A minivan, a small SUV, a small car, a man running, a man jumping 5 times, and a man walking on the bridge

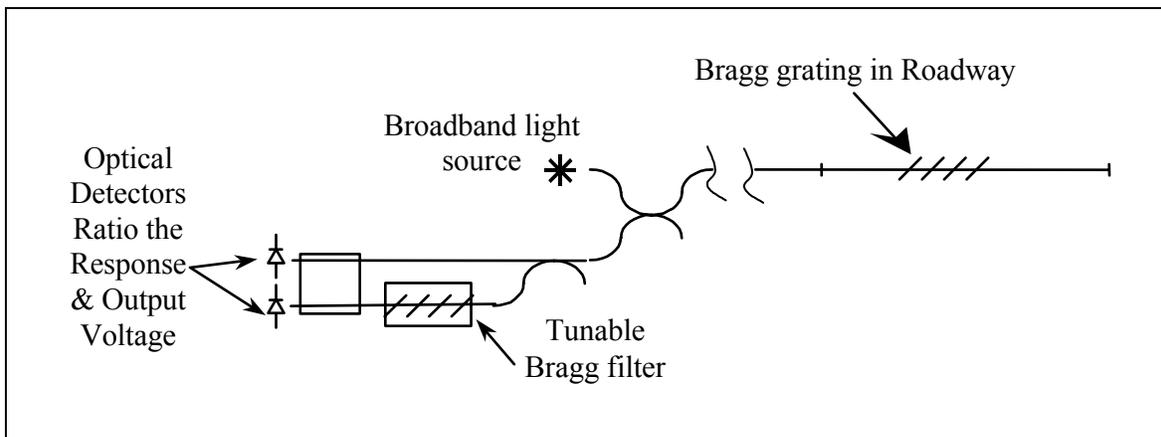
Figure 1.2: Schematic for FBG traffic sensor and demodulation system

As shown in Figure 1.2, the system functions by using a broadband light source (BBS) channeled into a fiber optic strand approximately 155 microns in diameter with a polyimide coating. The BBS light couples through a beam splitter and illuminates a Bragg grating connected through fiber at a remote location.

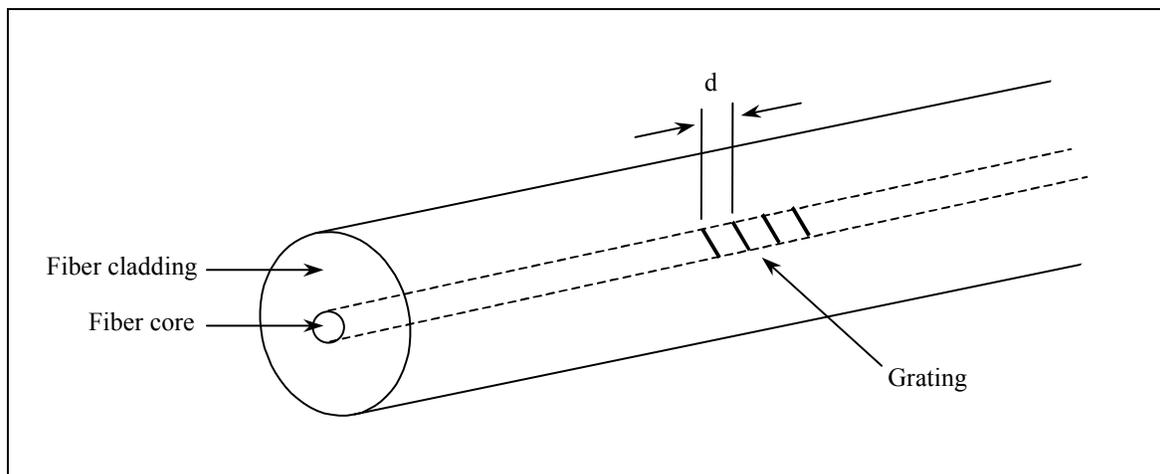
Figure 1.3: Fiber grating written onto core of fiber

Fiber gratings are formed by a periodic perturbation in the index of refraction along the length of the fiber. This grating, written onto the core of the optical fiber, has spacing “d” (Figure 1.3).

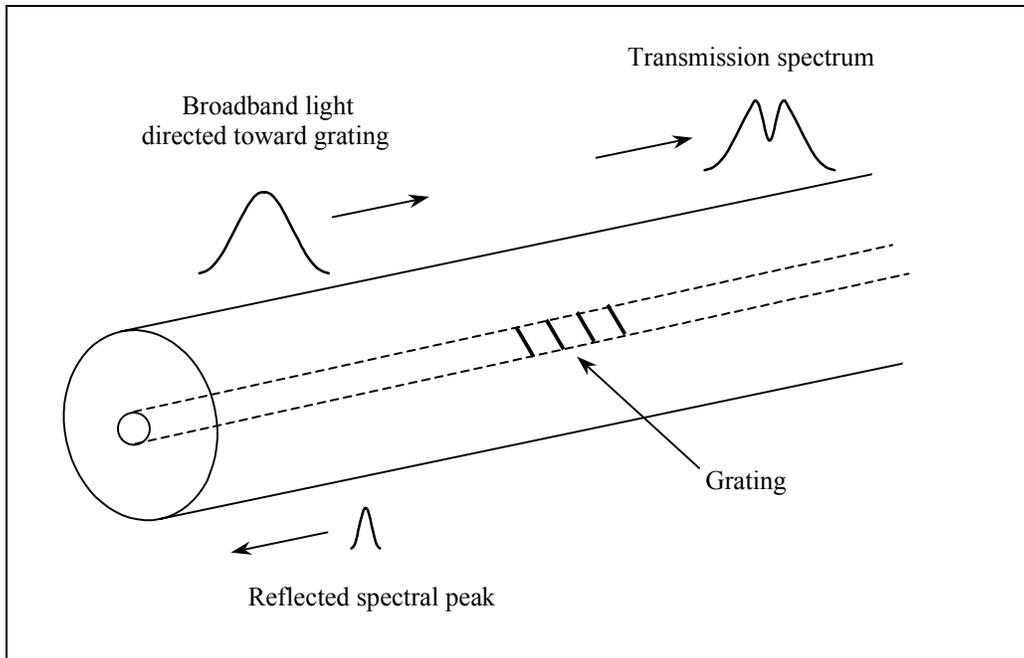
Figure 1.4: Transmission and reflection spectra from fiber Bragg grating

This grating acts as a spectral filter and reflects a peak based on the grating spacing (Figure 1.4). The grating spacing affects the center wavelength of the reflected peak. A larger grating spacing results in higher wavelength reflections (Figure 1.5).

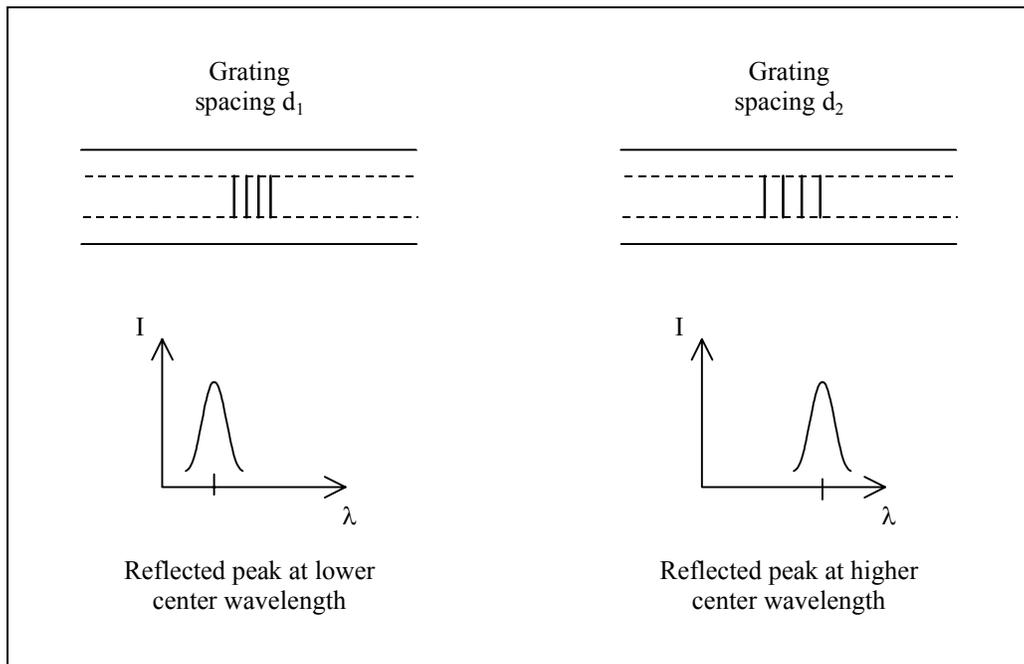
Figure 1.5: A larger grating spacing will result in a reflected peak with higher center wavelength

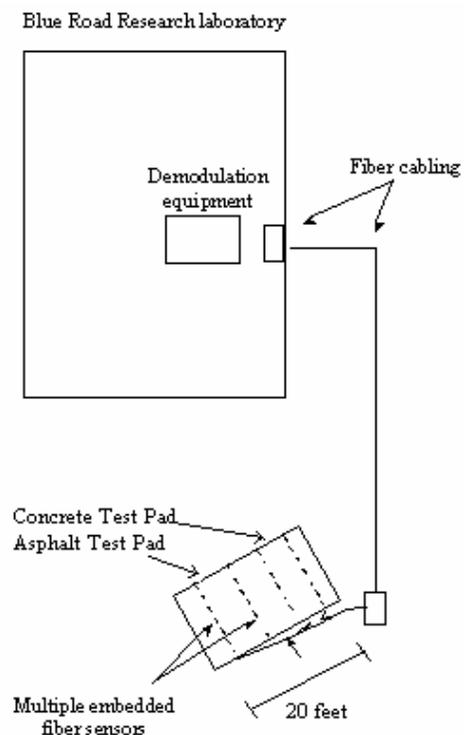
Figure 2.1: Layout of traffic test pad and sensor system

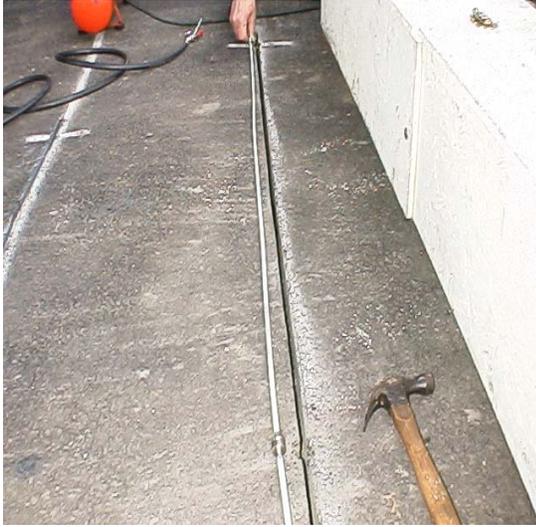
Figure 2.2: The ½" width housing chosen for FBG traffic sensor tests

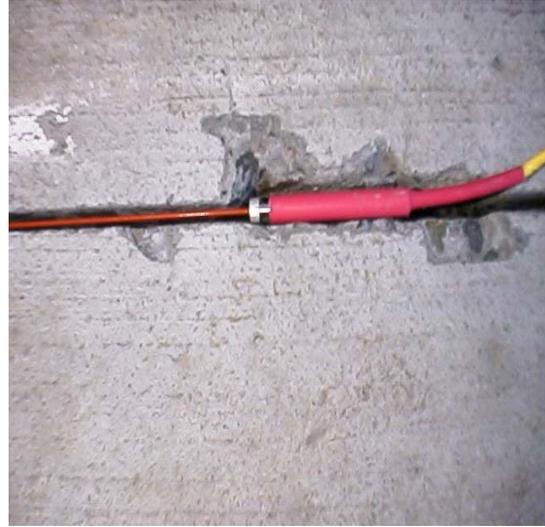
Figure 2.3: A 1/16" sensor shown with the anchor

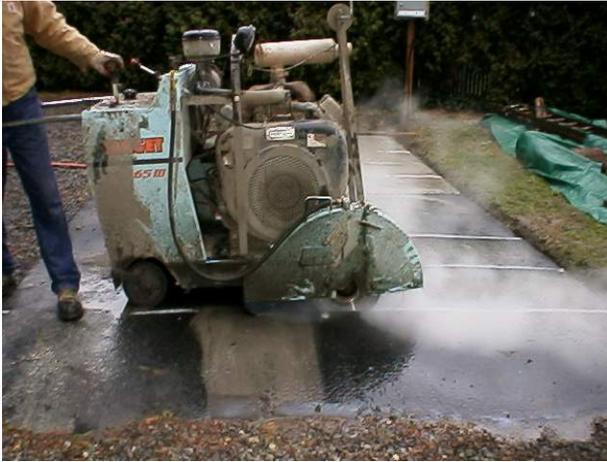
Figure 2.4: Cutting slots for the FBG traffic sensor installation

The procedure developed for installation was similar to that of loop inductors. First, a channel was cut into the roadway. The active sensing area (the portion between each anchor) was placed near the bottom of the slot. The slot was filled with a sealant that had moisture insensitive, flexible, and low exothermic properties. An epoxy and bituminous sealant from the ODOT approved products list was used. After the sealant cured, the sensor lead was connected and ready for monitoring.

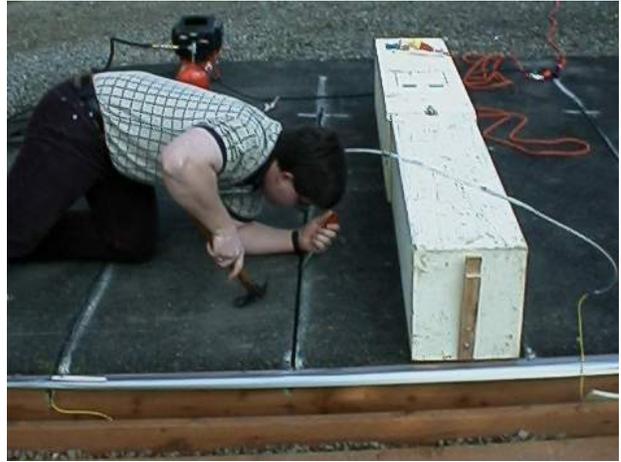
Figure 2.5: Optimizing sensor channels for ideal fit prior to installation. Heater boxes (right) were used for curing

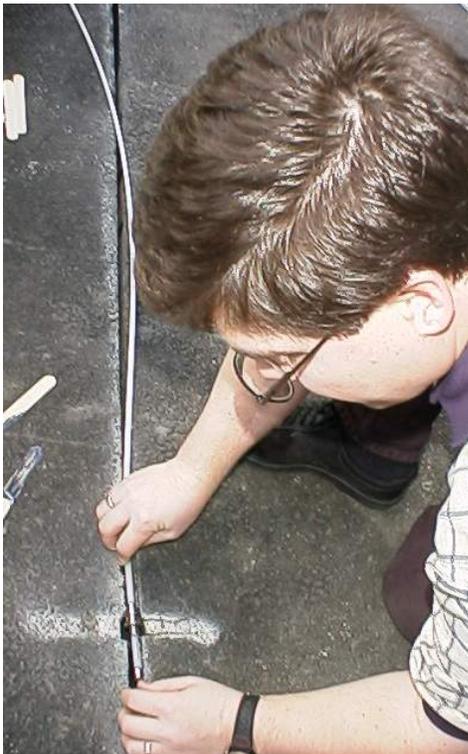
Figure 2.6: Placing the 1/2" sensors into the AC test pad

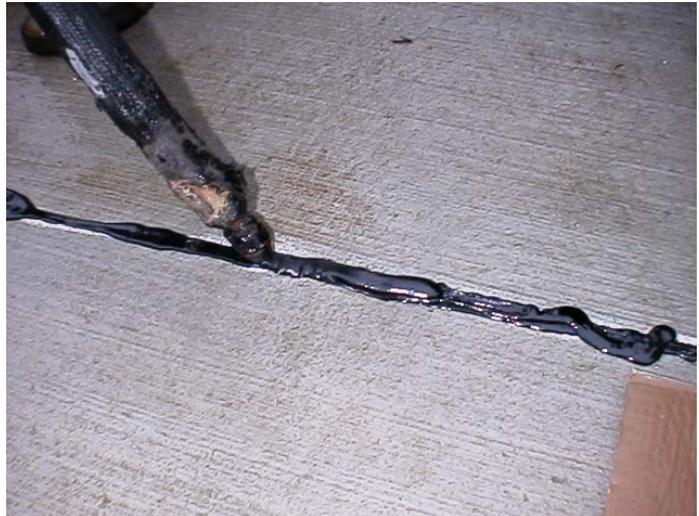
Figure 2.7: Hot bituminous sealant was used to fill the channels for half of the sensors. The protruding mound was later removed so the surface can be completely level

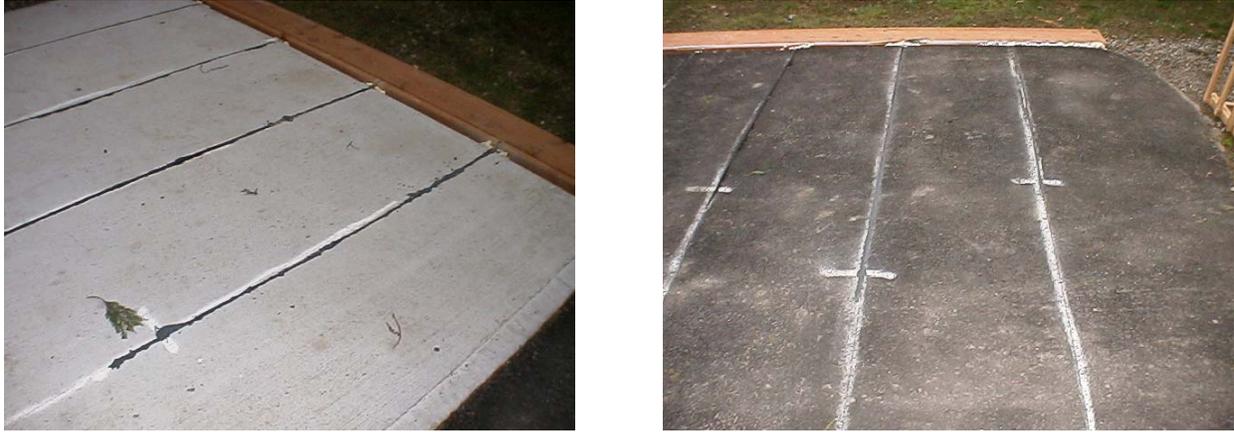
Figure 2.8: AC test pad (left) and PCC test pad (right) after the traffic sensors were installed and sealants dried

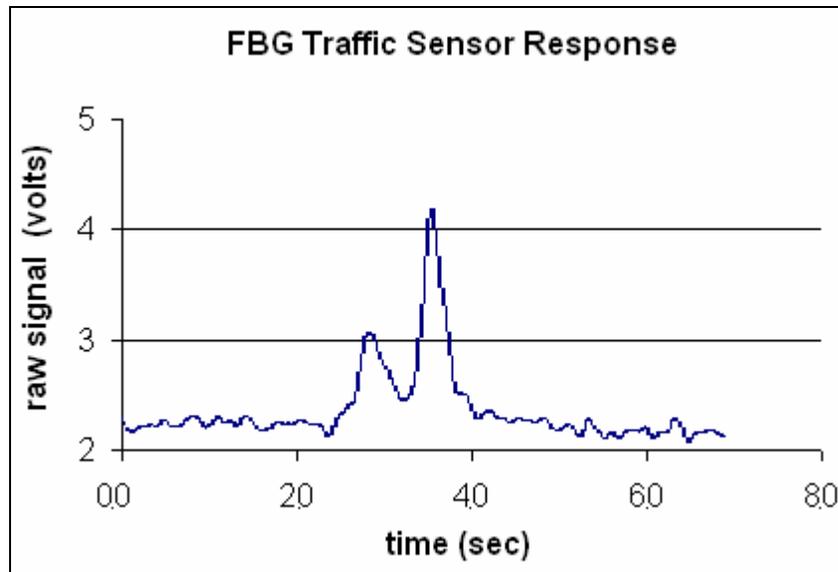
Figure 2.9: Sensor response to a vehicle backing across the sensor

Data obtained from the use of vehicles on the test pads gave engineers a basis for determining sensitivity levels of the sensors and their response under varying installation conditions. The primary vehicle used in data collection and measurement was a 3,200 lb (1,450 Kg) 4-door sedan. Figure 2.9 shows a typical response obtained from one of the sensors as the right wheel of a vehicle backs across the sensor placed at a 2 in (50 mm) depth in the AC.

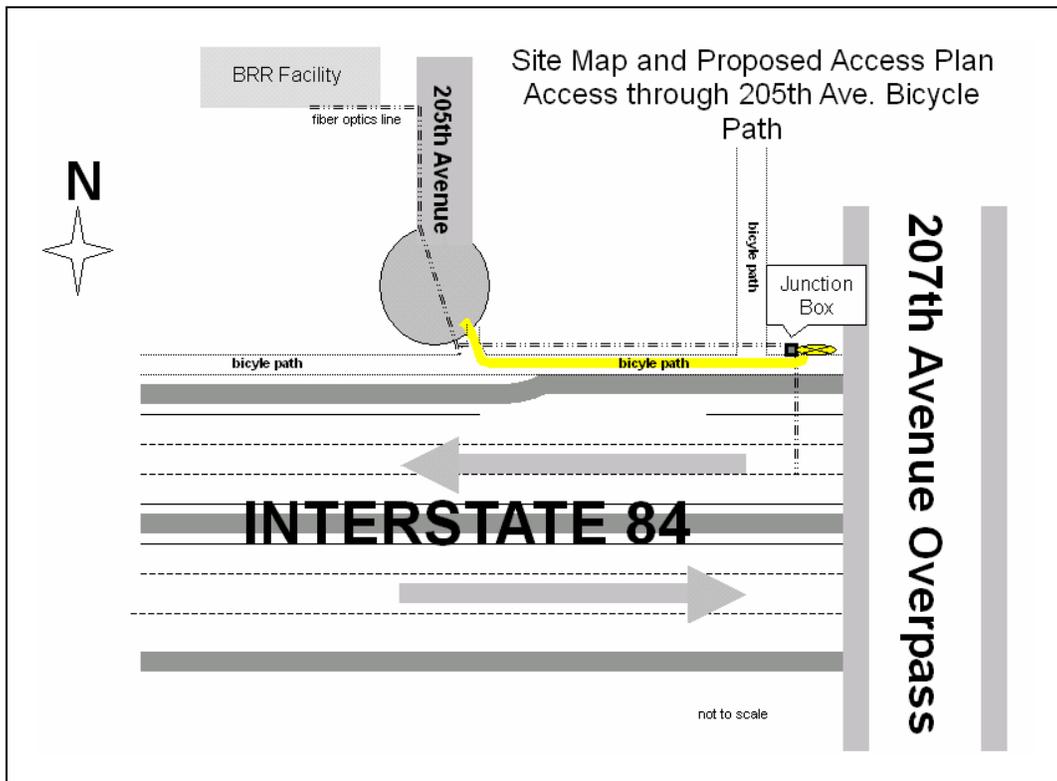
Figure 3.1: Site map of the final layout for FBG sensors

In August of 2001, four FBG traffic sensors and one temperature sensor were installed into the westbound right lane of the Interstate 84 freeway (I-84), near Exit 14 (Fairview). The average daily traffic across 6 lanes was 57,900. Figure 3.1 diagrams how the 1,120 ft (341 m) fiber cable line with 12 available channels was routed from the freeway junction box to the Blue Road Research facility where the demodulation equipment is housed.

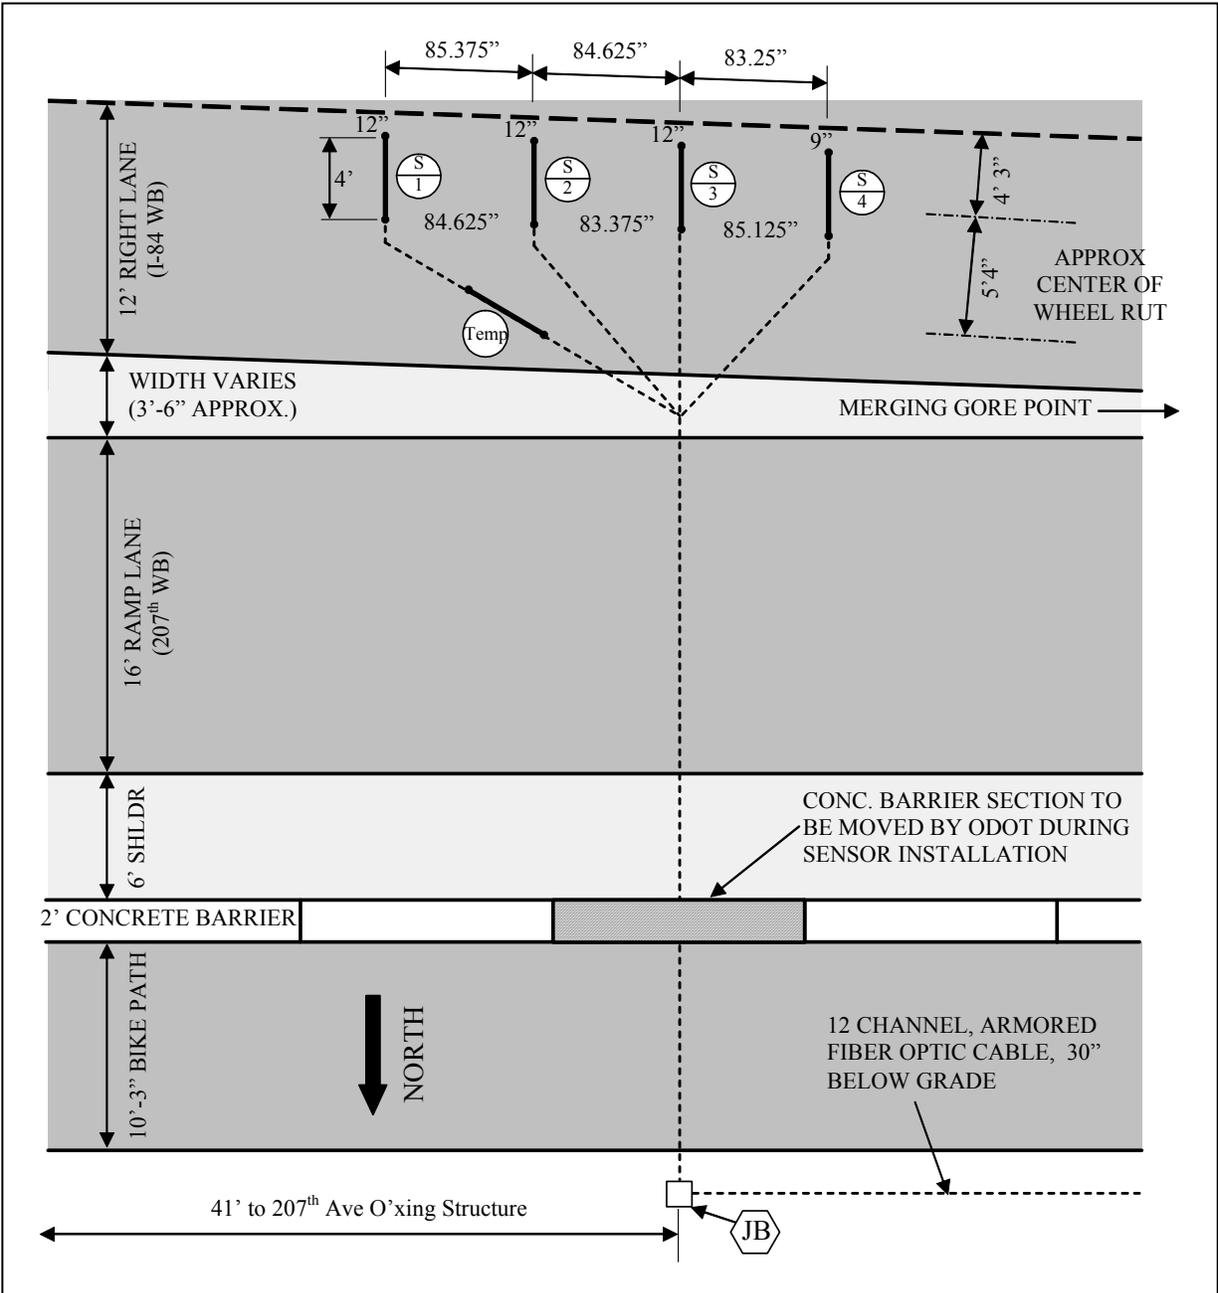
Figure 3.2: Layout of FBG traffic sensors on the westbound lane of I-84 freeway

Figure 3.2 shows the installation layout in the westbound lane. The on-ramp and right lane of the freeway were closed for a short time while the sensors and cabling were placed. Some of the steps in the sensor installation can be seen in Figures 3.3 to 3.8.

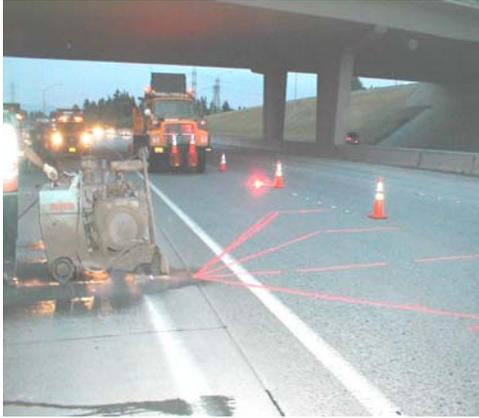
Figure 3.3: Saw cuts were made into the freeway in a fan-out pattern

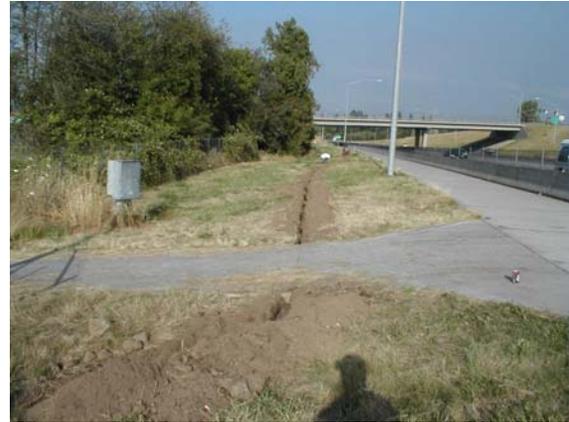
Figure 3.4: Trench for the fiber backbone carrying the traffic signals to a remote readout facility

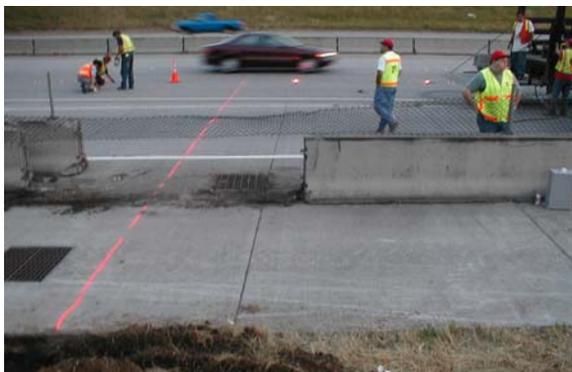
Figure 3.5: Marking was placed for the saw cut

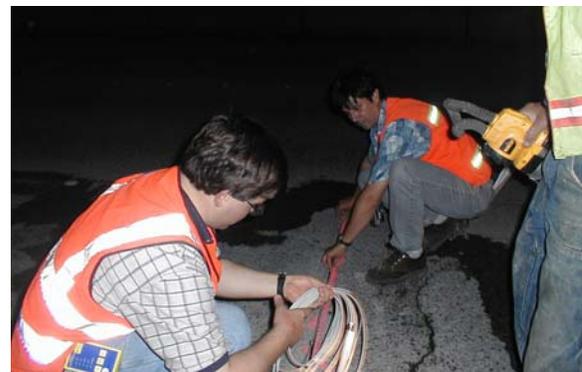
Figure 3.6: Sensors were placed into the freeway

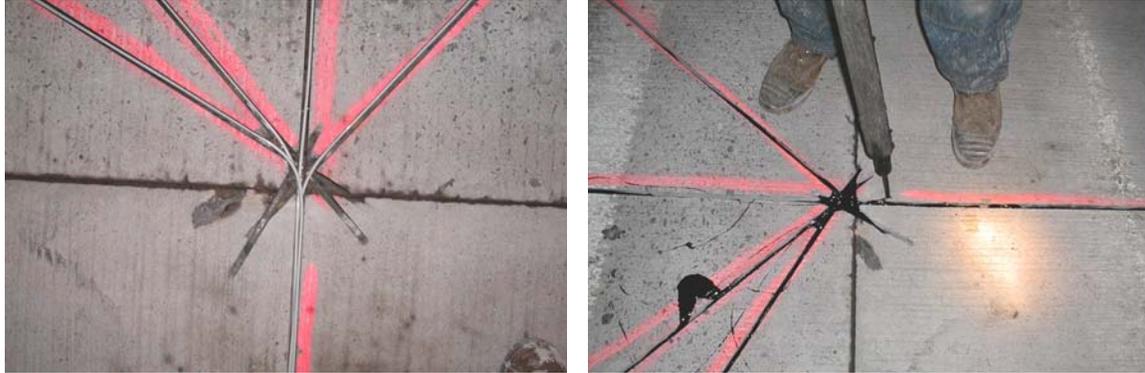
Figure 3.7: The sensors can be seen as they were routed through the junction point and then fan out to their respective locations in the AC (left). The junction point and sawed channels were later filled with hot bituminous sealant (right).

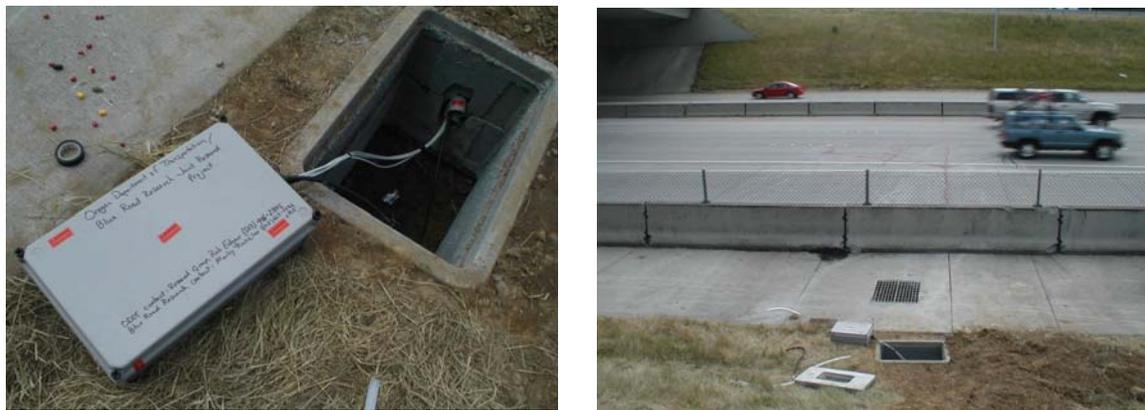
Figure 3.8: The ground-level junction box (left) as it was prepared for protecting the connections between the freeway sensors and the fiber line. Right, an overview of the sensor area and the junction box.

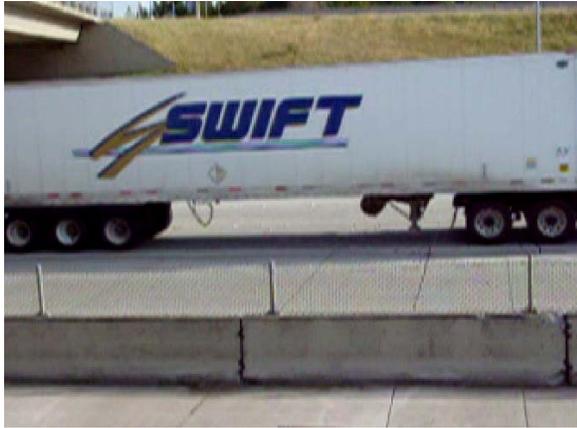
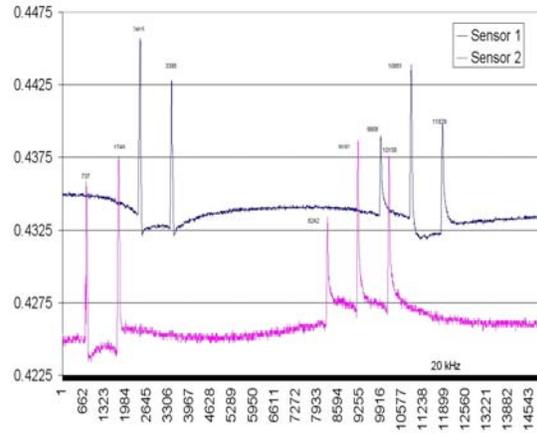
Figure 3.9: Left, semi-tractor trailer crossing embedded FBG sensors, traveling left to right. Response from two FBG sensors (right). From this data, velocity (57 mph), axle spacing and potentially weight may be determined.

After six months of testing, the sensors had not experienced any further deterioration in performance or sensitivity. Since sensor durability is proportional to strain on the grating, and the grating is essentially loose within the housing, it is theoretically possible that the FBG traffic sensors may last for the life of the roadway. Figure 3.9 shows raw data collected for a semi-tractor trailer on Sensors 1 and 2.

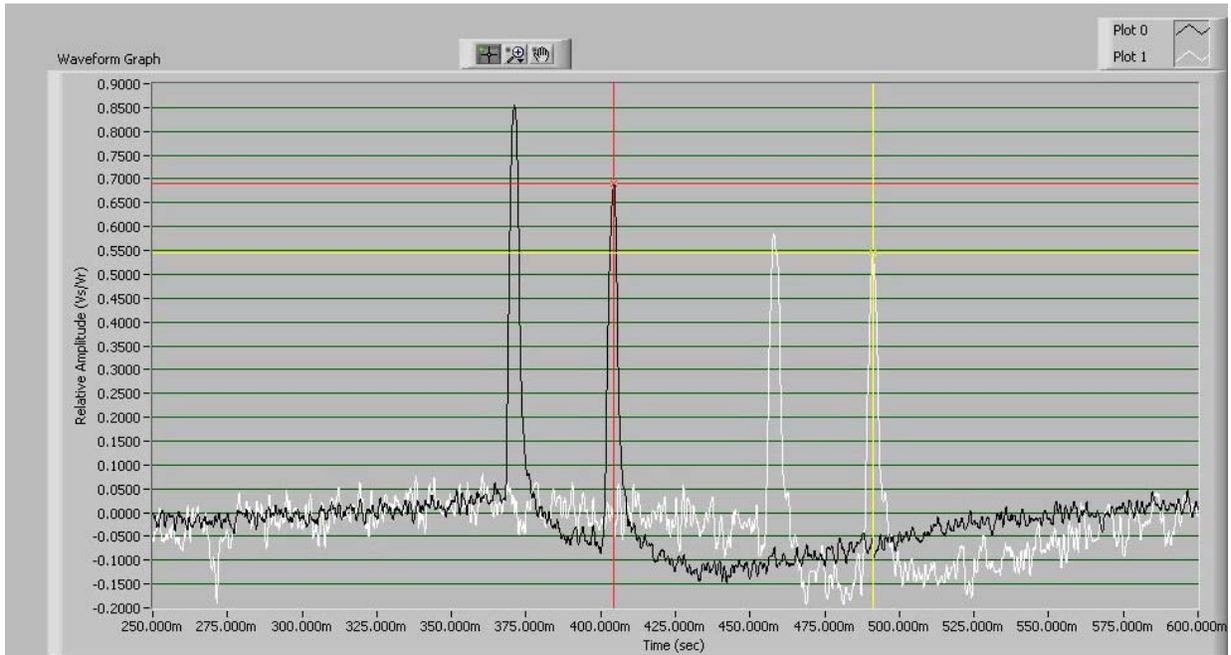
Figure 3.10: Data capture from a vehicle traveling 55 mph with 2.74 ft axle spacing

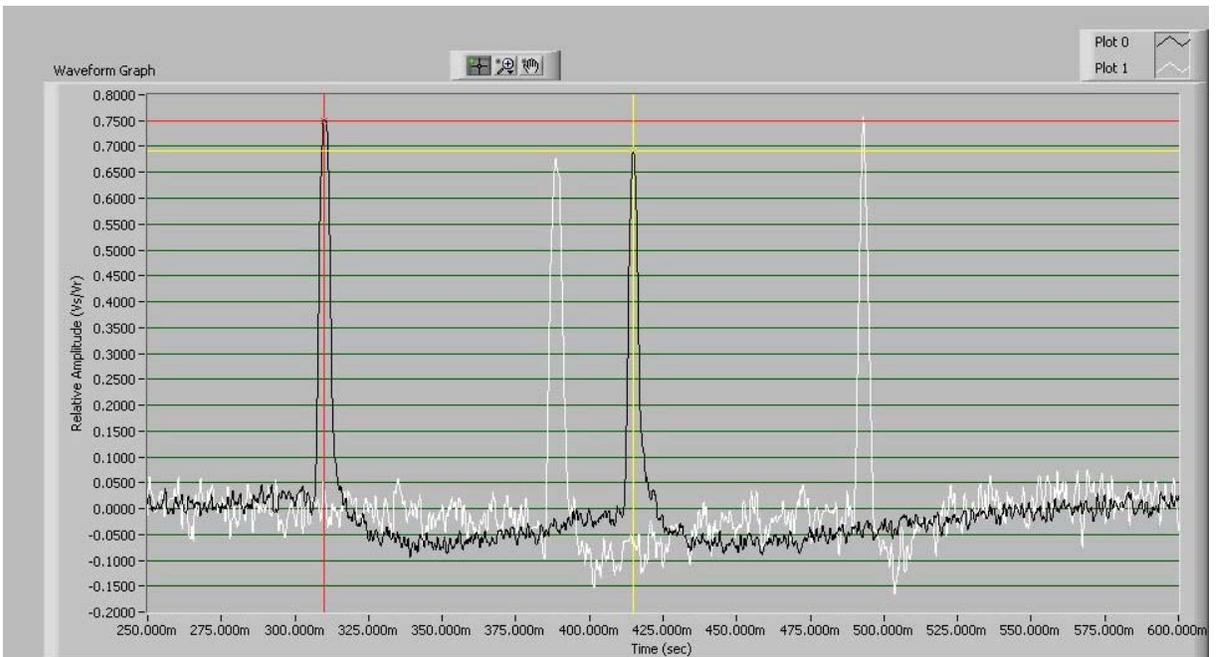
Figure 3.11: Profile of a small vehicle traveling 61 mph with 9.5 ft axle spacing

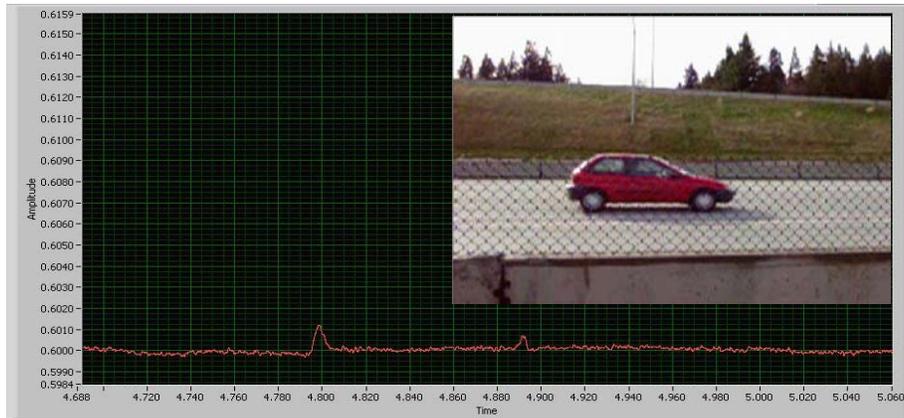
Figure 3.12: A Geo Metro and its profile are shown above. The graph shows relative amplitude versus time in seconds

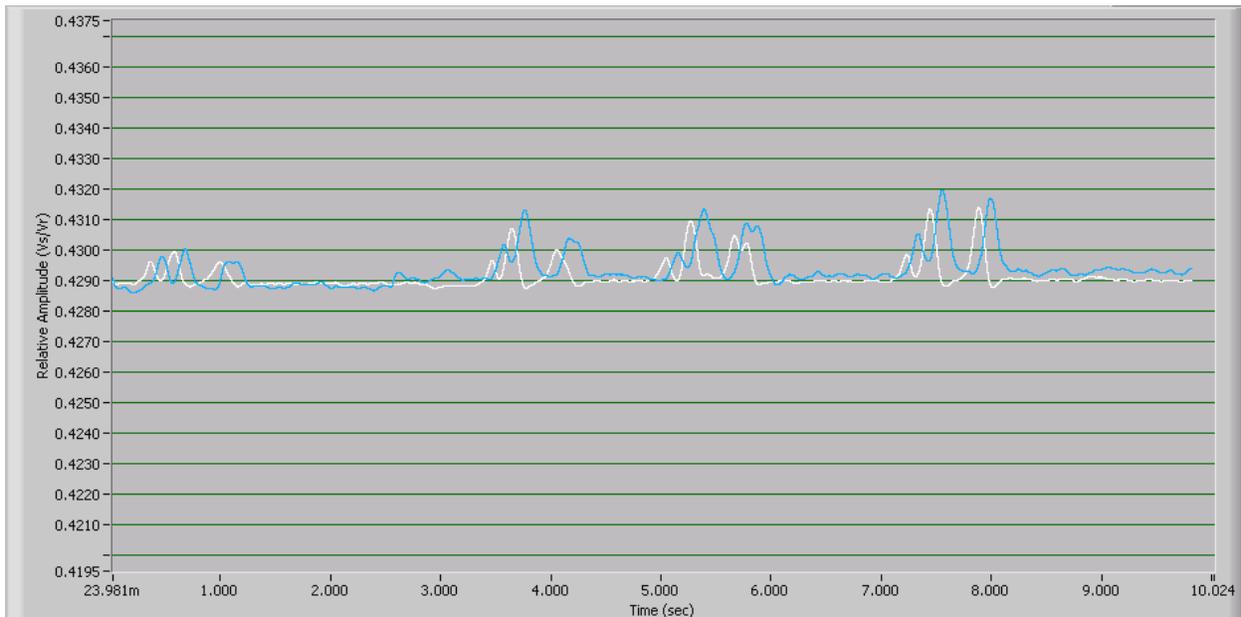
Figure 3.13: A series of vehicles detected in the adjacent lane

Figure 3.13 shows several vehicles detected in the adjacent lane. The traffic response appears as rolling peaks rather than spikes on the chart.

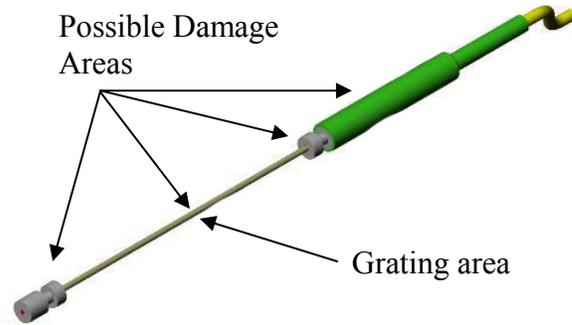
Figure 4.1: Possible physically-damaged areas in sensor housing

grating, and then the fiber is recoated. The next most likely places for a physical break are at the endpoints or in the splice area. Figure 4.1 shows the possible areas of damage to the sensor housing.

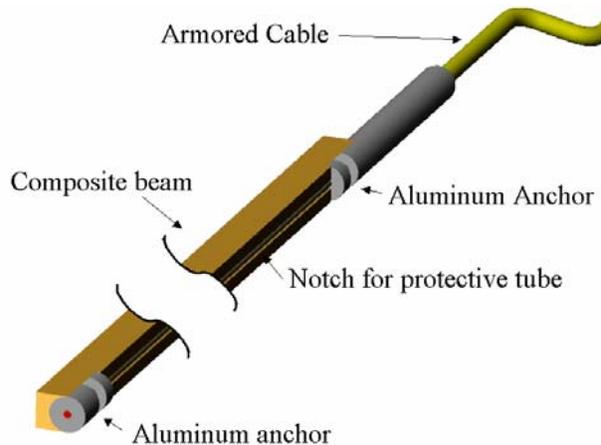
Figure 4.2: A composite beam encloses a long-gage traffic sensor

Design 1: A composite-reinforced sensor that would protect the sensor by limiting the strain force on the sensor is shown in Figure 4.2. The advantages of enclosing the original system inside a composite encasement was the protection it provided to the tubing and grating by absorbing extremely high strain forces.

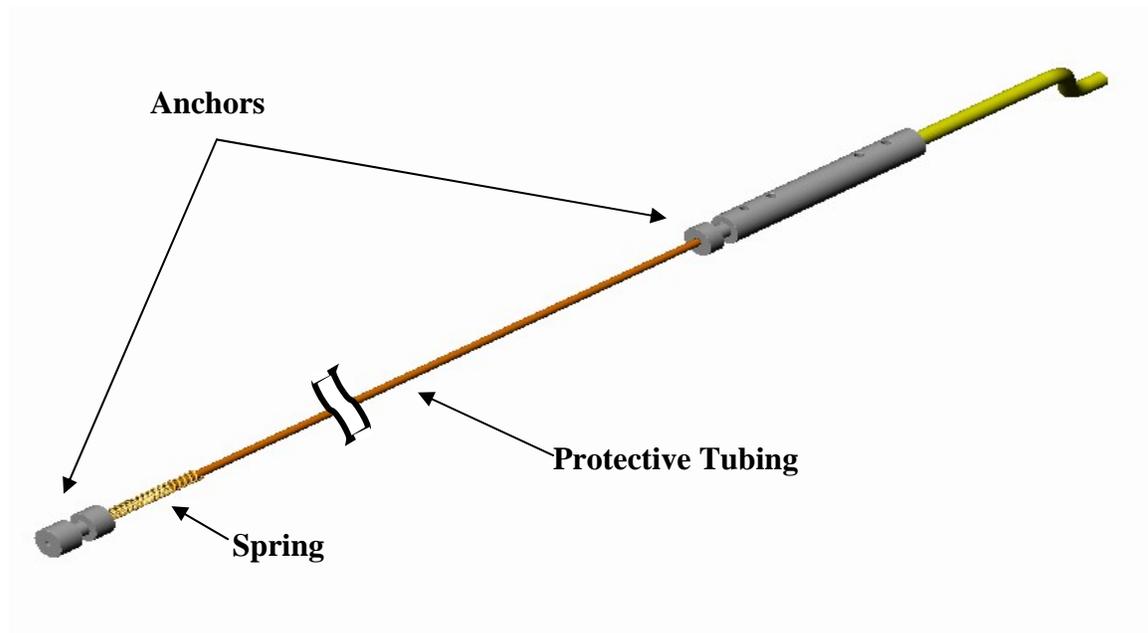
Figure 4.3: Possible sensor redesign using a spring to dampen strain

- Design 2: A spring-actuated sensor could be used to dampen the strain-effect of traffic. The advantage of something similar to Figure 4.3 is that the spring would allow for tension to be released if extremely large strain forces become present.

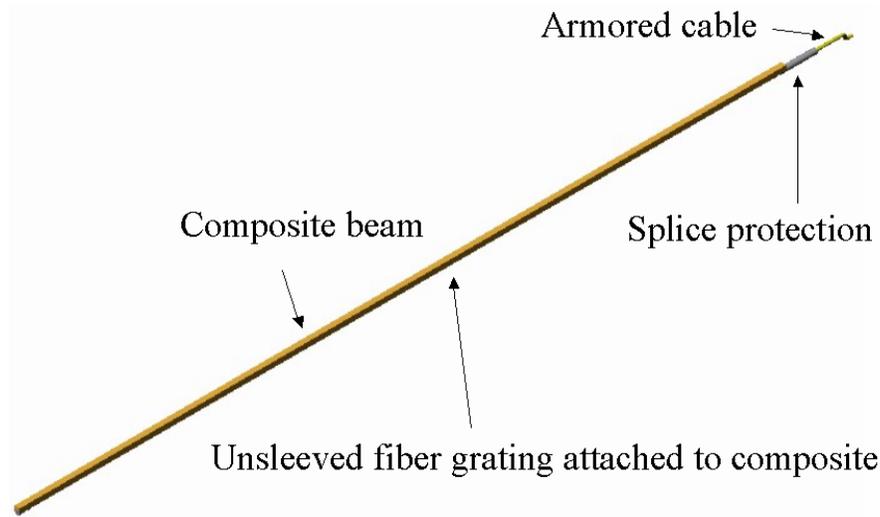
Figure 4.4: Design for composite reinforcement of optical traffic sensors

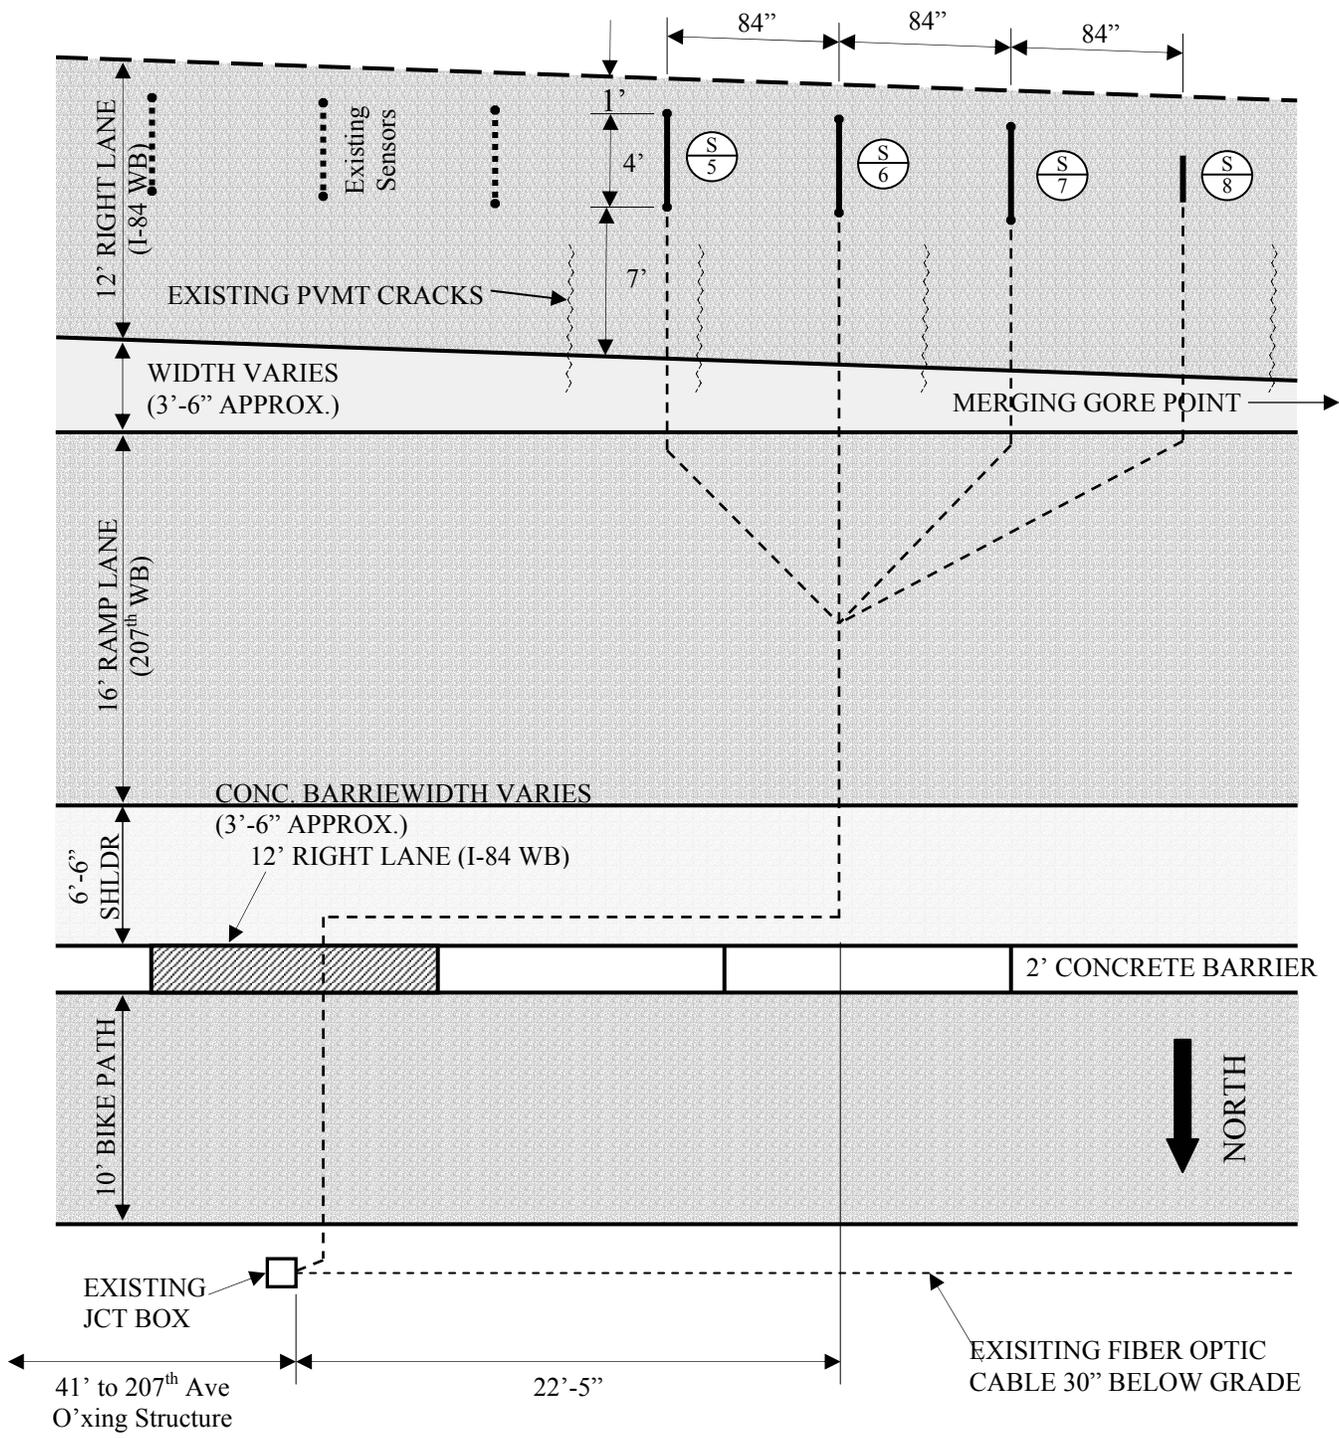
Figure 4.5: Sensor layout and placement for second installation

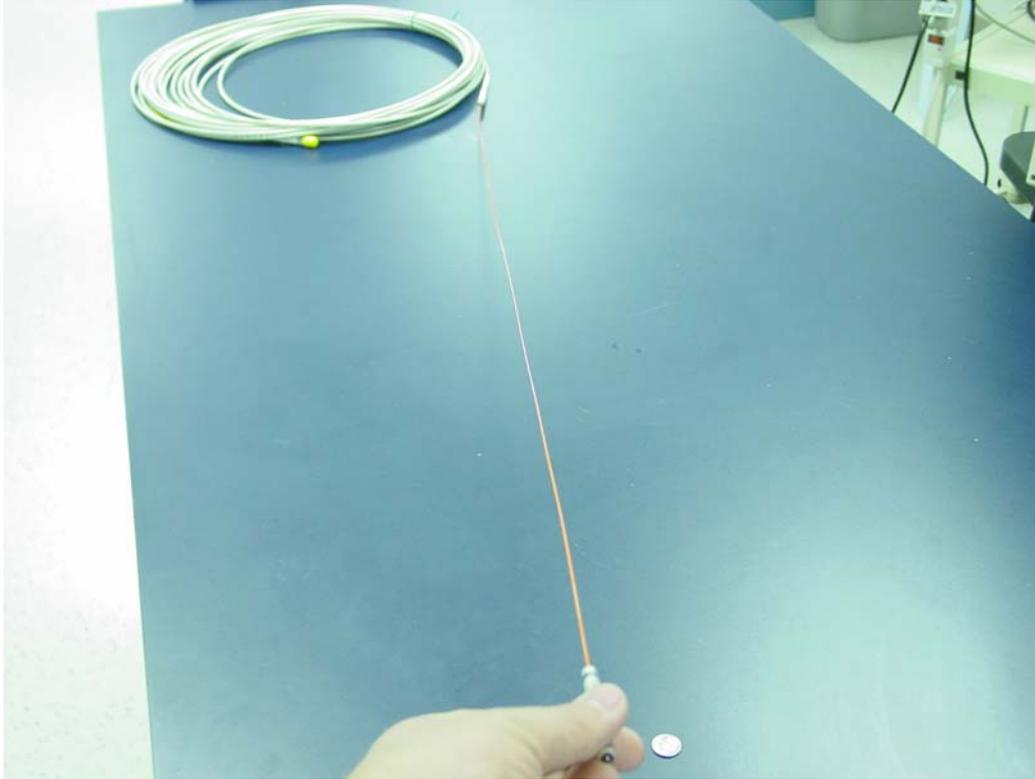
Figure 4.6: Enhanced FBG traffic sensors used in the I-84 freeway (Sensor 6)

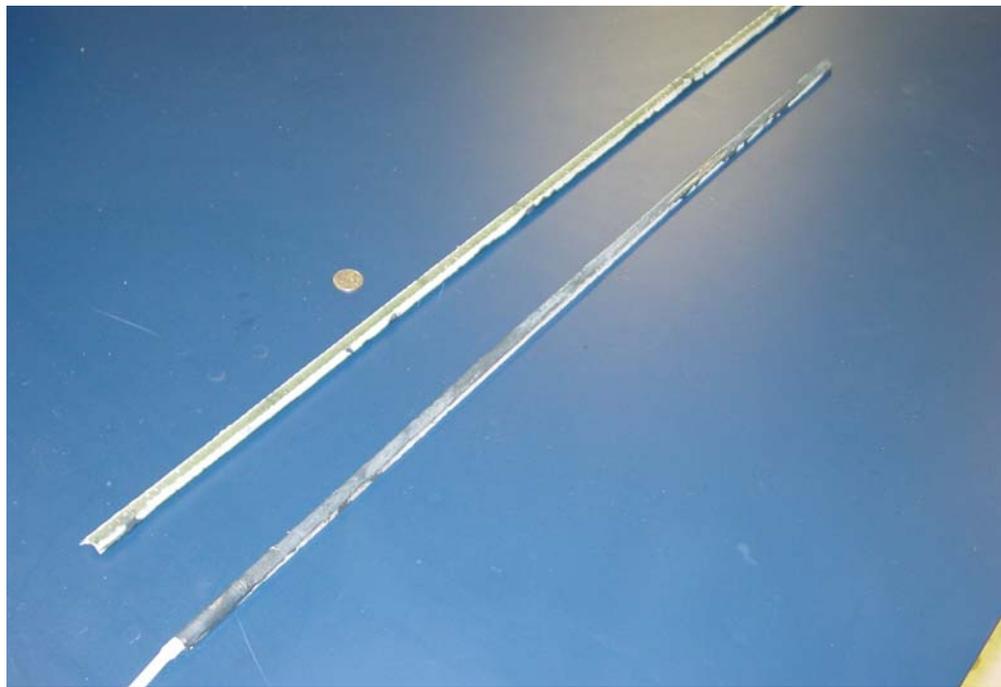
Figure 4.7: Long-gage composite FBG traffic sensors (LGC) configuration.  
The composite beam provides rigid support to prevent overstrain

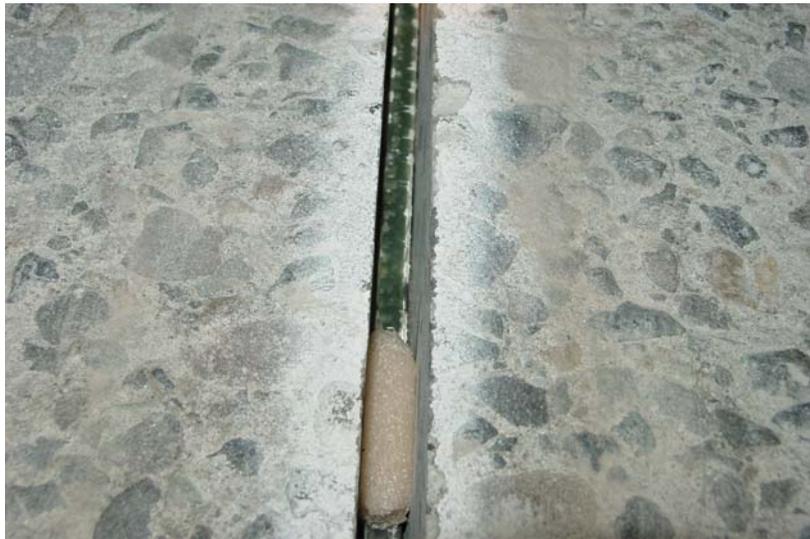
Figure 4.8: A composite sensor after being placed in the saw cut, awaiting bituminous sealant to complete the installation

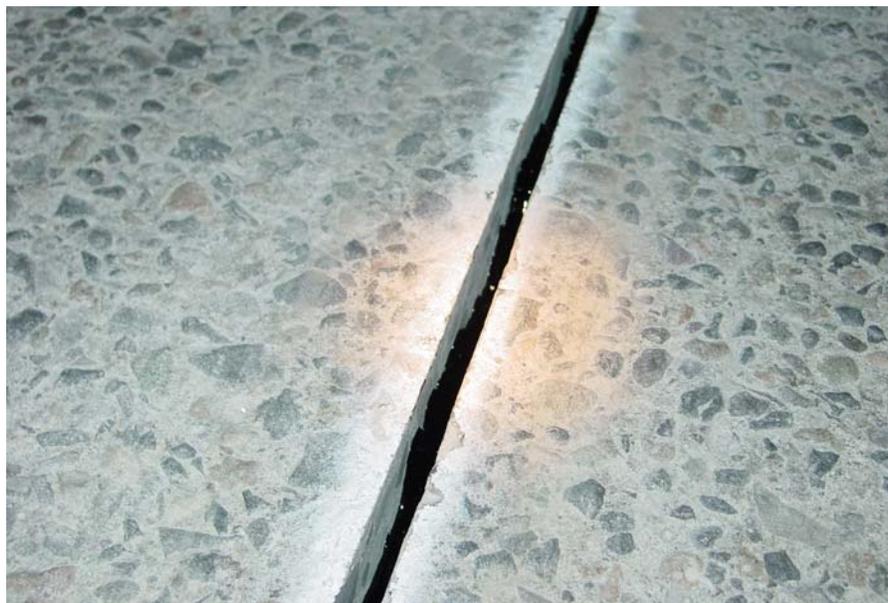
Figure 4.9: The sensor after one pass of bituminous sealant is applied

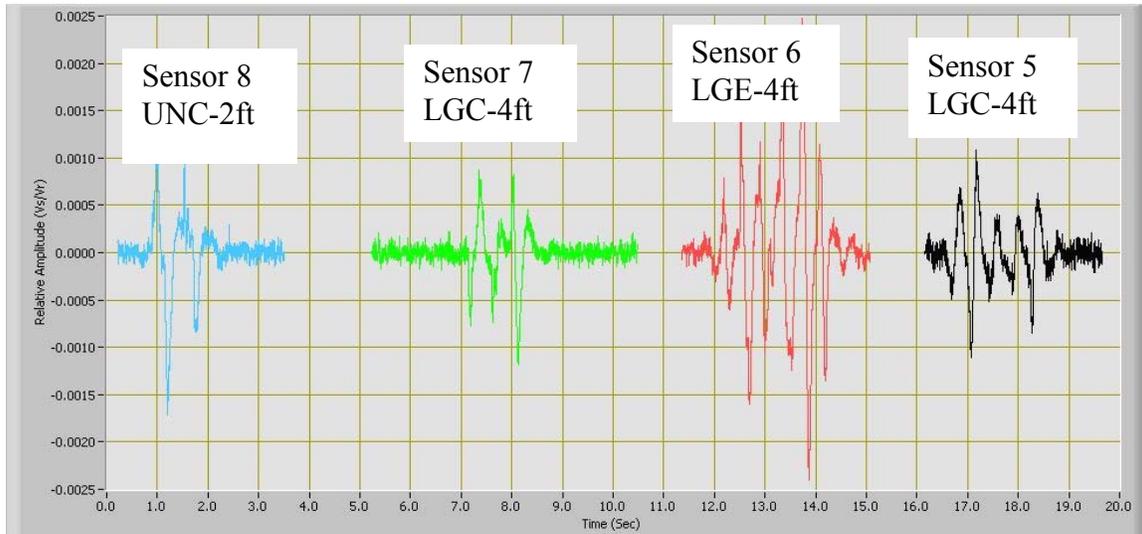
Figure 4.10: Responsiveness is tested by jumping a few times near each sensor

All four of the sensors installed in August 2002 remained fully functional with no indication of changes to the original pre-strained set during manufacture. Each separate sensor design appeared to yield varying responses to traffic, based on its type or design, but all sensors produced peaks corresponding to wheel passes. Figure 4.10 shows a profile of the second-generation sensors (Sensors 5-8) about 10 minutes after sealant was placed, as a 190 lb (86 kg) person bounced a few times near each sensor.
