**DEVELOPMENT AND EVALUATION OF  
FIBER OPTIC SENSORS**

**Final Report**

**PROJECT 312**

Eric Udd  
and  
Marley Kunzler  
Blue Road Research  
276 NE 219<sup>th</sup> Avenue  
Gresham, Oregon 97030

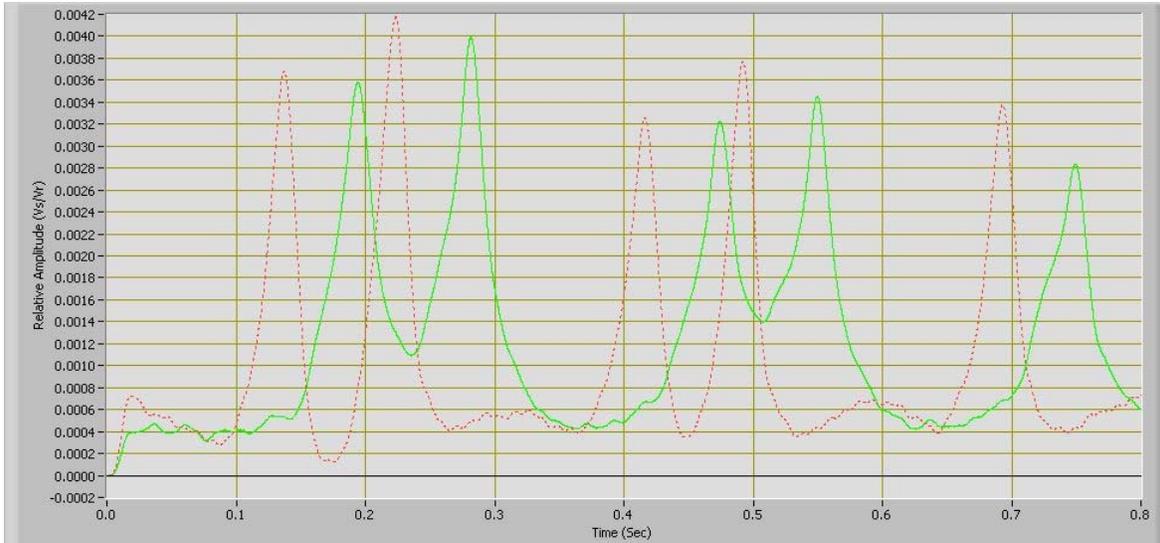
Figure 4.11: The LGE (first peak/dotted line) and LGC sensors, respectively, react to a 5-axle vehicle

Each of the three sensor types (LGC, LGE and UNC) had distinctly different responses. An interesting effect was the reaction of the enhanced long-gage (LGE) traffic sensor with its counterpart, the long-gage traffic sensor embedded in the composite (LGC). Figure 4.11 and 4.12 show the effect of each sensor as traffic crosses. In these figures, the first peak shown (dotted line) is that of the LGE. Although the reaction to the 5-axle vehicle was nearly identical, the LGE sensor tended to drop to the baseline slightly faster than its composite counterpart at a 10 KHz scan. Figure 4.12 also shows this effect, noting the differences in baseline between the axles 2-3 and 4-5. The solid line shows the peak of two axles, but blends them into one axle.

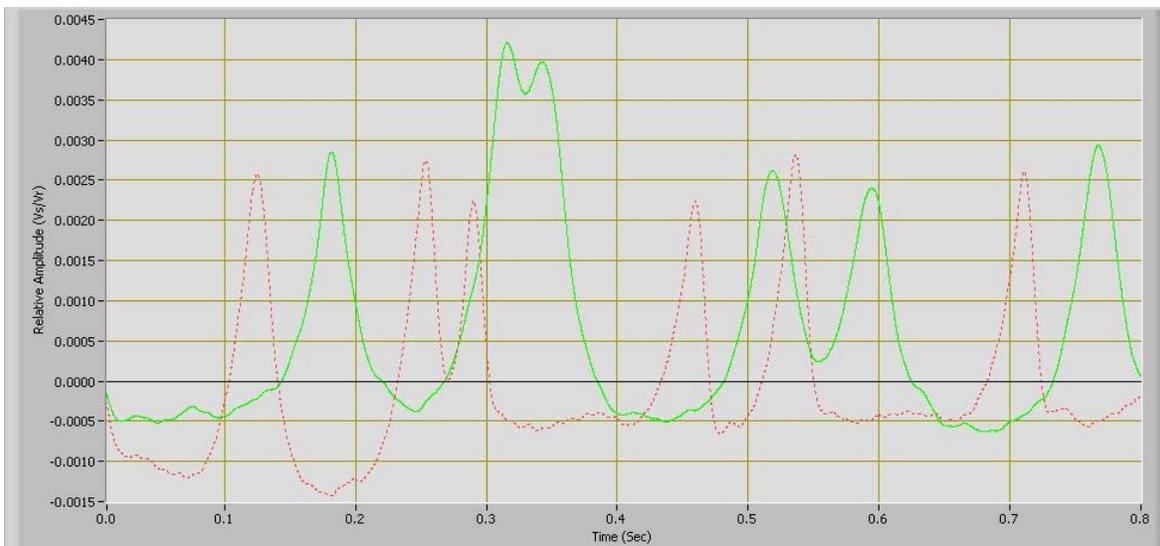
Figure 4.12: The LGE sensor (first peak/dotted line) appears to recover slightly faster than the LGC sensor

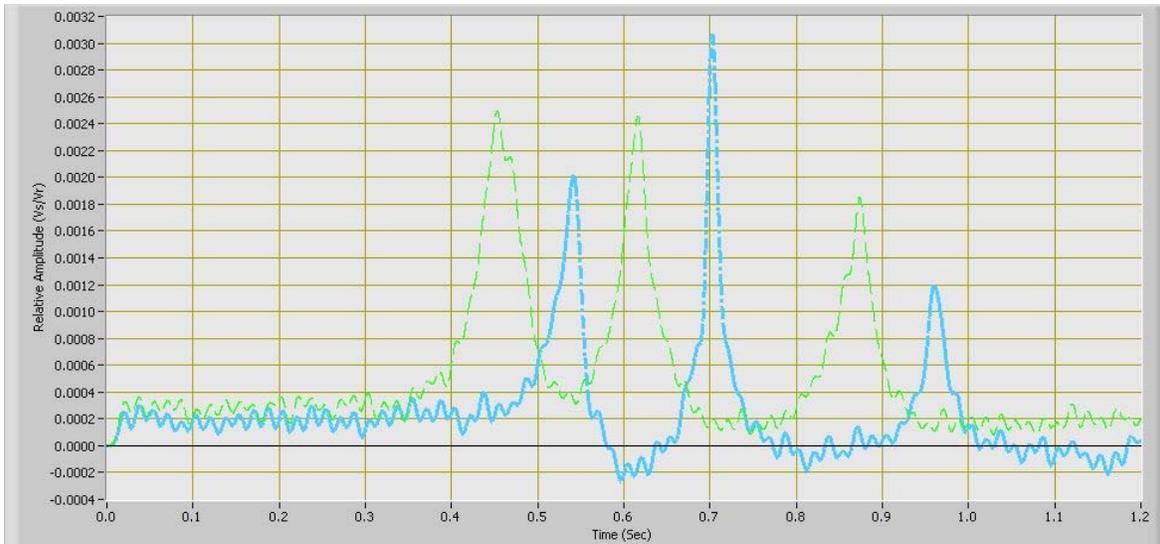
Figure 4.13: The LGC (lighter dashed line) and the UNC sensor react to traffic passing over

Overall, the UNC sensor appeared to be very sensitive to strain. This was expected because the grating area is not integrated over a larger distance. A strain in the direct vicinity of the grating, or 6 in (150 mm) on either side, produces the best response, but response decreases as the load-to-grating distance increases.

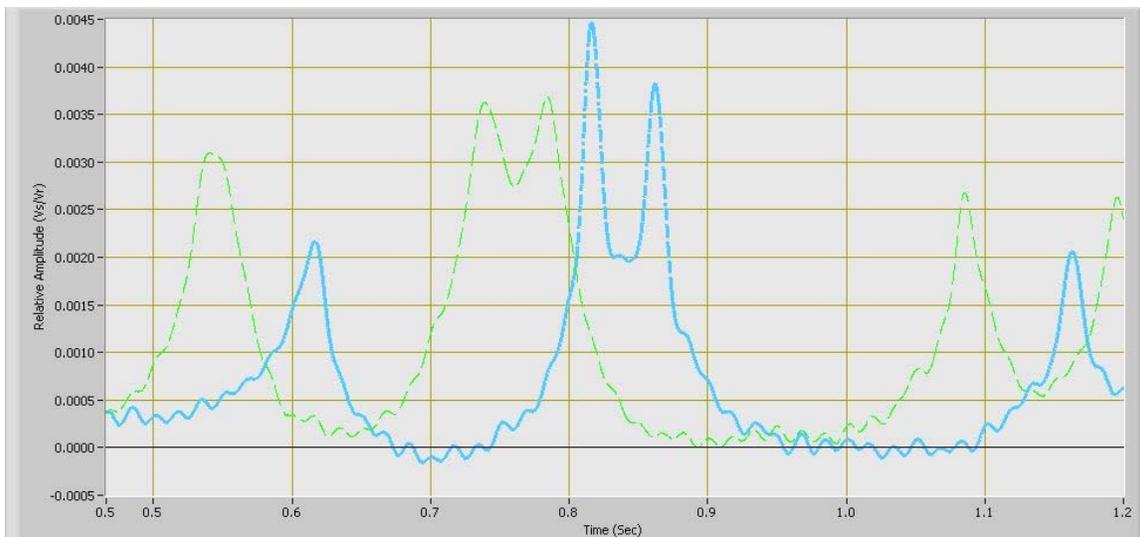
Figure 4.14: The LGC (lighter dashed line) and the UNC sensor react to traffic.  
The UNC appears to recover slightly faster

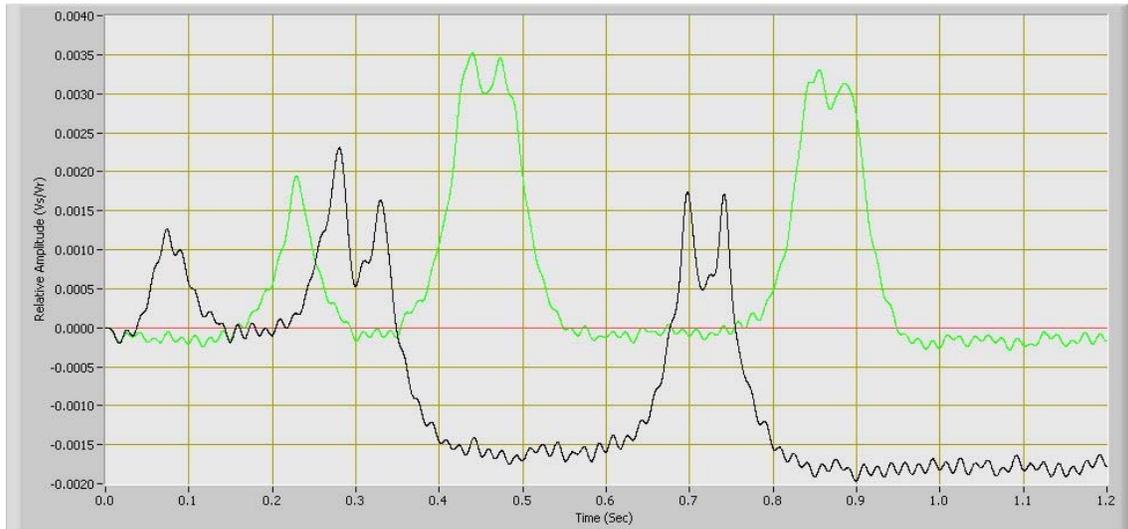
Figure 4.15: Two identical LGC sensors profile a vehicle. A baseline offset occurs in one line.

corrected by temperature compensation. One of the inherent problems of the detached, original-installation sensors was that the baseline drifted up or down after vehicles were detected. The baseline of three of the second-generation sensors appeared stable, but Sensor 5, LGC, had a noticeable shift in the baseline, as shown in Figure 4.15. Sensor 5 is shown as the darker line. From the data collected, Sensor 5 had the most noticeable shift.

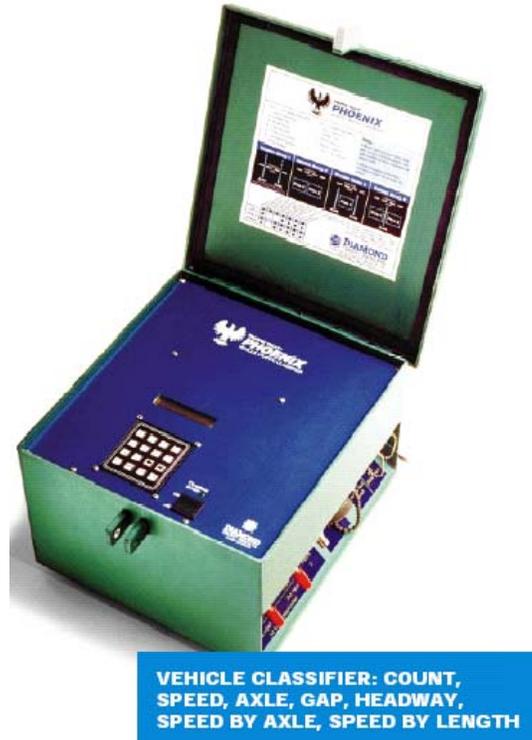
Figure 5.1: The vehicle classifier box used to interface to the fiber optic sensors

To test its compatibility, the stored data were converted to a scaled analog voltage signal and fed directly into the piezoelectric inputs of a Diamond Traffic Product's Phoenix traffic classifier. The signal was software-adjusted to match the classifiers amplitude-triggering requirements. The output data are shown in Table 5.1 and are typical of standard classification information obtained by traffic counters. A number of various axle vehicles are represented, with the majority of traffic comprised of passenger cars.

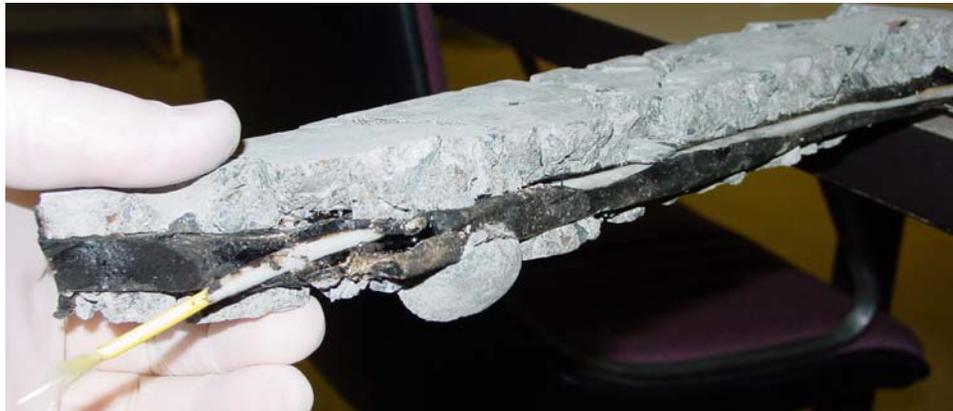
Figure 6.1: A sensor lead extends from an extracted fiber optic sensor

Figure 6.1 shows the cut PCC, sealant and extracted fiber optic sensor with the sensor lead extended.

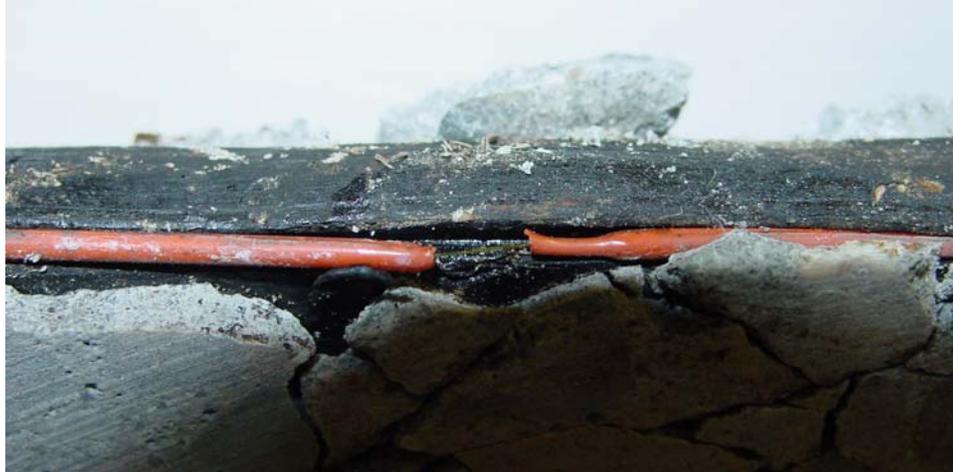
Figure 6.2: Over-capacity local strain forces most likely caused this tubing to stretch apart, as found at the bottom of the saw cut

Figure 6.2 shows that a 1 cm (0.4 in) break in the tubing was found as the sensor runs along the bottom of the channel. Note that only the tubing and not the fiber optic is broken at this point. Attempts to recreate this type of break in the laboratory using combinations of heat and large forces were unsuccessful. Due to the exposure of the tubing at the interface between the sealant and the PCC, a possible cause of this break may have been from forces exerted by a crow bar while loosening the interface for extraction. The rest of the tubing appears normal; thus the large amounts of strain were found in a very localized area.

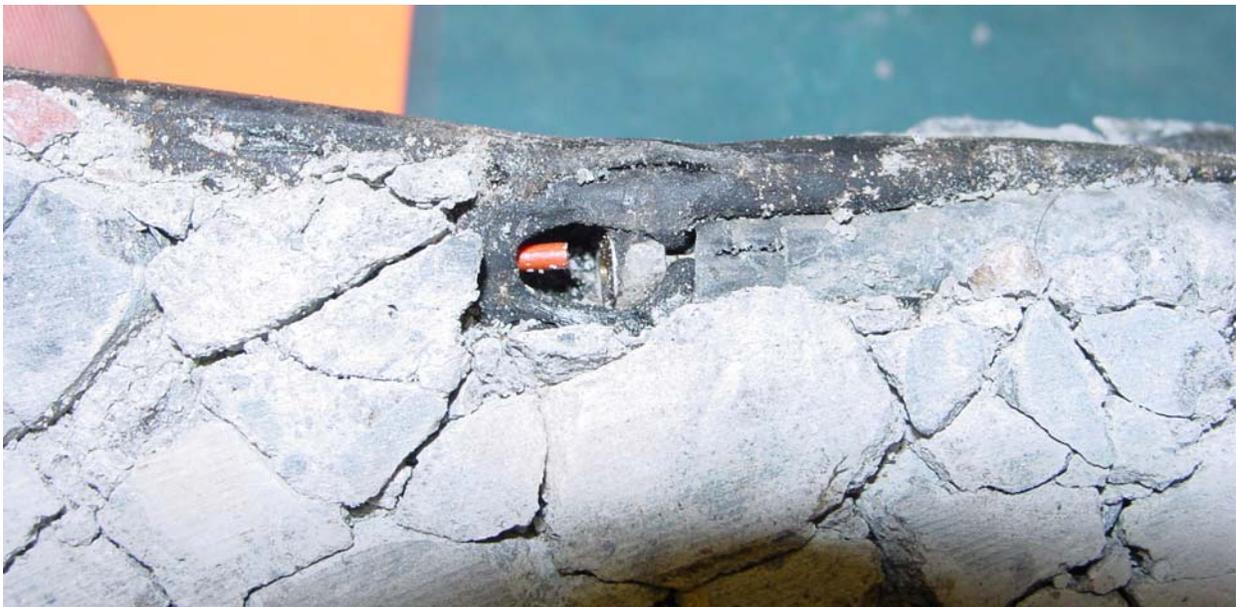
Figure 6.3: A 3 cm air pocket formed around this interface on the active sensing portion of the sensor

Figure 6.3 shows that the adhesion between the hot bituminous sealant and the traffic sensor was not optimal. At some point during or after installation, the tubing and bulkhead were forcefully separated. A possible explanation was that a 3 cm (1.2 in) pocket of air formed around the bulkhead/tubing interface which did not allow the sealant to properly adhere. When the forces of traffic were added, a lack of sealant may have caused the pressures from the vehicles to non-uniformly strain this interface and pull it apart.

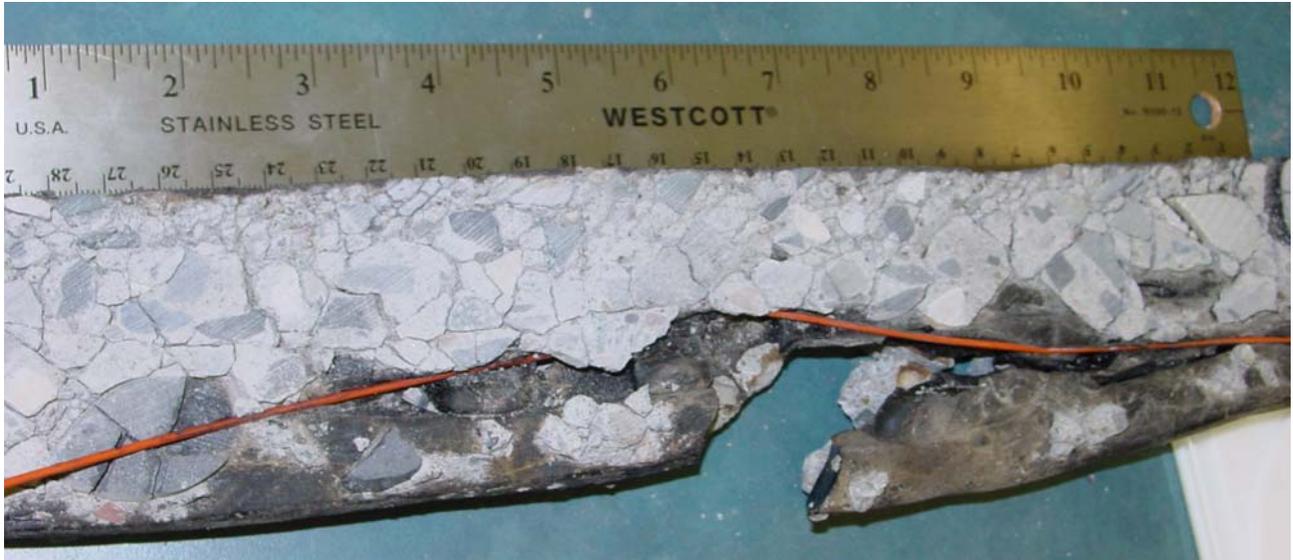
Figure 6.4: An arched sensor configuration is seen in this portion of the extraction
