**EVALUATION OF INLAID DURABLE
PAVEMENT MARKINGS IN AN
OREGON SNOW ZONE**

Final Report

SPR 304-231

April 2006

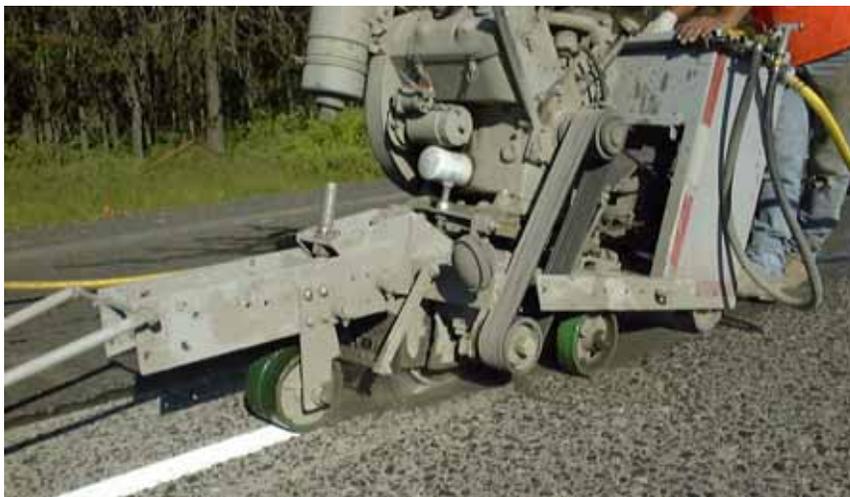
Figure 4.1: Wet scarifier in operation on the concrete section of the test deck

A gasoline powered pavement scarifier was used to create the 4 in (102 mm) wide slot. Figure 4.1 shows the scarifier in operation on the test deck. Grinding depths were verified to the nearest mil using a Starrett® Dial Depth Gage with a 6 in (152 mm) base, as shown in Figure 4.2. The grinding process was highly variable due to the rough surfaces of both the asphalt and concrete pavement sections, and more variable than desired. Although average slot depths closely matched the target depths, random measurements showed that slot depths varied by as much as 40 mil (1.016 mm) from the target depth in some locations. This was considered acceptable since it was nearly impossible to tighten the tolerances of the pavement scarifier. When grinding the 250 mil (6.35 mm) slot on the asphalt section, two separate passes were used to achieve the target depth. Using one pass at 250 mil (6.35 mm) deep allowed the grinder to be pulled down, resulting in a deeper slot. Two passes were used, the first at 125 mil (3.18 mm) and the second at 250 mil (6.35 mm), to keep the slot closer to the target depth.

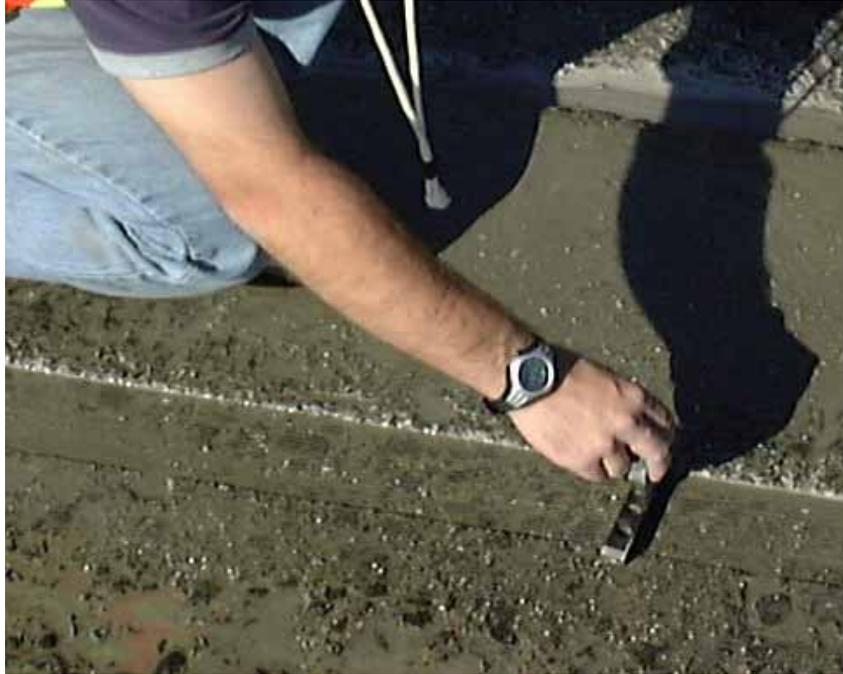
Figure 4.2: Starrett® Dial Depth Gage, with a 6 in (15.24 cm) base, used for measuring slot depths

For this research project, a dial depth gage was used to measure the slot depth and the protective recess from the surface of the pavement to the top of the material. The use of the dial depth gage may not be practical for field use by contractors or ODOT Inspectors. During the course of this project, a simple depth gage was designed by ODOT’s Traffic Line Personnel. Figure 6.1 shows the three gages designed to measure the depth of inlaid slots and the amount of material recess from the surface of the pavement. The gages were designed for depths of 50, 100, 150, 200, 250 mil (1.3, 2.55, 3.8, 5, 6.35 mm). One gage also includes a depth of 875 mil (22.2 mm) which is

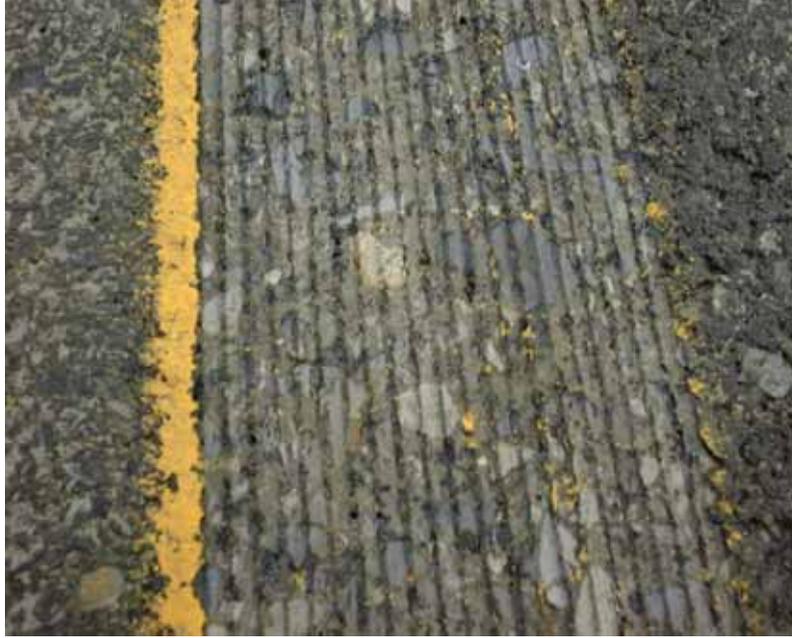
Figure 4.3: Slot just prior to the installation of the Dura-Stripe® and Permaline®

To prepare the slot for the pavement marking material it was cleaned of dirt and debris. First, a self-propelled shot blaster was used to clean the slot using 7 ½ oz steel shot. Compressed air was then used to remove any dirt or remaining steel shot. It should be noted, that to prepare the slot for the 3M™ Tape, the shot blaster made two passes over the slot. The second pass, smoothed the bottom of the slot to allow better adhesion to the pavement. Figure 4.3 shows the slot just prior to the installation of the Dura-Stripe® and Permaline®. Figure 4.4 shows the slot just prior to the installation of the 3M™ Tape after the second pass with the shot blaster to remove the ridges left from the scarifier blades.

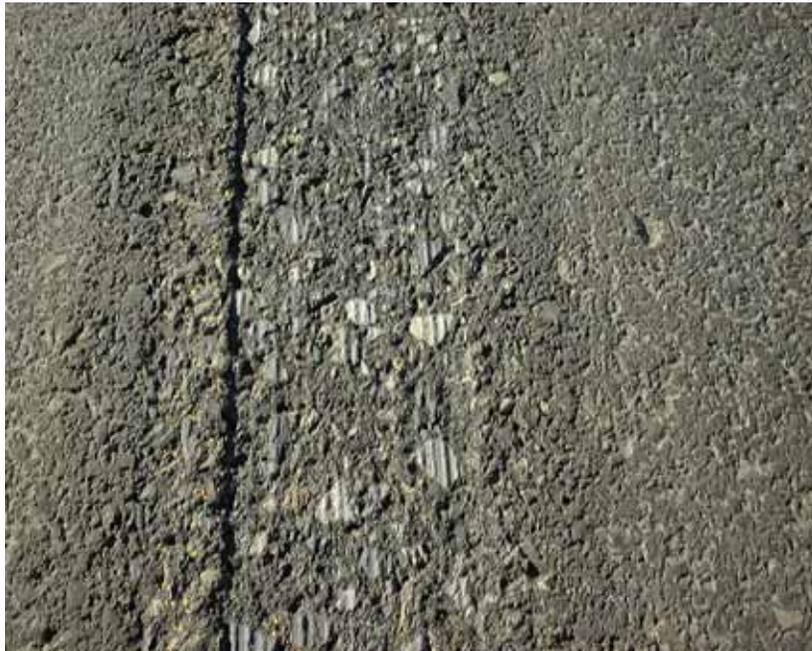
Figure 4.4: Slot just prior to the installation of the 3M™ Tape, after the second pass with the shot blaster

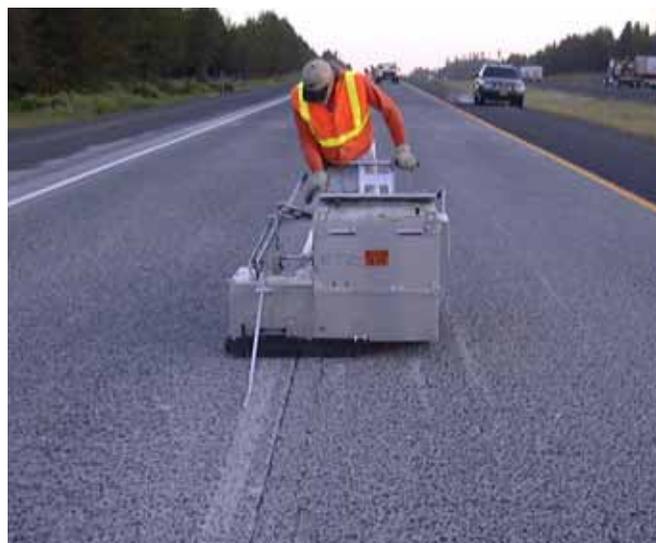
Figure 4.5: Thermoplastic applicator pushcart

The installation of the Permaline® material was also done at night to coordinate with the Dura-Stripe® installation. The material was installed using two different thermoplastic applicators, an Apollo 1 Pushcart and an Apollo 2 Pushcart, both manufactured by Pavemark. Two different applicators were used, one for white and the other for yellow. A large, truck mounted, pre-melter was also used to melt the white thermoplastic. Since there was less yellow thermoplastic used, it was melted in the applicator pushcart. Figure 4.5 shows the pushcart applicator.

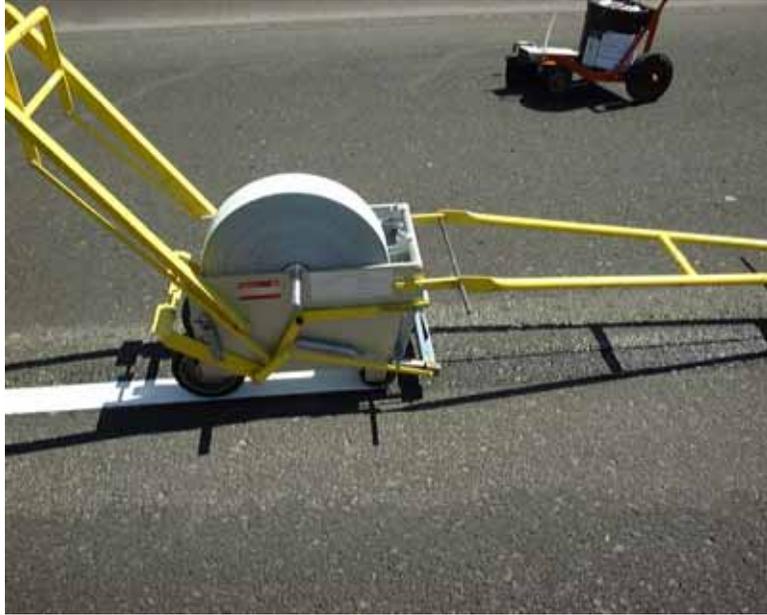
Figure 4.7: Tape installation

The installation of the 3M™ Tape was done by two representatives from 3M™. One employee from Apply-A-Line, Inc. was also there to operate the shot blaster to prepare the slot for installation. After shot blasting, compressed air was used to clean the slot. An Adhesive Spray Applicator PS-98 was used to apply a coating of 3M™ P50 Primer Adhesive. The primer was allowed to dry for approximately 10-15 minutes. A Mini Highway Tape Applicator was used to place the tape. A 3M™ Roller Tamper Cart RTC-2, weighing approximately 200 lb (90.8 kg), was then rolled over the tape to ensure proper adhesion. After installation, a vehicle's tire was then rolled over the tape to further ensure proper adhesion. Figures 4.6-4.8 show the primer applicator, tape applicator, and rolling tamper used during the application.

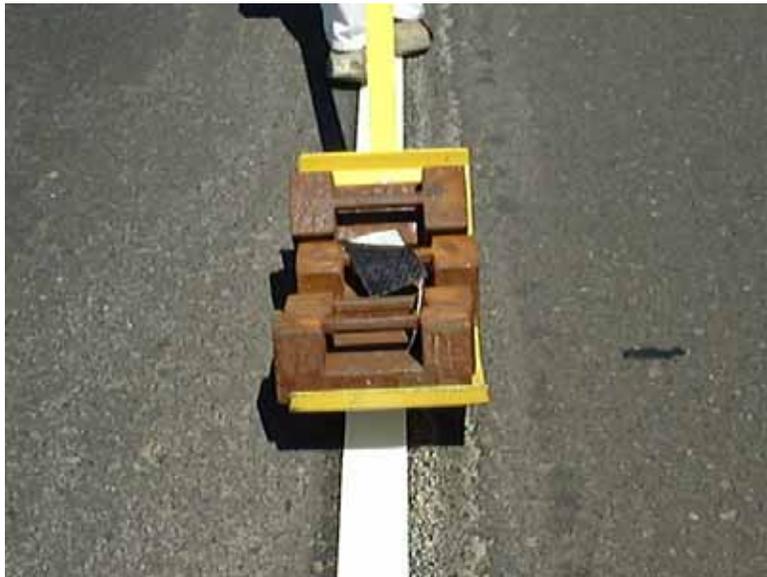
Figure 4.8: Rolling tamper

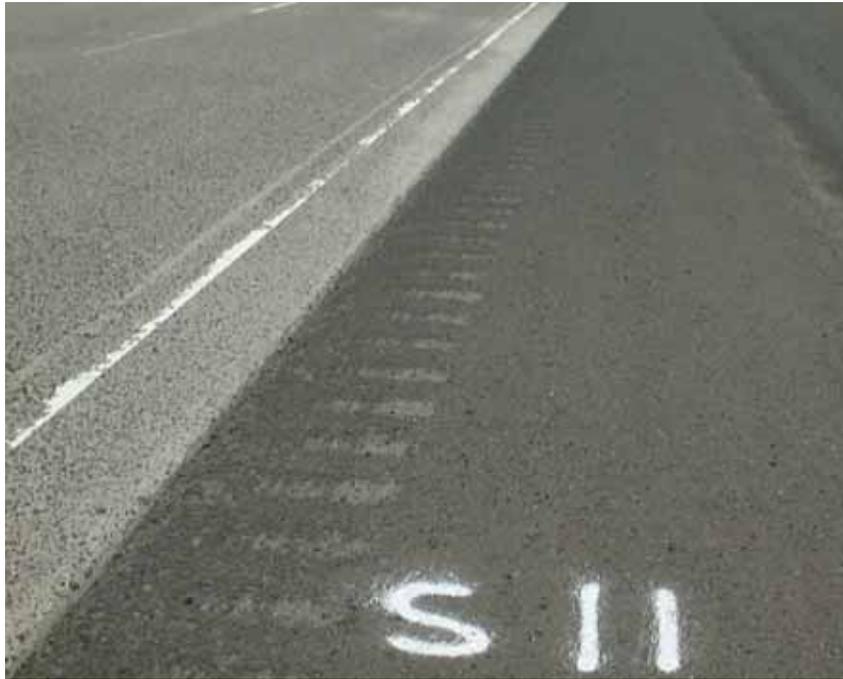
Figure 5.1: Section 11 – Permaline[®], on concrete edge line, after one winter maintenance season

from the white edge line. Figure 5.1 shows the thermoplastic white edge line in Section 11, which had a durability rating of 4.7. Figure 5.2 shows the white edge line in Section 14, which was rated the highest for the Permaline[®] concrete sections, at 7.2.

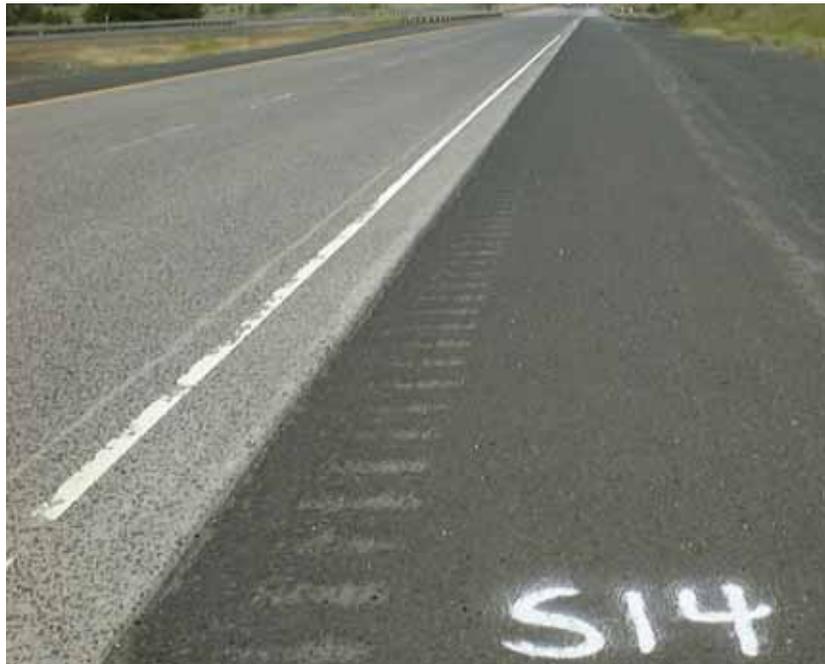
Figure 5.2: Section 14 – Permaline[®], on concrete edge line, after one winter maintenance season

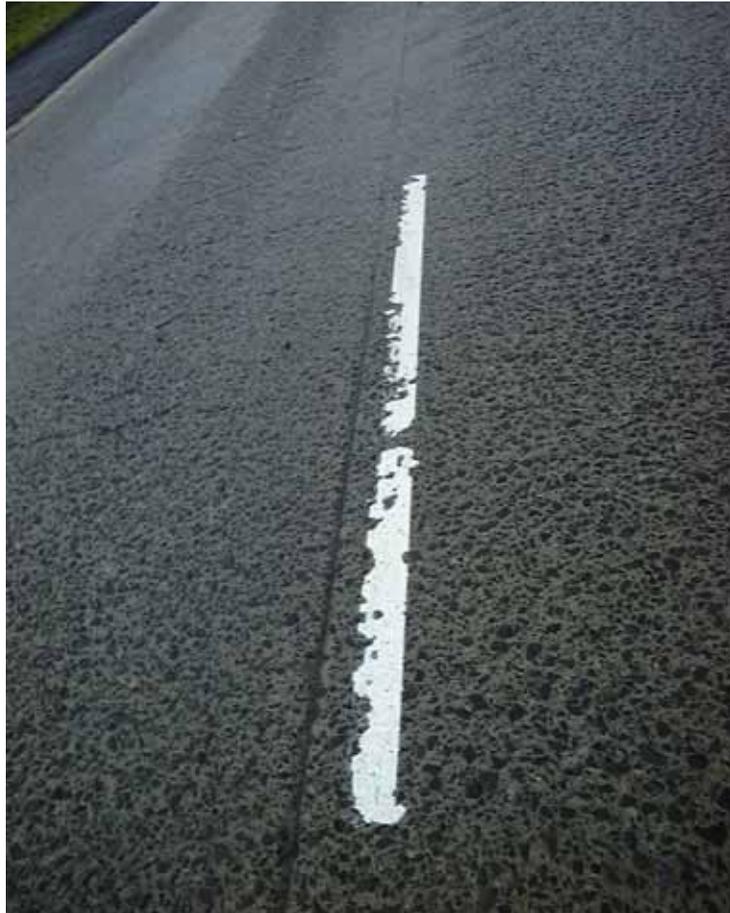
Figure 5.3: Section 11 - Permaline[®], on concrete skip, after one winter maintenance season

The Permaline[®] skip stripes on the concrete pavement performed similar to the white edge line, with some of the skips retaining more material than the edge line. Figure 5.3 shows a skip in Section 11, which averaged 4.3. Figure 5.4 shows a skip in Section 13, which averaged 7.7. The white edge line for Section 13 did not perform well and was essentially non-existent. However, the skip stripe performed the best out of the Permaline[®] sections on the concrete, with an average rating of 7.7.

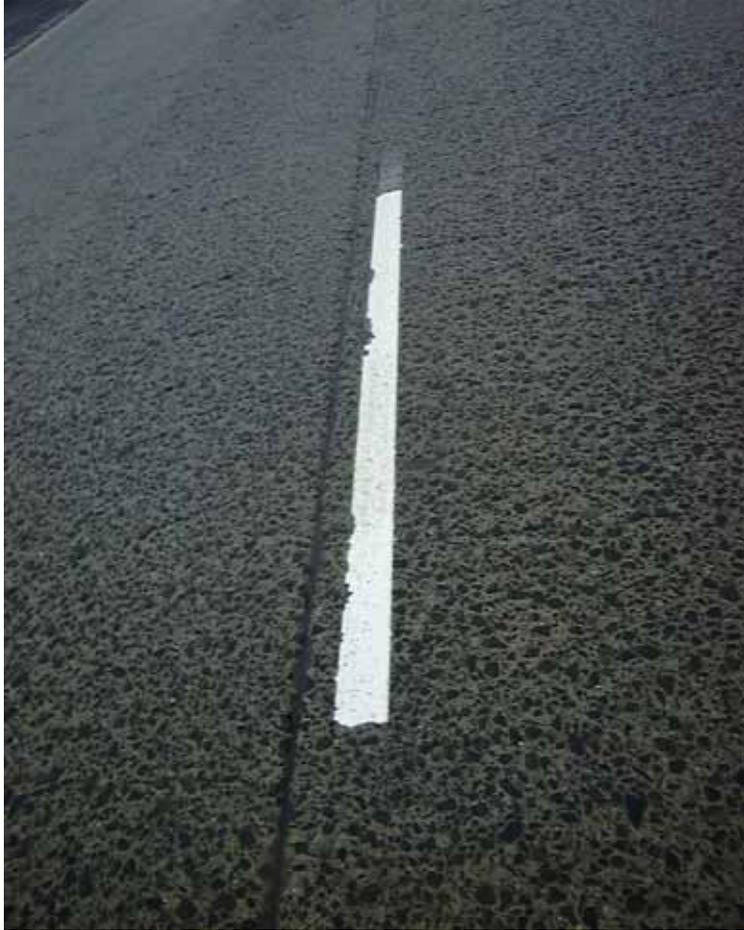
Figure 5.4: Section 13 - Permaline[®], on concrete skip, after one winter maintenance season

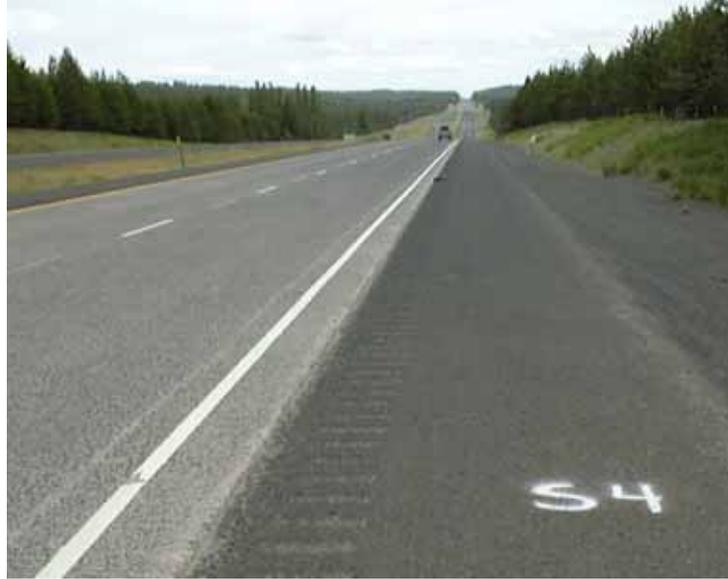
Figure 5.5: Section 4 – Dura-Stripe[®], on concrete, after one winter maintenance season

Table 5.1 shows that the Dura-Stripe[®] material was fairly consistent after one winter maintenance season. Two sections did not perform well when compared to the other five. Sections 6 and 7 were constructed using the shallow slot depth of 125 mil (3.18 mm). The skips were rated at 8.5 and the edge line averaged near 7. The remaining sections averaged approximately 10, for both the skips and edge line. Figures 5.5 and 5.6 show the lines in Section 4.

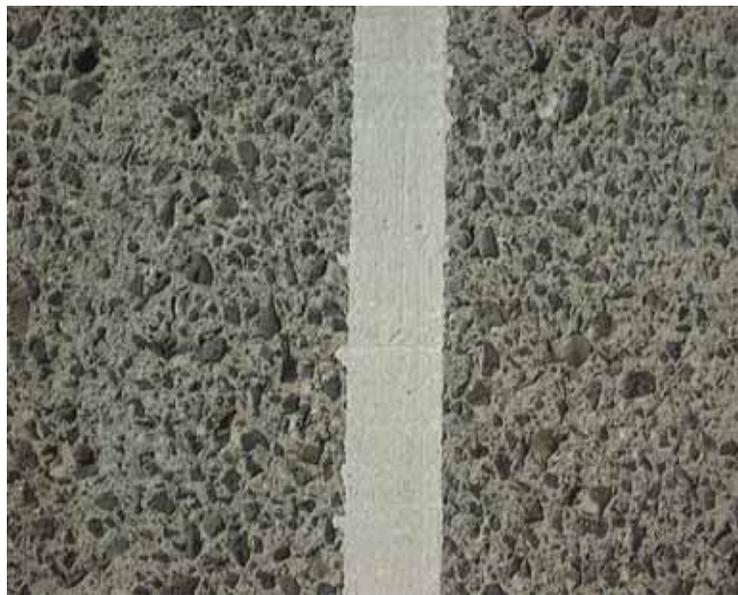
Figure 5.6: Section 4 – Close-up of Dura-Stripe[®], on concrete edge line, after one winter maintenance season

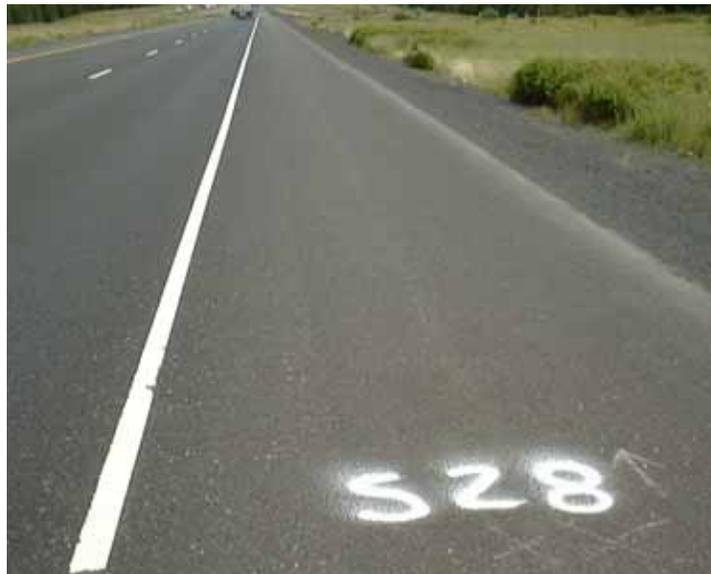
Figure 5.7: Section 28 – *Permaline*[®], on asphalt skip, after one winter maintenance season

The *Permaline*[®] sections on the asphalt performed better than those on the concrete pavement, after one winter maintenance season. The yellow edge line was rated higher for all sections, compared to the white edge line or the skips. This is likely due to less wheel traffic on the line, and less pavement loss. There was a clear distinction between the deeper 250 mil (6.35 mm) slot designs compared to the other sections. The three sections that used the 250 mil (6.35 mm) slot (Sections 28, 29, 30) performed better than the other four sections. Figures 5.7 and 5.8 show the white edge line and skip in Section 28 which used the deeper slot.

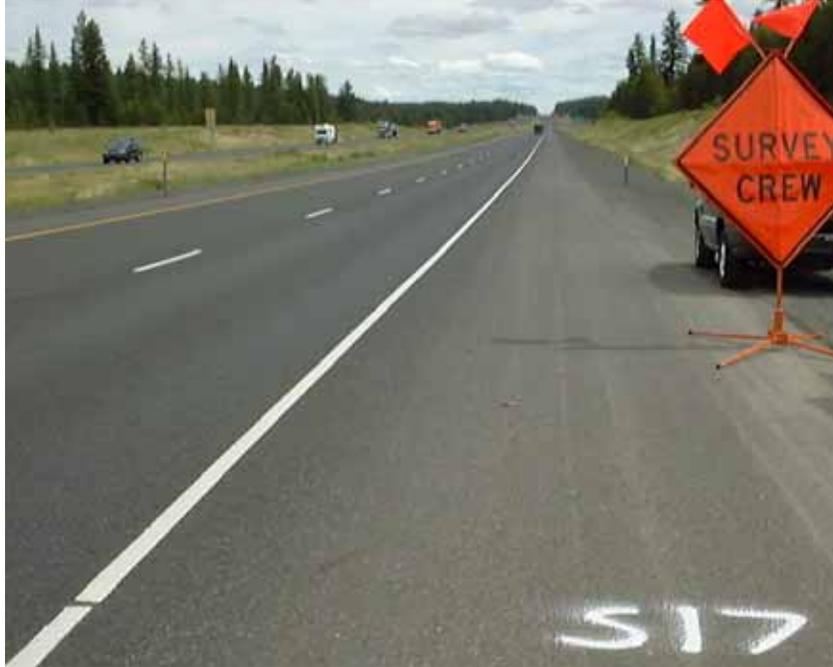
Figure 5.9: Section 17 – Dura-Stripe[®], on asphalt edge line, after one winter maintenance season

The seven sections of Dura-Stripe[®] on the asphalt pavement performed similarly to the sections on the concrete pavement. The sections on the asphalt were fairly consistent, with the exception of the two sections designed with the 125 mil (3.18 mm) slot. The other five sections, for all three lines, averaged a rating of approximately 10. Figures 5.9 and 5.10 show the white edge line in Section 17.

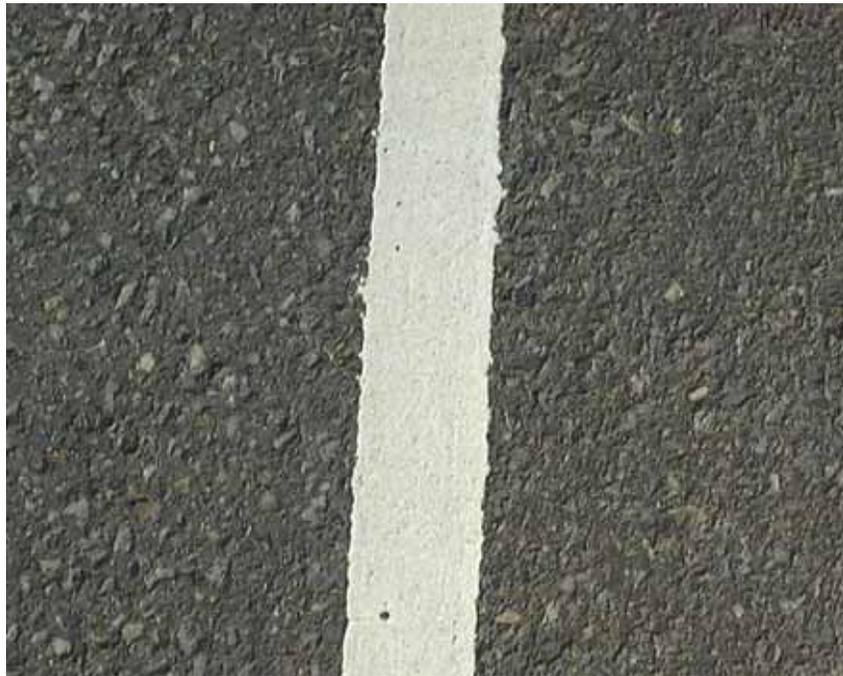
Figure 5.10: Section 17 – Close-up of Dura-Stripe[®], on asphalt edge line, after one winter maintenance season

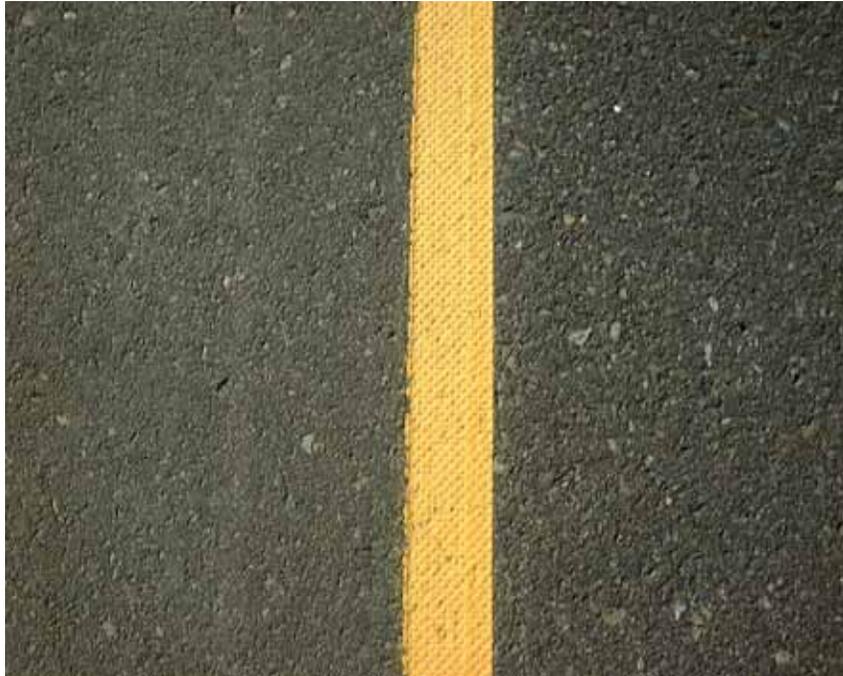
Figure 5.11: Section 31 – 3M™ Tape, on asphalt yellow edge line, after one winter maintenance season

3M™ Tape was applied to the yellow edge line and to the skip stripe in one-600 ft (183 m) section on the asphalt pavement. After one winter maintenance season the material performed very well, as shown in Figure 5.11. One 10 ft (3.05 m) skip had been damaged shortly after installation, losing approximately 3ft (1 m) of material. The yellow edge line had almost no damage. The tape did however flatten-out, as shown in Figure 5.12.

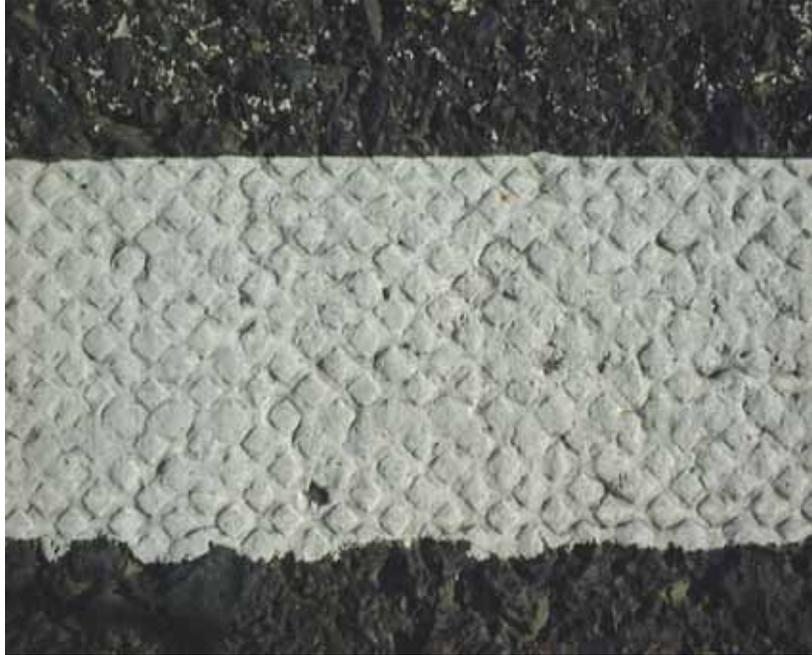
Figure 5.12: Close-up of a 3M™ Tape skip, after one winter maintenance season

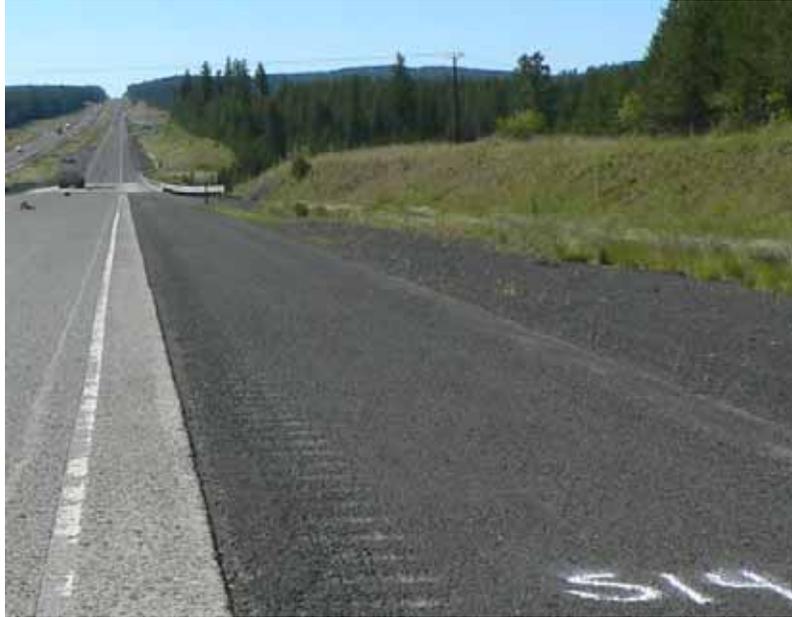
Figure 5.13: Section 14 – *Permaline*[®], on concrete white edge line, after two winter maintenance seasons

The *Permaline*[®] sections of material on the concrete pavement continued to perform poorly. After two winter maintenance seasons, most of the material was missing. Sections 13 and 14 were the only sections with any material remaining, but even that was limited. Section 14, as shown in Figure 5.13, had some material still visible, but not enough to be effective.

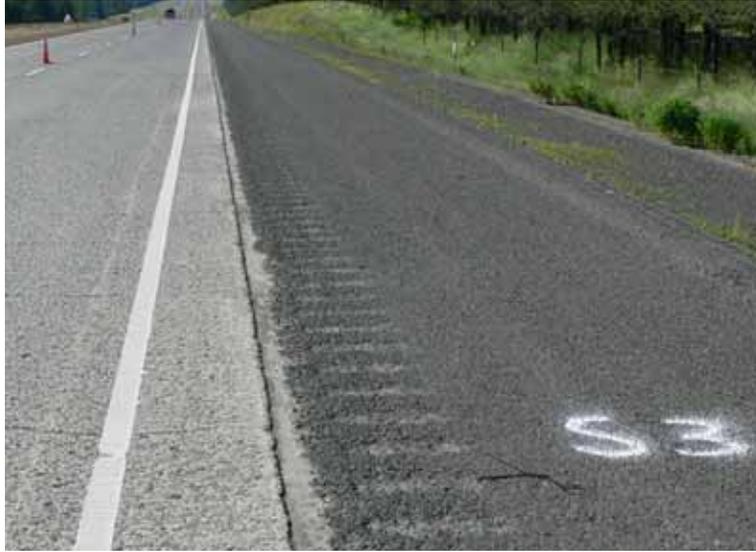
Figure 5.14: Section 3 – Dura-Stripe[®], on concrete edge line, after two winter maintenance seasons

After two winter maintenance seasons, the *Dura-Stripe*[®] sections on the concrete pavement changed little since the year one evaluation. Based on the rating of the skips, section one through five ranged 8.8 to 9.2. For the white edge line they all ranked 9.0. Sections 6 and 7, with the 125 mil (3.18 mm) slot depth, rated lower at 6.7 to 7.8. Figure 5.14 shows the white edge line of Section 3 after two winter maintenance seasons.

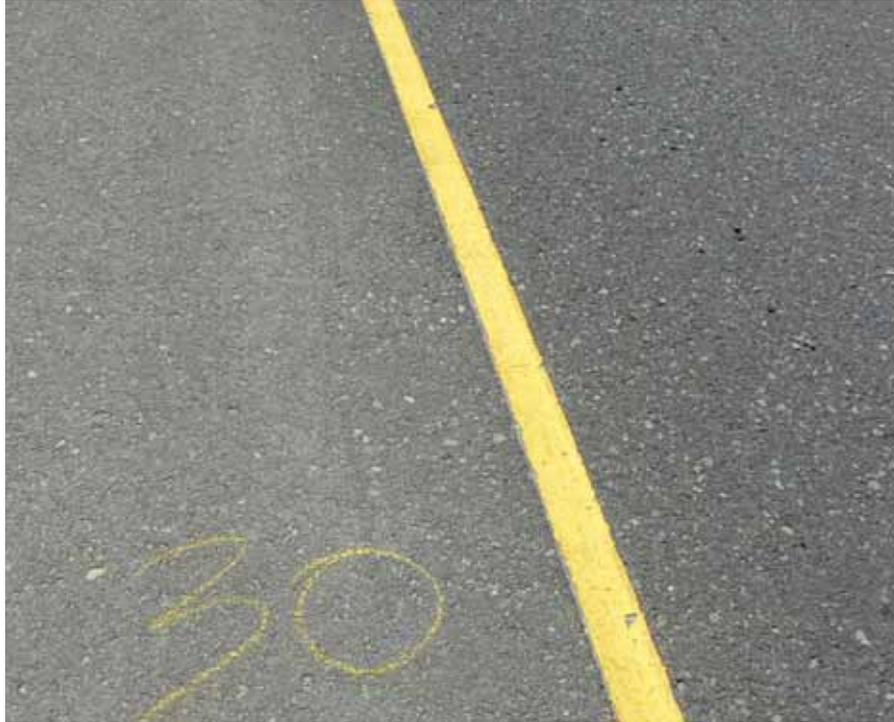
Figure 5.15: Section 30 – Permaline[®], yellow edge line on asphalt, after two winter maintenance seasons

The Permaline[®] sections on the asphalt pavement rated lower after the second year of winter maintenance. Again, the sections with the 125 mil (3.18 mm) slots were rated lower than the other five sections. Sections 26, 28, 29 and 30 were rated the highest, with an average rating between 7.6-7.1. It should be noted that the yellow edge line was rated higher than either the skips or the white edge line, for all seven sections. Figure 5.15 shows the yellow edge line in Section 30, and Figure 5.16 shows the white edge line.

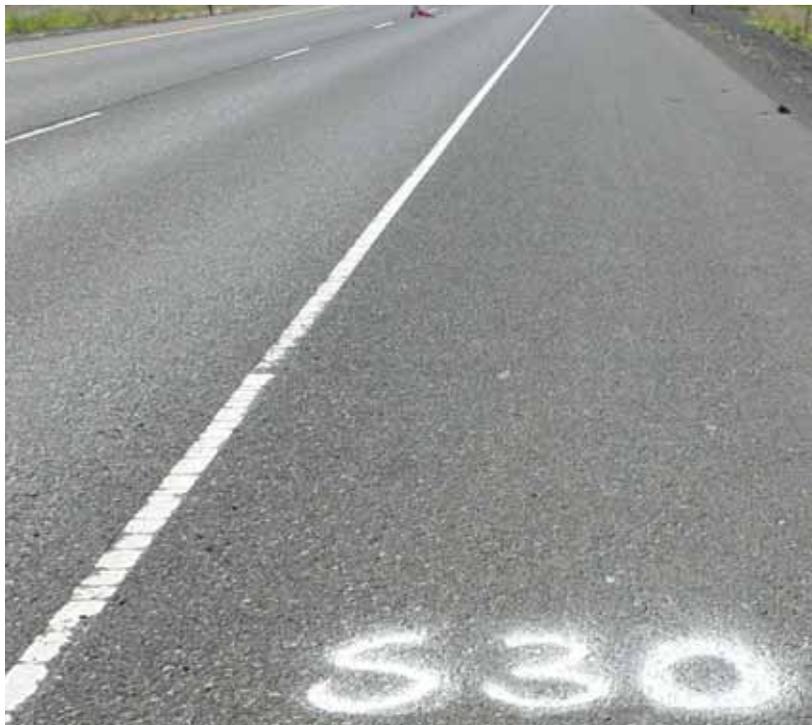
Figure 5.16: Section 30 – Permaline[®], white edge line on asphalt, after two winter maintenance seasons

During the installation of the Permaline[®] on the asphalt pavement, moisture bubbles formed in the material. The moisture bubbles were caused by the increased humidity during the time of installation. The material was applied between 3:00 am and 5:00 am, when a noticeable amount of dew had formed. When the hot thermoplastic was placed on the asphalt pavement, moisture bubbles formed. After two years, the moisture bubbles, combined with the shrinking of the thermoplastic, created cracks and voids in the line. The cracks can be seen in Figure 5.16

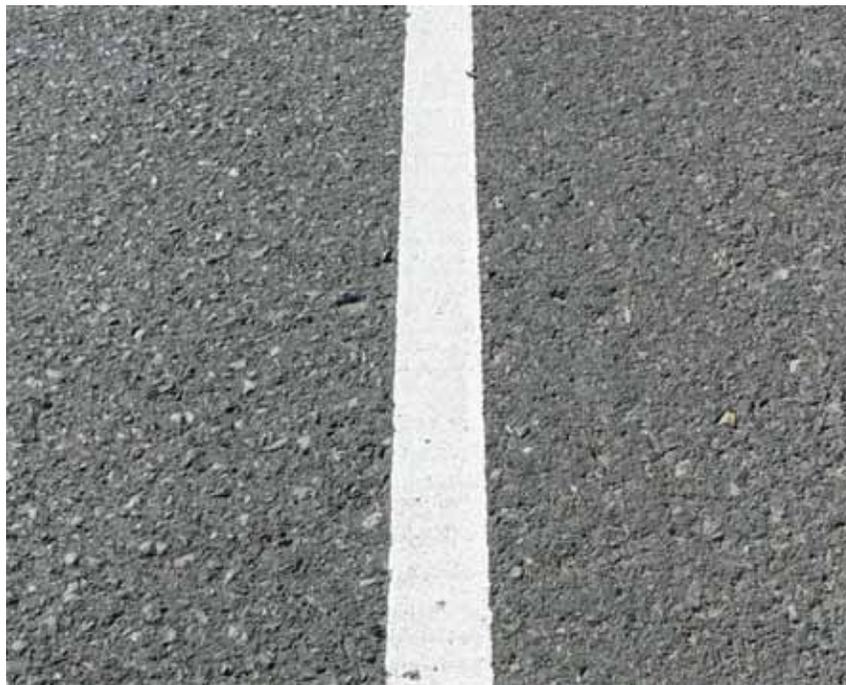
Figure 5.17: Section 17 – Dura-Stripe[®], white edge line on asphalt, after two winter maintenance seasons

The Dura-Stripe[®] sections on the asphalt pavement still had good physical presence after two winter maintenance seasons. Again, the two 125 mil (3.18 mm) sections were rated lower than the other five sections. All three lines in Section 17 were rated an average of 9. The other four sections ranged in averaged ratings from 8.9-8.3. Figures 5.17 and 5.18 show the white edge line and yellow edge line in Section 17. For the five sections (16, 17, 18, 19 and 20) that rated the highest, all of the yellow edge lines were rated 9.0 and were very consistent.

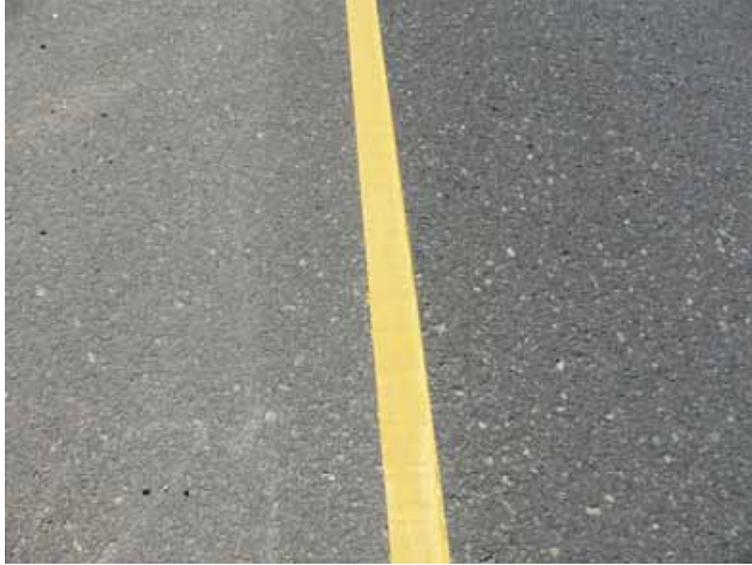
Figure 5.18: Section 17 – Dura-Stripe[®], yellow edge line on asphalt, after two winter maintenance seasons

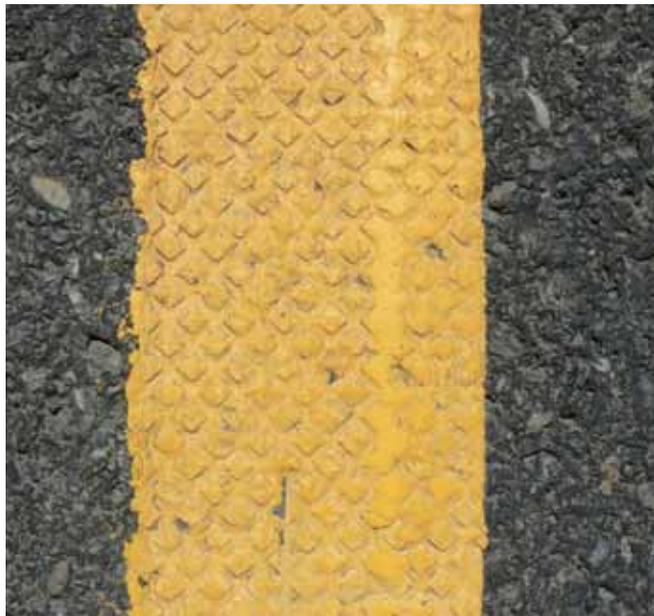
Figure 5.19: Section 31 – 3M[™] Tape, yellow edge line on asphalt, after two winter maintenance seasons. The smooth line, on the right side of the tape, was a result of the high ridge left by the grinder.

After two winter maintenance seasons, the 3M[™] Tape still had good physical presence and was rated 9.0, for both the yellow edge line and the skips. One additional skip was damaged after the second year of service, losing approximately 5% of material from the 10 ft (3.05 m) skip. Figures 5.19 and 5.20 show the 3M[™] Tape after two winter maintenance seasons.

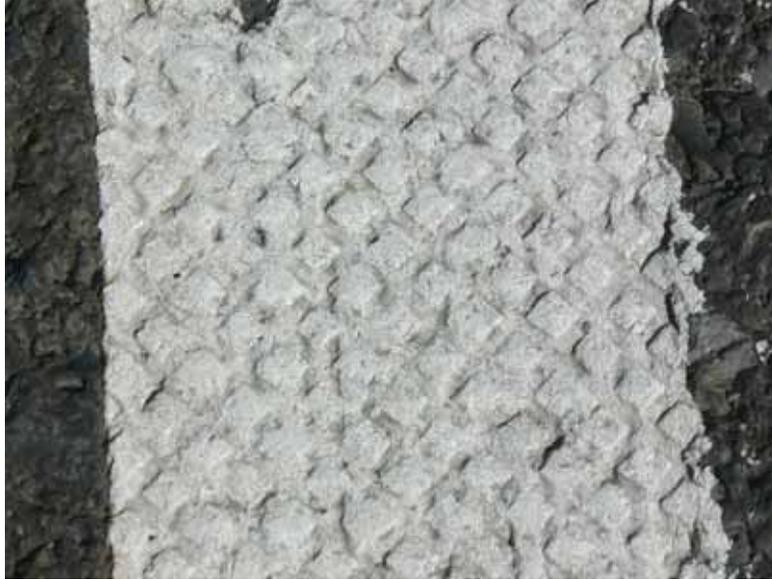
Figure 5.20: Section 31 – 3M™ Tape, skip on asphalt, after two winter maintenance seasons

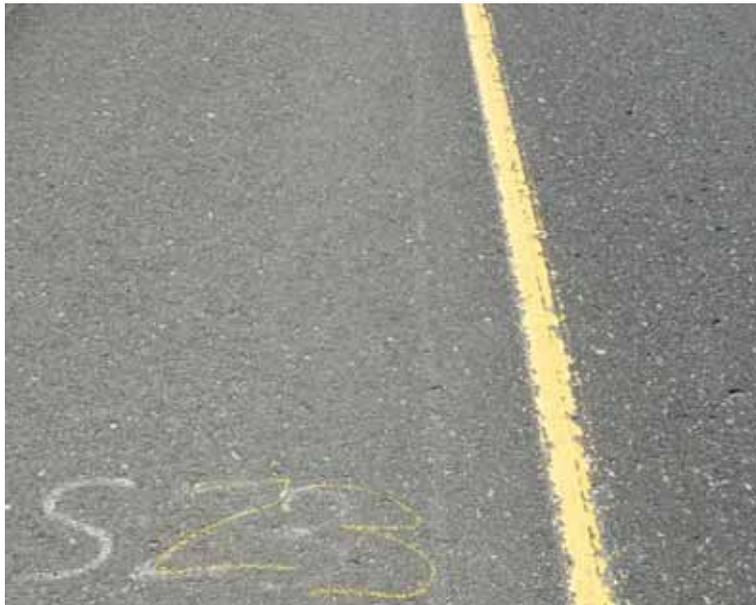
Figure 5.21: Section 23 – Waterborne Paint, yellow edge line on asphalt, after two winter maintenance seasons

The white edge line and skips installed with waterborne paint were not visible after one winter maintenance season. However, the waterborne paint on the yellow edge line was still visible after two winter maintenance seasons. Figure 5.21 shows the yellow edge line in Section 23, which was rated 8.0.

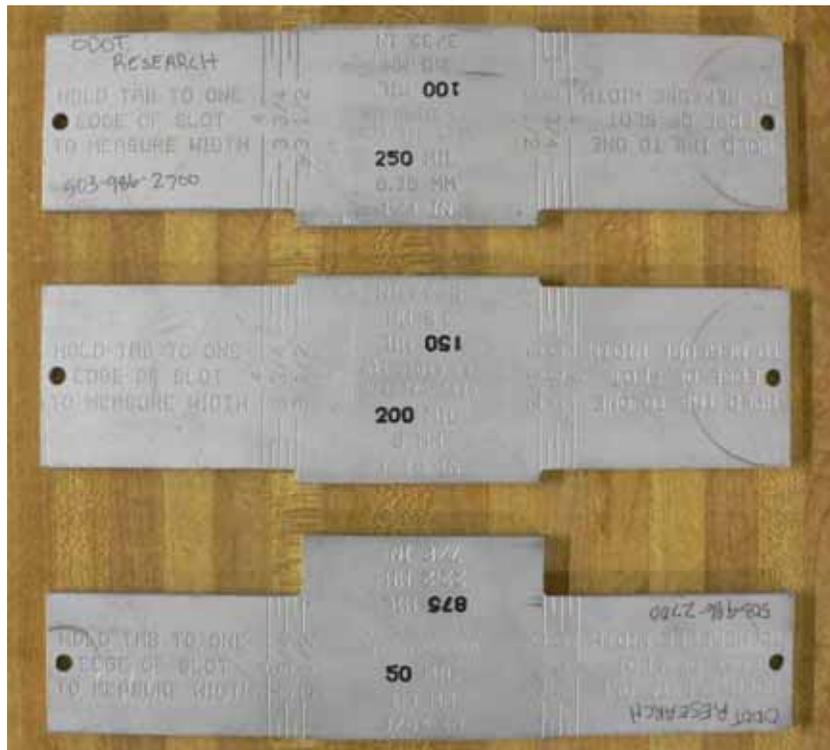
Figure 6.1: Metal gauges to measure slot depth and material recess.

the ODOT Specification depth for inlaid reflective pavement markers. The gages also include markings to measure the width of the line, up to 4 in (102 mm).
