**EVALUATION OF MODIFIED
WORK ZONE TRAFFIC CONTROL
DEVICES AT BUSINESS ACCESSES**

Final Report

State Planning and Research Project #311

Oregon Department of Transportation

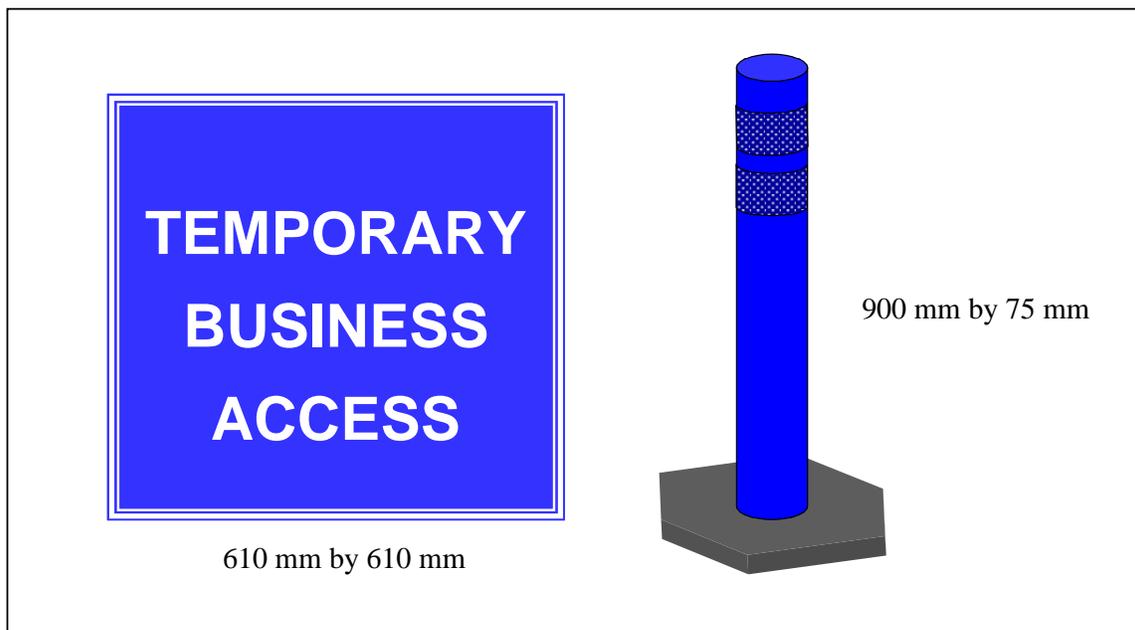
Figure 3.1: Modified Work Zone Traffic Control Devices Used at Business Accesses

Two non-standard work zone traffic control devices were evaluated. Figure 3.1 shows the devices, a blue sign designating the access for a business and a blue tubular marker.

The blue tubular markers and signs were provided by a local distributor, Traffic Safety Supply Co. in Portland, Oregon. Initially, there was some concern about finding a source for the blue tubular markers since these devices were not a standard item used in highway construction. Traffic Safety Supply Co. located Line Connection, a manufacturer of Dura-Post blue tubular markers. The Dura-Post urethane plastic tubular markers are typically surface-mounted directly to the pavement using an epoxy adhesive, and are frequently used to channelize or separate traffic. To meet ODOT's requirements for delineating business accesses, the tubular marker base was modified so that it could fit into the standard hexagonal base. Near the top of each marker, there are two bands of blue high intensity reflective sheeting. In 1999, the cost of the blue tubular marker with the hexagonal base was \$34.50 each.

The blue Temporary Business Access signs were specified as Type “B” 610 mm x 610 mm signs with 76 mm letters. When these devices were used together to delineate the driveways to a business during roadway construction, they were configured as shown in Figure 3.2.

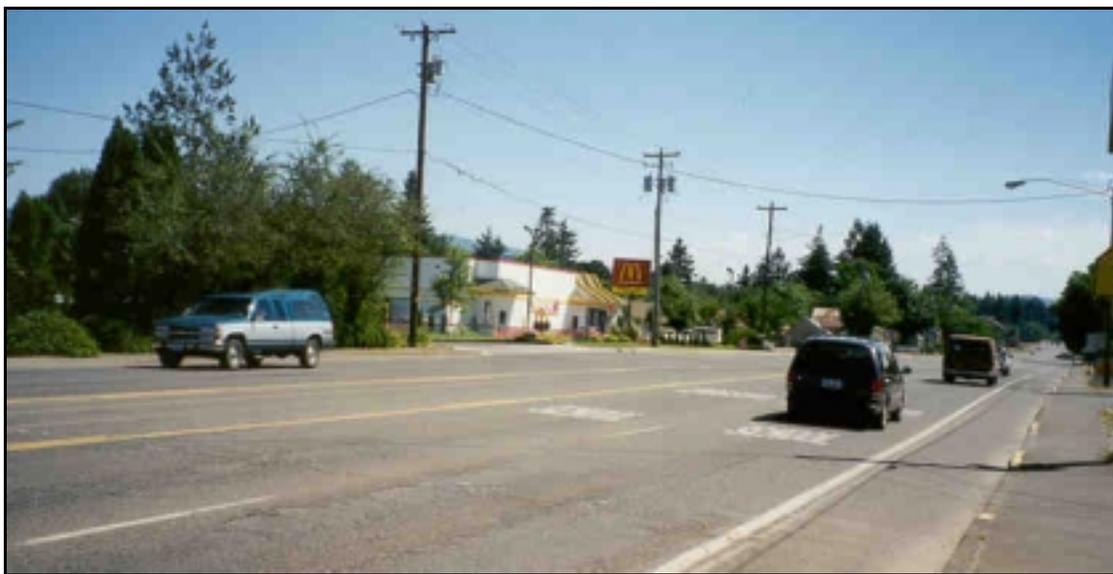
Figure 3.5: U.S. Route 20 Looking East from 18th Avenue.

The project scope consisted of cold plane pavement removal and placement of new asphalt concrete pavement. Other construction work in the project included installing drainage pipe and appurtenances, signing, guardrail, and traffic signals. Additionally, a major portion of work involved construction of concrete curbs, sidewalks, driveways and traffic islands. The existing roadway through Sweet Home consisted of four lanes (two in each direction) with a center-turn refuge lane in the median (Figure 3.5).

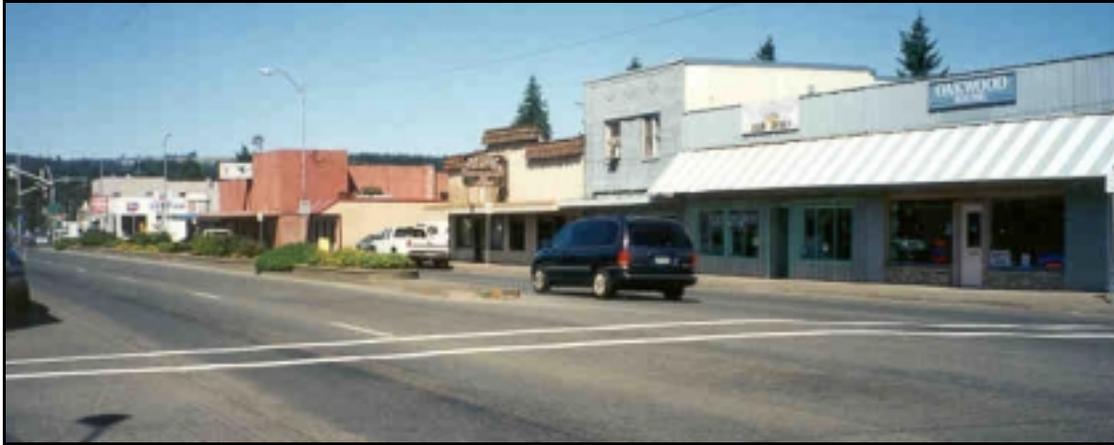
Figure 3.6: Downtown Sweet Home at 13th Avenue Looking West

In the downtown portion of Sweet Home, from about 10th Avenue to 18th Avenue, there is a raised median and left hand turn movements are accomplished from left-turn refuge lanes at cross street intersections (Figure 3.6).

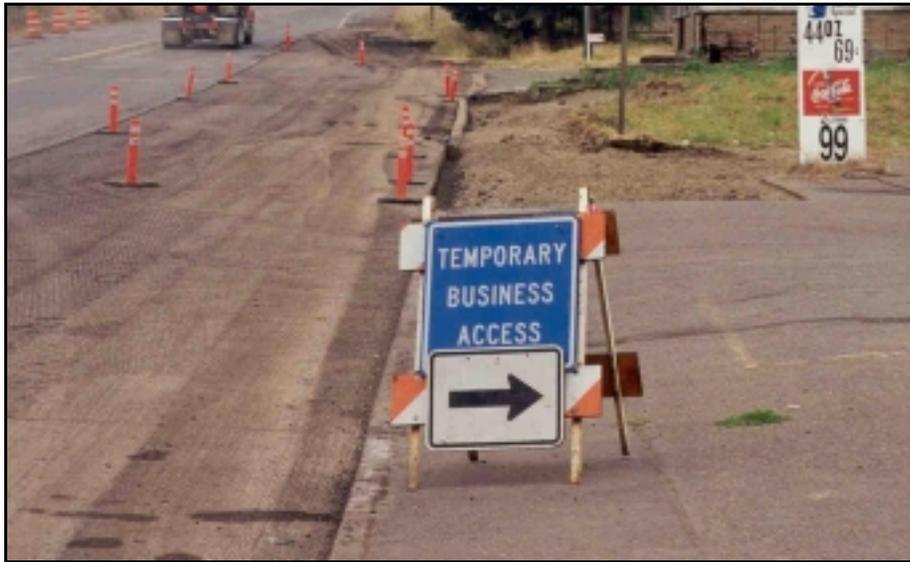
Figure 4.1: Business Access Sign Mounted on Type II (A-Frame) Barricade

After construction began, Temporary Business Access signs were placed at driveways when there were construction activities in the vicinity of the business site. Typically, these activities involved sidewalk and driveway construction which blocked a travel lane. The Temporary Business Access signs were mounted on two types of sign supports, either an A-frame (Type II) barricade (Figure 4.1) or a tripod support (Figure 4.2). Signs were placed to be visible to oncoming traffic that could turn right from the adjacent travel lane. In most cases, only one sign was used per access, either because: (a) a raised median prevented entry from the opposite travel lane; (b) there were space constraints; or (c) the sign could not be placed to be easily seen by traffic in the opposite travel lanes.

In Sweet Home and Pleasant Hill, the Temporary Business Access signs were mounted on a Type II (A-frame) barricade; a tripod was also tested in Sweet Home. During the study, some of the signs supports were broken or bent, perhaps because they were frequently moved during construction, or they may have been blown over by the wind, or knocked over by motorists or pedestrians. If used on future projects, a more durable sign support that meets the National Cooperative Highway Research Program (NCHRP) 350 crash testing requirements should be used instead of the tripod or Type II barricade. The sign supports should also elevate the sign at least one foot above the ground, as required by the Manual of Uniform Traffic Control Devices (MUTCD).

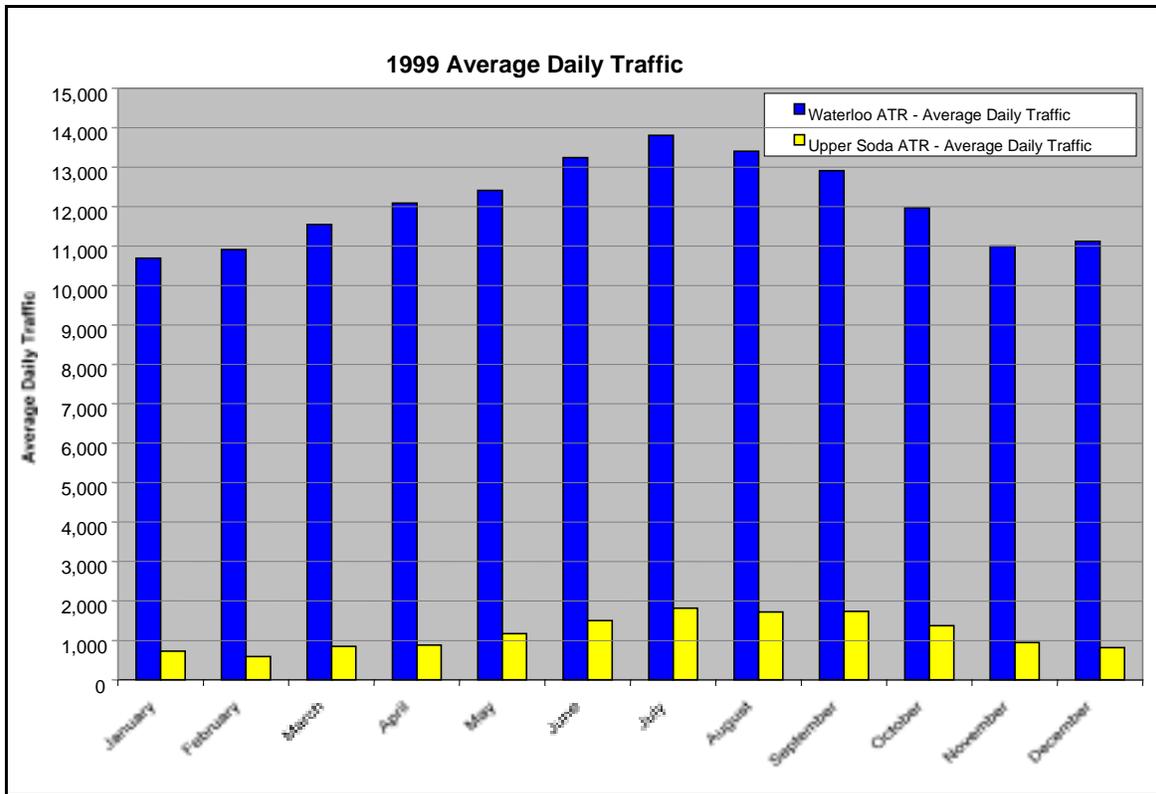
Figure 4.3: 1999 Average Daily Traffic for Waterloo and Upper Soda ATR sites.

Traffic was also impacted by summer recreational travel. U.S. Route 20 through Sweet Home is a major travel corridor that typically sees seasonal changes in traffic. An indicator of the seasonal volumes along the corridor is provided by ODOT’s Automated Traffic Recorder (ATR) sites near Sweet Home. Figure 4.3 provides the average daily traffic (ADT) data for 1999 recorded at an ATR site located near Waterloo, approximately 13 km northwest of Sweet Home on U.S. Route 20, and at an ATR site close to Upper Soda on U.S. Route 20, about 39 km east of Sweet Home.

The highest ADTs recorded at both sites occur in July and August. The baseline traffic counts for most business locations were taken in May and June, prior to the heaviest seasonal traffic. For the four sites that experienced increases in traffic during construction, those increases could be attributed to seasonal increases in traffic. Alternatively, seasonal variability could have also affected the six business sites that showed decreases in traffic during construction. It can be theorized that those decreases would have been even greater if there were no seasonal influx of traffic through Sweet Home in July and August.

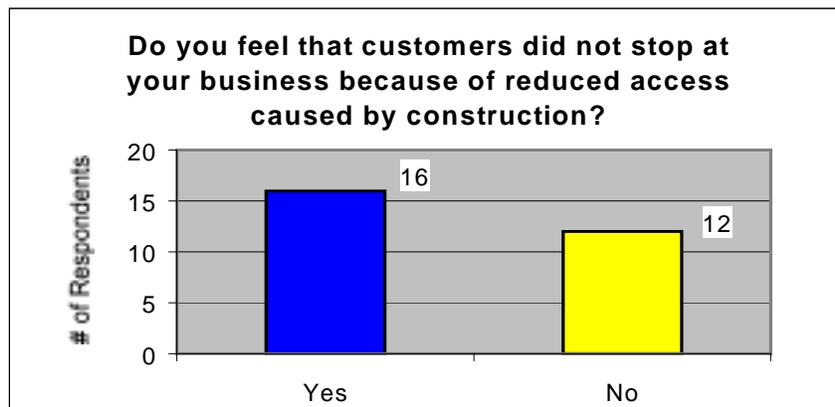
Figure 4.5: Responses to Question About Customer Impact with Reduced Access

Figure 4.4 shows the answers to the question about the difficulty in locating the business entrance due to construction. The distribution of responses was evenly split, with half of the responders feeling their customers had a difficult time locating the entrance to their business. As Figure 4.5 shows, 16 of 28 respondents (57%) felt they lost business because of reduced access. Yet, when asked if ODOT could have done more to provide better access, 15 of 24 (62%) said no (Figure 4.6).

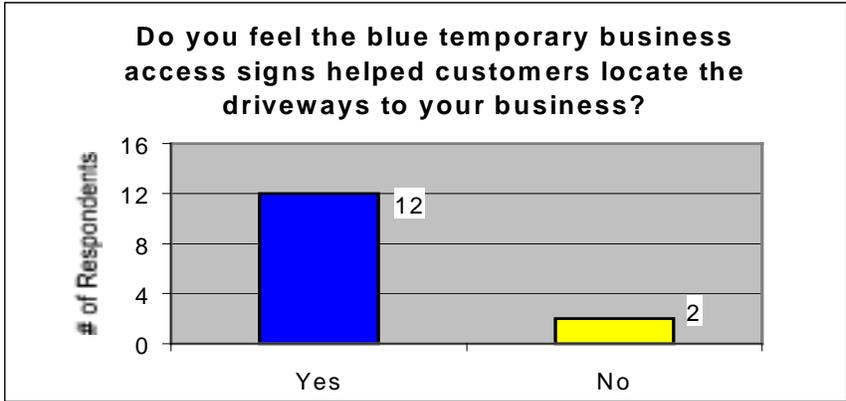
Figure 4.8: Responses to "Did the Business Access Signs Help Customers " Question

Fourteen of 26 respondents (54%) had Temporary Business Access signs placed in front of their driveways during construction (Figure 4.7). As seen in Figure 4.8, 12 of the 14 businesses (86%) indicated the signs helped customers locate their driveways.

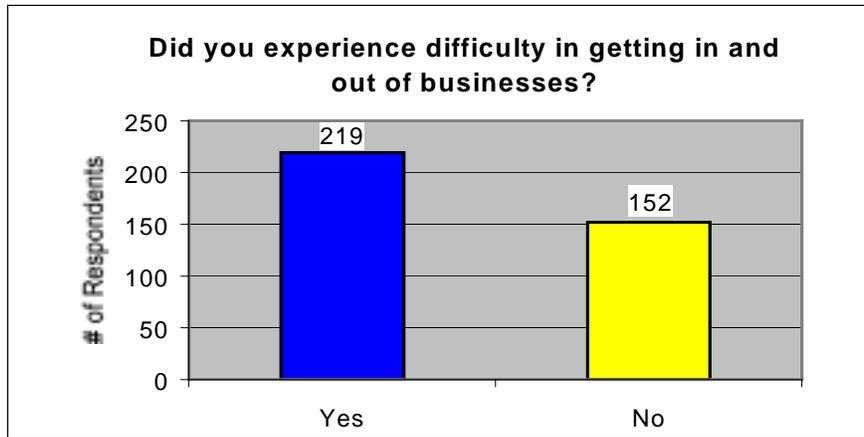
Figure 4.10: Responses to Difficulty Getting in and Out of Businesses

Figure 4.10 shows that 59% (219) of those surveyed said they experienced difficulty getting into and out of the businesses.

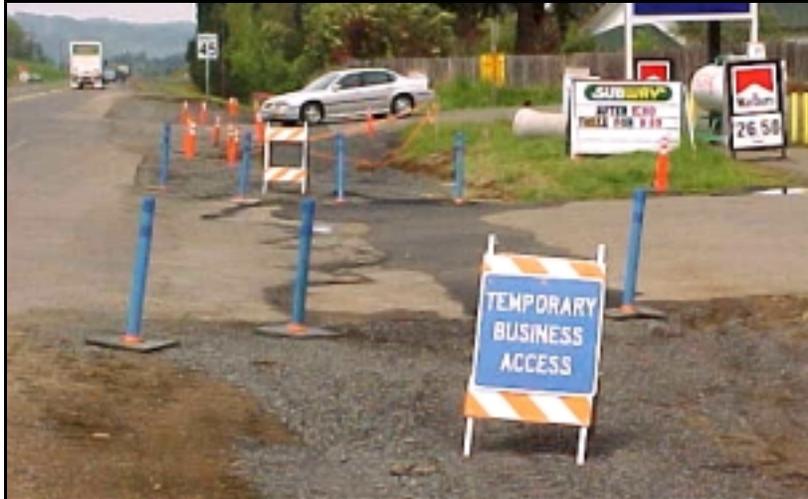
Figure 5.1: Business Access Sign and Blue Tubular Markers

Construction began in the Spring of 1999 and continued until November 2000. Blue tubular markers and signs were placed at the business access when there was construction activity in the vicinity of the business site. Typically, this work involved sidewalk and driveway construction, shoulder and road construction, paving, and drainage pipe installation. The signs were mounted on a Type II (A-frame) barricade which was placed in front of a taper of blue tubular markers at the business access (Figure 5.1). Since the geometry of the accesses was not the same for each access, the tubular marker spacing varied at different locations, ranging from one to three meters. Figure 5.2 and Figure 5.3 show two more examples of sign and cone placement.

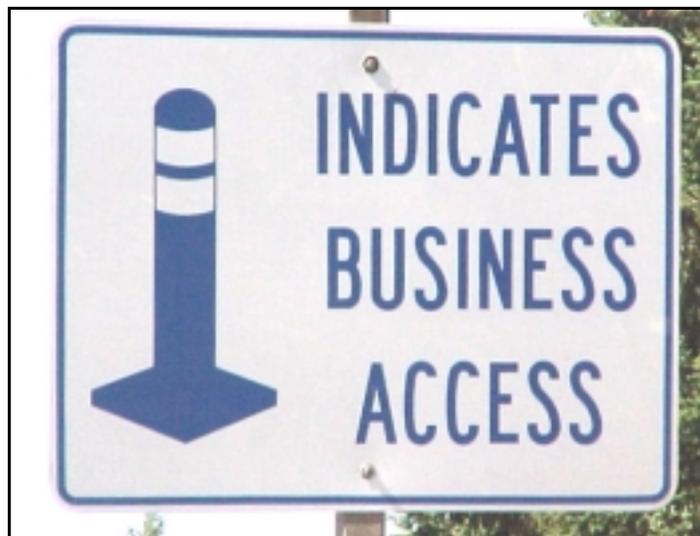
Figure 5.4: Informational Sign Alerting Motorists to Blue Tubular Markers

Additionally, two informational signs, one at each end of the project limits, were placed to alert motorists as they entered the construction work zone about the meaning of blue tubular markers. The signs (1219 mm x 914 mm), as seen in Figure 5.4, displayed a blue tubular marker and text (“Indicates Business Access”) on a white background.

The sign in Figure 5.4 shows a blue tubular marker with two bands of white reflective sheeting. The blue tubular markers actually used on this project were delineated with blue reflective sheeting as seen in Figures 5.1-5.3. Blue reflective sheeting was used to further distinguish the blue tubular markers from the orange ones, especially at night, since white sheeting is used on the orange markers.

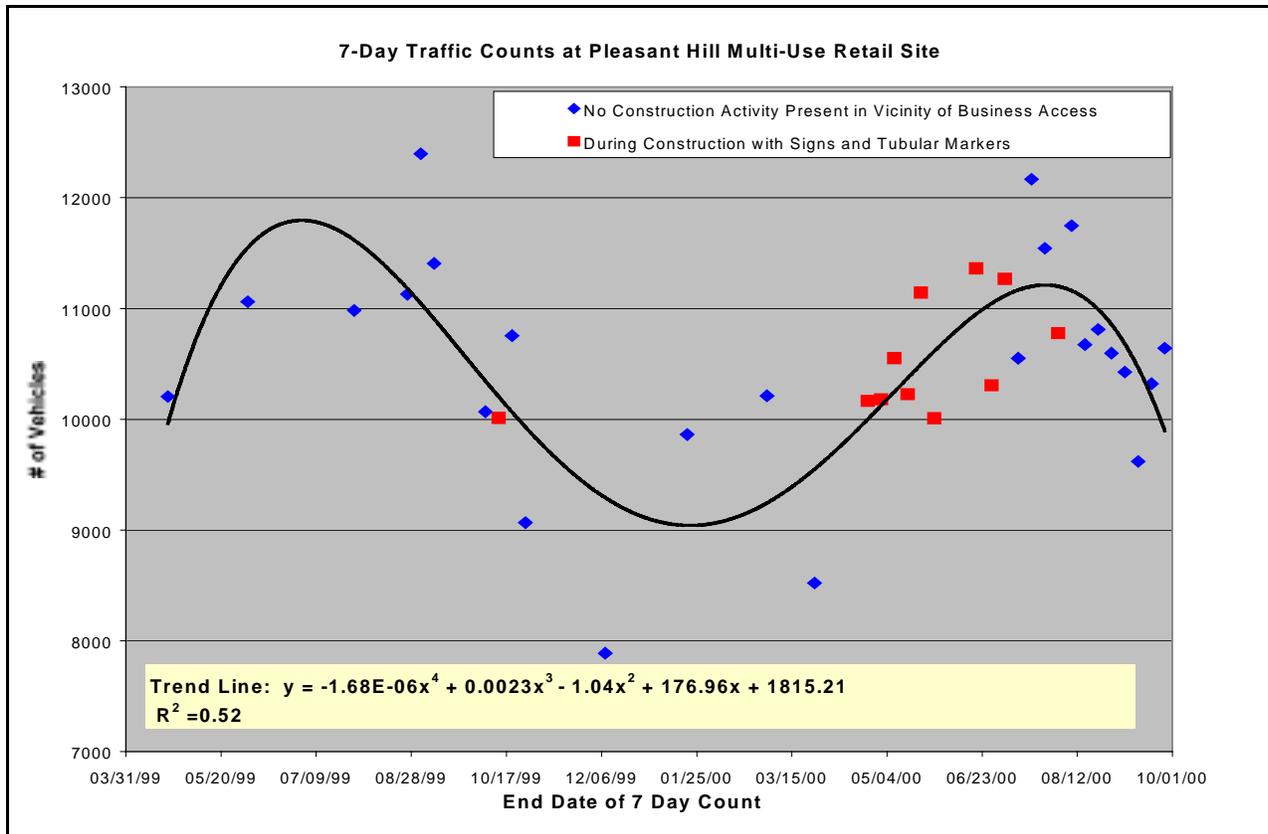
Figure 5.5: Plot of Traffic Counts Recorded at Multi-Use Retail Site in Pleasant Hill

At this site, five access drives were counted initially. To improve traffic flow and enhance safety, one of the accesses was eliminated by the construction when sidewalks, curbs and gutters were constructed in May 2000. Week-long traffic counts were conducted at this site 34 times during the construction period. Eleven of the counts were taken when construction activity was in the vicinity of the business accesses and blue tubular markers and signs were used. Figure 5.5 shows a plotted history of the week-long counts from April 1999 to September 2000. Each data point corresponds to a one-week count. Two sets of data points are plotted on the graph, which represent: (a) no construction was present in the vicinity of businesses accesses; and (b) construction was present and blue tubular markers and signs were used to mark the accesses.

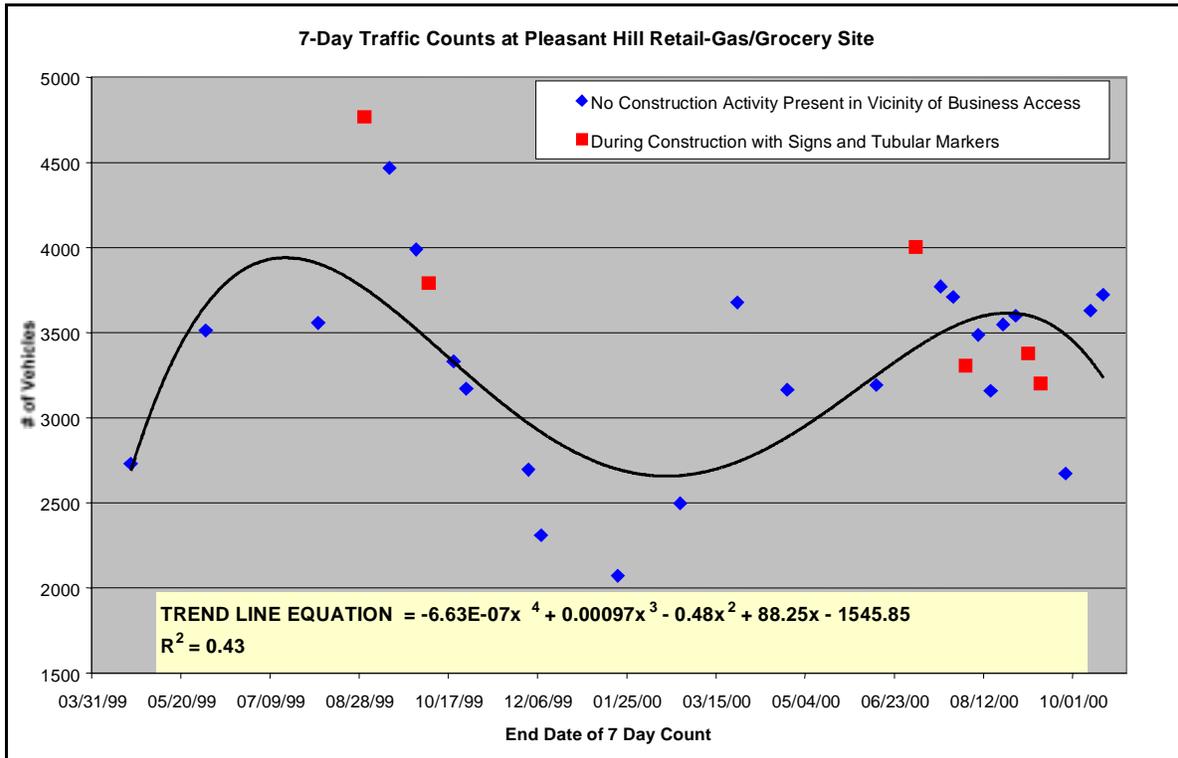
Figure 5.6: Plot of Traffic Counts Recorded at Gas/Grocery Site in Pleasant Hill

The two accesses at this site were counted 30 times during the construction period. Six of the counts were taken when construction activity was in the vicinity and blue tubular markers and signs were used at each access. Figure 5.6 shows a plotted history of the week-long traffic counts for the “no construction” and “with construction” conditions.

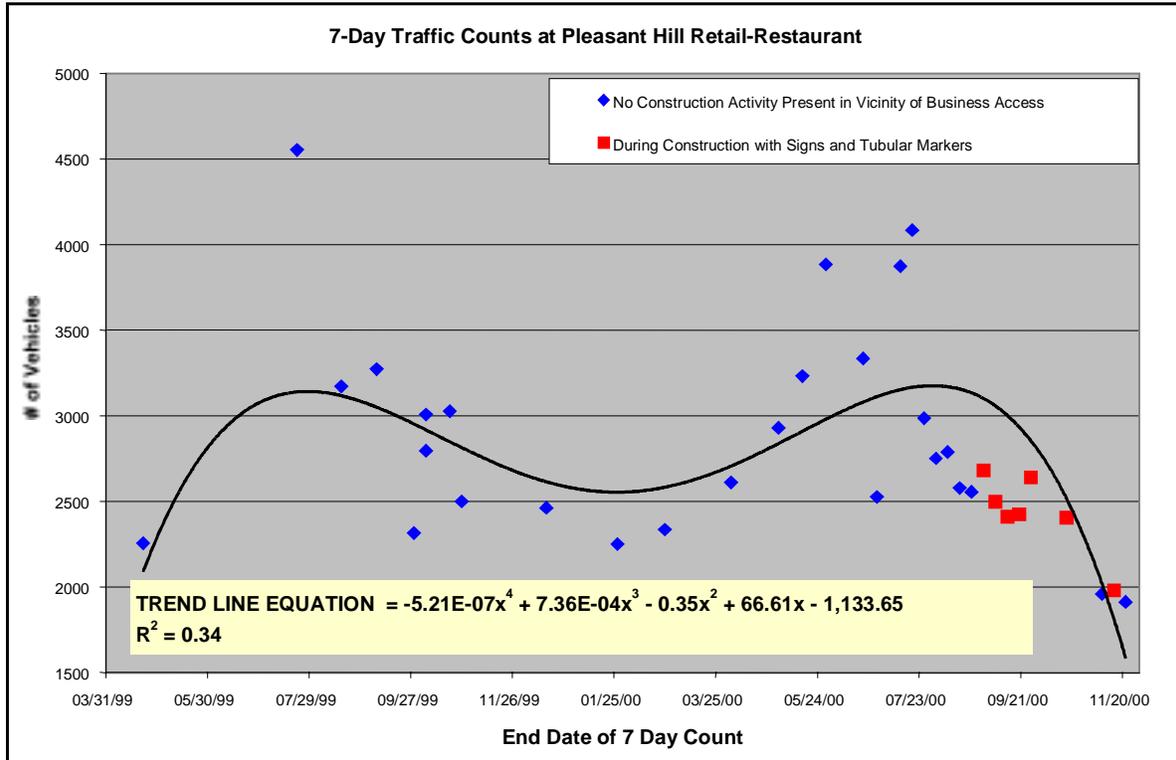
Figure 5.7: Plot of Traffic Counts Recorded at Restaurant Site in Pleasant Hill

The two accesses at this site were counted 35 times during the construction period. Seven of the counts were taken with construction activity in the vicinity and blue markers and signs at each access. Figure 5.7 is the plotted history of the week-long traffic counts for the “no construction” and “with construction” conditions.

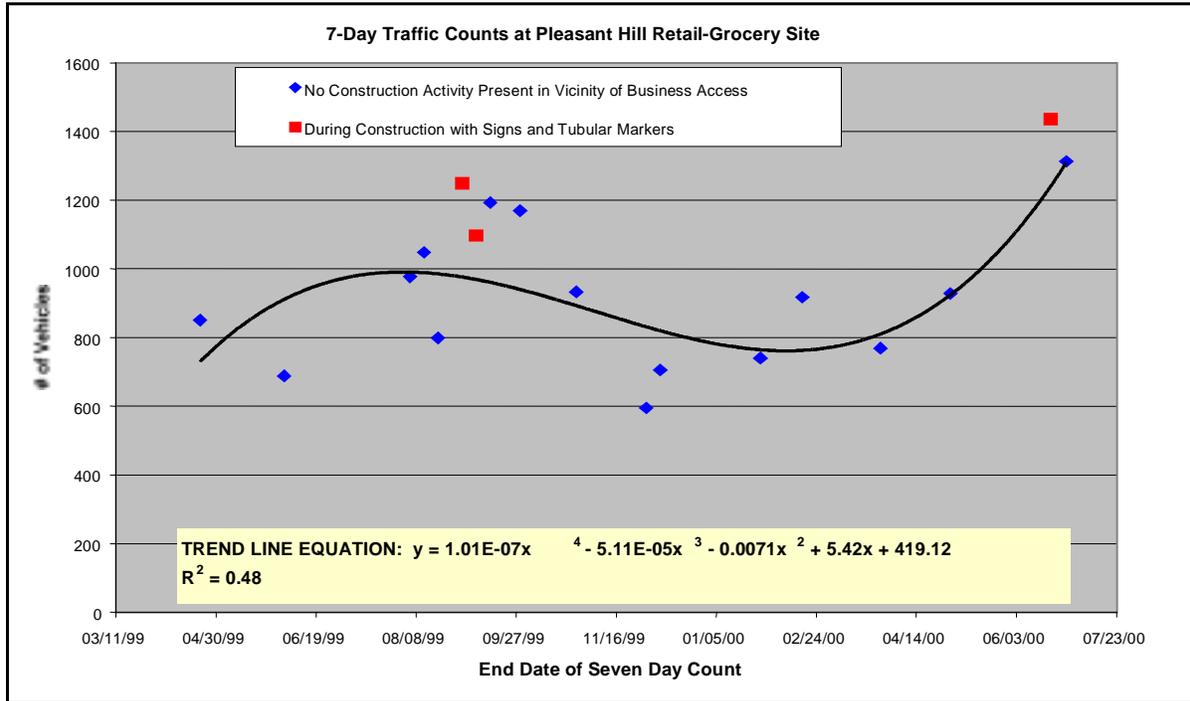
Figure 5.8: Plot of Traffic Counts Recorded at Grocery Site in Pleasant Hill

Two accesses at this site were counted 18 times during the construction period. The total number of counts was lower for this site because in June 2000, the business owner asked ODOT to stop counting his accesses. Figure 5.8 shows the plotted history of the week-long traffic counts from April 1999 to June 2000.

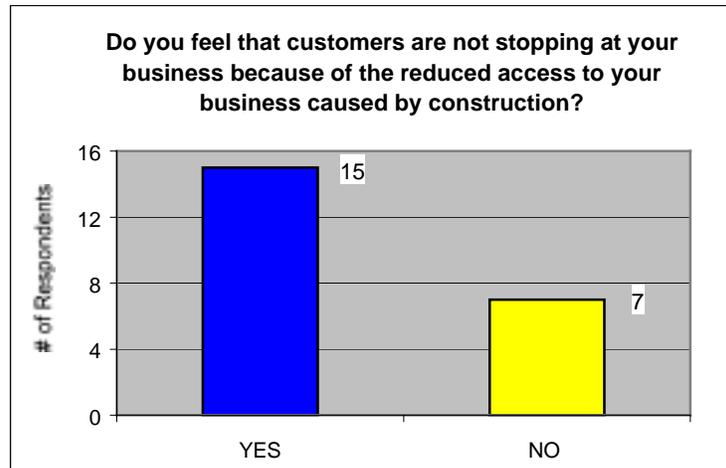
Figure 5.9: Responses to Question About Customers Not Stopping Because of Reduced Access

Figure 5.9 shows the responses of the 22 businesses to a question about whether customers were not stopping at the business because of reduced access. The majority of business owners or managers (68%) said that they believed their customers were not stopping because of reduced access caused by the construction. However, when asked if ODOT could have done more to provide the better access, 12 of 22 (55%) said no (Figure 5.10).

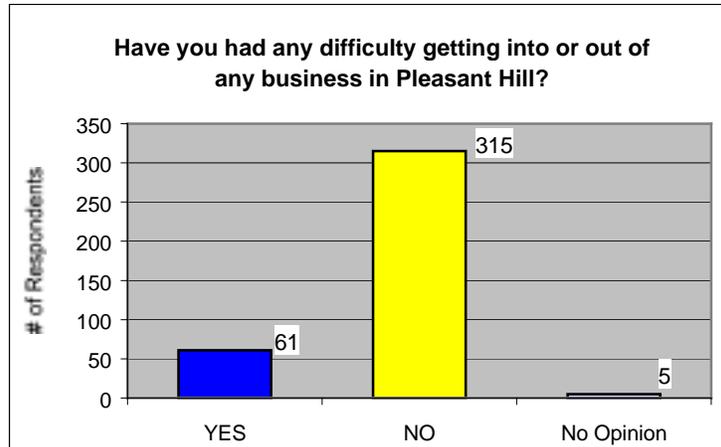
Figure 5.14: Responses to Difficulty Getting Into and Out of Businesses in Pleasant Hill

Of the people surveyed, most indicated they experienced no difficulty getting into and out of the businesses. Figure 5.14 shows the distribution of responses to the question: “Have you had any difficulty getting into or out of any business in Pleasant Hill?” with 16% (61) of those sampled answering yes.

A substantial majority (315) had no difficulty getting into and out of businesses. Several reasons could be proposed for the high number that did not have difficulty. First, the relatively small numbers of businesses in Pleasant Hill are spread along the length of the project. Secondly, more than half of the respondents had driven through the project area more than ten times in the last two months, and so, were familiar with the site. Third, much of the construction did not directly affect business accesses. However, this is not to imply that construction upstream did not impact a business. For example, some business owners noted that travelers, stuck in long lines of traffic due to a lane closure much further upstream, were less apt to stop at their business even if the accesses were not affected.
