**EVALUATION OF ROCKY POINT
VIADUCT CONCRETE BEAM**

FINAL REPORT

SPR 381

Oregon Department of Transportation

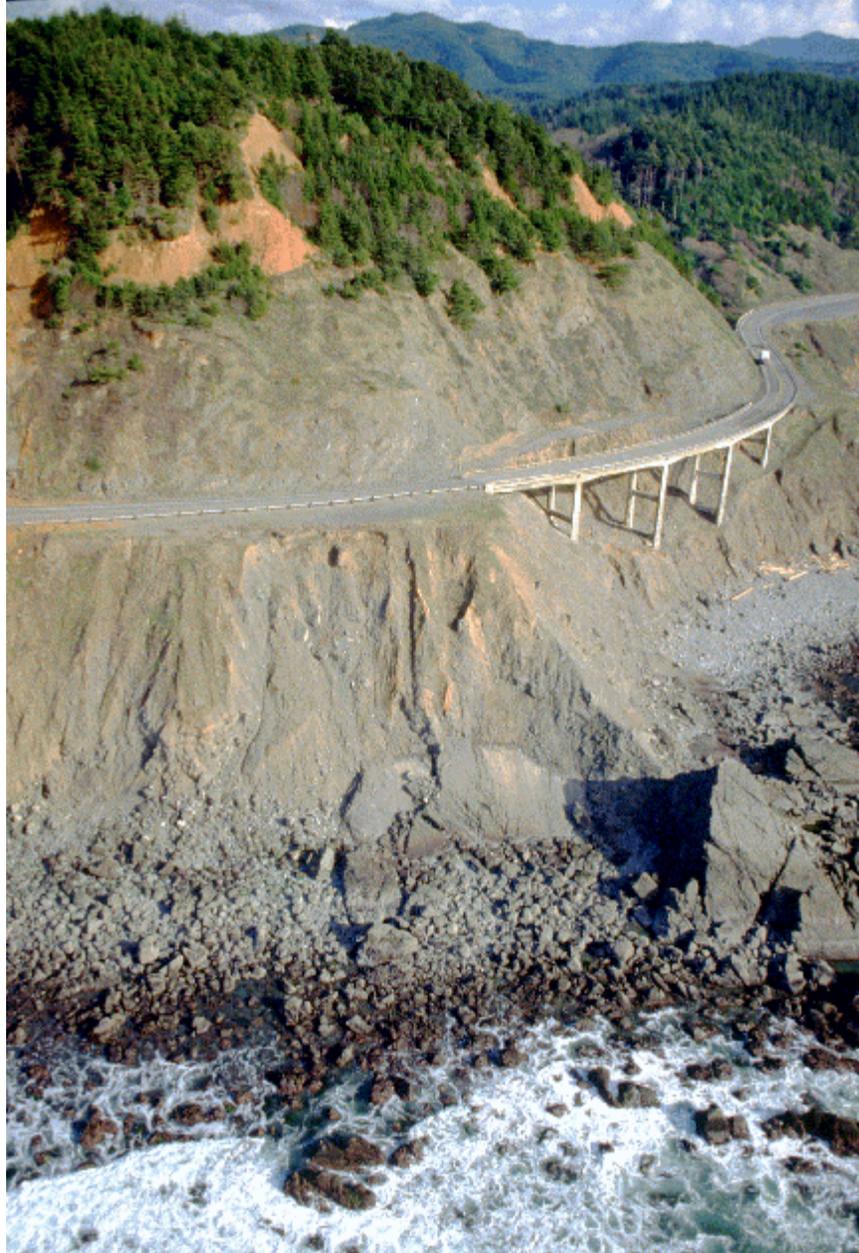
The Rocky Point Viaduct, Figure 1.1, was replaced after just 40 years of service because of severe corrosion damage that resulted in loss of rebar cross-section and compromised the structural integrity of the viaduct. Sound older structures, such as McCullough bridges circa 1930, are present on the coast in seemingly similar environments. The early replacement of the Viaduct suggests corrosion damage effects that were not anticipated or understood at the time of construction. An understanding of those effects would provide a basis for improving construction practices for future bridges and renovation practices for existing bridges.

Figure 1.1: Original Rocky Point Viaduct (ca. 1975).

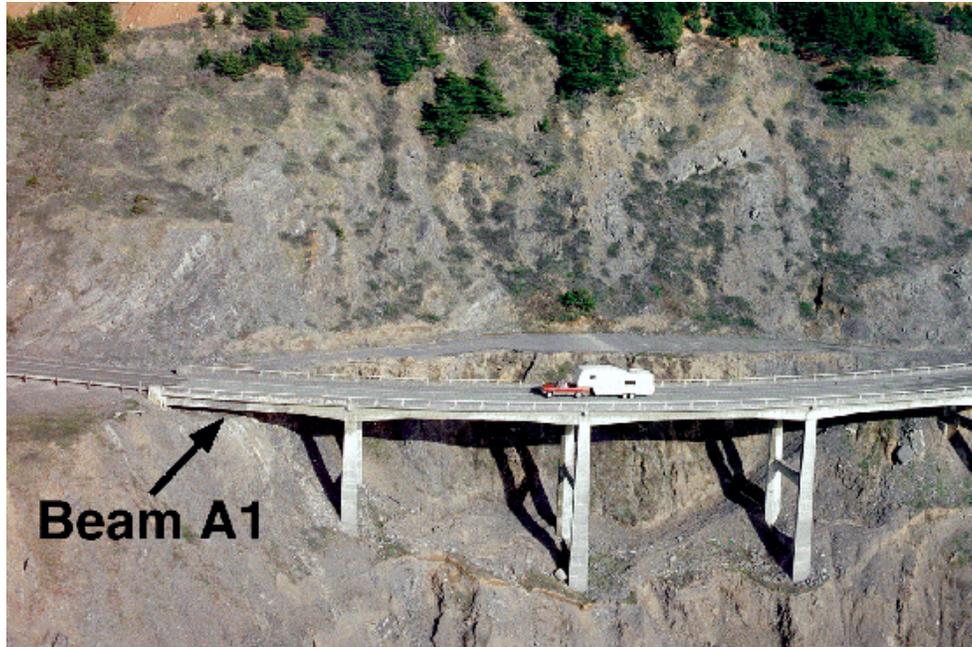
Figure 1.2: Original Rocky Point Viaduct (ca. 1975), showing location of Beam A1.

The Rocky Point Viaduct was demolished in 1994, Figure 2.3. One beam from the original structure, Beam A1 in Figures 1.2 and 2.3, was preserved with the deck intact for study. The north end of Beam A1 rested on Abutment No. 1 while the south end rested on Bent No. 1. Beam A1 was at the extreme west edge of the viaduct and thus was exposed to the full impact of the environment.

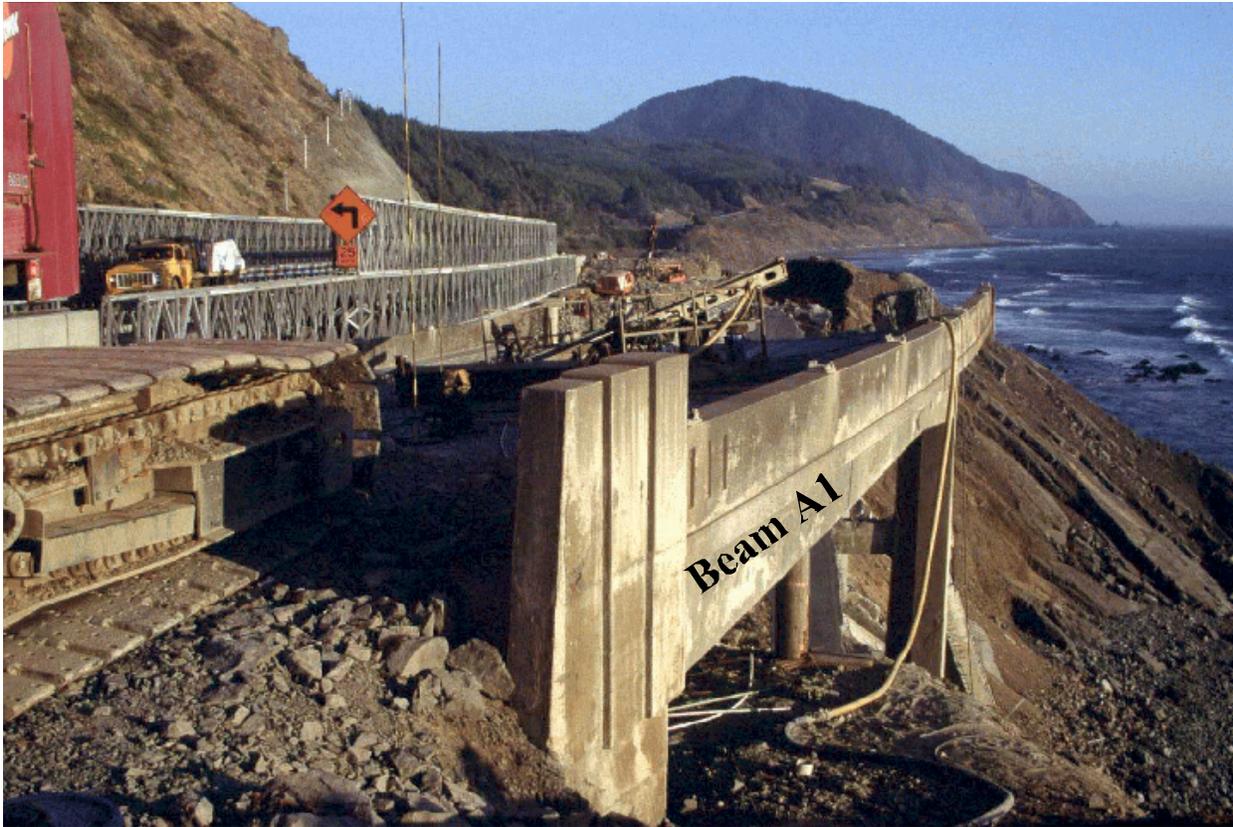
Figure 2.3: Rocky Point Viaduct demolition (1994).

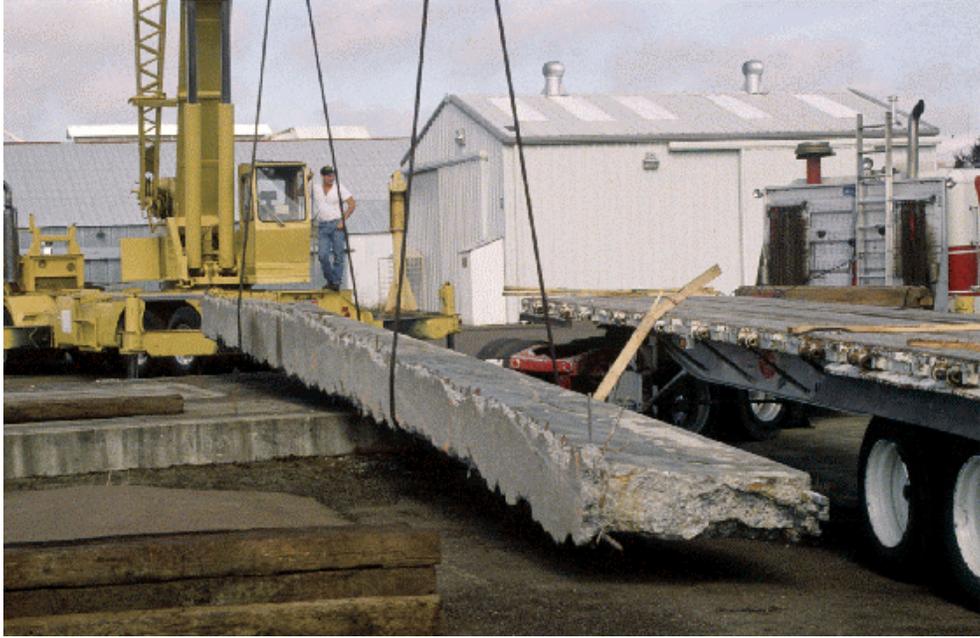
Figure 2.4: Unloading of Beam A1 from lowboy at Albany Research Center using two cranes to support the beam.

Approximately 14.4 m (47 ft) of the 20 m (66 ft) beam was delivered in one piece to the U. S. Department of Energy, Albany Research Center (ARC) in Albany OR, Figure 2.4. For convenience in transportation, the beam was cut 5.6 m (18.4 ft) short of abutment No. 1. At ARC, the beam was cut in half at its midpoint using a diamond saw. The two resulting sections so formed are referred to in this report as Section 1 (Figure 2.5) and Section 2 (Figure 2.6). In addition, three 0.3 m (1 ft) thick vertical slices were cut from the beam for studying chloride migration during cathodic polarization using planar thermal-sprayed zinc anodes, Figure 2.7. These slices were taken at the midpoint of the beam where structural damage from corrosion appeared least severe.

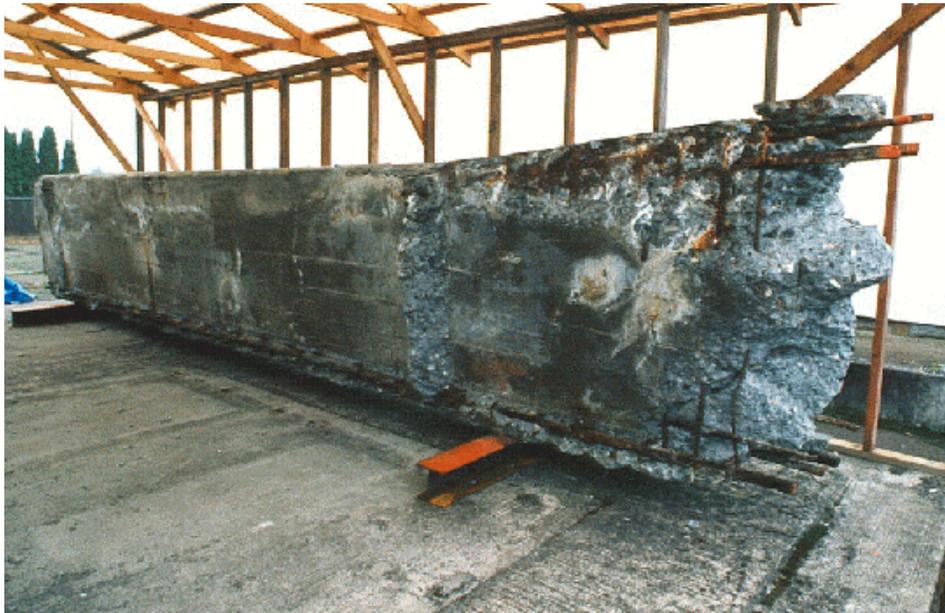
Figure 2.5: Section 1 of the Rocky Point Viaduct beam (east face), grid elements A1 to G47 (right to left).

The probability that corrosion damage initiated with the shear stirrups is also suggested by Figure 2.5. Here the portion of the beam that rested on Bent No.1 has an inclined lower edge (top of the figure) that is severely spalled, and all of the shear stirrups are exposed. The inclined lower edge would have been a collector for precipitation draining from the beam, particularly dew and fog containing high concentrations of chloride ion. This would lead to longer periods of wetness and higher rates of chloride diffusion into the concrete. As a consequence, corrosion of the shear stirrups would initiate earlier along this edge, the concrete would crack and spall, and more aggressive conditions would exist for continued corrosion of the shear stirrups and square rebar.

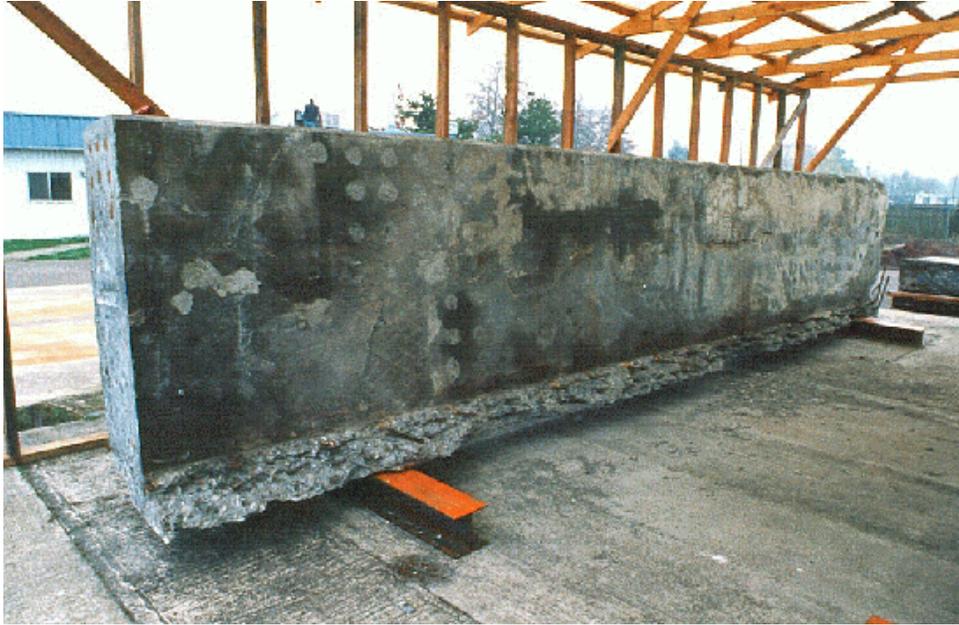
Figure 2.6: Section 2 of the Rocky Point Viaduct beam (west face), grid elements A54 to G94 (left to right).

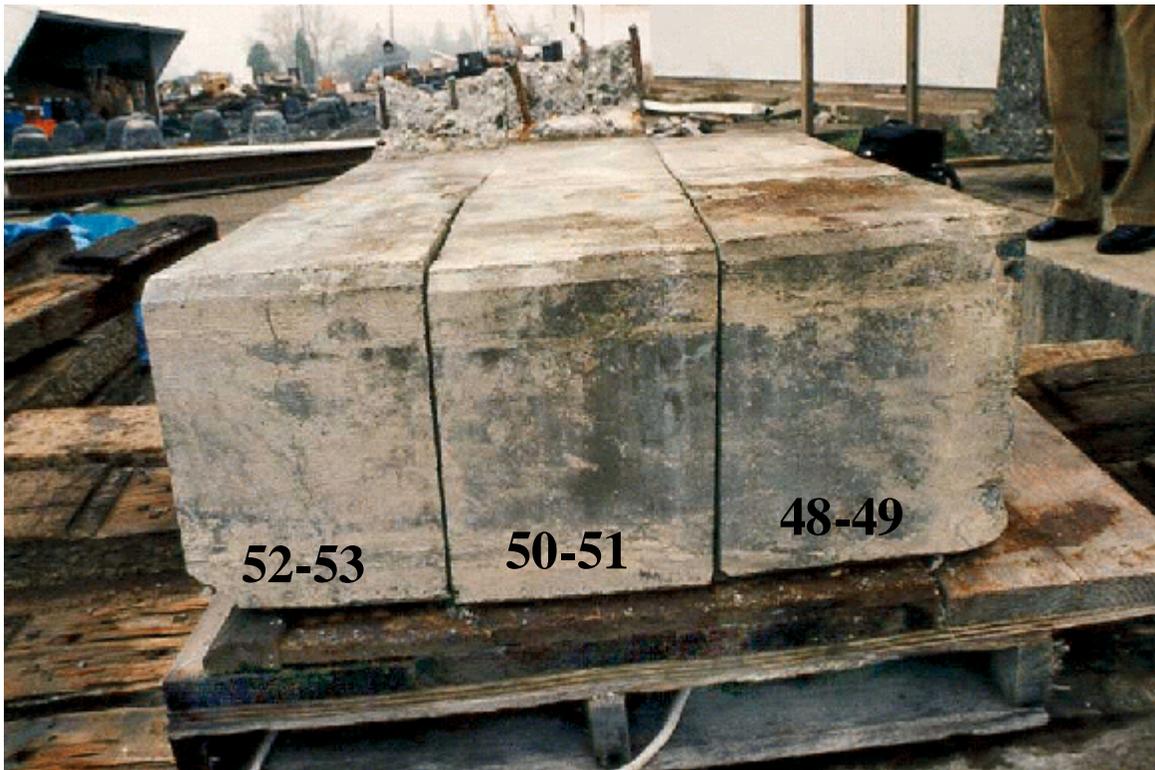
Figure 2.7: Beam slices for chloride migration studies, grid elements A48-G49, A50-G51, and A52-G53.

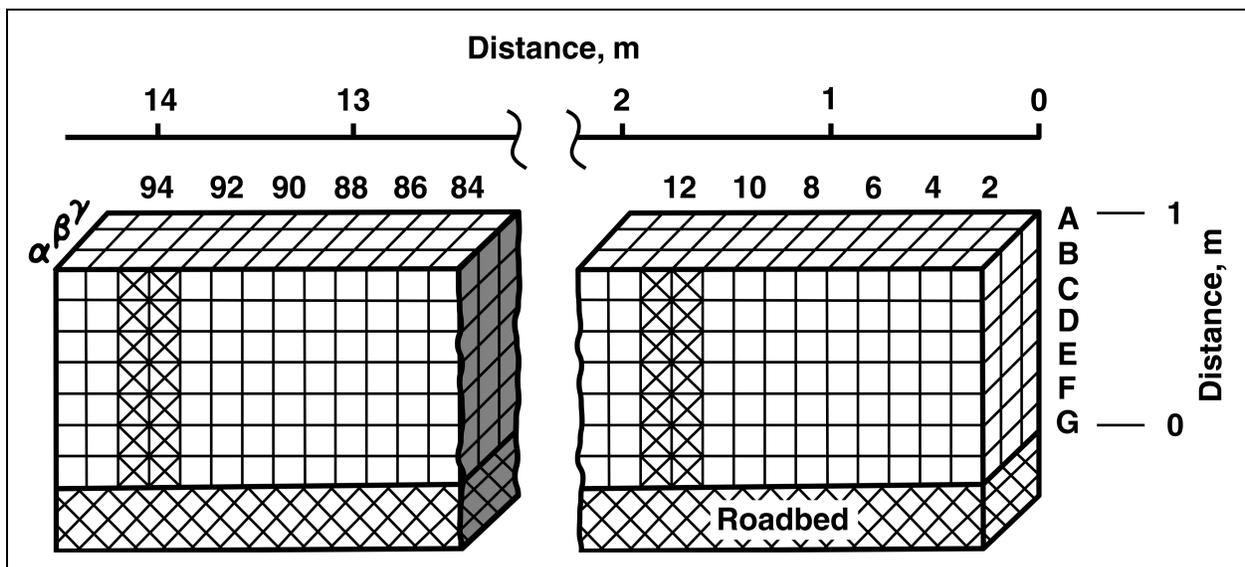
After sandblasting, a grid with elements measuring 152 x 152 mm (6 x 6 inch) was painted onto the east and west faces of the beam sections. A grid with elements measuring 152 x 127 mm (6 x 5 inch) was applied to the bottom of the beam. **All observations and measurements are referenced to these grids.** The grid is illustrated in Figure 2.8 and runs continuously the length of the two sections. Longitudinal grid locations on Section 1 ran from 1 to 47; on Section 2 from 54 to 94. The three 0.3 m (1 ft) thick slices included the remaining longitudinal grid locations, i.e., 48-49, 50-51, and 52-53, Figure 2.7. The vertical grid on the sections ran from A to G, with A being the bottom of the beam (top of Figure 2.8) and G being the deck. With the beam inverted, the vertical grid starts with A at the top and descends to G at the deck.

Figure 2.8: Grid placement on beam, Sections 1 and 2.

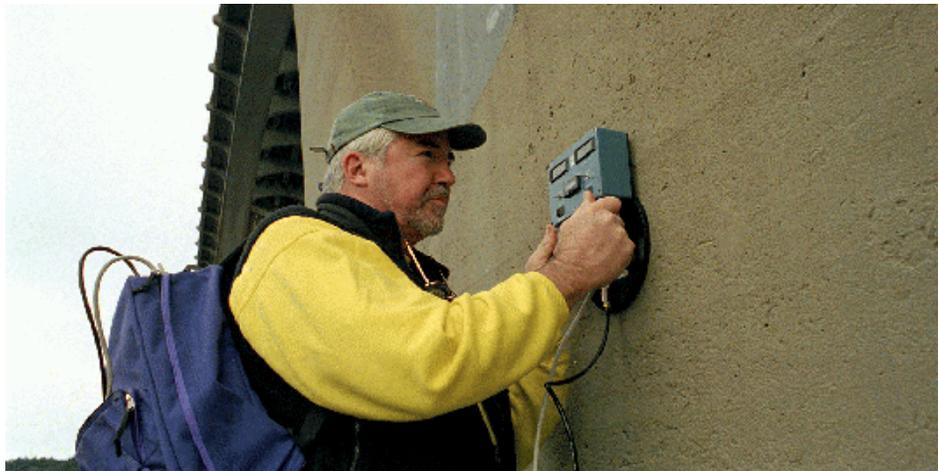
Another measure of the permeability of the concrete to the ingress of atmospheric constituents is surface air permeability. Surface air permeability of the concrete on the east face of Section 1 was measured using a concrete air permeability tester (also described as a surface air flow permeability indicator). This instrument is based on the principle that flow of air through a concrete surface will be higher for concrete with a higher permeability. Operation of the instrument required a vacuum of about 640 mm (25 inch) Hg. Air flow was measured by a mass flowmeter. The instrumentation is available as a self-contained portable unit, Figures 3.1 (a) and 3.1(b). Its operation is described in the “Showcase Workshop on Concrete Durability” (*FHWA-SHRP, 1995*) and in SHRP-S-329, “Condition Evaluation of Concrete Bridges Relative to Reinforcement Corrosion – Volume 7: Method for Field Measurement of Concrete Permeability” (*Whiting and Cady, 1993*).

Figure 3.1a: Measuring permeability of concrete with portable Surface Air Flow Permeability Indicator (SHRP Product 2031).

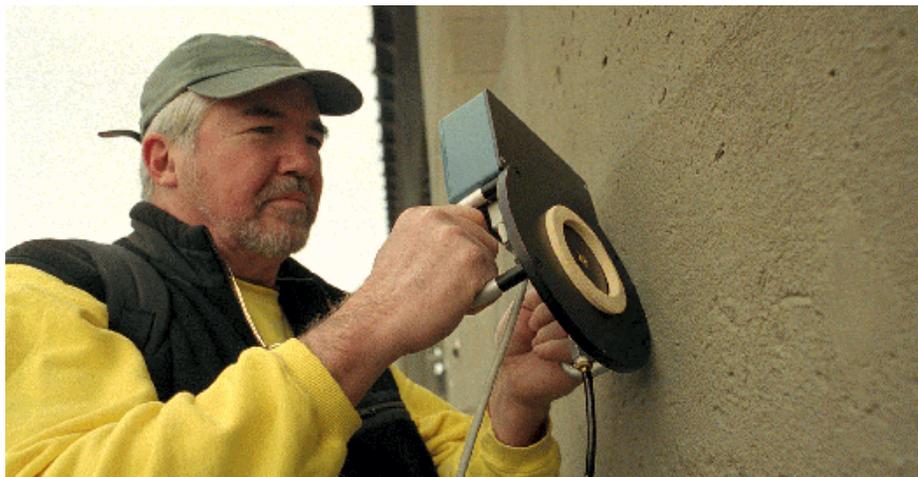
Figure 3.1b: Surface Air Flow Permeability Indicator showing measuring head with foam rubber gasket that makes an airtight seal with the concrete surface.

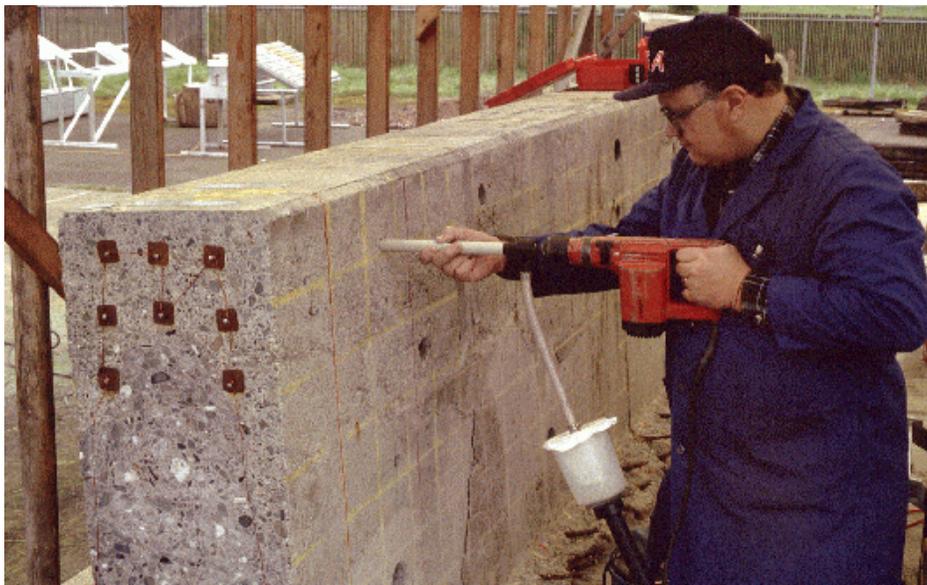
Chloride ion concentration in the concrete was determined using the Oregon DOT sampling technique and equipment, Figure 3.2. Pulverized concrete powder samples are removed through the hollow center of a drill bit from the hole created by a hammer drill. The concrete powder is collected on a filter for later analysis of calcium and chloride ion concentration. The concrete powder samples are collected over equally spaced depth increments into the concrete so that the chloride ion distribution profile can be reconstructed. The sampling equipment included an impact hammer drill, a hollow drill bit, a powder collector, and a vacuum source. Concrete powder samples were collected at 12.7 mm (0.5 inch) depth increments through the entire 0.38 m thickness of Beam A1. Care was taken to avoid cross-contamination of samples with powder from earlier samples. This was done by vacuuming out the drill hole(s) in the concrete between each sample collection, and by removing powder from the hollow drill and the collection line after each sample collection. Full descriptions of the equipment and procedures followed in powder sampling the concrete to produce samples for chemical analysis are given in APPENDIX D – Sections D.1.1 and D.1.2.

Figure 3.2: Chloride profiling beam with Oregon DOT powder sampling apparatus. Worker is holding the rotary hammer with the left hand and the polypropylene pipe spacer surrounding the air bit with the right hand. The powder collection filter is hanging from the air system adapter below the air bit.

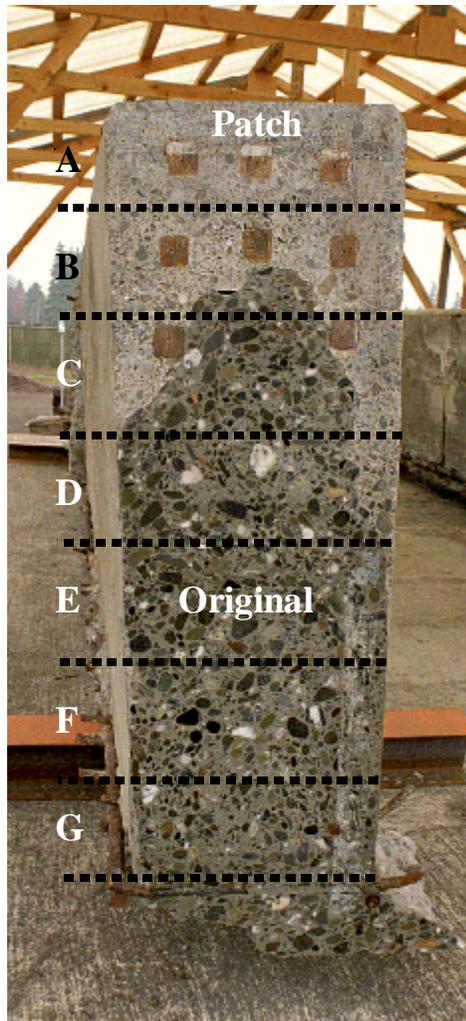
All of the square rebar lay in the patch concrete in grid locations A through C, Figure 3.3. Original concrete contained only shear stirrups and represented most of the beam cross-section, grid locations D through G. Patch concrete chloride ion samples were taken from grid locations A and B, with the axis of the sampling hole running between the square rebar. Original concrete samples were taken from grid locations E and F. The first set of powder samples was taken from the “as-received” beam. Two additional sets were taken after 0.5 and 1.0 years of ICCP, and were labeled 0.5 and 1.0 year samples.

Figure 3.3: Cut end of Section 2 showing square rebar, the original and patch concrete, and the grid locations used in taking Cl powder samples for determining chloride profiles and chloride migration under ICCP.

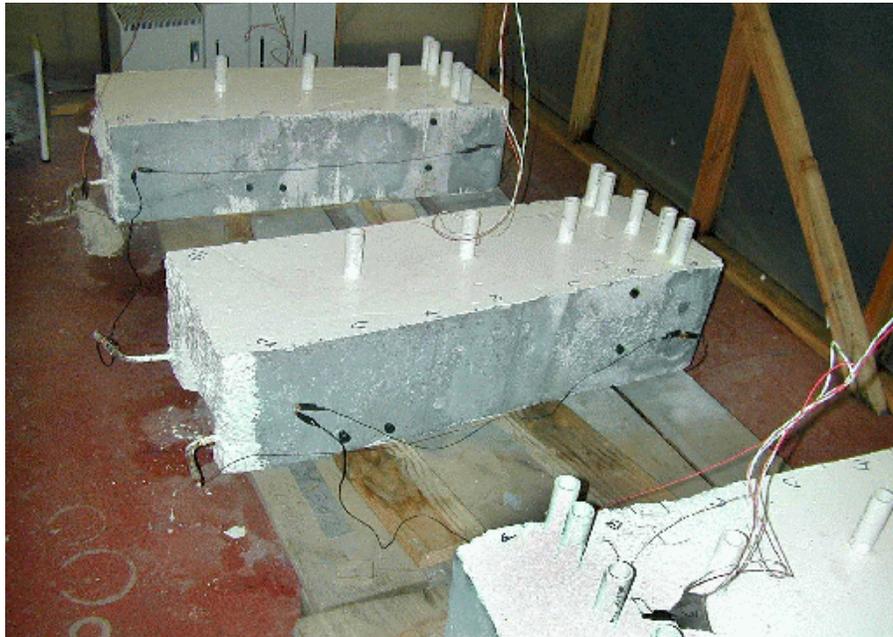
The beam slices, with Zn anode in place, were then placed inside a tented enclosure constructed in the laboratory for controlling humidity and temperature, Figure 3.4. The enclosure conditions were 70 pct relative humidity (RH) and 21° C (70° F). The slices were kept in this enclosure for one month to equilibrate with tent conditions before ICCP was begun.

Figure 3.4: Beam slices in temperature and humidity controlled tent. The white polypropylene pipes are locations for measuring rebar potential with Cu/CuSO₄ reference electrode.

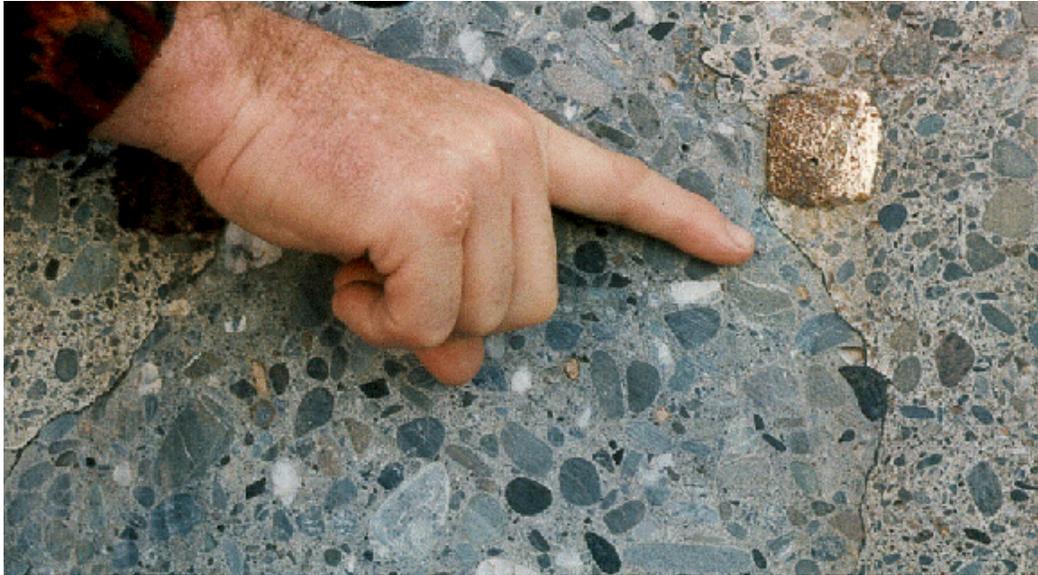
A coal-tar epoxy joint was found at the interface between the patch and original concrete. This joint is the continuous black line between the patch and original concrete seen in Figure 4.1. It was installed during the 1969 repair to prevent salt from diffusing into the patch concrete from the original concrete.

Figure 4.1: Coal-tar epoxy joint between patch and original concrete.

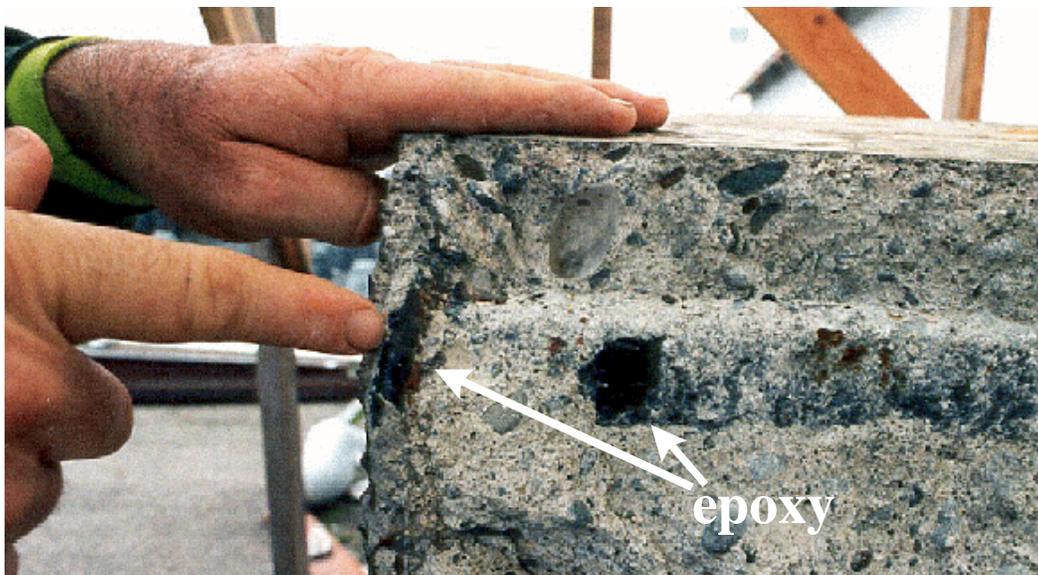
Inspection of the exposed rebar showed: a coal-tar epoxy coating on some of the square rebar, evidently to act as a barrier to further corrosion, Figure 4.2; and an inorganic zinc paint on some of the remaining rebar, evidently to serve as a sacrificial coating and prevent further corrosion damage to the rebar, Figure 4.3. In addition, a linseed oil coating was applied to the exterior of the beam, covering both exposed original concrete and patch concrete, Figure 4.4. Clearly, given the premature failure of the Viaduct, the coal-tar epoxy joint, the coal-tar and inorganic zinc coatings on the square rebar, and the linseed oil coating were ineffective in preventing further corrosion damage.

Figure 4.2: Coal-tar epoxy coating on square rebar.

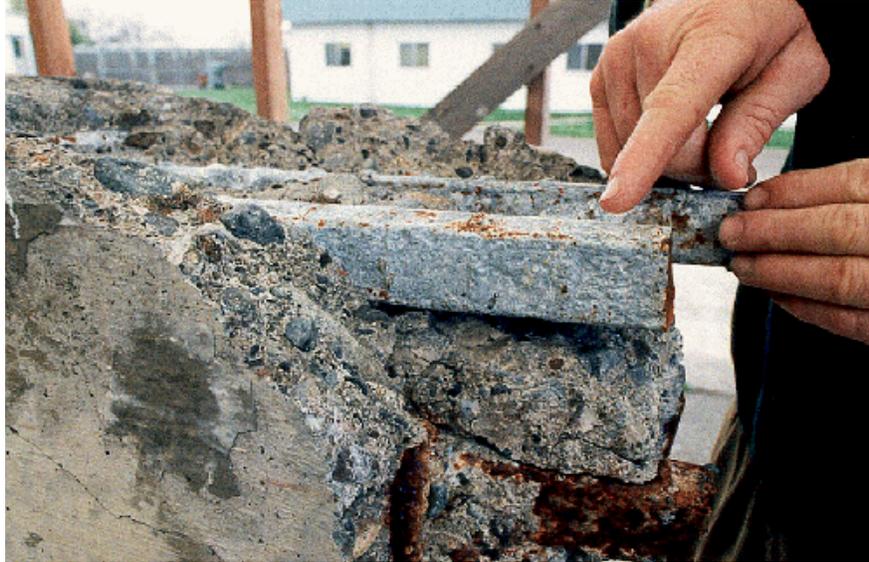
Figure 4.3: Inorganic zinc coating on square rebar.

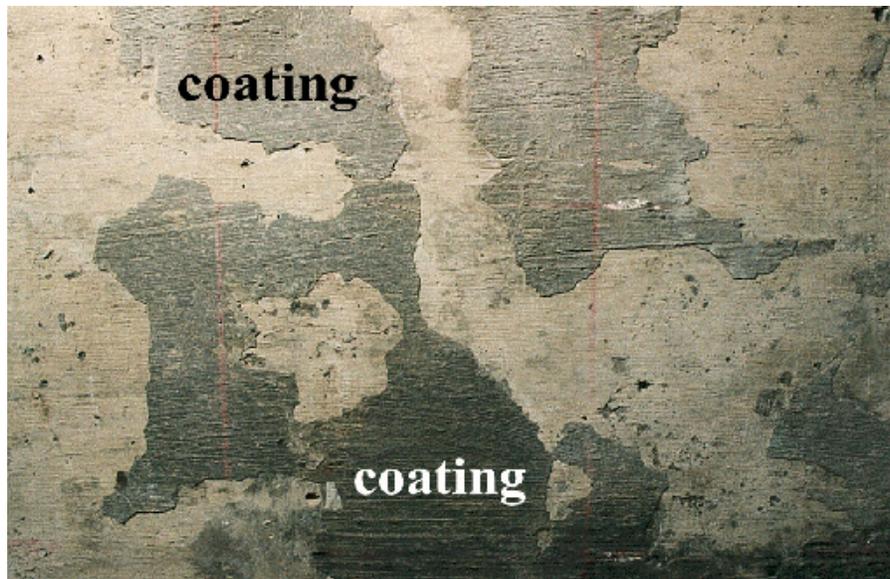
Figure 4.4: Remnants of linseed oil coating on concrete.

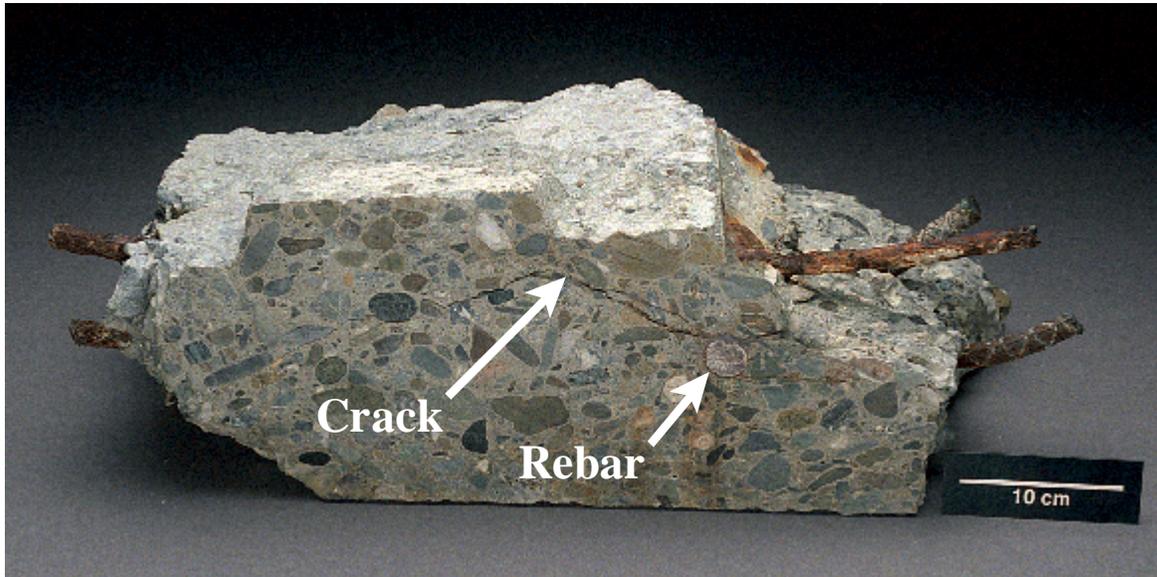
more voluminous corrosion products generate stresses within the concrete that exceed the tensile strength of the concrete (*Allan, 1995*). The resultant cracking of the concrete exposes rebar to additional paths for chloride penetration of the structure that further accelerate corrosion. These processes can lead to massive spalling of cover concrete and further exposure of the underlying rebar to the environment. Concrete damaged in this way has been seen on a number of reinforced concrete bridges on the Oregon coast. The cracking seen in Figures 4.5 and 4.6 is a manifestation of these processes.

Figure 4.5: Deck cross-section showing cracks radiating from rebar.

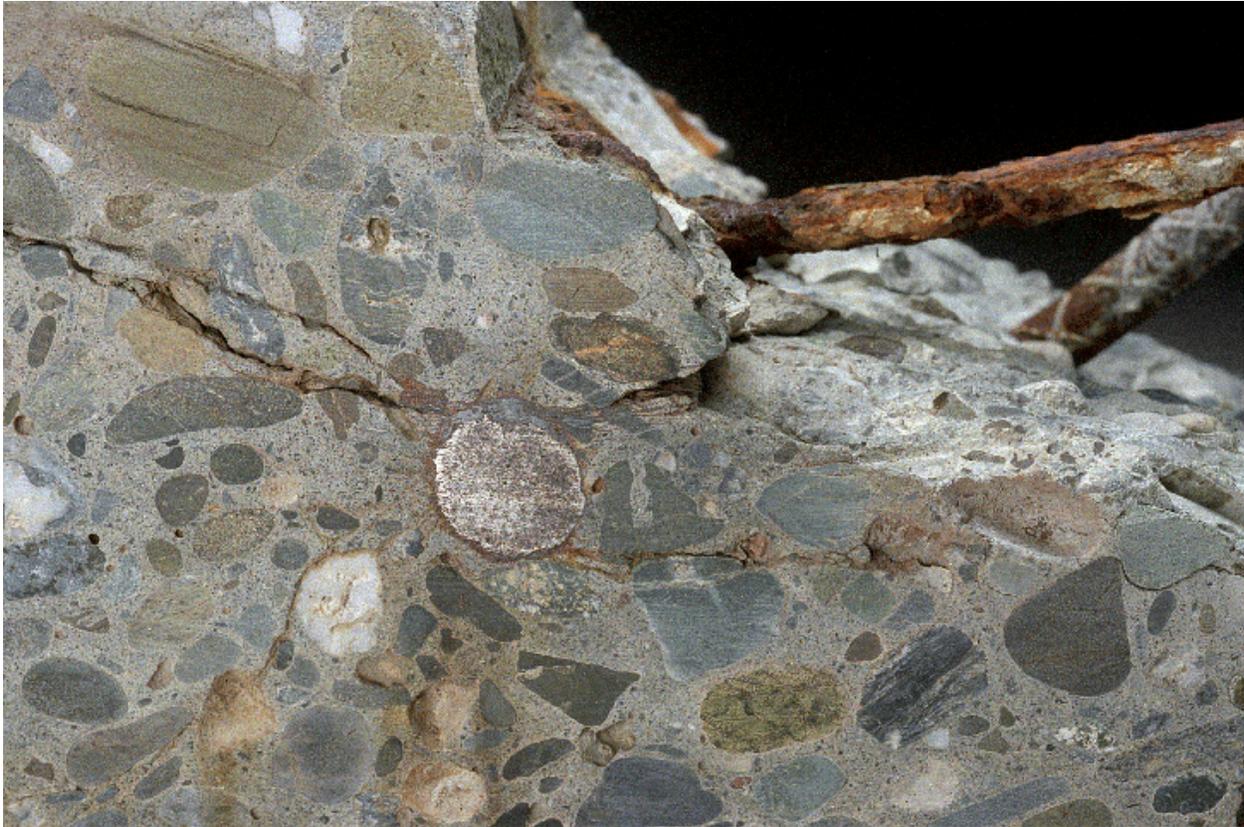
Figure 4.6: Close-up of deck cross-section showing cracks radiating from rebar.

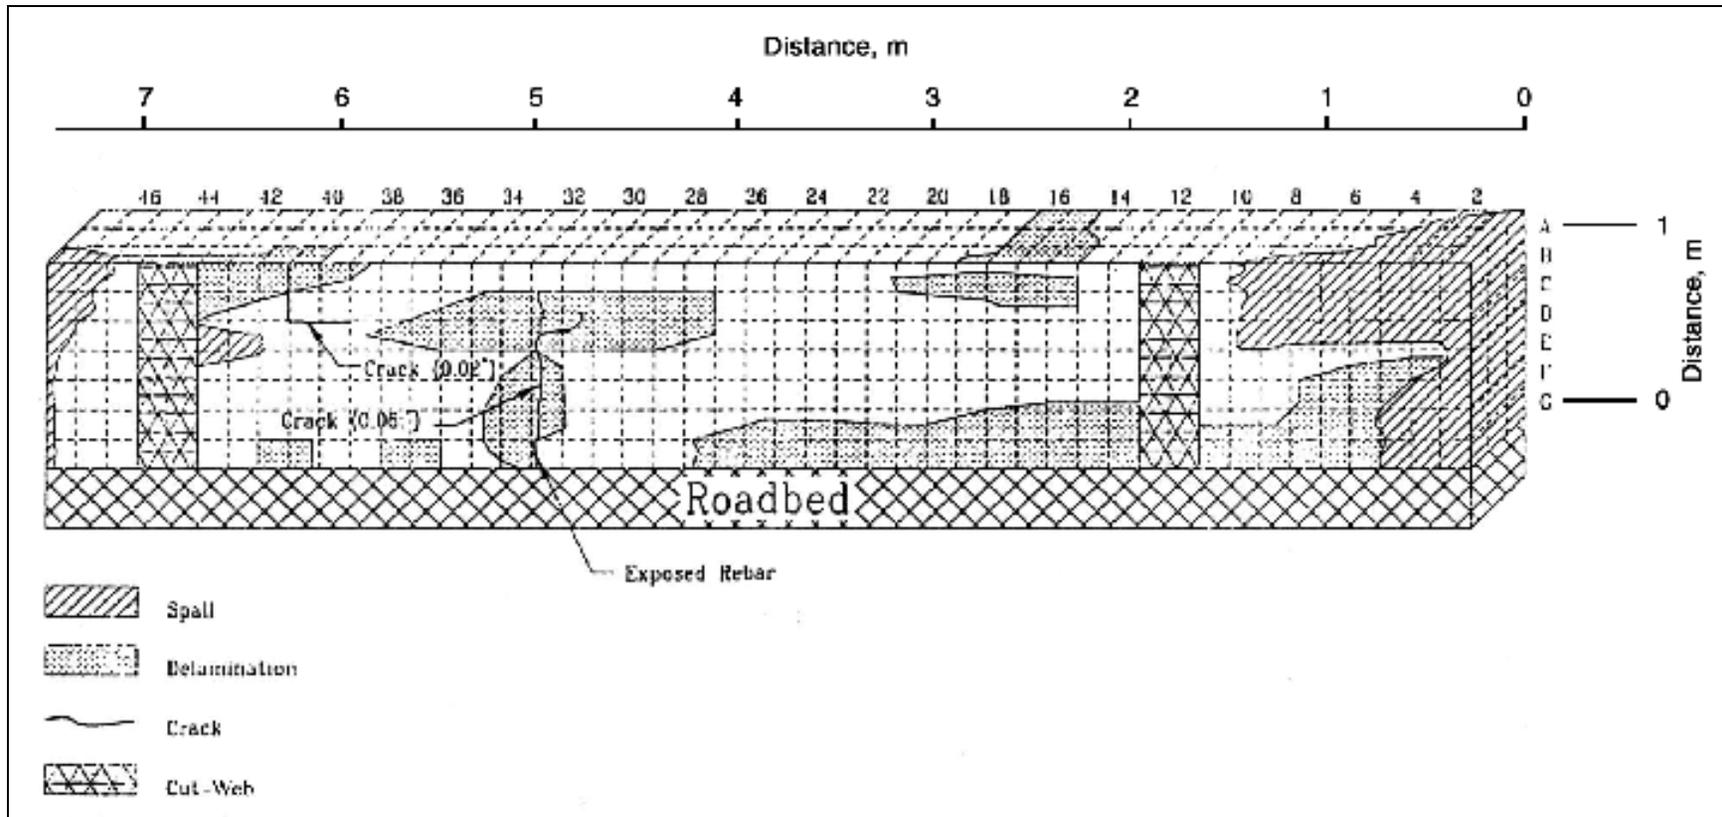
Cracks, delaminations, and spalls in the beam are schematically shown in Figures 4.7 through 4.10. These are the features that ultimately led to the replacement of the Rocky Point Viaduct. Once they began to develop, the rebar was increasingly exposed to the corrosive coastal environment and experienced loss of section at an accelerating rate, weakening the structure.

Figure 4.7: Schematic of section 1, east face, showing visual inspection and delamination survey results.

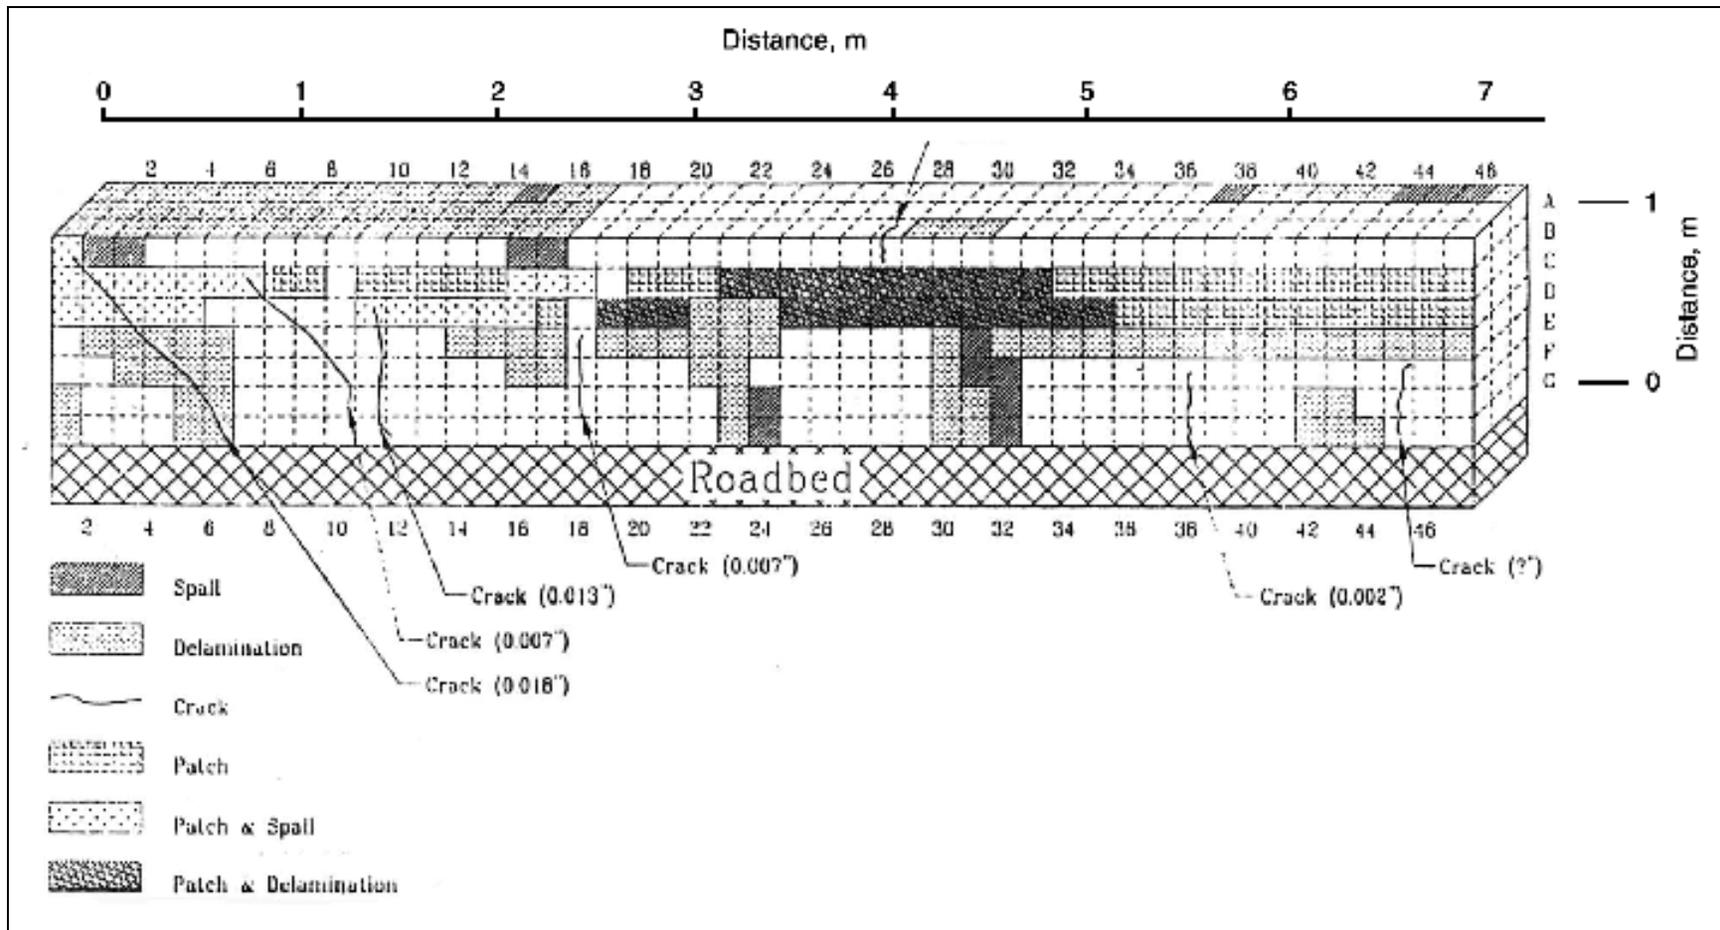
Figure 4.8: Schematic of section 1, west face, showing visual inspection and delamination survey results.

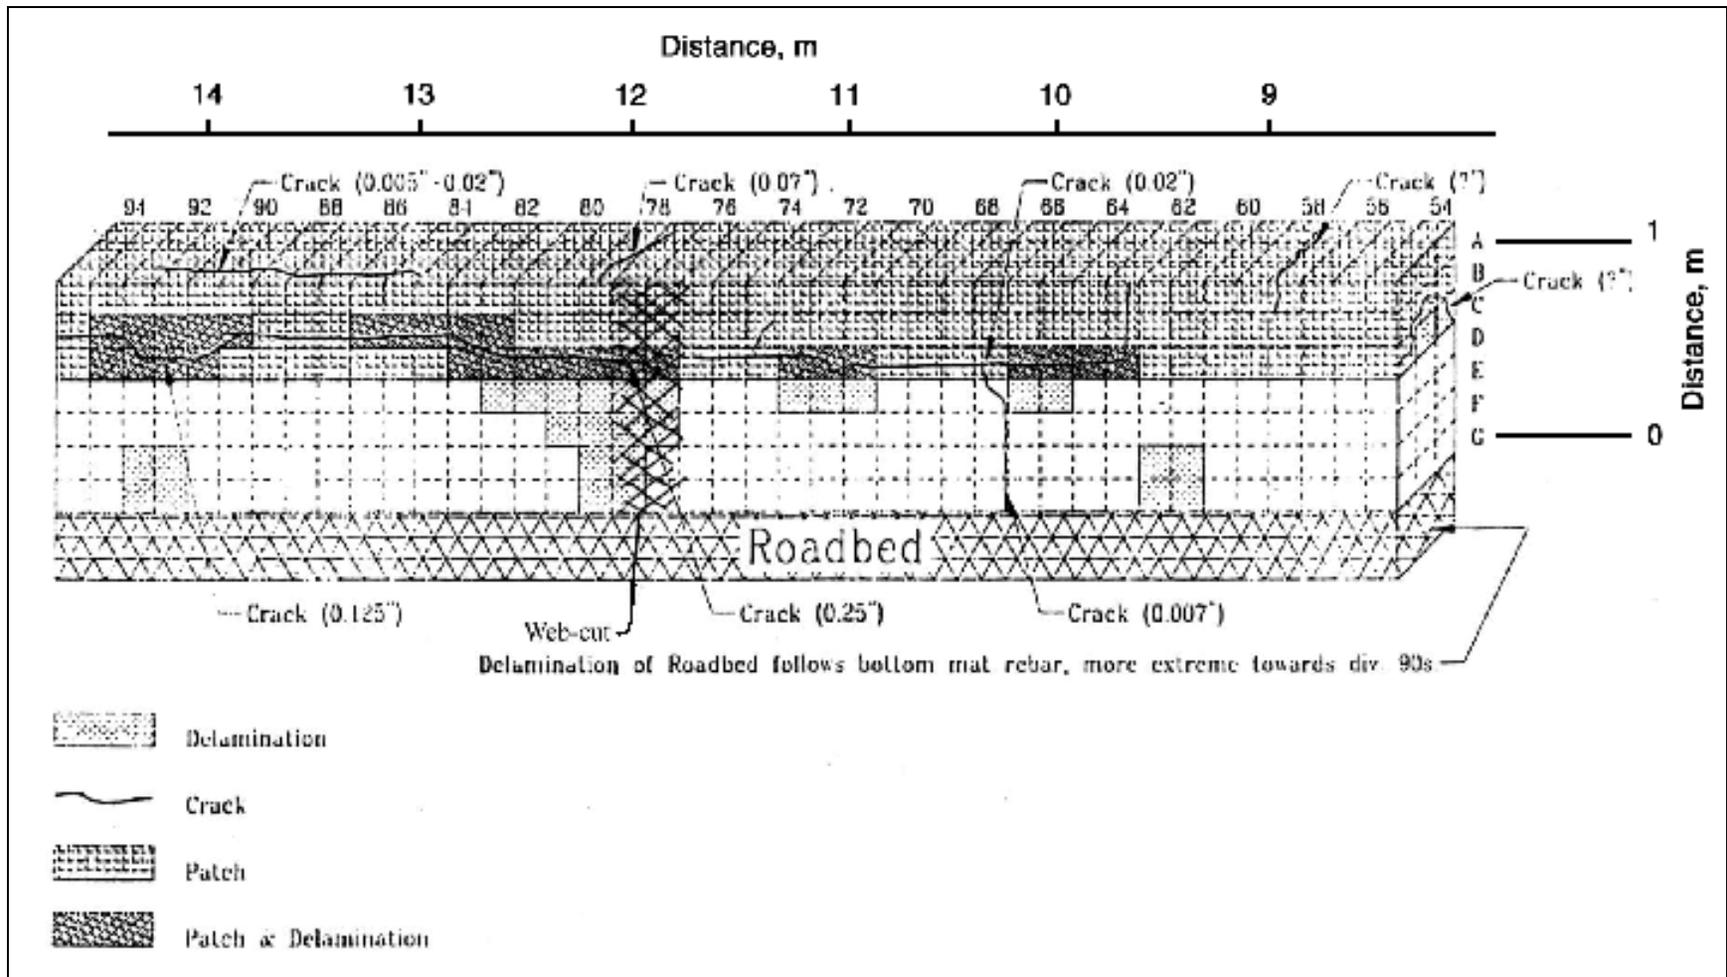
Figure 4.9: Schematic of section 2, east face, showing visual inspection and delamination survey results.

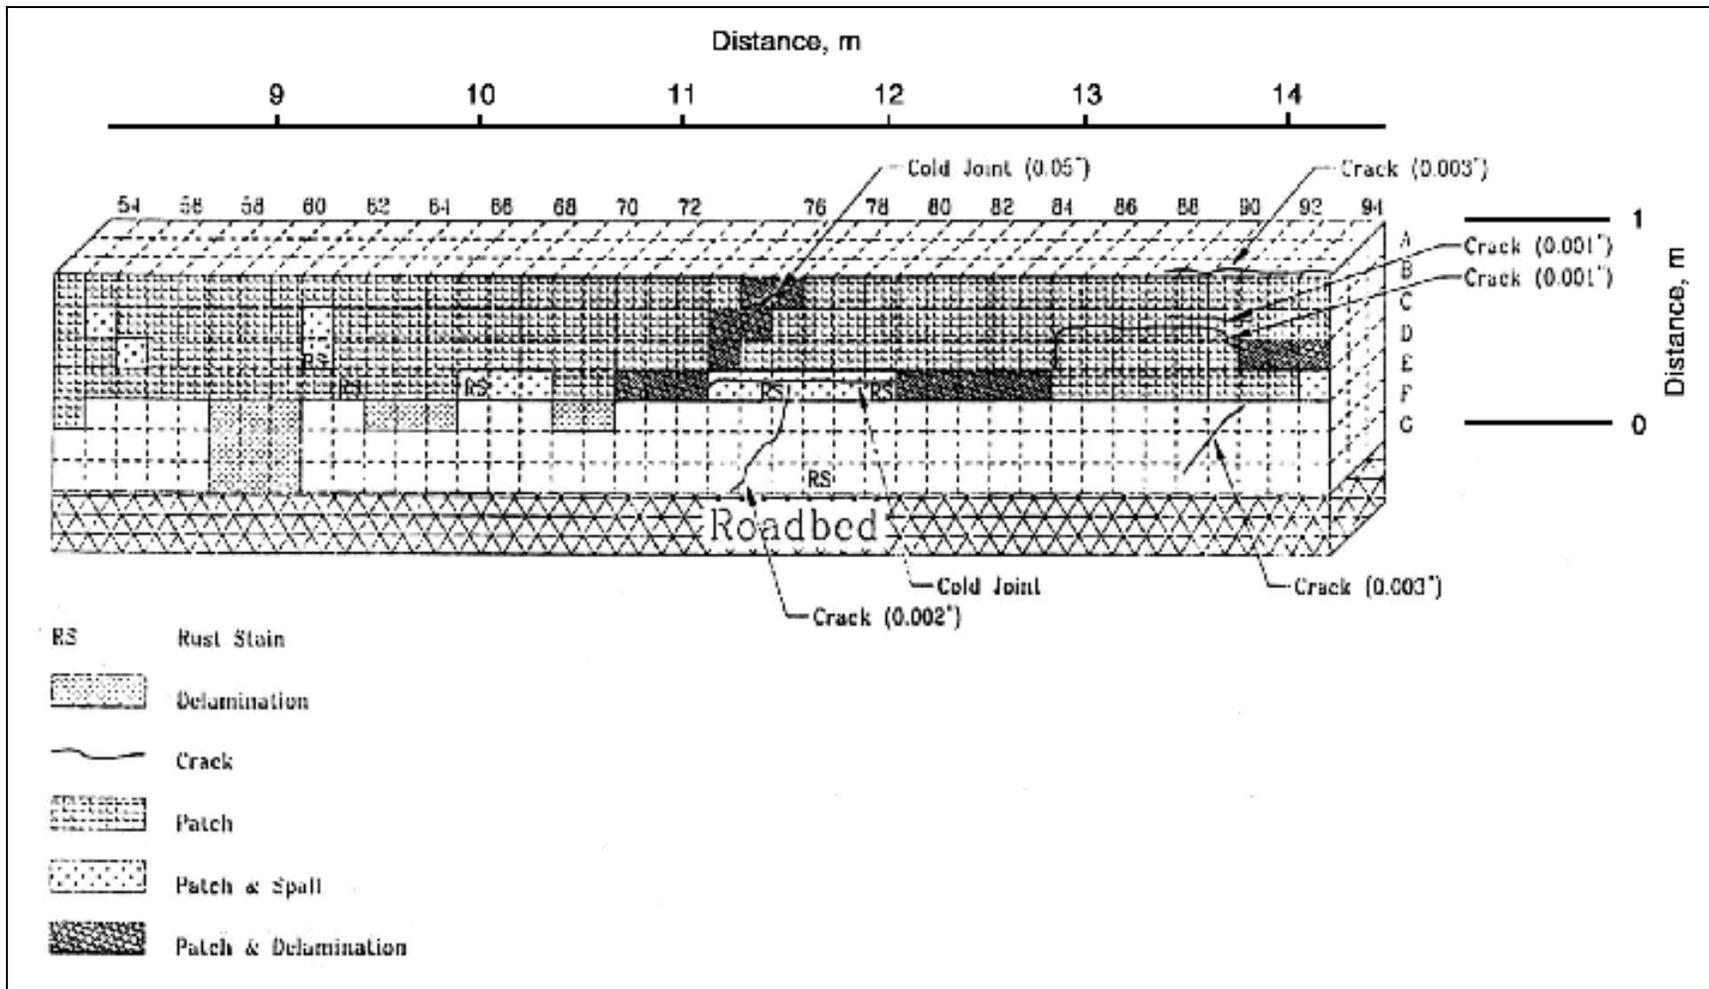
Figure 4.10: Schematic of section 2, west face, showing visual inspection and delamination survey results.
