**EVALUATION OF ROCKY POINT
VIADUCT CONCRETE BEAM**

FINAL REPORT

SPR 381

Oregon Department of Transportation

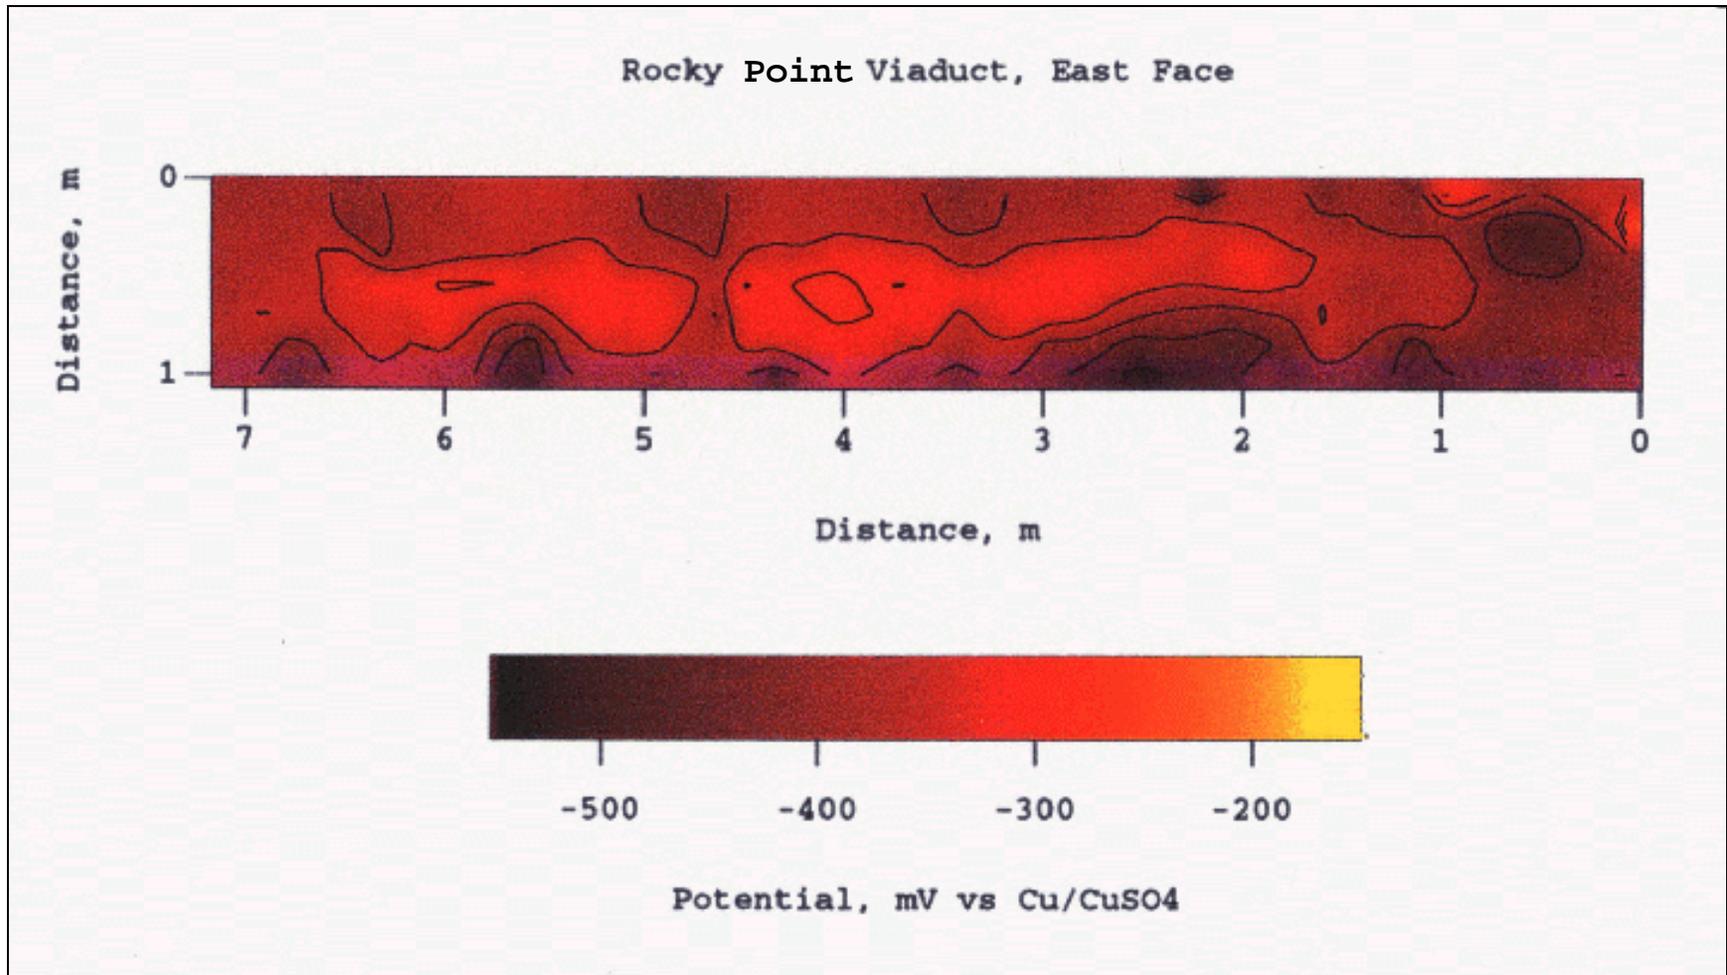
Figure 4.11: Contour map of rebar potential for Section 1 (east face).

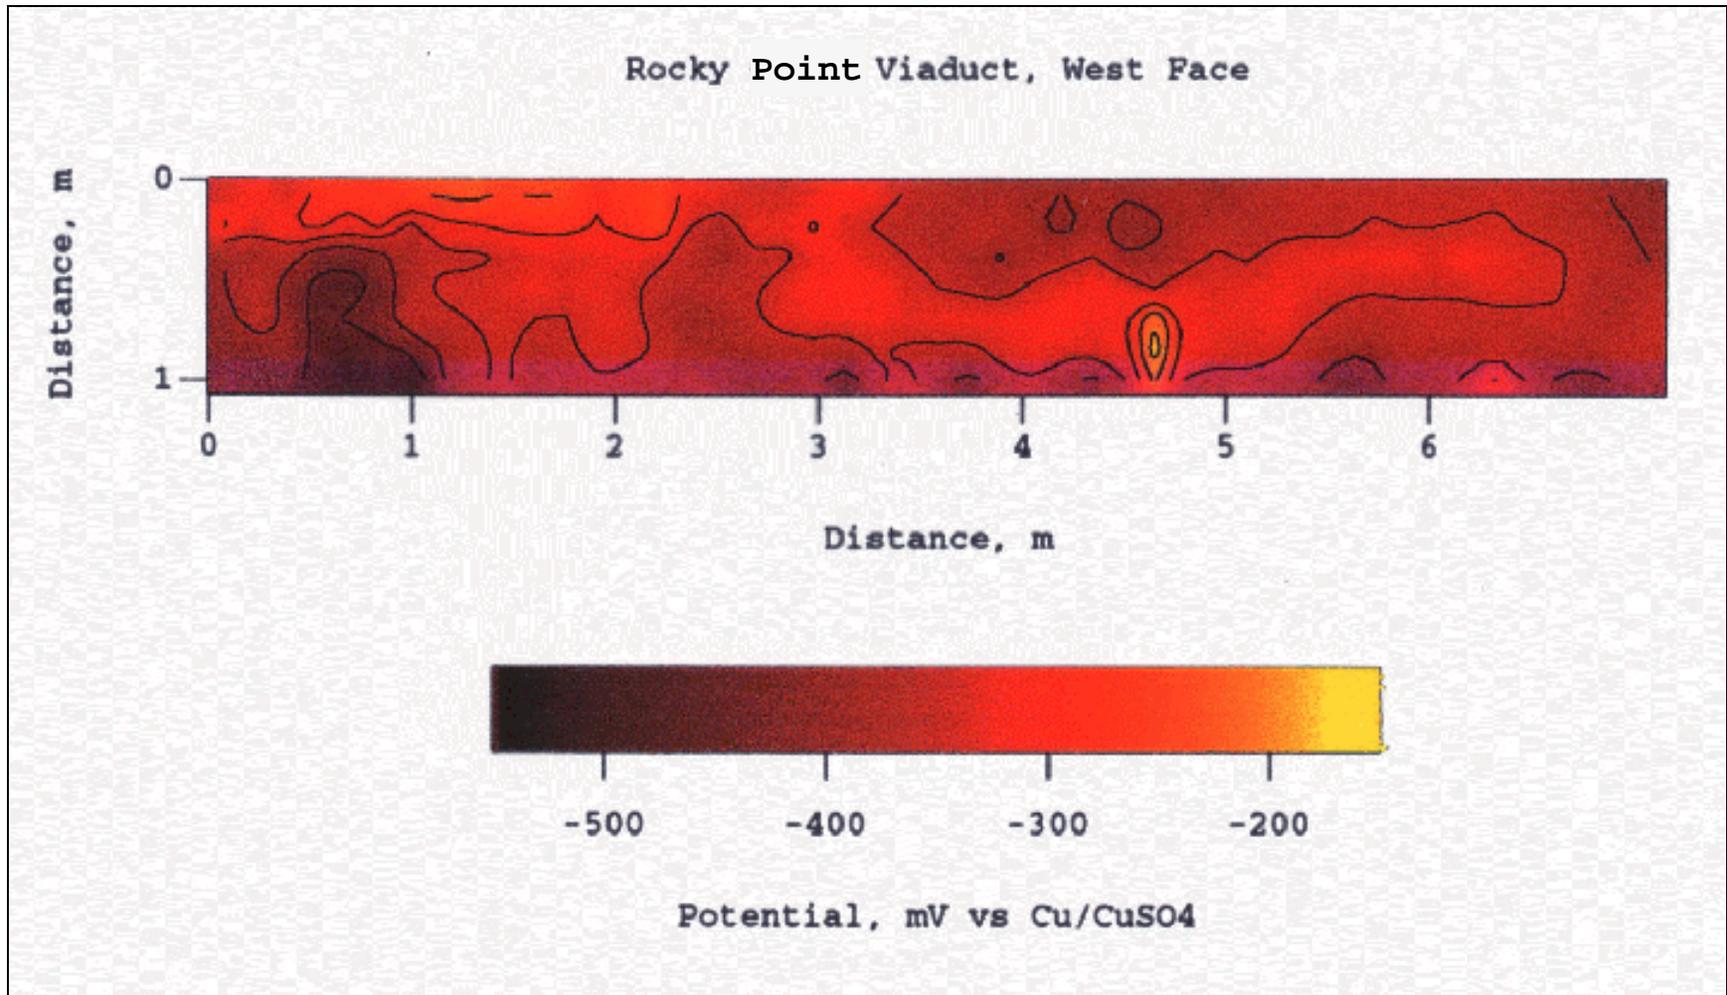
Figure 4.12: Contour map of rebar potential for Section 1 (west face).

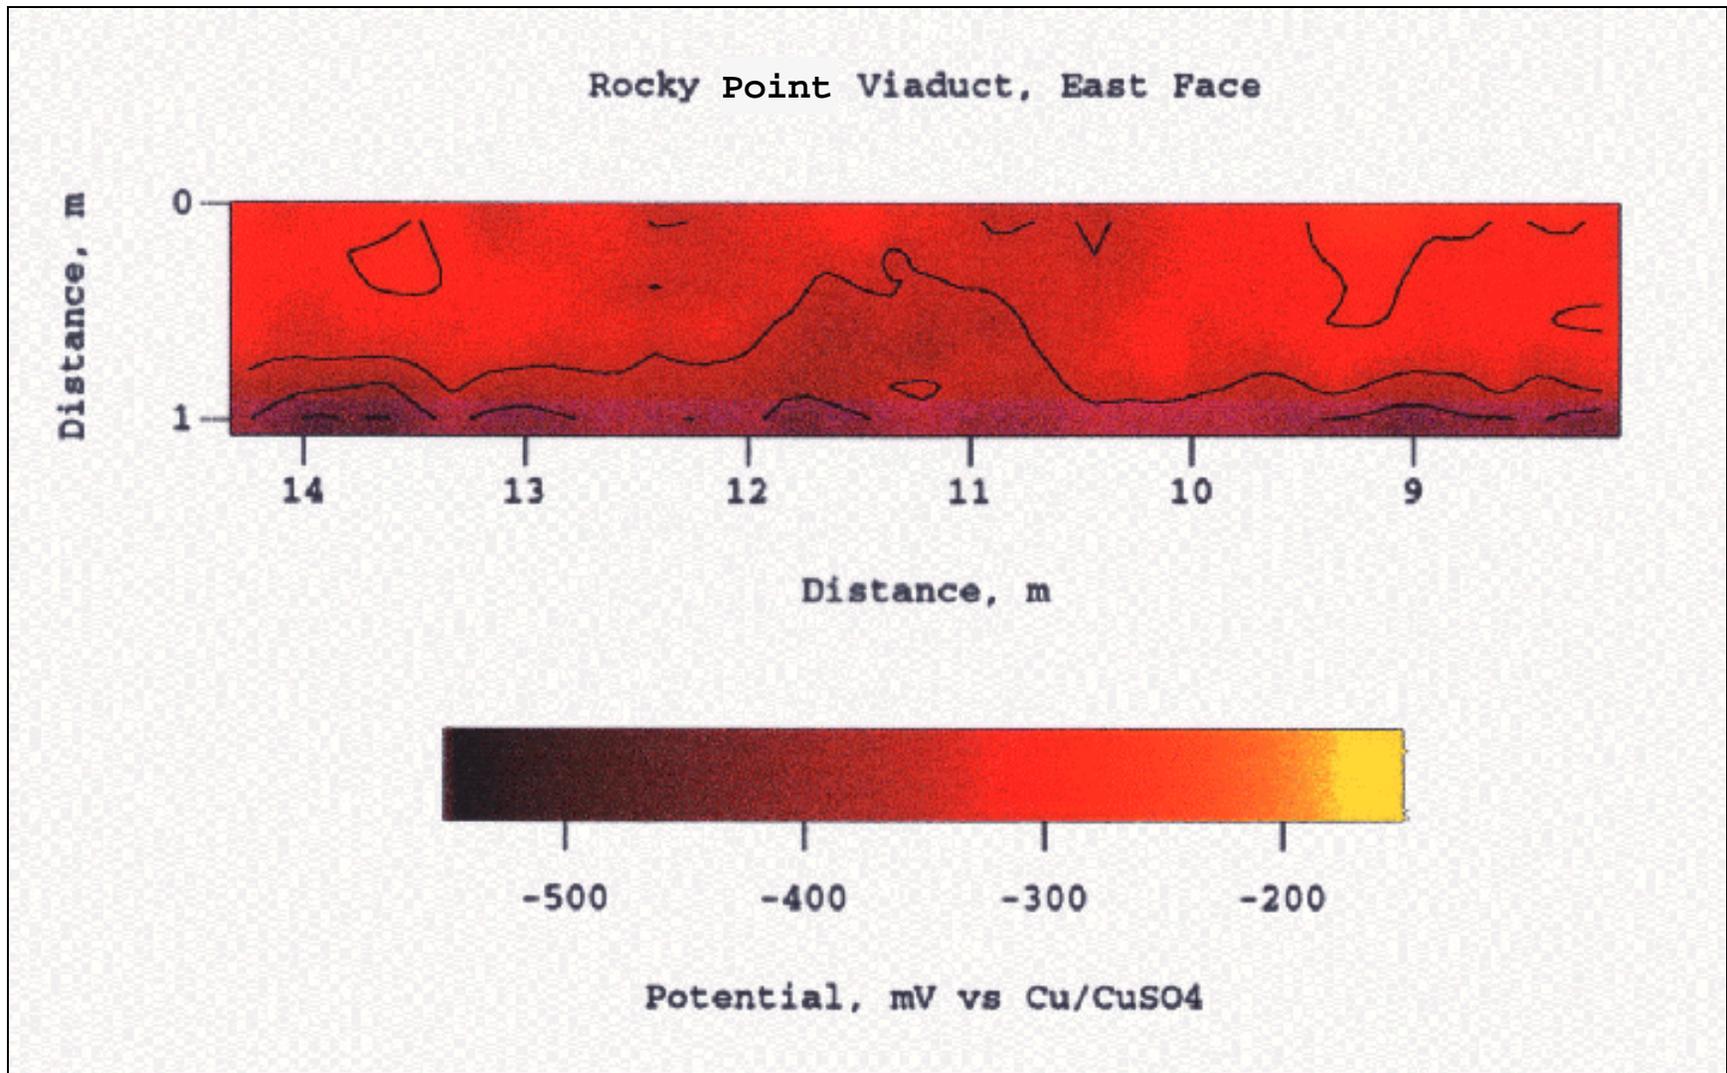
Figure 4.13: Contour map of rebar potential for Section 2 (east face).

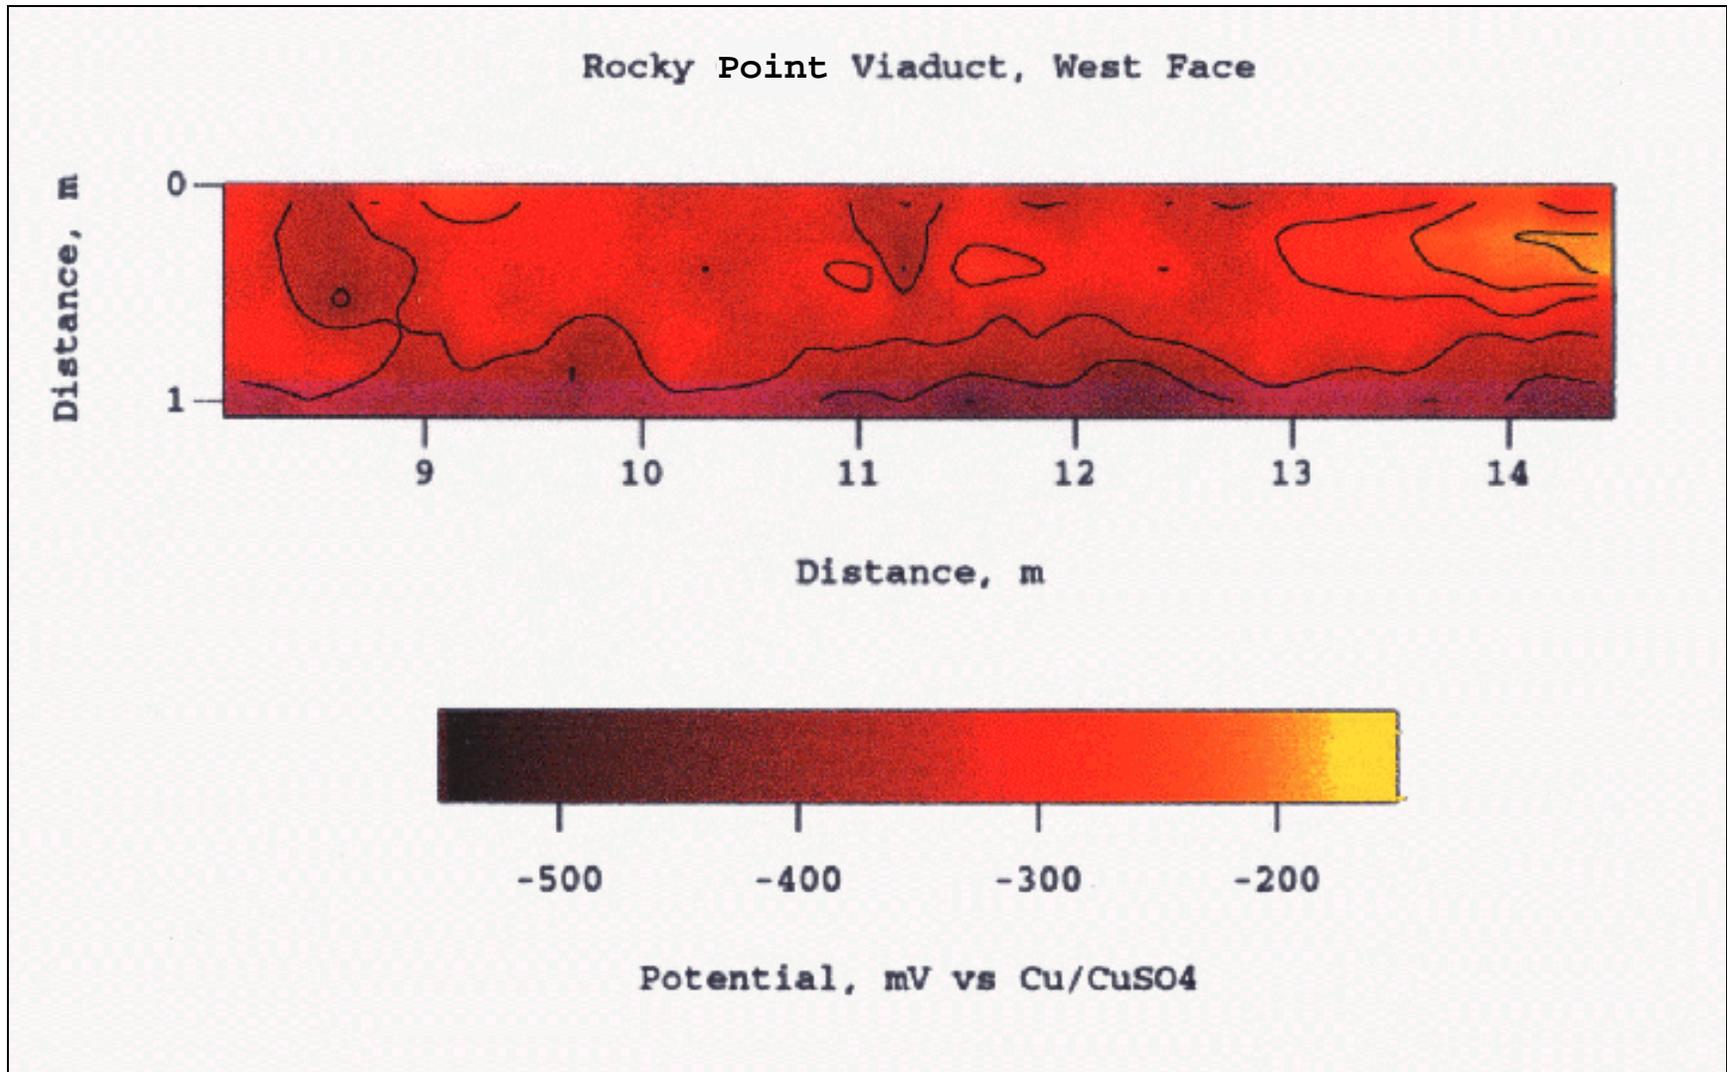
Figure 4.14: Contour map of rebar potential for Section 2 (west face).

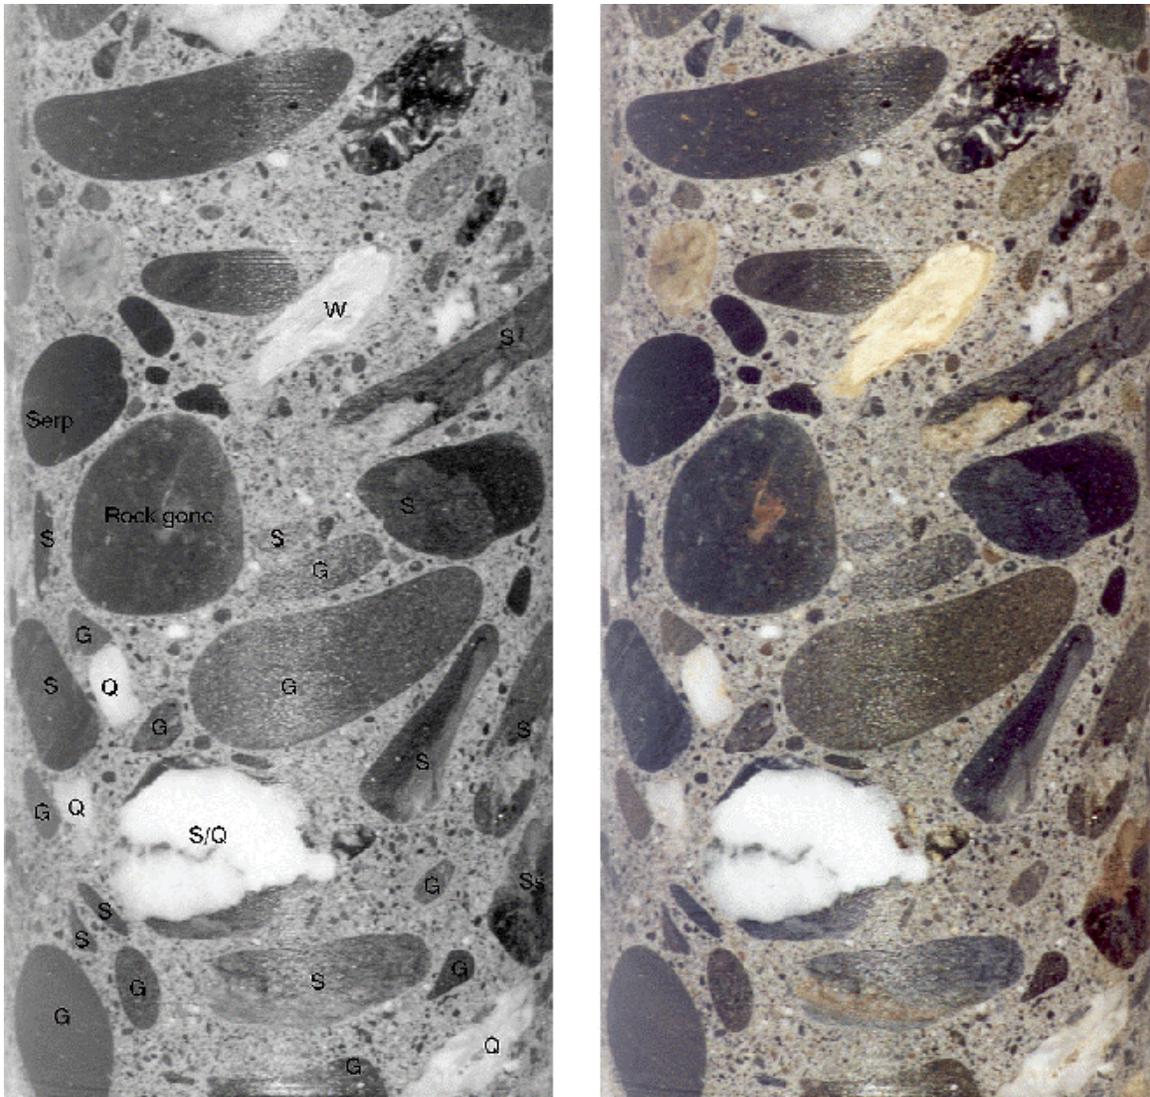
Core 27F-E

Figure 4.15: Coarse aggregate minerals in 3-inch diameter core 27F-E. See Appendix B.2.3 for key to coarse aggregate mineral identification.

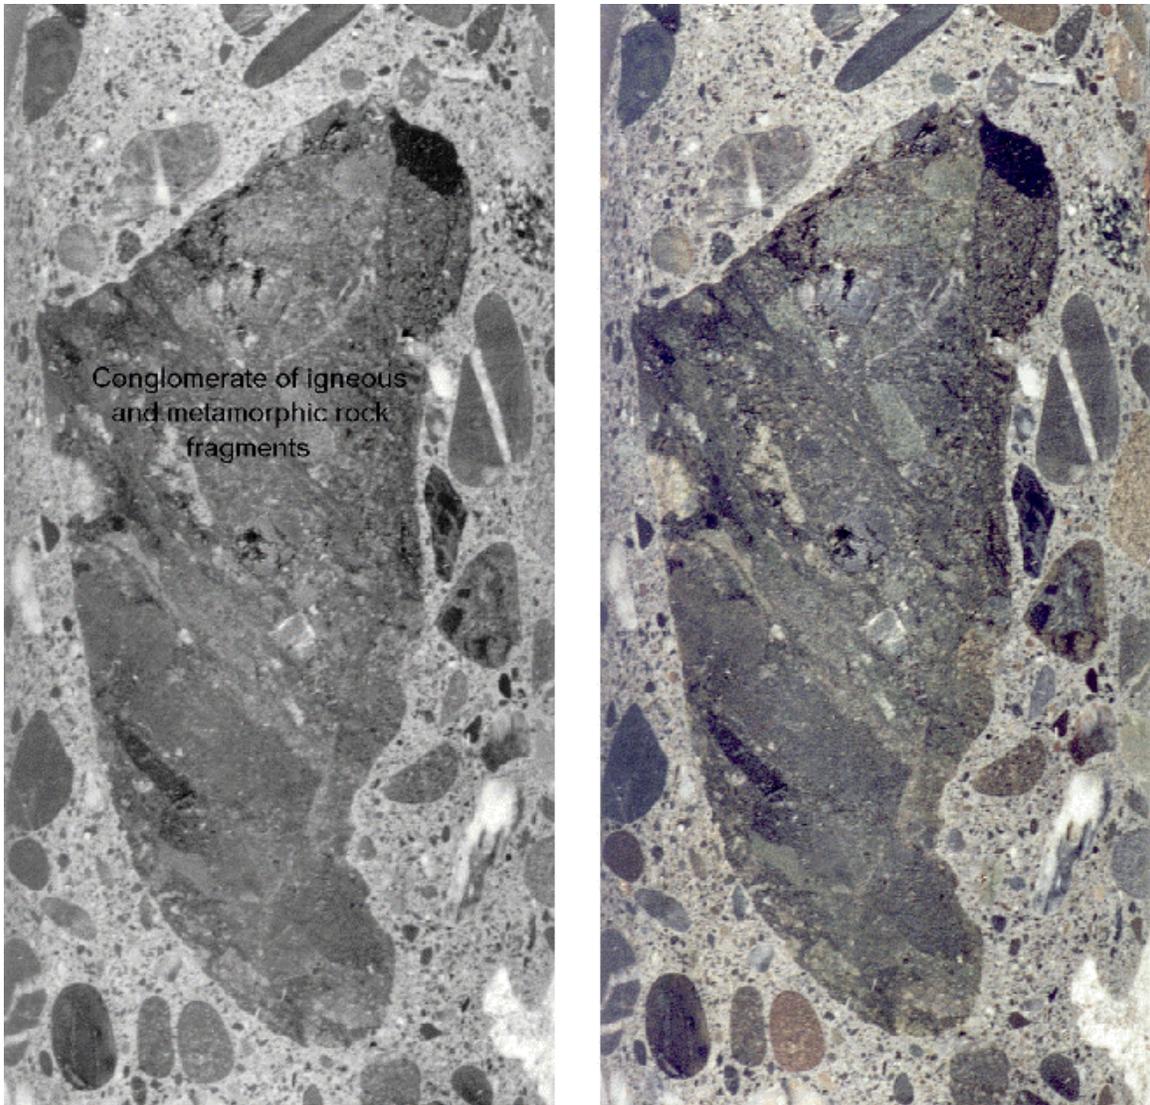
Core 41-E

Figure 4.16: Coarse aggregate minerals in 75 mm (3-inch) diameter core 41E-E. See Appendix B.2.3 for key to coarse aggregate mineral identification.

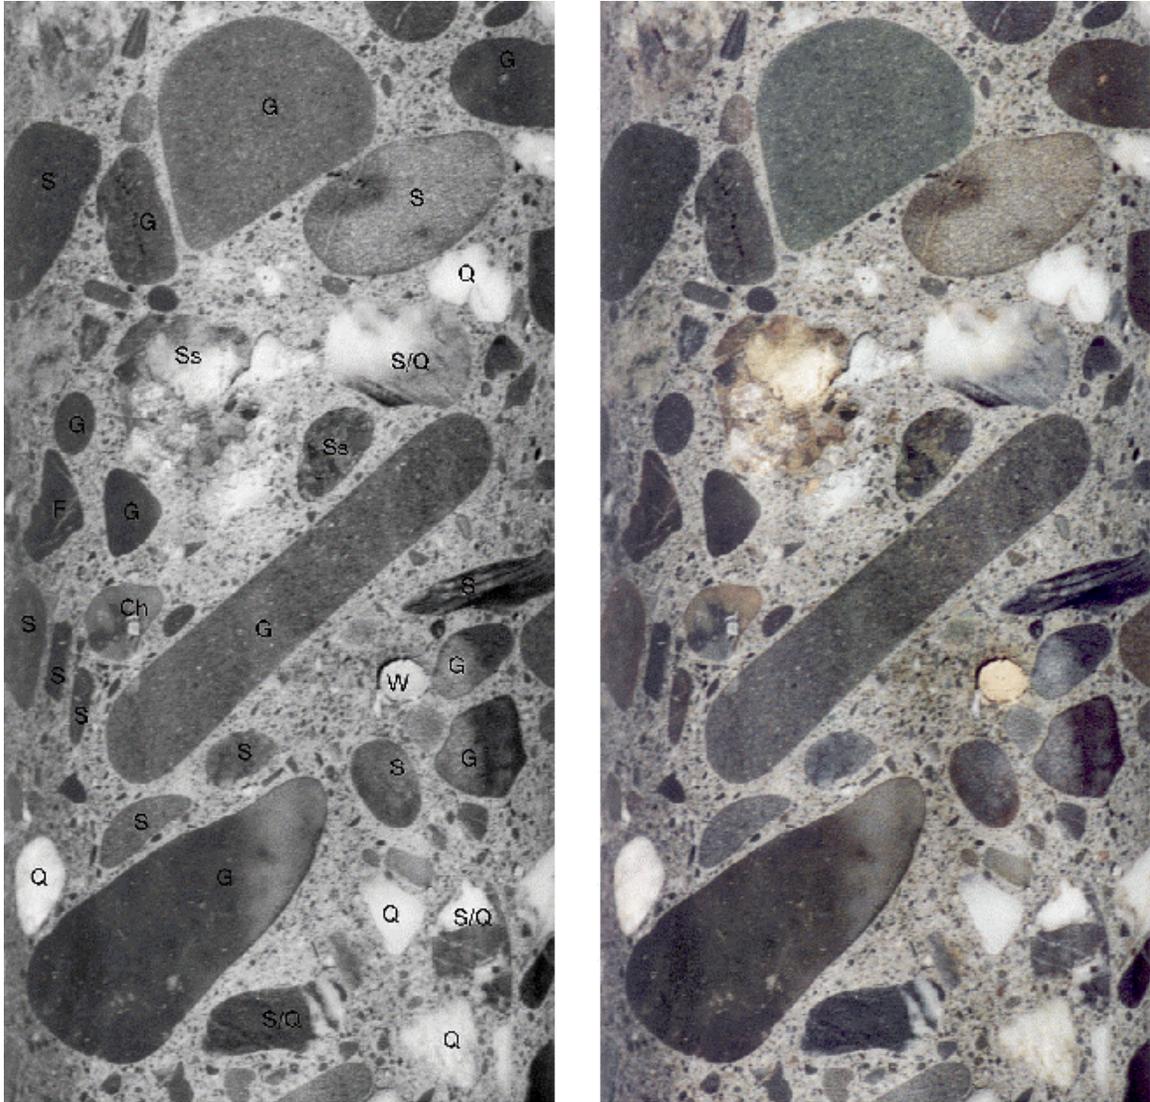
Core 41E-W

Figure 4.17: Coarse aggregate minerals in 75 mm (3-inch) diameter core 41E-W. See Appendix B.2.3 for key to coarse aggregate mineral identification.

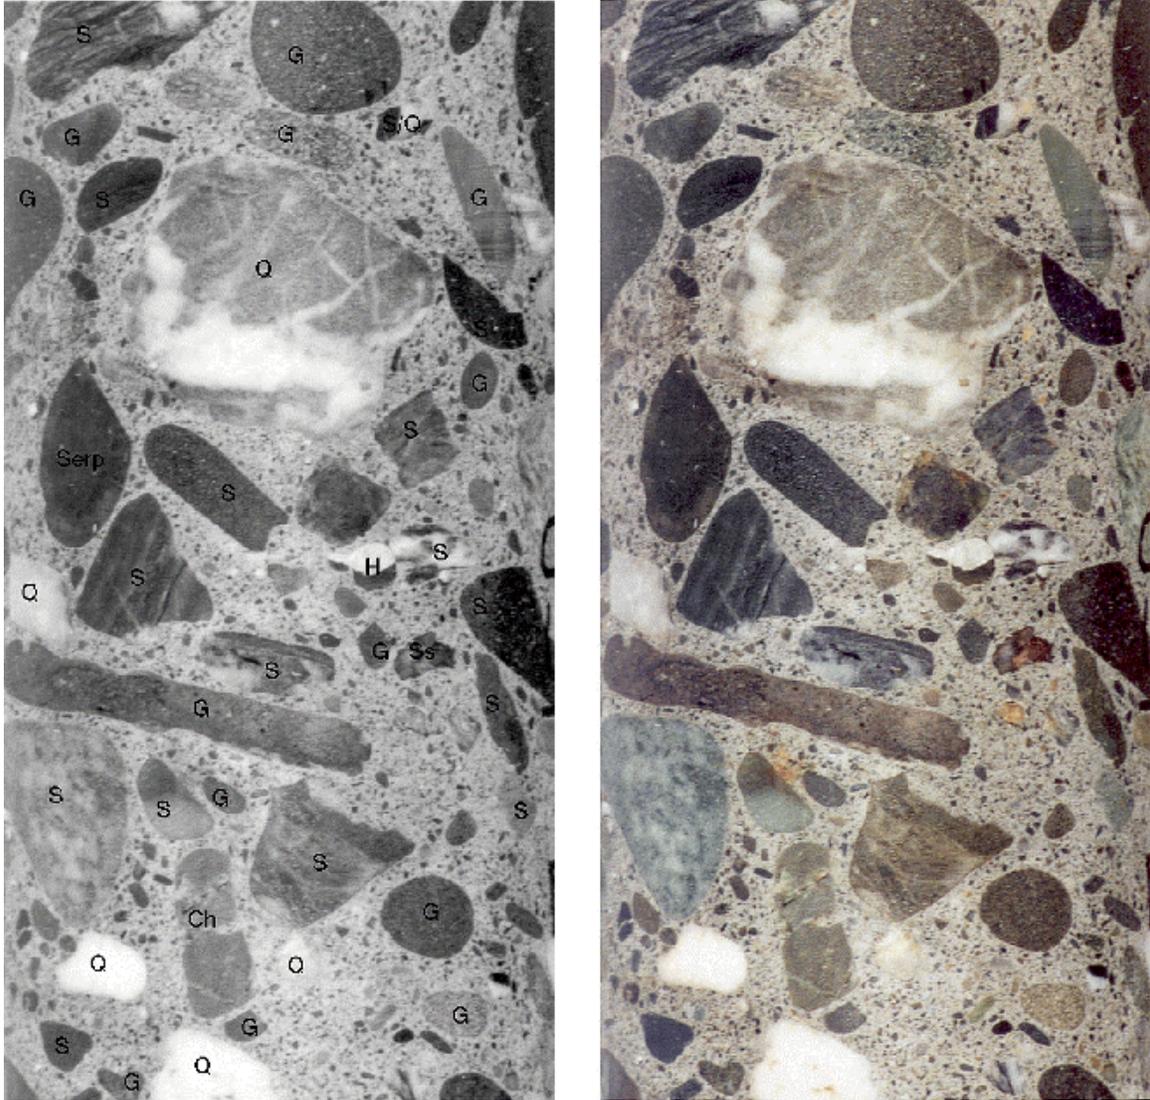
Core 63F-E

Figure 4.18: Coarse aggregate minerals in 75 mm (3-inch) diameter core 63F-E. See Appendix B.2.3 for key to coarse aggregate mineral identification.

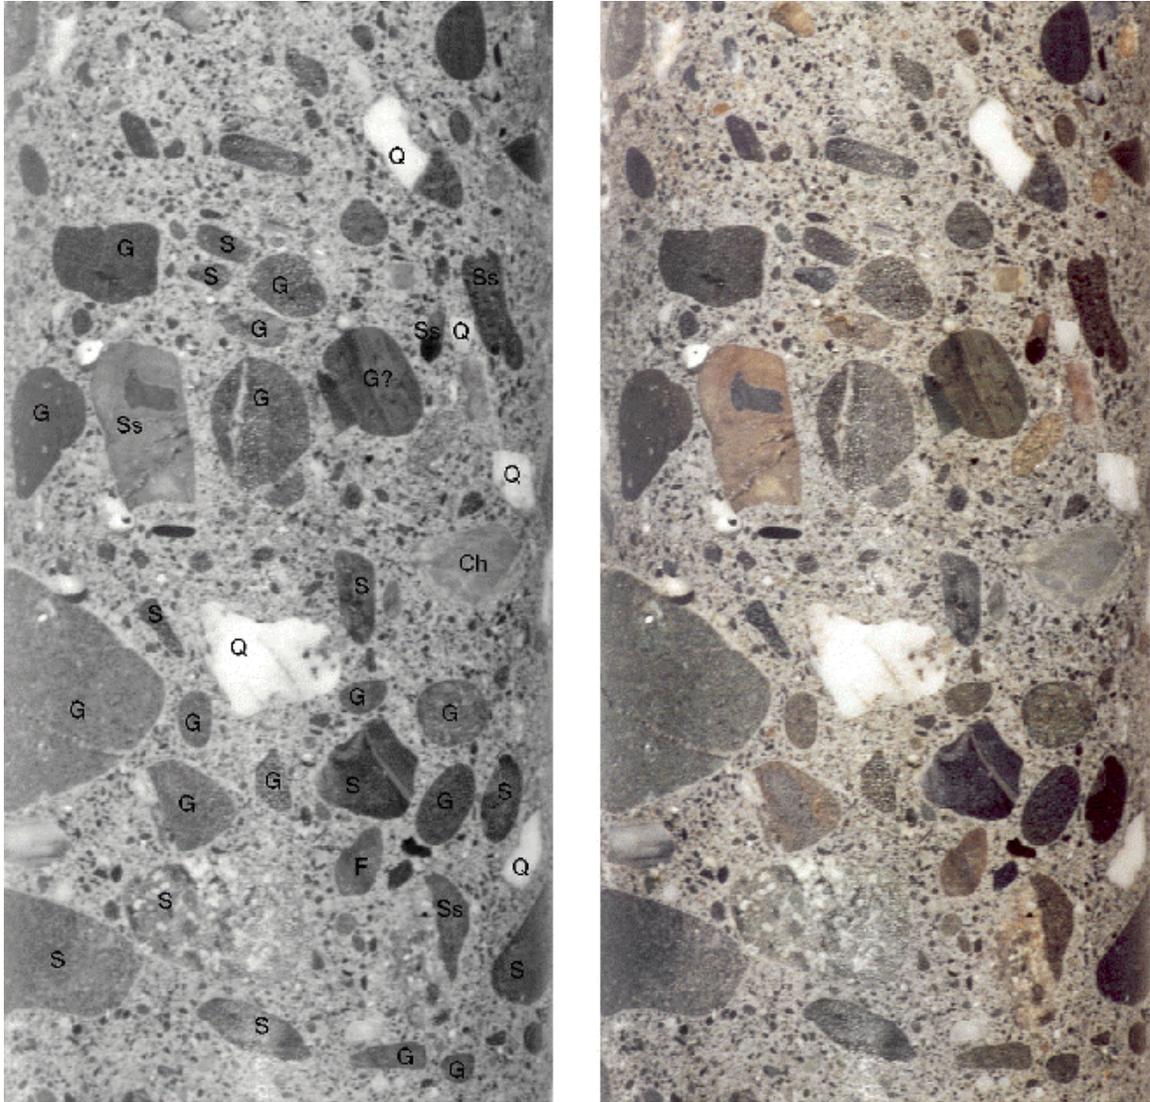
Core 82G-E

Figure 4.19: Coarse aggregate minerals in 75 mm (3-inch) diameter core 82G-E. See Appendix B.2.3 for key to coarse aggregate mineral identification.

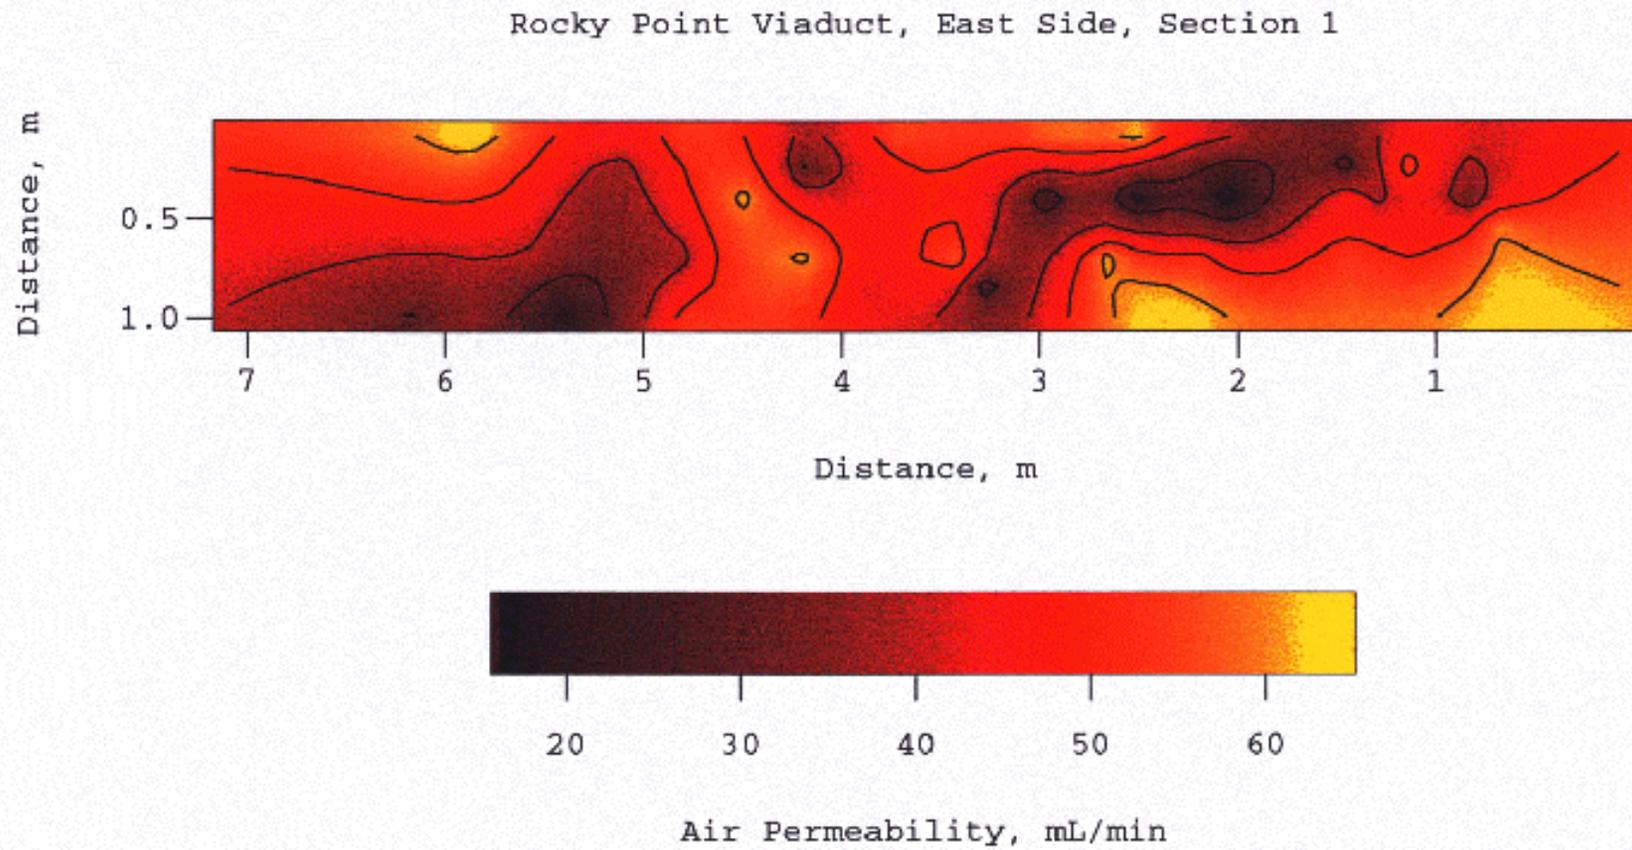
Figure 4.21: Contour map of surface air permeability for Section 1 (east face).

Surface air permeabilities for several other structures on the Oregon Coast were measured in an effort to provide additional meaning to the measurements presented in Fig. 4.21. Bare concrete on Bent 8 and Pier 9 of the Yaquina Bay Bridge (Newport OR) gave values ranging from 14.5 to 17.2 mL/min (0.9 to 1.1 in³/min). Measurements on a 2-year old thermal-sprayed zinc anode installed as part of an ICCP system on the Yaquina Bay Bridge south approach gave values ranging from 42.8 to 50.0 mL/min (2.6 to 3.1 in³/min). Measurements on the Cape Creek Bridge (south of Yachats OR) gave measurements ranging from 51.5 to 57.6 mL/min (3.1 to 3.5 in³/min) for bare concrete on a cross brace, and from 55.5 to 56.3 mL/min (about 3.4 in³/min) for a thermal spray zinc anode in use for the past 5 years in an ICCP system. The variability of these field measurements did not allow further refinement of the air permeability data.

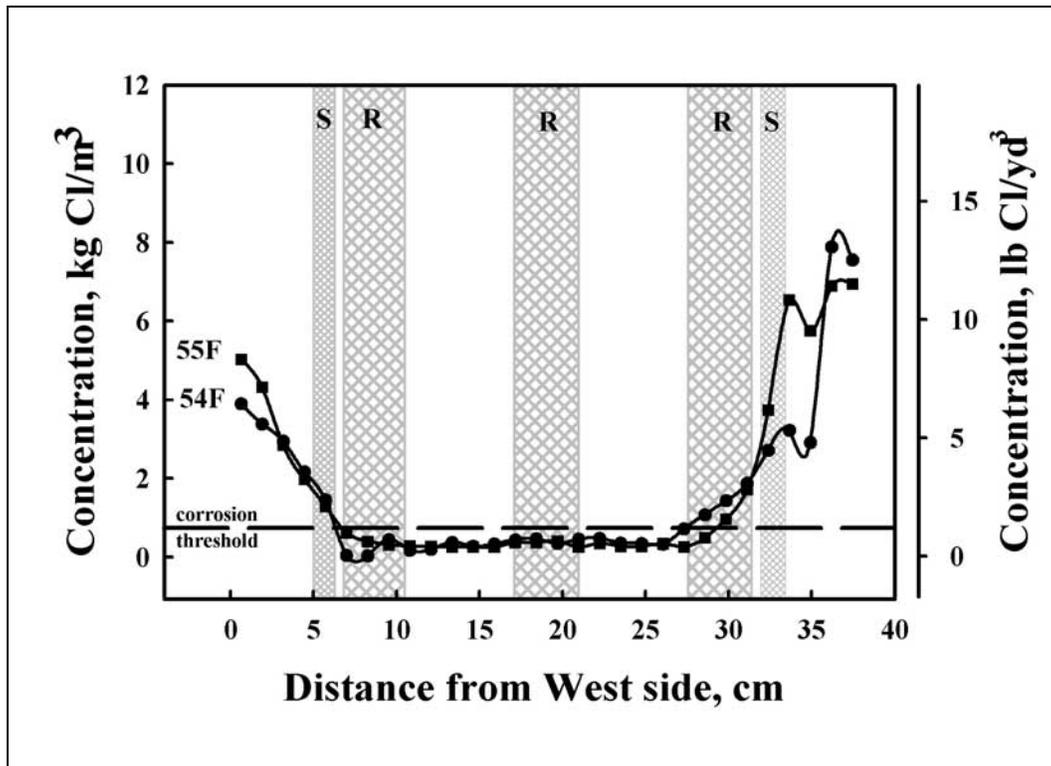
The chloride ion profile results are plotted in Figures 4.22 and 4.23 for original and patch concrete, respectively. The positions of the square rebar (R) and the shear stirrups (S) are included in the figures. Shear stirrups had substantially less concrete cover than the outer course of square rebar. The chloride ion corrosion threshold for black iron bar, 0.74 kg Cl/m³ (1.25 lb Cl/yd³) (McDonald, Pfeifer, and Sherman, 1998), has been drawn on the figures to provide a reference for the initiation of corrosion on the shear stirrups and square rebar. Literature values of the chloride ion corrosion threshold for black iron rebar range from 0.47 to 0.83 kg Cl/m³ (0.8 to 1.4 lb Cl/yd³) of concrete (McDonald, Pfeifer, and Sherman, 1998; Thomas, 1996; West and Hime, 1985).

Figure 4.22: Chloride distribution profiles for original concrete in the “as-received” beam. The average of the profiles is the heavy solid line. West is the ocean facing side of the beam.

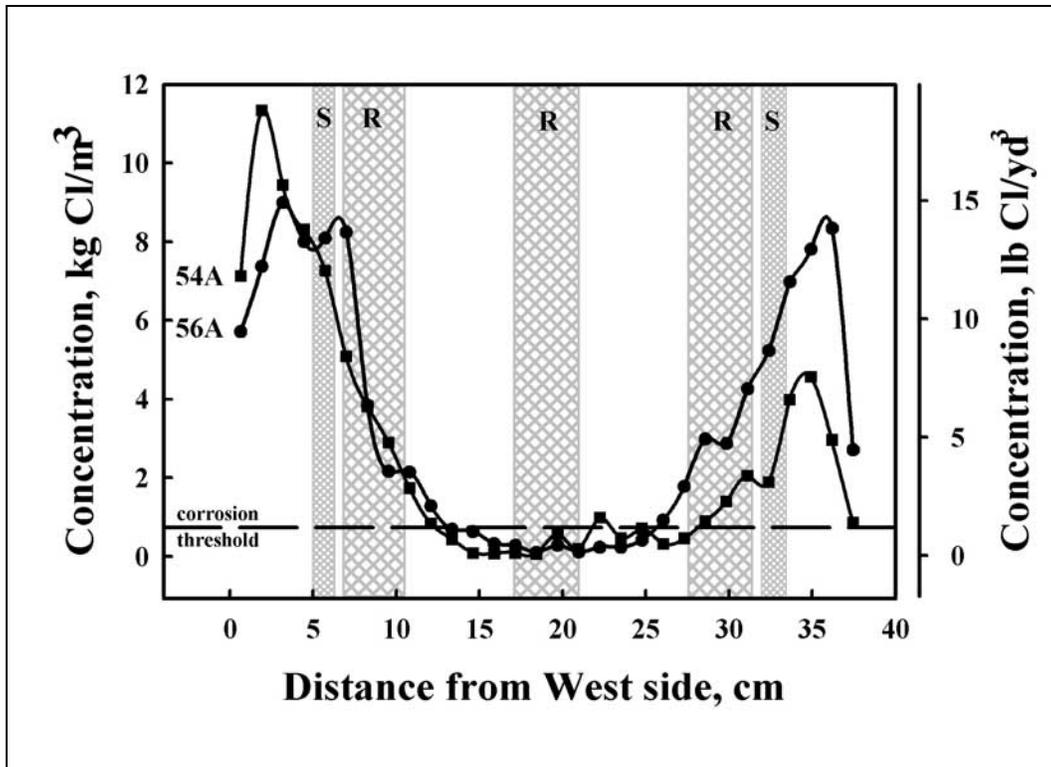
Figure 4.23: Chloride distribution profiles for patch concrete in the “as-received” beam. The average of the profiles is the heavy solid line. West is the ocean facing side of the beam.

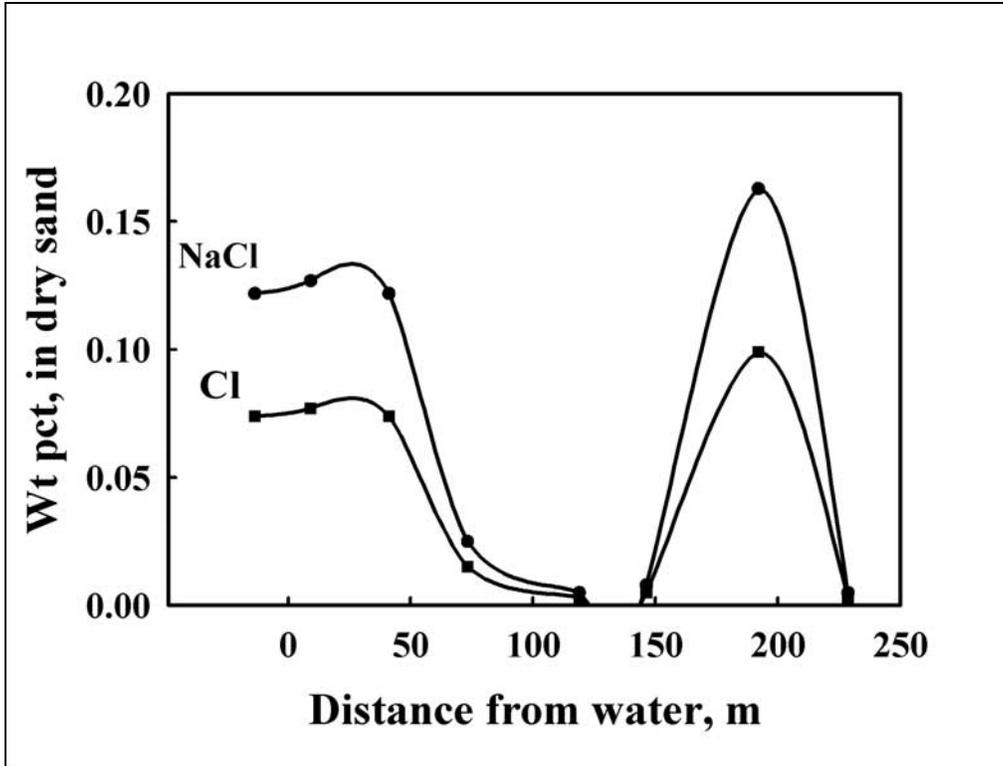
To test this idea, surface samples of sand were removed from the beach north of the Yaquina Bay inlet (at Newport OR) at regular distances from the waterline up to the bluff overlooking the beach. These sand samples were analyzed for total chloride using the same analytical procedure for the concrete powder samples. The results are given in Figure 4.24. They show that 0.1 weight percent sodium chloride is not an unreasonable level to find in unwashed beach sand, and unwashed beach sand could very well have been the source of the background level of chloride in the original concrete.

Figure 4.24: Cl and NaCl concentration profiles for surface samples of beach sand from Newport OR.

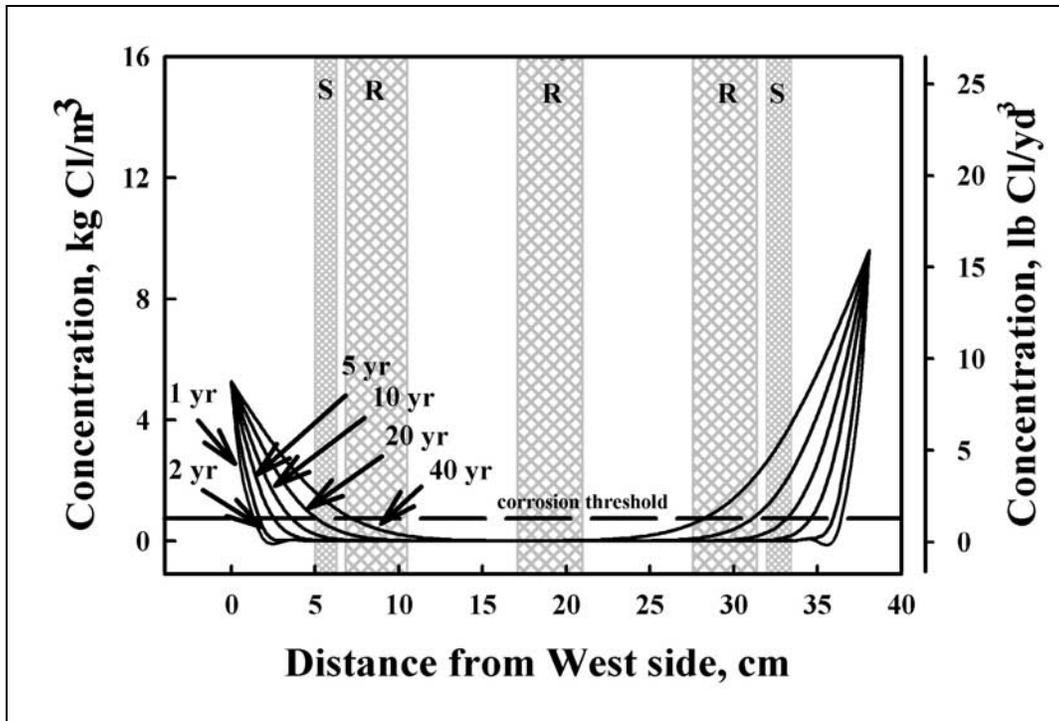
The values for C_o and D given in Table 4.7 were used to compute chloride profiles in original and patch concrete for selected times, Figures 4.25 and 4.26, respectively. The positions of the shear stirrups and square rebar are shown in these figures. Figure 4.25 shows that the shear stirrups were at the corrosion threshold in original concrete after about 14 years on the west side of the beam and about 8 years on the east side. These times clearly could lead to the observed concrete cracking and corrosion damage observed in the 15-year period preceding the 1969 repair and patching. The presence of the background level of chloride in the original concrete may have shortened the time to corrosion initiation, but not by very much. Figure 4.26 shows that the shear stirrups were at the corrosion threshold in patch concrete after about 4 years on the west side of the beam and after about 2 years on the east side. The installation of patch concrete clearly did not significantly extend the service life of the Viaduct by protecting the rebar from exposure to corrosion-inducing chloride ion.

Figure 4.25: Chloride distribution profiles for original concrete as a function of time exposed to the environment. Basis: least-squares fitted parameters in Table 4.6; time zero is 1954. West is the ocean facing side of the beam.

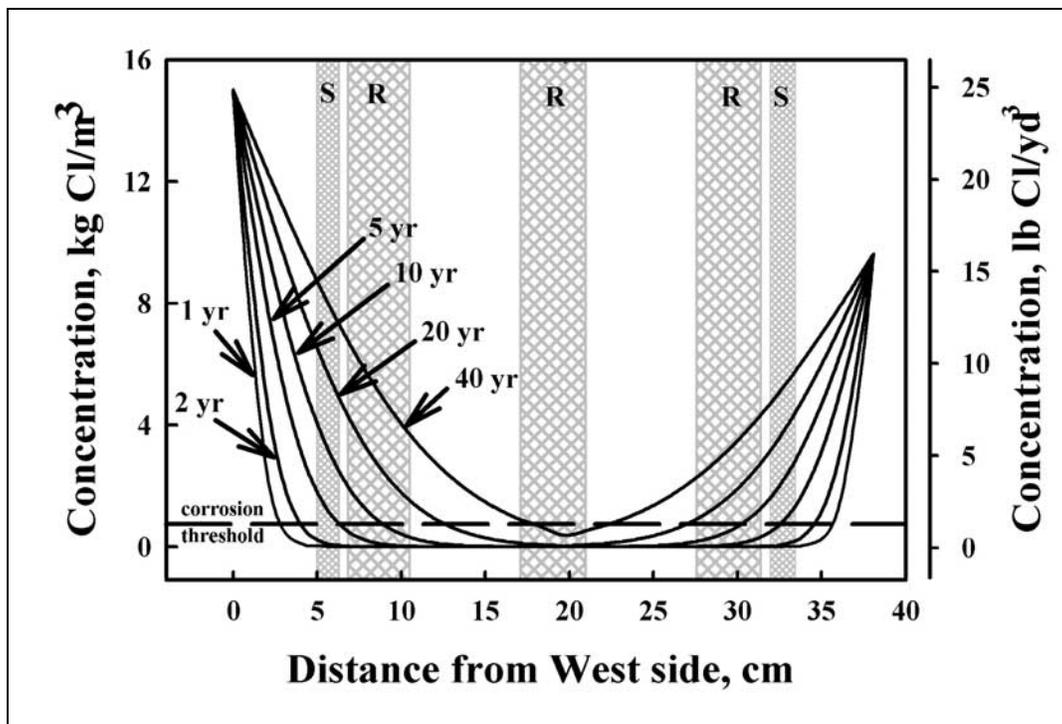
Figure 4.26: Chloride distribution profiles for patch concrete as a function of time exposed to the environment. Basis: least-squares fitted parameters in Table 4.6; time zero is 1969. West is the ocean facing side of the beam.

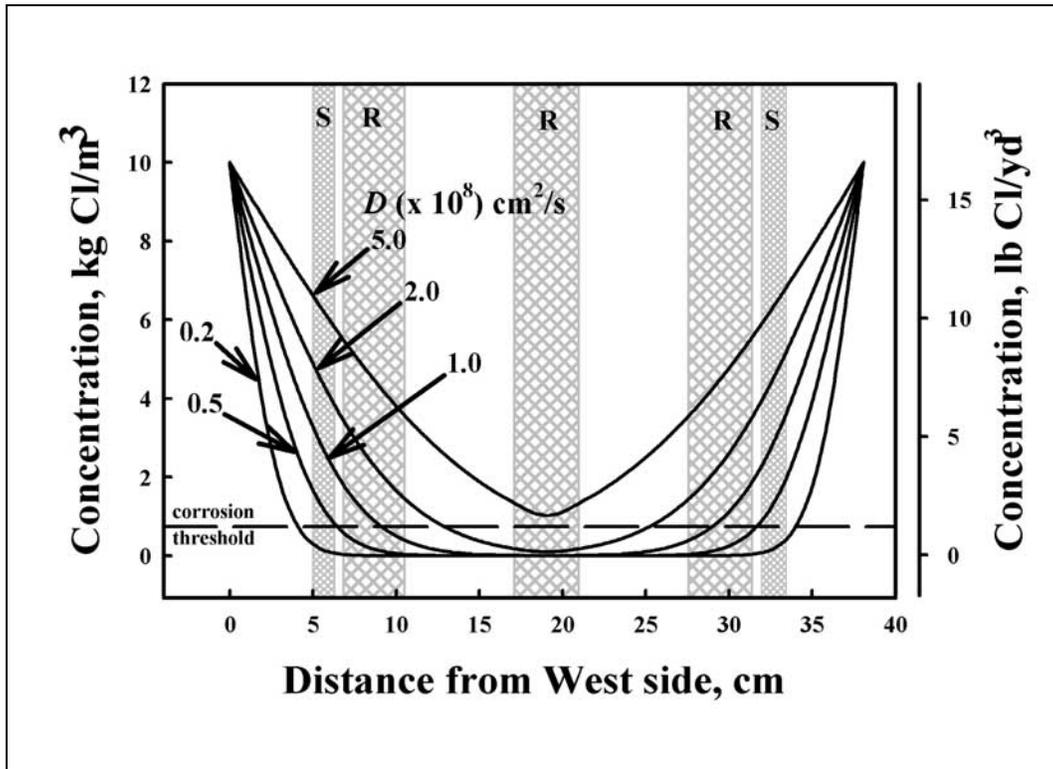
Figure 4.27: Chloride distribution profiles for patch concrete as a function of diffusion coefficient, D . Basis: $t = 40$ years; $C_o = 10 \text{ kg Cl/m}^3$. West is the ocean facing side of the beam.

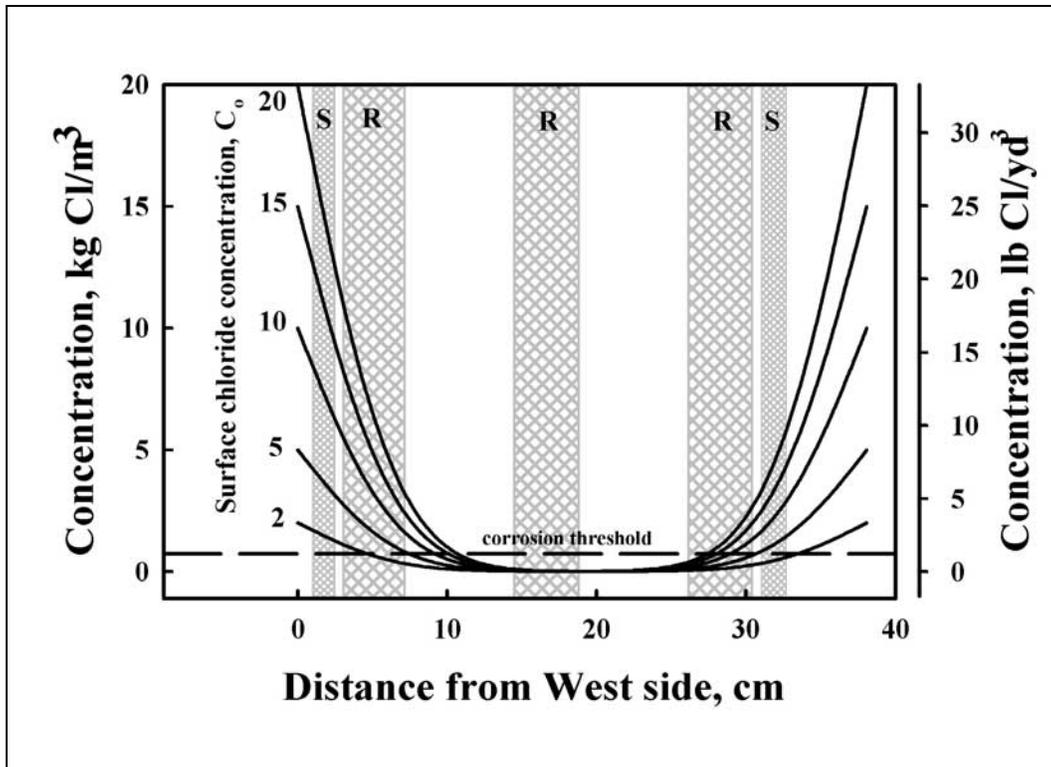
Figure 4.28: Chloride distribution profiles for patch concrete as a function of the surface chloride concentration, C_o . Basis: $t = 40$ years; $D = 10^{-8}$ cm²/s. West is the ocean facing side of the beam.
