**EVALUATION OF ROCKY POINT
VIADUCT CONCRETE BEAM**

FINAL REPORT

SPR 381

Oregon Department of Transportation

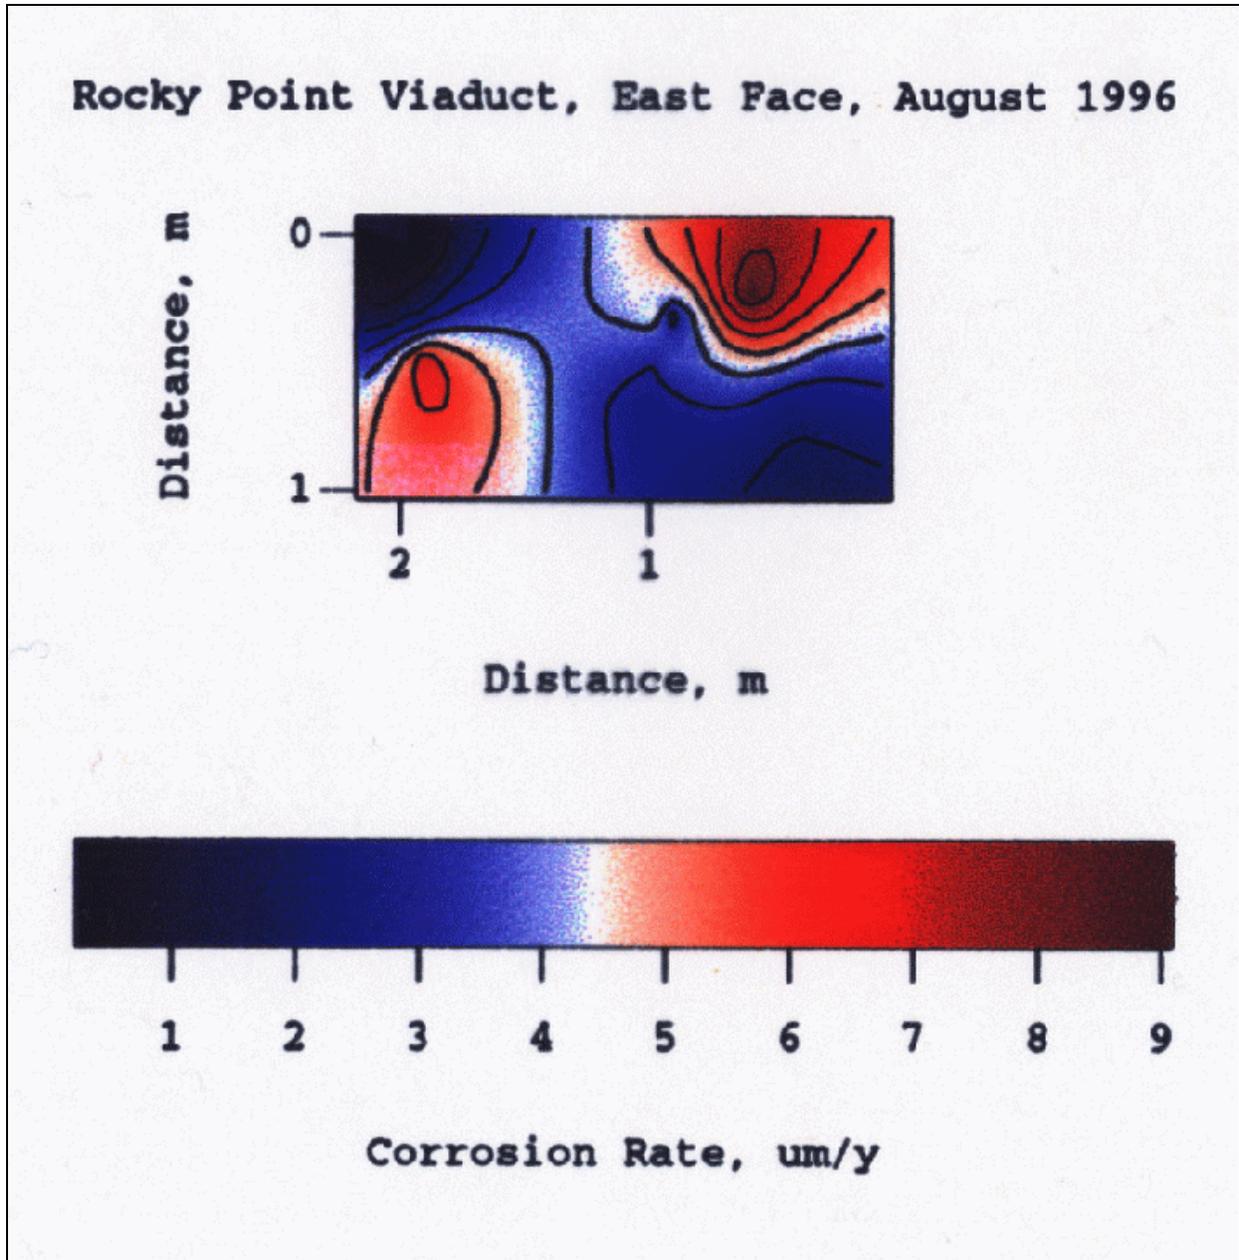
Figure 4.29: Contour map of corrosion rate for Section 1 (east face).

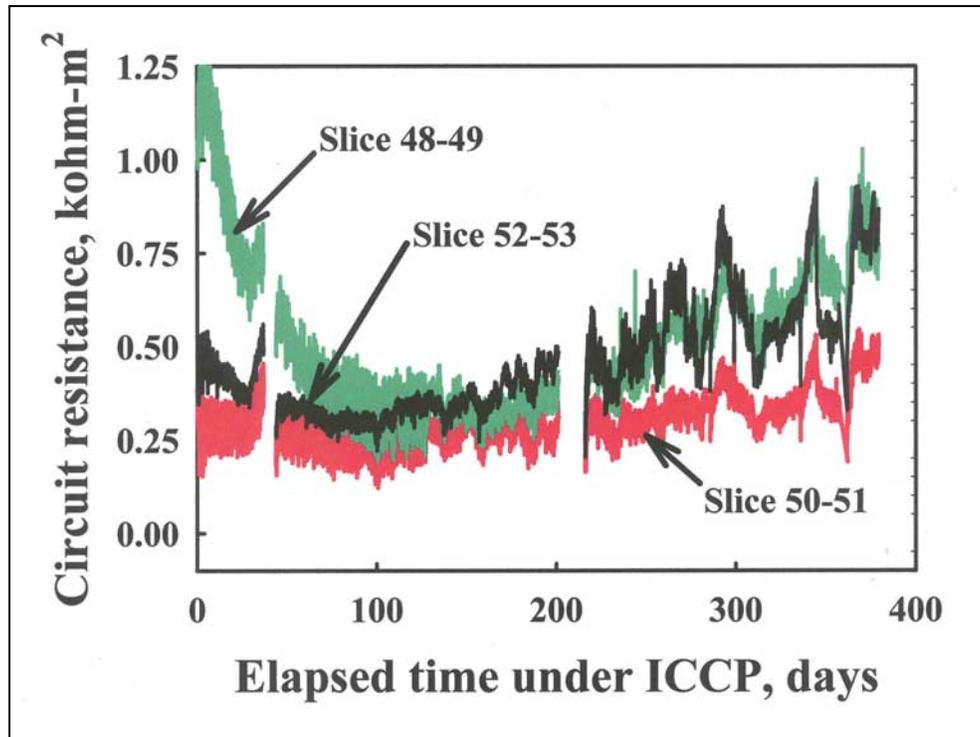
Figure 4.30: Voltage of beam slices as a function of time for ICCP in chloride migration experiment. Anode current density, 20 mA/m² (2 mA/ft²); cathode current density, 33 mA/m² (3 mA/ft²).

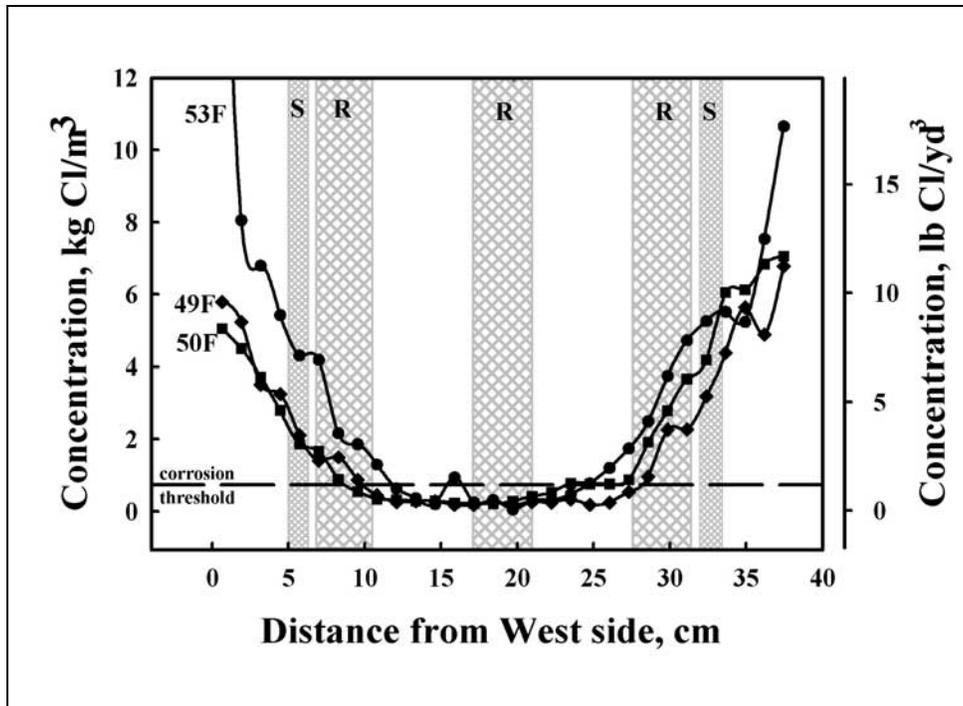
Figure 4.31: Chloride profiles for original concrete showing chloride migration after 0.5 years ICCP. West is the ocean facing side of the beam.

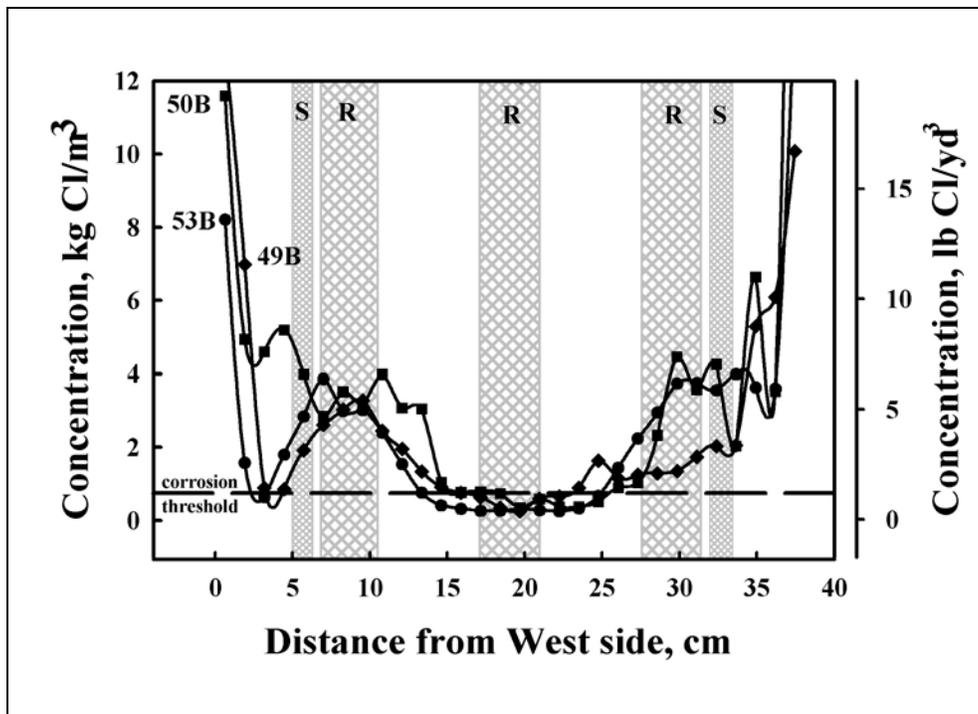
Figure 4.32: Chloride profiles for patch concrete showing chloride migration after 0.5 years ICCP. West is the ocean facing side of the beam.

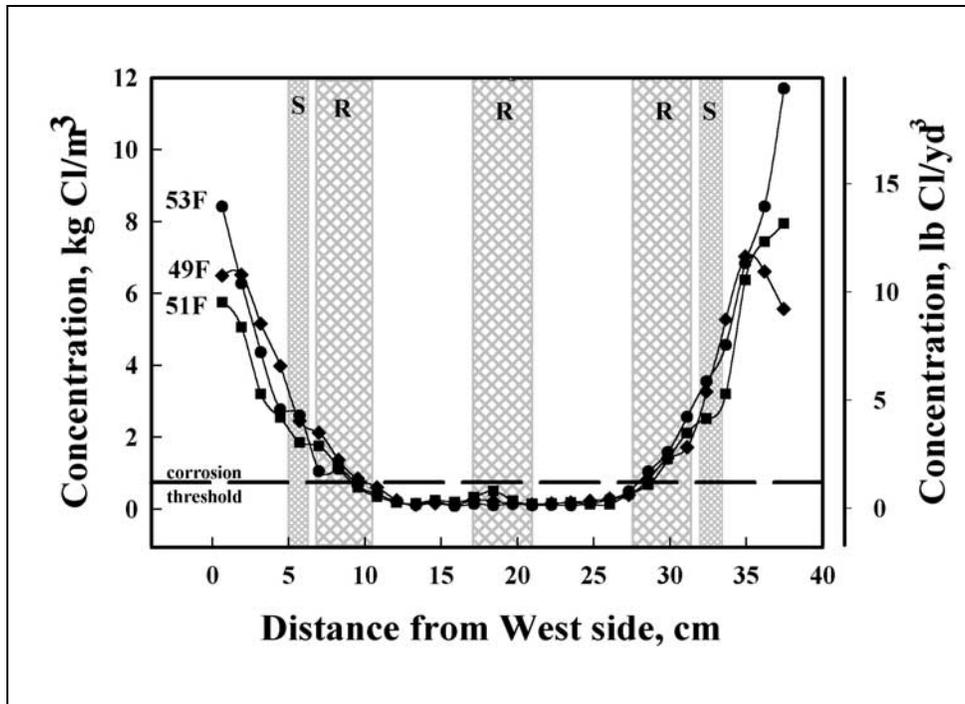
Figure 4.33: Chloride profiles for original concrete showing chloride migration after 1.0 years ICCP. West is the ocean facing side of the beam.

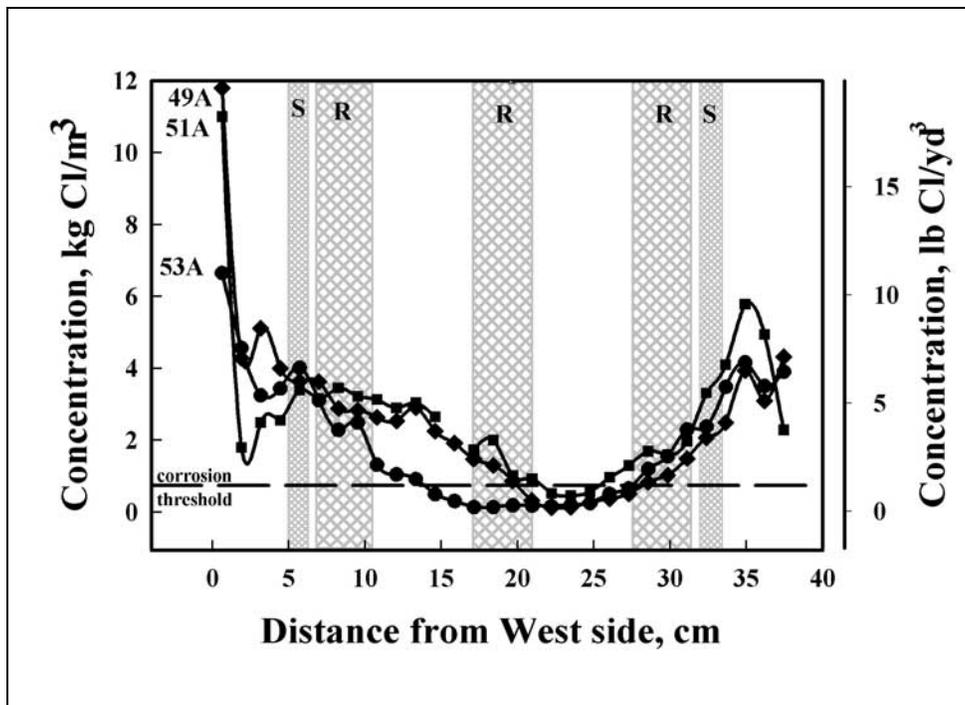
Figure 4.34: Chloride profiles for patch concrete showing chloride migration after 1.0 years ICCP. West is the ocean facing side of the beam.

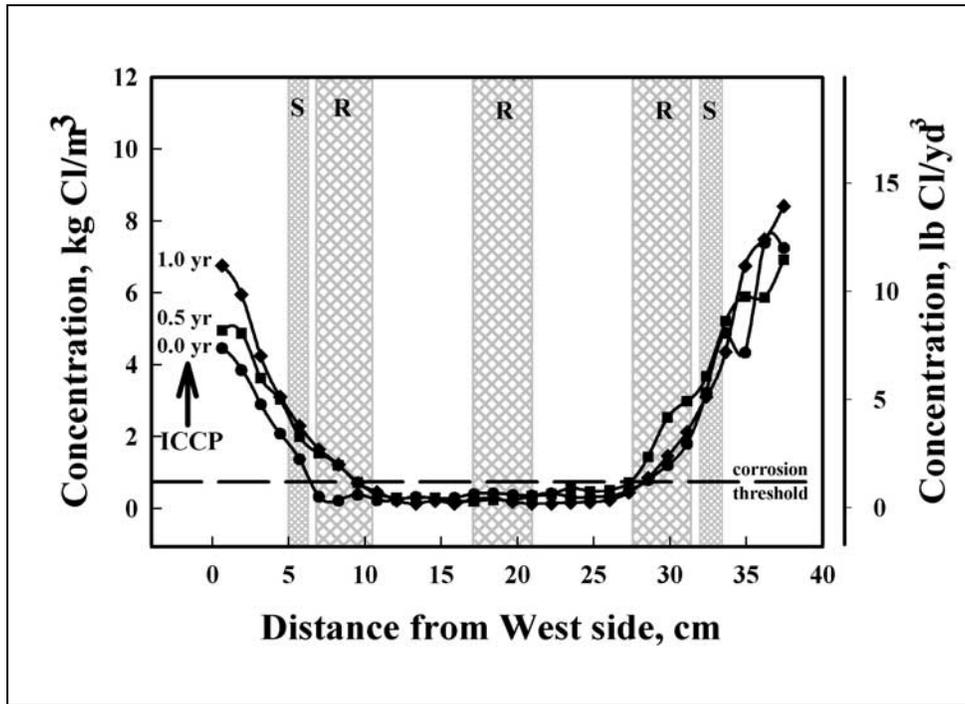
Figure 4.35: Chloride profiles for original concrete showing chloride migration after 0.0, 0.5 and 1.0 years ICCP. West is the ocean facing side of the beam.

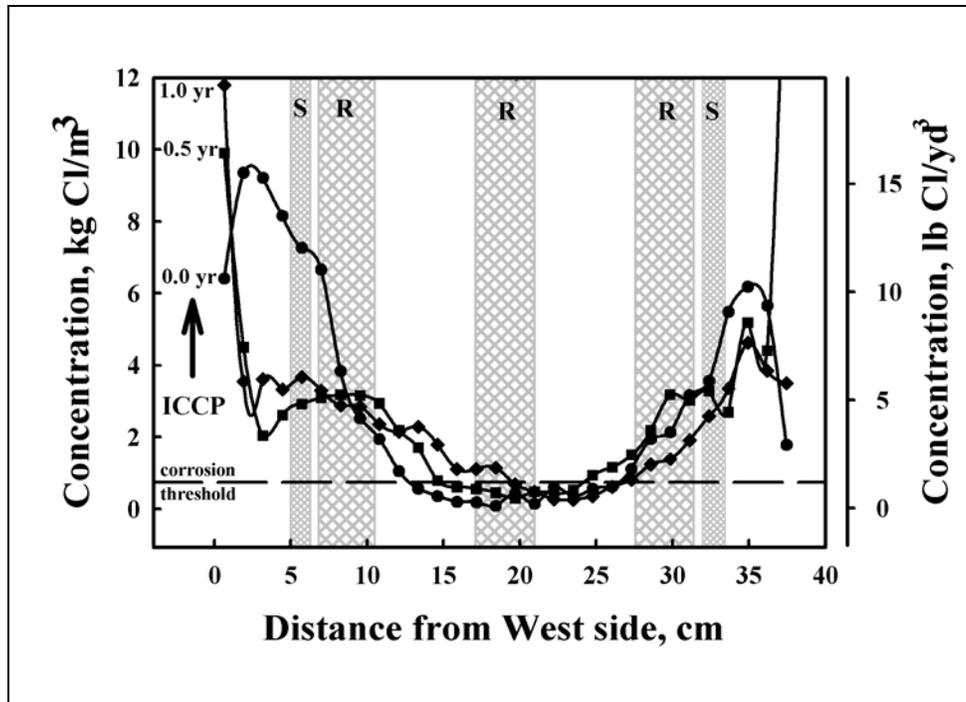
Figure 4.36: Chloride profiles for patch concrete showing chloride migration after 0.0, 0.5 and 1.0 years ICCP. West is the ocean facing side of the beam.

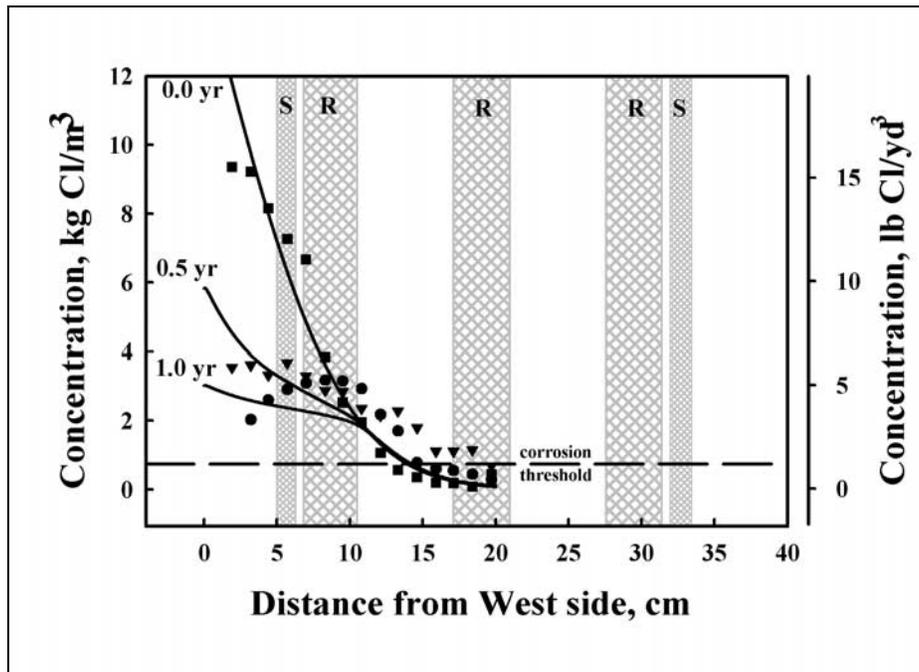
Figure 4.37: Chloride ion migration in concrete under potential and concentration gradients modeled using finite element analysis; comparison between experiment and theory.

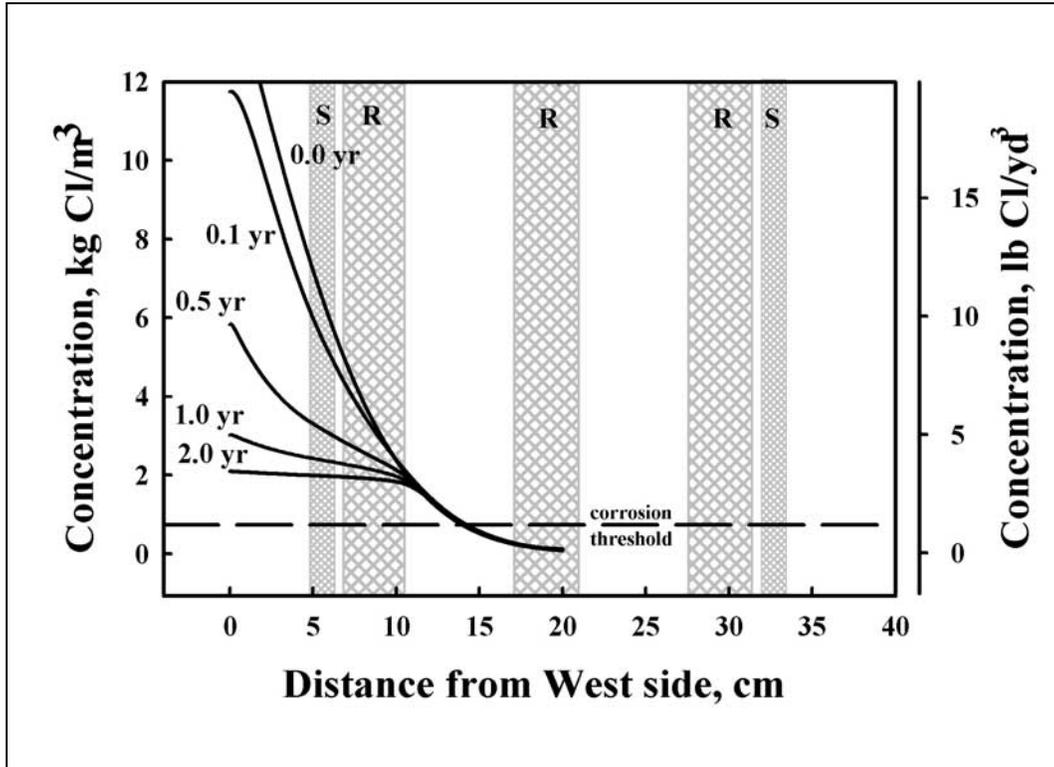
Figure 4.38: Chloride ion migration in concrete under potential concentration gradients generated from finite element analysis for 0 to 2 years ICCP at a current density 10 times higher than ODOT uses on coastal bridges.

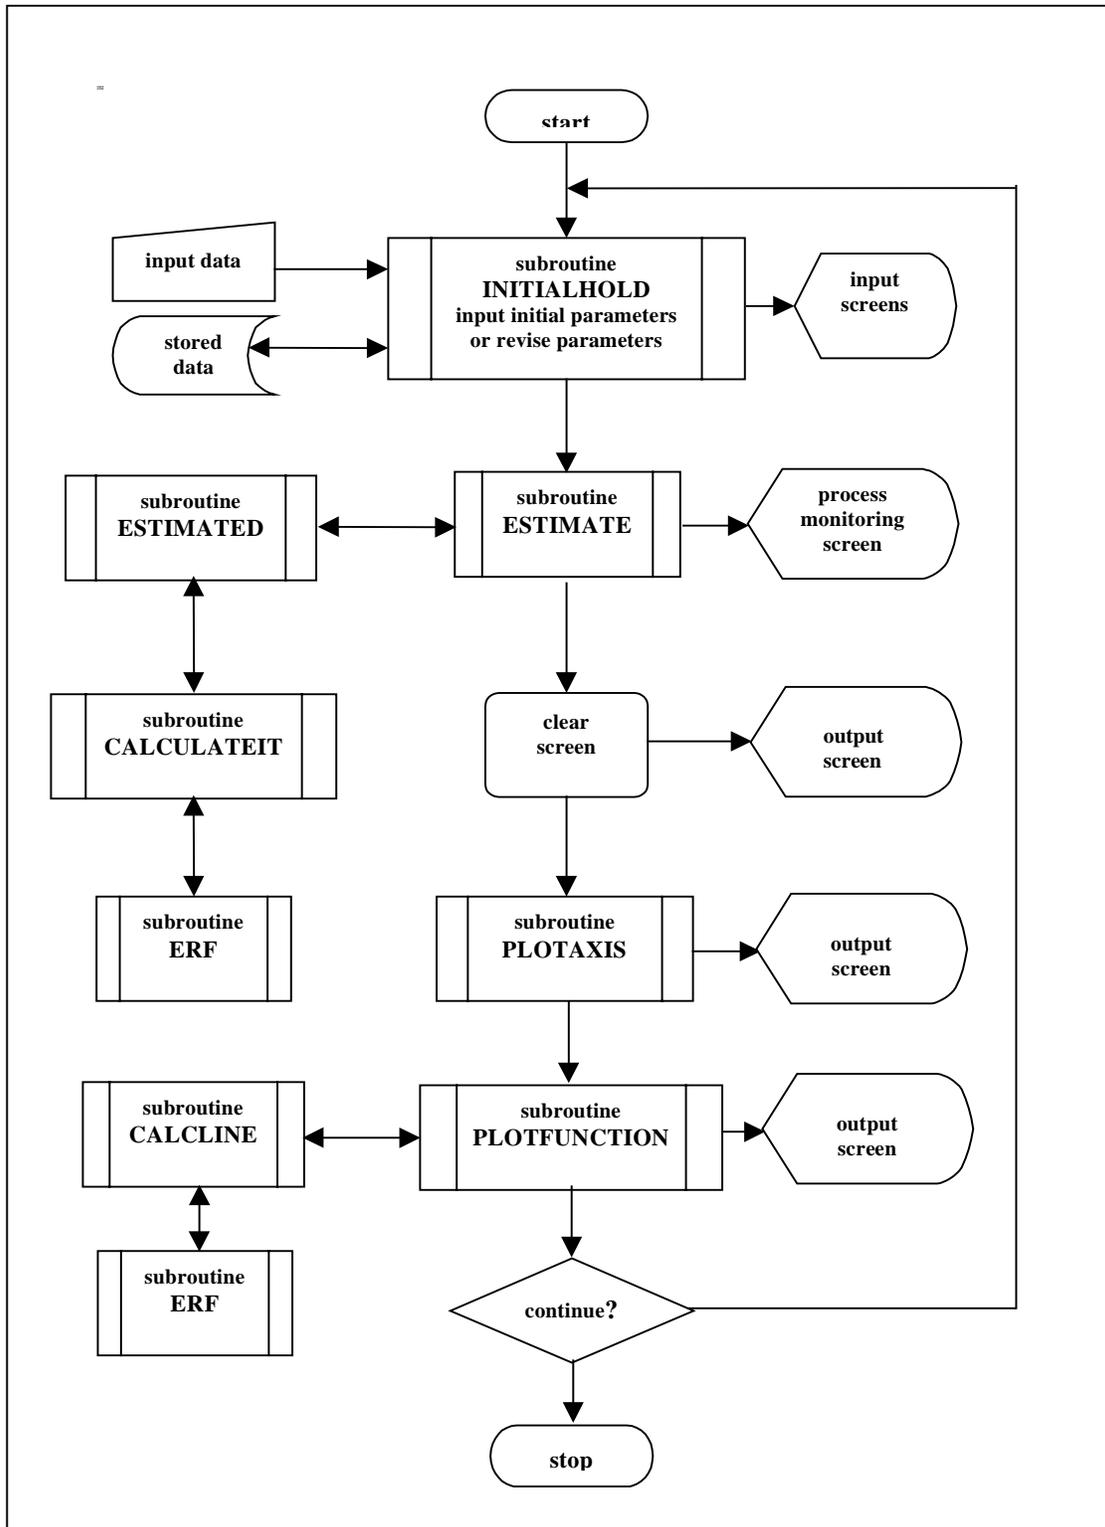
Figure D.1: Flow diagram for BASIC computer program to determine diffusion coefficient, D , and surface chloride ion concentration, C_0 , from chloride profile in concrete.
