Recycling of Asphalt Concrete-  
Oregon's First Hot Mix Project

Interim Report  
for  
FHWA Demonstration Projects Division  
Contract DOT-FH-15-220

Oregon Department of Transportation  
Highway Division  
Salem, Oregon 97310

November, 1977

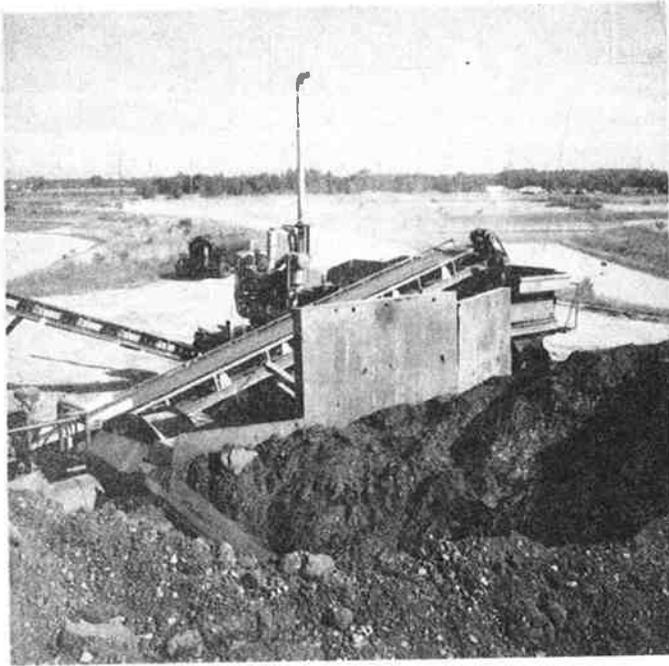
Feed into crusher

First day of crushing, June 30, 1977. A 988 rubber tired loader feeding crusher but not working well; it was unable to pick up a full bucket of material.

The crusher was fed by a D-8H Caterpillar crawler tractor with rippers for the rest of the crushing operation. The rippers were only used occasionally.

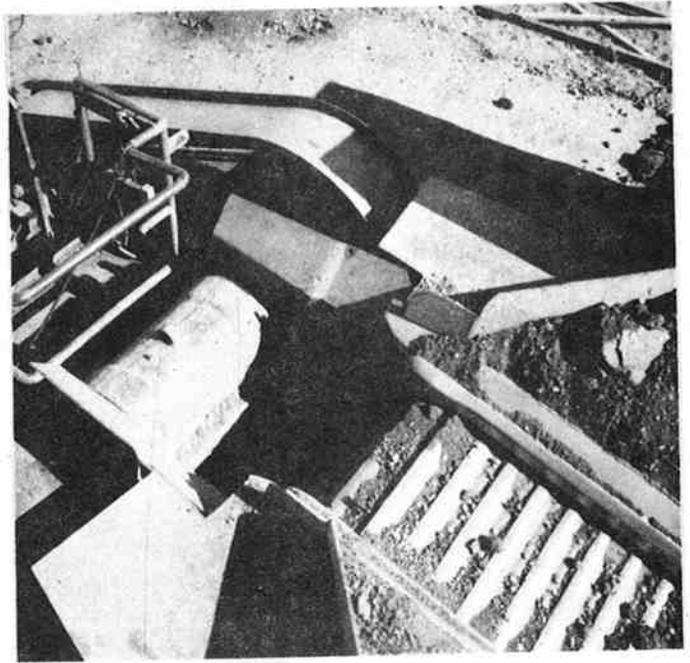
20"x36" Jaw crusher

Crusher components; a 20" x 36" jaw crusher, an impact crusher, and two 5' x 14' screen decks with 2" screen cloth. Jaw crusher set at 4" opening and the impact crusher at 950 rpm. After first sieve analysis, the jaw was opened to 5 inches.

There were no problems in crushing the material other than large chunks would wedge into the jaw and ride up and down for a time before the chunk would catch and break. Crushing specifications were 100% of the material passing the 2" sieve, 50-90% passing the 3/4" sieve, and 0-15% passing the #10 sieve. Crushing was done within specifications except passing the #10 sieve; slightly too many fines. Crushing was done in dry warm weather, 90 F. There was some pile consolidation when left in the stockpile, especially in warm weather, but this easily came apart when picked up by the loader.

Third day of crushing, July 20, 1977. The dies on the jaw crusher were roughened up by welding beads. This helped very much to grip the larger asphalt concrete chunks and pull them into the jaw crusher. The jaw was opened to 6", the cone remained at 2-1/2" and the impact remained at 650 rpm. The crusher components remained at these settings for the rest of the crushing operation.

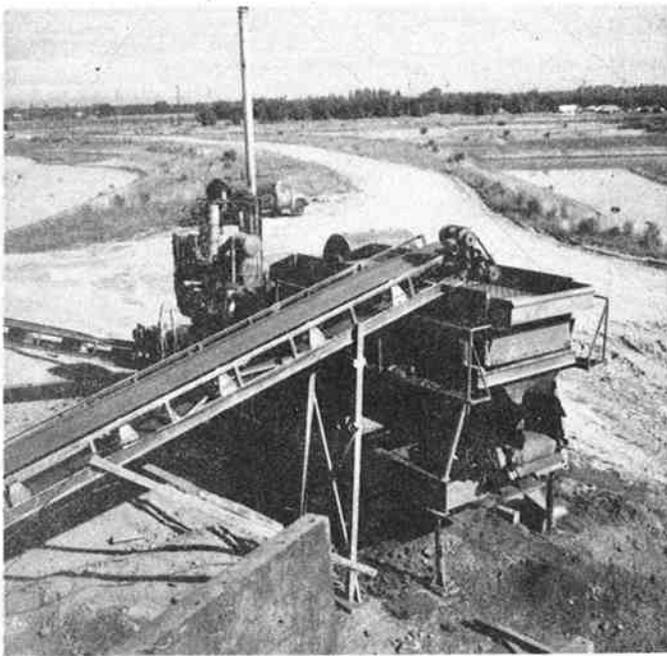
Screen deck and 54" Cone crusher

Second day of crushing, July 7, 1977. A 54" cone crusher was added in addition to the other crushing components, and this was set with an opening of 2-1/2". Also, the impact crusher was slowed down to 650 rpm to try and reduce the amount of material passing the #10 sieve.

Another 5' x 14' screen deck was added; one screen deck prior to entry into the cone with the material that passes the 2" screen going to the final belt and the rest of the material going into the cone. The second screen deck was mounted between the cone and the impact crushers with the material passing the

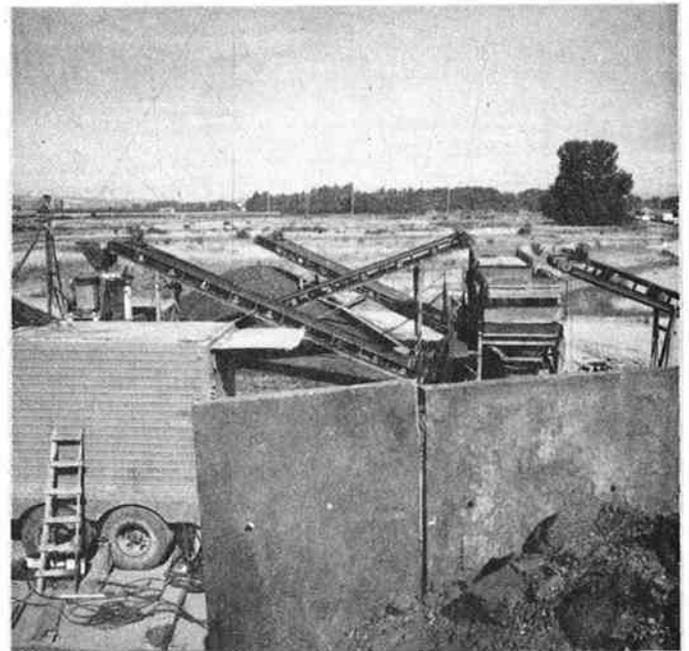
Impact crusher, screen deck  
and final stockpile

screen going to the final belt and the oversize going to the impact crusher. The third screen deck was placed after the impact crusher; the material passing the 2" screen deck going to the final belt and the oversize going back through the impact crusher.

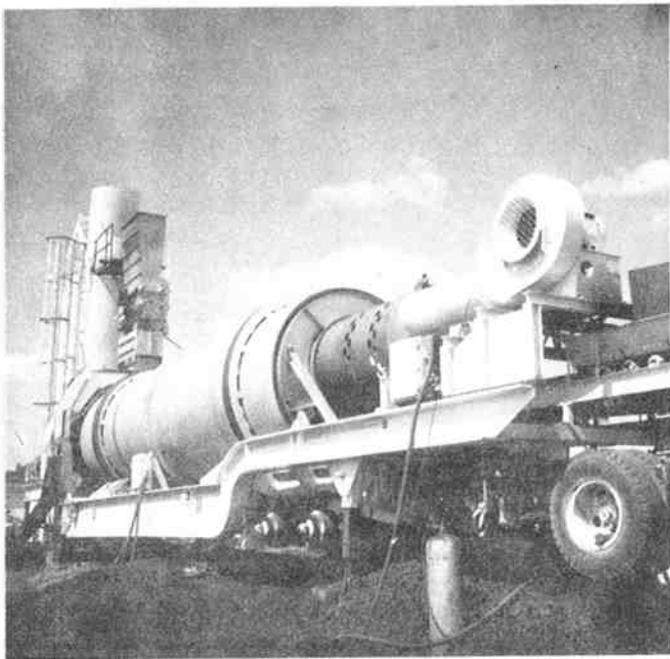
Boeing 400 Dryer Drum

The paving plant used for the project was a newly designed and constructed dryer drum plant manufactured by the Boeing Construction Equipment Company. The contractor, Babler Brothers Inc., leased the plant and Boeing personnel assisted with its operation during the project. The plant is a Model 400 (400 tons per hour) having a conical, perforated plate heat shield between the burner and the paving mix in the drum. The heat shield made it possible to re-mix the salvaged asphalt concrete without burning the asphalt.

The dryer drum plant used on this project was quite different from a conventional drum in that the burner was set back from the drum itself with a cylinder of stainless steel providing a heat passageway from the burner to the drum. This cylinder had air vents for proper air flow. Immediately at the head end of the drum was a metal cone with 1 inch holes for heat transfer. This shield allowed the heat but not the flame to enter into the drum. The asphalt feed was a spray bar inserted nine feet into the drum, beyond the heat shield. The spray bar was positioned longitudinally and was adjusted between 8 and 10 feet beyond the heat shield.

Fourteen feet from the rear of the drum was a steel baffle that covered all but 10 inches around the perimeter of the inside drum diameter. The baffle aided with dust control. The conveyor that feeds into the bottom of the drum was a high speed conveyor, designed to "throw" the material into the drum farther away from the heat, to prevent burning of the oil.

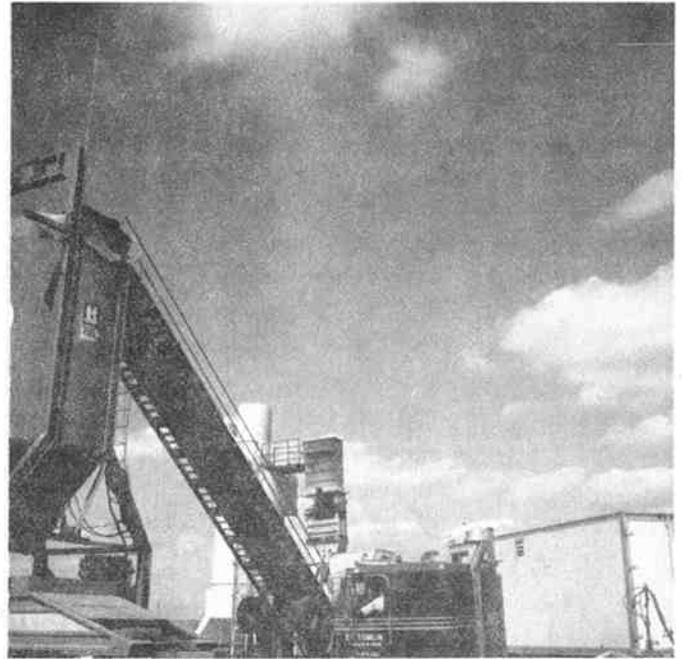
Clean stack- 20% opacity

There was considerable concern from the Department of Environmental Quality and understandably so, that emissions might not be kept in control. During the seven weeks of operation, the plant demonstrated its ability to run below the 40 percent average opacity readings without any external control devices. Daily opacity readings followed a downward trend as modifications and experiments and better plant control were initiated. The plant ran six days with a daily average of less than 15 percent opacity, proving the plant has the ability to run below 20 percent average opacity.

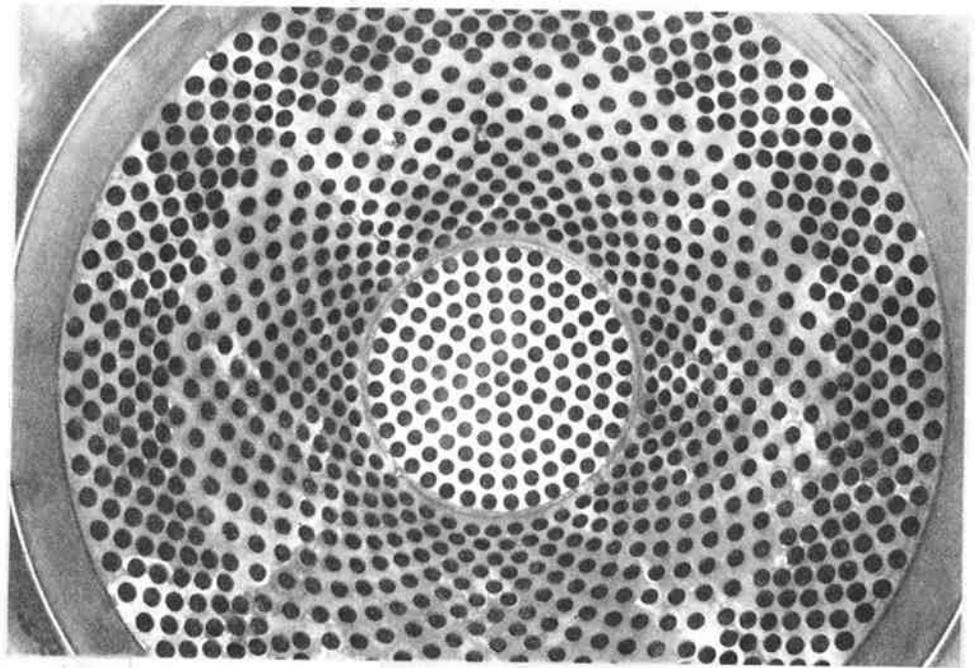
Boeing Heat Shield

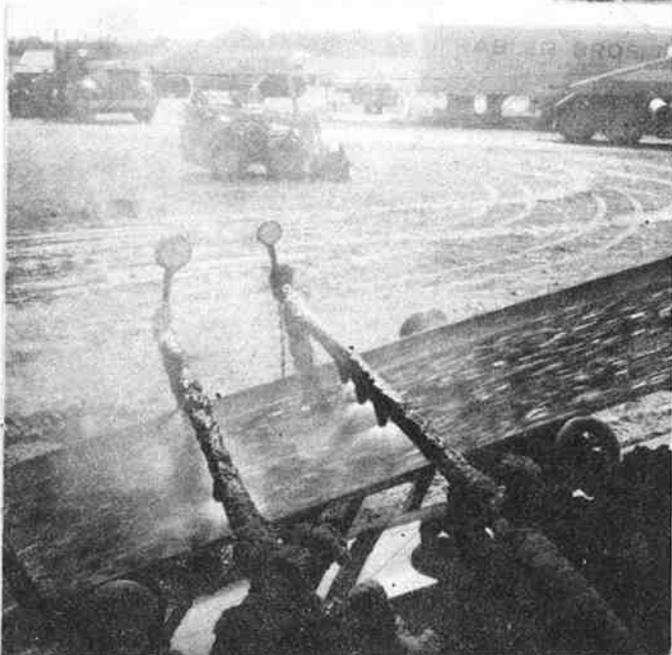
Water spray bars on conveyor  
feed belt

Twenty-fourth day of plant operation, August 22, 1977. As learned recently from preliminary observations and applied very effectively today, while the humidity was high in the morning hours the water added was 0.5 percent, and as the humidity decreased and the ambient temperature rose, the water added to the feed belt was raised to between 2 and 2-1/2 percent. Opacity readings averaged under 10 percent for the day.

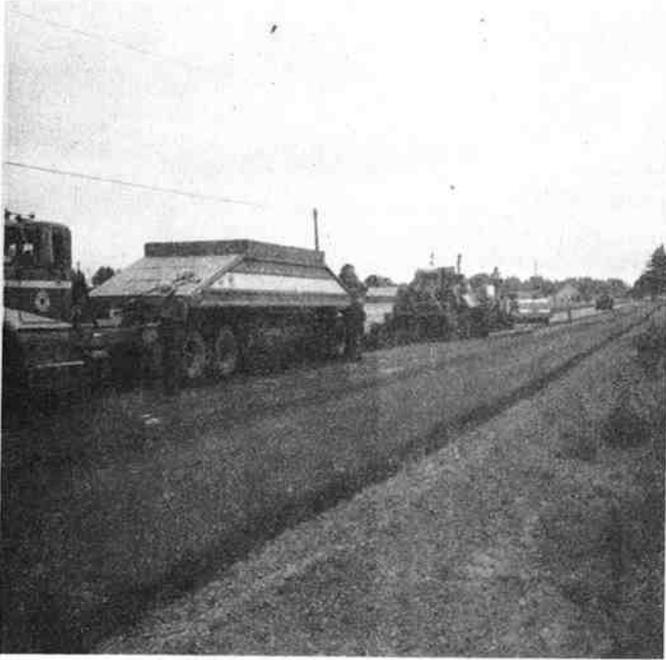
Placing recycle asphalt concrete

paving machine and slat conveyor pickup machine, keeping the length of the windrow short to prevent heat loss. This was the recommended procedure using "belly" dumps.

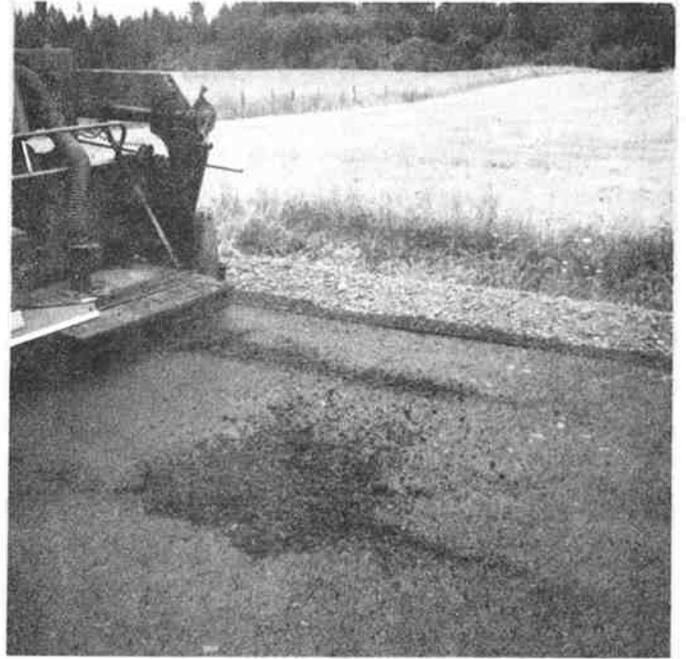
Base lift - recycle mixture

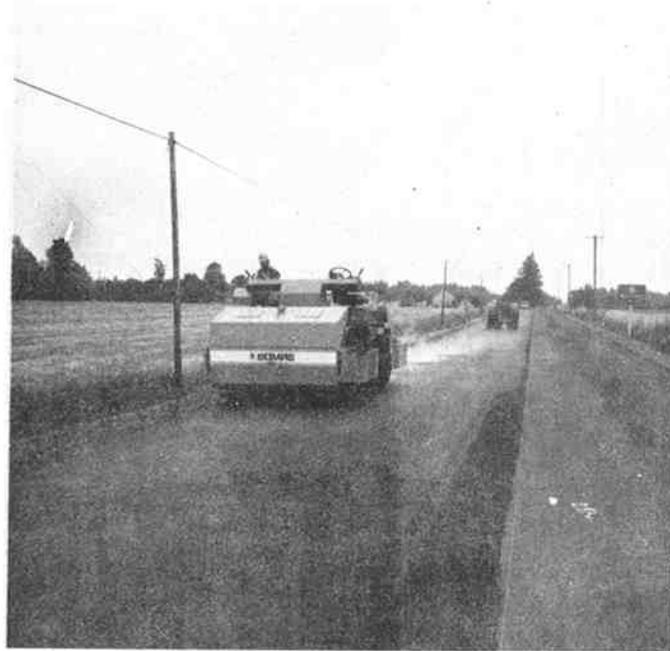
Break down and Intermediate rollers

The compaction was in some cases good even at low temperatures of the mix, but there were 21.8 percent failing compaction tests recorded (below 92 percent relative compaction). This was attributed primarily to the low mix temperatures. Only 13 percent of the compaction tests were below 91 percent relative density.

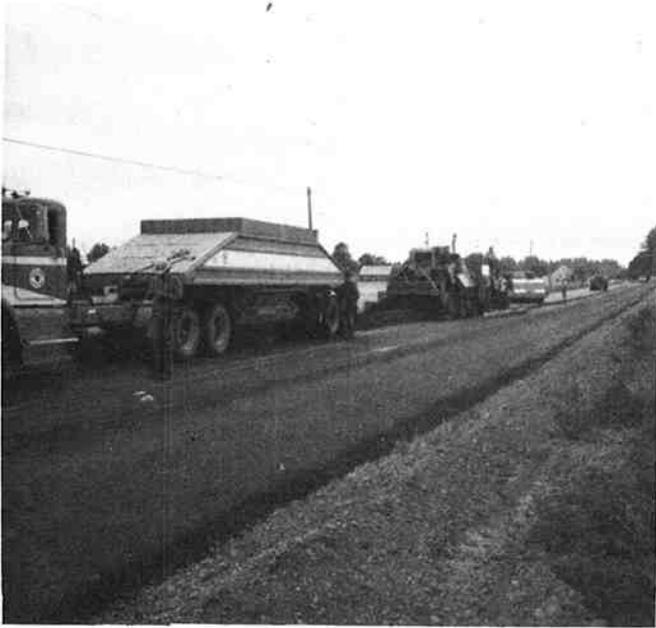
Placing recycle asphalt concrete

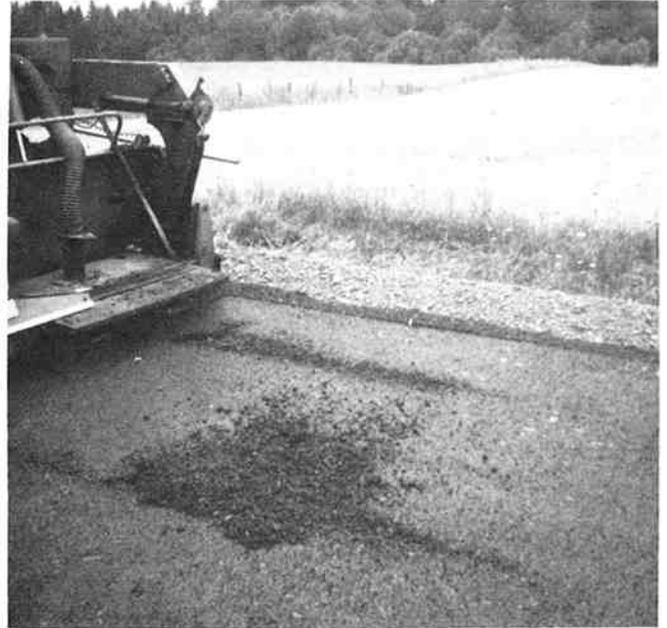
Base lift - recycle mixture

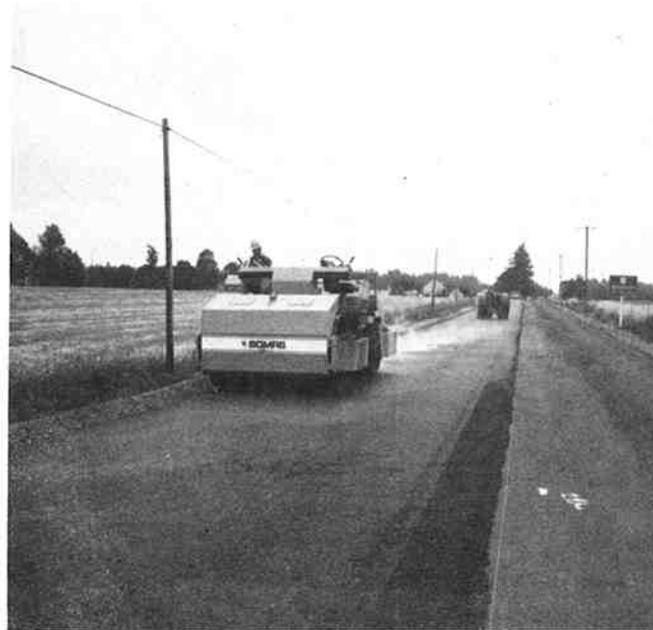
Break down and Intermediate rollers

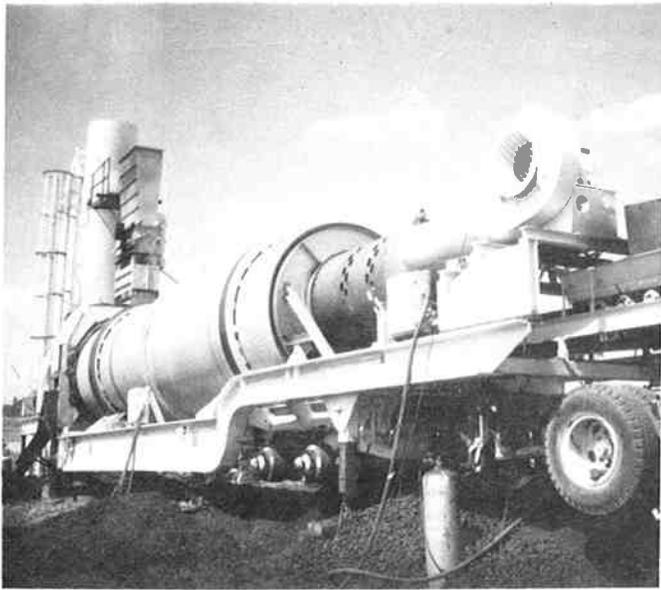
Boeing 400 Dryer Drum

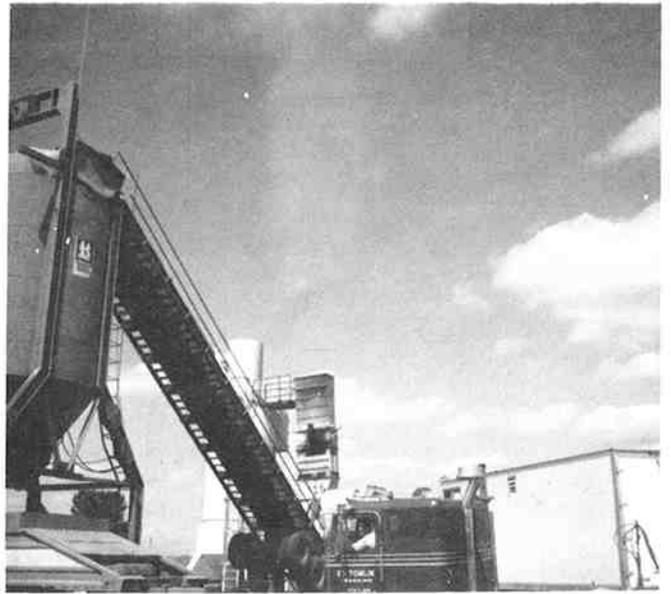
Clean stack- 20% opacity

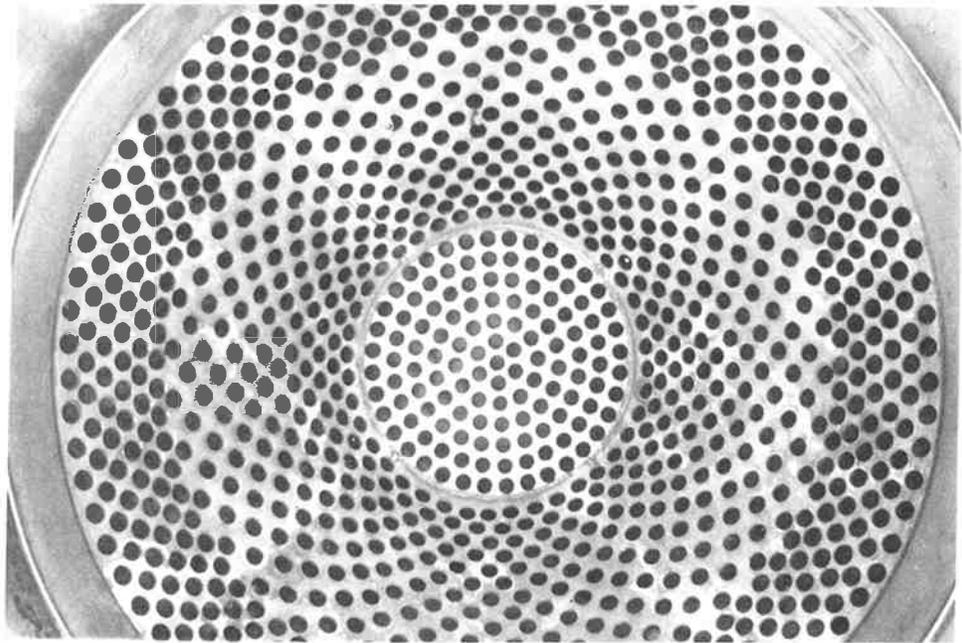
Boeing Heat Shield

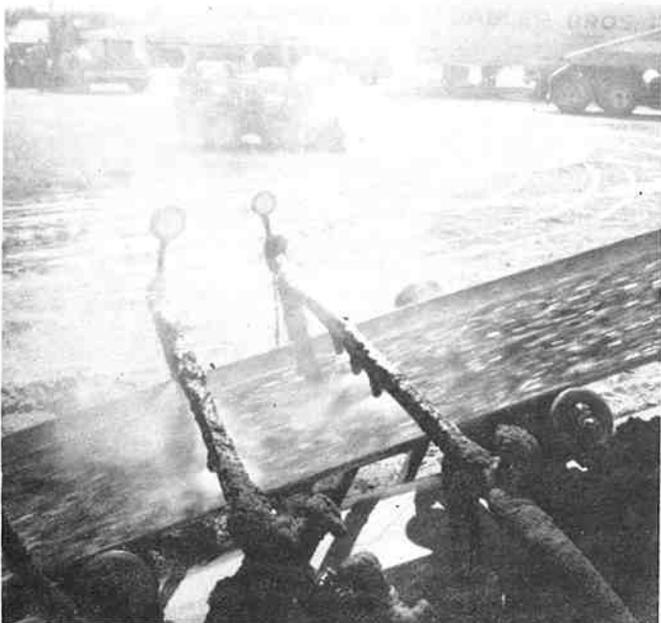
Water spray bars on conveyor  
feed belt

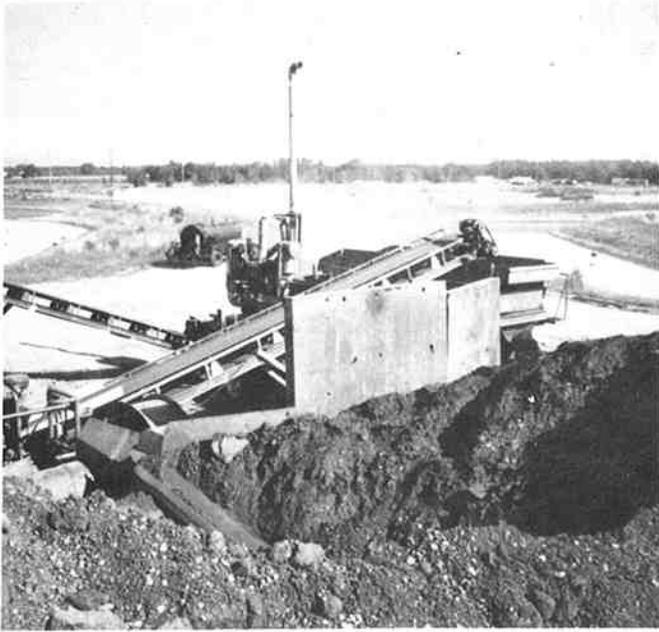
Feed into crusher

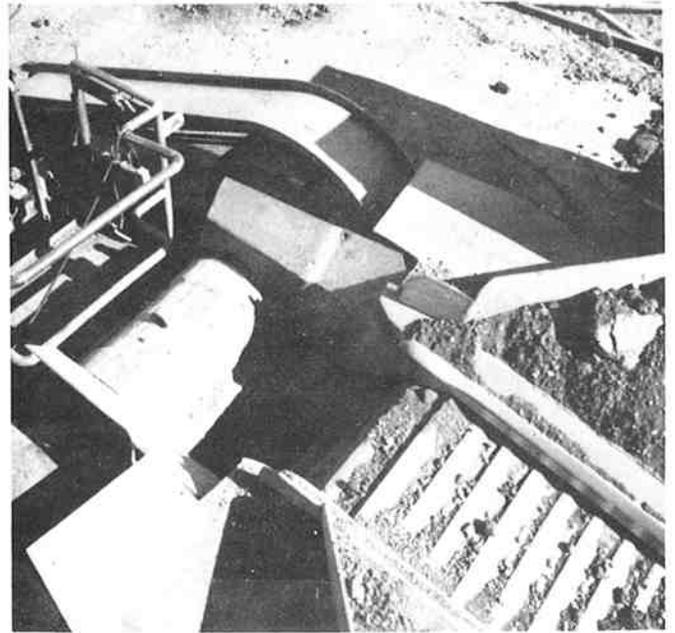
20"x36" Jaw crusher

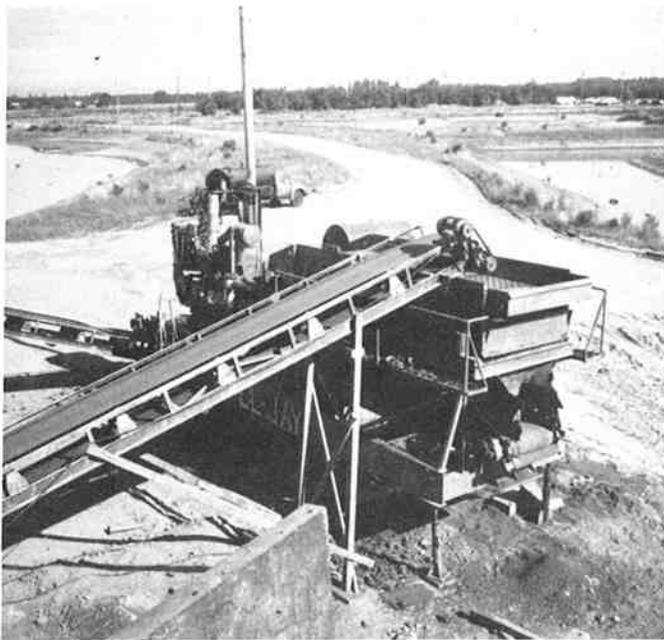
Screen deck and 54" Cone crusher

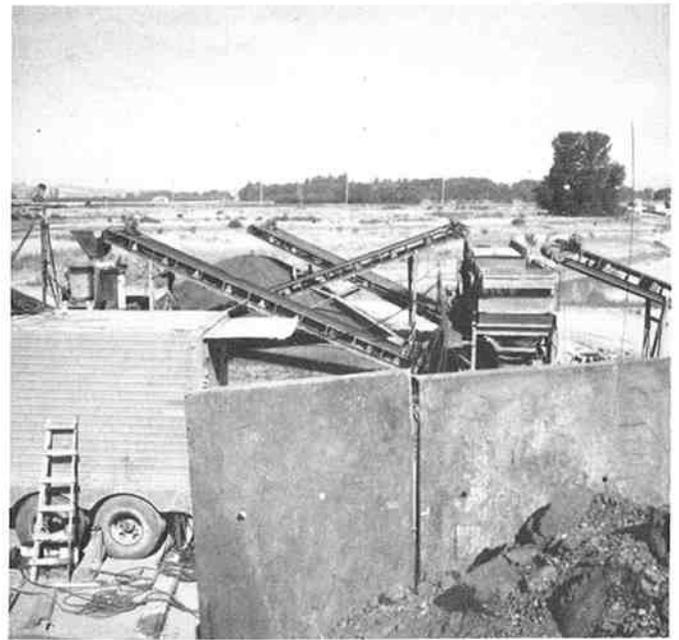
Impact crusher, screen deck  
and final stockpile
