**FIELD EVALUATION OF THE  
MYRTLE CREEK ADVANCED  
CURVE WARNING SYSTEM**

**Final Report**

**SPR 352**

**June 2006**

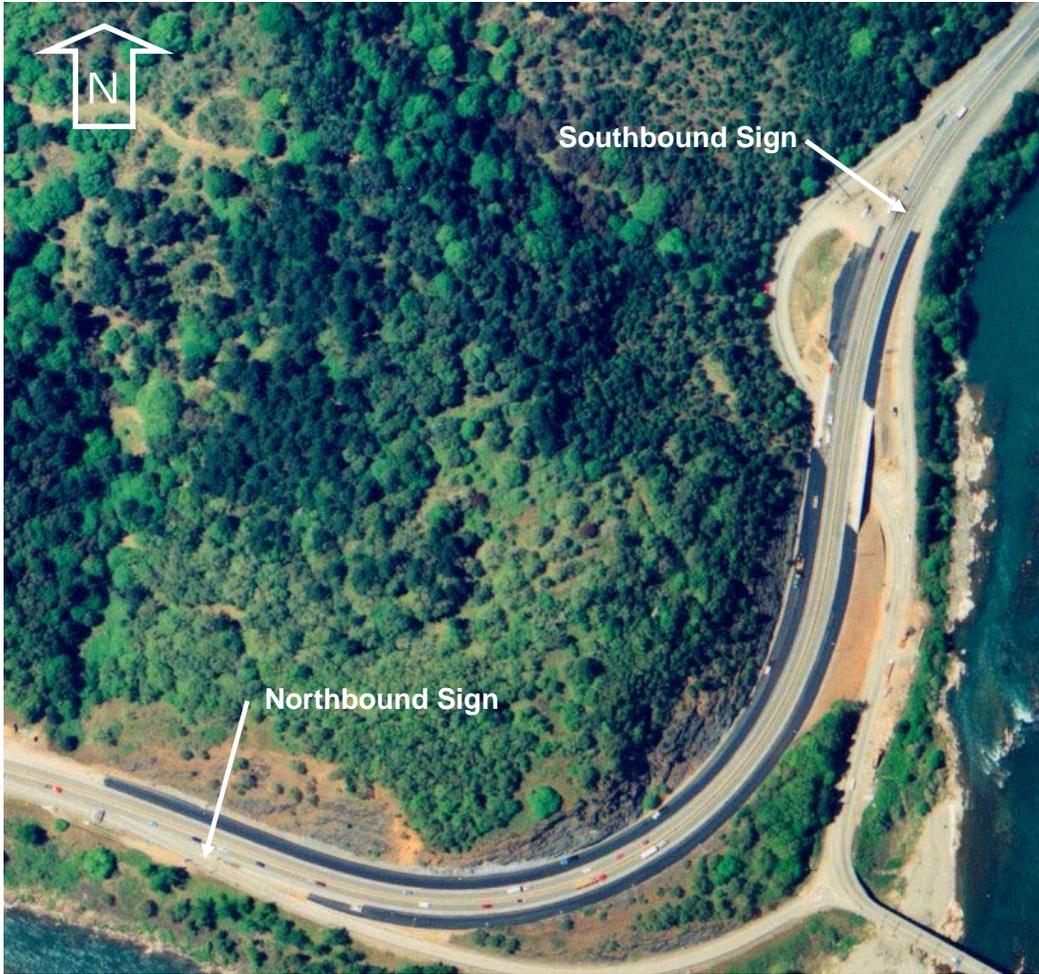
Figure 3.2: Aerial photograph of Myrtle Creek curves

As shown in Figure 3.2, the curved section of Interstate 5 is tightly constrained by an embankment on one side and the South Umpqua River on the other. The curves are located in a 50 mile per hour (mph) speed zone and are posted with an advisory speed of 45 mph for all vehicles in both directions. Approximately 0.5 mile upstream and downstream of the signs the posted speed is 65 mph for passenger cars and 55 mph for trucks.

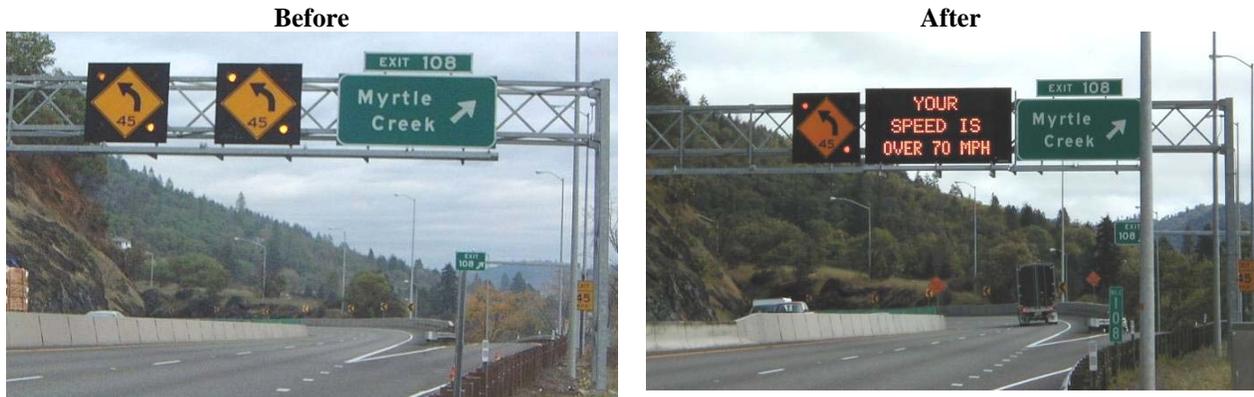
Figure 3.3: Northbound sign bridge, I-5 Milepost 108.00, before and after ACWS installation

The static warning signing in place prior to the installation of the ACWS consisted of dual overhead horizontal alignment/advisory speed combination sign assemblies (MUTCD W1-2a) with 4 flashing beacons. A ground mounted truck rollover warning sign was also present (Oregon OW8-12) slightly upstream of the sign bridge in the northbound direction and on the sign bridge support pole in the southbound direction. There are chevrons (MUTCD W1-8) installed through the curves in the northbound direction but there are no chevrons in the southbound direction. The “before” sign conditions are visible in Figure 3.3 and 3.4.

The Myrtle Creek ACWS consists of the following key elements at each sign location: a dynamic message sign (DMS), a radar unit for speed measurement, a controller unit and computer software to manage the speed inputs and (locally) modify the sign message. Fortunately, the existing sign bridges were of sufficient structural capacity to accommodate the DMS without modifications. For the northbound sign bridge one of the W1-2a assemblies was removed to provide sufficient space for the DMS. The DMS were installed overhead on existing sign bridges as shown in Figures 3.3 and 3.4.
