**SOIL NAILING  
OF A  
BRIDGE EMBANKMENT**

**Report 2:  
DESIGN AND FIELD PERFORMANCE  
REPORT**

Experimental Features  
Project OR 89-07

**Oregon Department of Transportation  
Salem, Oregon 97310**

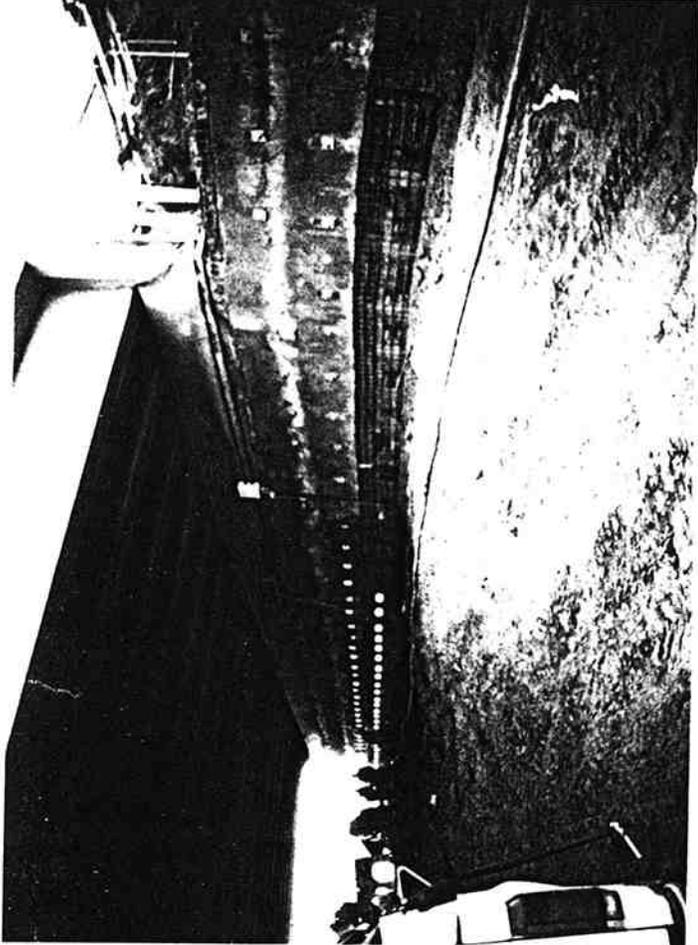
FIG. 8 - Drilling and installing Row 3 nails. The use of blockouts at nail locations (in the background) allowed the contractor to drill through the one-day old shotcrete facing

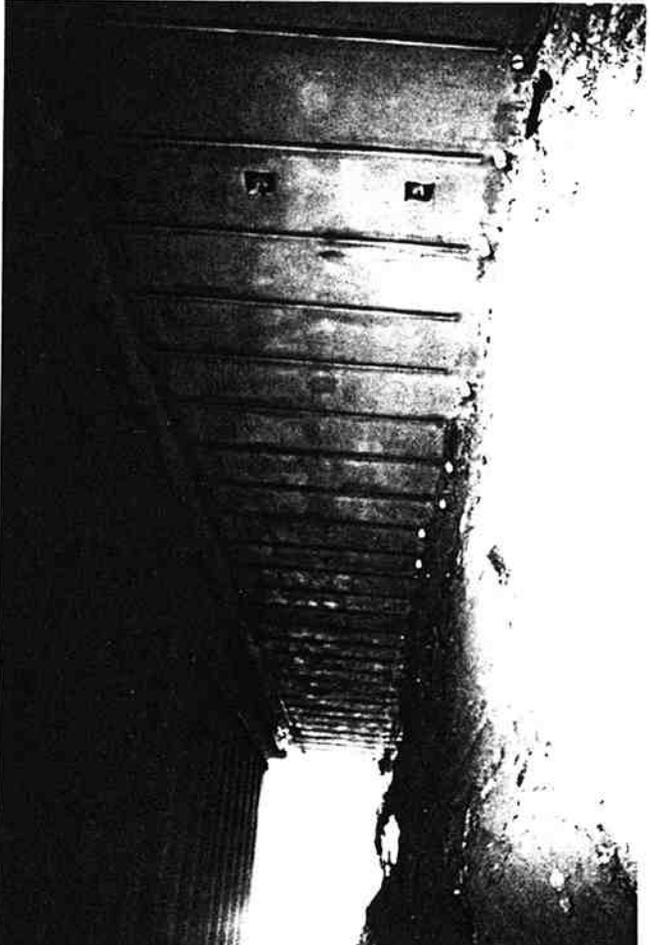
FIG. 10 - Wall after placement of the second shotcrete application and removal of architectural scoring strips. Notice blockouts at instrumented Section 1.

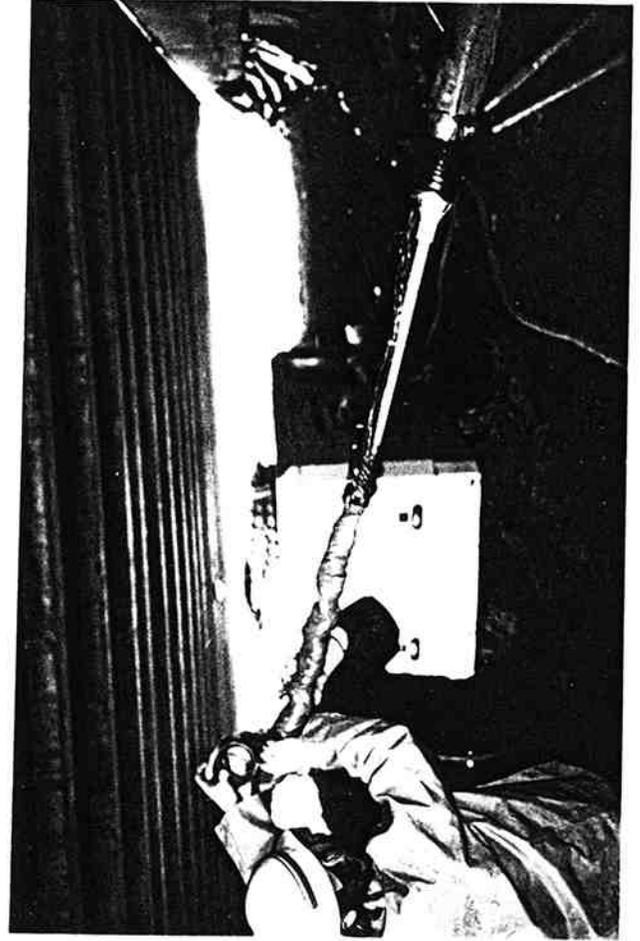
FIG. 19 - Protecting instrumentation wire leads at the head of the nail

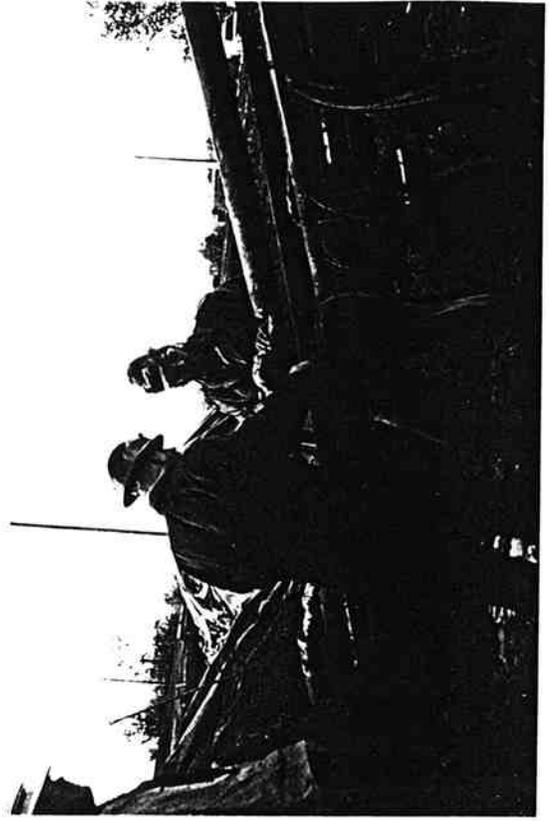
FIG. 20 - Advancing the drilling head around the instrumented nail in preparation for grouting the cased drill hole

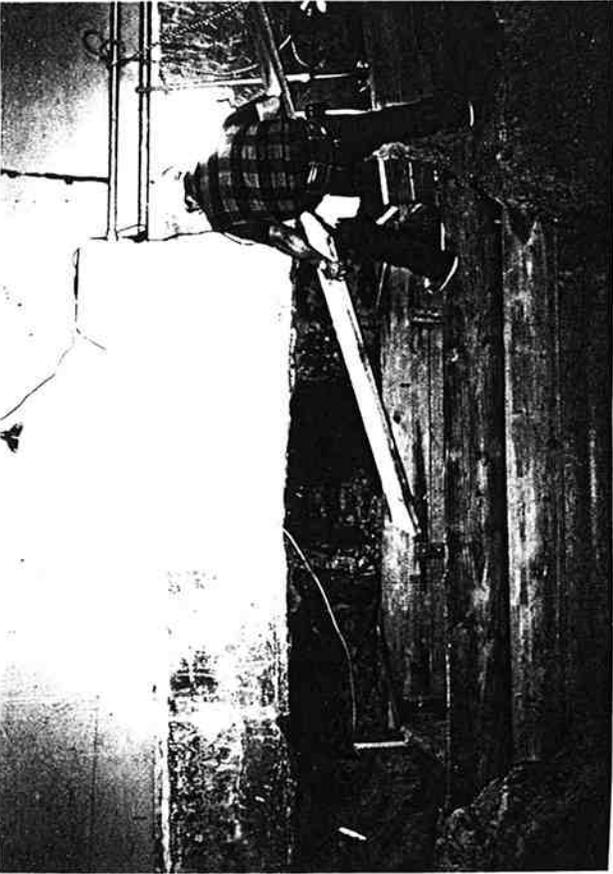
FIG. 25 - (Top left)

Hand excavating to instrument two existing piles prior to any soil nailing activity. Notice the exposed steel pipe piles in the background.

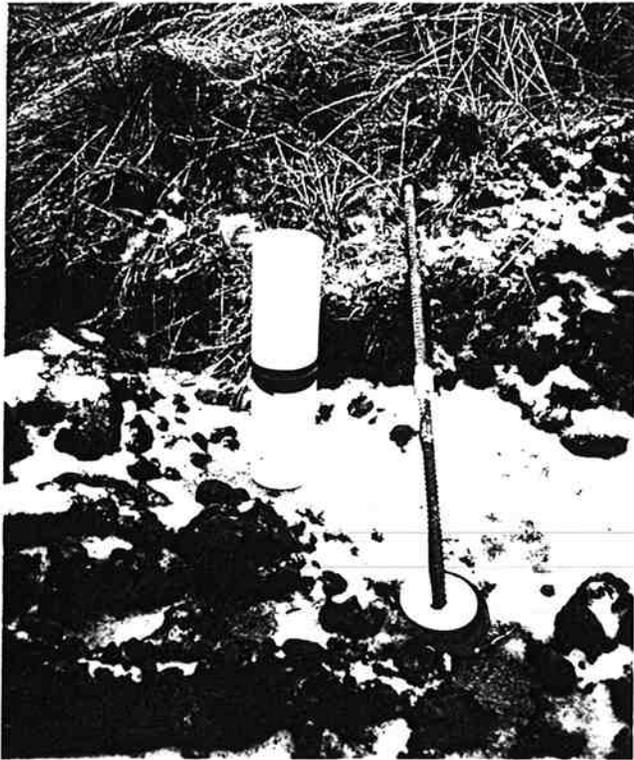
FIG. 29 - Ungrouted Dywidag test bar with vibrating wire strain gauges

For the Swift-Delta project, a Dywidag bar was instrumented with a pair of vibrating wire strain gauges (Figure 29). A column of grout was cast around the bar and allowed to cure for a week (Figure 30). The specimen was load tested, in the lab, in direct tension (Figures 31 and 32). The resulting strain was measured for different, known, load levels. The force-strain relationship from this test nail was applied to strains measured at both instrumented sections convert the strain readings into equivalent forces.

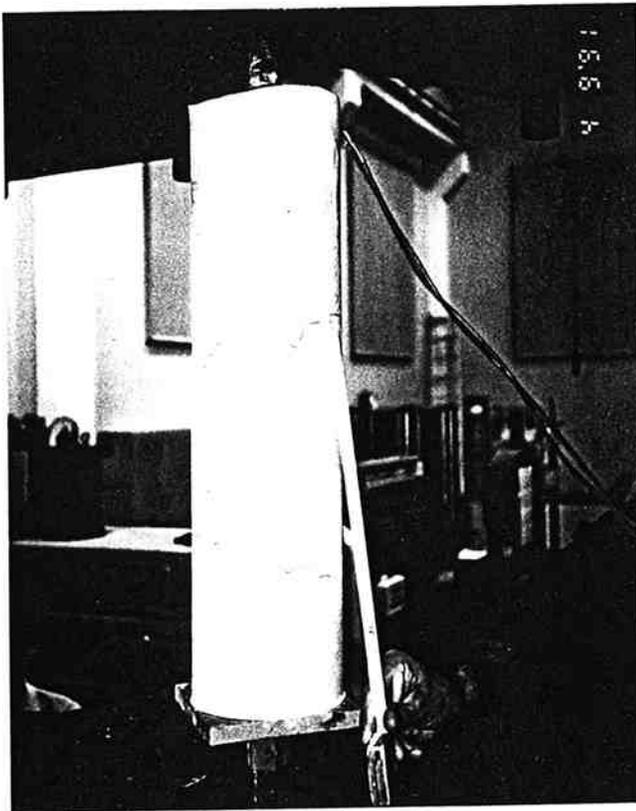
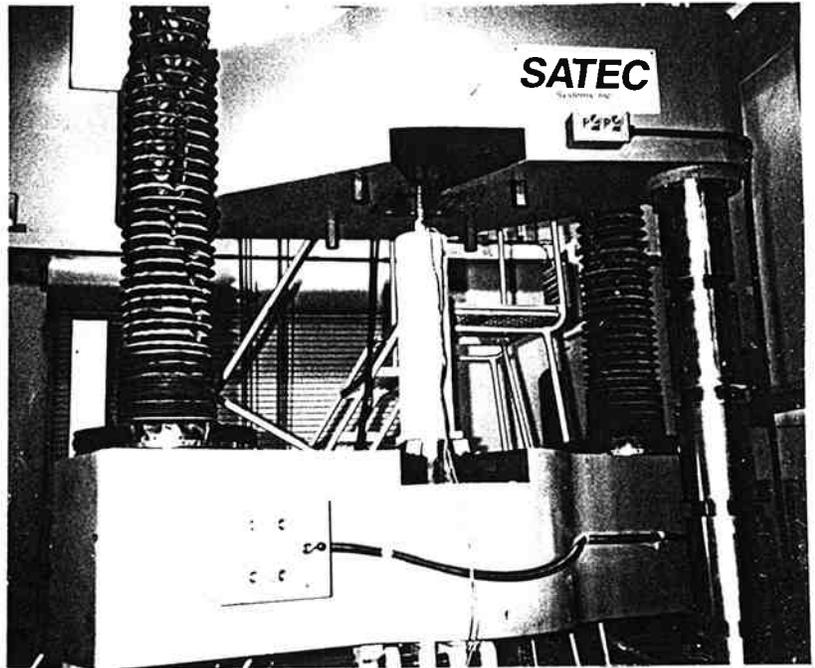
FIG. 31 and FIG. 32 - Lab testing of grouted test nail in direct tension.

The test nail was load tested in the lab in direct tension prior to casting the column of grout. The Dywidag bar was incrementally tensioned to a tensile load of 40 kips (18 tonnes). The resulting strains were measured for each load increment (Table 2). Two load-strain relationships were obtained, one for each gauge (Figure 33). Strain gauge G0 had a change in strain with load equal to 40.25 microstrain/kip. Strain gauge G1 had a change in strain with load equal to 40.87 microstrain/kip. The average change in strain with load for the ungrouted bar was 40.56 microstrain/kip. The calculated modulus of elasticity was 24,845 ksi ( $1.7 \times 10^5$  MPa).

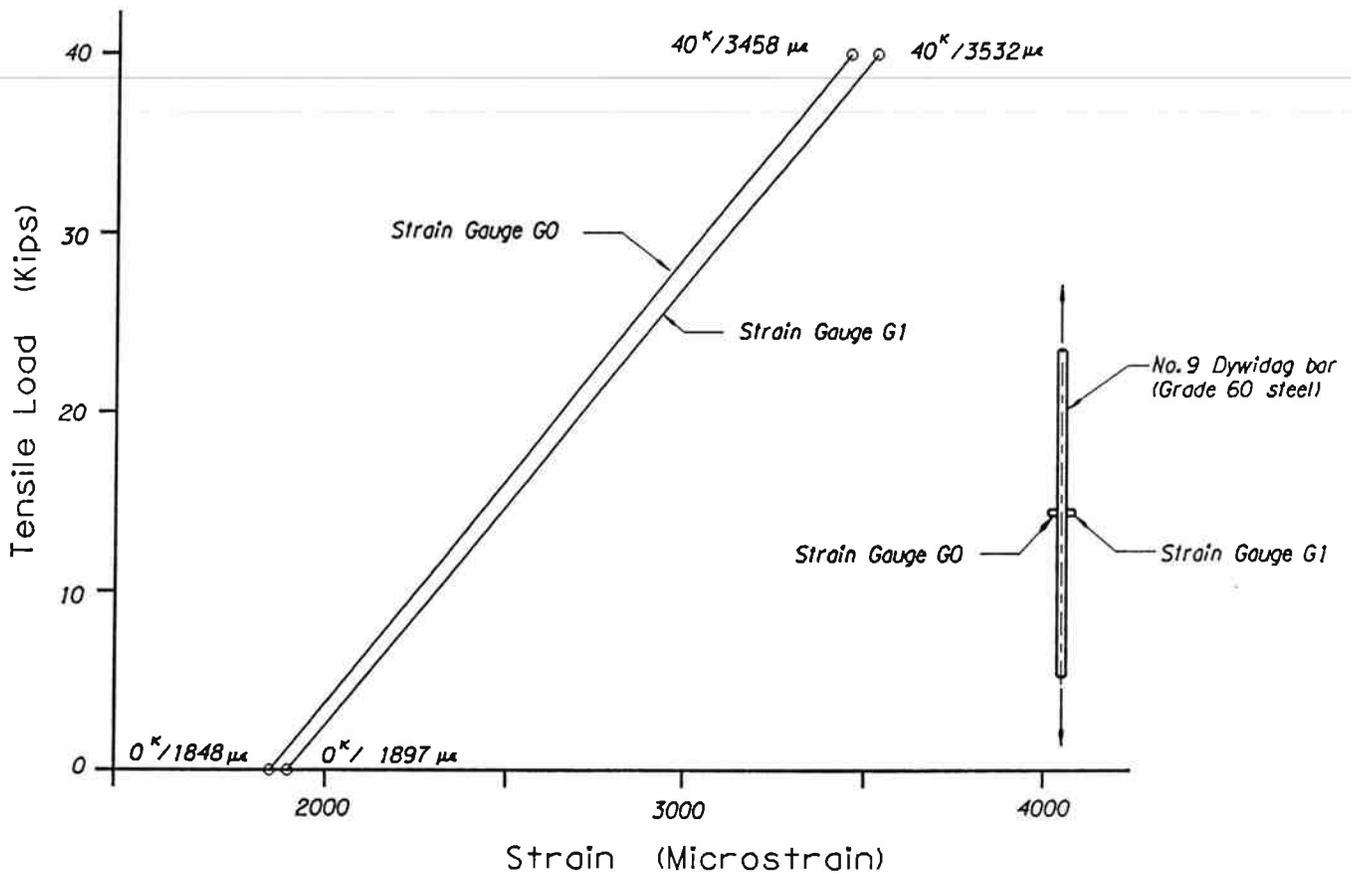
- Area of no. 9 bar = 1.0 in.<sup>2</sup>
- Average change in strain with load = 40.56 microstrain/kip
- Modulus of elasticity of bar =  $1.0 \text{ in.}^2 / 40.56 \times 10^{-6}$   
= 24,845,000 psi

**Figure 33** FORCE - STRAIN RELATIONSHIP CURVES OF A NO. 9 DYWIDAG TEST BAR

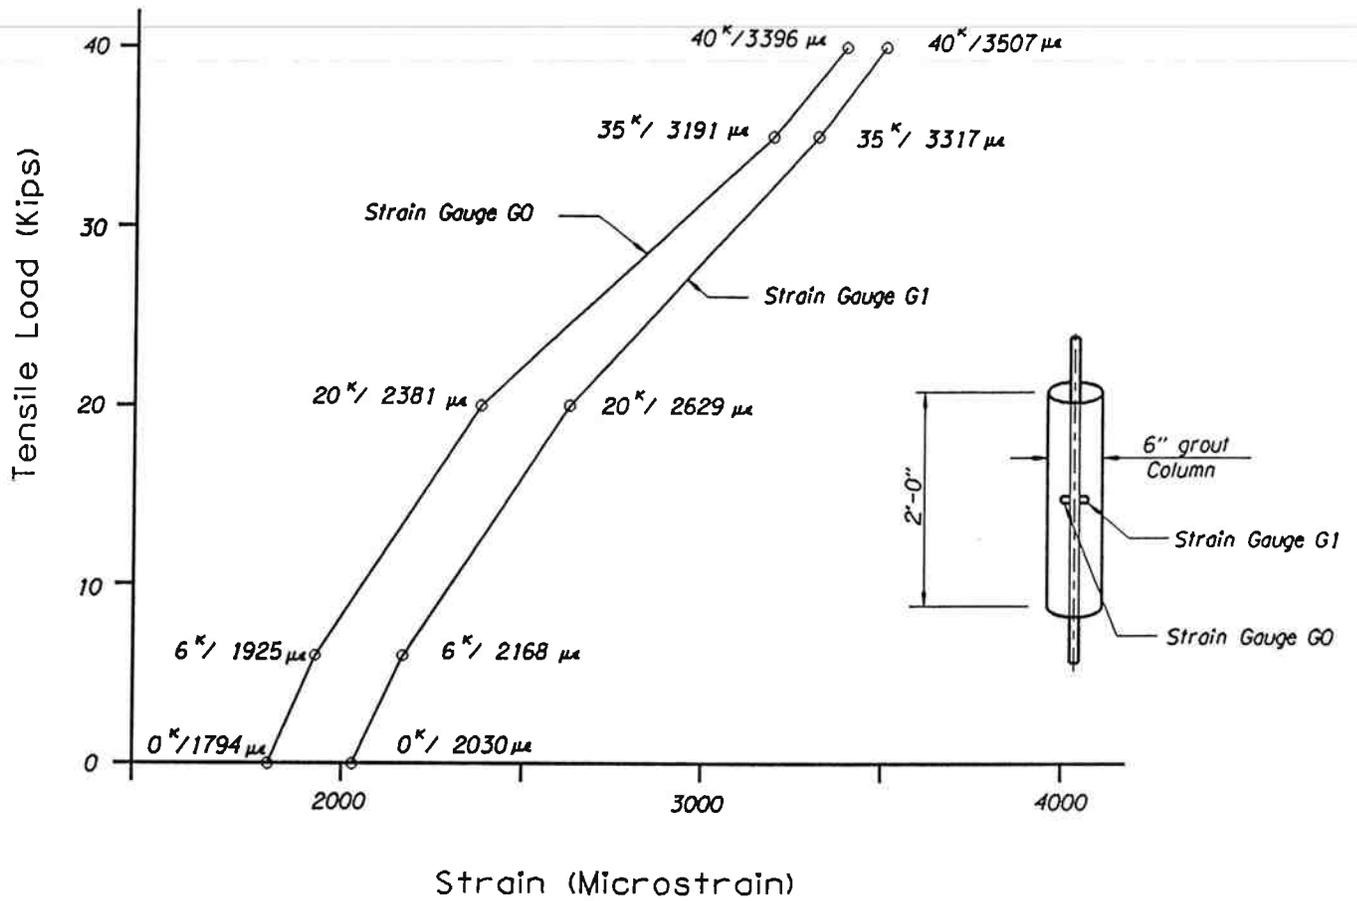
**Figure 34** FORCE - STRAIN RELATIONSHIP CURVES  
OF A GROUTED TEST NAIL

Both strain gauges exhibited nearly identical load-strain relationships (Figure 34). One exception was noted between the 20 to 35 kips (9 to 16 tonnes) load range. This difference will be discussed later. Figure 35 shows the average force-strain relationship curve of the grouted test nail. The bar behaved elastically during the testing. Four different load strain zones were identified.

3. The third zone was in the 20 kips to 35 kips (9 to 16 tonnes) load range. Strain gauges G0 and G1 registered a change in strain with load equal to 54.0 and 45.8 microstrain/kip respectively. The average change was 49.9 microstrain/kip. An audible crack was heard between the 25 kip (11 tonnes) and the 28 kip (13 tonnes) load increment.

The change in strain measured with gauge G0 was larger than the change measured with gauge G1. This difference could be attributed to the formation of the first grout crack adjacent to gauge G0.

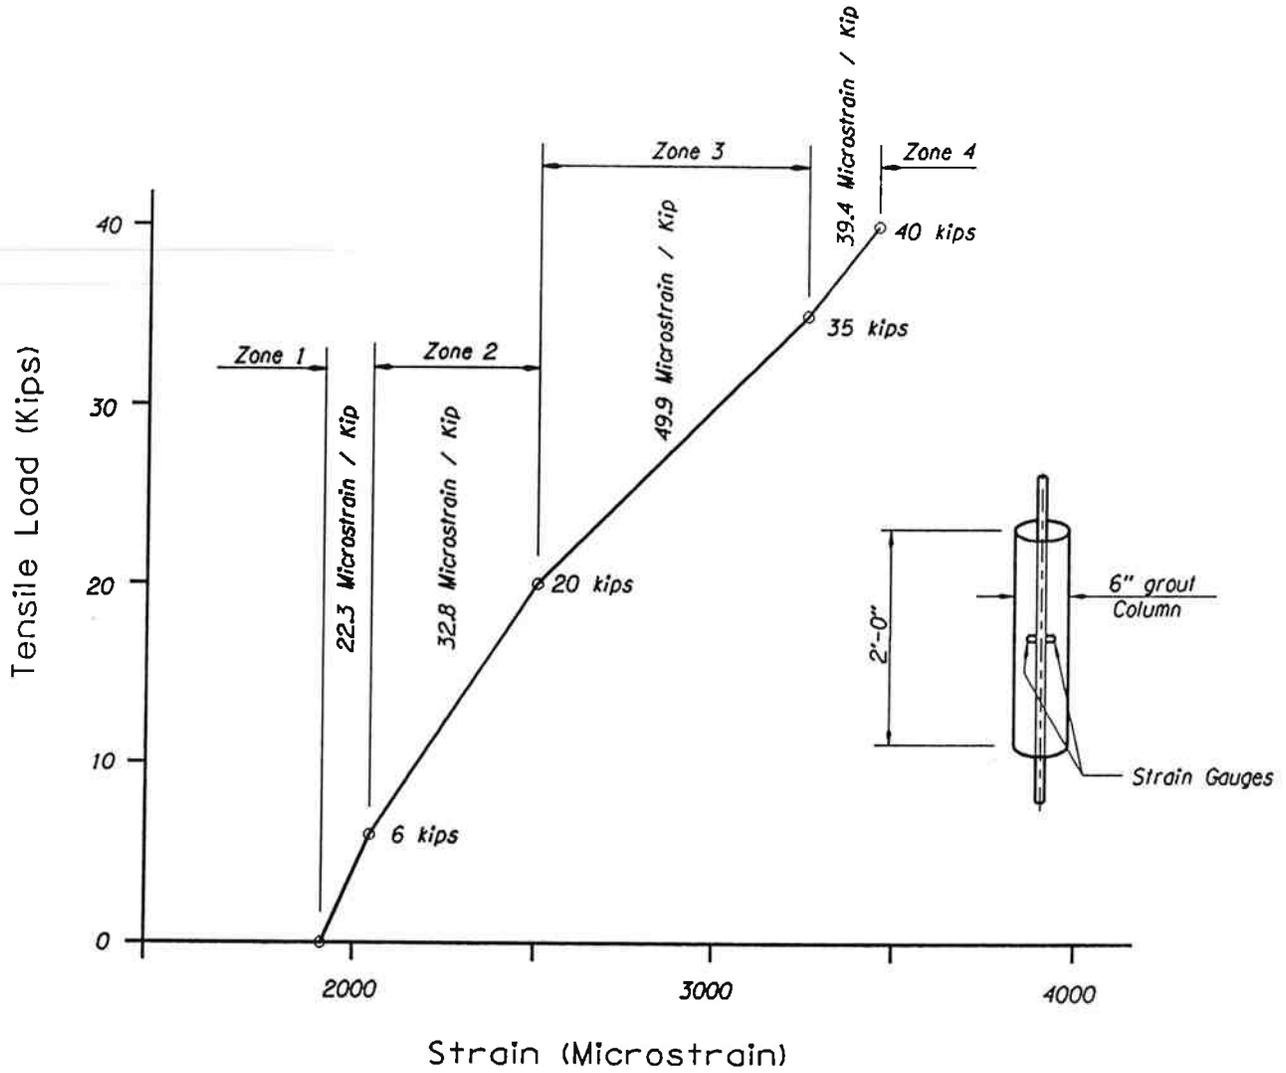
**Figure 35** AVERAGE FORCE - STRAIN RELATIONSHIP CURVE OF A GROUTED TEST NAIL

1. The first zone was in the zero to 6 kips (0 to 3 tonnes) load range. Strain gauges G0 and G1 registered a change in strain with load of 21.8 and 23.0 microstrain/kip respectively. The average change in strain with load was 22.3 microstrain/kip. The cement grout was intact.
2. The second zone was in the 6 kips to 20 kips (3 to 9 tonnes) load range. Strain gauges G0 and G1 registered a change in strain with load equal to 32.6 and 32.9 microstrain/kip respectively. The average change in strain with load was 32.8 microstrain/kip.

The average change in strain with load in this zone reflected a loss in the axial stiffness of the cement grout-Dywidag bar system. The increased strain in the bar was most likely due to the initiation of microcracks in the cement grout. This in turn caused the cement grout to shed part of its tensile load to the bar. The cement grout was partially ineffective in carrying the tensile load due to microcracking.

The measured strains reflected a rapid loss in the axial stiffness of the cement grout-Dywidag bar system. The average change in strain of 49.9 microstrain/kip was larger than the measured average change of 40.4 microstrain/kip for the ungrouted bar. The larger increase in strain in the grouted bar system indicated that the cement grout was rapidly becoming ineffective as a load-carrying member due to widening of the cracks, and the rapid transfer of load from the cracked grout to the bar.

4. The fourth zone was in the 35 kips to 40 kips (16 to 18 tonnes) (maximum test load) load range. Strain gauges G0 and G1 registered a change in strain with load equal to 41.0 and 38.0 microstrain/kip respectively. The average change was 39.4 microstrain/kip.

The average change in strain of 39.4 microstrain/kip was nearly equal to the measured average change of 40.4 microstrain/kip for the ungrouted Dywidag bar. This indicates the Dywidag bar was acting alone in carrying the tensile load while the cement grout was totally ineffective.

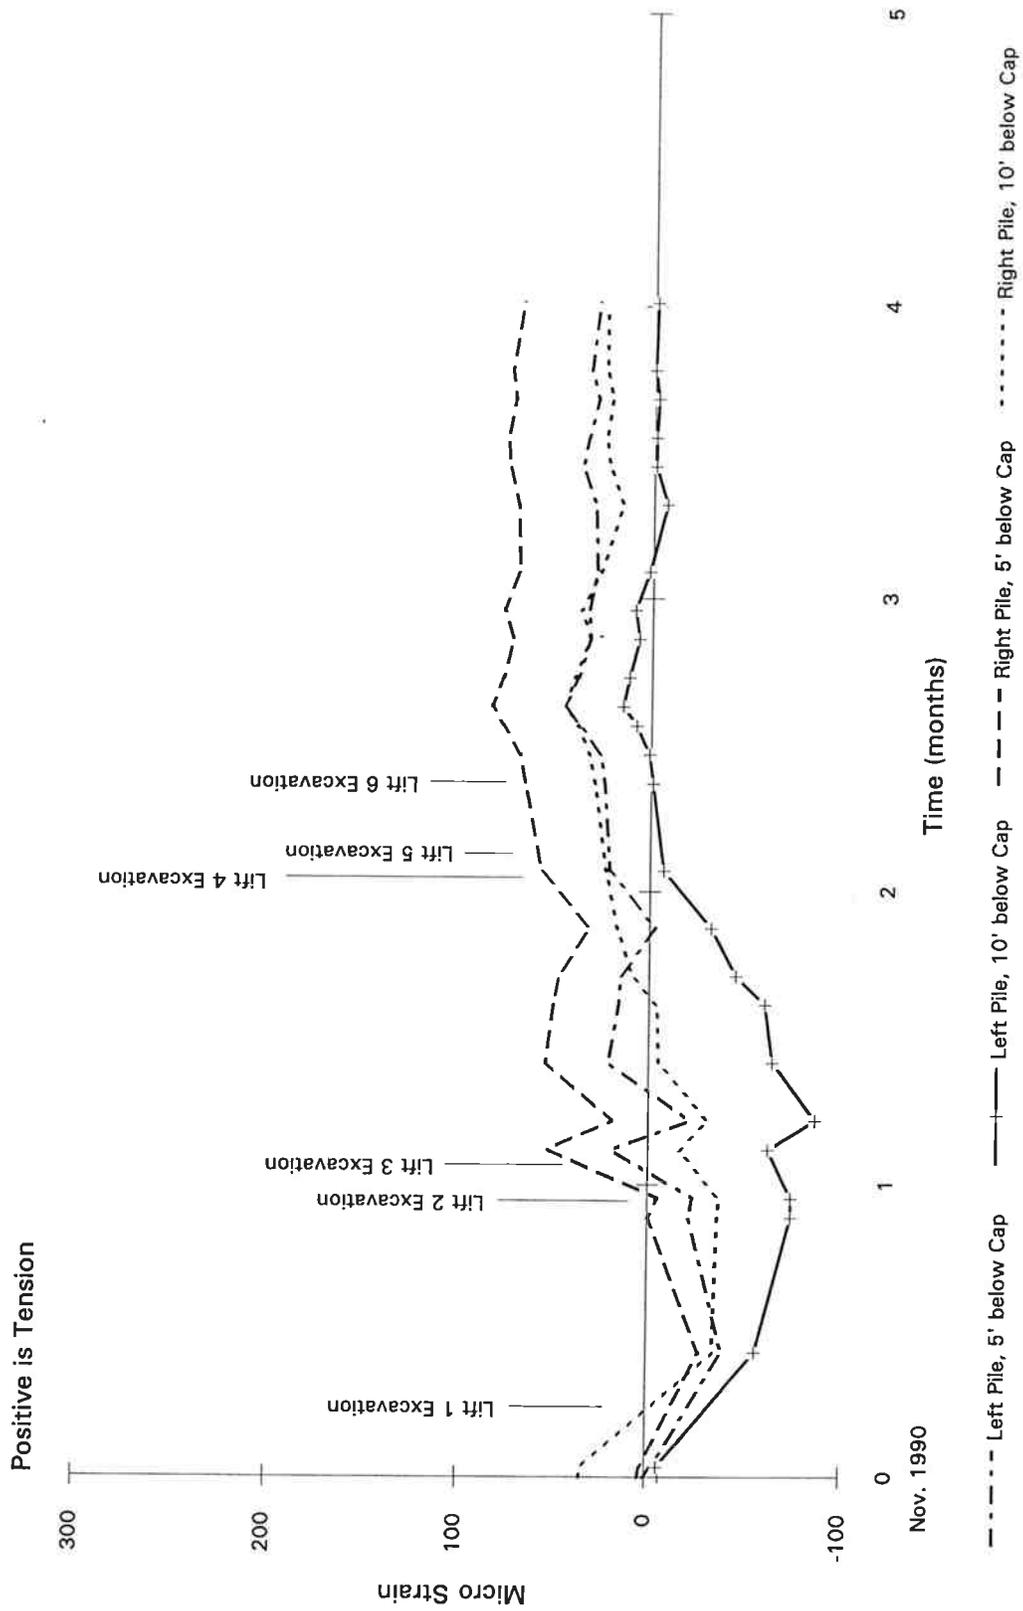
**Fig. 84 - Short Term Pile Strain Gauge Readings**

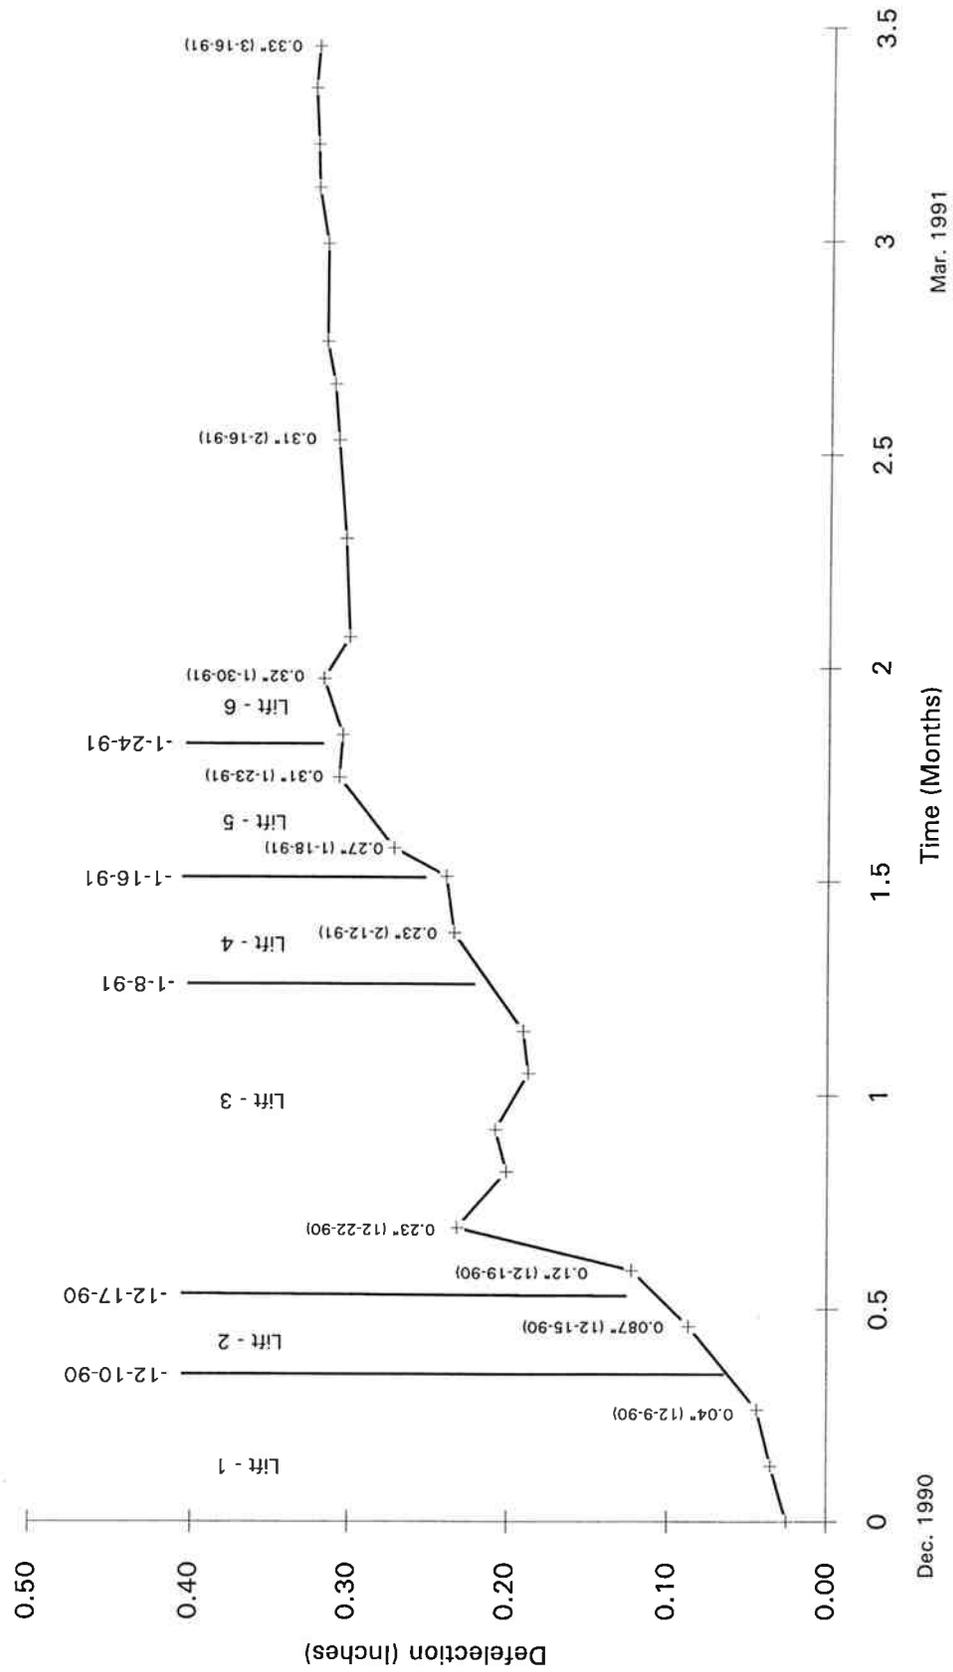
**Fig. 86 - Short Term Pile Cap Deflection Measured by Single Point Extensometer**

The contractor drilled a hole through the existing pile cap and installed the single point extensometer at the center of the cap (Figure 12). The anchor depth of the extensometer was 61.0 feet (19 m) behind the bridge pile cap. The reference head of the extensometer was mounted in the pile cap. Readings are made using a manual digital readout micrometer which measures the distance between the reference plate and the stainless steel rod tip, located inside a small diameter hole in the reference plate.

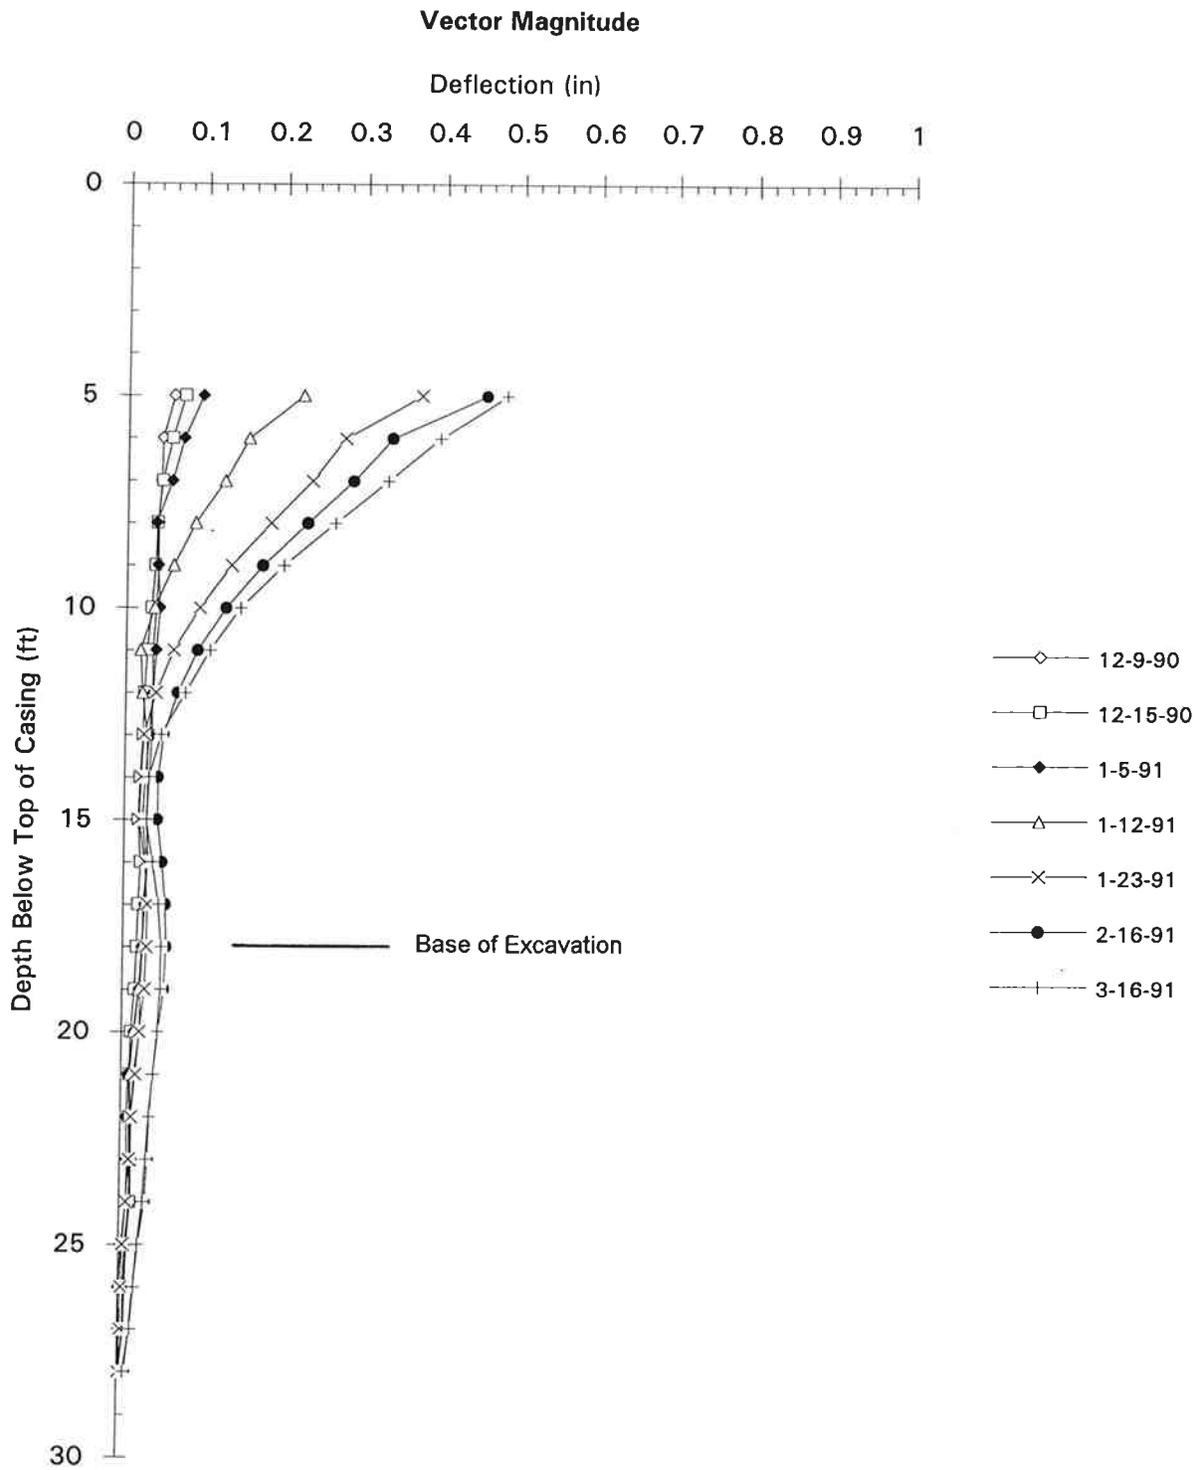
**Fig. 87 - Short Term Deflections - Slope Inclinometer SD129**

The inclinometers were located 10 feet (3 m) (SD128) and 38 feet (12 m) (SD129) west of the bridge. Both inclinometers were located  $\pm 3.5$  feet (1 m) behind the back face of wall. During the installation of the soil nails for lift No. 1, the casing for SD128 was severed. The damaged inclinometer was replaced by SD130 which was installed next to the abandoned SD128.

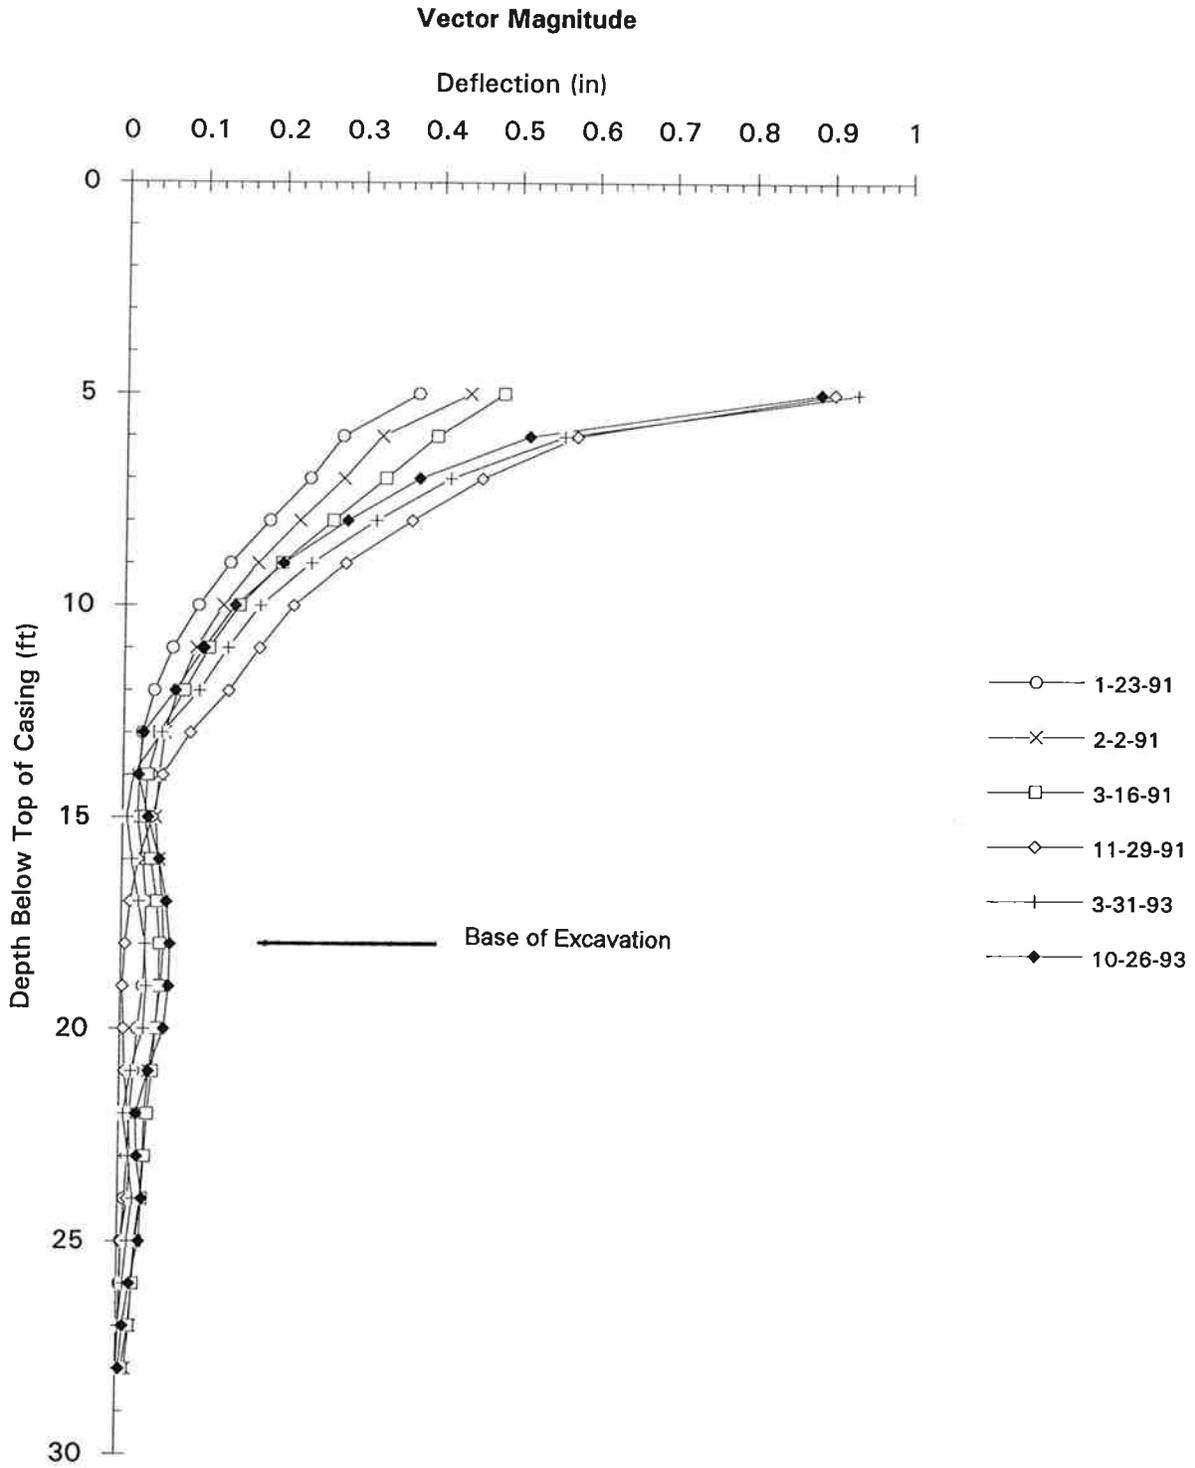
Fig. 147 - Long Term Deflections - Slope Inclinometer SD129

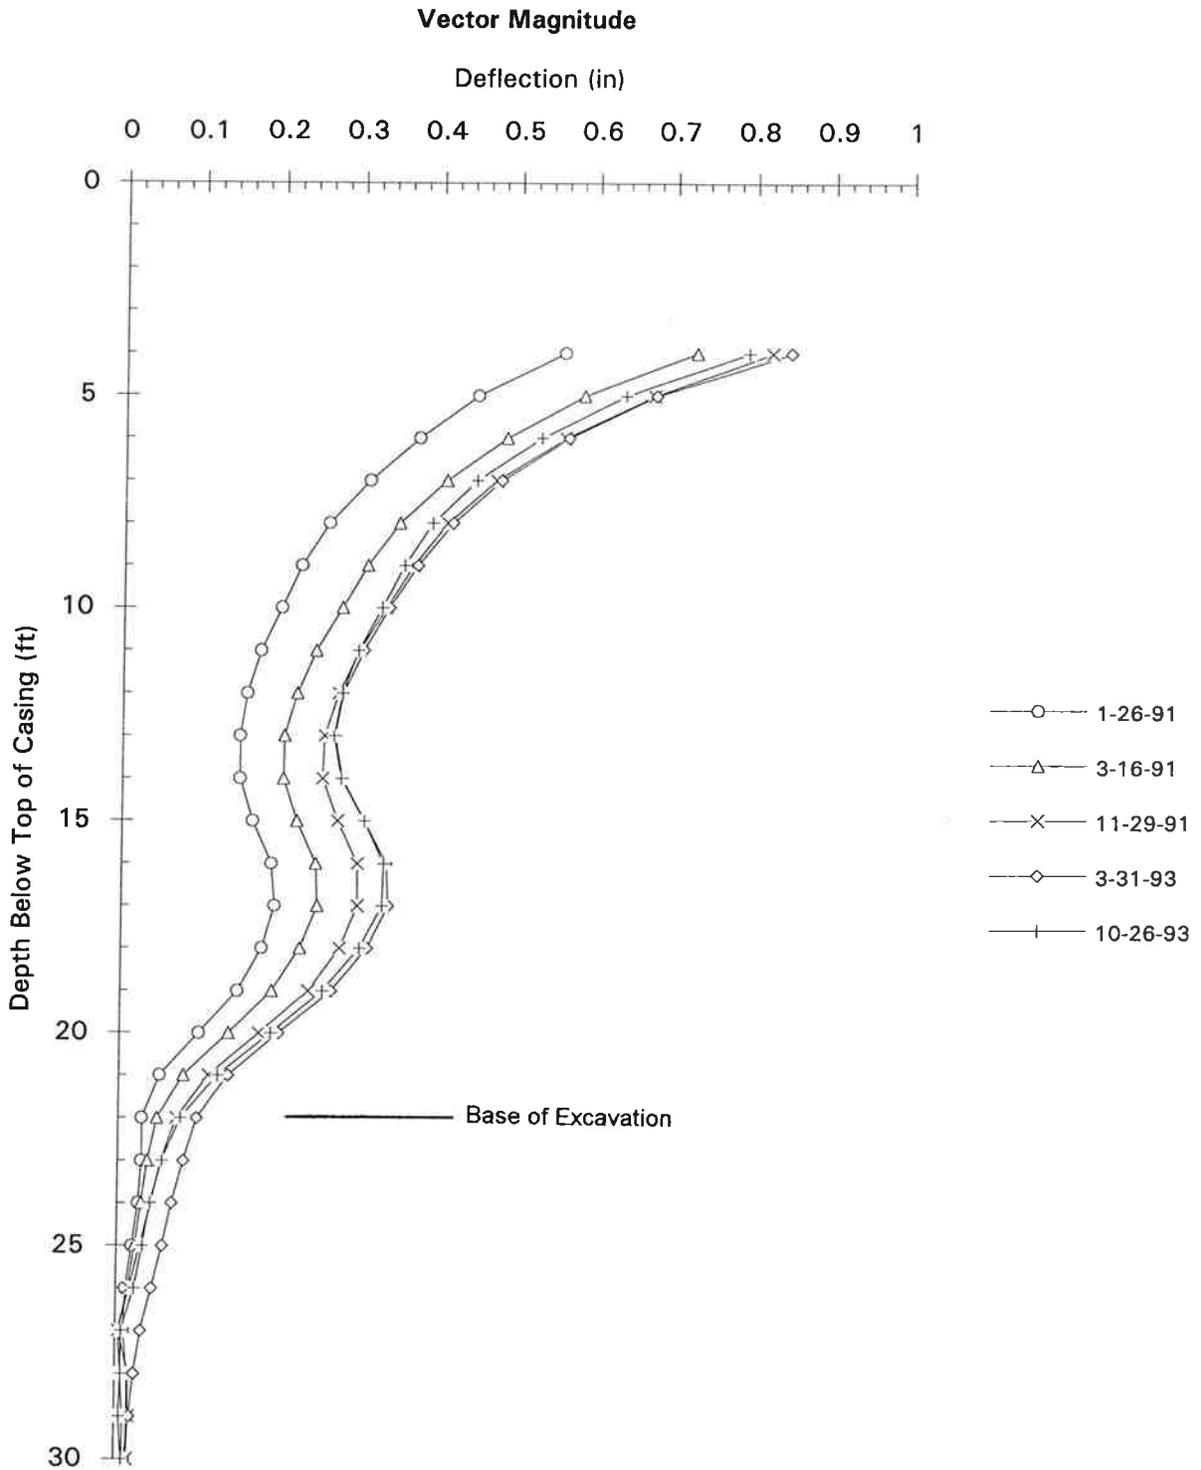
**Fig. 148 - Long Term Deflections - Slope Inclinometer SD130**

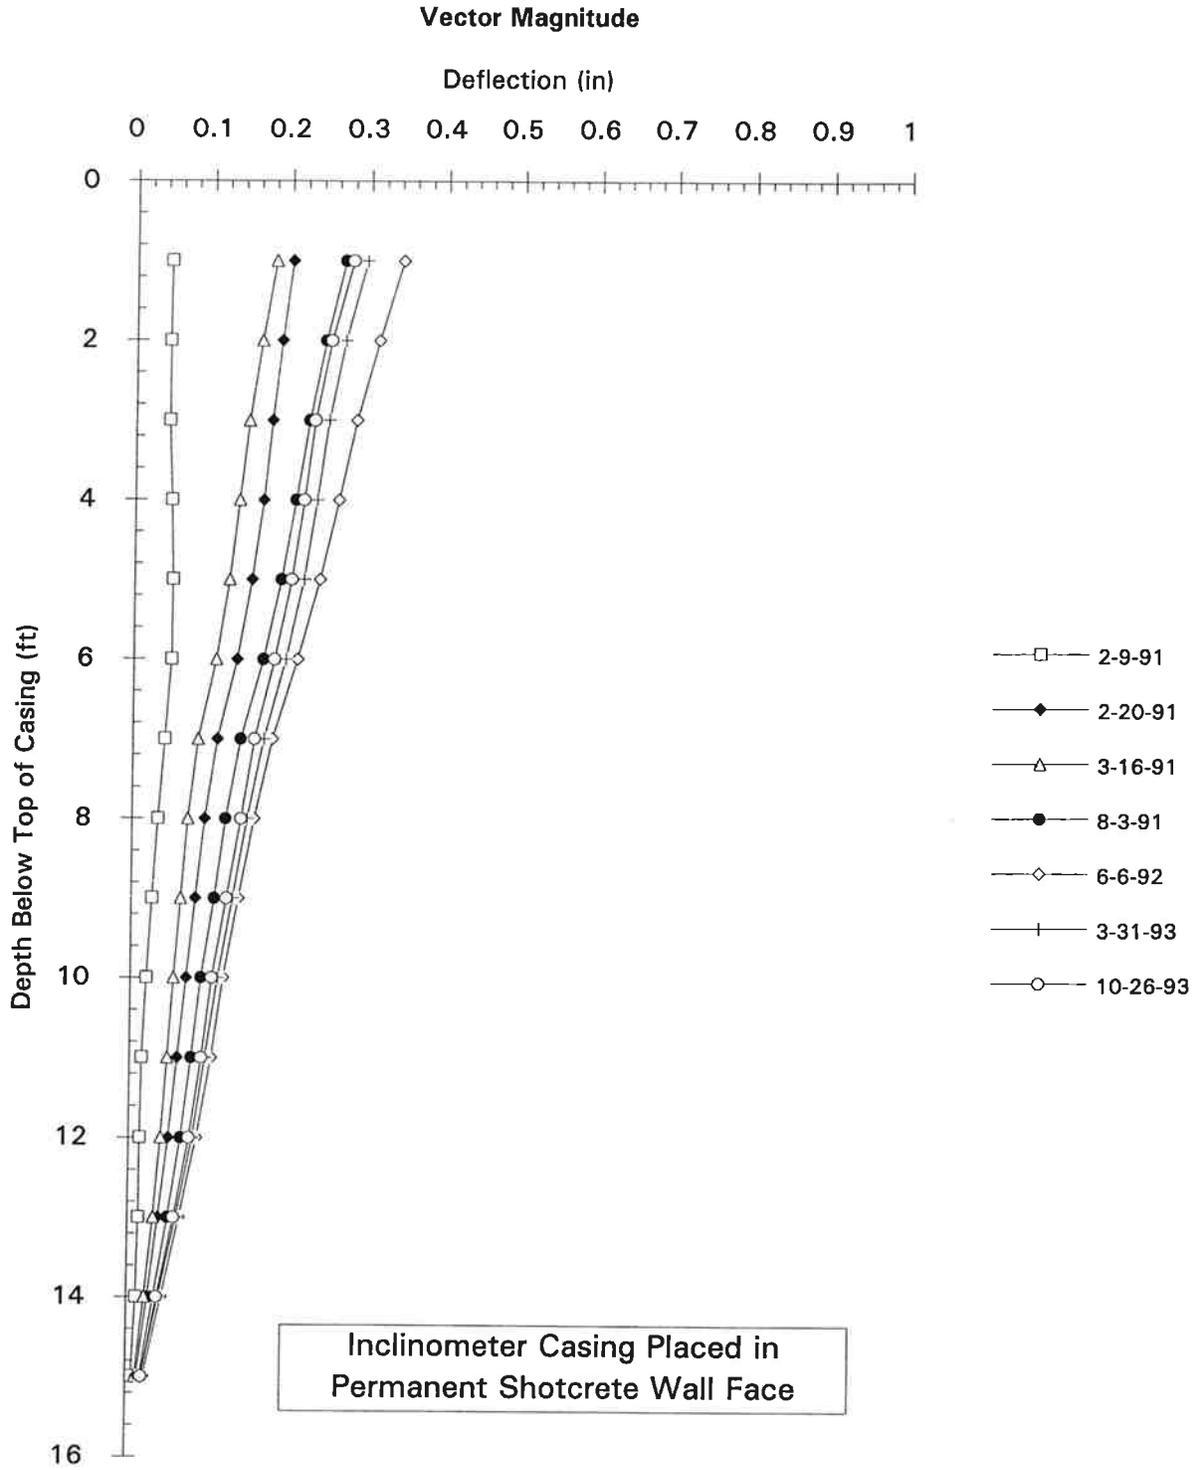
Fig. 149 - Long Term Deflections - Slope Inclinometer SD131

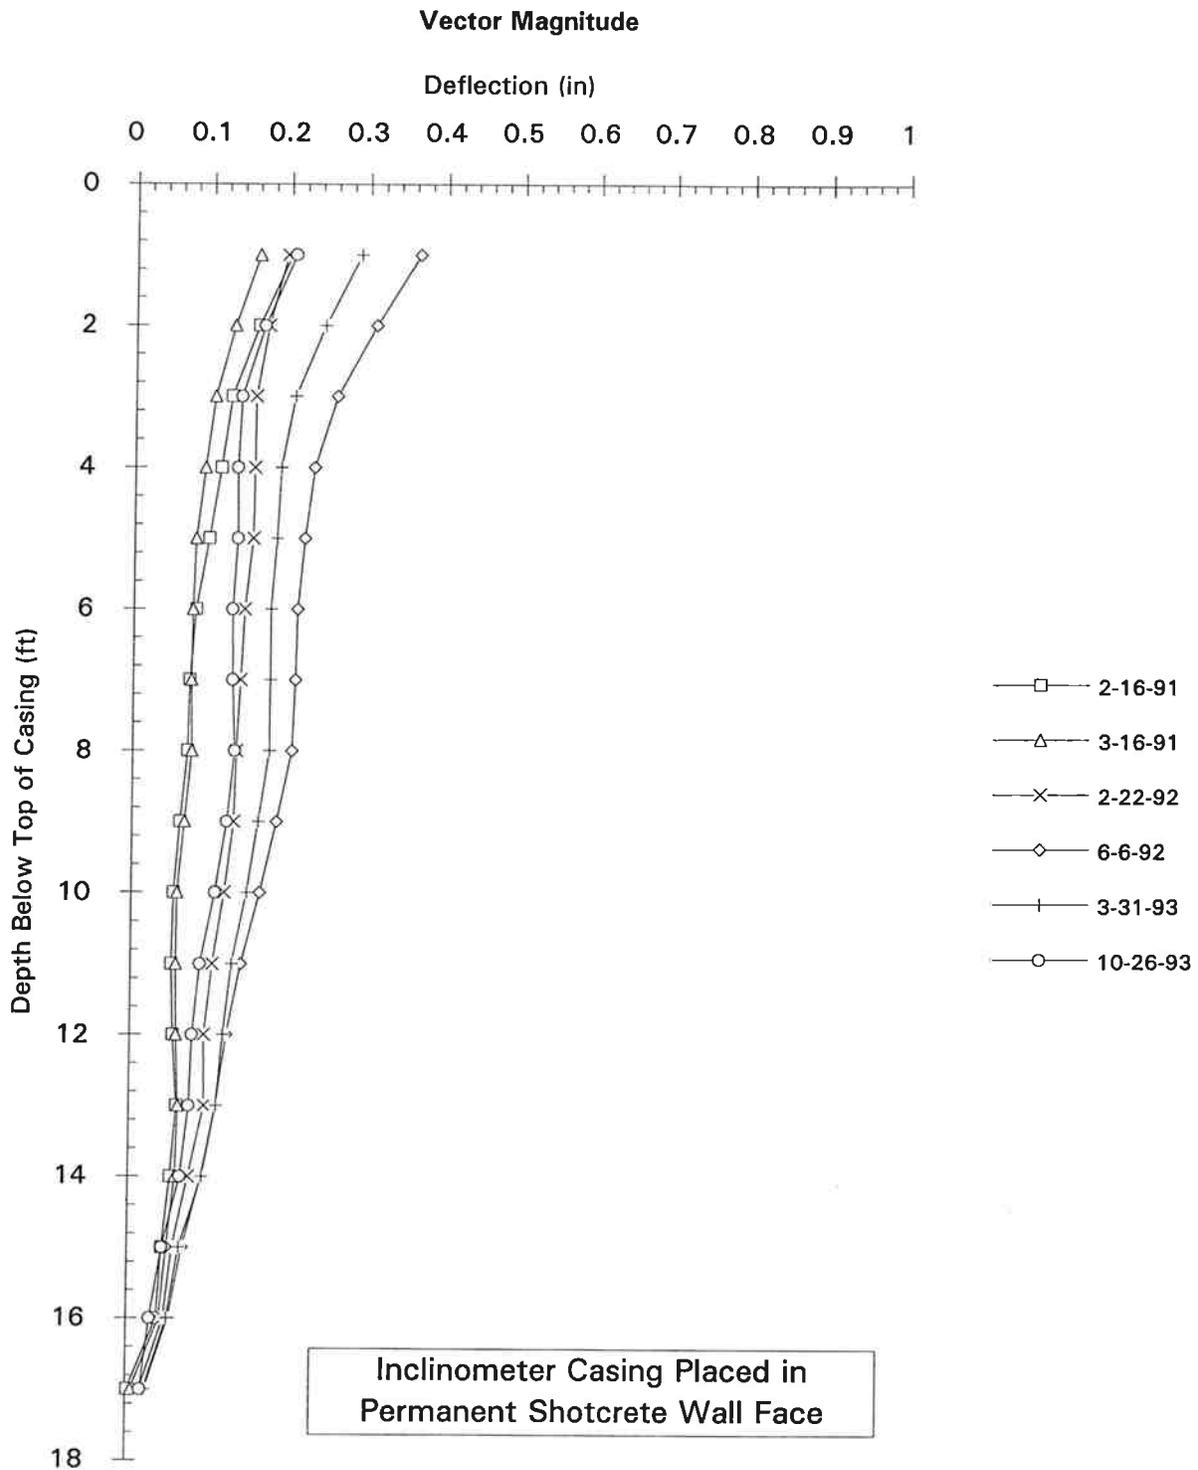
**Fig. 150 - Long Term Deflections - Slope Inclinometer SD132**
