**SOIL NAILING  
OF A  
BRIDGE EMBANKMENT**

**Report 2:  
DESIGN AND FIELD PERFORMANCE  
REPORT**

Experimental Features  
Project OR 89-07

**Oregon Department of Transportation  
Salem, Oregon 97310**

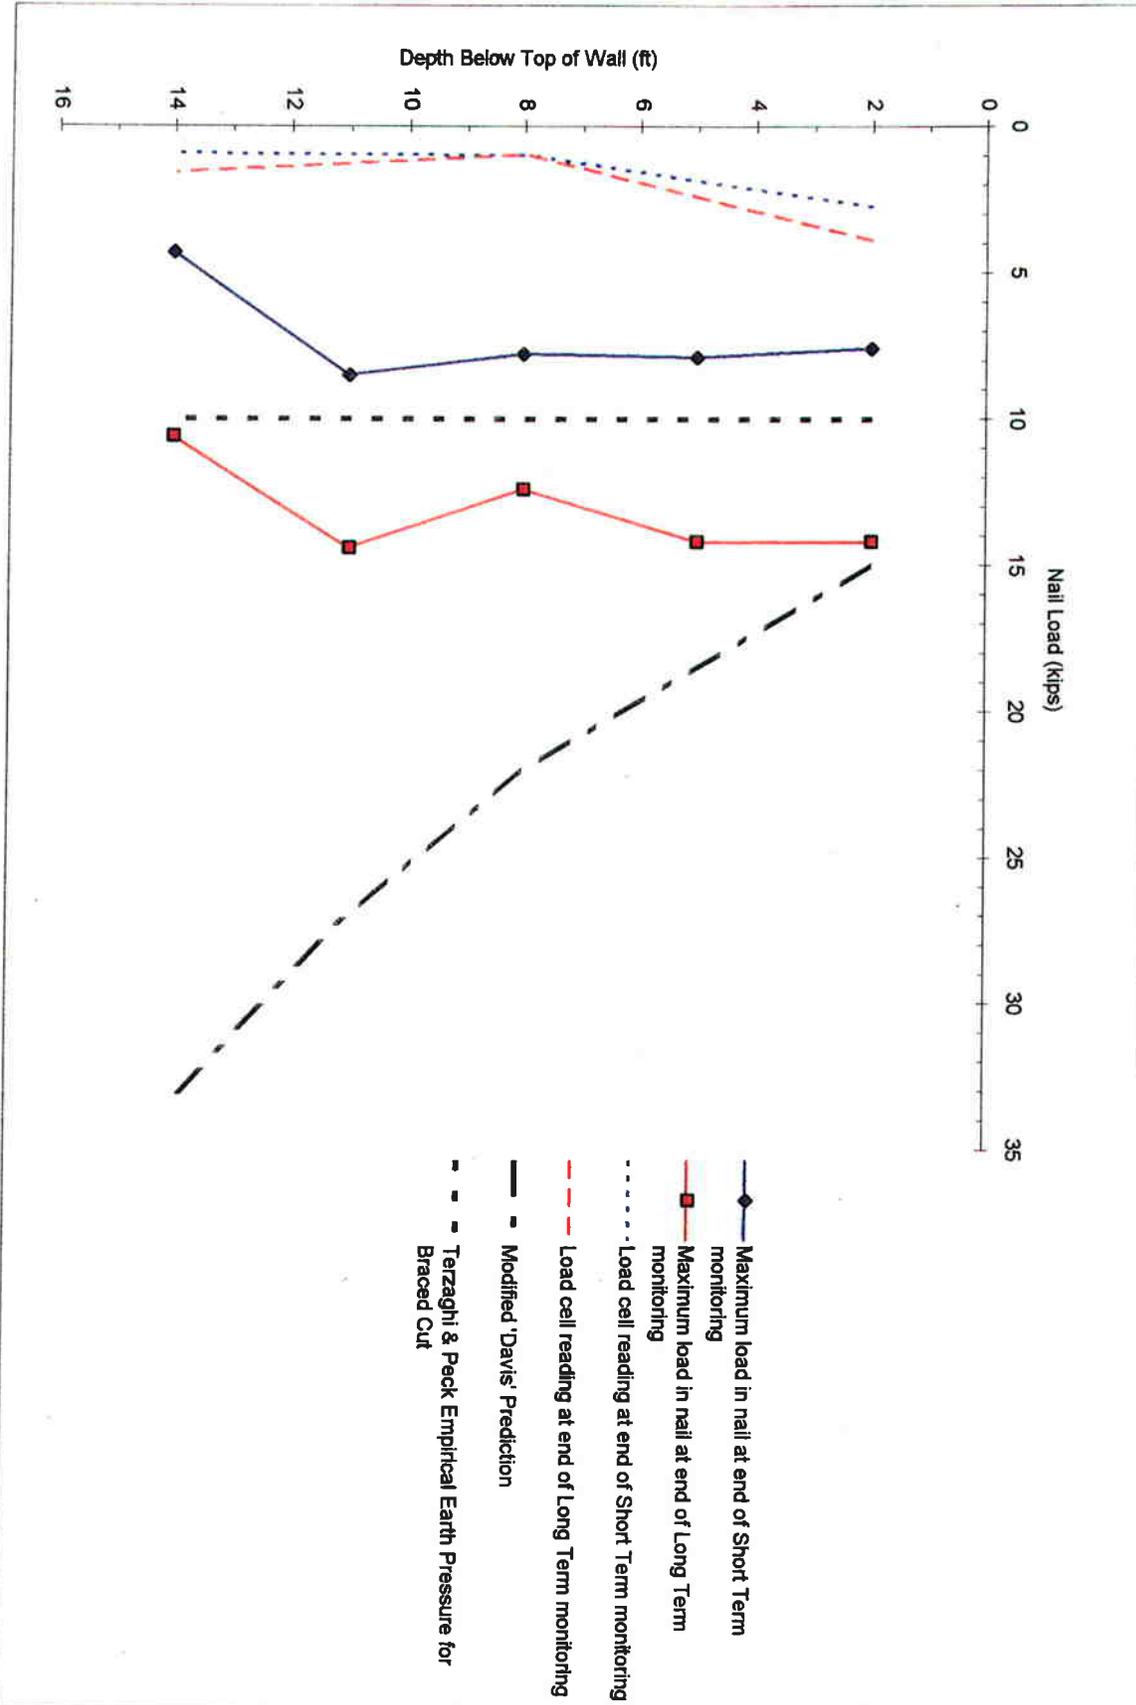
**Fig. 151 - Maximum Measured vs. Theoretical (design) Nail Loads at Section 1**

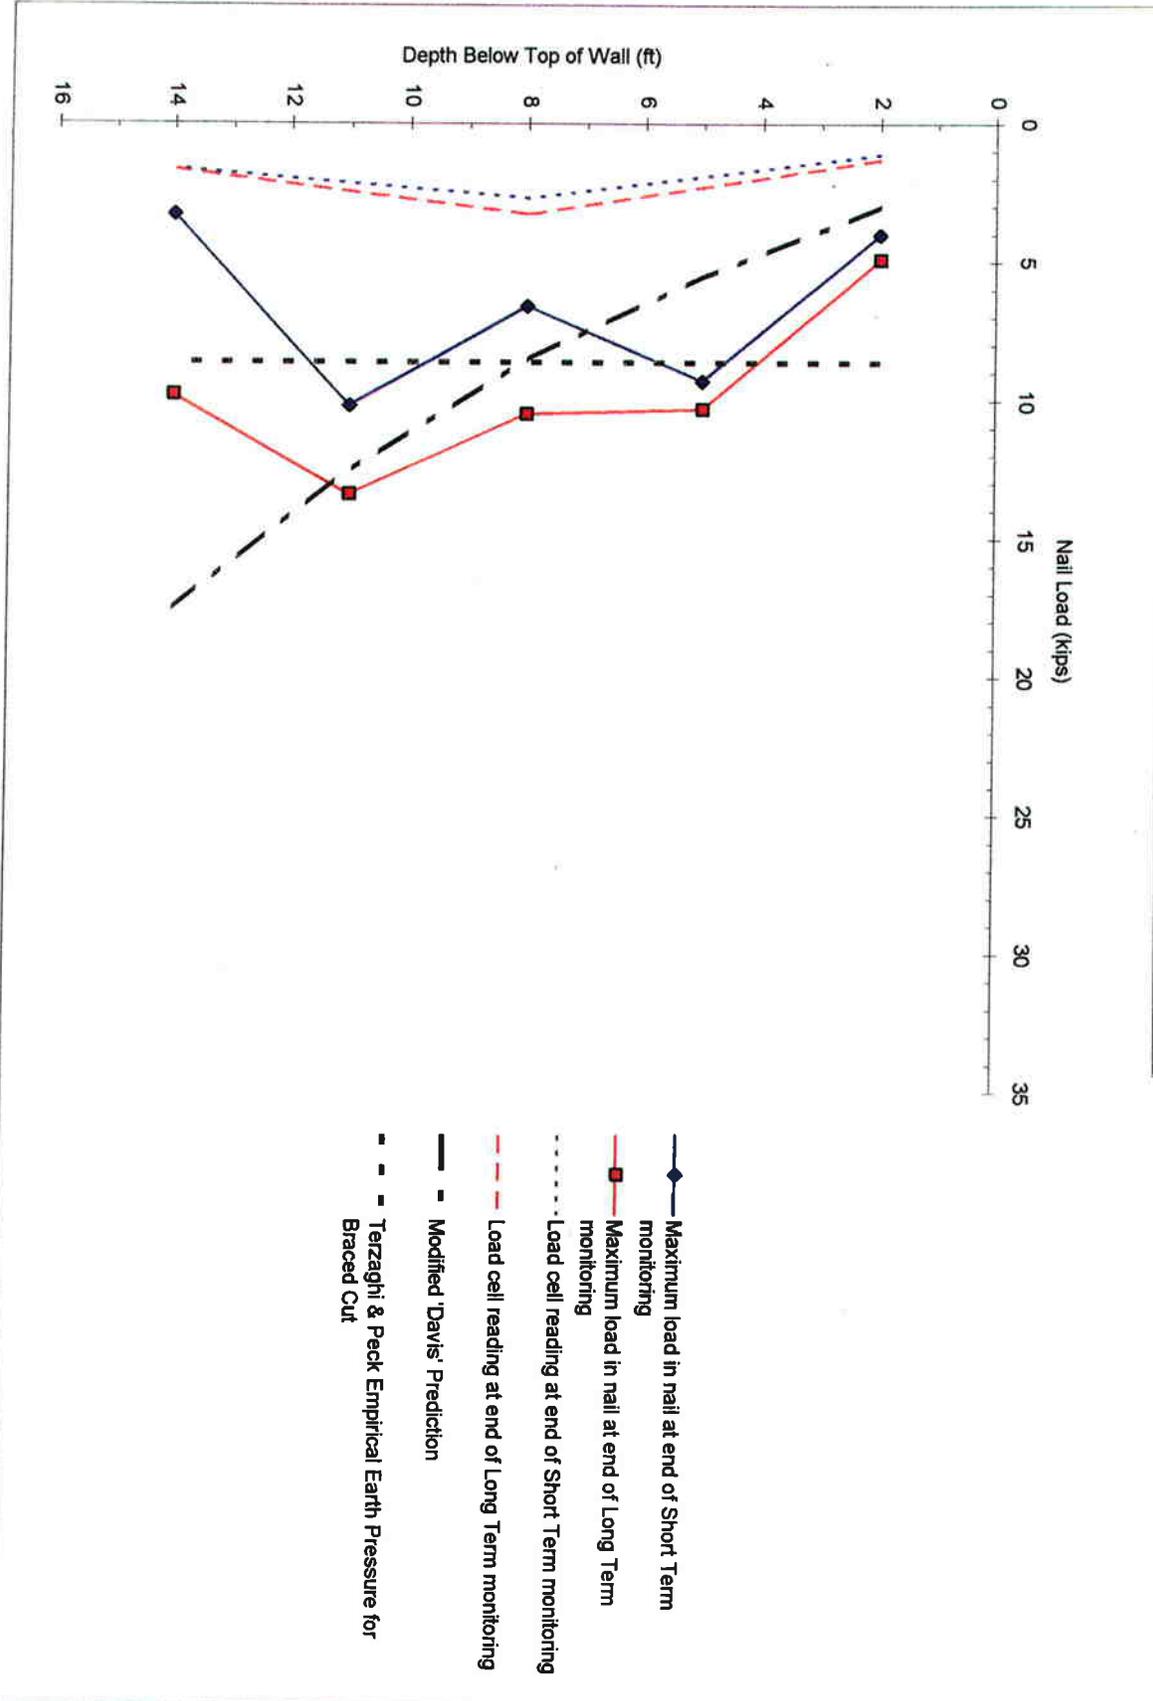
**Fig. 152 - Maximum Measured vs. Theoretical (design) Nail Loads at Section 2**

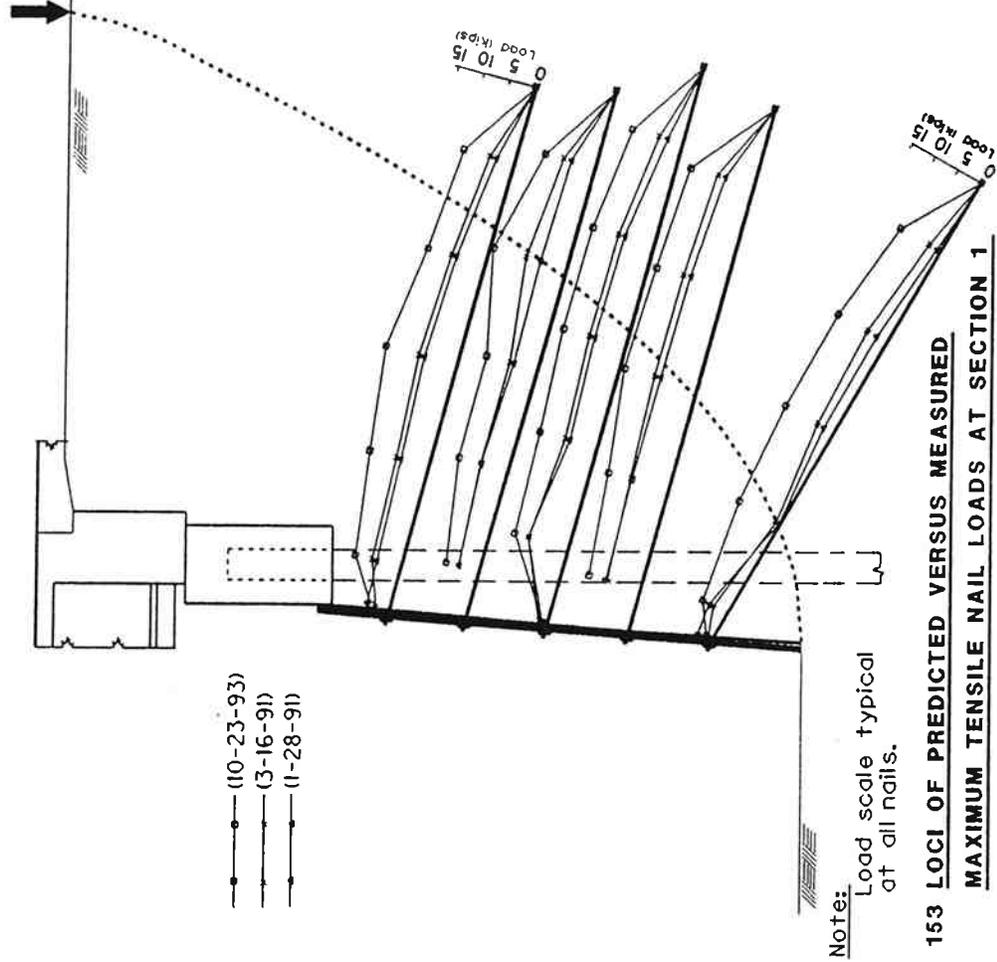
Modified 'Davis' Method - Minimum F. S.  
Slope Stability Failure Surface

FIG. 153 LOCI OF PREDICTED VERSUS MEASURED  
MAXIMUM TENSILE NAIL LOADS AT SECTION 1
