**EXPERIMENTAL PROJECT
USE OF SHREDDED TIRES
FOR LIGHTWEIGHT FILL**

**FHWA Experimental Project No. 1
DTFH-71-90-501-OR-11**

Post-Construction Report

**OREGON DEPARTMENT OF TRANSPORTATION
HIGHWAY DIVISION
ROADWAY SECTION
Salem, Oregon 97310**

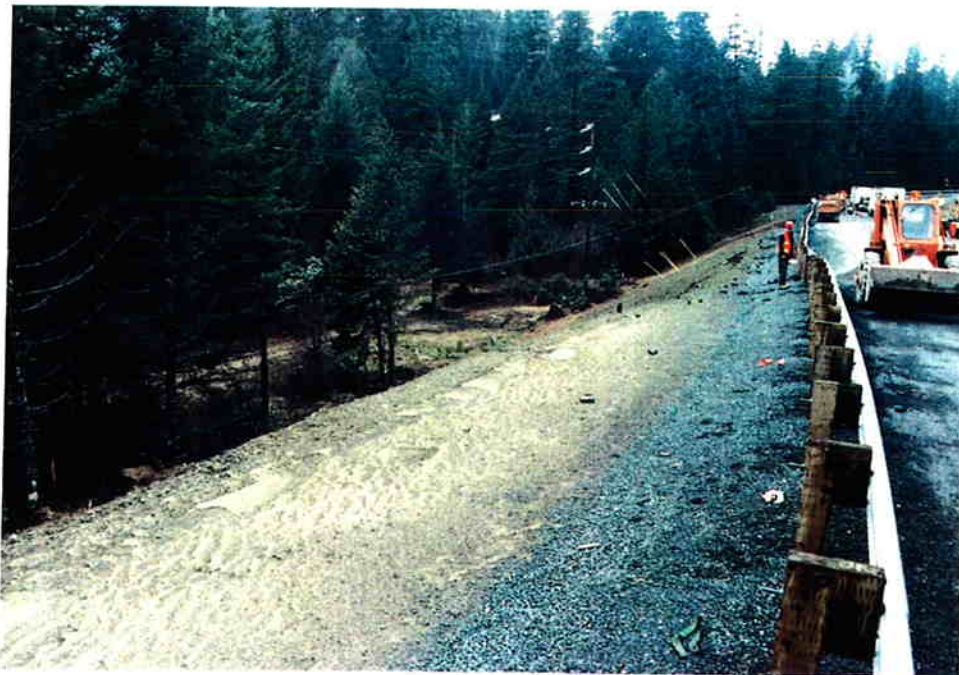
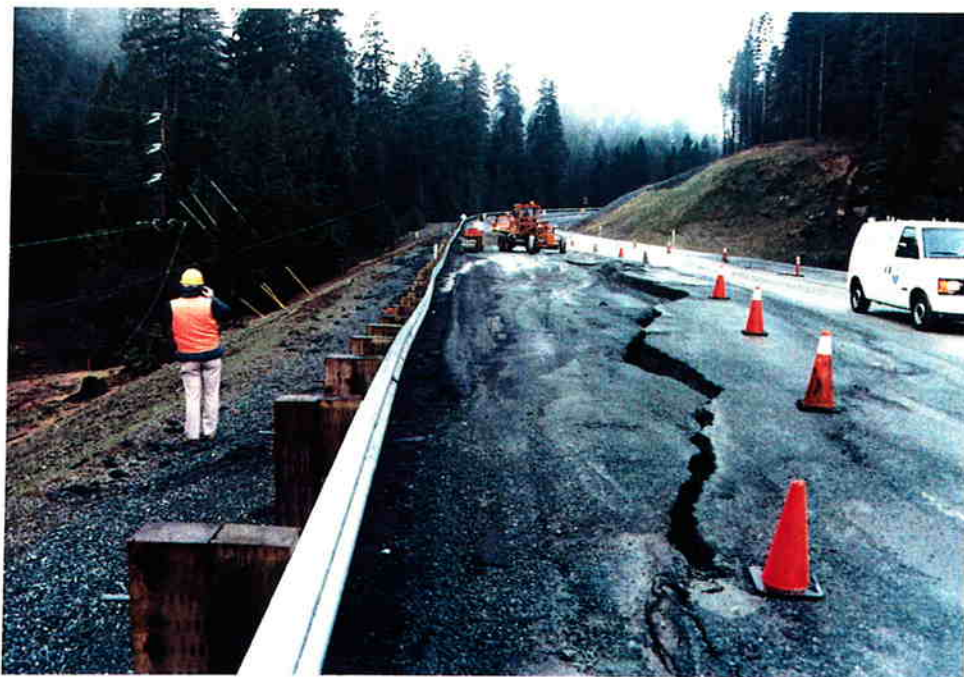
Figure 2

LANDSLIDE DISTRESS: FEBRUARY 6, 1990

The first indications of a possible landslide problem were pavement cracks which appeared in September, 1989, shortly after construction of new embankment that raised the previous highway embankment 4 feet and widened it about 20 feet. More definite slide symptoms, as shown in Figures 2 and 3, appeared early in 1990. The original ground underneath the embankment is gently sloping. The slide is a block slide riding on an old slip plane of an ancient slide. Although the old slip plane had "healed" and had enough strength to support the original 11-foot-high embankment, the additional load of the new construction was sufficient to activate the portion of the ancient slide between the highway and the creek. The head scarp of the new slide is at approximately the centerline of the highway. Figure 4 is a plan drawing of the slide.

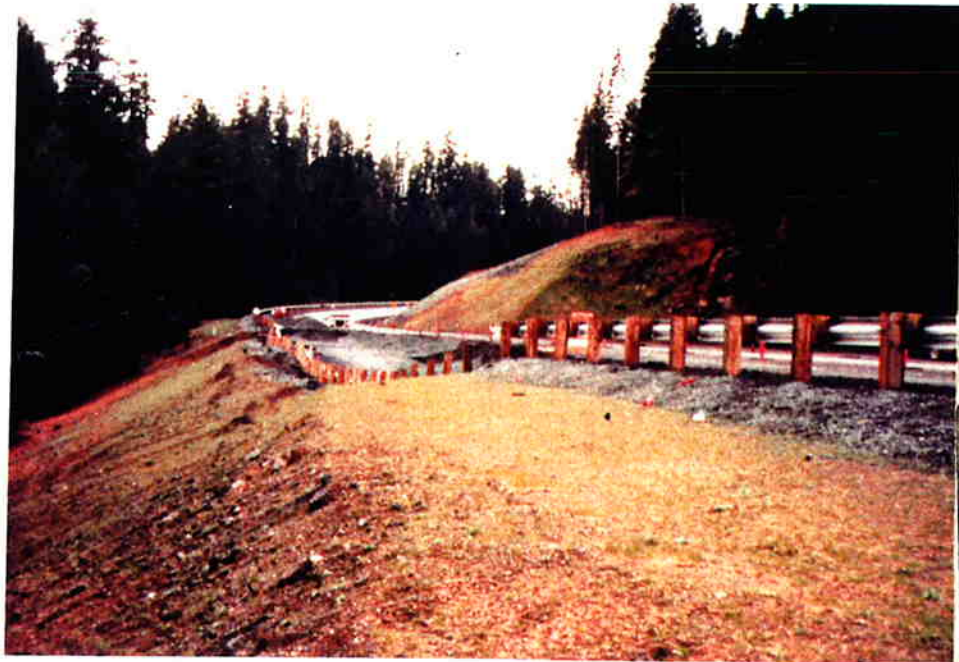
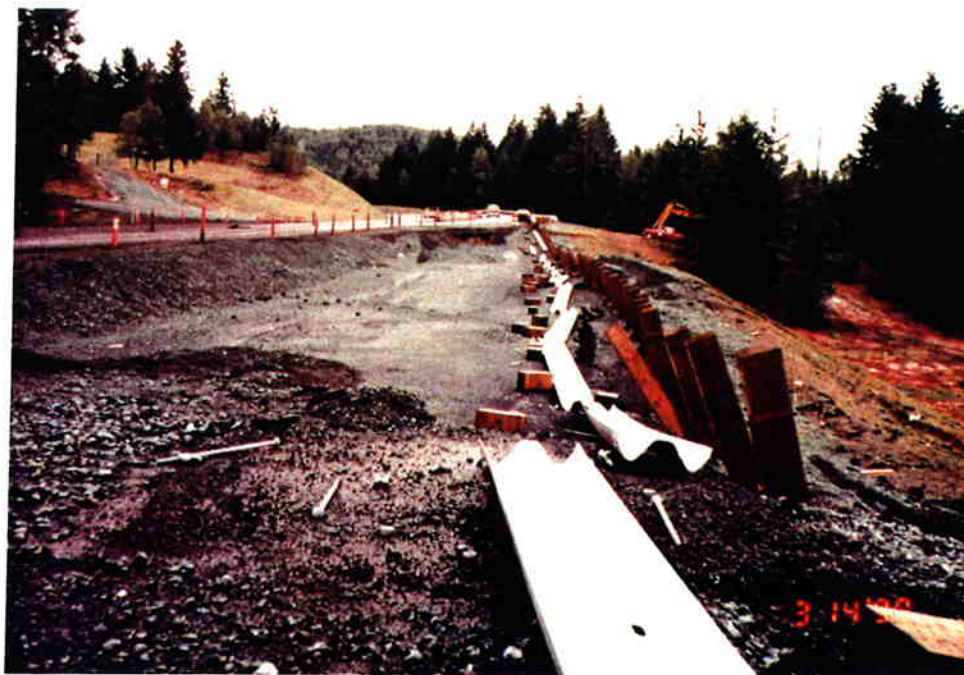
Figure 3

LANDSLIDE DISTRESS: MARCH 14, 1990

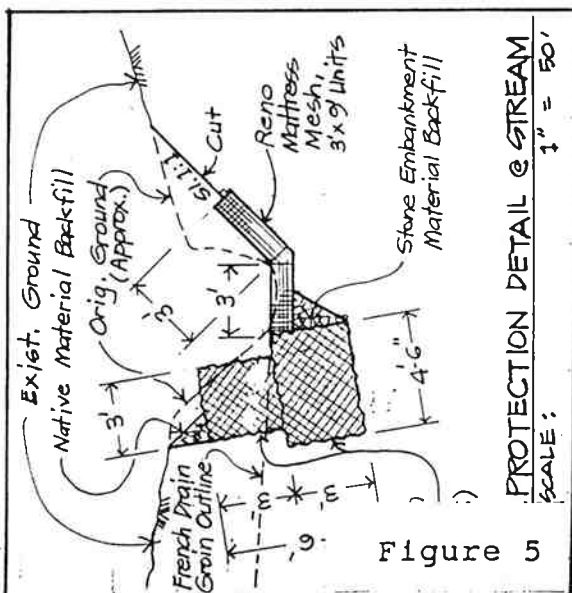
Figure 5

SECTION: STA. 1864 + 50
SCALE: 1" = 20' H & V

PROTECTION DETAIL @ STREAM
SCALE: 1" = 50'

CAMAS VALLEY-MUNS CREEK DOUGLAS COUNTY
SECTION: STA. 1864 + 50 AND DETAIL
HWY. 35 (Coo's Bay - Roseburg) M.P. 56.0-61.8
E.A. NO. C10.G.5.3 DATE: APR. 90
GEOTECHNICAL GROUP Oregon State Highway Division

Geotechnical analyses indicated that an effective correction scheme would be removal of some of the embankment weight by replacement with shredded tires and use of the excavated embankment soil to construct a counterbalance berm between the embankment toe and the creek. The weight of the counterbalance acts as a force resisting the movement of the landslide.

The design called for removal of 8,500 cubic yards of earth embankment to be replaced with shredded tires. (Final tire volume was 8,260 cubic yards.) The weight of soil removed was approximately 12,800 tons compared to 5,800 tons of shredded

tires used as replacement. An estimated 580,000 tires were used. Details of the design are shown on Figures 5, 6 and 7.

A drainage blanket consisting of 12 inches of free-draining rock between two layers of geotextile was placed beneath the shredded tire embankment and beneath the counterbalance in order to prevent the groundwater table from rising into the embankment. Three 10-foot-deep french drains which outlet into Shields Creek were located beneath the blanket to enhance the subsurface drainage. The tire chips would have served as a good drainage medium without the rock blanket, but the Oregon DEQ required the rock blanket so the tire chips would not be submerged.
