**EVALUATION OF INFRARED  
TREATMENTS FOR MANAGING  
ROADSIDE VEGETATION**

**Final Report**

**SPR 376**

*Oregon Department of Transportation*

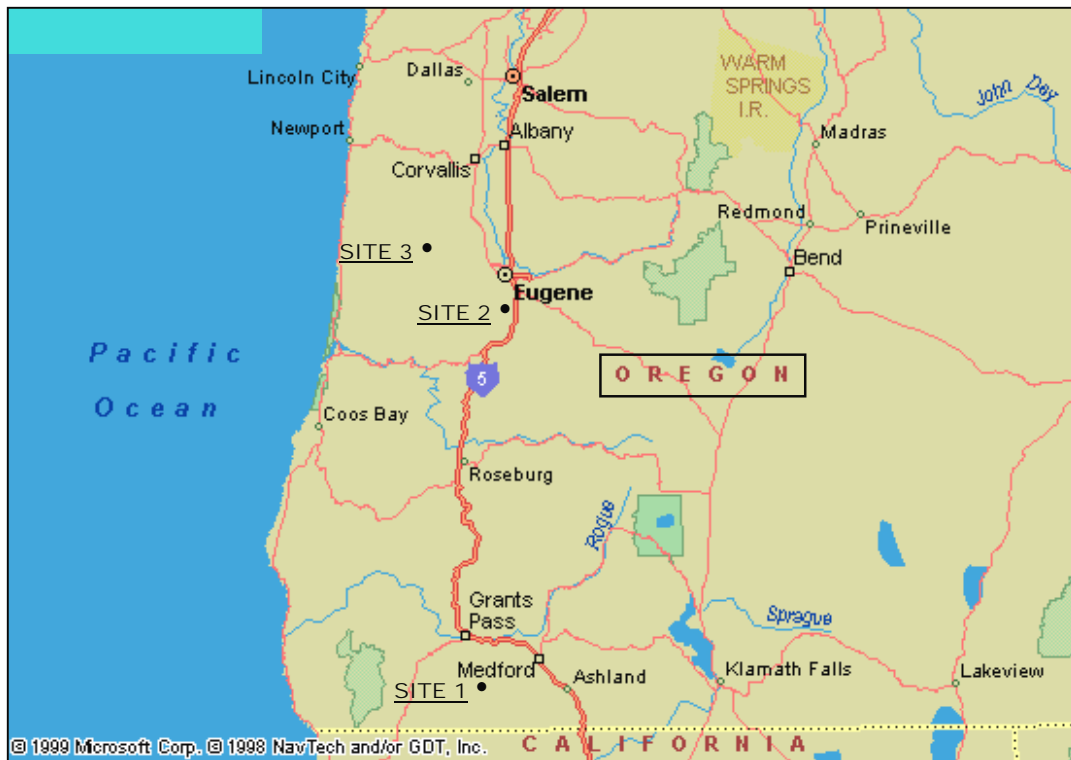
Figure 3.1: Test site locations

Three physiographic sites were used in this study. The sites were located in rural areas of western Oregon between the Coast and Cascade mountain ranges. They were along two-lane asphalt highways with gravel shoulders. Figure 3.1 shows the general locations of the three test sites. The study began with infrared treatments at Site 1 in November 1996. Sites 2 and 3 were added in February 1998 to test different climates and vegetation. Site 2 was the most typical of Western Oregon climate. Table 3.1 gives a summary description of the test sites.

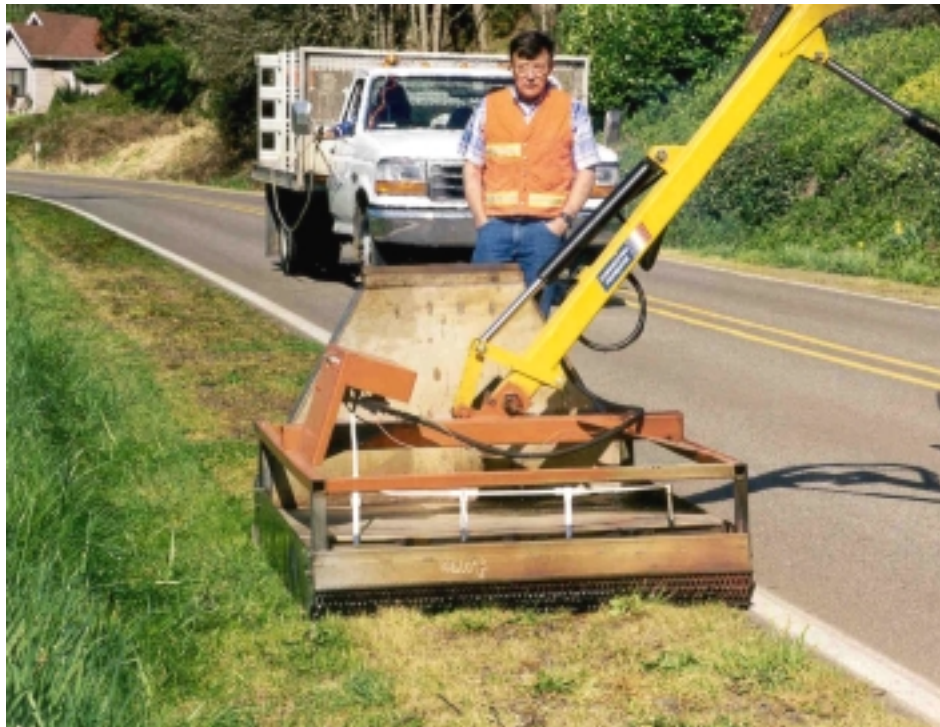
Figure 4.1: Infrared vegetation control unit

Infrared treatments were applied to the gravel shoulder of the road using a roadside infrared vegetation control unit (Figures 4.1). The prototype unit was manufactured by Sunburst, Inc. located in Eugene, Oregon. It applies an intense heat of about 1500° F (800° C), generated from a liquid propane fuel.

The radiating unit is a steel deck measuring 4 ft wide x 6 ft long (1.22 m x 1.83 m). The width of the treated area is the same as the deck width. The bottom of the deck travels 2 - 4 in. (50-100 mm) above the ground. The distance allows infrared heat to radiate down to the target vegetation with no equipment-to-vegetation contact. A hydraulic boom is used to maintain the proper deck elevation and is combined with a hydraulic pivot at the deck to match the slope of the road shoulder. The boom also provides some flexibility in moving the deck around obstacles such as sight posts, mailboxes and guardrail.

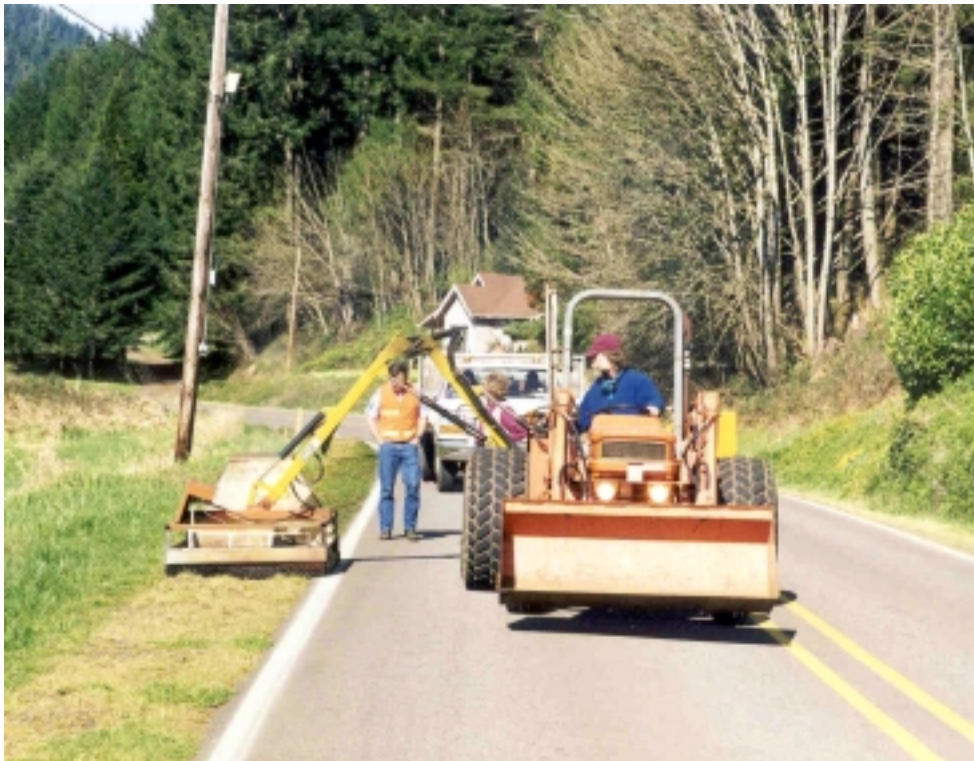
Figure 4.2: Tractor with infrared unit, followed by support truck

Fire control equipment accompanied the operation to extinguish ignited vegetation or debris. This consisted of a support truck with water tank, hose and spray nozzle (Figure 4.2). A laborer on foot with a shovel occasionally assisted in the fire suppression as needed.

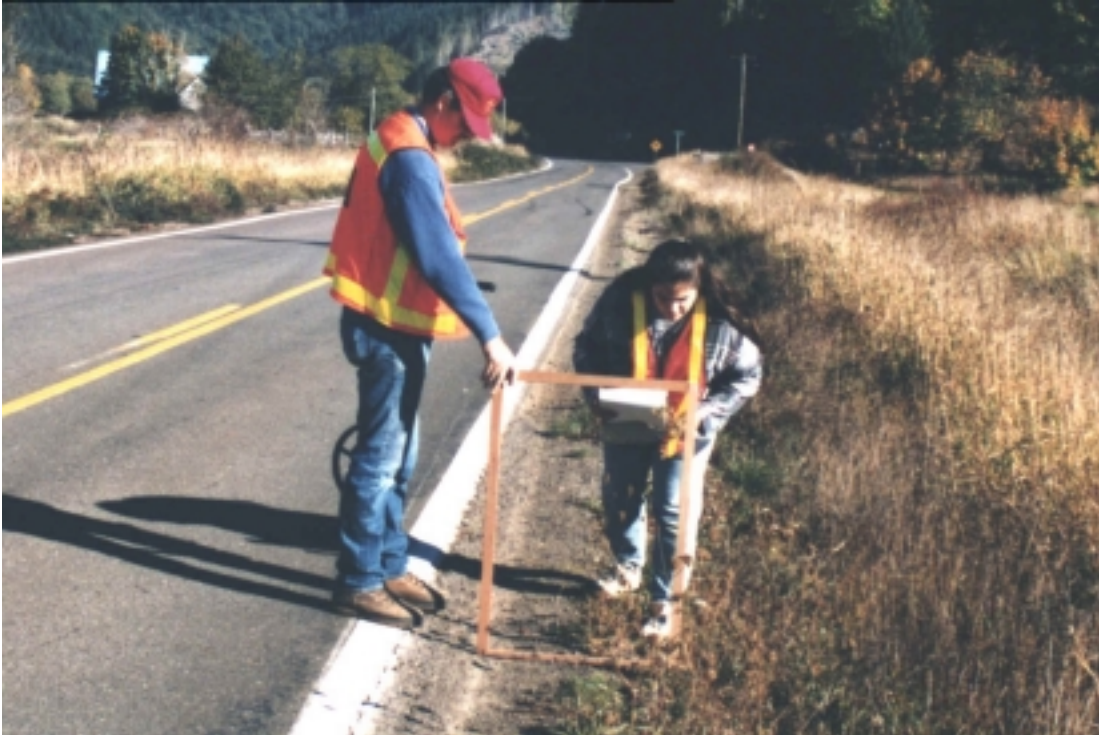
Figure 5.1: Measuring frame used in evaluation

All live vegetation that came in contact with one edge of the measuring frame between 15 and 60 cm was observed. The length of ground coverage was recorded and categorized as grass, broadleaf, or sedge. In addition, any vegetation that extended over the top of the measuring frame was measured by projecting downward over the tape. Dead vegetation was not counted.

In the case of sparsely spaced vegetation, the individual length of plant type coverage (grass, broadleaf or sedge) was recorded over the measured area, and then summed to equal the total length of growth per plant type in the 45-cm range. For example, if two species of grass were scattered along the 45-cm measuring area, the evaluation would proceed as follows:
