Research Notes

RSN 12-01

Improved Gusset Plate Inspection Method

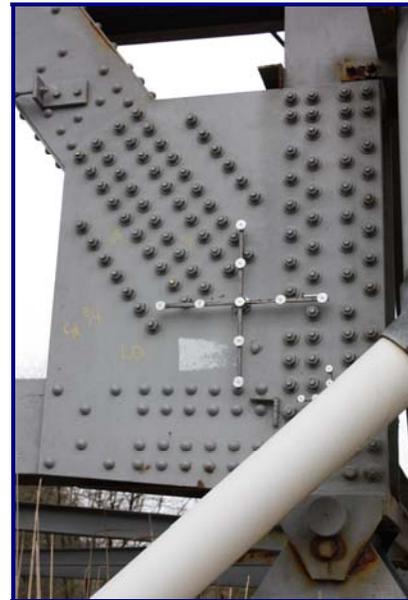
Gusset plate and obstacle

Since the original effort, the Bridge Section has supported further refinement to the photographic method to improve its field applicability for large gusset plates and to acquire images of sections blocked by obstructions. Consequently, OSU developed a method to convert fisheye images to perspective images that can be used in the photographic procedure. Also, multiple images can now be stitched together to make a single image of a gusset plate for analysis. These critical additional features now allow the procedure to be deployed in nearly all field situations.
