Research Notes

RSN 97-2

Cable Guard Rail Preventing Injuries on I-5

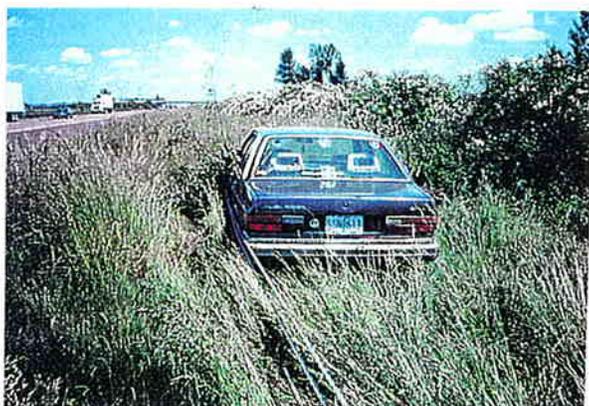
Vehicle prevented from crossing into oncoming traffic

So far, the system is proving effective in reducing the fatalities and injuries caused by crossover collisions on this section of I-5. There have been approximately 21 hits on the system since it was constructed in December of 1996. Eight of these were potential or likely crossovers, but there have only been two injury accidents. No one striking the barrier has been seriously injured. Since the barrier has been in place there have not been any crossover accidents, with the exception of a crossover semi-truck that struck a passenger vehicle. Neither cable

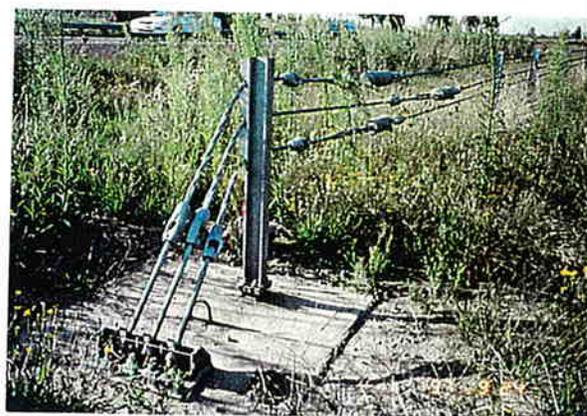
This type of barrier has passed NCHRP 350 crash test requirements. Accident and maintenance history is currently being collected in order to make future recommendations for the use of this type of median barrier. Pictured below is the guardrail anchor assembly with breakaway anchor base plate, breakaway anchor post, turn buckle assembly and tensioning springs.

ET-2000 guardrail anchor assembly
