Cultural Landscape Report: Cant Ranch Historic District

JOHN DAY FOSSIL BEDS NATIONAL MONUMENT

JOHN DAY FOSSIL BEDS NATIONAL MONUMENT, OREGON

September 1996

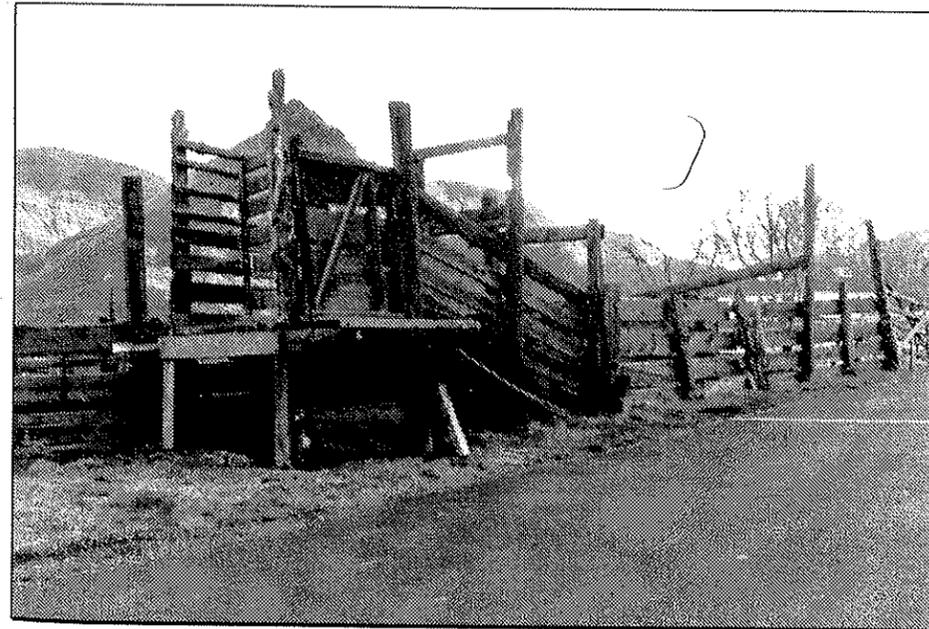
Cattle chute next to Highway 19. Photo, 1993.

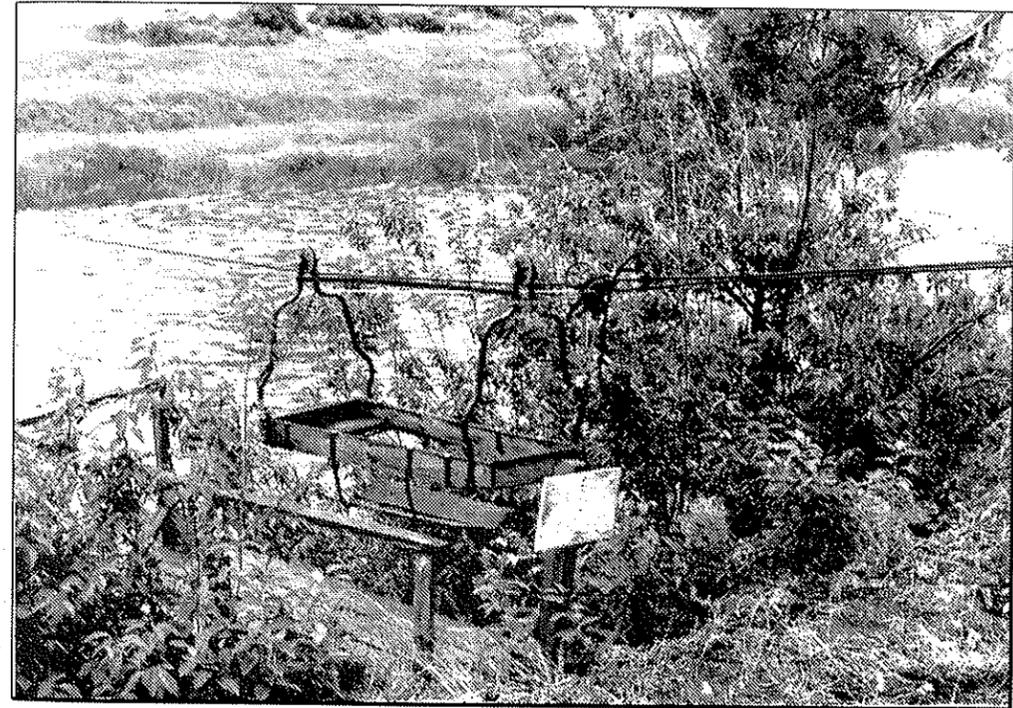
*Cable car dating from the
Sheep Ranch era. Photo,
1993.*
