**CULTURAL  
RESOURCE  
INVENTORY:**

**Sheldon National  
Wildlife Refuge**

**Hart Mountain National  
Antelope Refuge**

**REGION ONE  
U.S. FISH &  
WILDLIFE SERVICE  
February 1985**

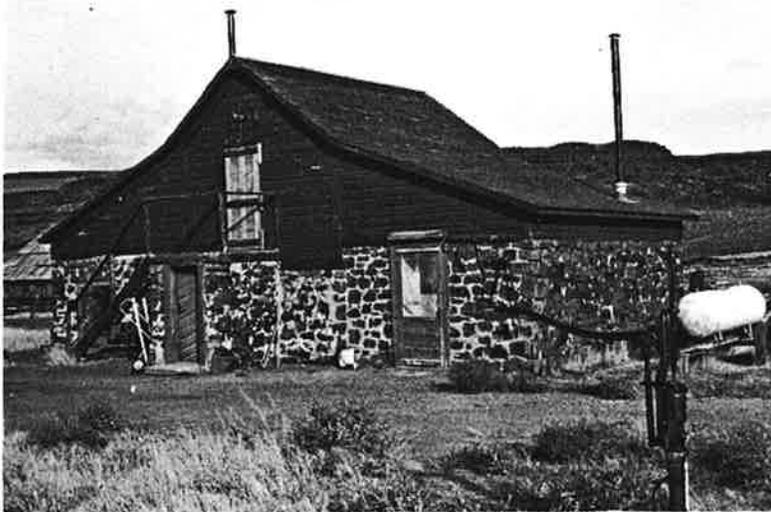
Residence (former bunkhouse and cooler), northeast view: ca. 1907; 43'3"x19'14"; rectangular, one and one-half story, wood frame and masonry structure, uncoursed rubble to second story floor line, wood frame above sheathed with wide shiplap, corner and rake boards. Wood shingle medium gable roof with broad slopes. Narrow one-over-one double-hung sash window, two small rectangular windows on east elevation. Three door openings on west elevation: paneled wooden door offset center to south; one story, central projecting entry, diagonal plank door; stairway to roof of first floor entry provides access to second floor, vertical plank door. No apparent material or structural alterations. Masonry cracked; mortar deteriorating. Fair condition.

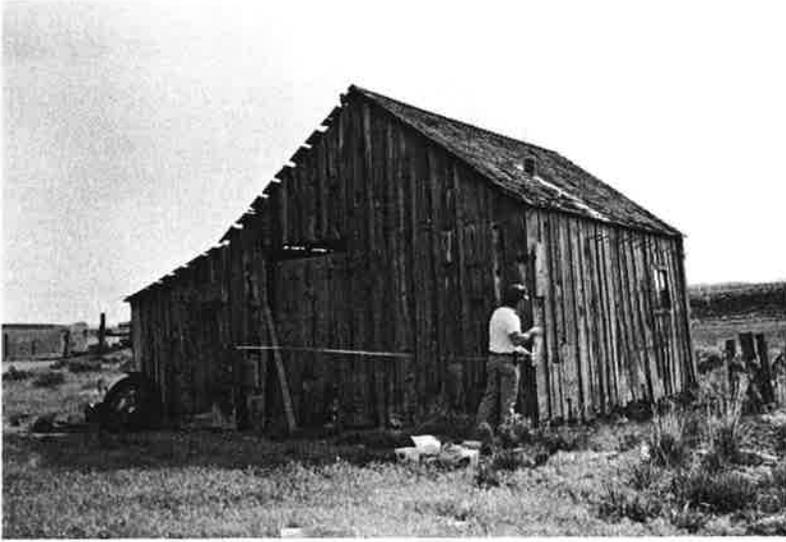
Blacksmith Shop, northwest view: ca. 1907; 20'x20'; rectangular, one-story, wood frame, vertical plank walls with exterior batts. Medium gable roof, wood shingle, lean-to on west elevation. Dry stone foundation. Small, 4-light window in east elevation. Two vertical plank doors offset center in south (gable end) elevation, Z-bracing, falling off hinges. Exterior siding warped and deteriorating. Roof materials missing. Fair condition.

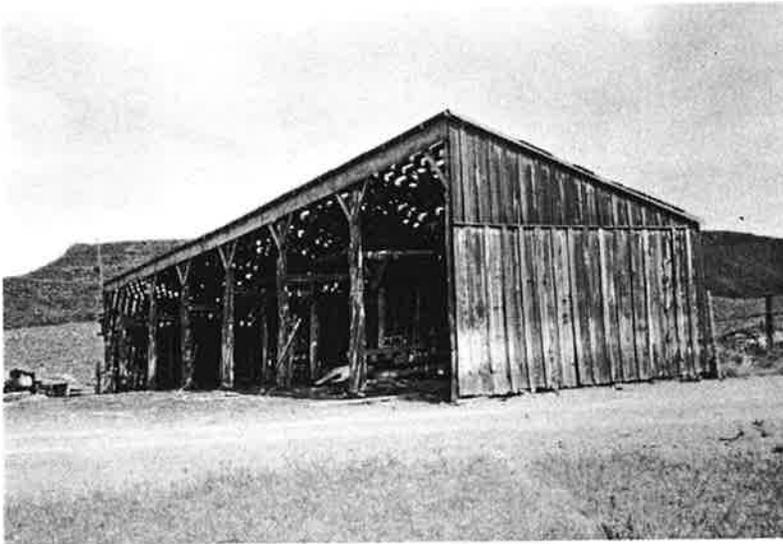
Shed, southwest view: n.d.; 80'x15'; rectangular, one story, shed roof, wood, shingle. Enclosed on three elevations by vertical boards with wide exterior batts, north elevation open, roof supported by large juniper posts. Roof materials missing. Fair condition.

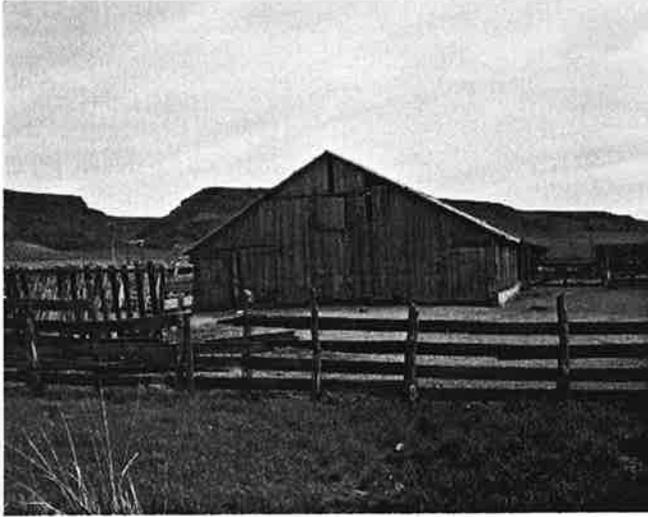
Barn, south view: ca. 1907; 46'x42'; rectangular, wood frame, mortise and tenon joinery with wooden pegs. Medium gable roof covered with sheet metal. Board and batten siding, most batts missing. Large door openings in north and south (gable end) elevations, vertical plank, strap hinges. No major structural or material alterations. Wall boards deteriorating, some missing. Fair condition.

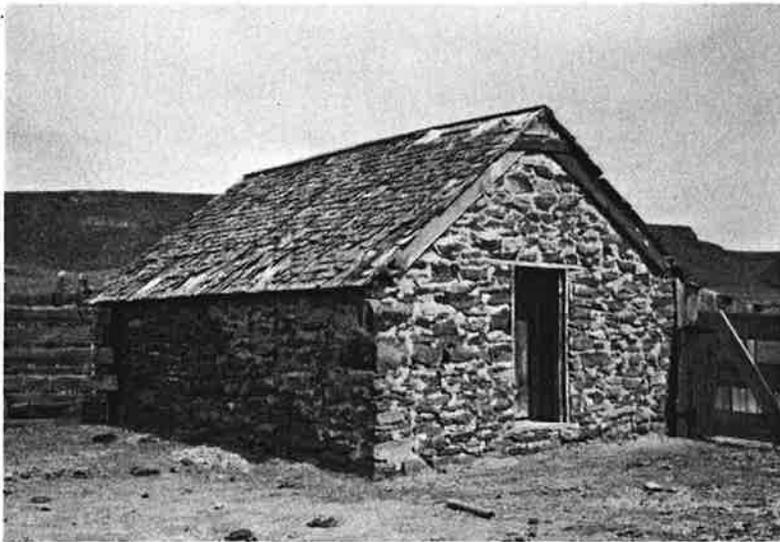
Chicken House, southeast view: ca. 1907; 18'x16'; rectangular, one story stone structure, uncoursed rubble walls 3' thick. Medium gable roof covered with wood shingles. Central, vertical plank door in west gable end. Small, six-light window in south elevation. Roof shingles deteriorating, some missing. Fair condition.

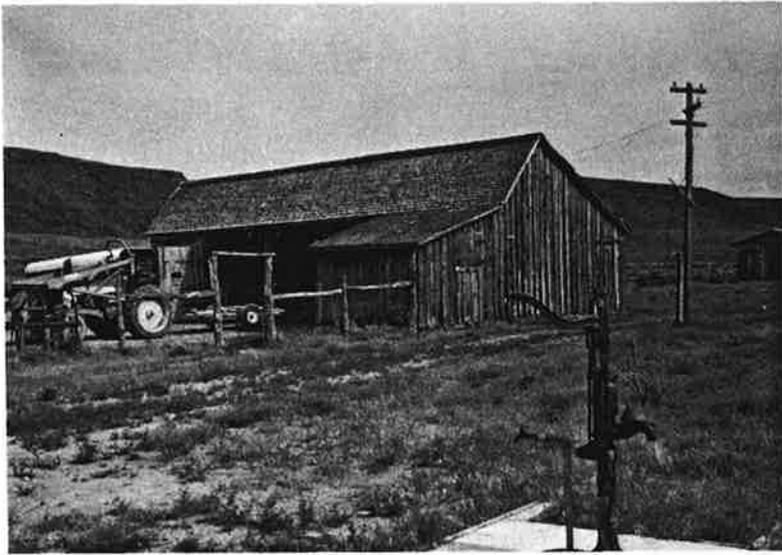
Machine Shop, southeast view: n.d.; rectangular, one-story, wood frame, vertical plank walls with exterior batts, shed-roofed wing on northeast corner. Wood shingle medium gable roof (catslide). Three bays on north elevation with juniper post supports. Large vertical plank doors with strap hinges. No apparent material or structural alterations. Fair condition.

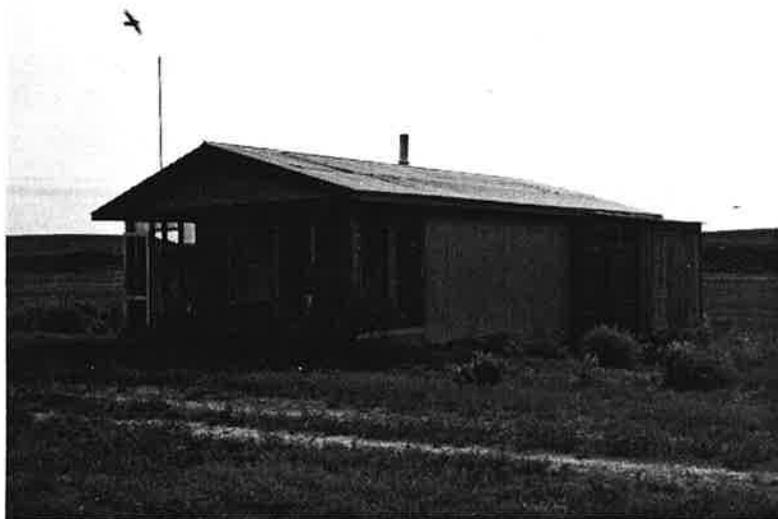
Bunkhouse, west view: ca. 1927; rectangular, one-story, stone foundation, wood frame, sheet metal siding. Vertical wood plank addition on northwest corner, paneled wooden door. Six-over-six double-hung sash window south elevation. Low pitch gable roof covered with sheet metal. Recessed porch on east (gable end) elevation, enclosed with screen, vertical panel door offset center with ornate knob, narrow double-hung sash window with leaded glass. Bird and rodent infestation. Stairway to entrance on west elevation deteriorating. Fair condition.

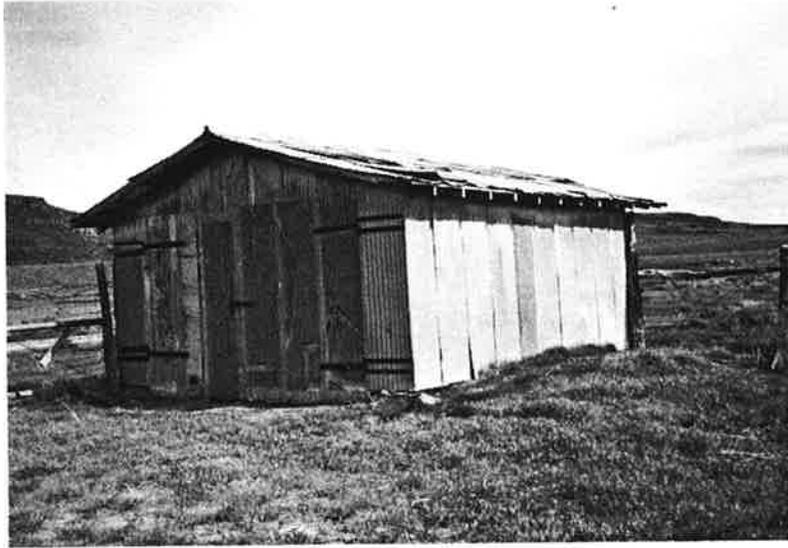
Garage, southeast view: ca. 1930; rectangular, one-story, stone foundation, wood frame, sheet metal siding. Low pitch gable roof covered with sheet metal. Door openings in north gable end, strap hinges. No windows. Good condition.

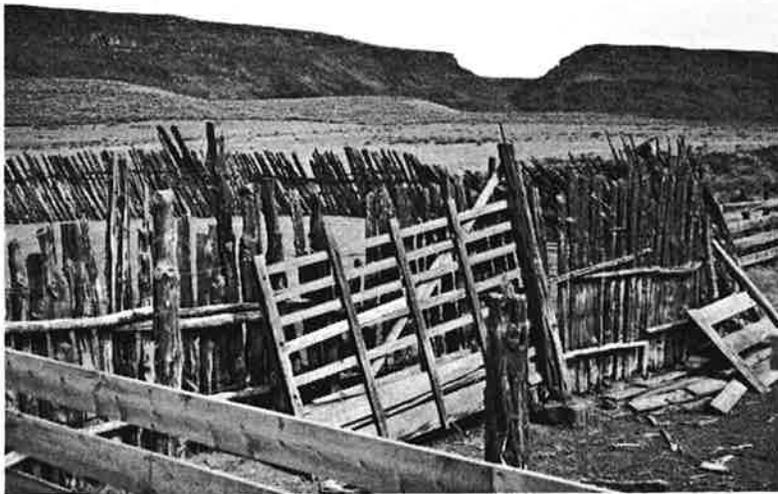
Corrals and Fences: Extensive system, variety of types and materials. Round corral constructed of vertical juniper posts set close together. Holding corrals, vertical juniper posts set several feet apart, with horizontal planks between. Rock wall (built ca. 1900), dry stacked rubble stone, several hundred yards long.

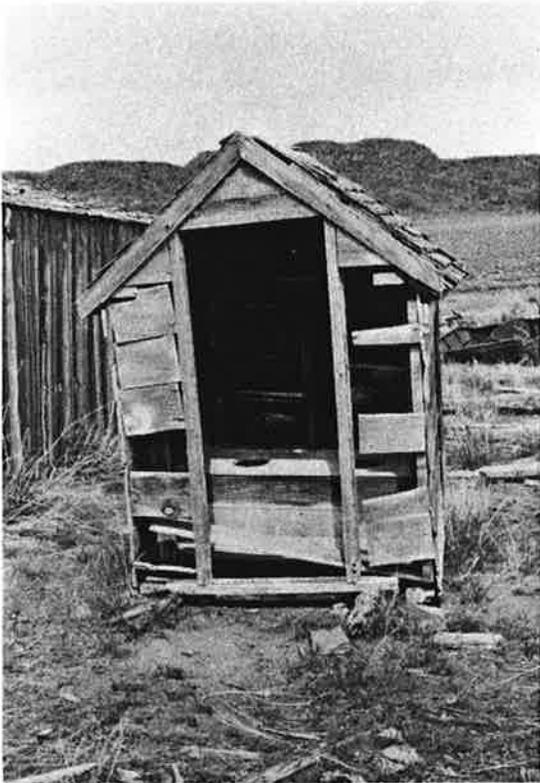
Outhouse #1, east view: n.d.; rectangular, one-story, wood frame with vertical plank siding. Wood shingle medium gable roof. Double seater. Door opening on west elevation, no door. Plank siding missing on facade. Poor condition.

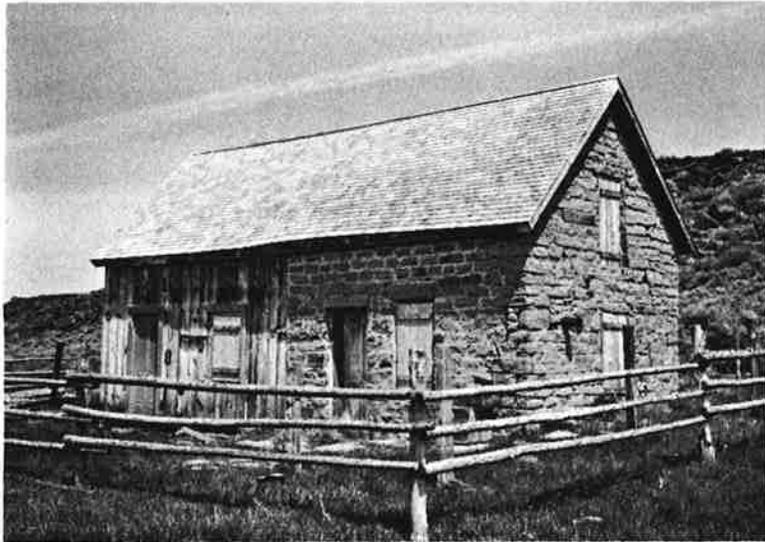
House, northeast view: 34'7" x 16'5"; built in two phases, wood portion to north, constructed ca. 1885, vertical plank walls, most batts missing Southern half, built ca. 1910, coursed, square rubble. Two halves share wood shingle, medium gable roof. Each half has door on west elevation, single leaf, four panel. Window openings boarded up, originally six-over-six double-hung sash on south elevation, openings on other elevations shorter and squattier. Shed roof porch on facade removed, n.d. Severe bird and rodent infestation. Mortar deteriorated, stone wall, south elevation, cracking. Some repair and replacement of materials, not incompatible. Roof resingled 1981. Fair condition.

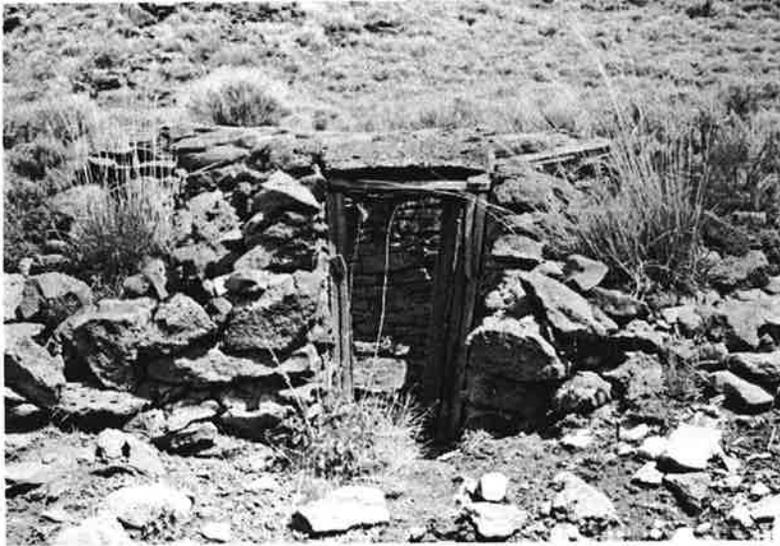
Root Cellar, west view: 6'0"x5'0"; dug directly into bank approximately 10' off northeast corner of house, lined with roughly coursed stone. Roof is gone except for several large juniper logs. Vertical plank door falling off hinges. Poor condition.

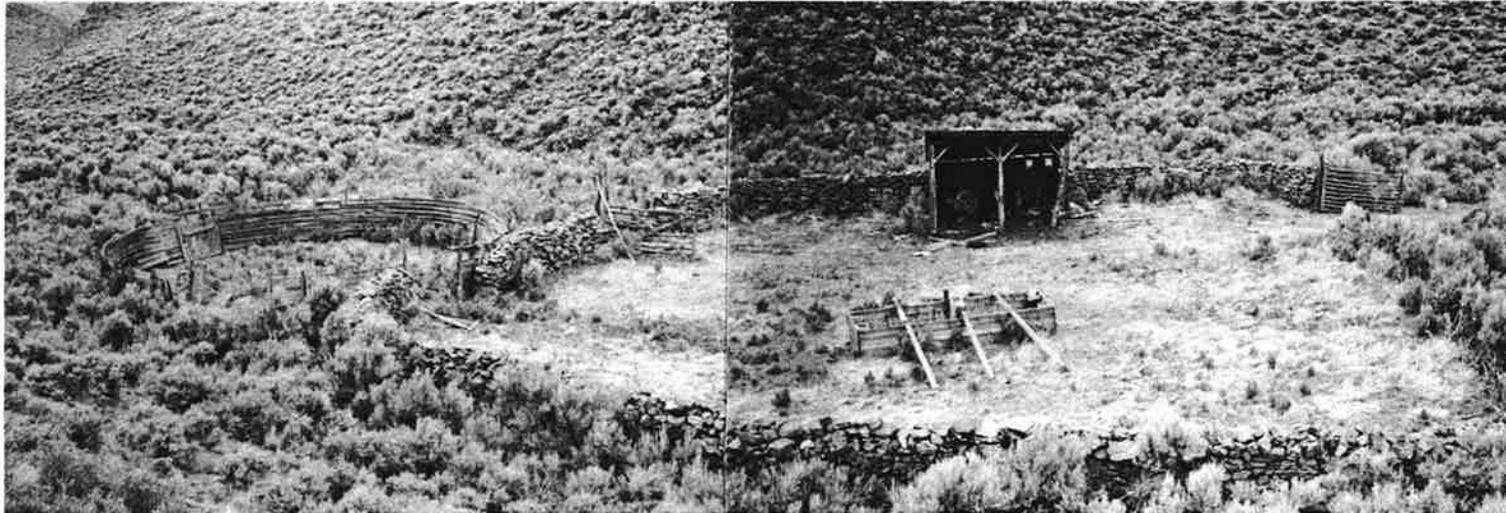
Horsetrap, southwest view: ca. 1900; roughly rectangular, dry stacked, stone corral, 105'x864', 3' wide at base, 6' high in spots. Interior wall surface quite smooth. Stone wall runs from northeast corner of corral along base of hill approximately 50 yards. Small shed, 17'x14', on west side of corral. Two gates directly opposite one another on north and south walls of corral, peeled poles with x-bracing. Wooden feed bin in center. Wood frame construction, juniper post supports, open on east elevation. Poor condition. Round corral adjoins stone corral on south, 47' in diameter, vertical juniper posts set in ground approximately 3'-5' apart, horizontal planks form walls. Sections of corral collapsed. Gate separating stone corral from round corral deteriorated.

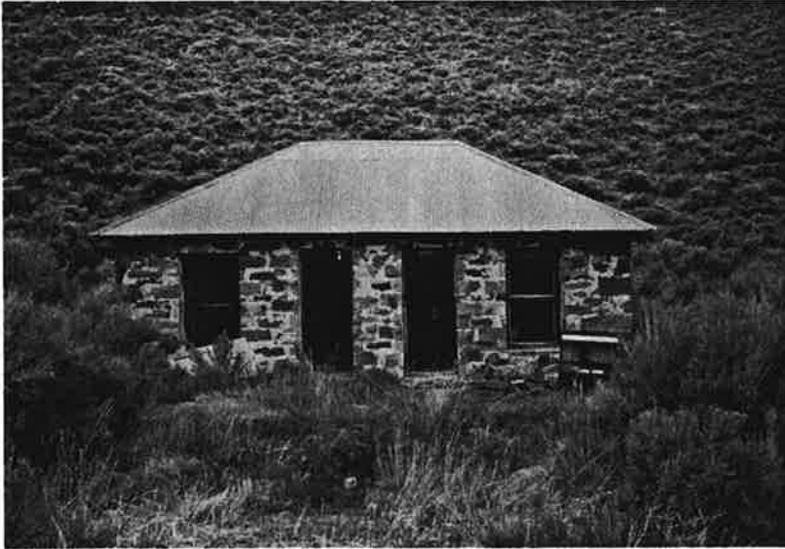
House, west view: ca. 1925; 27'10"x18'0"; rectangular, one story, truncated hip roof covered with sheet metal. Uncoursed rubble walls, 2' thick. Symmetrical facade, two doors, single leaf, paneled, flanked by one-over-one, double-hung, sash windows. Mortar is deteriorated. Fair condition. No major material or structural alterations.

1. No further action/study is recommended for the stone house. However, preservation of the building is encouraged. It is still occasionally used as a line camp by employees of the MC Cattle Company.
2. A NHRP or Determination of Eligibility form should be prepared for the Gooch Camp horsetrap.
3. The round corral, small shed, and gates on the stone portion of the trap are in poor condition. Salvage as much original material as possible and use to repair and maintain in accordance with the Secretary of the Interior's Standards (Appendix A).

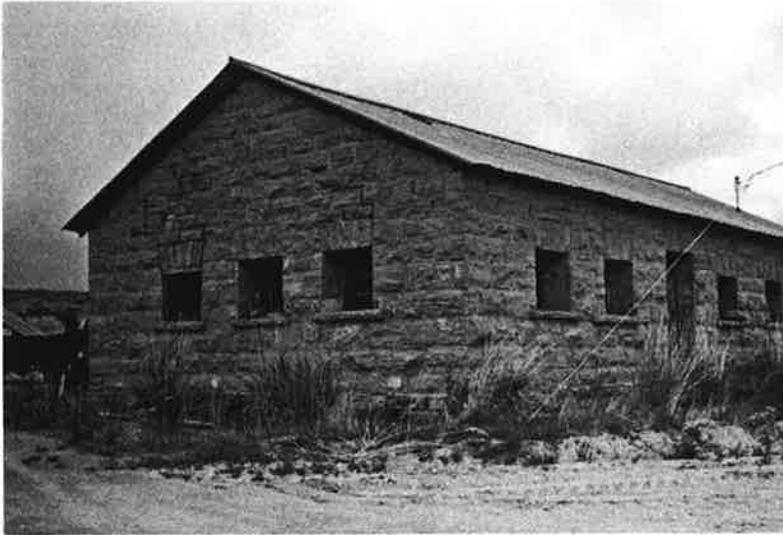
Machine Shop, northwest view: 1936; no dimensions; rectangular, one-and-one-half story, concrete foundation. Medium gable roof covered with sheet metal. Cut stone wall construction, coursed, rough-faced pink sandstone. Double doors in gable end, vertical plank with Z-bracing; reinforced with plywood at later date. Single door on west elevation with diagonal boards and strap hinges. Small square windows on north and east elevations with stone sill and voussoir. Good condition.

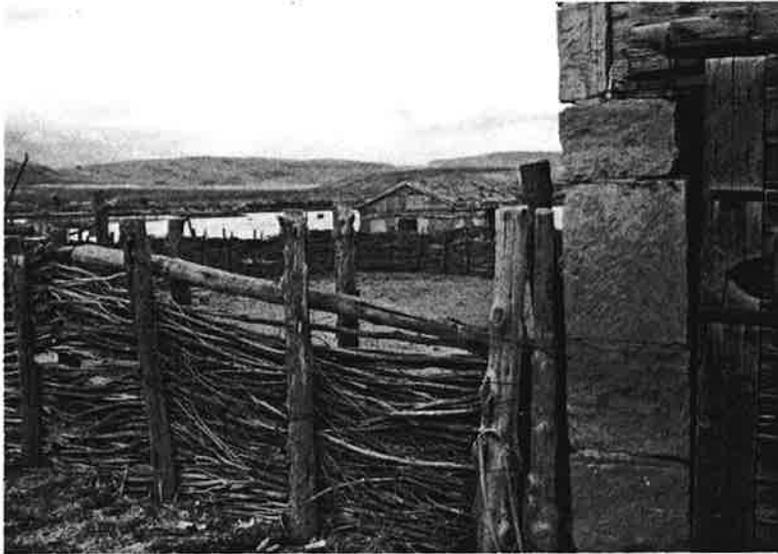
Willow Corral, southwest view: n.d.; part of extensive system of willow corrals to south of barn. Tops of juniper posts sawn off ca. 1936. Southeast corner of barn in right foreground; chicken house in center background. Fair condition.

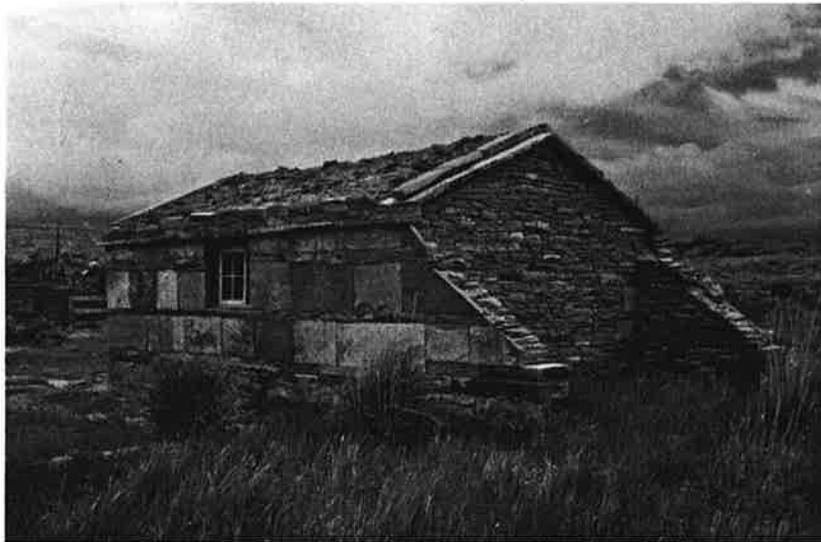
Chicken House, northwest view: n.d.; 15'x21'; rectangular, one story, dirt floor. Low pitched gable roof, large (timber) ridgepole, rough sawn lumber rafters covered with sod and willow branches. Stone wall construction 1.5' thick, narrow dry-stacked slabs of pink and red sandstone sheathed with "panels" of same. Single leaf, wood door on east elevation. Small square, 4-light window on north and south elevations. Reroofed 1983 using materials to match originals. Good condition.

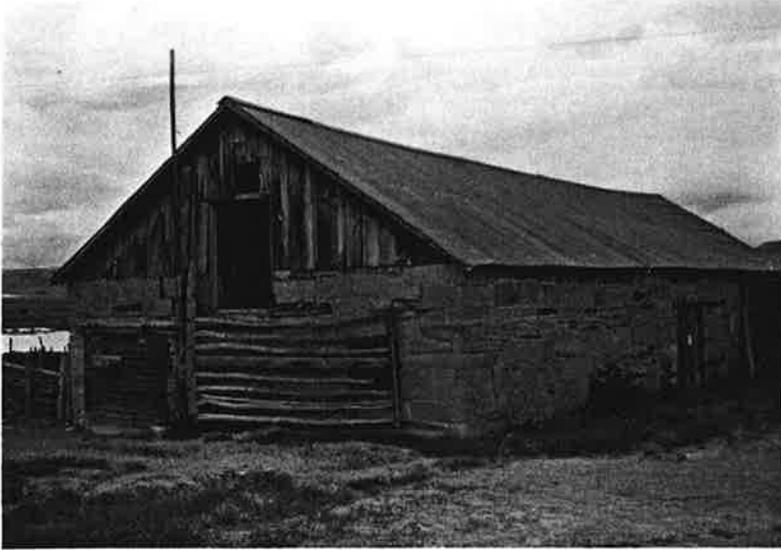
Barn, view to southwest: Koenig Bros., builders; 1900; 29'0" x 83'5"; rectangular, one and one-half story, dirt floor. Medium gable roof covered with sheet metal. Semi-coursed, rough cut blocks of pink sandstone to second floor line, vertical plank wood frame above. Wall on southeast corner cracked, may be structurally unsound. Vertical or horizontal plank sliding doors: one on each elevation. Door openings in upper gable ends. Fair condition.

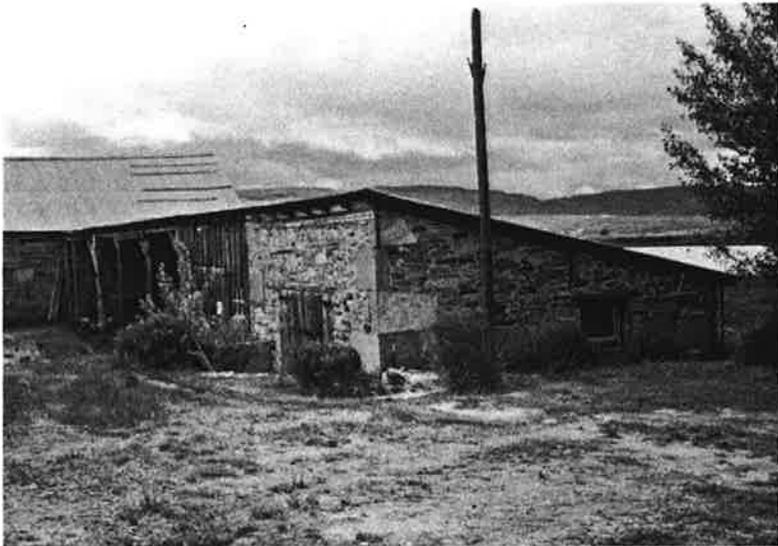
Shed roof wing off northeast corner of barn, south view: n.d.; 22'x82'. Wood frame and rubble wall construction, large blocks of pink sandstone used for corner quoining. Juniper post supports. Roof covered with sheet metal. Two sets of hinged, rough sawn, vertical plank, double doors. No major material or structural alterations. Fair condition.

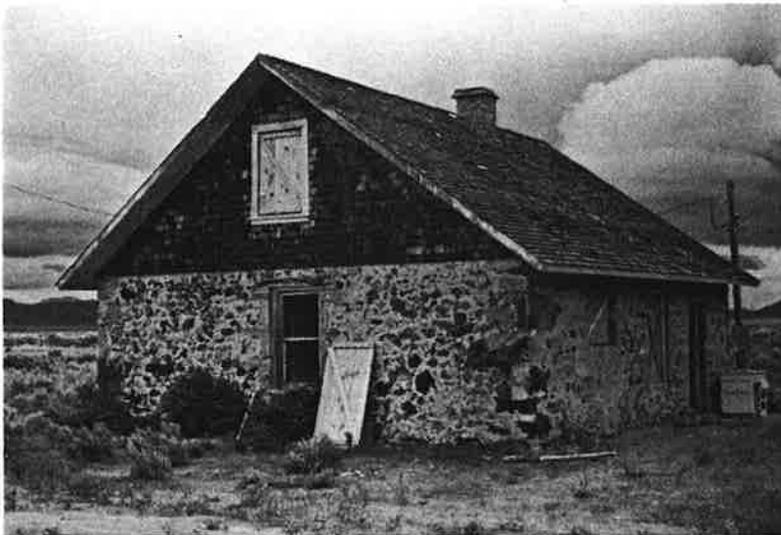
House, view to southeast: ca. 1912; 29'x29'; rectangular one and one-half story, wood shingle, medium gable roof with wide eaves, central stone chimney with corbeled cap. Uncoursed rubble walls up to second floor line, wood frame above, wood shingle exterior. Window openings boarded up, various sizes, originals double-hung sash. Single leaf, paneled doors on east and south elevations. Corner quoining and door and window jambs, pink sandstone. No major alterations/additions to exterior. Significant interior alterations. Good condition.

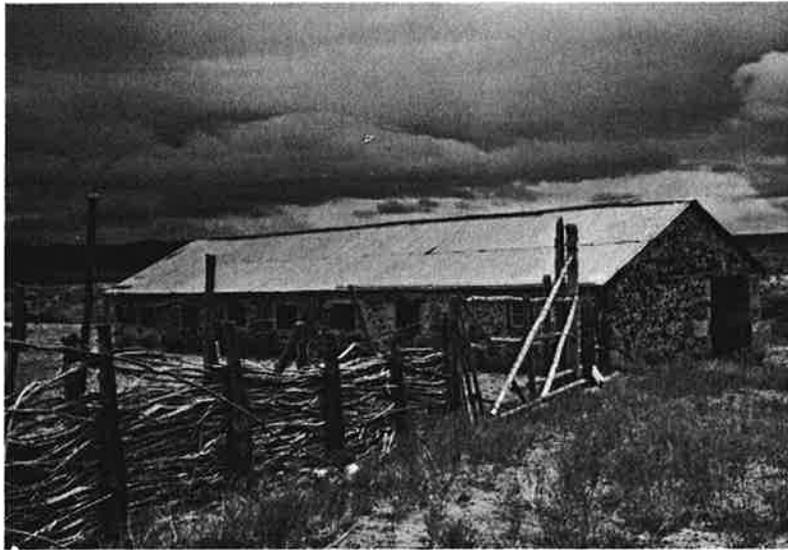
Barn, view to southeast: ca. 1912; 22'10"x66'4"; rectangular, one-story, dirt floor. Low pitch gable roof covered with sheet metal, originally wood shingle (?). Uncoursed rubble walls, 2' thick. Large door openings on gable ends, jambs are massive blocks of pink sandstone, hand hewn timber lintel over door. Seven, small square windows on west elevation, pink sandstone surrounds. No apparent alterations or additions. Mortar deteriorating. Fair condition.

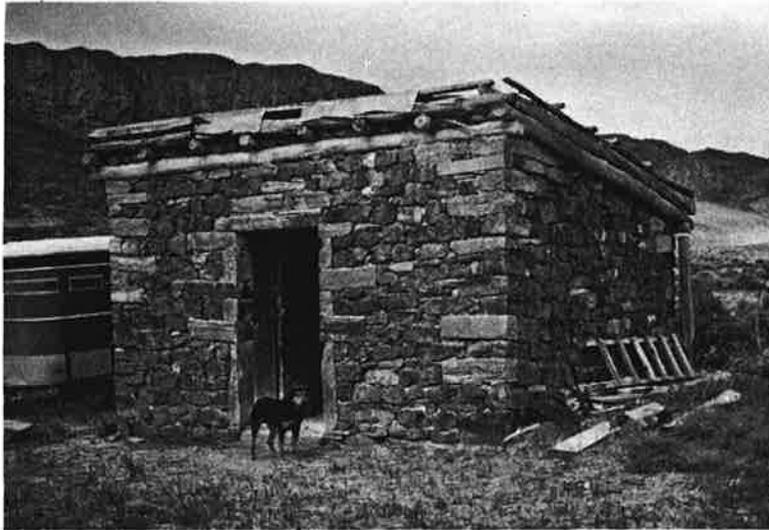
Chicken House, southwest view: ca. 1912; 16'x14'; rectangular, one-story, dirt floor. Shed roof, peeled pole rafters originally covered with willow branches, now sheet metal. Tightly stacked, roughly squared, semi-coursed rubble walls, corner quoining and door jambs are large slabs of pink sandstone. Hinged, horizontal plank door. Peeled pole roost inside. No major alterations or additions. Good condition.

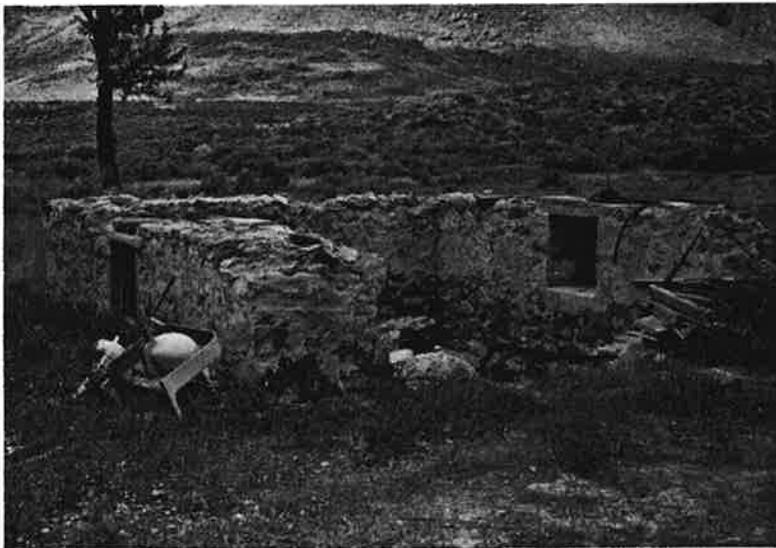
Bunkhouse/Cooler, rock foundation, west view: ca. 1912; 15'8" X 13'9"; excavated approximately three feet into ground. Uncoursed rock walls partially mortared, 3' thick. Square window openings, one each on north and south elevation. Building was originally one and one-half story with low pitched hip roof. Upper story was wood; accessed by exterior wood staircase on east elevation.

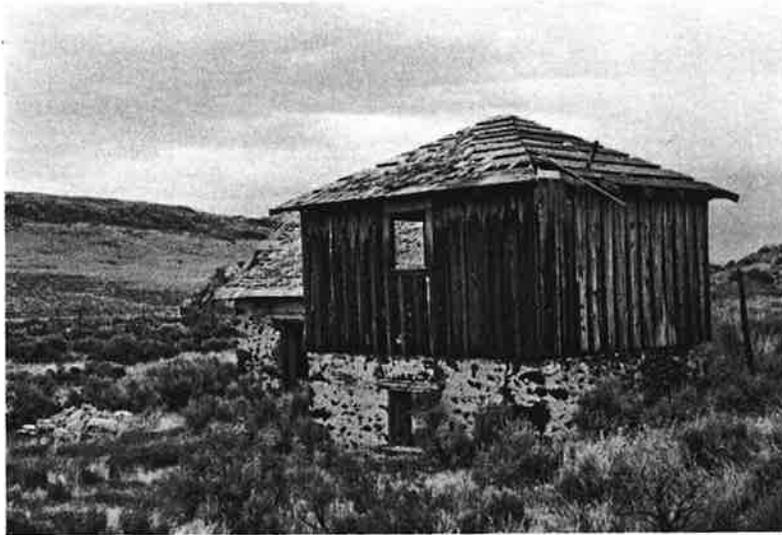
Bunkhouse, northeast view: ca. 1912; 15' 8"x13' 9"; rectangular two story, low pitch hip roof with wide eaves, exposed rafters. First floor dug partially into ground, floor lined with large, smooth, slabs of pink sandstone. Uncoursed rubble walls, 1'10" thick, to second floor line, wood frame above, board and batten siding. Large, peeled log spans interior with nails and hooks, used to hang meat. Second floor originally used as bunkhouse. Juniper posts set in ground support wooden platform, ladder access to second story door opening, originally wooden staircase. Small square windows on west and east elevations. Roof materials missing. Wood siding deteriorating. Fair condition.

3. Immediate steps should be taken to protect the structures at Kinney Camp from further deterioration. The main house , bunkhouse, chicken house, and barn should have temporary roofing installed to protect what remains of the original roofs and interiors. Sheet metal is one option; however it is an expensive temporary measure and given the high demand for this material in the area its use is questionable. More to the point is installing spaced sheathing to which roofing paper could be applied immediately, and shingles at a later date, should restoration be undertaken. All door and window openings on the bunkhouse, main house, and chicken house should be boarded over.

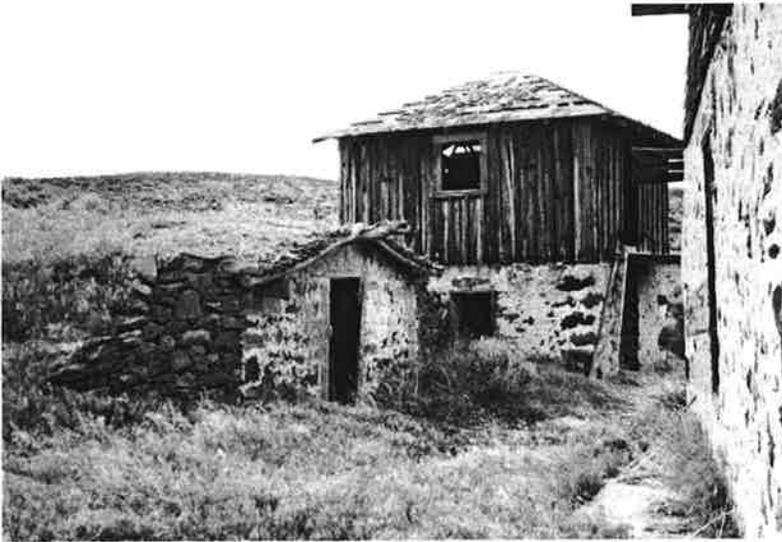
Root Cellar (to left of bunkhouse), southwest view: ca. 1912; 20'6"x14'8"; excavated into hillside, interior side walls lined with rubble; rear wall is natural rock, partially mortared rubble facade. Dirt floor, two large timbers in interior with hooks and nails for hanging/storage of foodstuffs, sod roof. Original door replaced, present door beaded paneling. No other apparent additions or alterations. Good condition.

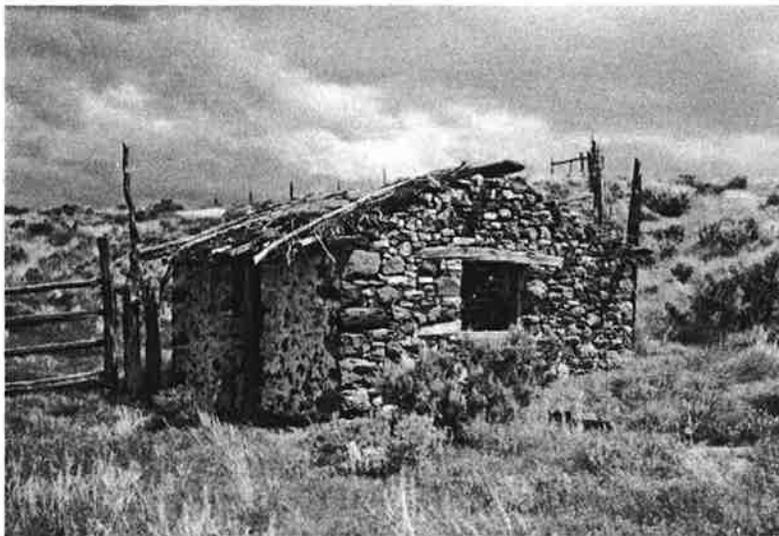
Chicken House, east view: ca. 1912; 14' 4"x16'6"; rectangular, one-story, dirt floor. Low pitch, medium gable roof, sod construction. Uncoursed rubble walls, 1'10" thick. Small, square window openings in east and west elevations, panes removed, hand hewn wood lintel, pink sandstone sill. Vertical plank door with wooden latch (off hinges) in north elevation. No major material or structural alterations. Some roof materials missing. Fair condition.

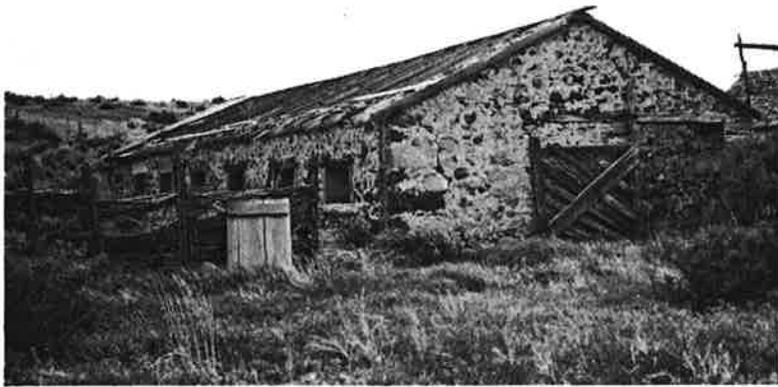
Barn, northeast view: ca. 1912; 23'0"x53'5"; rectangular, one-story, dirt floor. Uncoursed rubble walls. Low pitch, gable roof, original roof materials missing. Door openings on gable ends, pink sandstone jambs, hand-hewn timber lintels. Hinged doors, diagonal plank, X-bracing. Six small square windows, no panes, on east elevation; two on west elevation. Fair condition.

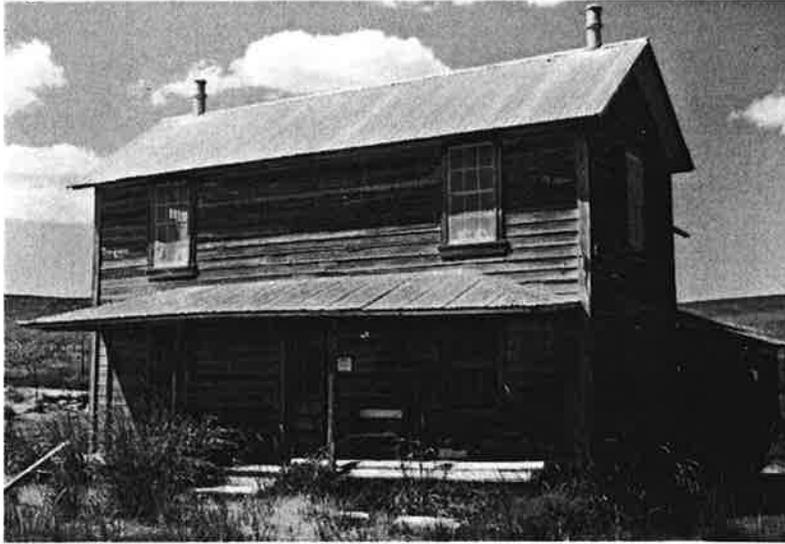
Residence, northwest view: ca. 1910; 30'4"x44'5"; two-story, wood frame, gable roof. T-plan. Shiplap siding with corner and rake boards. Symmetrical facade. Porch on each elevation, partially enclosed on northeast and northwest corners; hand-carved chamfered posts. Six-over-six double-hung sash windows with simple architrave molding. Doors are paneled, screen doors have rough wooden frames. Porch floorboards deteriorated. Some porch posts and window panes missing. Minor alterations on rear (north) elevation. House painted white at one time. No major material or structural alterations or additions. Fair condition.

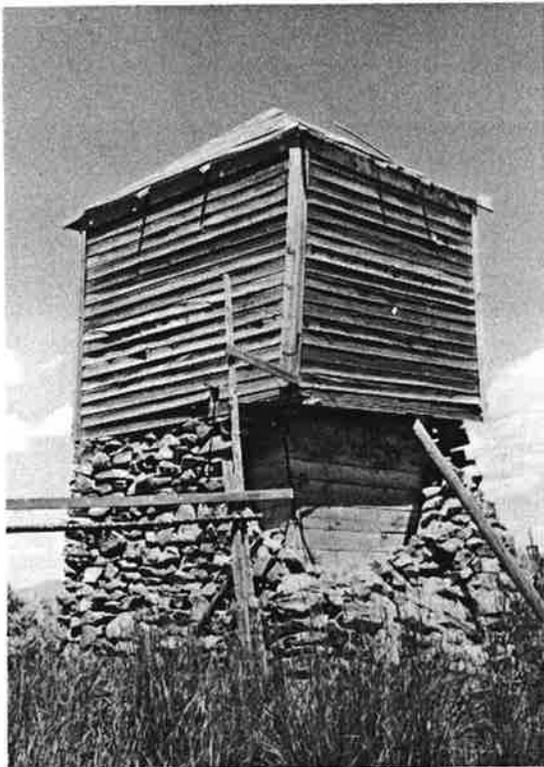
Watertower, northeast view: ca. 1910; 15'6"x16'4"; pump and gravity system, rectangular, two story, dirt floor. Low pitch hip roof. Large sheet metal tank in second floor supported by floor boards and log joists resting on bents made of poles; bents sit on floor boards resting on earth. Exterior walls formed of sheathing nailed over bents; application of rubble stone applied over this. Stone wall partially collapsed; severe settlement. Props placed under tank to support weight of tank. Two door openings on east elevation: first floor door vertical board and batt with Z-bracing, strap hinges; pole ladder access to second story opening, no door. Loose hay packed around water tank. Poor condition.

2. The significance of the property is due in large part to the wide variety of buildings, structures, and objects associated with ranching activities. The partially collapsed barn, water tower, stone shed, and root cellar are integral components of the ensemble. Each is in extremely poor condition. The barn may be beyond restoring. However, every effort should be made to preserve each of these structures.

Contract with historic architect to assess the structural and general physical integrity of these buildings and make recommendations concerning the technical and economic factors involved in preserving them. All recommendations to be consistent with the Secretary of the Interior Standards for Rehabilitation of Historic Places. (See Appendix A). Minimally, the report should include the following items:

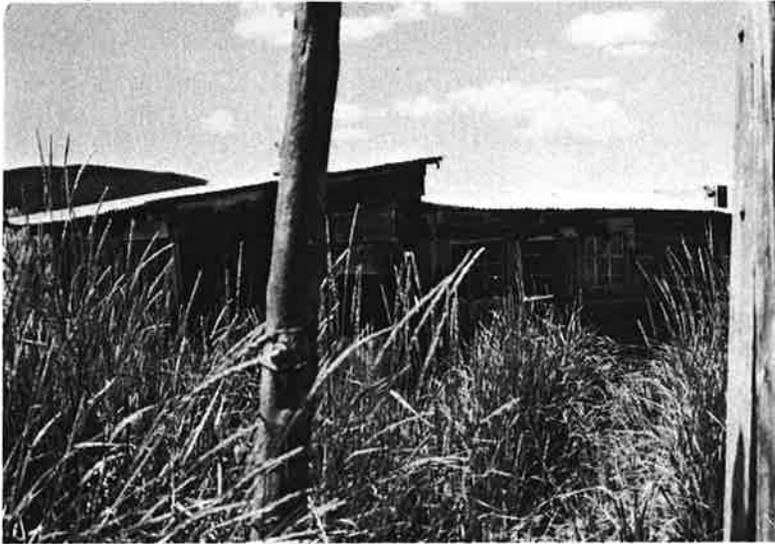
Animal shed, northwest view: n.d.; 28'1"x9'1"; rectangular, one-story, dirt floor. Shed roof covered with sheet metal. Wood frame construction, peeled pole studs sheathed with rough sawn horizontal planks on north half, vertical board and batt on south end. Small, square, six-light window and two door openings in east elevation. Peeled pole roost suspended from ceiling with wire in south half of structure. Wood trough in north portion. Siding warped. Fair condition.

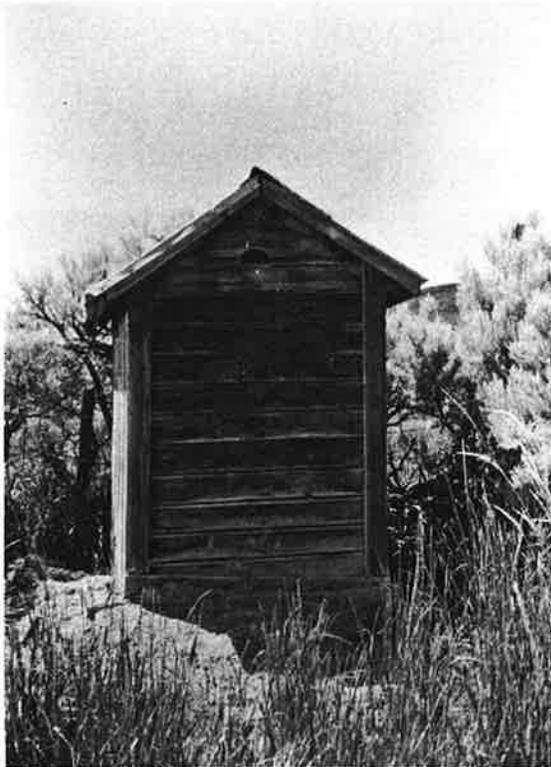
Outhouse, west view: n.d.; 5'0"x6'3"; rectangular, one-story, wood frame, two and one-half seater. Gable roof covered with sheet metal. Shiplap siding with corner boards, south elevation covered with sheet metal. Vertical plank door on north elevation. Good condition.

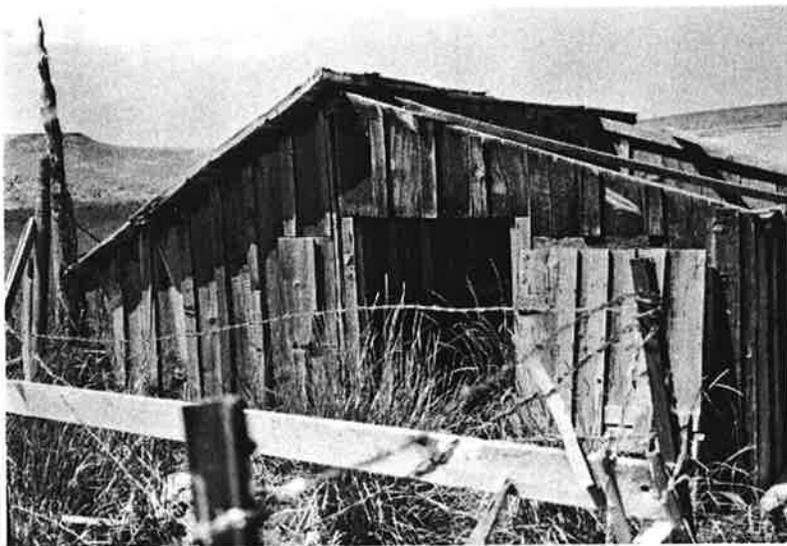
Woodshed, north view: ca. 1910; two adjoining rectangular structures, dirt floor, west portion 18'1"x6'8", shed roof covered with sheet metal. East half 14'2"x8'3", no roof. Both wood frame construction with board and batten siding. Each section has door opening on east elevation. Door opening on south elevation of east half. Fair condition.

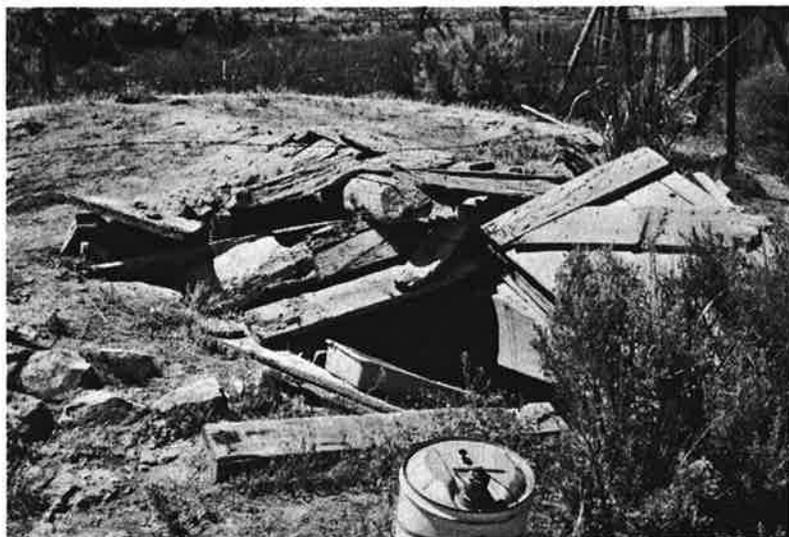
Root cellar, west view: ca. 1910; approx. 8' x 10'. Dug into ground; accessed by wooden stairway. Roof has heavy log ridge pole, dimensional lumber purlins and top plates covered with earth, supported by approximately ten cedar posts. Boards are nailed to inside of posts to retain earth. Roof collapsing. Half-buried furniture includes pie-safe. Poor condition.

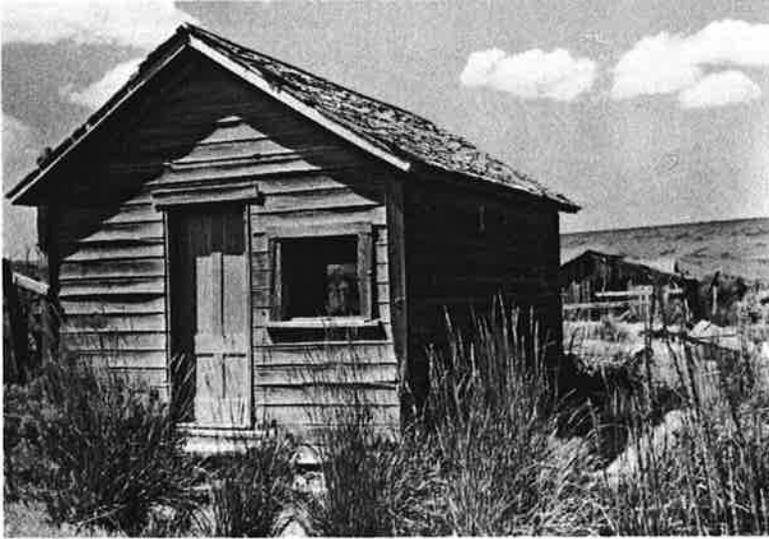
Bunkhouse #1, northwest view: n.d.; 12'7"x18'3"; rectangular, one-story, stone foundation, box frame. Medium pitch gable roof, shingled. Shiplap siding with corner boards. Single leaf paneled door on north and south (gable end) elevations, each flanked by small square window opening, no panes. Roof material missing, siding warped. Fair condition.

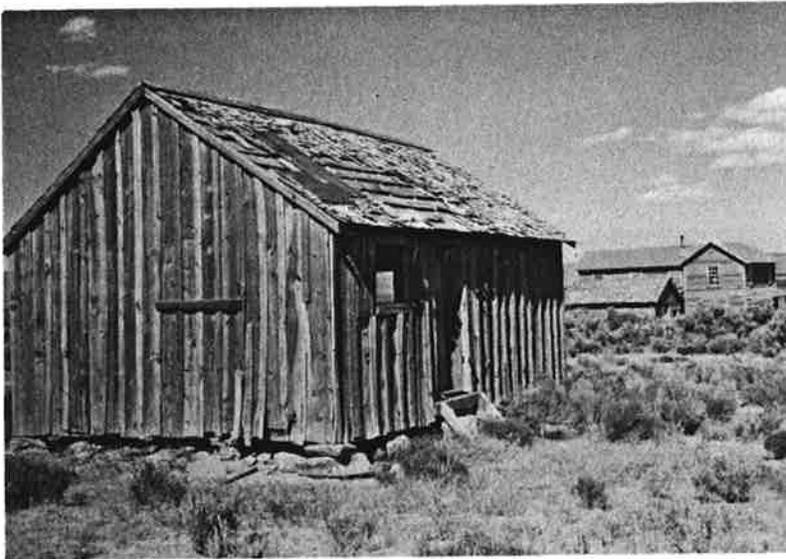
Bunkhouse #2, northeast view: n.d.; 22'1"x16'4"; rectangular, one-story, box frame, stone foundation, plank floor. Medium pitch gable roof, shingled. Vertical board and batten siding. Vertical plank, hinged door in south (side) and east (gable end) elevation. Small square window flanks each door, no panes. Roof materials missing. Siding warped. Porch stoop deteriorated. Fair condition.

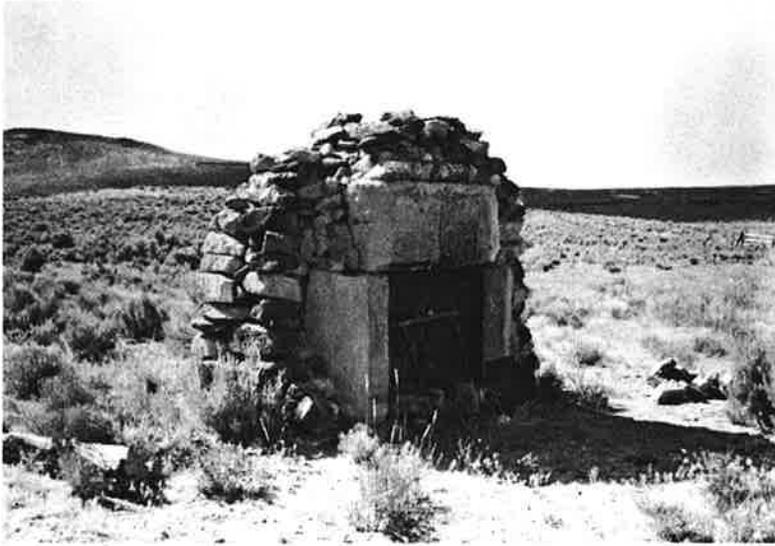
Fireplace remnant, northwest view: n.d.; remains of former stone structure possibly original residence. Huge slabs of stone form walls and hearth, encased by smaller pieces of dry-stacked rubble. Nails with tin washers extend across top of opening - may have secured cover to reduce smoking. Mortar deteriorating; needs re-pointing to stabilize. Poor condition.

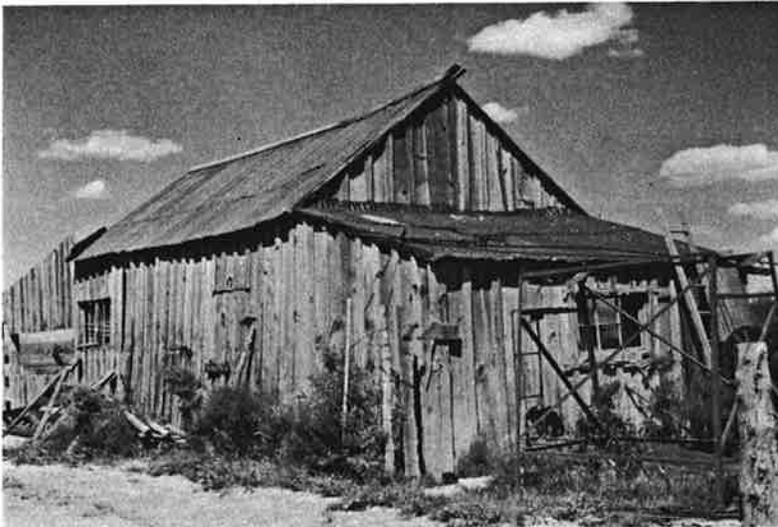
Blacksmith Shop, northeast view: ca. 1910; 30'7"x14'6"; rectangular, one story, dirt floor, box construction, stone foundation. Medium gable roof covered with sheet metal, lean-to on south elevation. Vertical plank door west elevation, double doors, hinged, on east elevation. Small, square six-light window in south elevation. New addition under construction on north elevation does not appear to alter fabric of main structure. Siding warped and deteriorating. Fair condition.

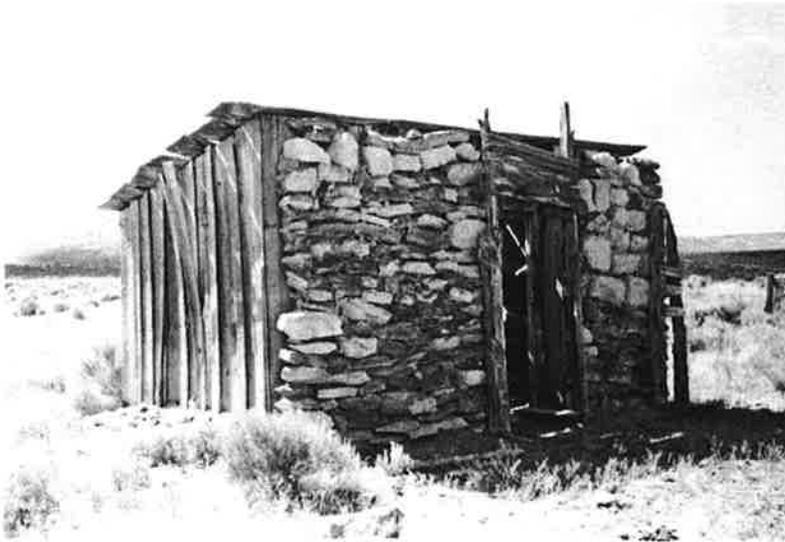
Shed, northwest view: n.d.; 8' 1" x 14' 6"; rectangular, one-story, box construction with exterior batts, exterior sheathed with dry-stacked stone, approx. 1' thick. Shed roof, shingled. Door opening on east elevation framed with rough sawn lumber and juniper posts, door locked from outside. No windows. Roof boards warped, most shingles missing. Exterior stone wall partially collapsed. Once used as chicken coop, original use unknown. Original boards square-nailed. Poor condition.

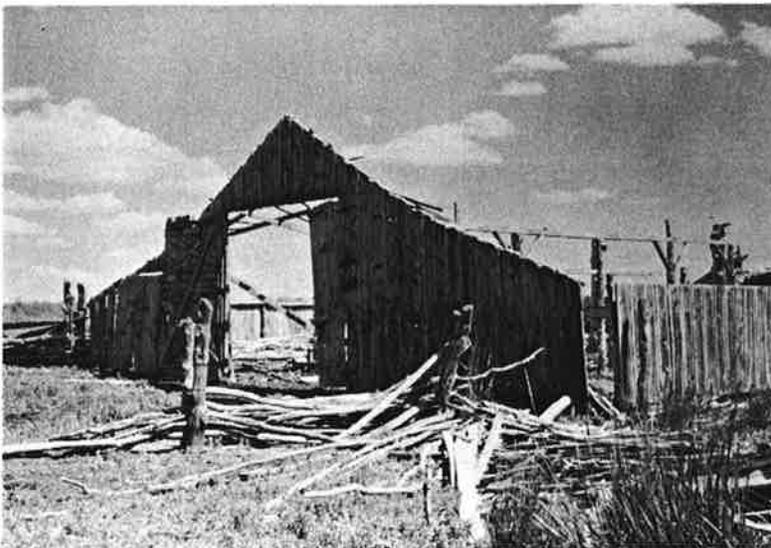
Barn, southeast view: ca. 1910; 46' x 112' rectangular; partially collapsed; no roof. Vertical plank walls with exterior batts. End-opening doors, strap hinges, x-bracing. Large juniper post supports in northern section; mortise and tenon joinery in what were probably lofts. Northern wall relatively intact; west wall rebuilt, n.d. Southern portion probably different date; entirely collapsed; juniper post are smaller, manger at center. Poor condition.

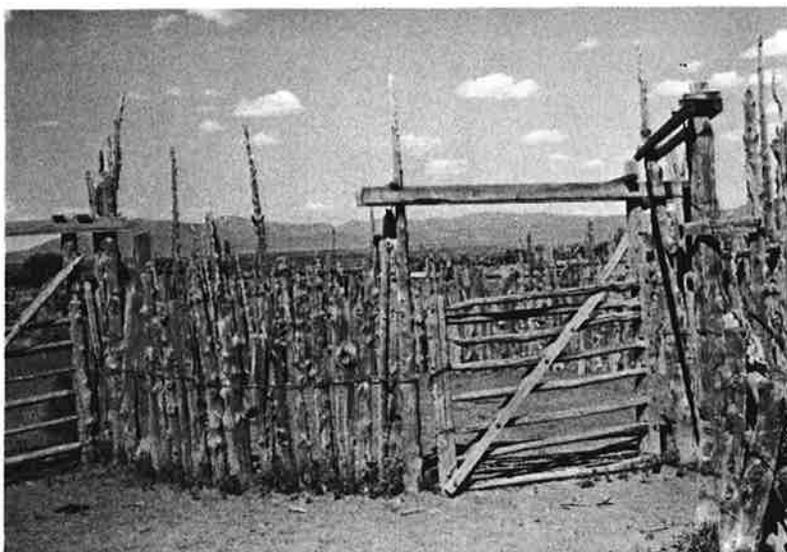
Juniper Post Corral, east view: n.d.; extensive system of corrals and fences include round corral of vertical juniper posts; board fences; willow fences. Various repair and replacement of materials over the years. Generally good condition.
