**CULTURAL  
RESOURCE  
INVENTORY:**

**Sheldon National  
Wildlife Refuge**

**Hart Mountain National  
Antelope Refuge**

**REGION ONE  
U.S. FISH &  
WILDLIFE SERVICE  
February 1985**

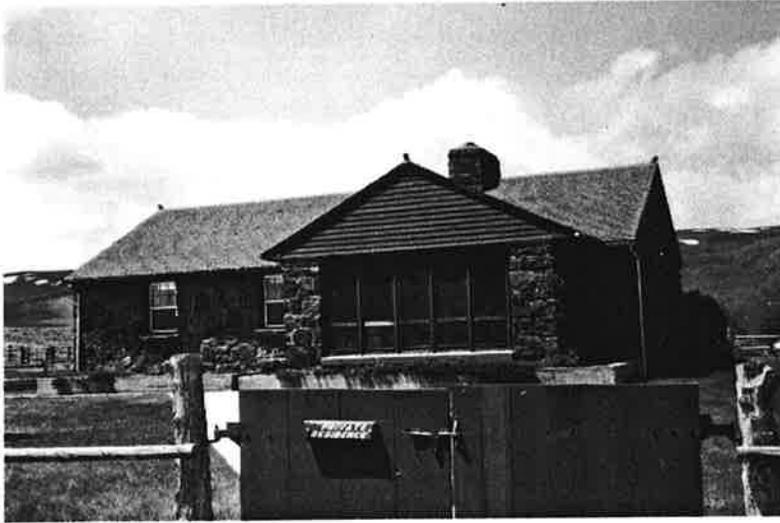
Manager's Residence, southwest view: 1939; 52'x30'; rectangular, one-story, concrete foundation, basement. Projecting, front-facing gable offset to north encloses porch. Composition-shingle, medium gable roof, finials at gable peaks. Offset stone chimney, four-inch concrete cap, copper flashing at base. Uncoursed stone walls, red and green rhyolite and grey basalt. Bevel cedar siding in upper gable ends. Six-over-six, double-hung sash windows, simple surrounds, wide stone sills. Storm windows and concrete block flower beds added at later date. Good condition. No major additions/alterations.
