# Coordinated Monitoring Program for Livestock Exclusions

## 2009 Annual Progress Report

**Oregon Watershed Enhancement Board**  
**Washington Salmon Recovery Funding Board**  
**Coordinated Monitoring Program for**  
**Livestock Exclusion Projects**

**2009 Annual Progress Report**

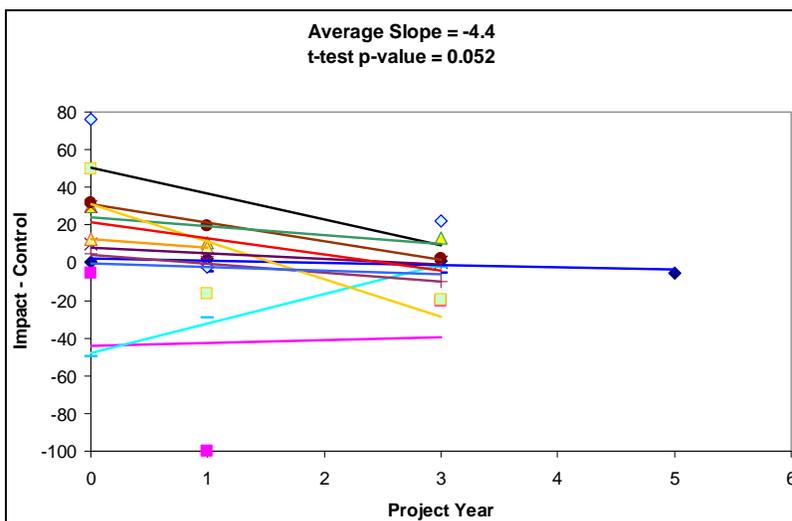
**Figure 2.** Linear Regressions by Project for Bank Erosion

Figure 2 displays the linear regression trend for bank erosion. Most (83 percent) of the sites show a negative slope, indicating a reduction in bank erosion for each subsequent monitoring year.

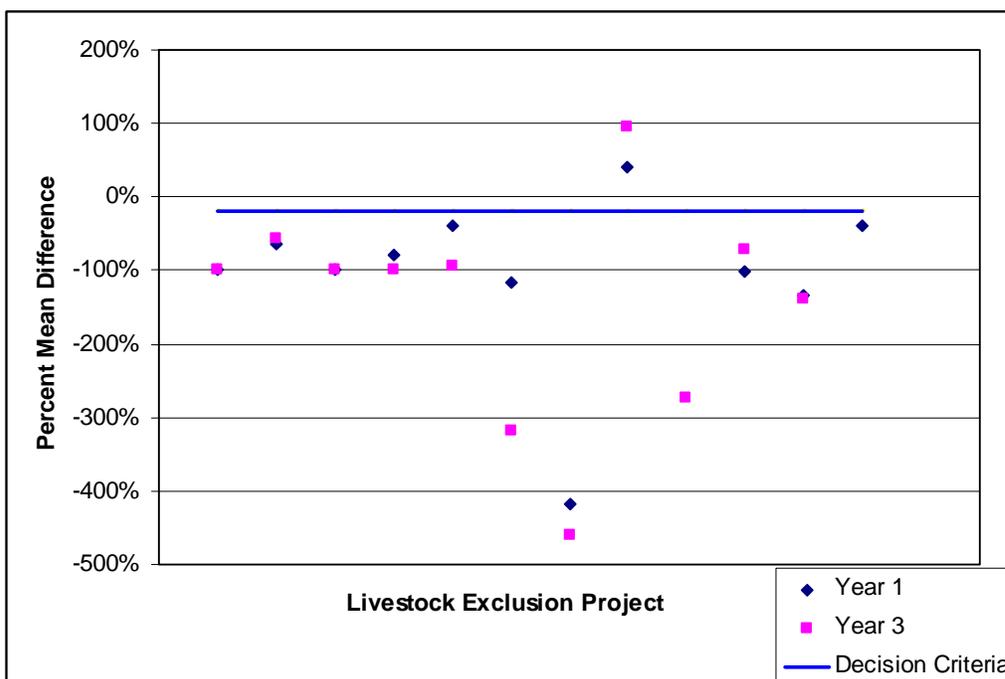
**Figure 3.** Mean Difference of Bank Erosion from Baseline Year 0 for Each Project

The mean reduction in the proportion of actively eroding banks was calculated for 11 projects that included monitoring in Year 3. The mean percent difference for Year 3 monitoring compared to Year 0 was -111 percent. This decrease is greater than the 20 percent decrease decision criteria; therefore, as of Year 3 monitoring, livestock exclusion projects are determined to be successful at reducing bank erosion on a regional scale. All but one project (206-072 Gray Creek) have reduced bank erosion by at least 20 percent (see Figure 3). However, three projects (Abernathy Creek, Vance Creek, and Indian Creek Yates) had a percent difference of 100 in Year 3 because there was no difference between the impact and control reach in either Year 0 (Abernathy) or Year 3 (Vance and Indian), and 100 percent is used as the default value.

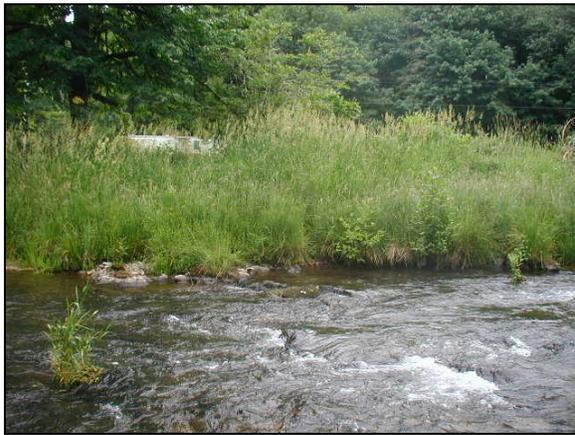
Impact reach Transect K right bank in 2004 (Year 0)

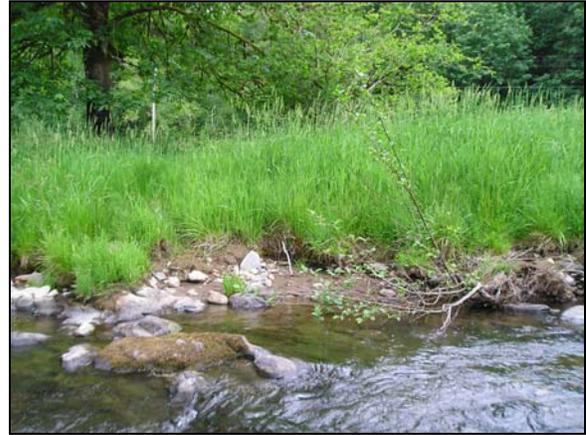
Impact reach Transect K right bank in 2009 (Year 5)

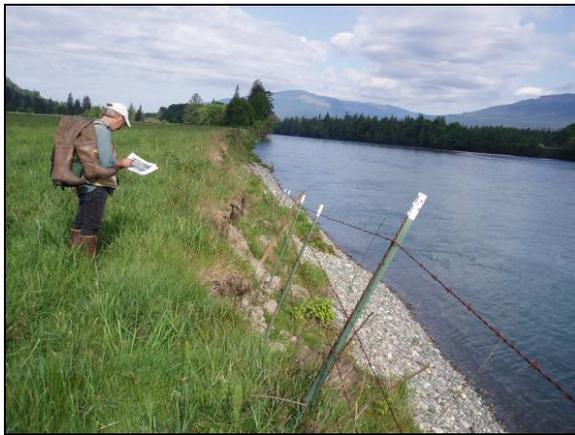
Impact reach before livestock exclusion fencing in 2005 (Year 0). Fence shown here was original fencing and was removed by bank erosion between 2005 and 2006.

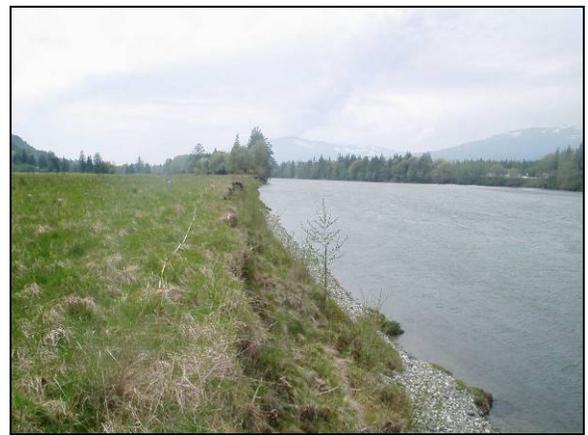
Impact reach after fencing in 2008 (Year 3)

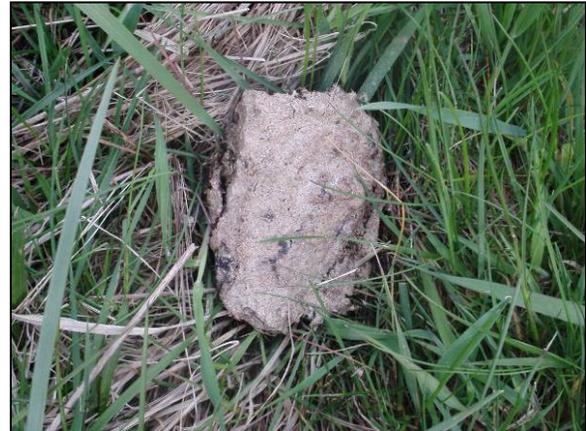
Cattle droppings observed along the exclusion fence within the riparian planting area in 2008 (Year 3)

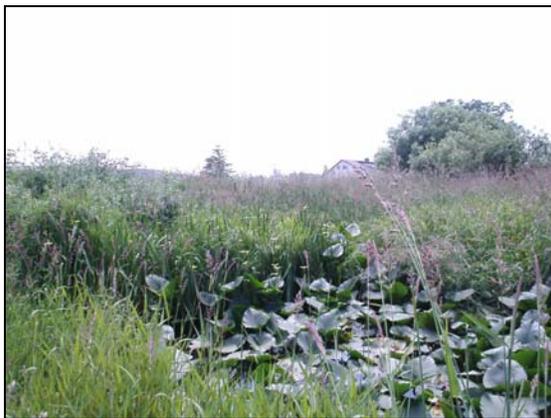
Impact reach – overgrown with reed canarygrass (2009)

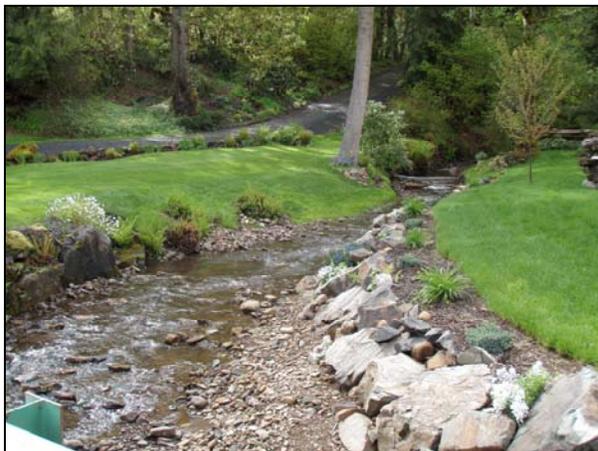
Fenced impact area with no erosion issues (Year 3)

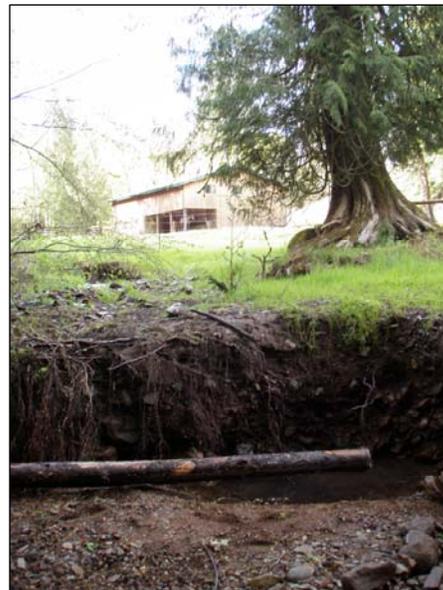
Stormwater erosion in impact area (Year 3)

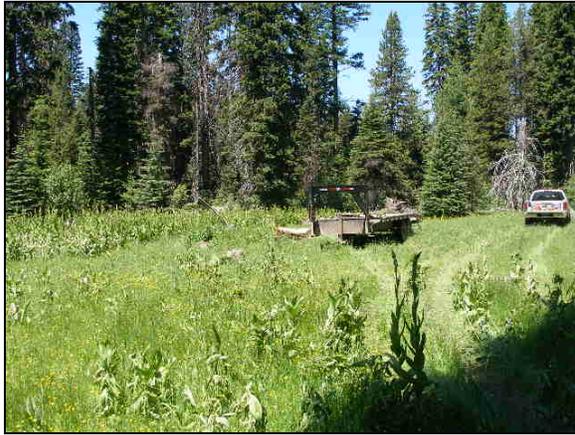
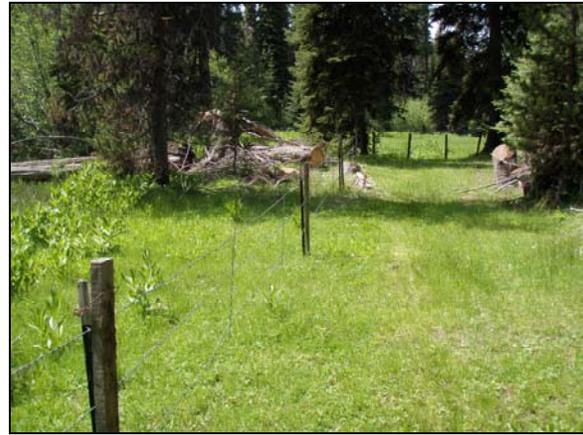
In addition to collecting data, photographs are taken at the site during each monitoring event to document changes in the condition of the site over time. The following photos were taken at Bottle Creek during Year 0 and Year 3. The Year 3 photo shows the fence installed and intact in the impact reach.

Impact reach in 2006 (Year 0)

Impact reach in 2009 (Year 3)

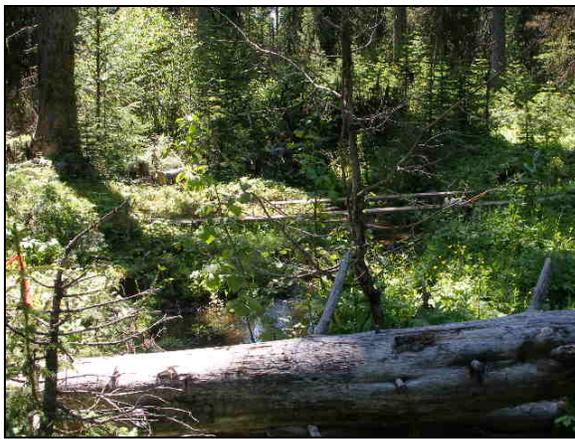
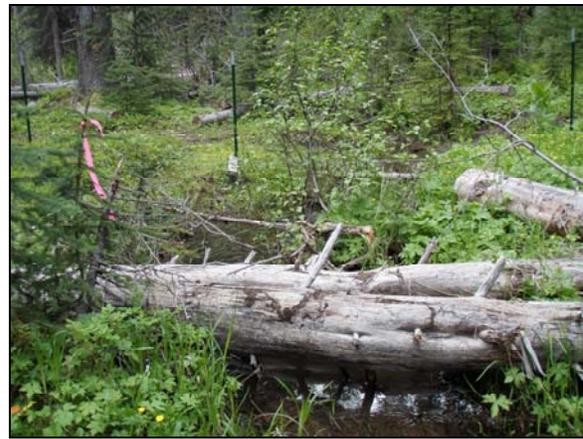
In addition to collecting data, photographs are taken at the site during each monitoring event to document changes in the condition of the stream or river over time. The following photos were taken at North Fork Clark Creek Tributary during Year 0 and Year 3. The Year 3 photo shows increased undergrowth after project implementation.

Impact reach facing upstream at Transect K in 2006 (Year 0)

Impact reach facing upstream at Transect K in 2009 (Year 3)

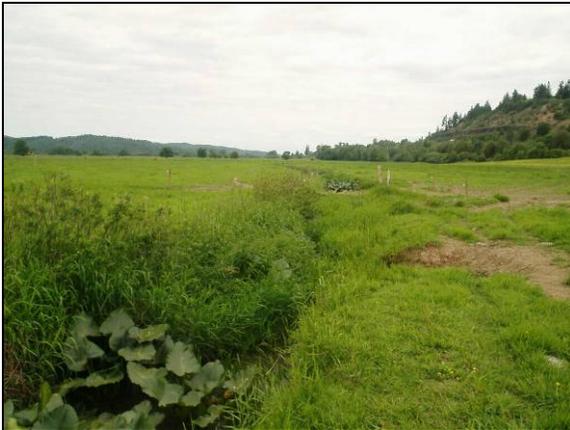
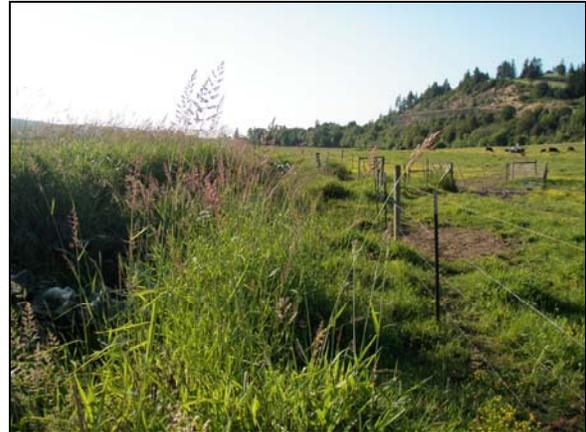
In addition to collecting data, photographs are taken at the site during each monitoring event to document changes in the condition of the stream or river over time. The following photos were taken at Gray Creek during Year 0 and Year 3. Fence installation and dense vegetation growth in the stream are apparent in the Year 3 photo.

Impact reach at Transect A in 2006 (Year 0)

Impact reach at Transect A in 2009 (Year 3)

After the first year, improvements in measured variables were observed at the Gray Creek project site for canopy density and riparian vegetation structure. During Year 3 monitoring (2009), fencing was observed onsite and all posts and lines were intact in the impact reach. All livestock were observed to be excluded from Gray Creek in the impact reach at the time of the survey. However, vegetation was impacted within the exclusion area. Note the short grass adjacent to the fence line in the 2009 photo above.

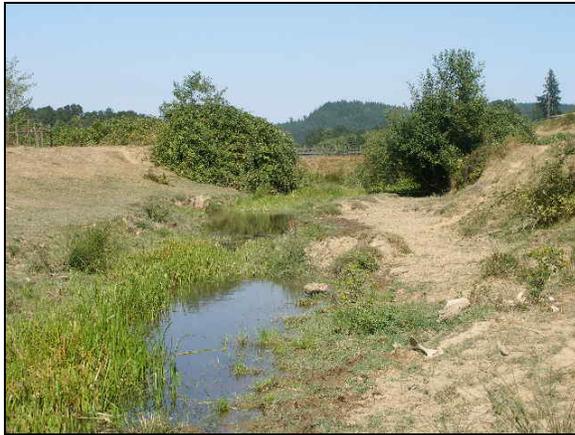
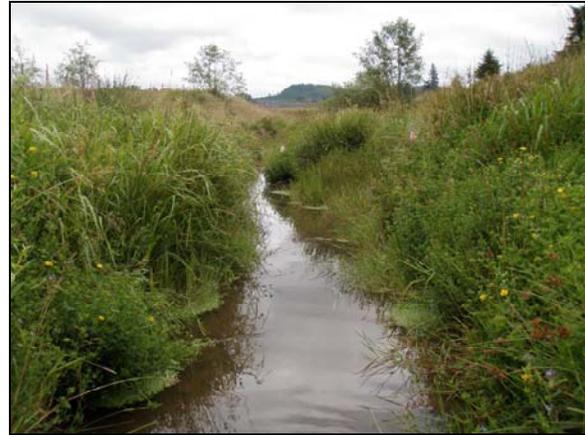
In addition to collecting data, photographs are taken at the site during each monitoring event to document changes in the condition of the stream or river over time. The following photos from Jordan Creek show new growth of vegetation along the stream in the photo from 2009.

Impact reach Tr K facing downstream in 2006 (Year 0)    Impact reach Tr K facing downstream in 2009 (Year 3)

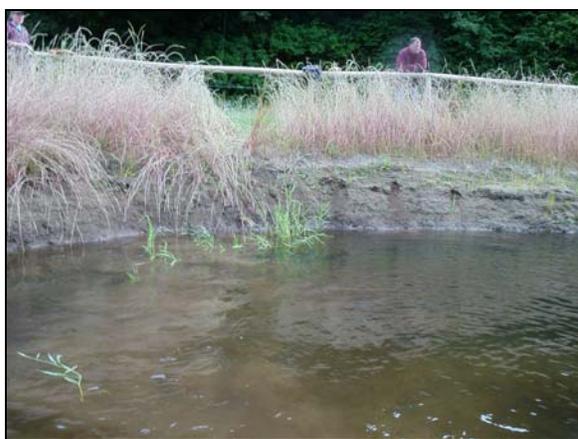
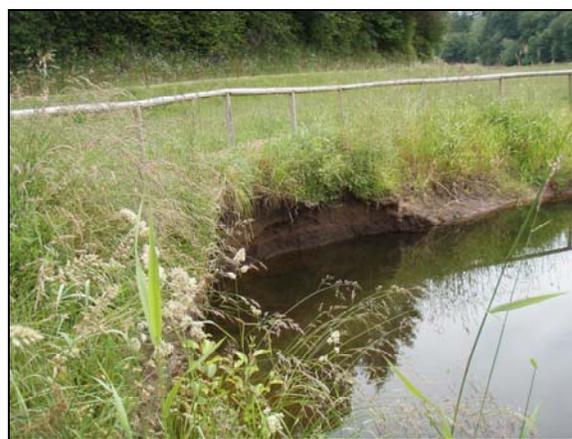
The photos show an exposed right bank at Transect A in the impact reach during Year 1 and the sloughing that occurred before the Year 3 monitoring in the same area where the rebar was placed in Year 1. The erosion was not caused by livestock, but likely due to high water flows. This bank will likely continue to erode due to high water flows.

Impact reach at Transect A in 2007 (Year 1)

Impact reach at Transect A in 2009 (Year 3)

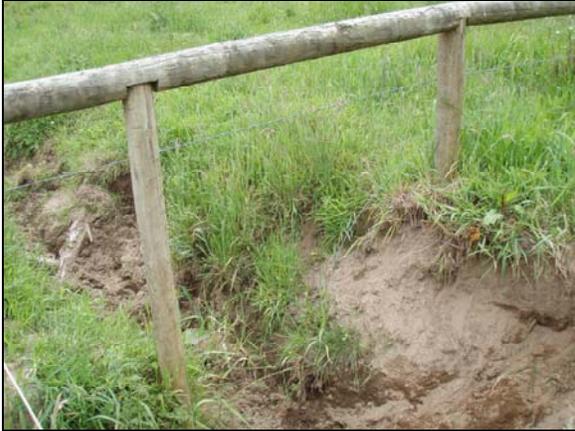
The fencing appeared to be impaired in both the impact and control reaches during the 2009 monitoring. Although at the time of the survey no livestock were observed within the exclusion area, there was evidence of livestock access to the creek at the control reach. Livestock have accessed the control reach as shown by evidence of trampled vegetation and

bank erosion along the left bank at Transect E-F. The landowner explained that a calf was birthed in the creek at that location and the livestock accessed the site on more than one occasion.

Control reach at transect E-F in 2009 (Year 3)

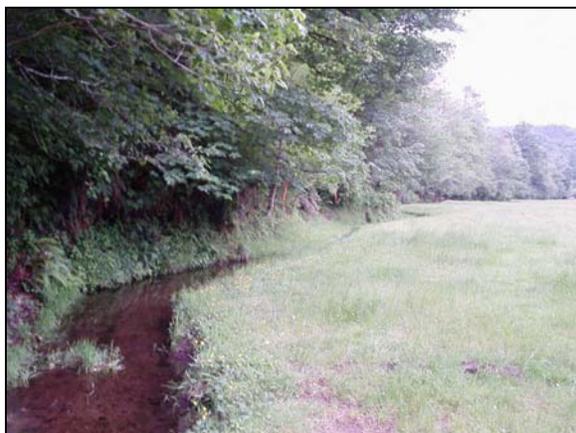
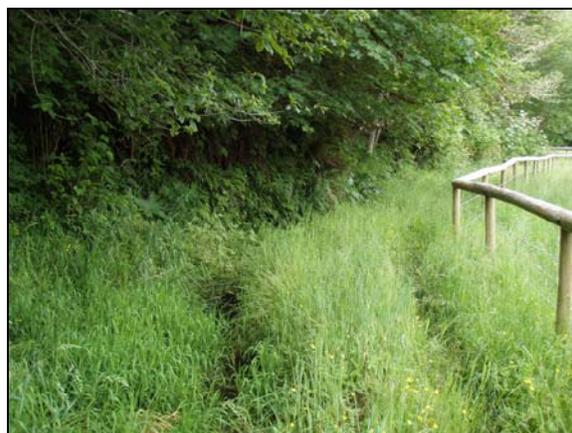
In addition to collecting data, photographs are taken at the site during each monitoring event to document changes in the condition of the stream or river over time. The 2009 photo from Year 3 shows the fence in place and increased vegetation growth as compared to 2006 (Year 0). Wildlife have access to the impact reach from the hillside on the left bank. Notice the game trail adjacent to the fence in the 2009 photo.

Impact Transect F facing downstream in 2006 (Year 0)      Impact Transect F facing downstream in 2009 (Year 3)

The fencing was inspected along the impact reach and found to be fully intact along the right bank as shown in the photo above. There is no fence along the left bank of the impact reach

which is adjacent to a forested hillside. The forest is inhabited by elk and other wildlife which potentially can impact the stream habitat at the project site. There was evidence of game trails to the stream from the hillside as well as along the fence line as shown in the 2009 photo above.

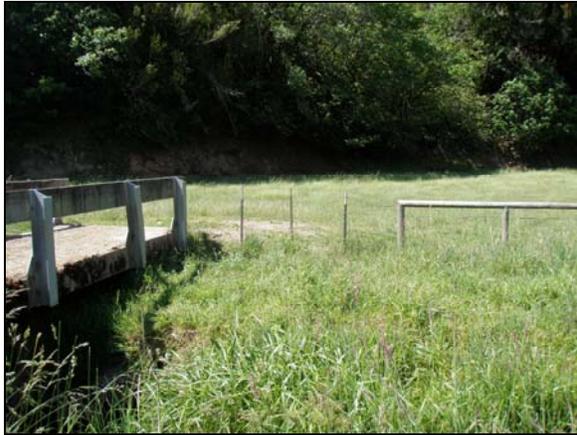
The fence along the control reach on Noble Creek was not intact in the vicinity of Transect F (see photo below), and the gate was left open for livestock to pass through. Evidence of livestock access to Noble Creek is shown in the photo below.

Impaired fence on control reach (Noble Creek 2009)

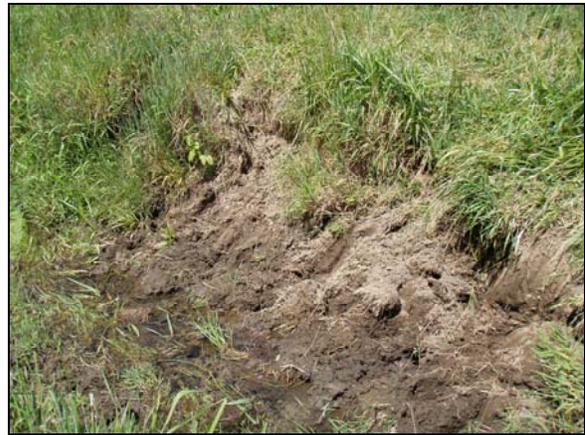
Evidence of livestock in control reach (2009)

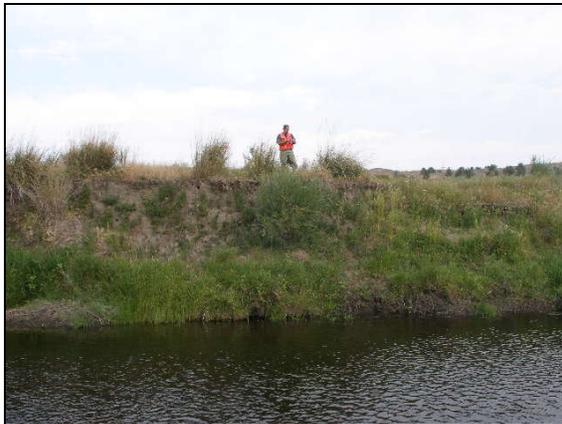
Impact reach prior to livestock fencing in Year 0 (2006) (2008)
