**Interim Project Effectiveness Report
Moose Creek Steelhead Improvement Project
OWEB #208-3057-6820
South Santiam Watershed Council
January, 2010**

Moose Creek Steelhead Habitat Improvement Project

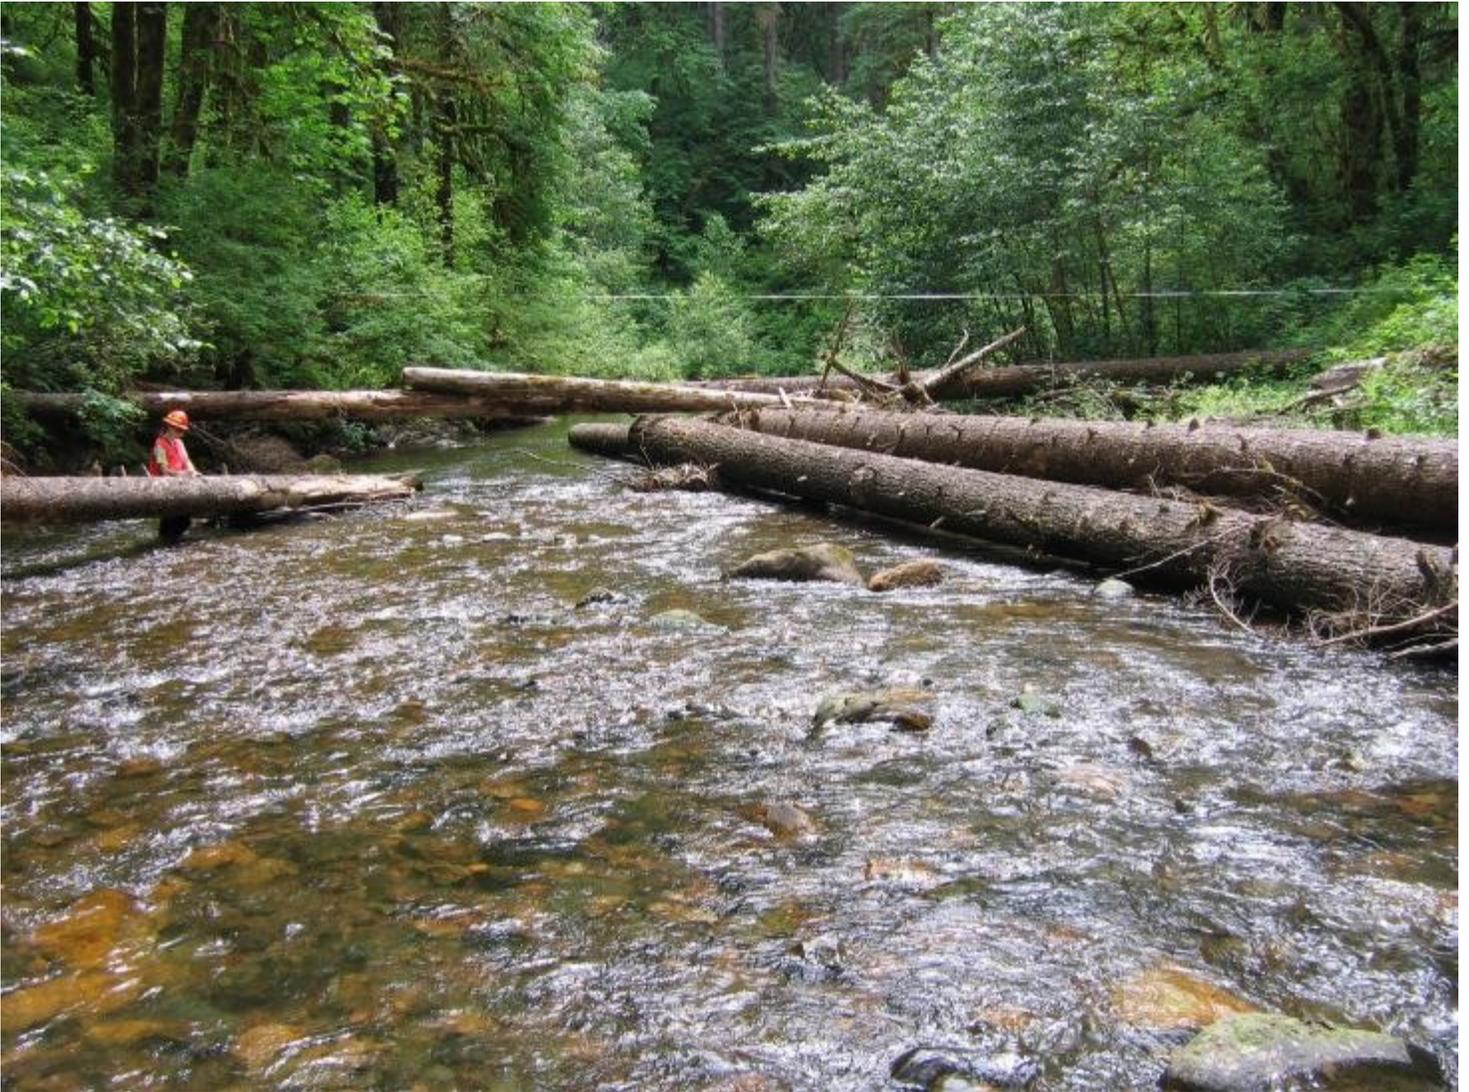
Cover Photo: Moose Creek cross-section #5, looking downstream. Photo taken 6/16/2009

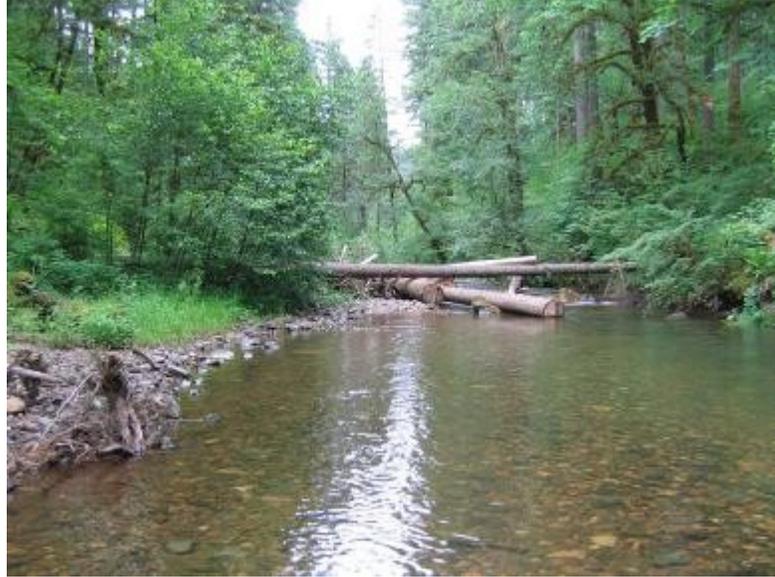
Photo #1: Looking upstream at cross-section #4

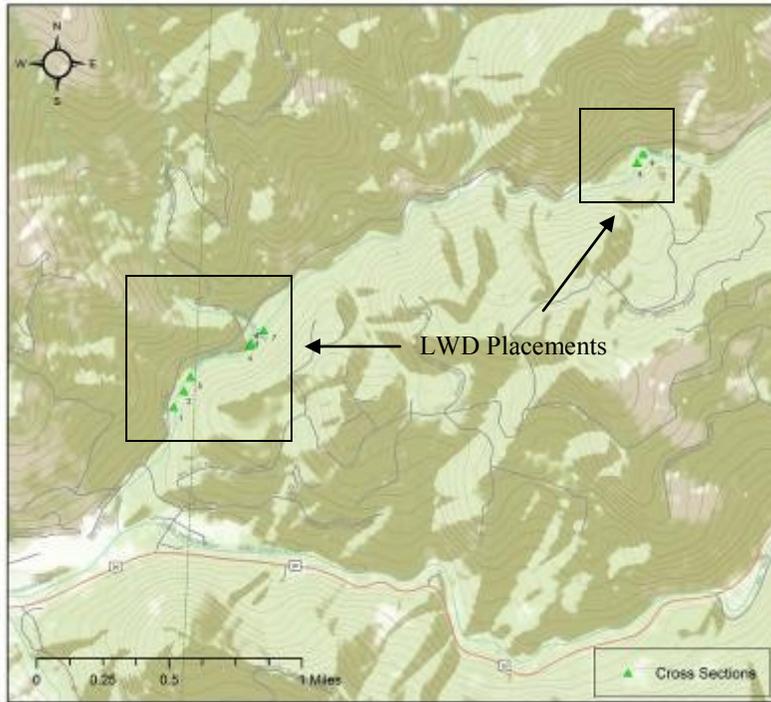
Map #1: Location of LWD placements in relation to stream cross-section points.

Stream cross-sections were conducted pre-project in 2008 at seven locations that were selected as sites that would reflect any changes in channel morphology after project implementation. These are numbered 1-7 in Map #1. Post project cross-sections were conducted in 2009 at these seven locations, and at two other locations higher in the watershed, numbered 8 and 9. Over time, it is expected that the stream cross-sections will demonstrate aggregation of the stream as sediment is retained by the place large woody debris structures. Cross-section graphs and photopoints are found in the appendix of this document.

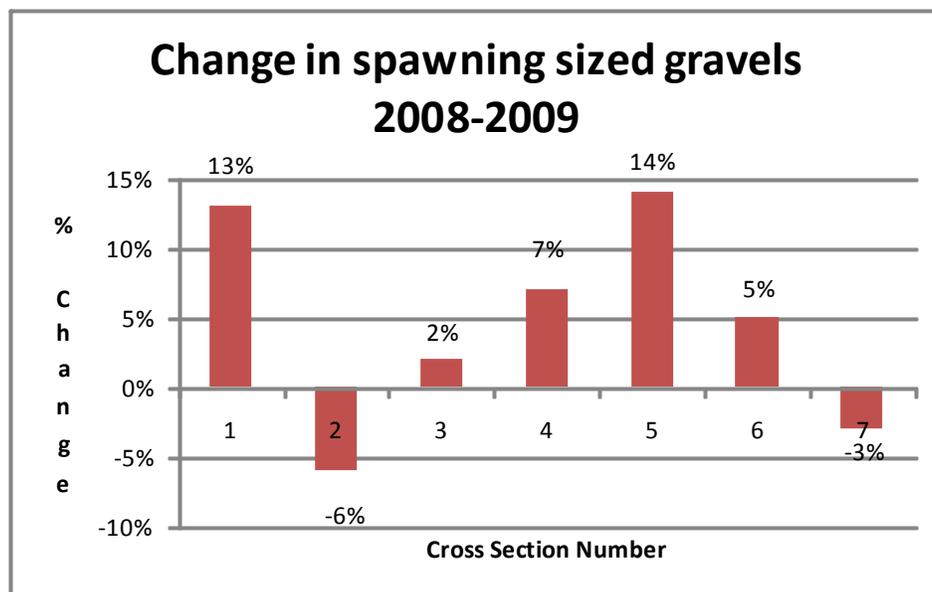
Figure #1: Change in spawning gravels (8-90 mm) in 7 cross sections between 2008-2009.

Along with cross-sections, a pebble count was conducted to monitor the amount of spawning-size gravels (8-90mm) were present before the project was implemented and those present one year post-project. Initial analysis of the pebble counts show a 4.5% increase in steelhead spawning size gravels in 2009 compared to 2008. Spawning sized gravels increased in 5 of the 7 cross-section locations. The percentage of bed material at each cross-section is graphed in the appendix. Protocols used for the cross-sections were provided by the *USFS Stream Channel Reference Sites: An Illustrated Guide to Field Technique*.

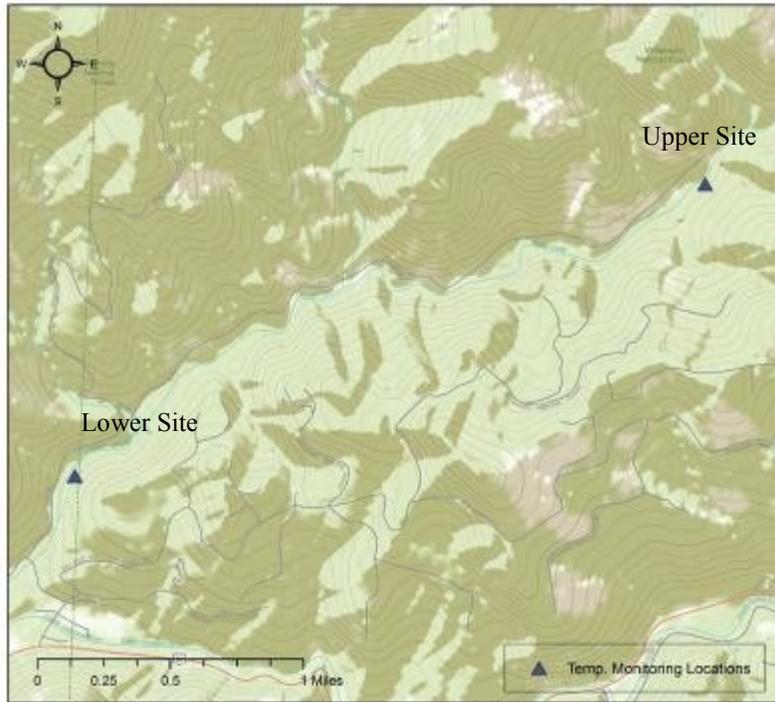
Map#2: Location of Water Temperature Probes

at two sites, reflected in Map #2, and are categorized as low and high in the Moose Creek sub-watershed. It must be noted that temperature collected in the “upper site” in 2006 was actually much higher in the watershed, and should not be directly associated with data collected at the upper site 2007-2009. However, it is included here for reference purposes.

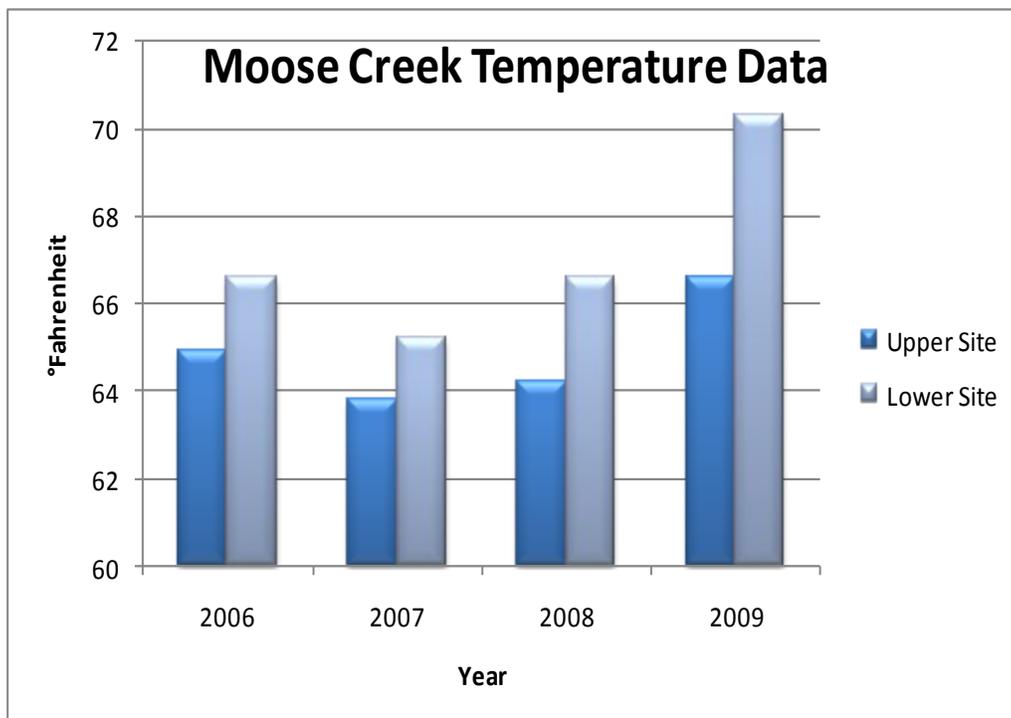
Figure #2: Moose Creek Temperature Graph. 2006 “Upper Site” at different location than “Upper Site” 2007-2009. Temperatures are maximum seven-day moving averages June-September.

As seen in figure #2, data collected in 2009 show warmer water temperatures. Further investigation and data collection are warranted to see if this trend continues and is associated with air temperature, hydrology of Moose Lake, or some other influence.

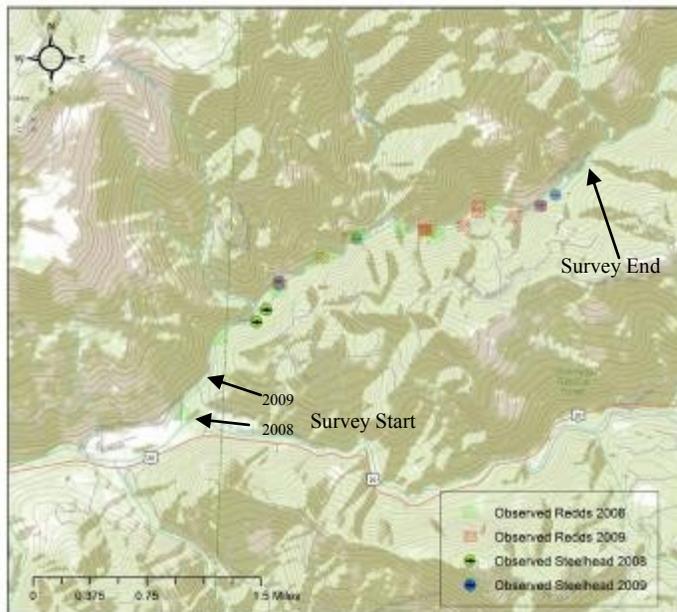
Map #3. Observed spawning activity 2008-2009

Spawning surveys in Moose Creek have been conducted prior to project implementation in the spring of 2008 and post-project in the spring of 2009. In both years, Moose Creek was surveyed for adult steelhead and steelhead redds in the April-June timeframe. In 2008, five complete surveys were conducted between the Moose Creek confluence with the South Santiam River and the junction of USFS roads 2025 and 580. In 2009, five complete surveys were conducted along a similar 4 mile-long span (only differing from the 2008 survey in that it began 0.25 miles from the confluence in 2009). The same observer was present in both 2008 and 2009. As referenced in Map #3 adult steelhead and redds were observed and their location marked in 2008 and 2009. In addition, the location of all gravel beds suitable for spawning, and measuring at least 50 feet in length, were recorded and are seen below in Map #4. It should be noted that there appeared to be an increased amount of spawning activity observed in 2009. As

spawning size gravel beds continue to develop, it will be interesting to see if the trend continues to develop in future surveys.

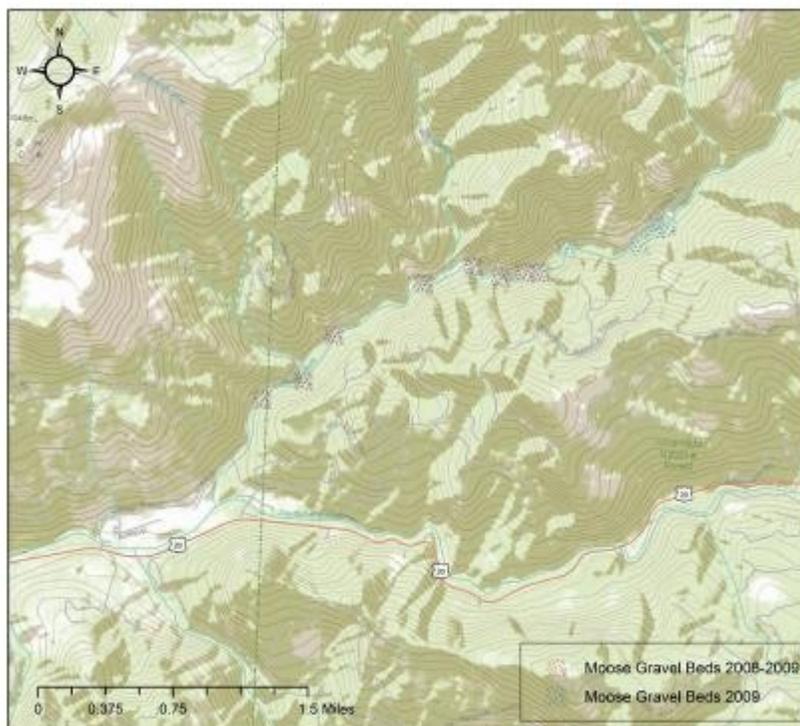
Map #4: All large gravel beds in 2008 were observed in the same location in 2009. In addition, four more beds were noted in the upper survey reaches.

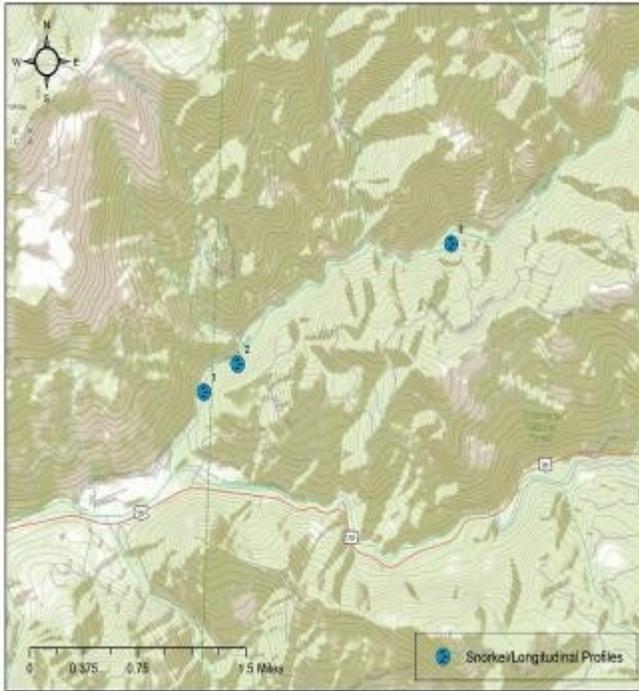
Map #5: Location of snorkel surveys and longitudinal profiles.

Longitudinal profiles of Moose Creek were conducted in 2008 and 2009 in accordance with *USFS Stream Channel Reference Sites: An Illustrated Guide to Field Technique*. These profiles will document stream elevation changes over time. Sample sites were selected to reflect possible changes below, above, and in the middle of wood placements. Profile lines reflect the “center line”, water surface points were also collected but not shown here. The first profile begins at the lower end of the wood placements and extends over 800 ft. to cross section #3. The second profile begins downstream of cross section #4 and extends over 700 ft. to just above cross-section #7. An additional longitudinal profile was conducted in 2009, and extends approximately 760 ft. through cross-sections #8 and #9.

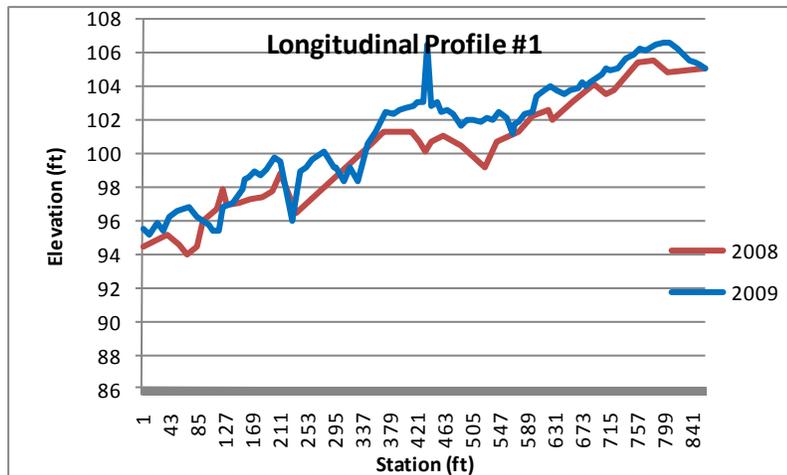
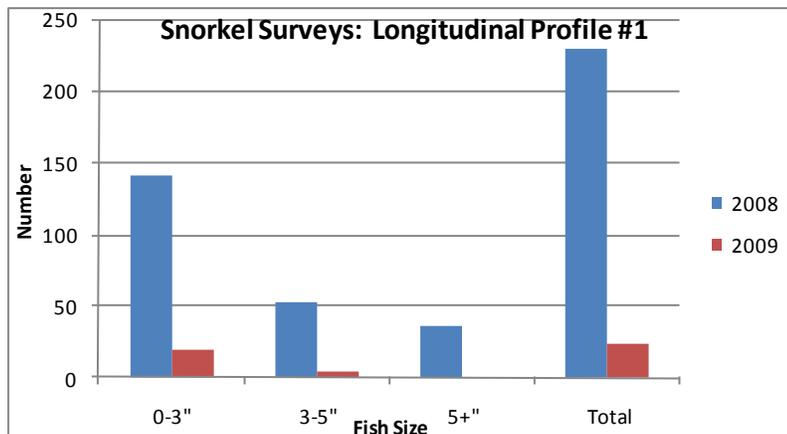
Figure #3: Longitudinal Profile and Snorkel Survey #1

Each longitudinal profile was also snorkeled by two surveyors. Results of the snorkel surveys are graphed in figures #3-#5. Snorkel surveys in longitudinal profile #3 were conducted only in 2009. In 2009, fewer fish were observed in all size classes.

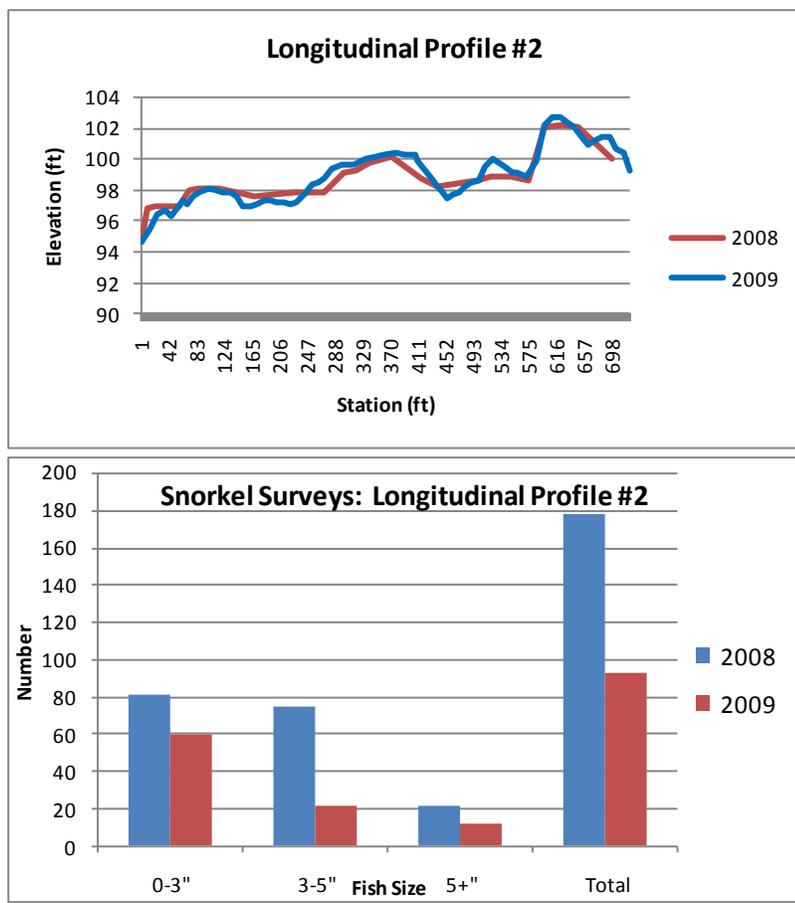
Figure #4: Longitudinal Profile and Snorkel Survey #2

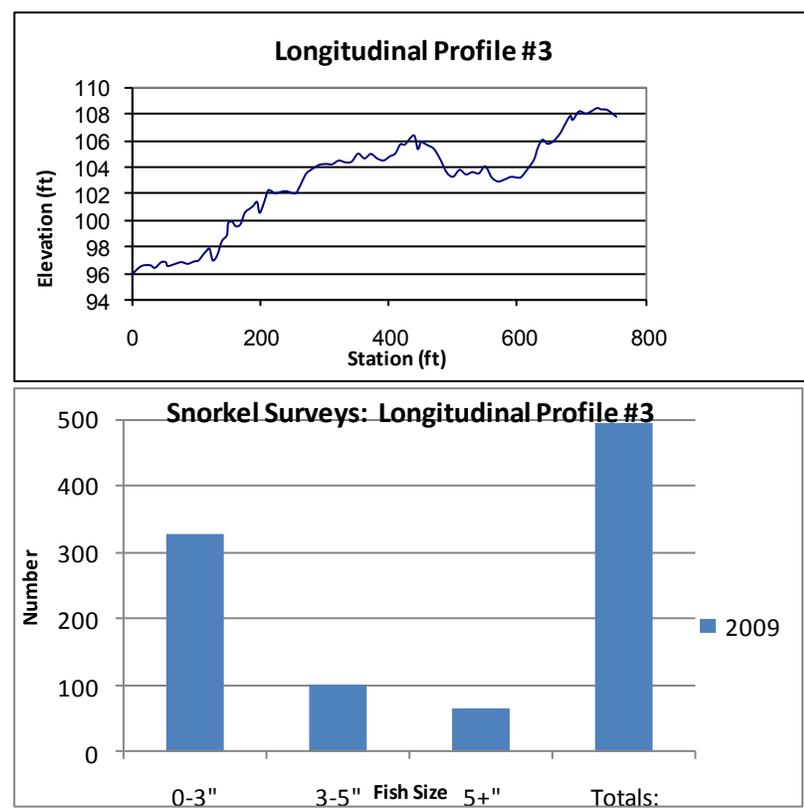
Figure #5: Longitudinal Profile and Snorkel Survey #3

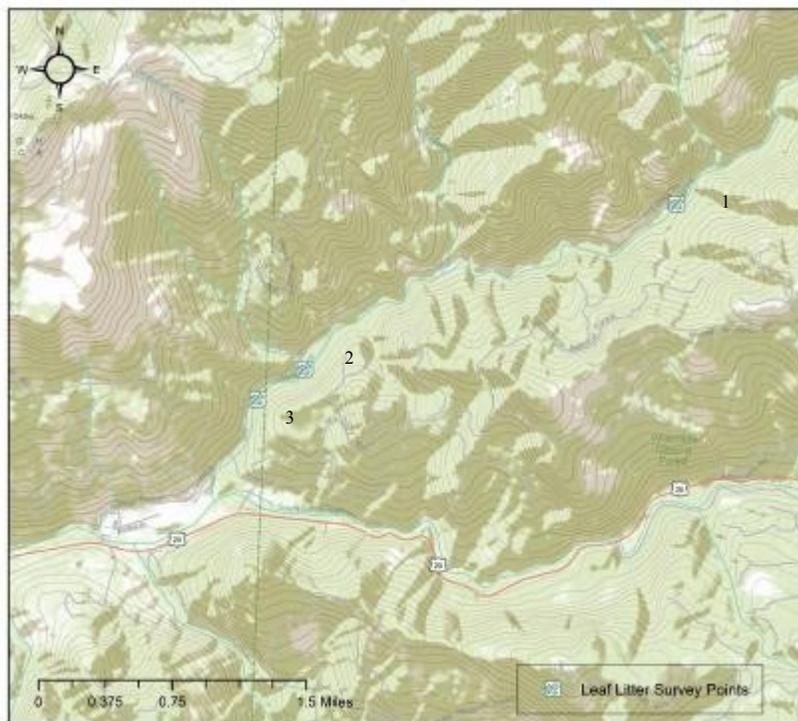
Map #6: Location of leaf litter survey collection points.

Three leaf litter collection points were established in 2008. Leaf packs were prepared using 4 species of tree leaves for a total of 20 grams per sample. They were tied around rocks and submerged in Moose Creek in October, 2008. There were four leaf packs per site for a total of 12 leaf packs. Site #1 is the furthest upstream. Site #2 is located at the White Rock Creek confluence with Moose Creek and the leaf packs were placed right in the wood placement area. Site

#3 is further downstream at the water temperature monitoring structure, and leaf packs were also placed within a wood placement area. Packs were left in the creek throughout October until they were recovered by students from the Santiam Wilderness Academy and taken back to their classroom for analyses. Eleven of the twelve leaf packs were recovered; one broke off and was lost. Leaf packs were placed in October, 2009 and lost to high water. The surveys will continue on a yearly basis. Protocols were derived from the Stroud Water Research Center and are included in a “Pack Stream Ecology Kit” manual.

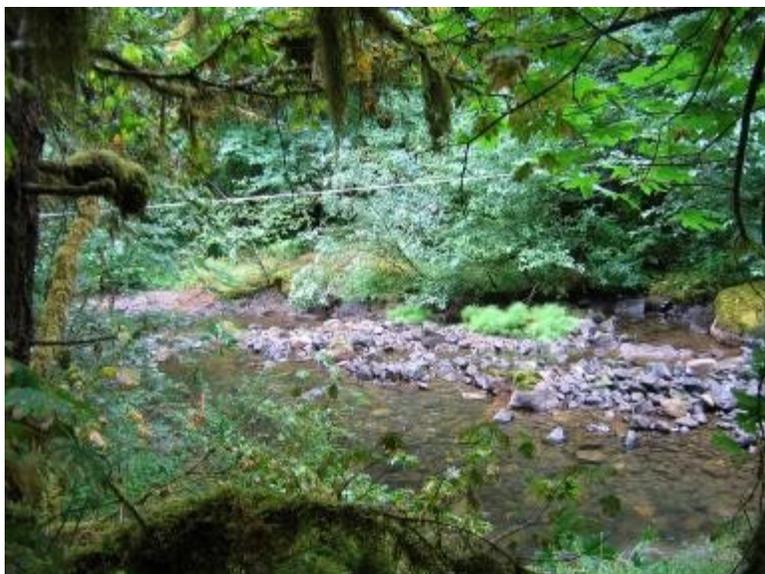
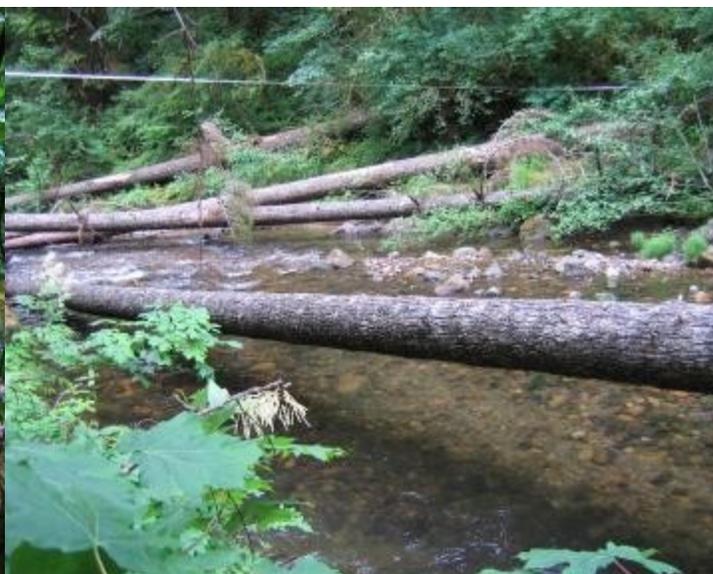
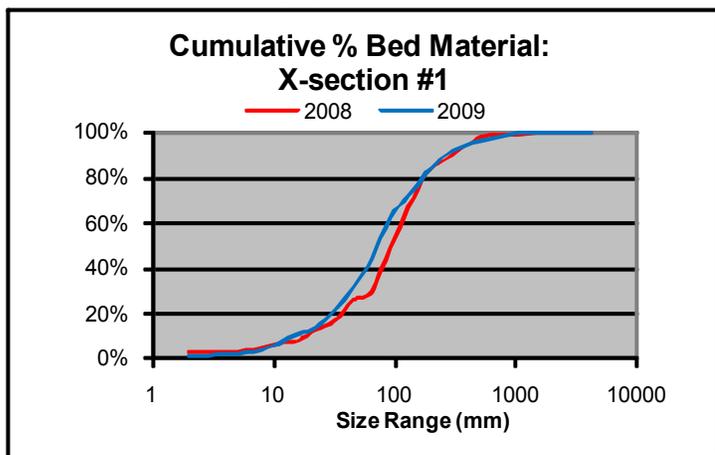
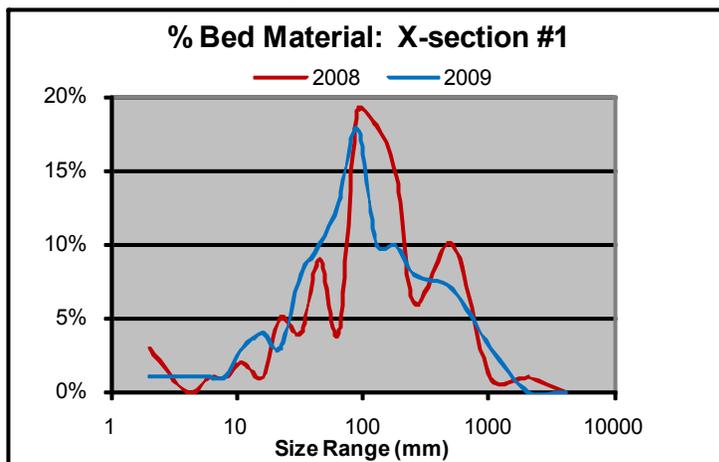
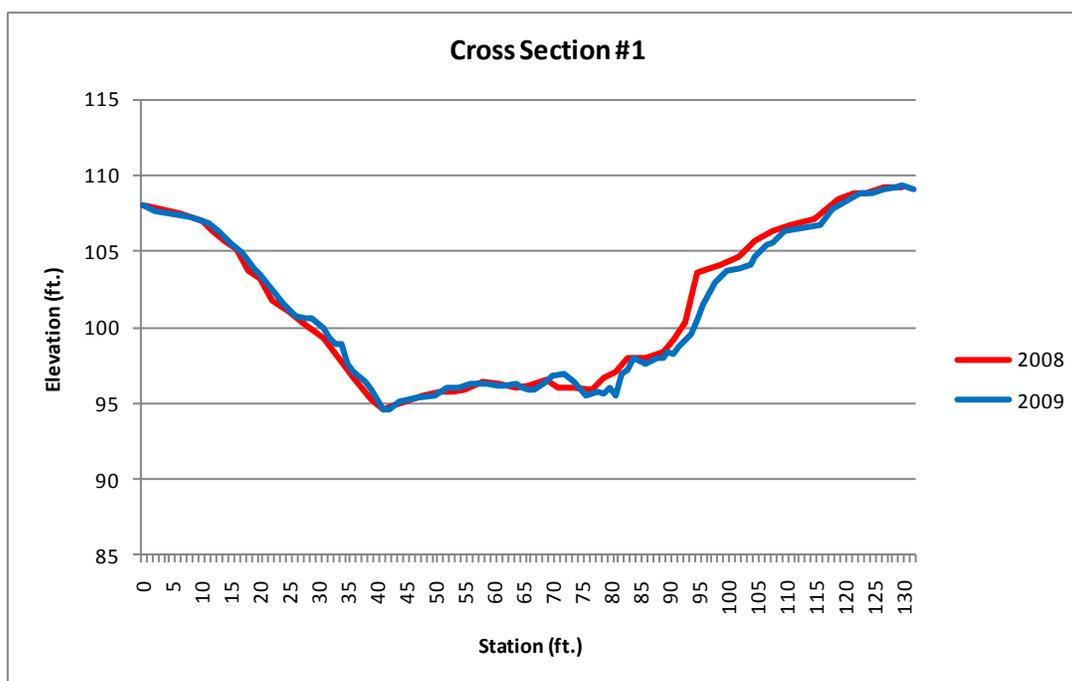
Moose Creek Cross-Section #1

Pre-project: 7/30/2008

Post-project: 6/16/2009

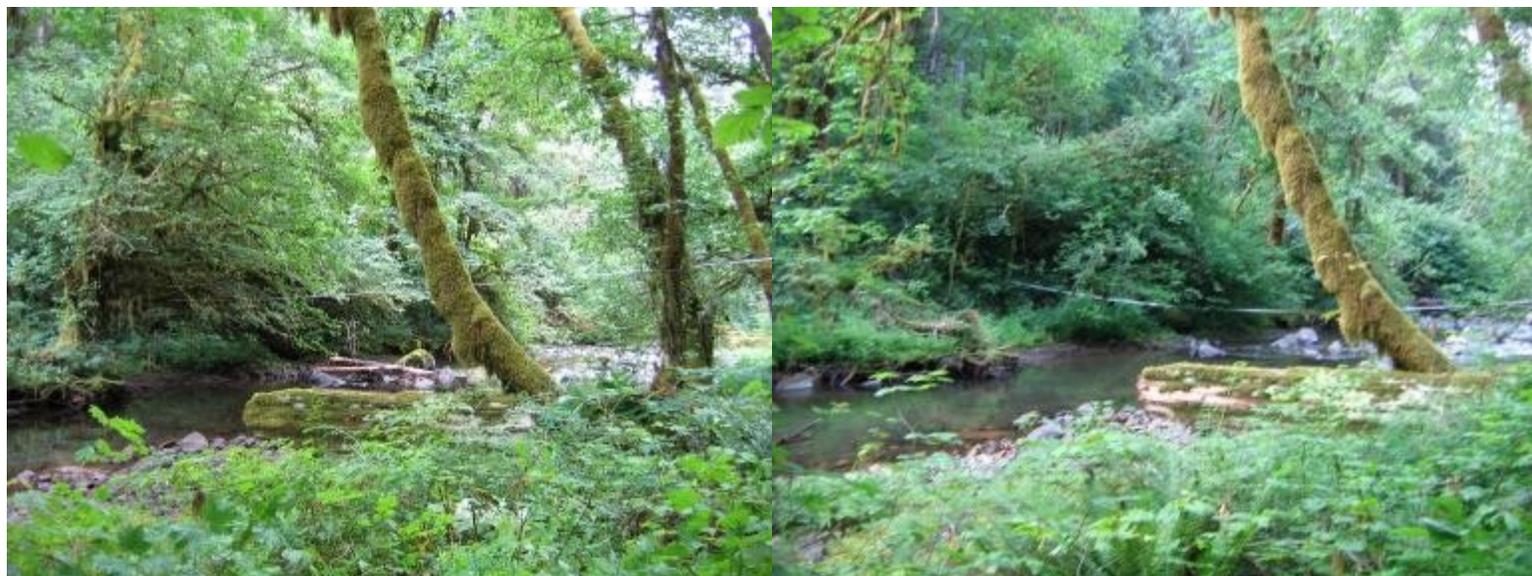
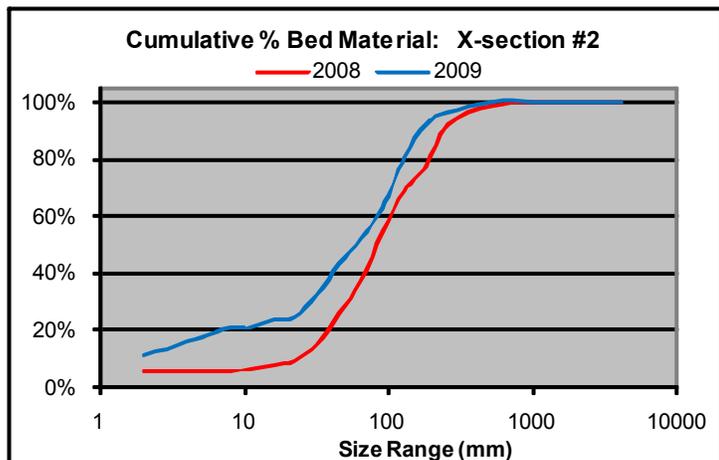
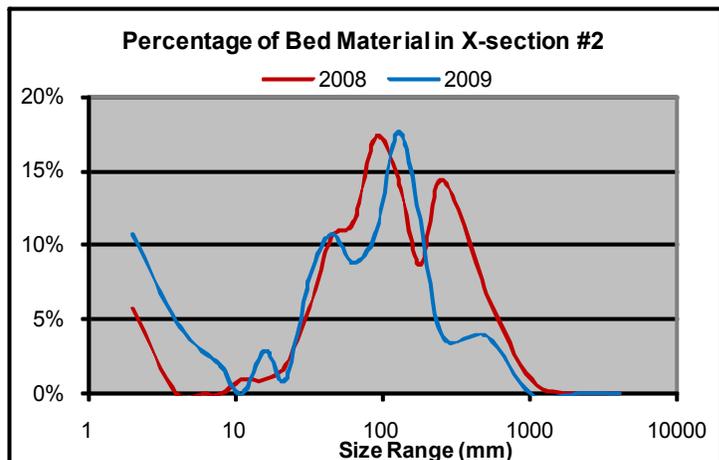
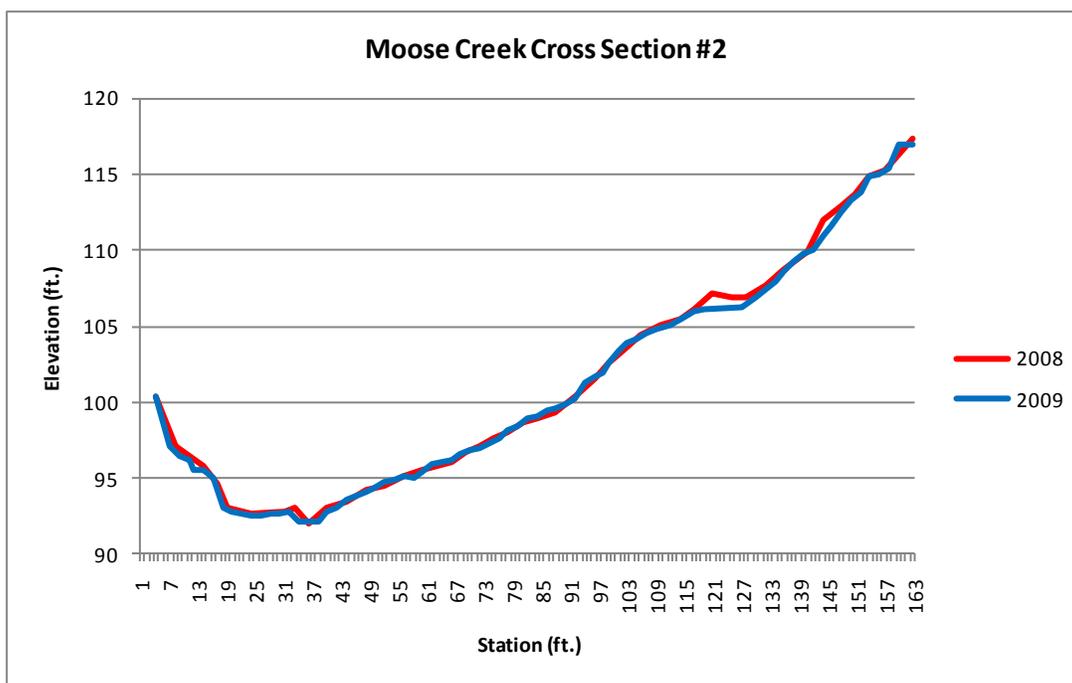
Moose Creek Cross-Section #2

Pre-project 7/30/2008

Post-project 6/16/2009

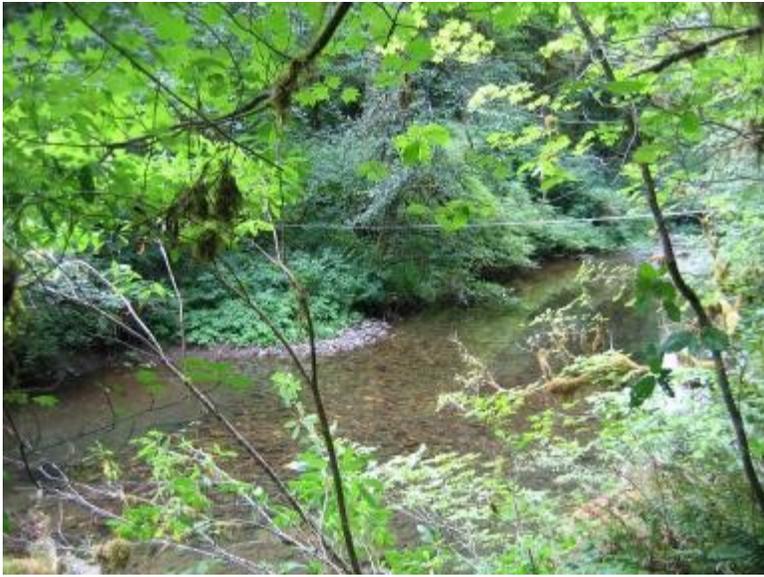
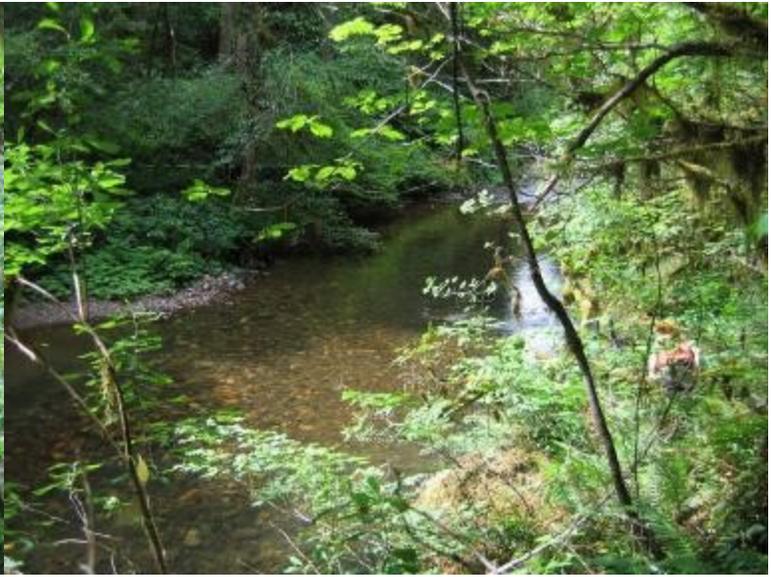
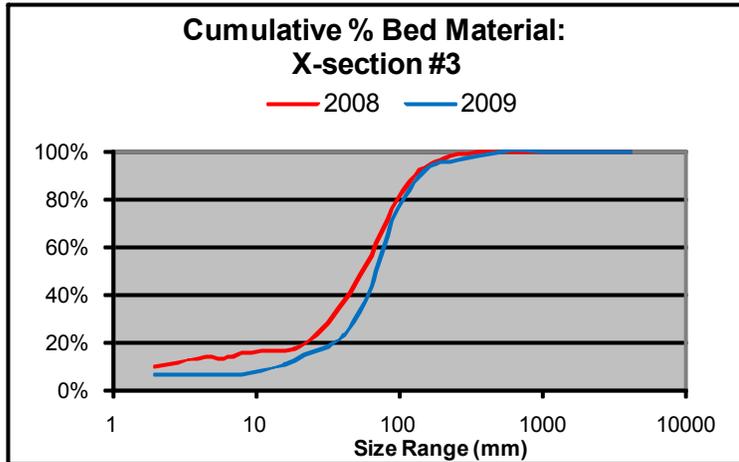
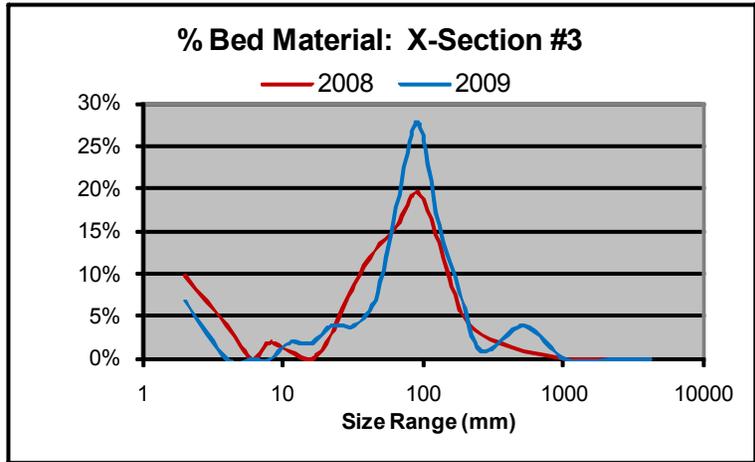
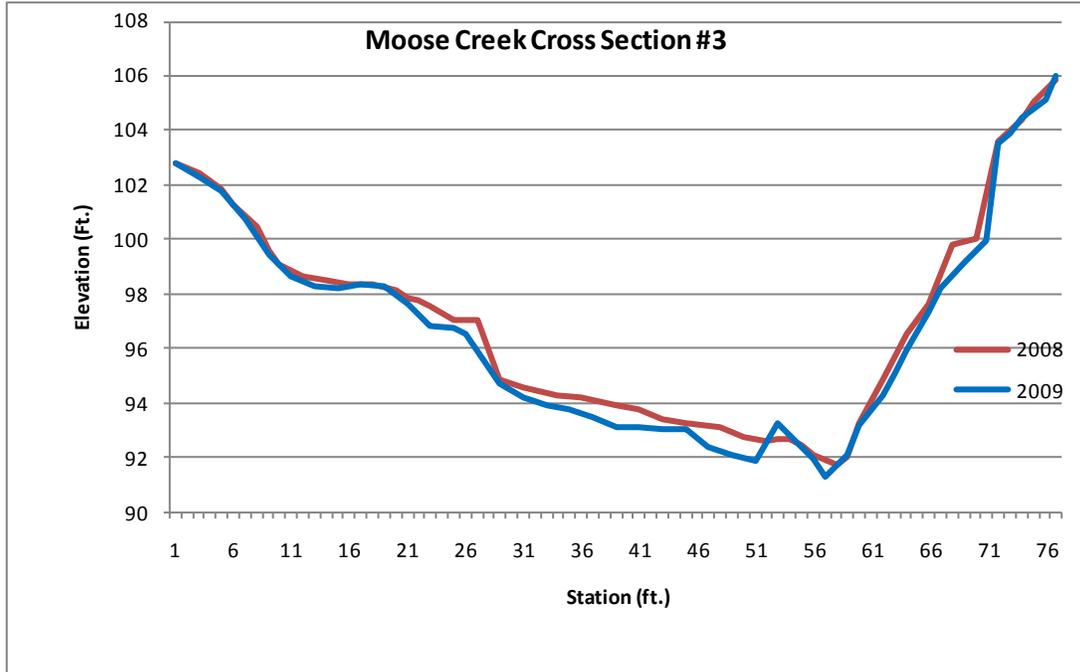
Moose Creek Cross-Section #3

Pre-project 7/30/2008

Post-project 6/16/2009

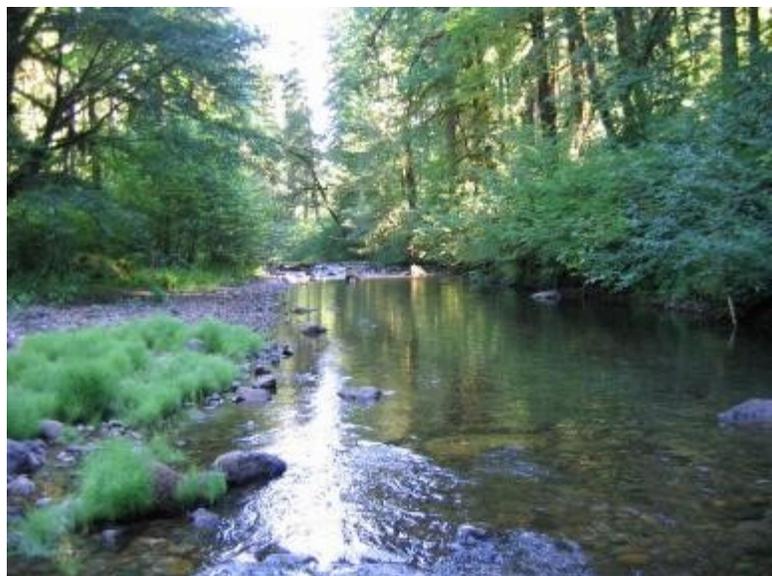
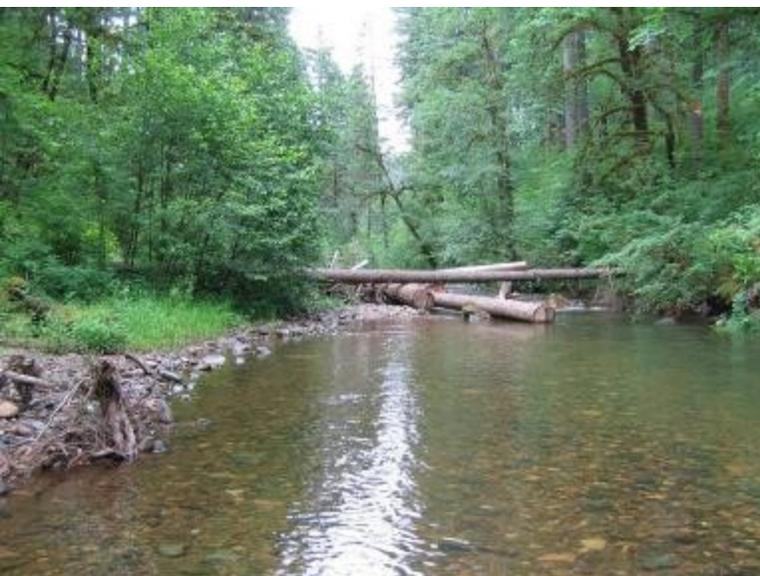
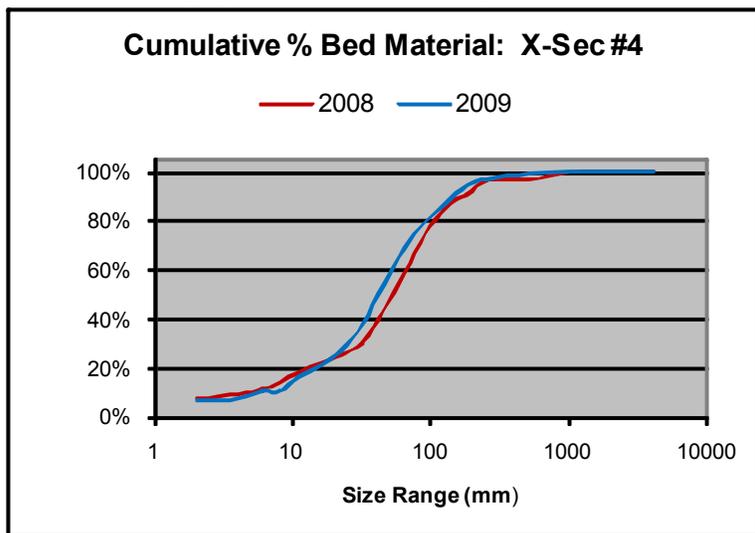
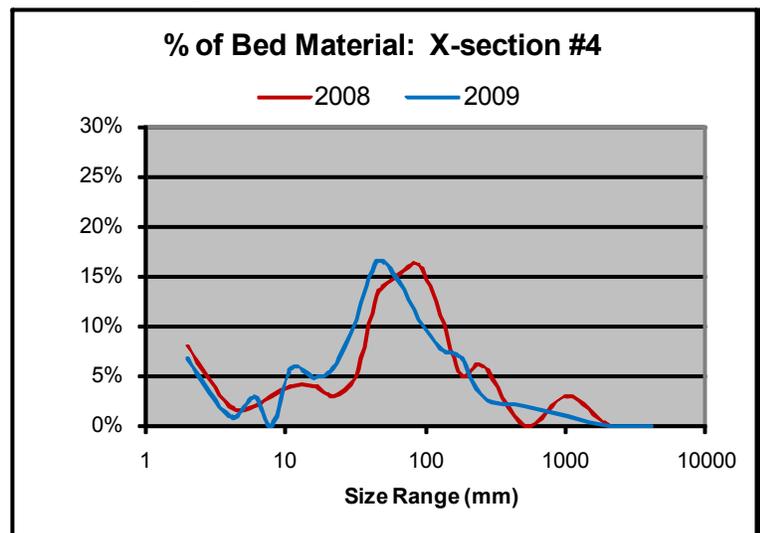
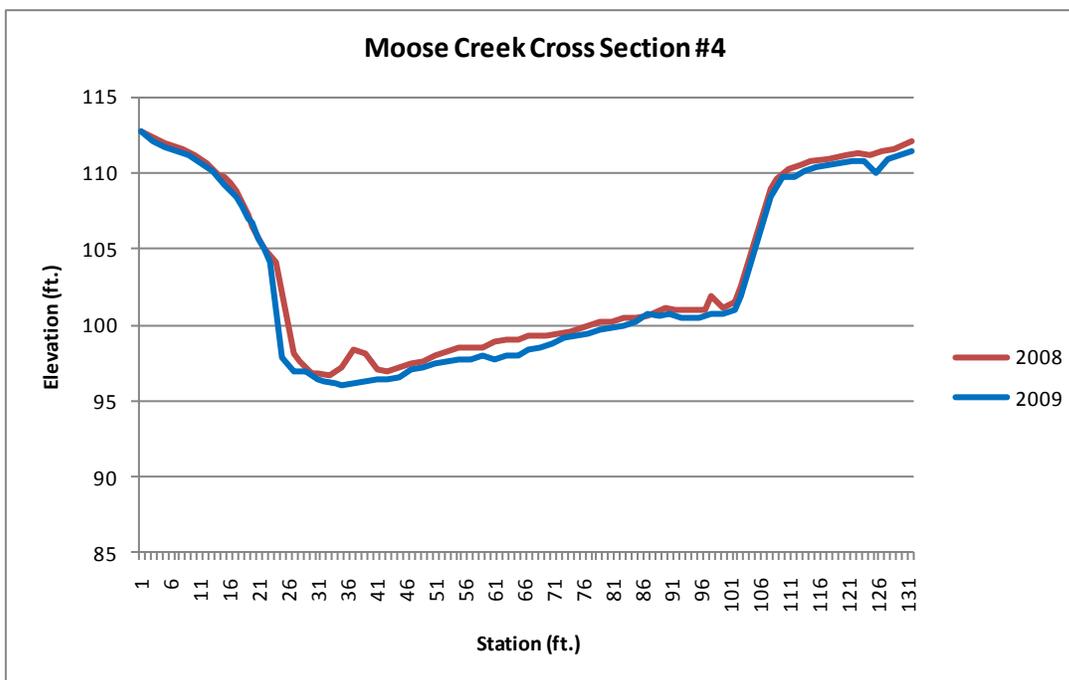
Moose Creek Cross-Section #4

Pre-project 7/31/2008: Looking Downstream

Post-project 6/16/2009: Looking Downstream

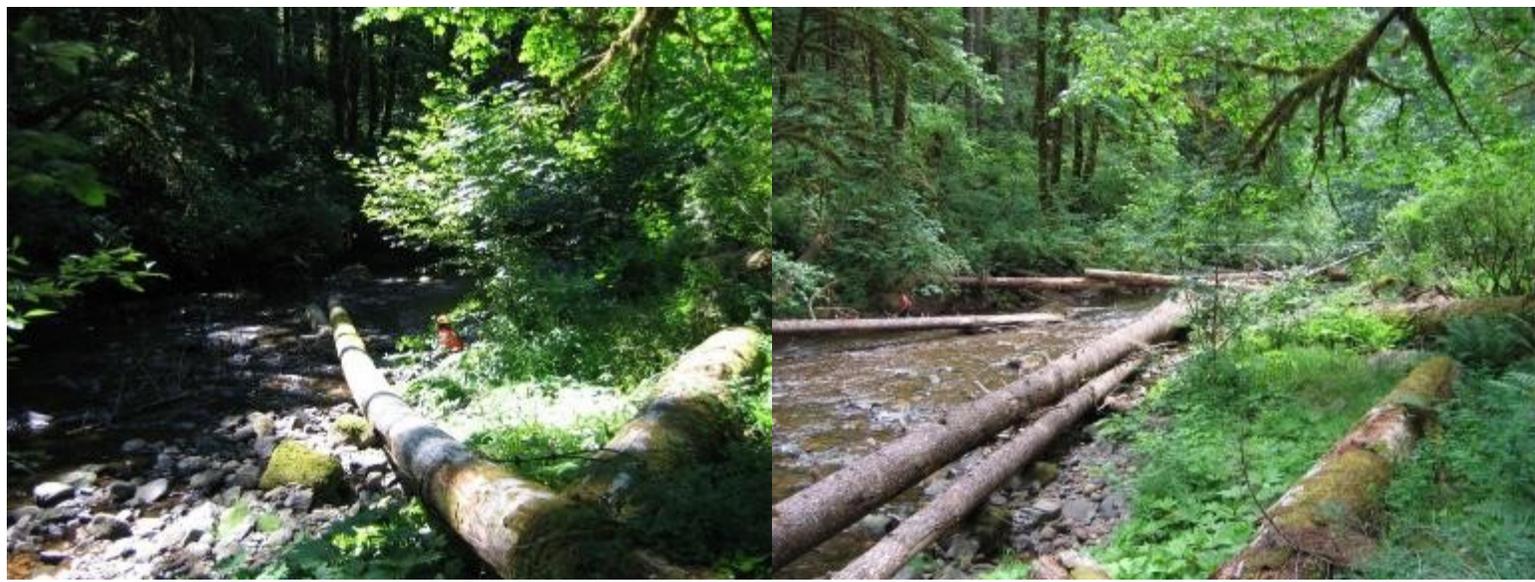
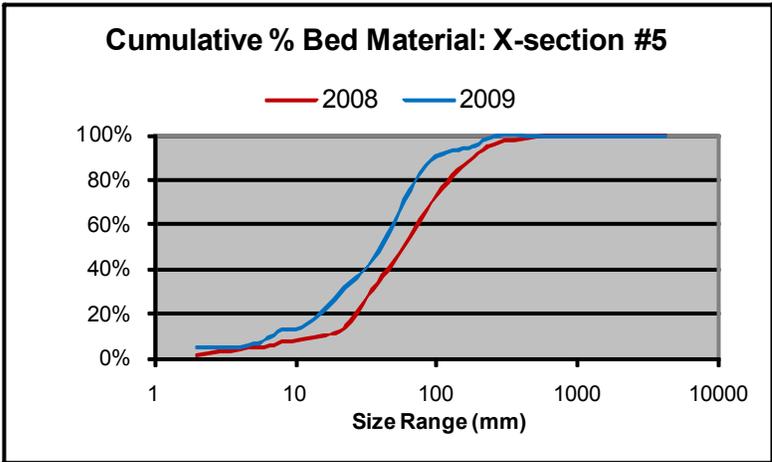
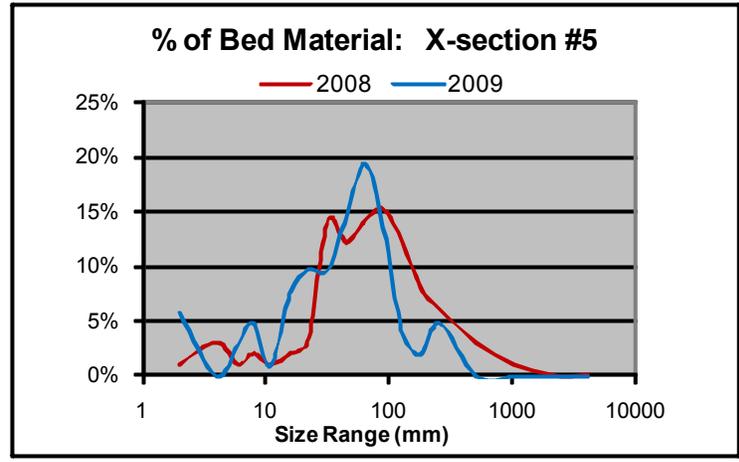
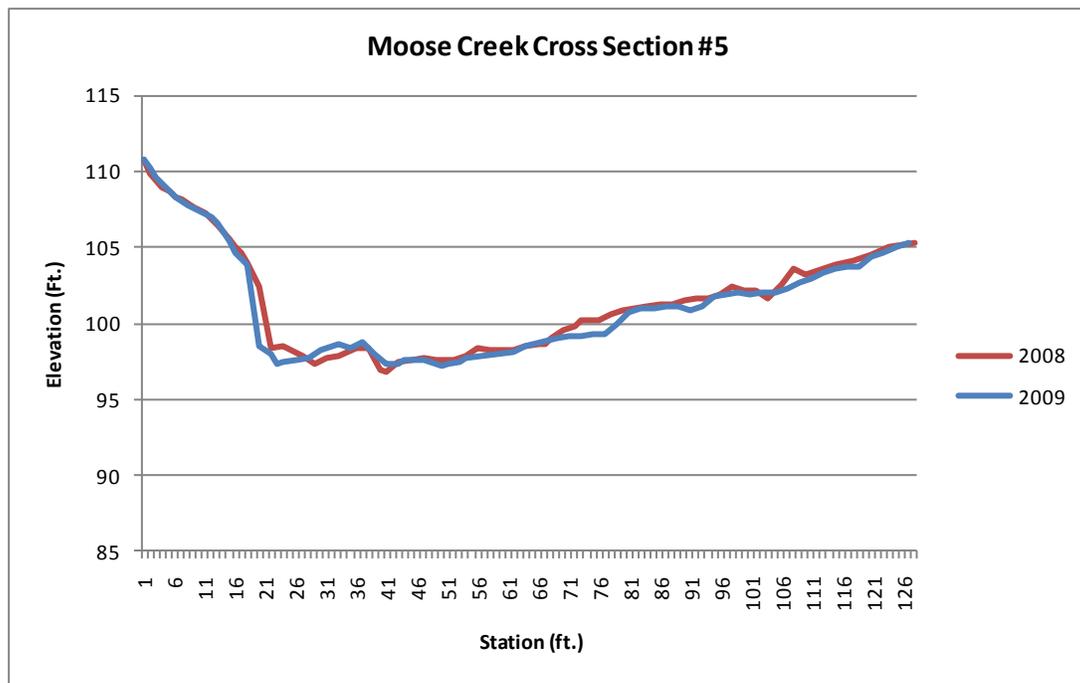
Moose Creek Cross-Section #5

Pre-project 7/31/2008

Post-project 6/16/2009
